## **NATIONAL TRANSPORTATION SAFETY BOARD**

### **ENGINE EXAMINATION SUMMARY**

**WPR20FA079**

| Aircraft: | N3672K, Piper PA28-140 |

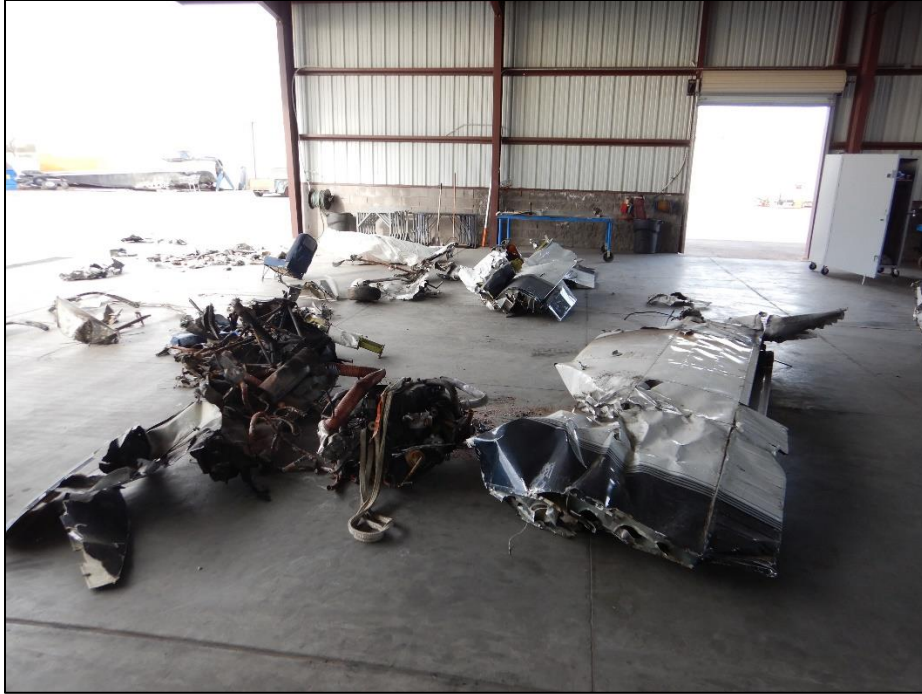
Examination of the recovered airframe and engine was conducted on February 28, 2020, at the facilities of Air Transport, in Phoenix, Arizona. No evidence of preimpact mechanical failure was noted during the examination of the recovered airframe and engine.

Figure 1-Main wreckage, follow-up examination.

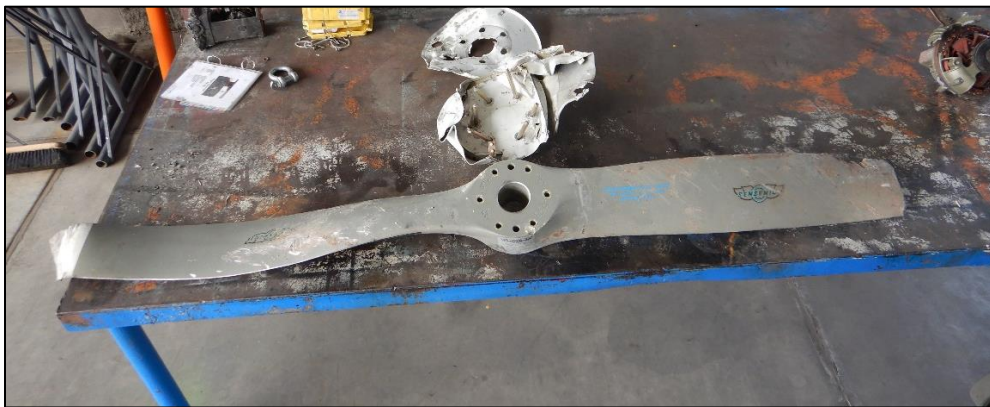
The engine remained attached to the firewall and had impact damage. There was no evidence of catastrophic engine failure during an exterior examination of the engine. The propeller separated from the engine during the accident sequence. Both blade ends had missing material. The blades had bending and leading-edge gouging.

Figure 2-Propeller blade assembly.

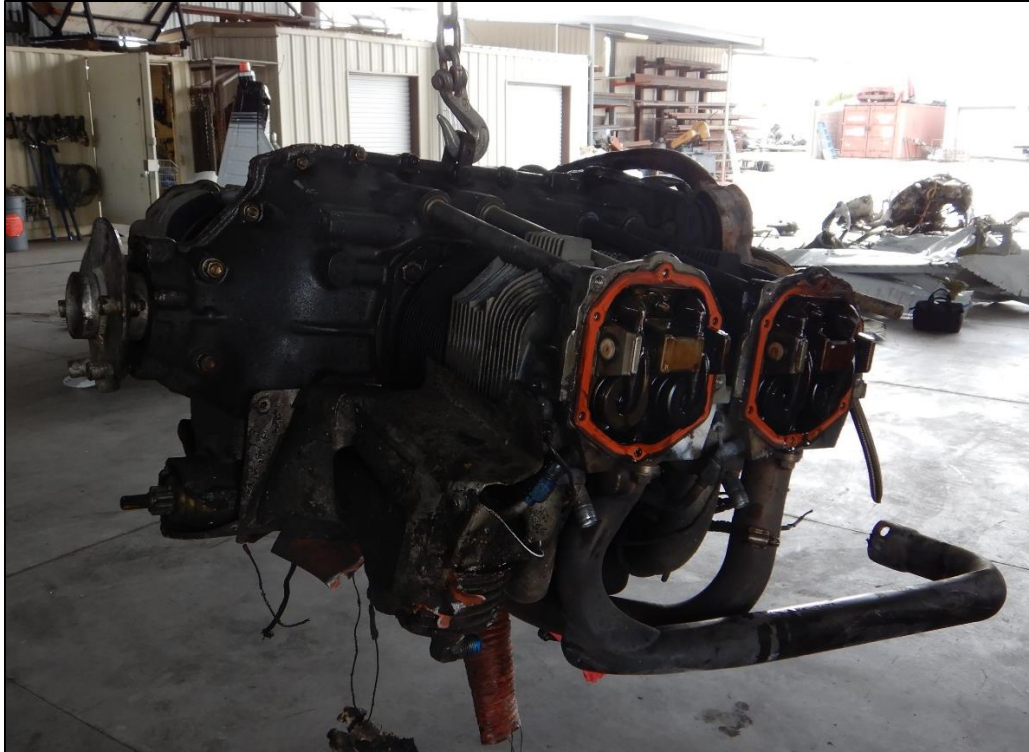
Figure 3-Engine, forward left view.

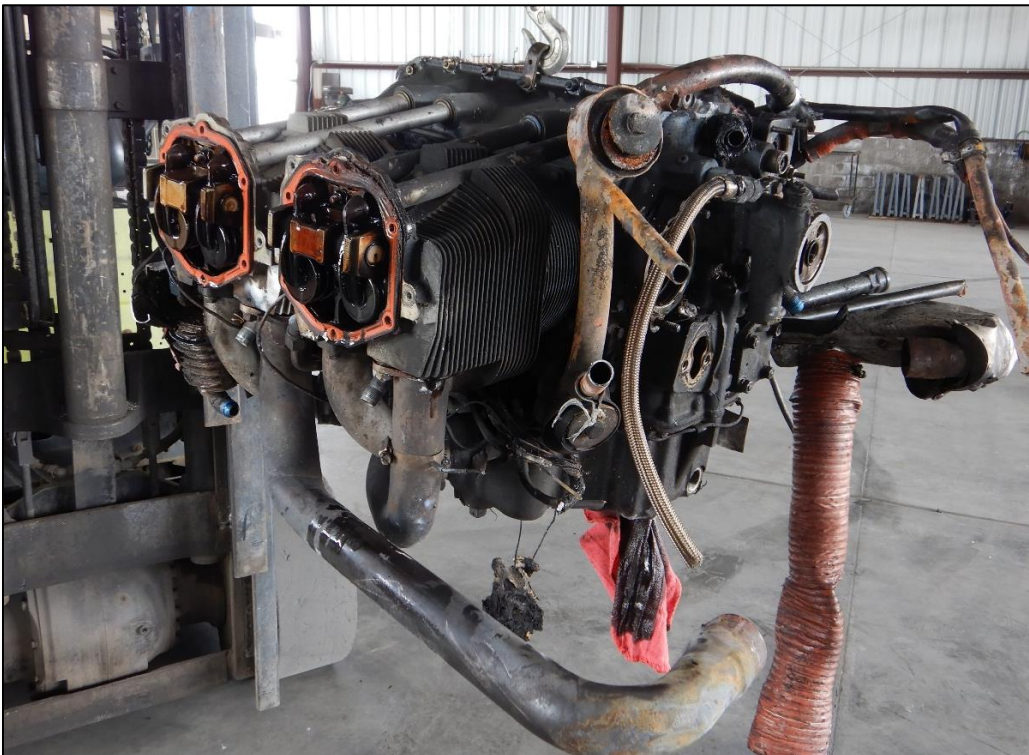
Figure 4-Engine, rear left view.

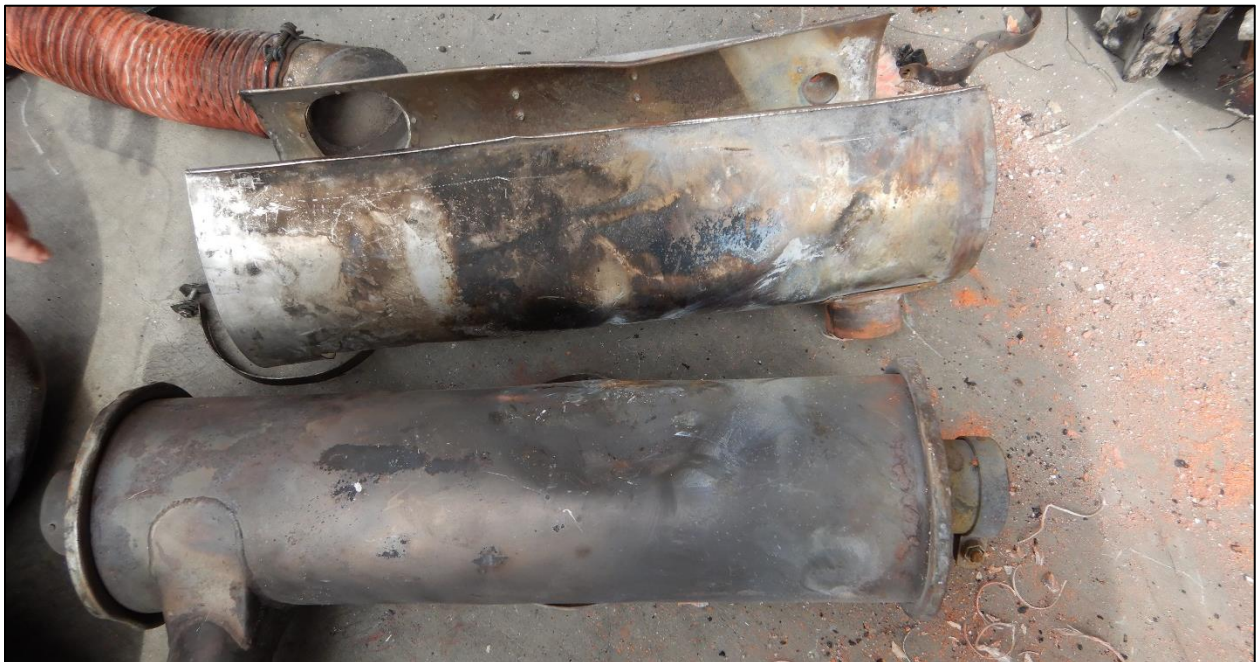
The exhaust system was free of obstructions and its baffles were intact. The cabin heat shield was removed from the exhaust muffler. The examination of the muffler revealed no evidence of exhaust gas leakage that would have contaminated the cabin heat ducting.

Figure 5-Exhaust assembly, removal of the cabin heat shield.
