## **NATIONAL TRANSPORTATION SAFETY BOARD**

# **ACCIDENT SITE EXAMINATION SUMMARY**

**WPR20FA079**

| Aircraft: | N1682G, American Champion-7KCAB |

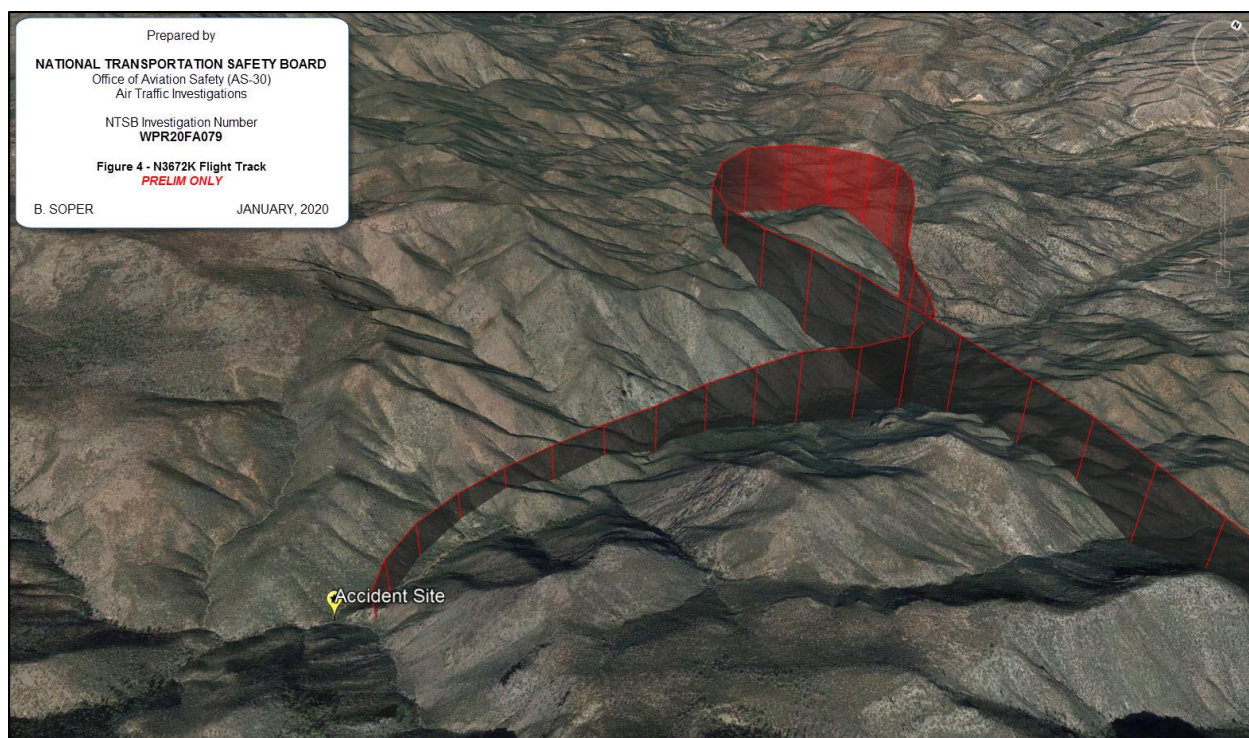
**Figure 1-Flight track data and the accident site location**

Preliminary flight track data showed the airplane depart PAN and fly to the Mazatzal Mountain Range. While maintaining an altitude of about 1,000 ft agl above the mountainous terrain, the airplane made a 280° turning maneuver, then descended over a canyon. About a half mile from the accident site, the flight track turned left and the turn radius increased before the track data ceased. The last recorded flight track data point was located about 500 ft from the accident site and about 200 ft agl.

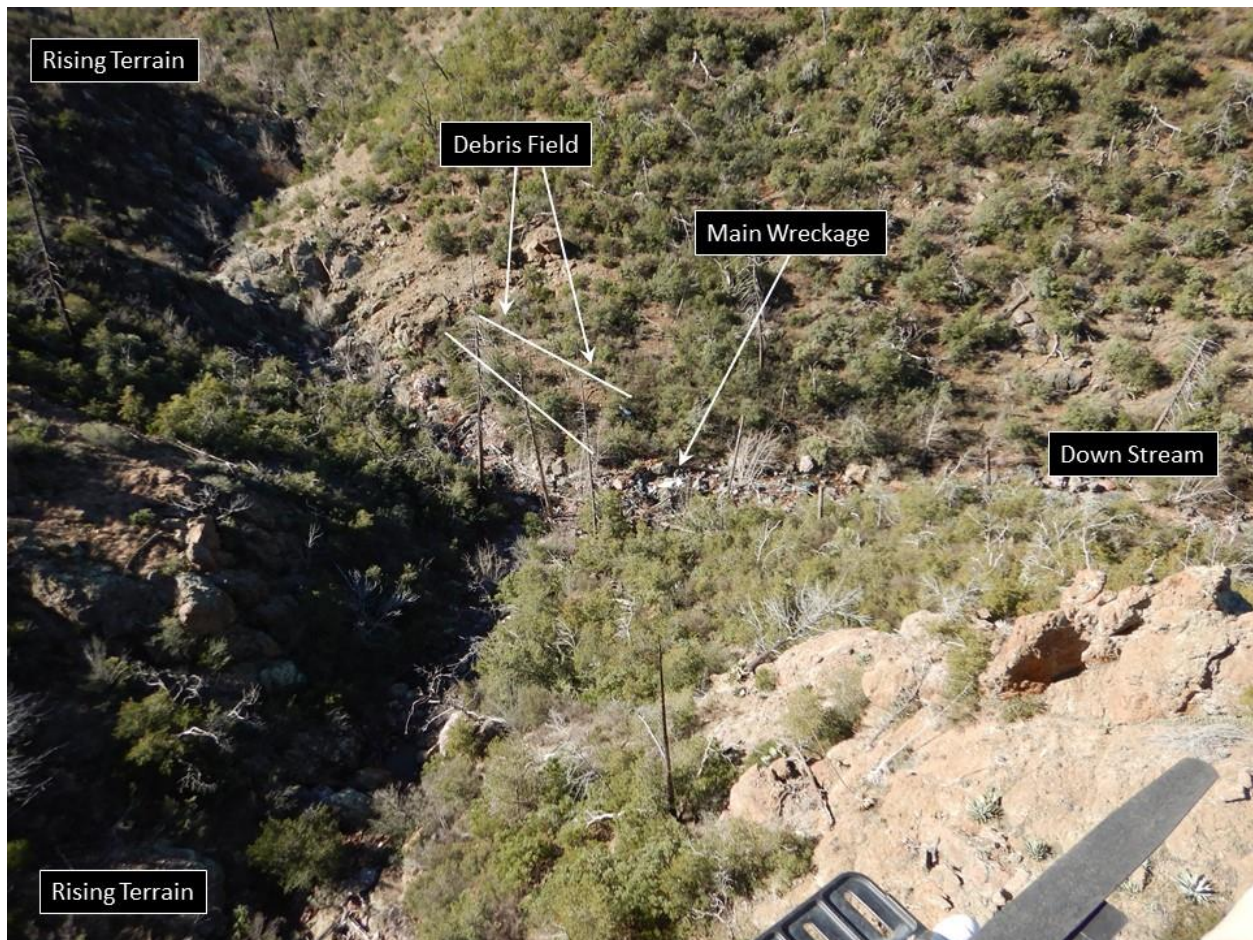
Figure 3-Accident site aerial view, view to the South

The debris field was about 145 ft long and about 12 ft wide, on a directional heading of about 35° magnetic, paralleling, and uphill from a small stream. The first identified point of contact (FIPC) were strike marks found on several small trees and bushes about 5 to 7 ft tall.

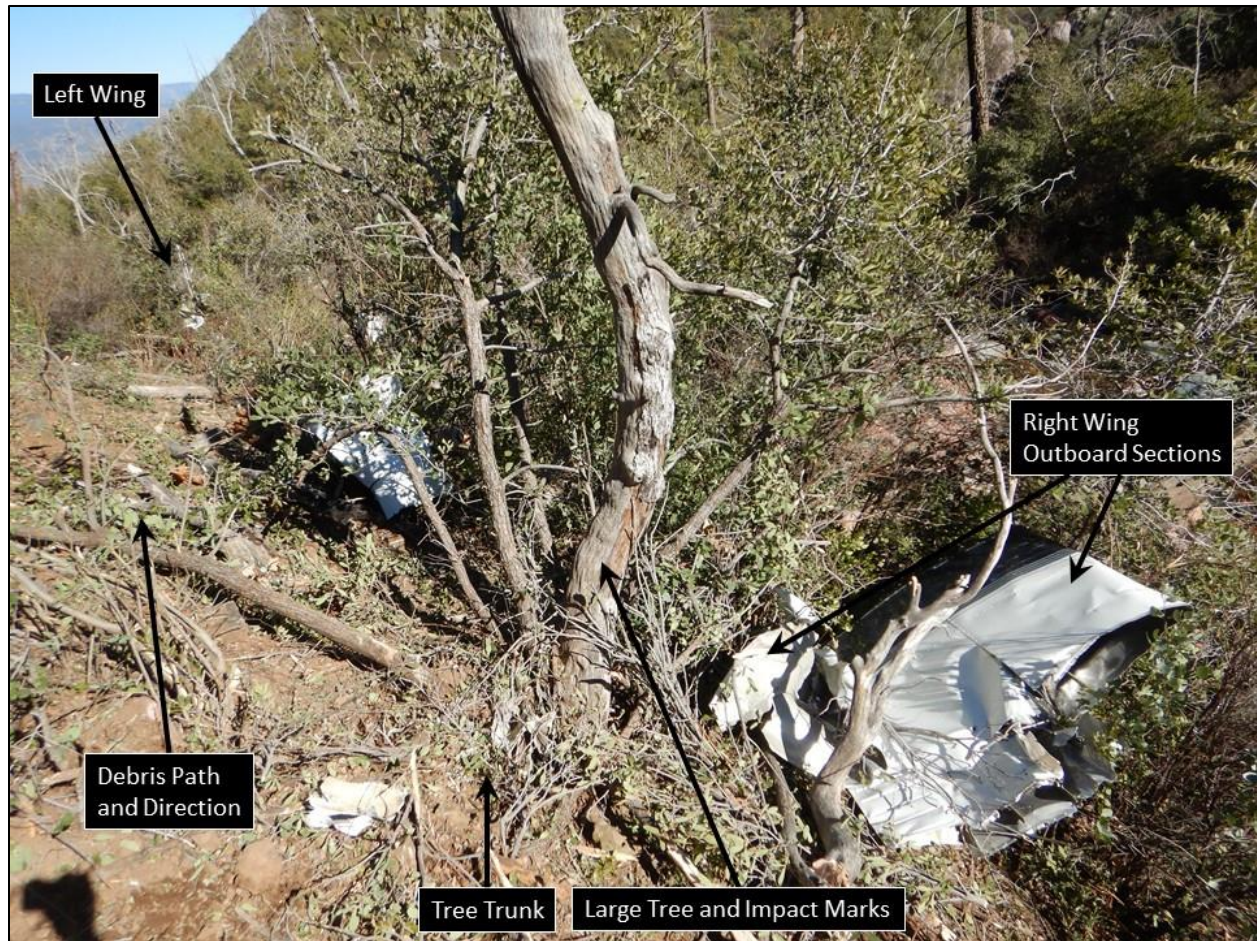
Figure 4-Accident site and debris path, view to the North

About 30 ft further in the debris field, the trunk of a large standing tree revealed scoring. To the left of the large tree was evidence of another tree similar in size where only a short tree trunk remained. Broken tree sections were found further down the debris field. To the right of the large tree were two sections of the outboard right wing.

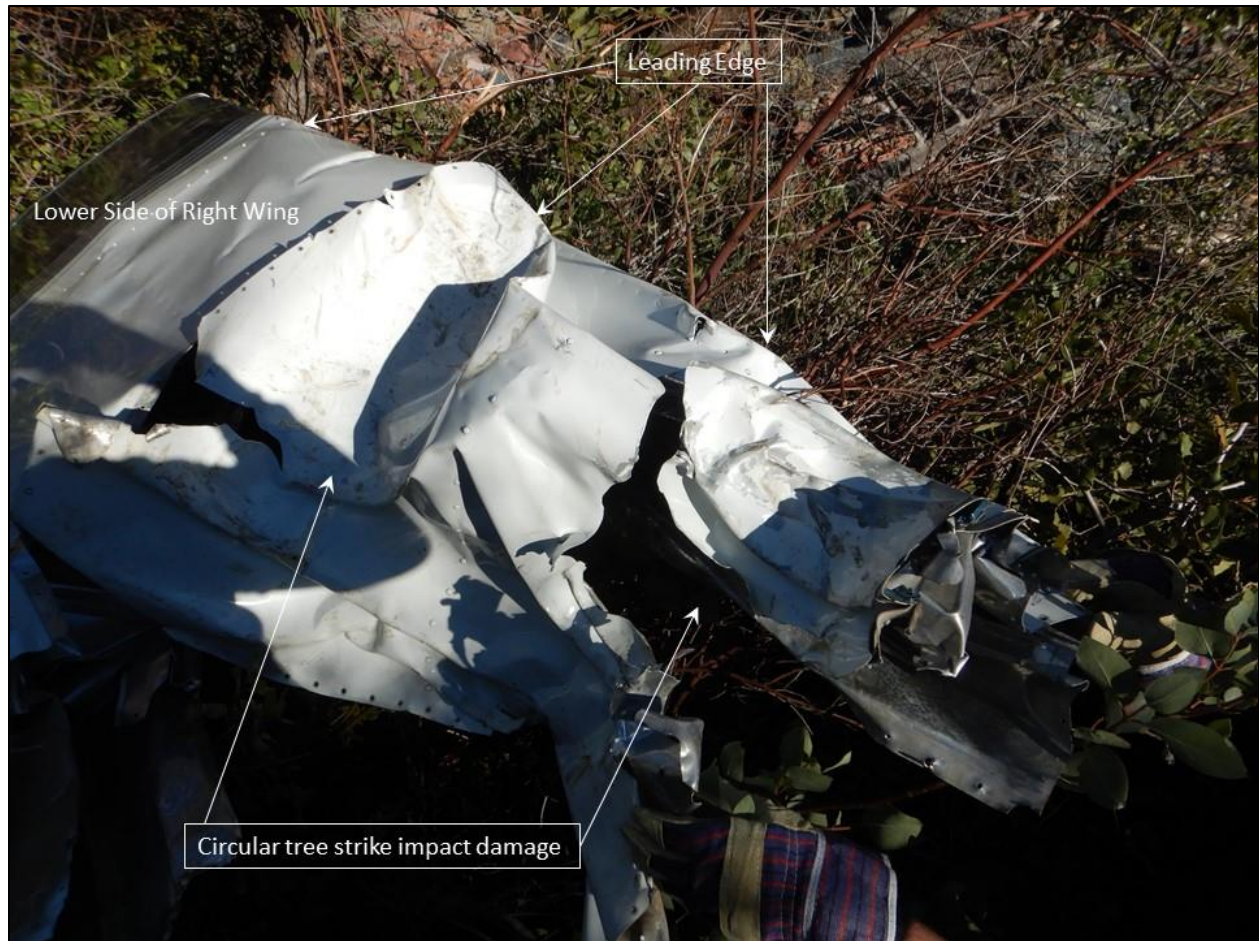
**Figure 5-Right wing lower surface and tree strikes**

The outboard right wing sections revealed leading edge impact damage, similar in size and shape to the large tree and location of the tree trunk. The circular impact damage was found on the lower forward side of the wing near the leading edge, suggesting that the airplane was positioned in a nose up attitude at the time of impact with the ground.

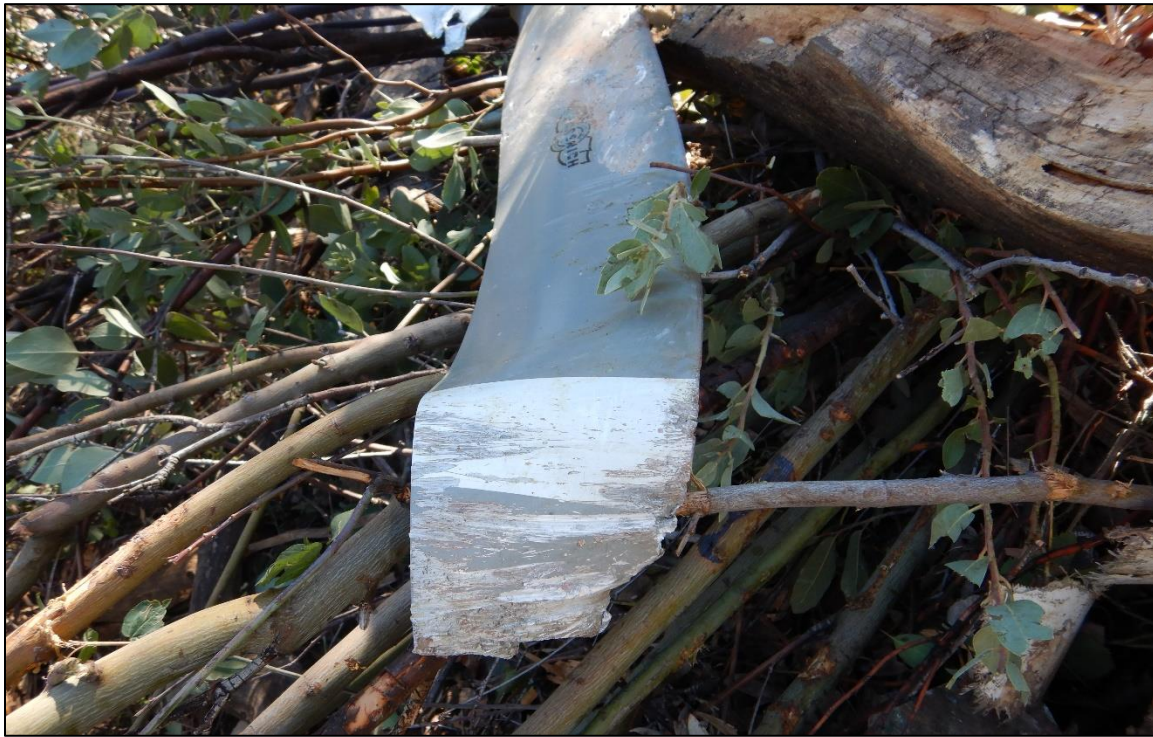
**Figure 6-Propeller assembly**

About 15 ft further along the debris field was the right wing tank found on the right side of the debris field and was breached. To the left of the tank in the center of the debris field was an area of disturbed rock and dirt, consistent with the engine impacting the ground in this area. The debris field continued through dense brush revealing about 70 ft of disturbed ground and rock. About 30 ft further along the debris field was the propeller and spinner back plate. The propeller had heavy leading edge gouging at the tips and about 4 inches of material was missing at one blade tip. About 20 ft further down and on the left side of the debris field broken red lens near a rock with impact marks.

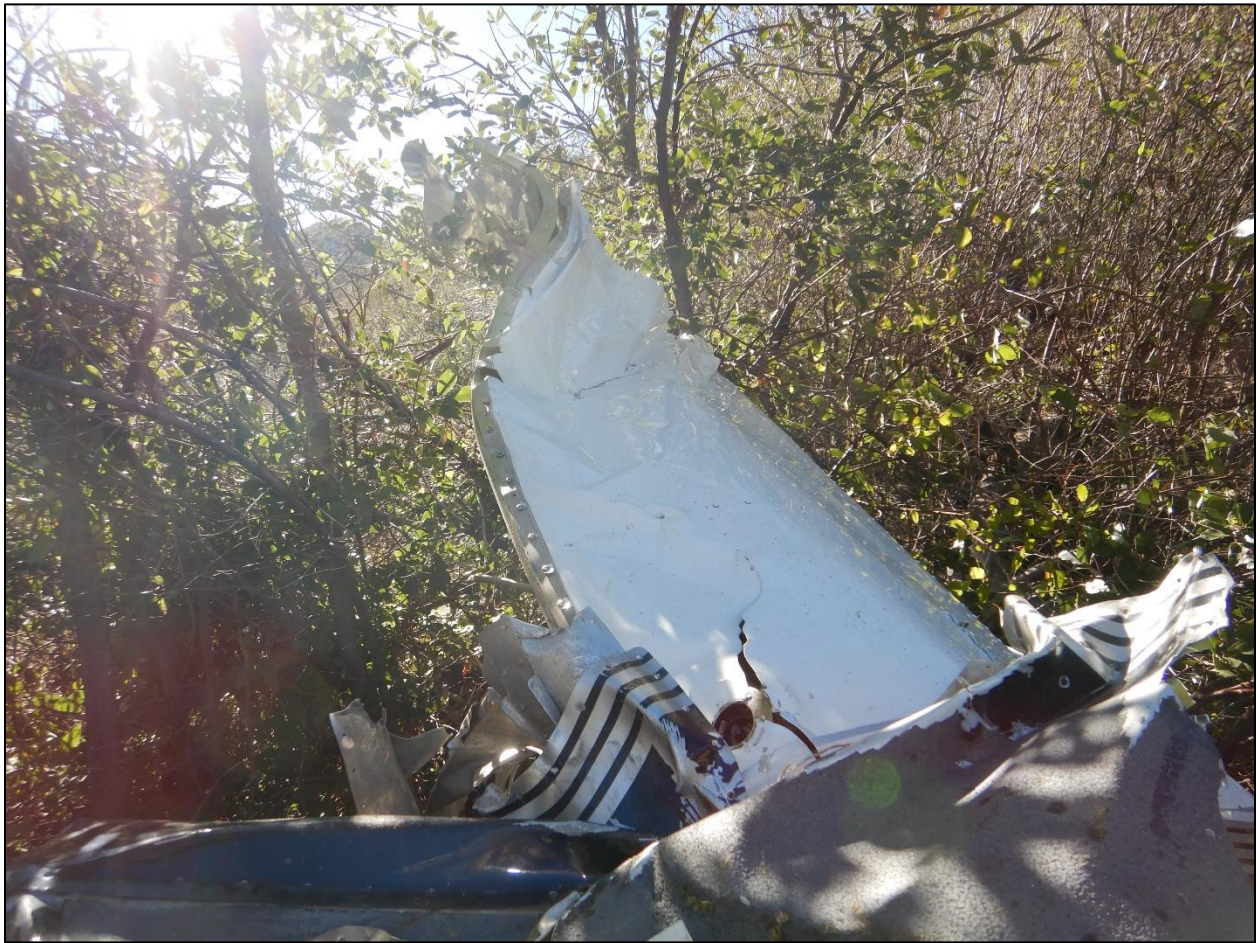
**Figure 7-Inboard section of the right wing**

The inboard right wing section was found at the end of the disturbed ground and rock. Several small trees and bushes remained standing and were found between the inboard right wing section and the main wreckage. The right wing portion had the landing gear partially attached by the brake line, and impact damage to the leading edge and wing root area. The wing spar was visible and had various bending and twisting. The nose landing gear wheel and lower strut was found near the right wing inboard section.

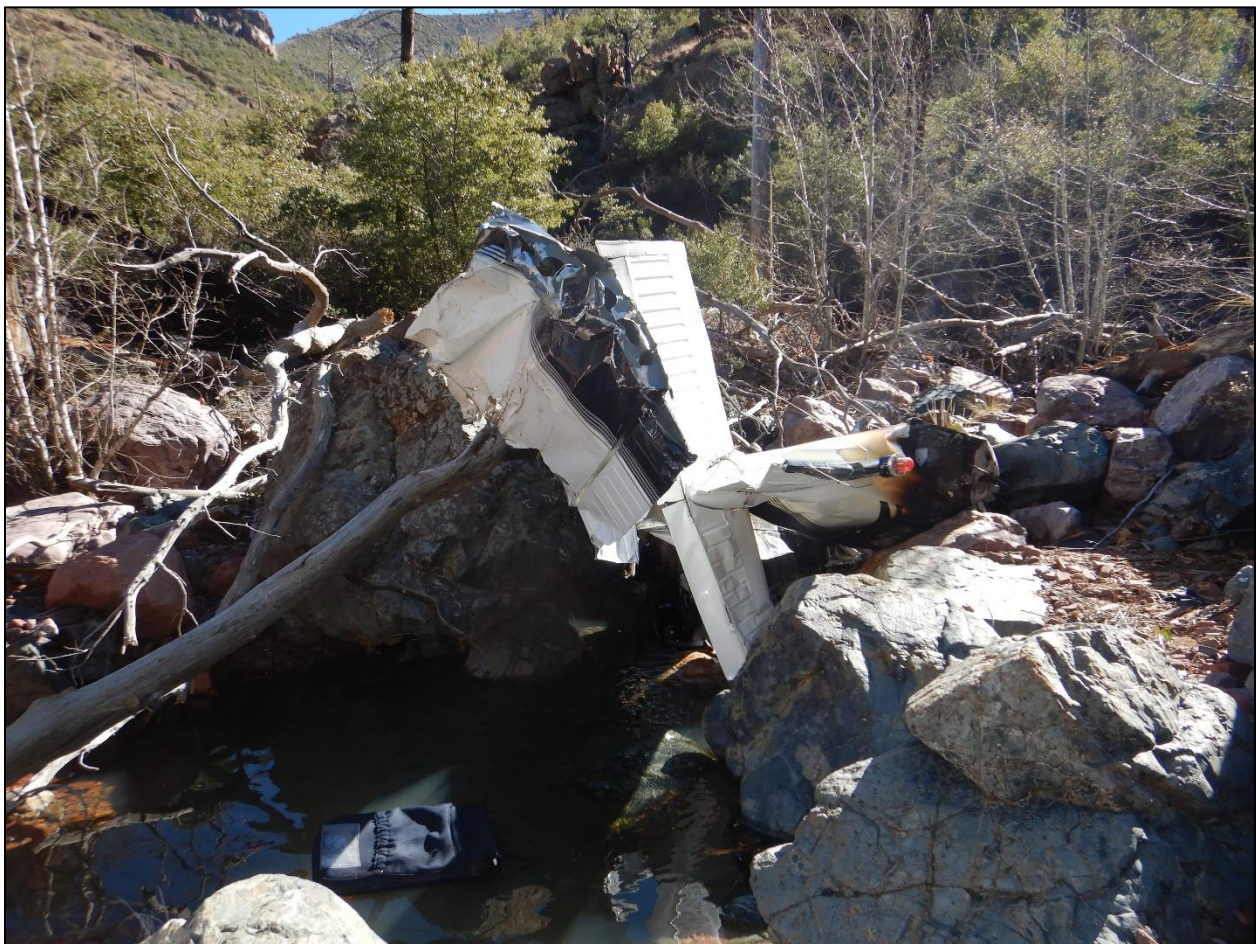
**Figure 8-Main wreckage, south view**

The main wreckage came to rest alongside a large boulder and was partially submerged in a pool about 10 ft in diameter and about 4 feet deep. The main wreckage had postimpact fire damage. The left wing and fuselage remained partially attached. The cabin and forward fuselage was mostly consumed by fire. The cabin floor was found upright and the firewall and engine remained attached to each other and came to rest against the large boulder. The engine was found in a nose-down position and the propeller separated from the crankshaft flange. The engine cowling was mostly consumed by postimpact fire. The left wing was found attached to the fuselage and was resting alongside the boulder. The wing tip fairing separated from the wing, and the outboard 3 ft of the wing remained partially attached by the upper wing skin. The left wing had buckling throughout. The left wing fuel tank appeared to be intact with fire damage near the leading edge. The fuel cap was not fully engaged and had a small tree twig wedged between the cap and top of the tank. The tank was tapped and appeared to be empty.

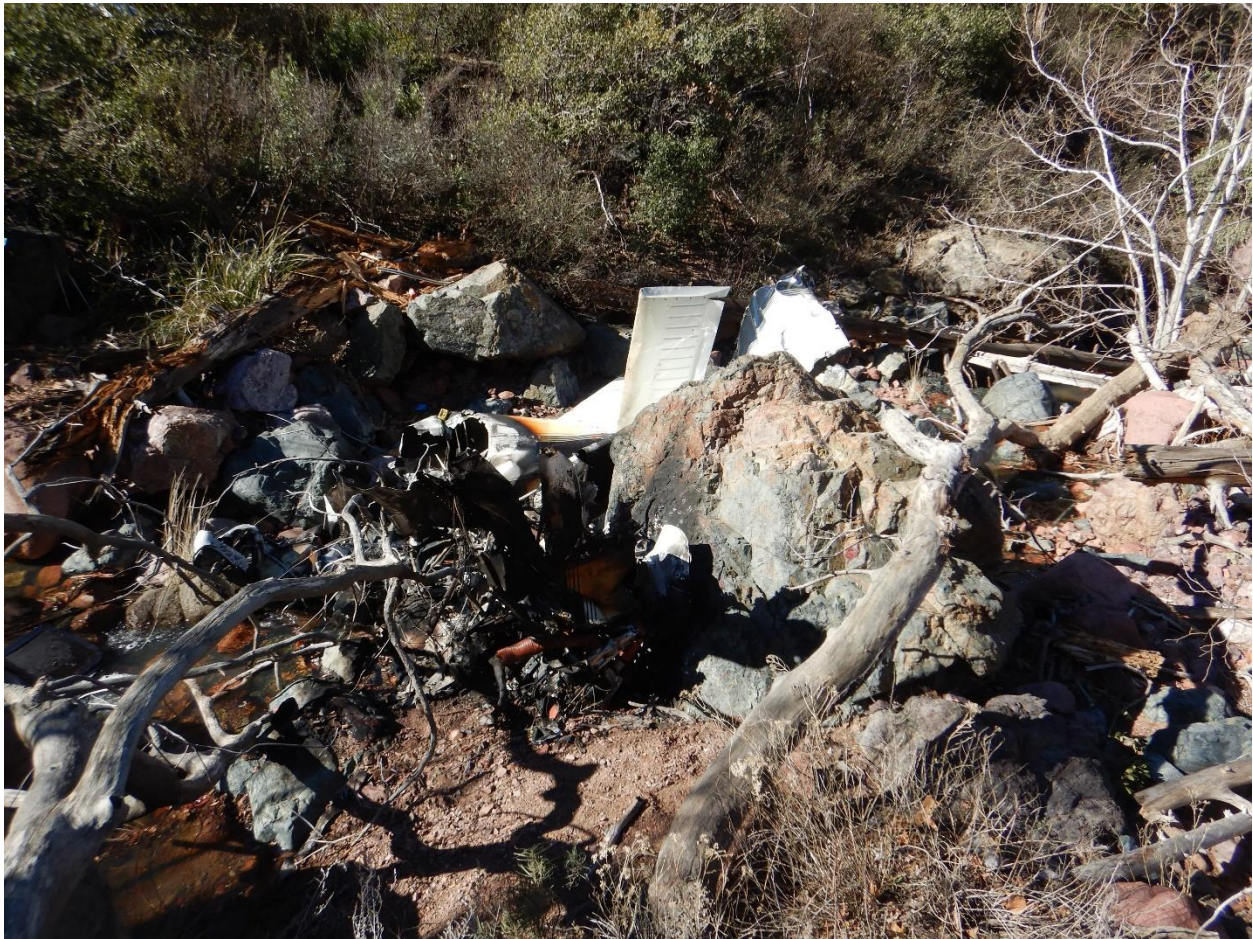
**Figure 9-Main wreckage, west view**

The empennage remained partially attached to the cabin floor by control cables and some structure and came to rest on its right side and had postimpact fire near the cabin area. The empennage came to rest on the right horizontal stabilator that was submerged in the pool. The right elevator and horizontal stabilator was buckled throughout and crushed near the tip. The left elevator and horizontal stabilator had leading edge dents and the elevator was crushed downward. The vertical stabilizer was undamaged, and the rudder was buckled throughout. The ELT was found on top of the empennage. The pilot and surviving passenger locations, after they were ejected from the airplane during the accident sequence, were about 10 ft upstream from the main wreckage near a small sandy area between large rocks on the east side of the stream. The fatal passenger was found on the west side of the stream up against a large boulder. No occupants showed any type of thermal injuries from the accident.
