## Air Safety Investigations Aircraft Incident/Accident Technical Report

| Aircraft Incident/<br>Accident Information | Year: 1949 | Make: Cessna | Model: 140A |
| Air Safety Investigator: Jennifer D. Barclay | | Report #: ASI-20-AH-T | Report date: 08-07-20 |

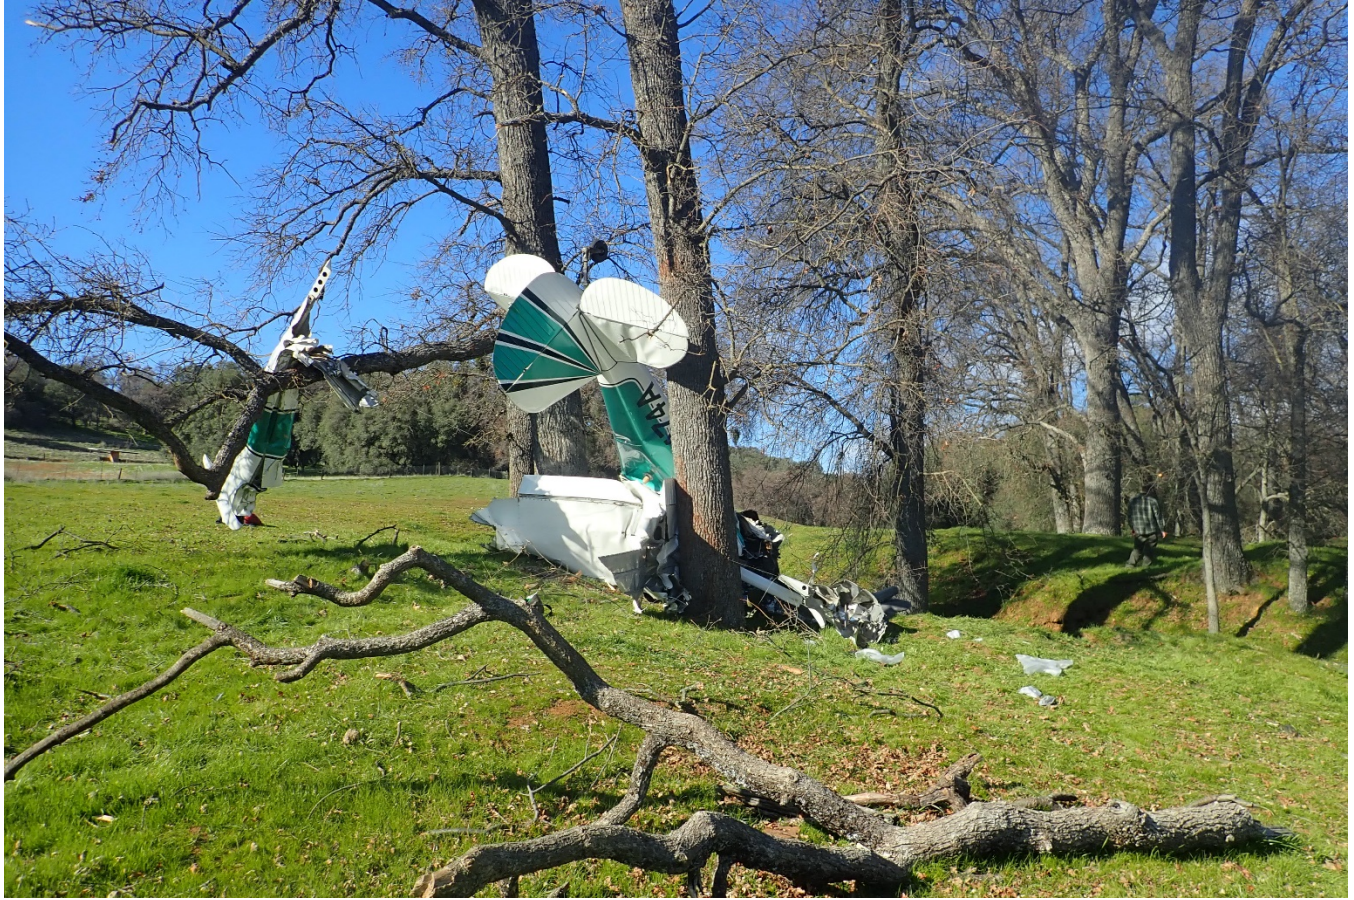
The left wing of the aircraft impacted a 50' pine tree approximately 0.4 NM from the approach end of Runway 35 at Columbia Airport (O22), Columbia, CA. The aircraft came to rest inverted approximately 300' from the initial impact point on a magnetic heading of 337°. The wreckage impacted between two trees causing both wings to separate at the flap-aileron intersection. The outboard section of the right wing remained suspended in a tree.

Wreckage overview, ASI-20-AH-013

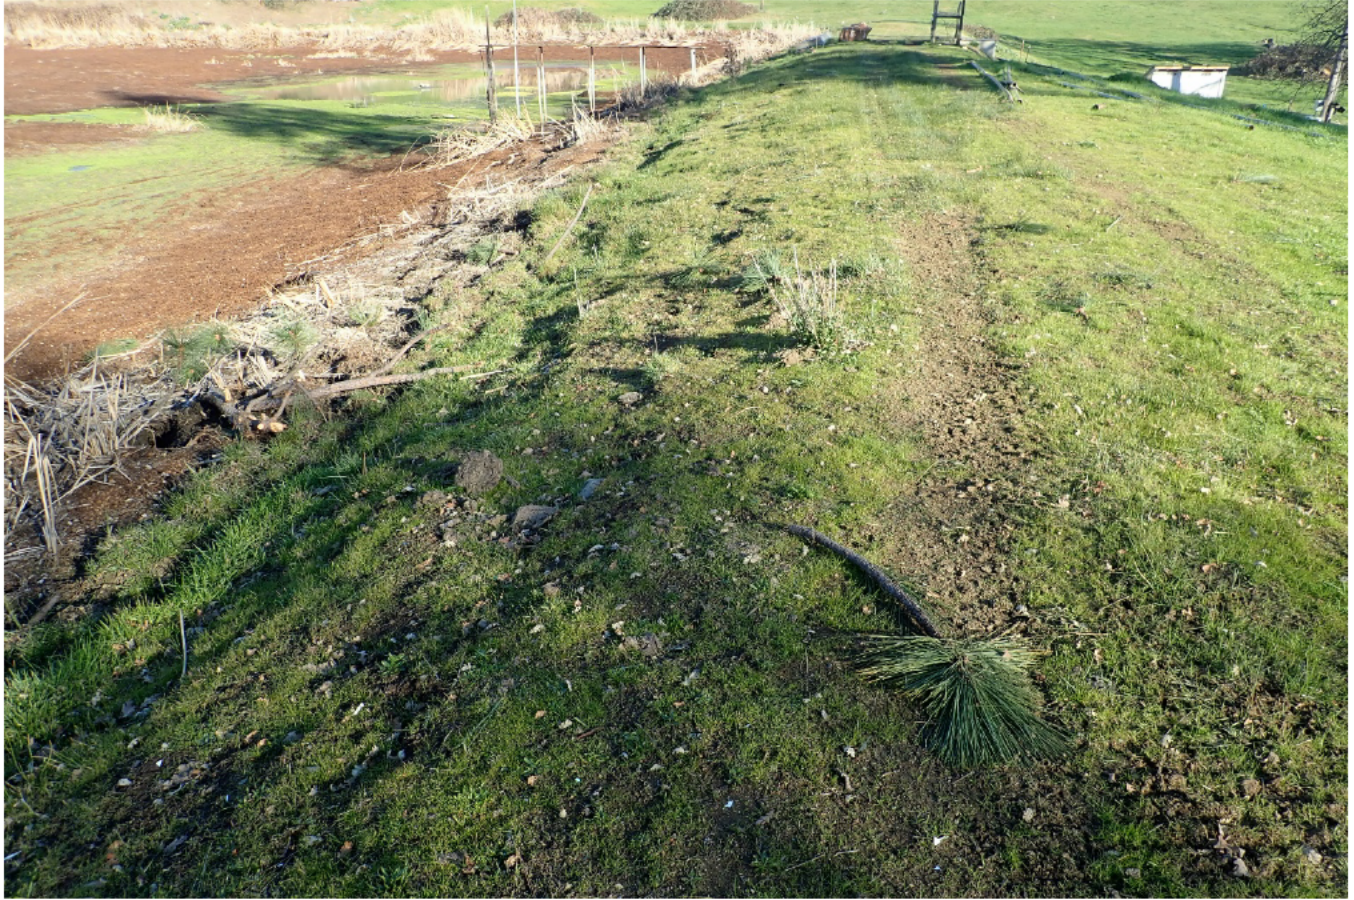
Pieces of pine tree located under flight path, ASI-20-AH-078

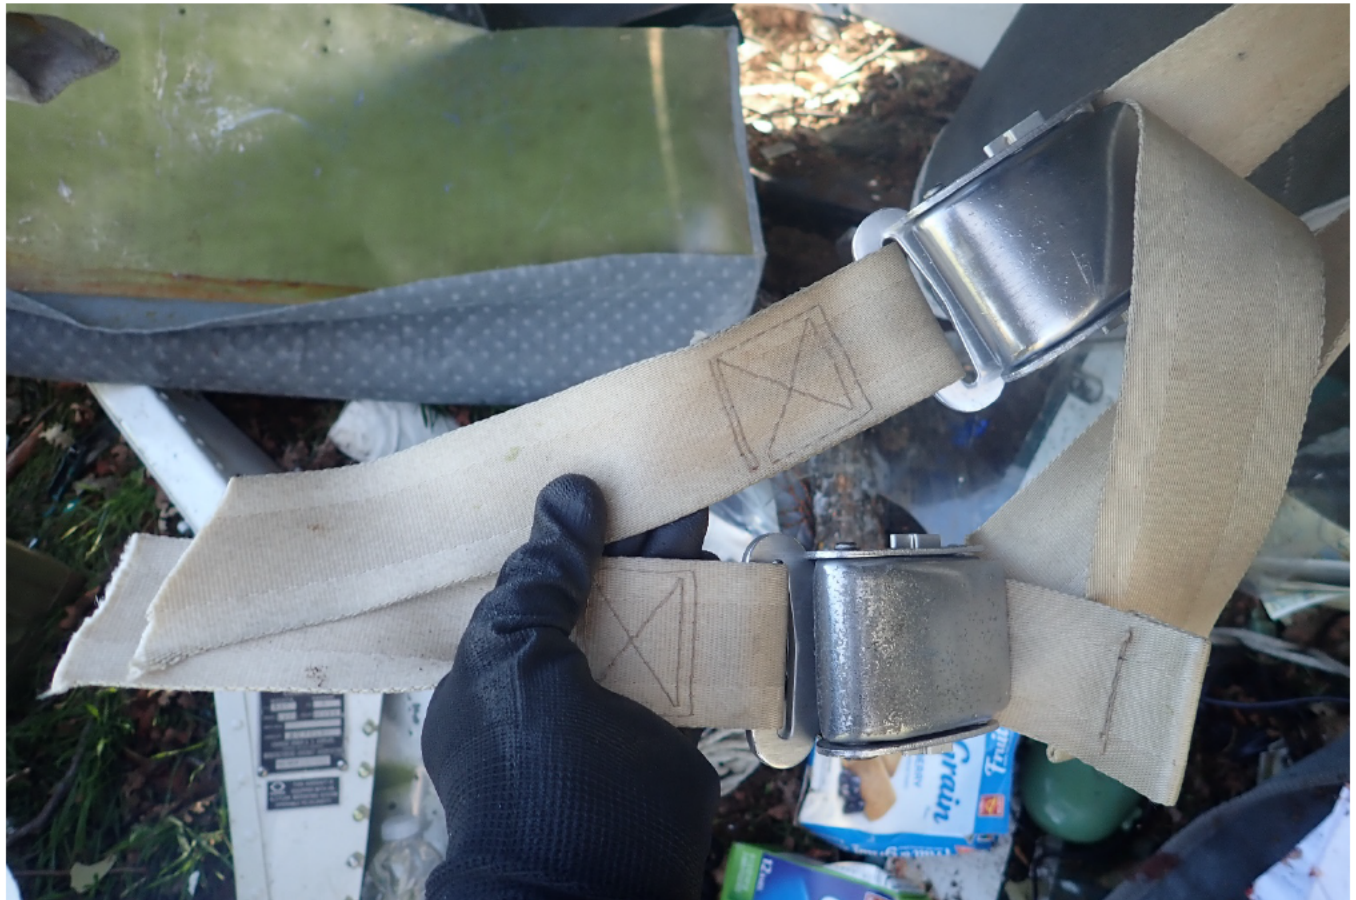
| Restraint System Information | | | | | | |
|---|---|---|---|---|---|--|
| 1 | Yes | 2-Point | Yes | Cut by first responders | Non-OEM | |
| 2 | Yes | 2-Point | Yes | Cut by first responders | Non-OEM | |

Restraints, ASI-20-AH-031

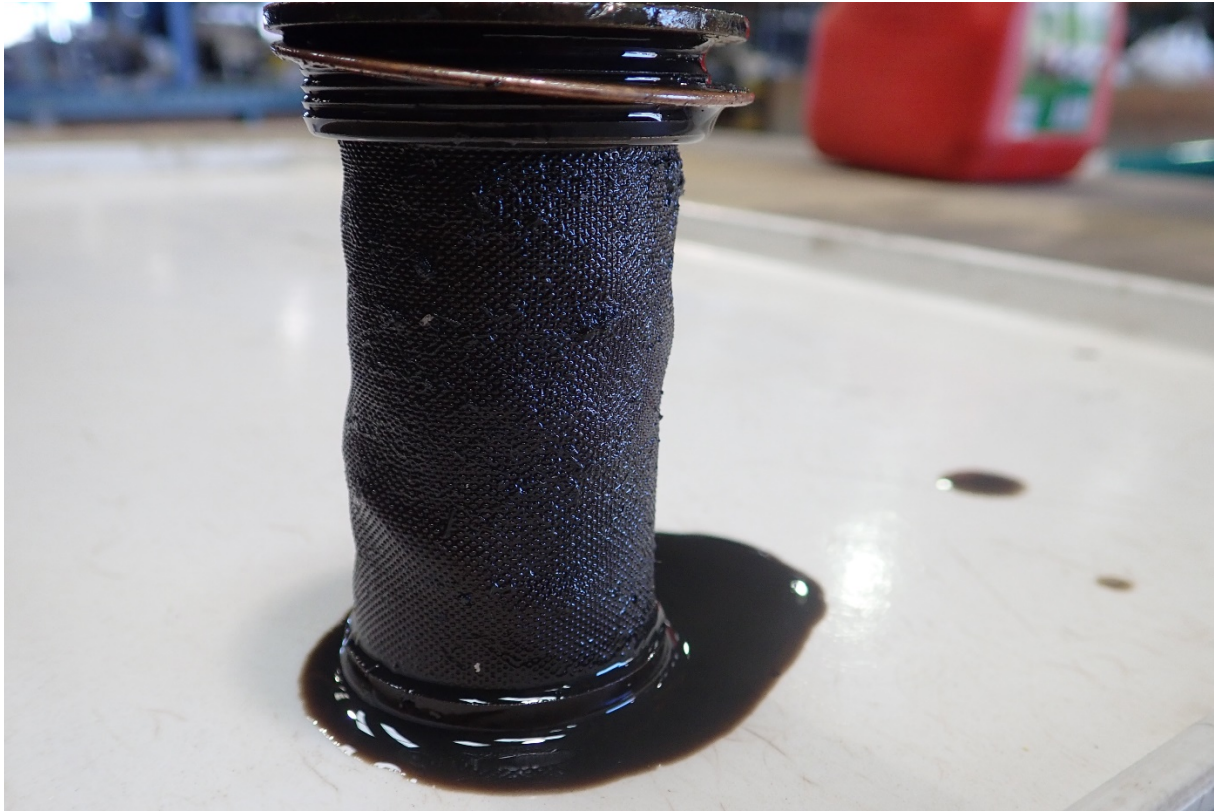
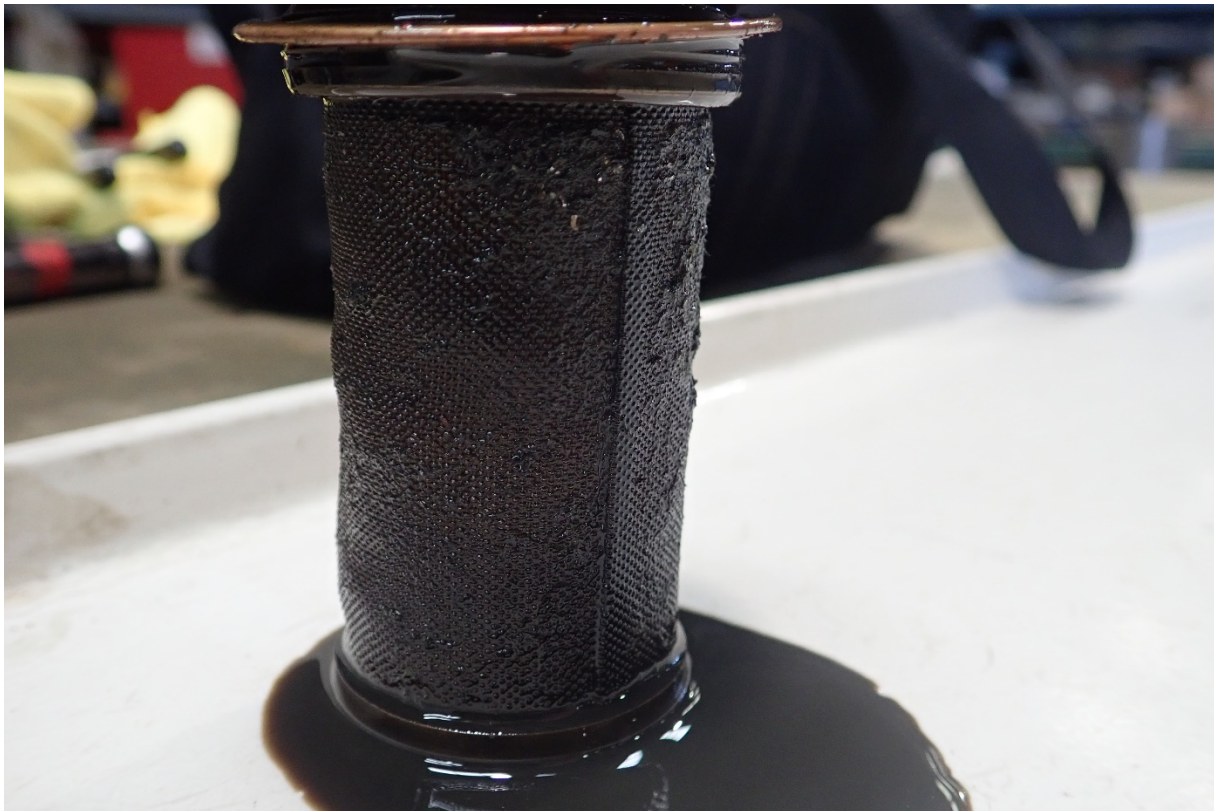
The throttle control cable to the carburetor fractured at the base of the rod end. The control at the carburetor rotated freely and its position could not be determined. The oil screen contained a small amount of metal shavings and some organic debris. A small piece of organic debris was observed in the carburetor inlet screen. The carburetor was disassembled, and no other anomalies were noted.

Oil screen, ASI-20-AH-143

Oil screen, ASI-20-AH-144

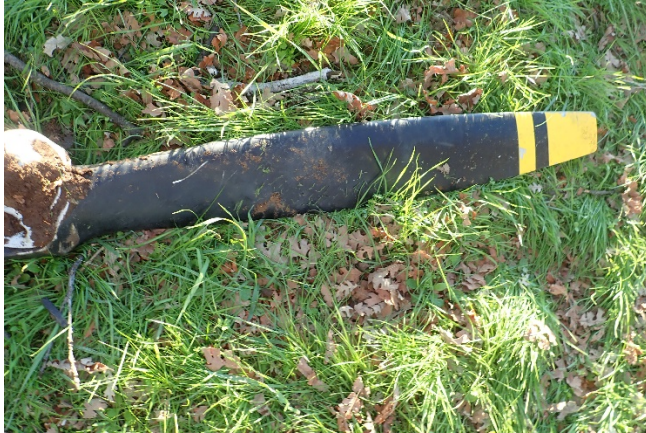
The propeller separated from the engine and came to rest underneath the main wreckage. Blade A was straight and unremarkable. Blade B had chordwise and spanwise scratches and a leading edge gouge at the tip.

Propeller blade A, ASI-20-AH-099

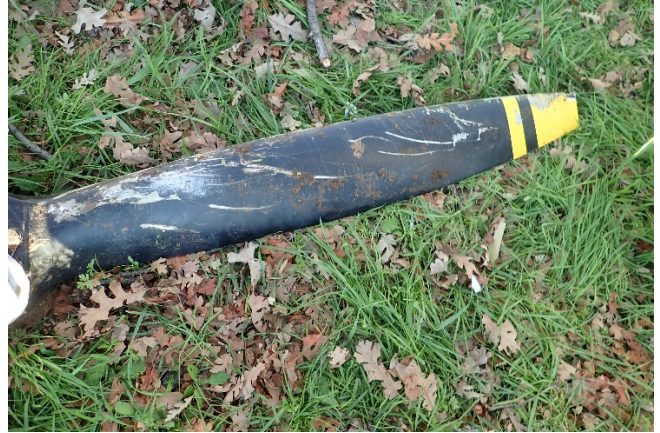
Propeller blade B, ASI-20-AH-100
