## **NATIONAL TRANSPORTATION SAFETY BOARD**

### **Field Examination Report**

**WR20FA086**

Location: Sonora, California  
Date: February 5, 2020  
Aircraft: Airplane Cessna 140A, Registration Number: N9474A, Serial #15295  
NTSB IIC: Tealeye Cornejo

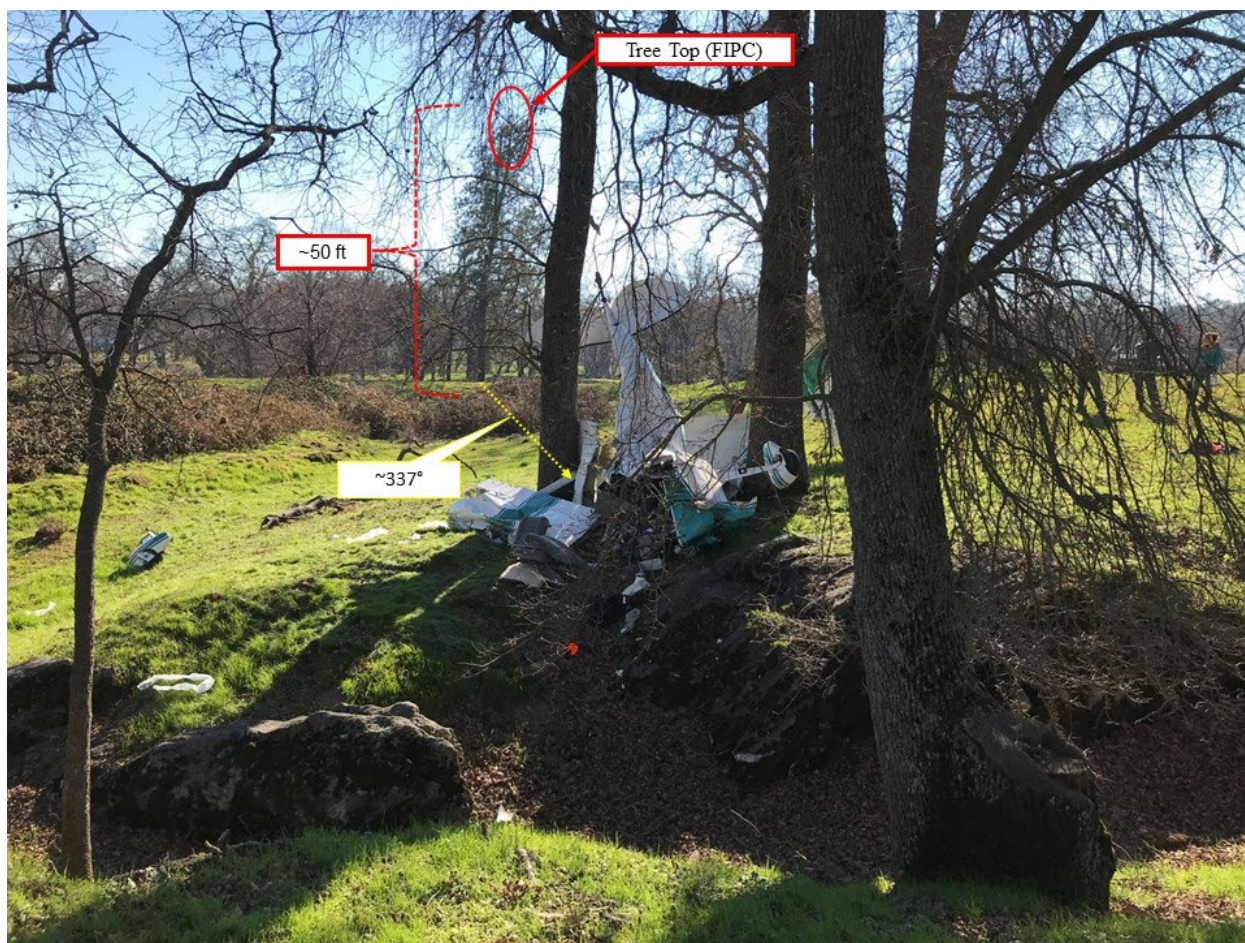
The first identified point of impact (FIPC) was a 50-foot pine tree about 300 ft south of the main wreckage; portions of the left wing were at the FIPC. The accident site was about 0.4 nautical miles from the approach end of runway 35.

The airplane came to rest inverted in-between two trees in a pasture at an elevation of 2,020 ft mean sea level (msl). The right wing separated and came to rest in low-lying branches. The left wing had partially separated and was wrapped around a tree.

Photo 1 - Accident Site Overview (NTSB)

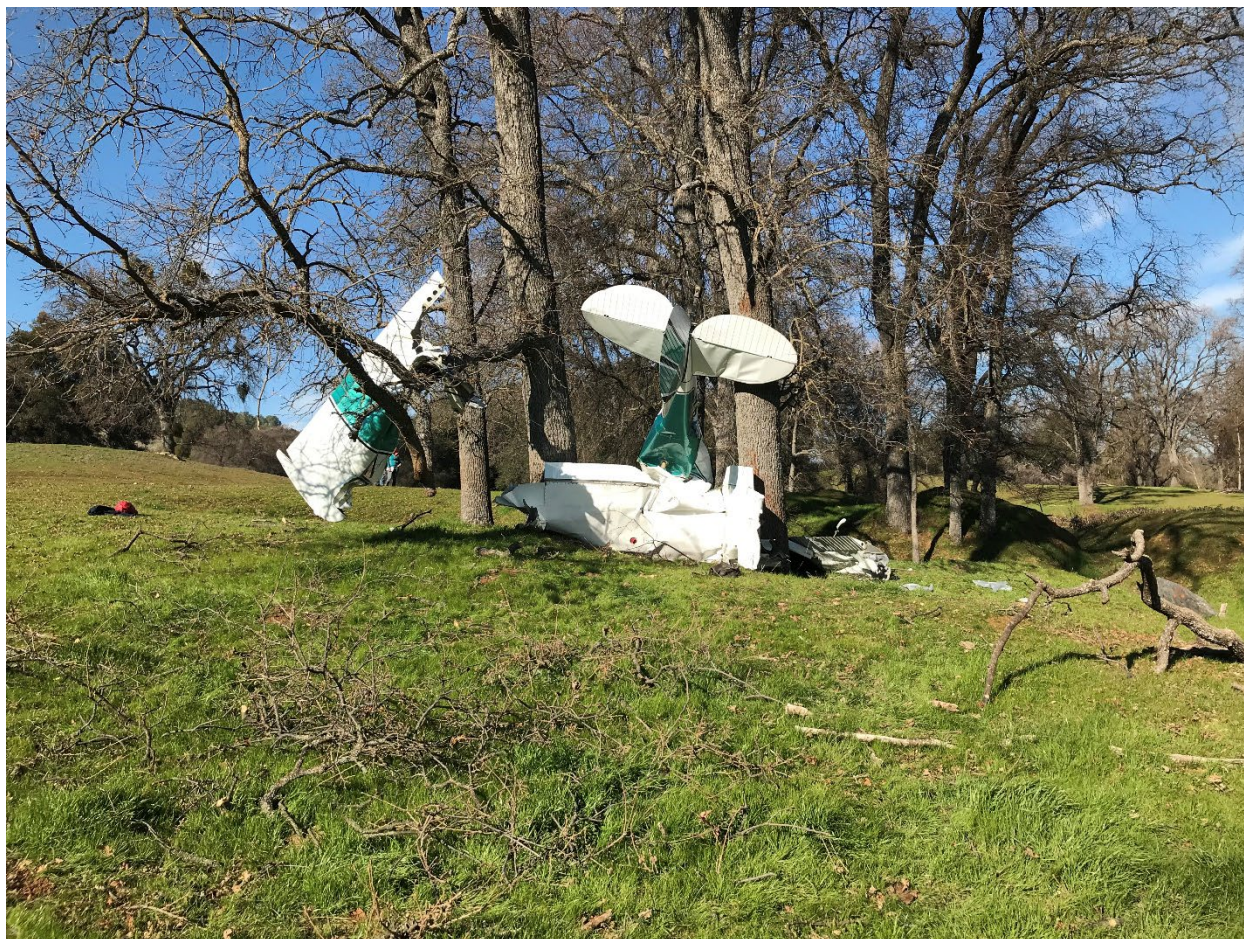
The empennage and the tail section remained attached to the cabin area with the tail section raised and leaning against a tree. Flight control continuity was established from the cockpit to all flight control surfaces. Flight control separations were noted as overload due to the accident sequence.

Photo 2 - Rear View of Main Wreckage (NTSB)

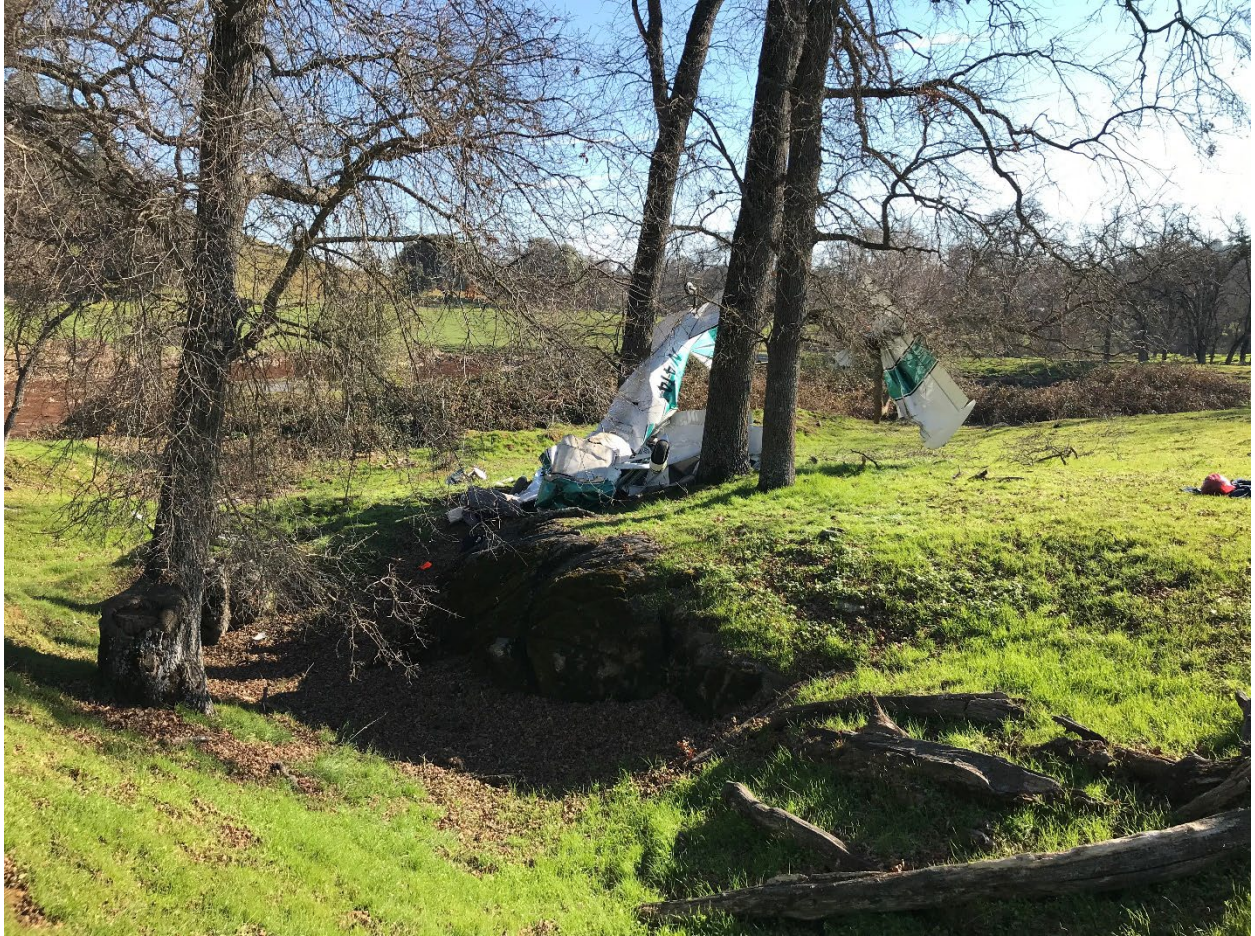
Photo 3 - Left side view of main wreckage (NTSB)

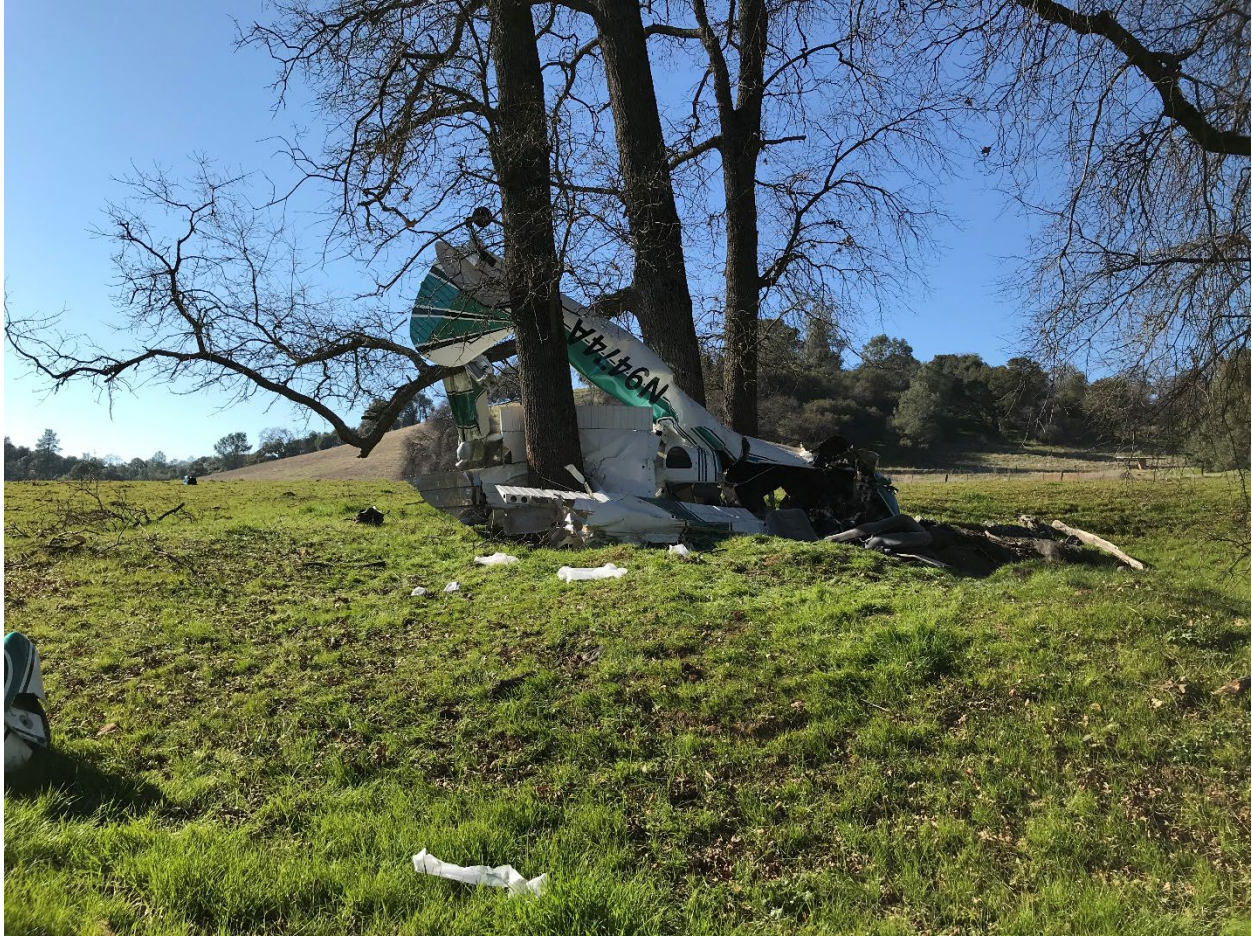
The engine remained attached to the firewall in its normal position on the airframe; however, the propeller separated and came to rest underneath the right side of the airplane.

Photo 4 – Right side view of main wreckage (NTSB)

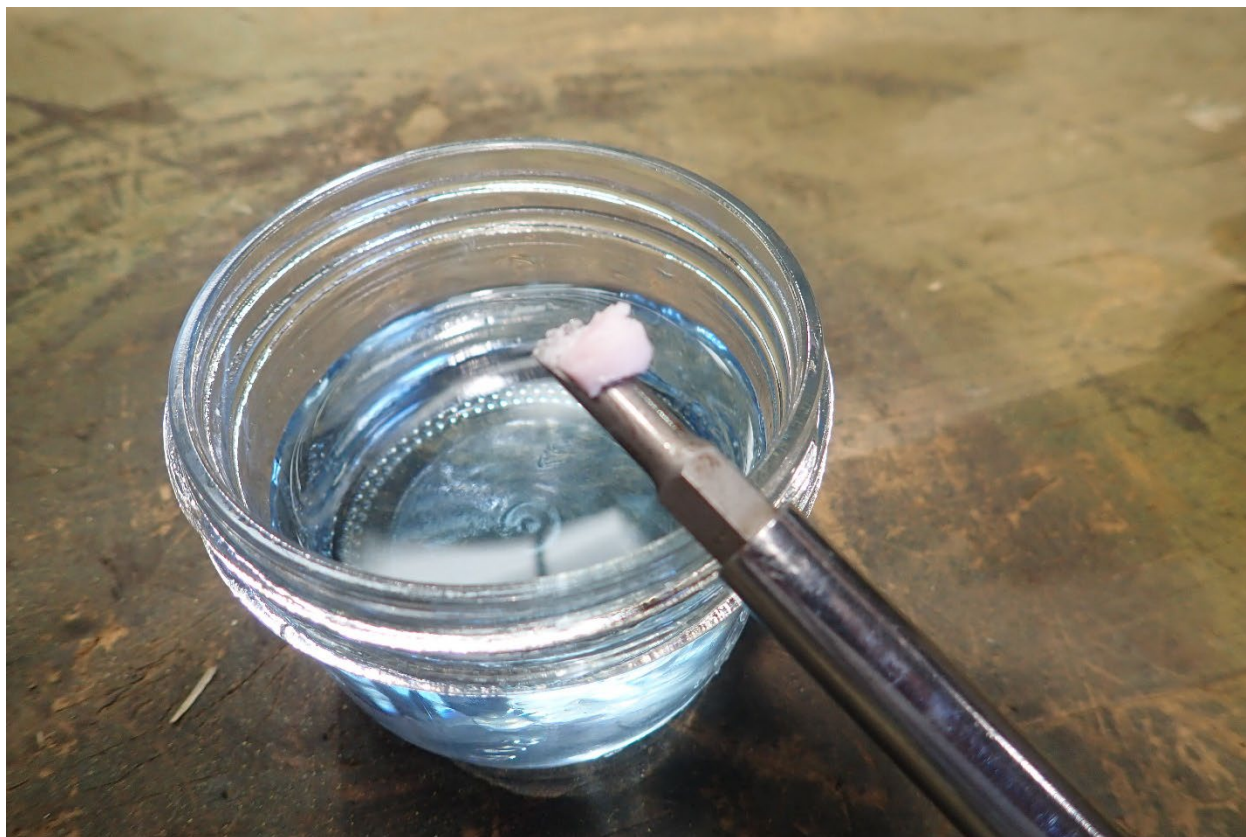
Both fuel tanks had been breached with about one gallon of fuel drained from the LEFT fuel tank. The fuel as blue in color and tested negative for water contamination using Sar-Gel.

Photo 5 - Fuel Sample (Textron Aviation)

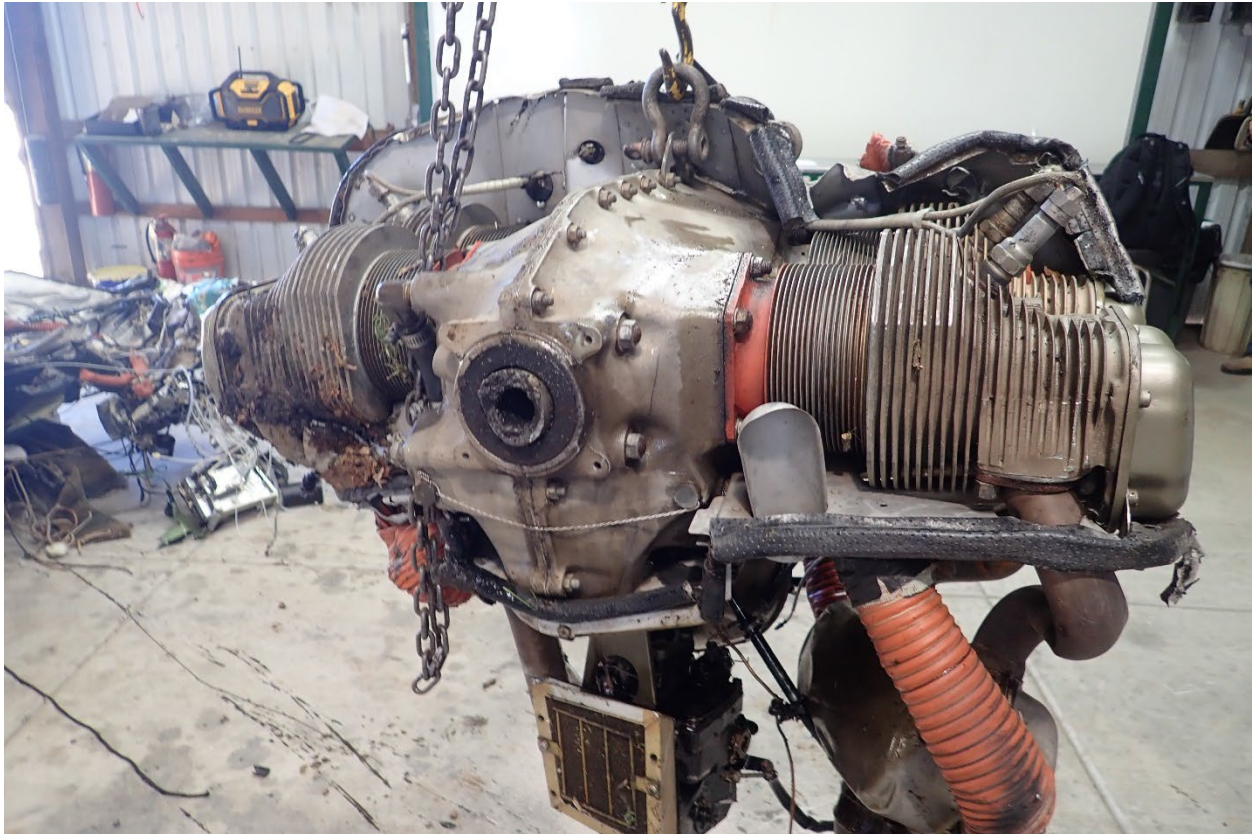
Photo 6 - View of the engine (Textron Aviation)

The engine had partially separated from the airframe due to impact forces. There were no obvious holes in the engine case. The top spark plugs were and were oil coated. According to the Champion Aviation Check-A-Plug chart, the electrodes exhibited a worn out - severe appearance.

The throttle control cable to the carburetor had fractured at the base. The magnetos remained attached to their respective mounting pads; both magnetos produced spark at their respective leads. The oil screen contained a small amount of metal shavings and organic debris. The carburetor also had some organic matter in the inlet screen; the carburetor was disassembled with no anomalies noted.

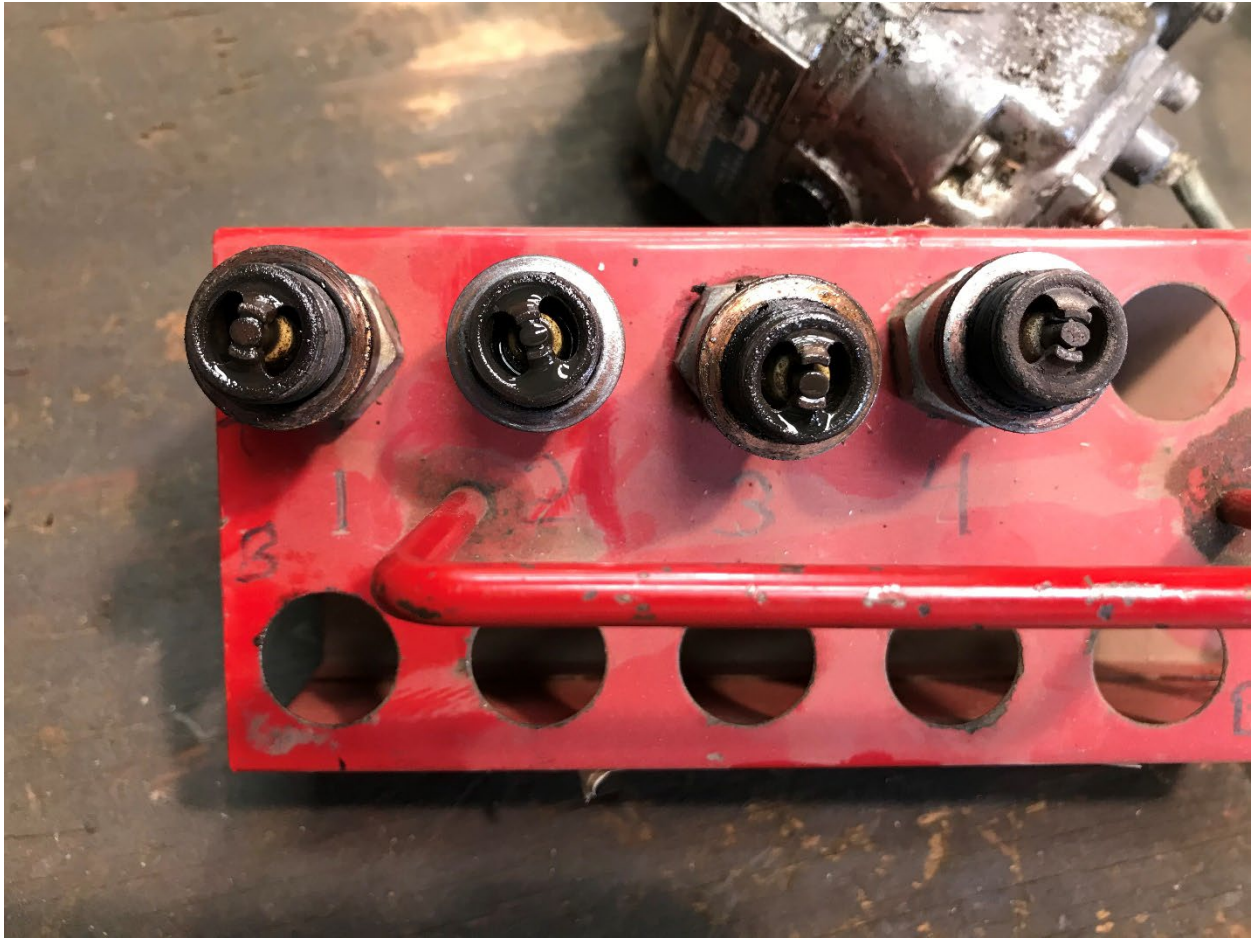
Photo 7 - Spark Plugs (NTSB)

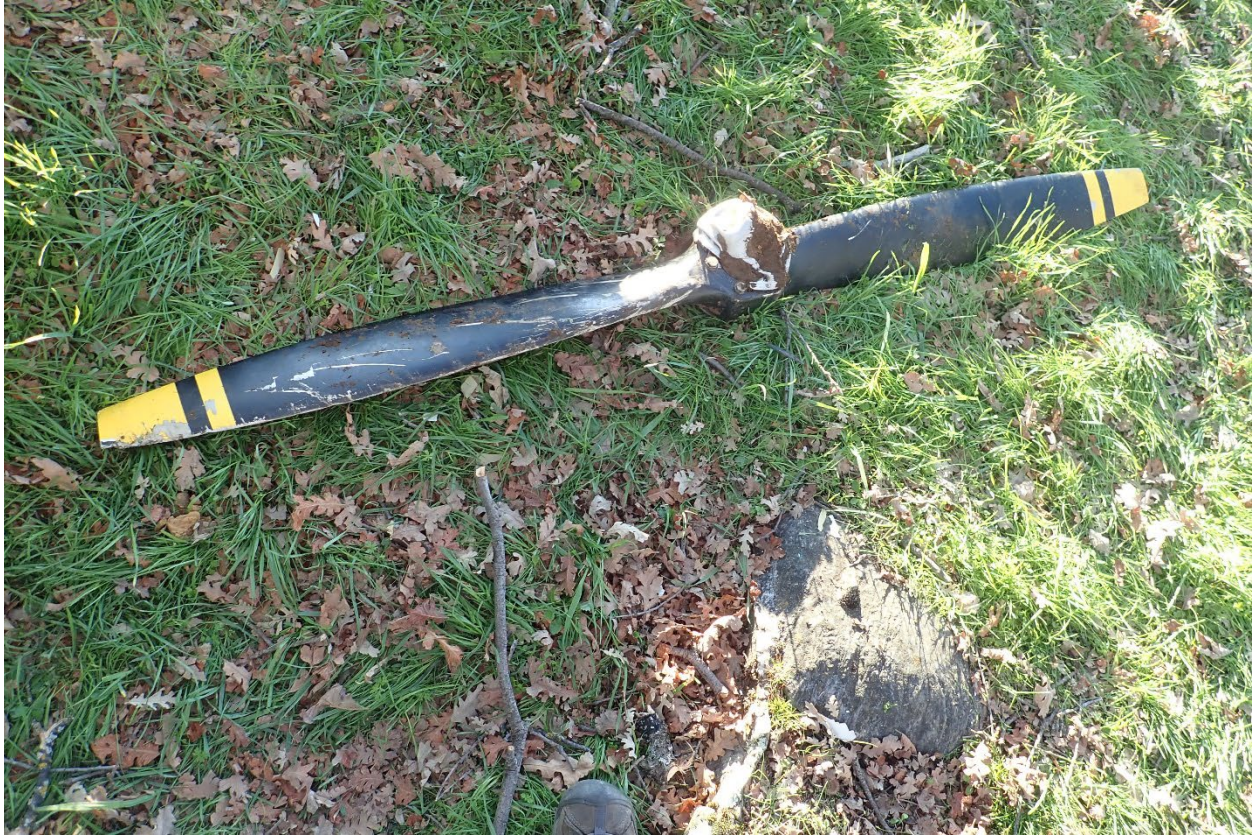
The propeller blades were marked A and B for the purpose of the investigation. Blade A was straight and unremarkable. Blade B had chordwise scratches the length of the blade as well as a leading-edge gouge at the tip of the blade.

Photo 8 - Propeller Assembly (Textron Aviation)
