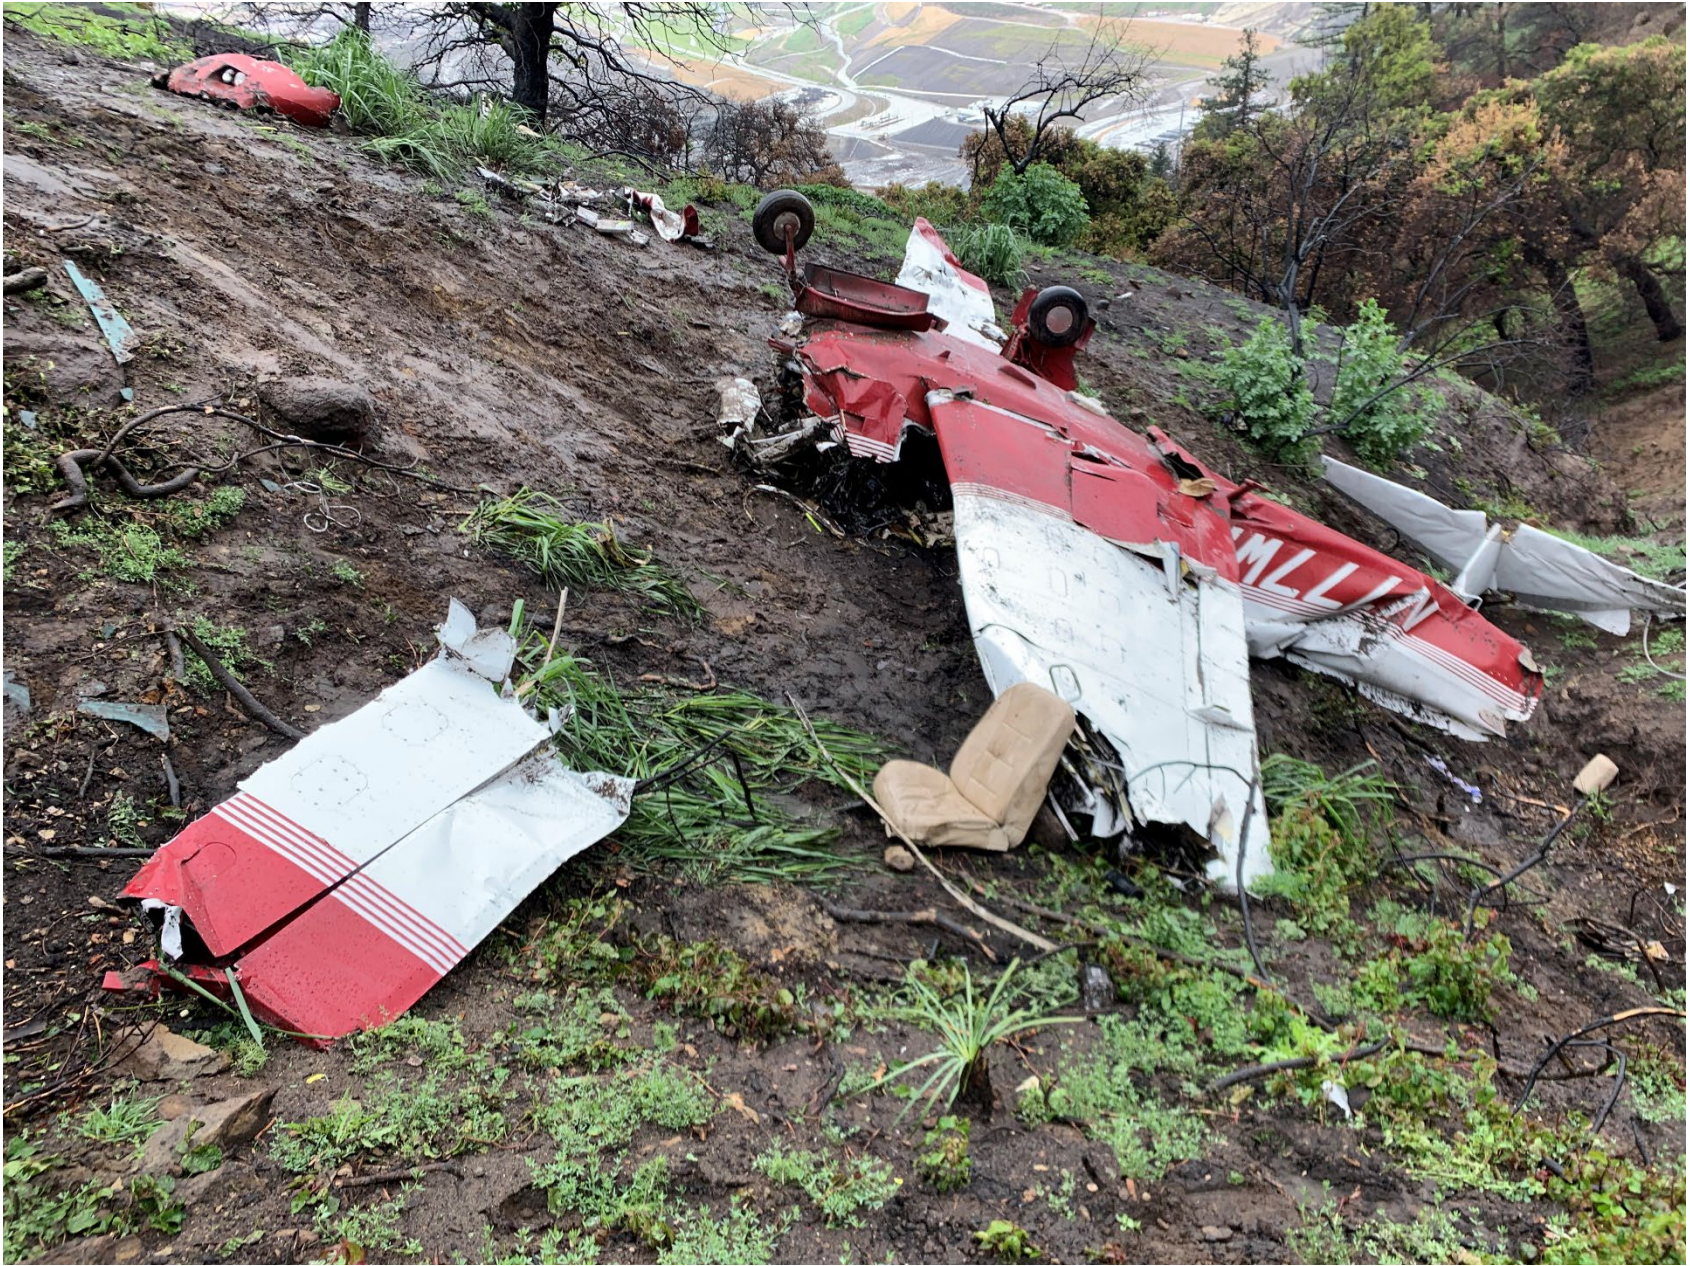
**Photo 1 – Main wreckage at the accident site.**

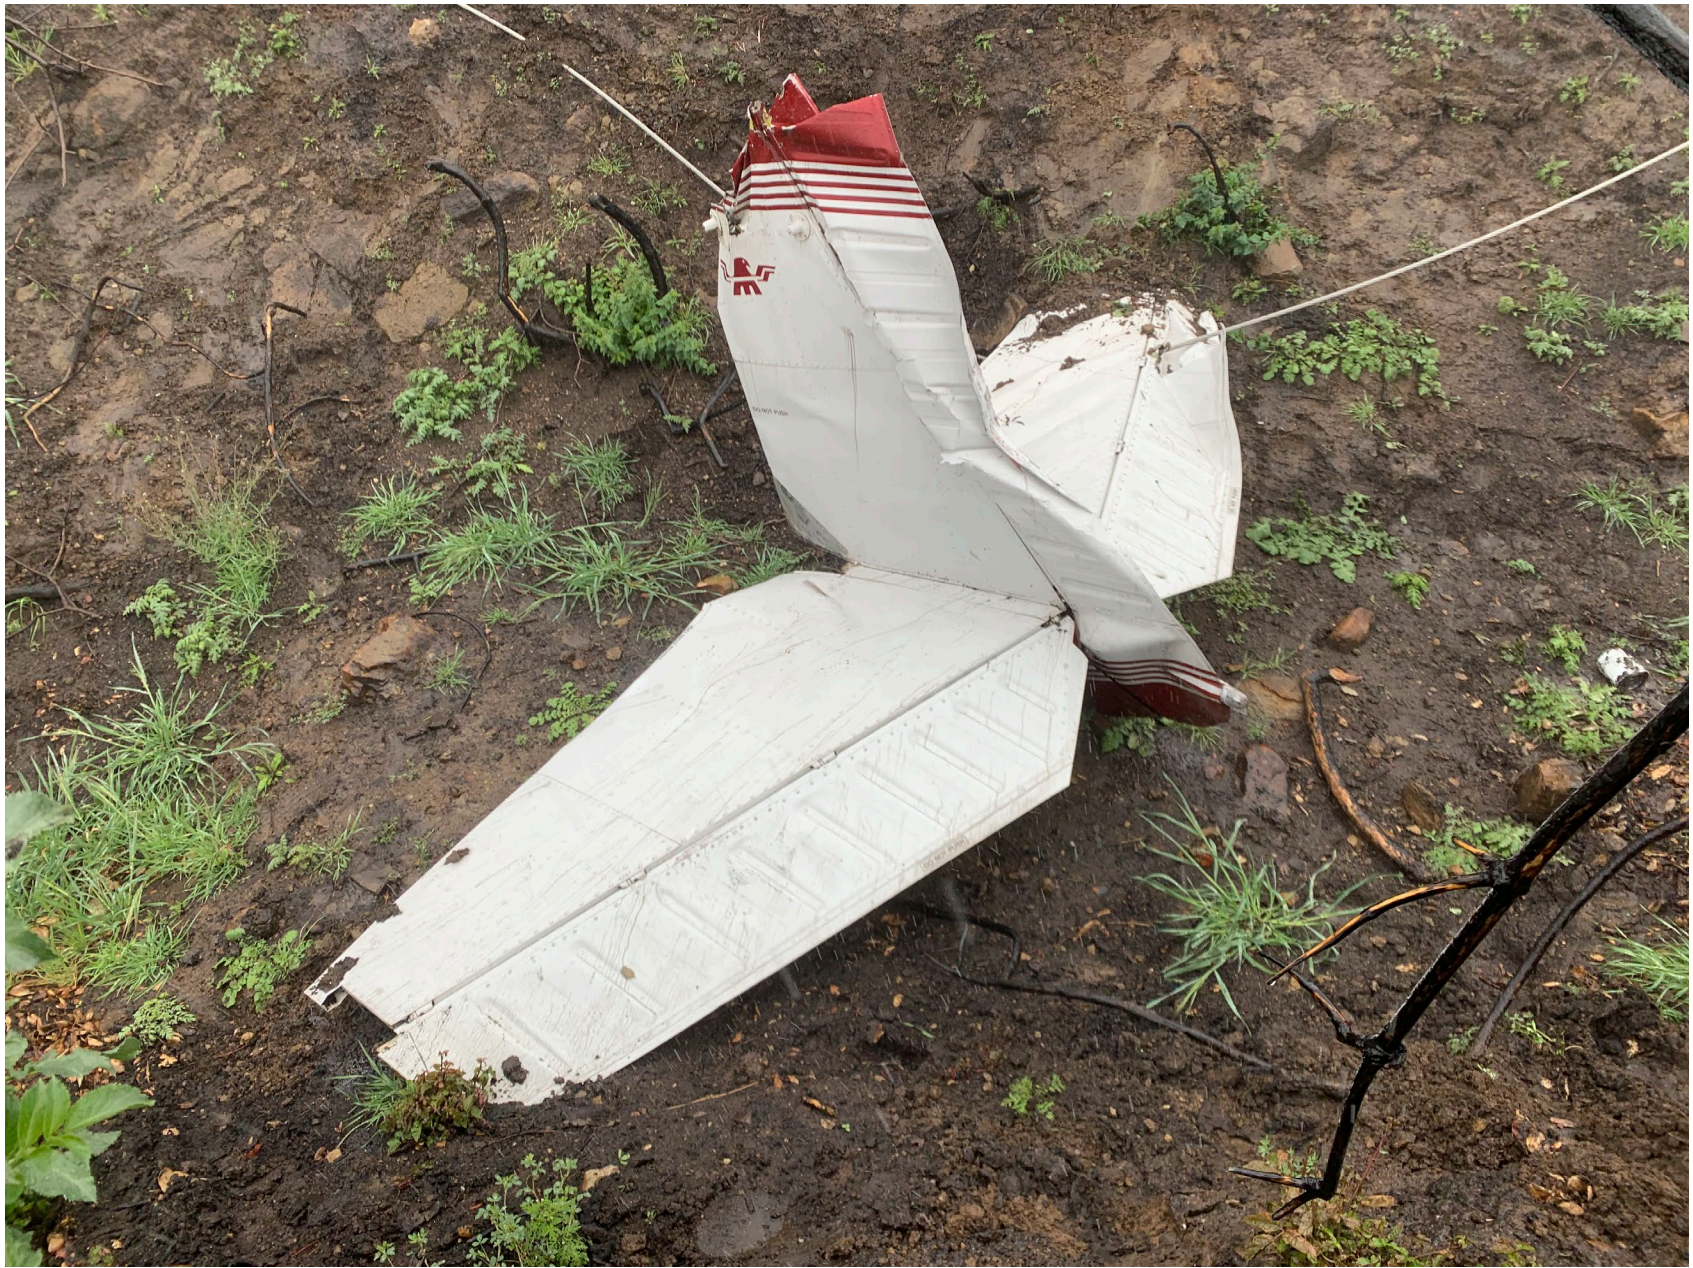
**Photo 2 - Empennage**

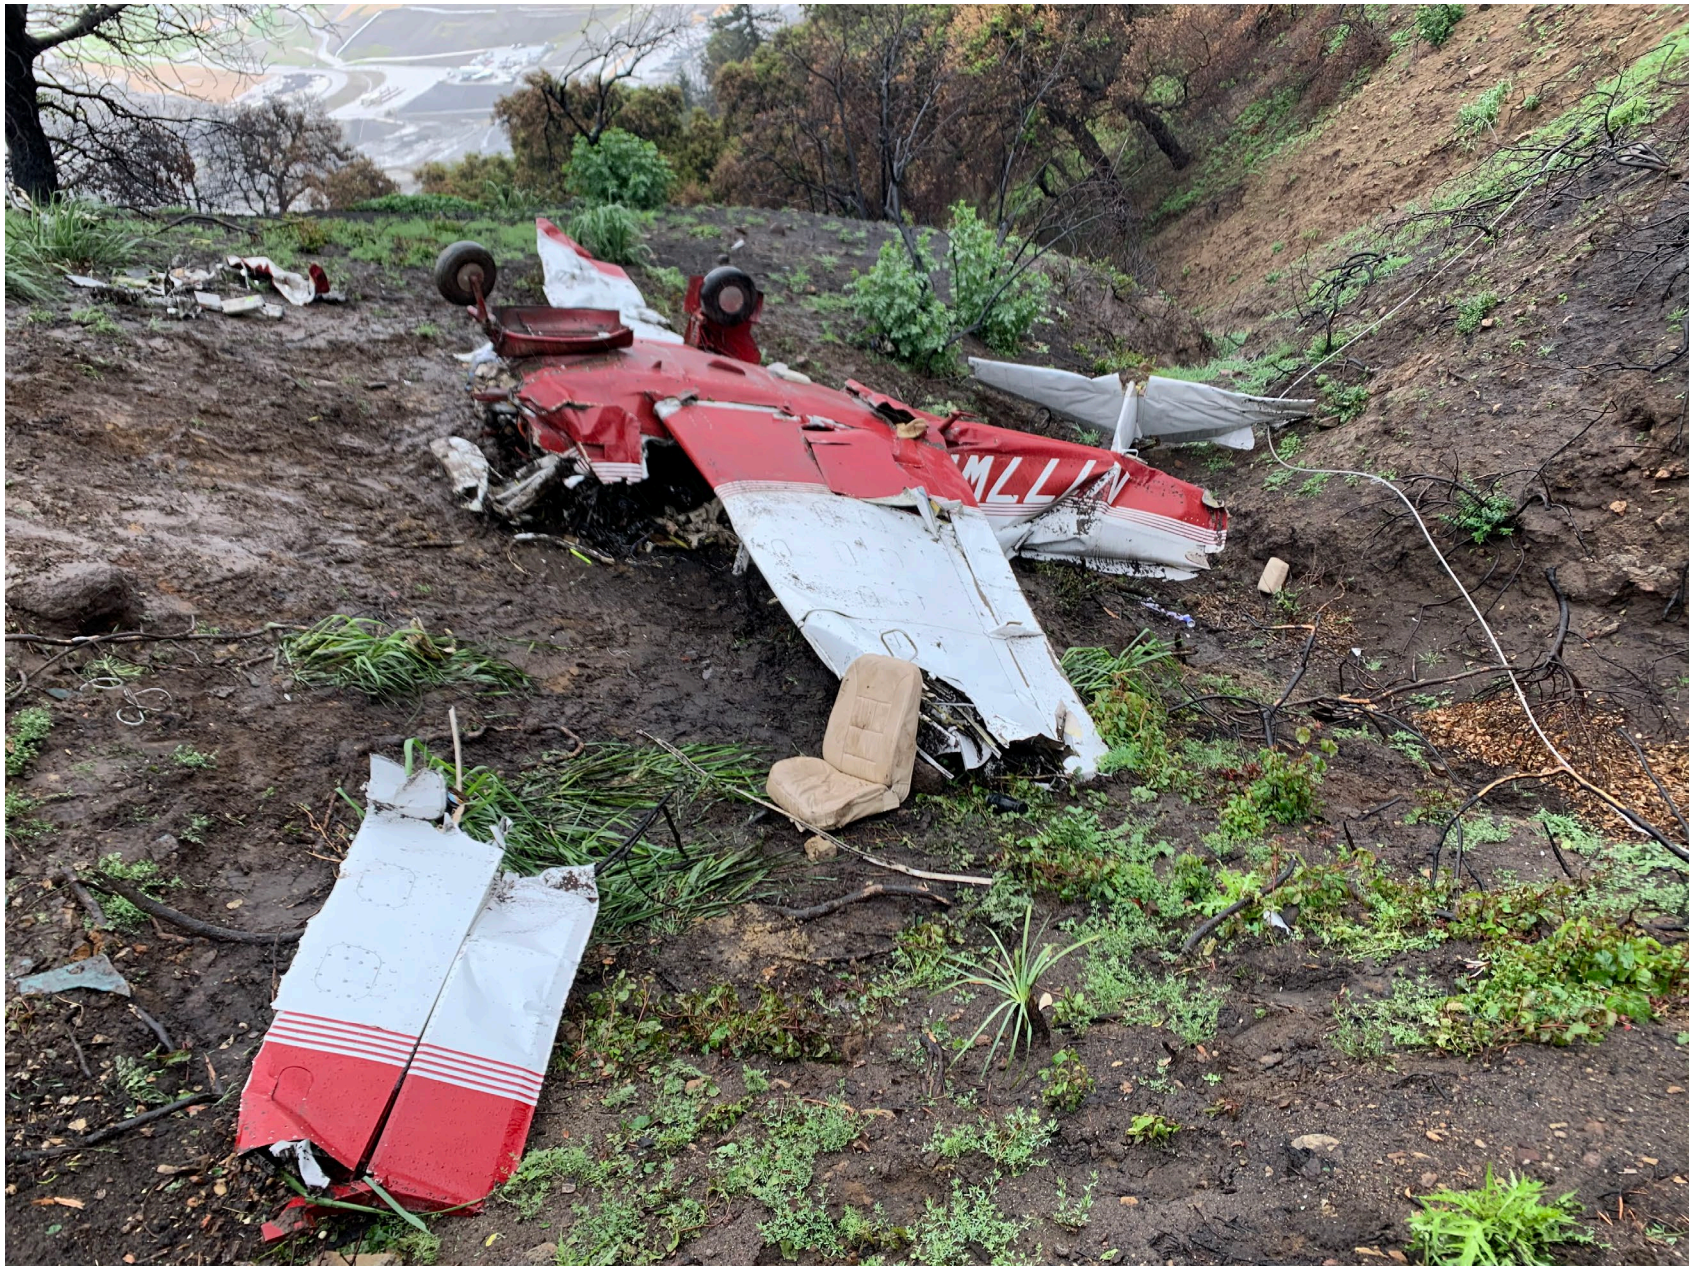
**Photo 3 - Main wreckage at the accident site.**

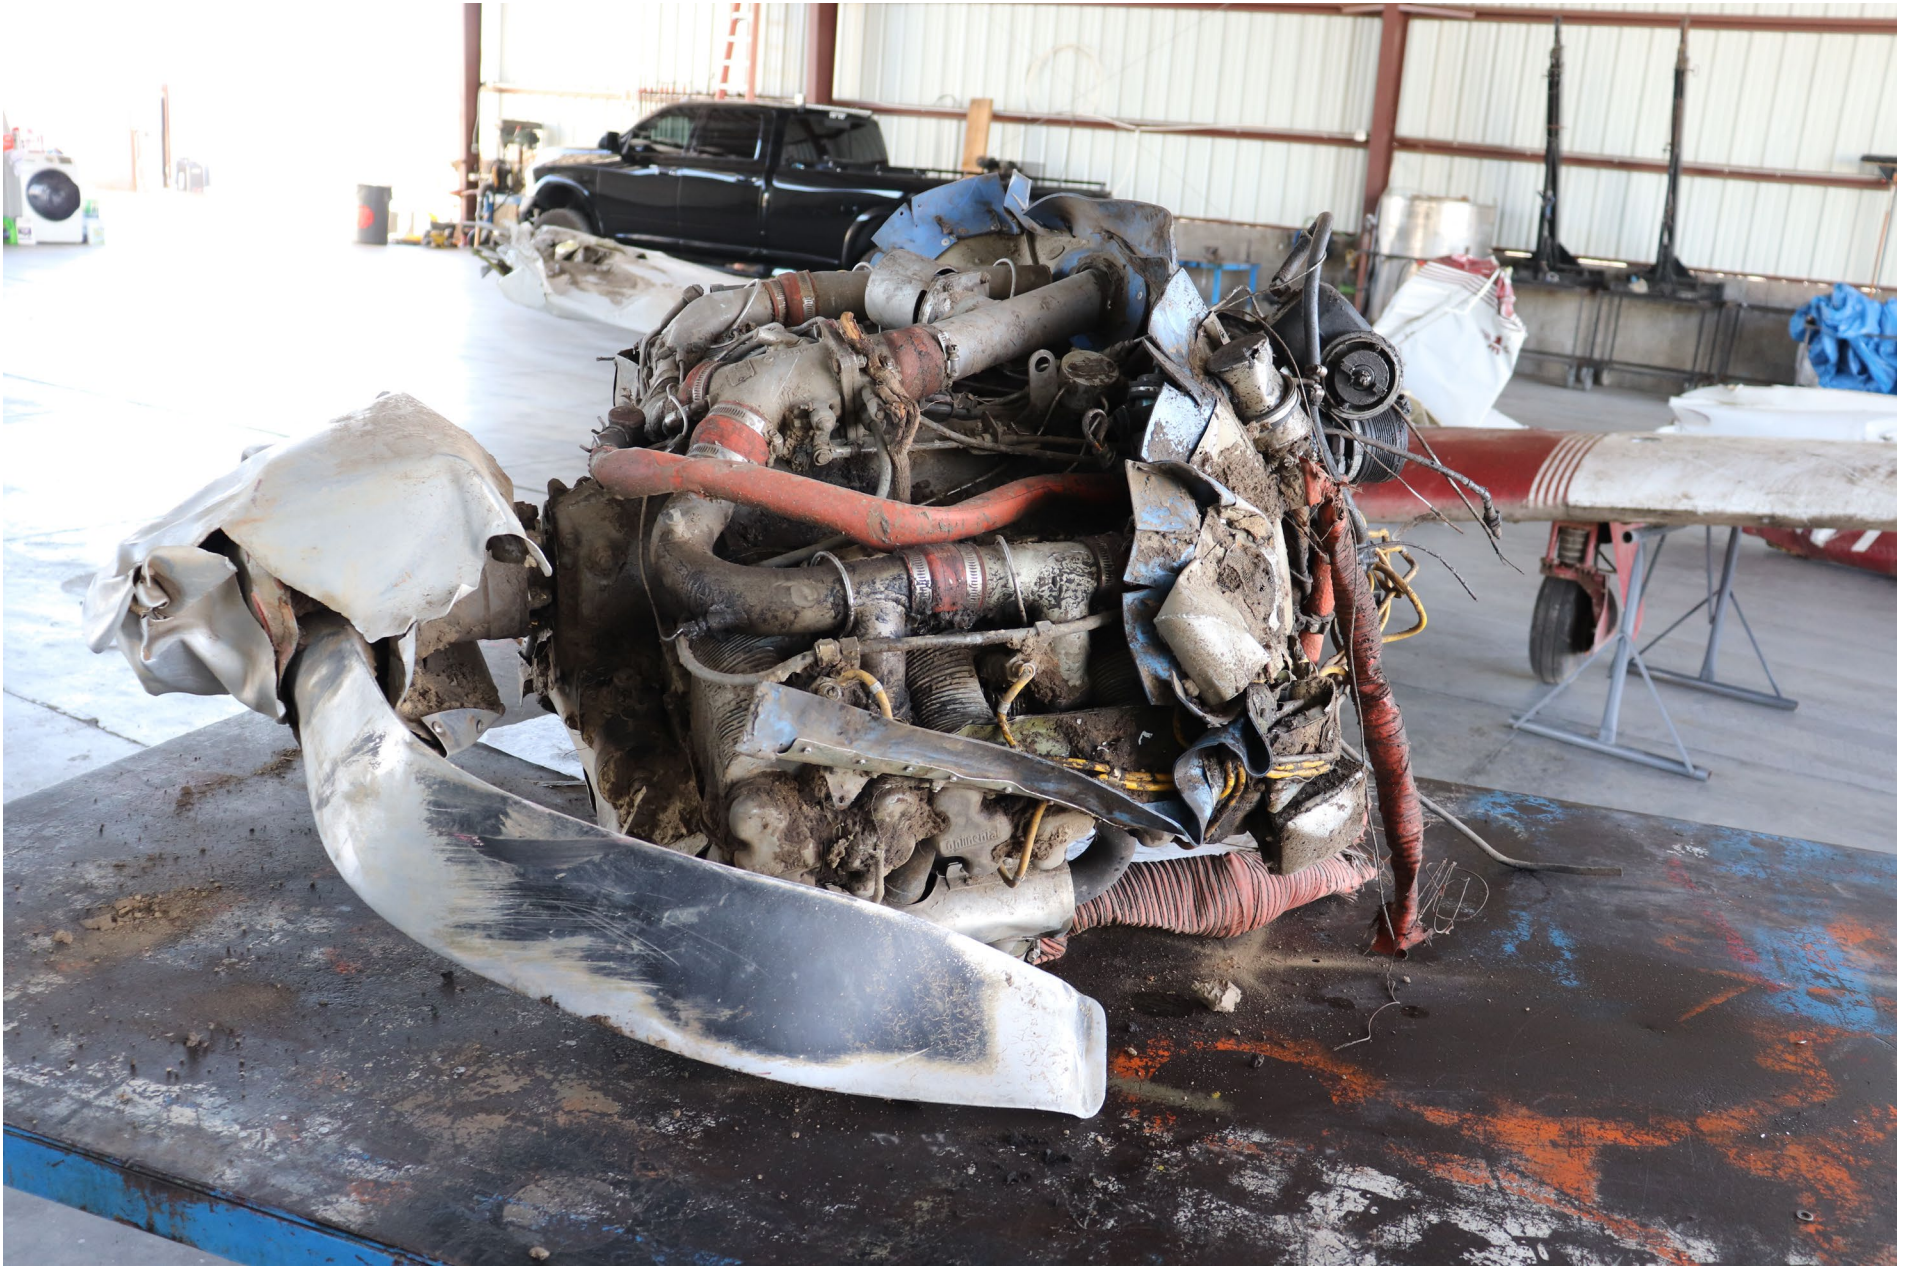
**Photo 4 – View of the recovered engine.**

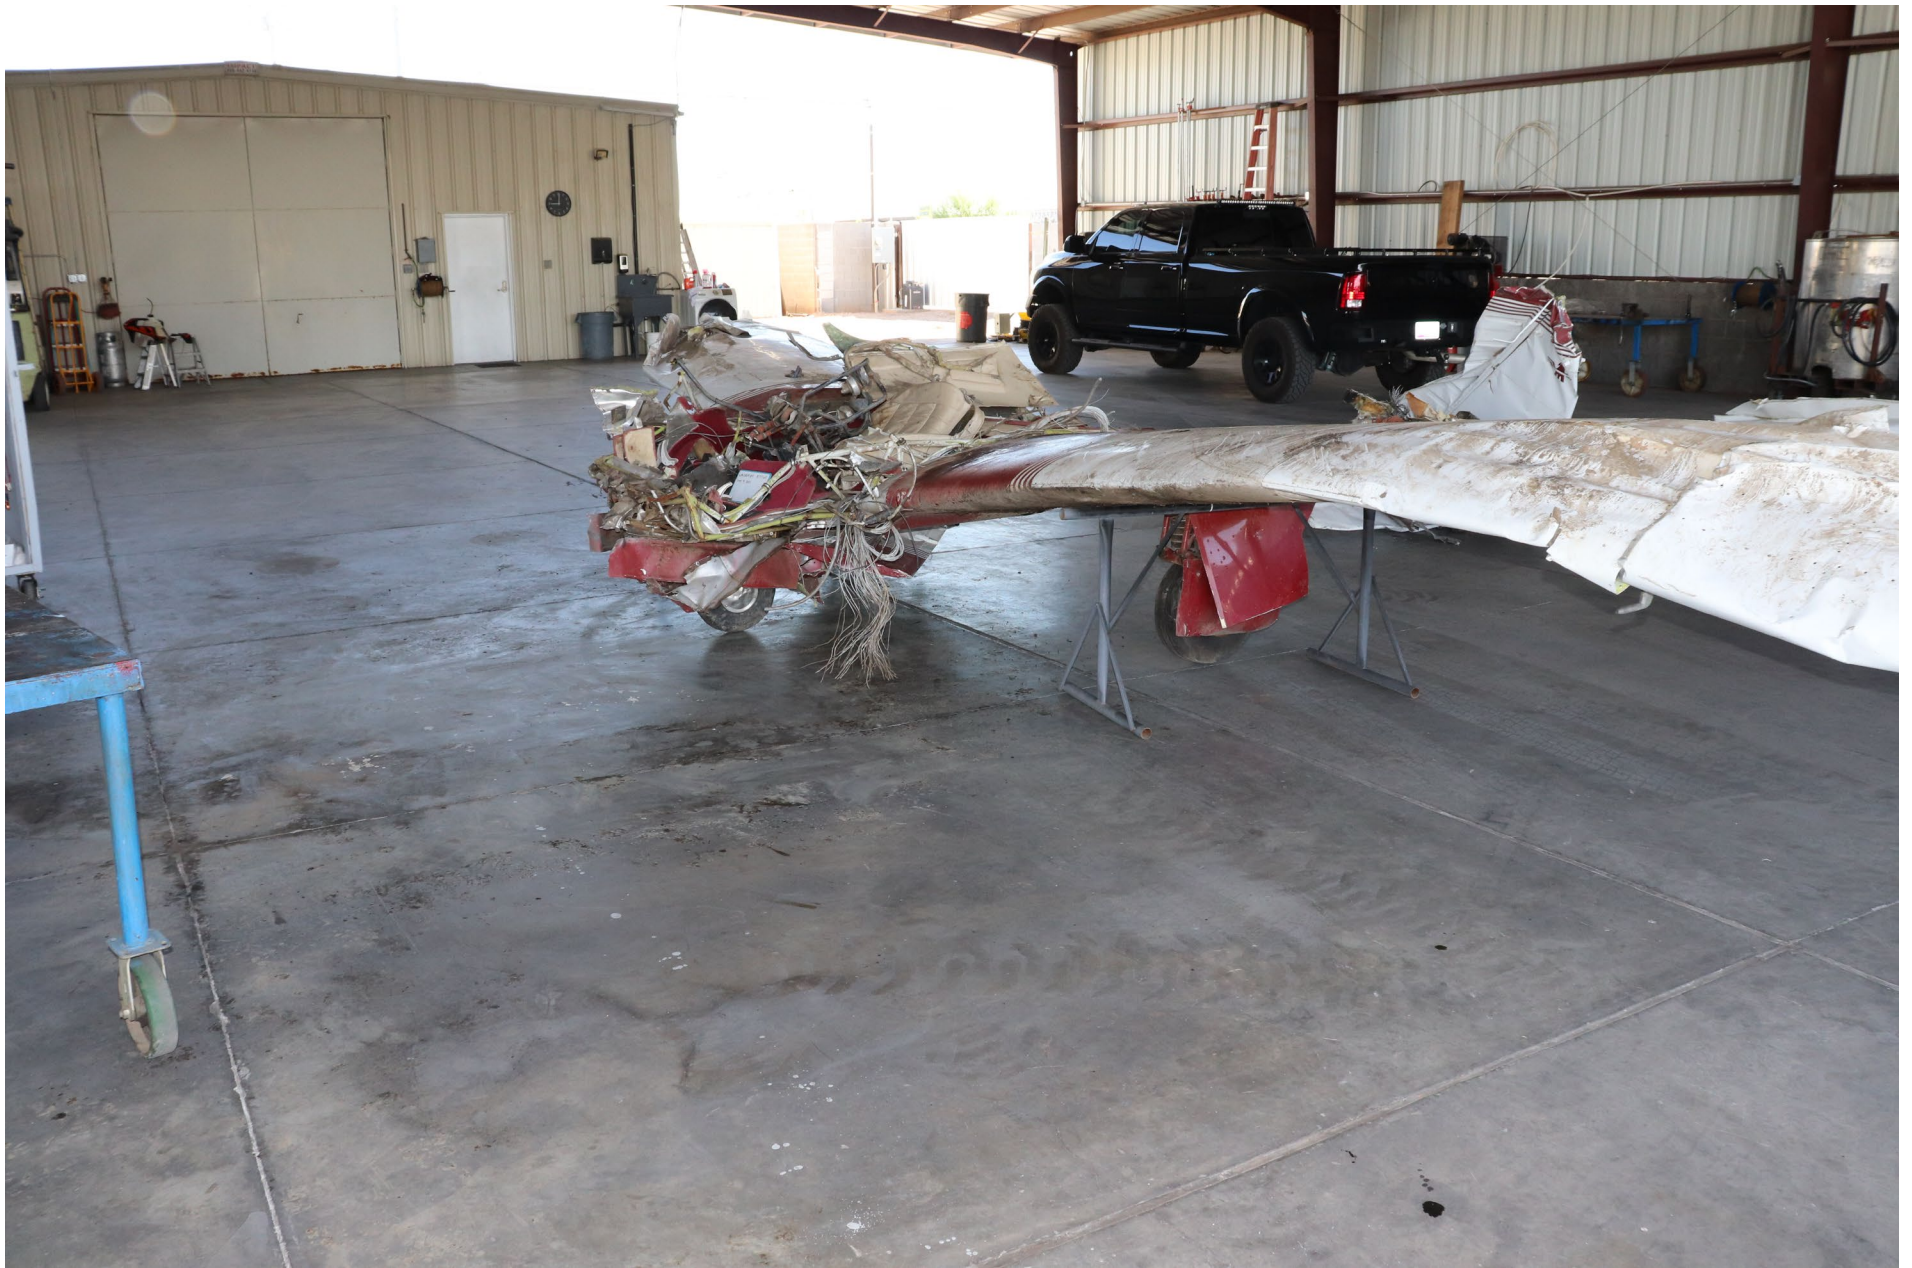
**Photo 5 - View of the recovered airframe**

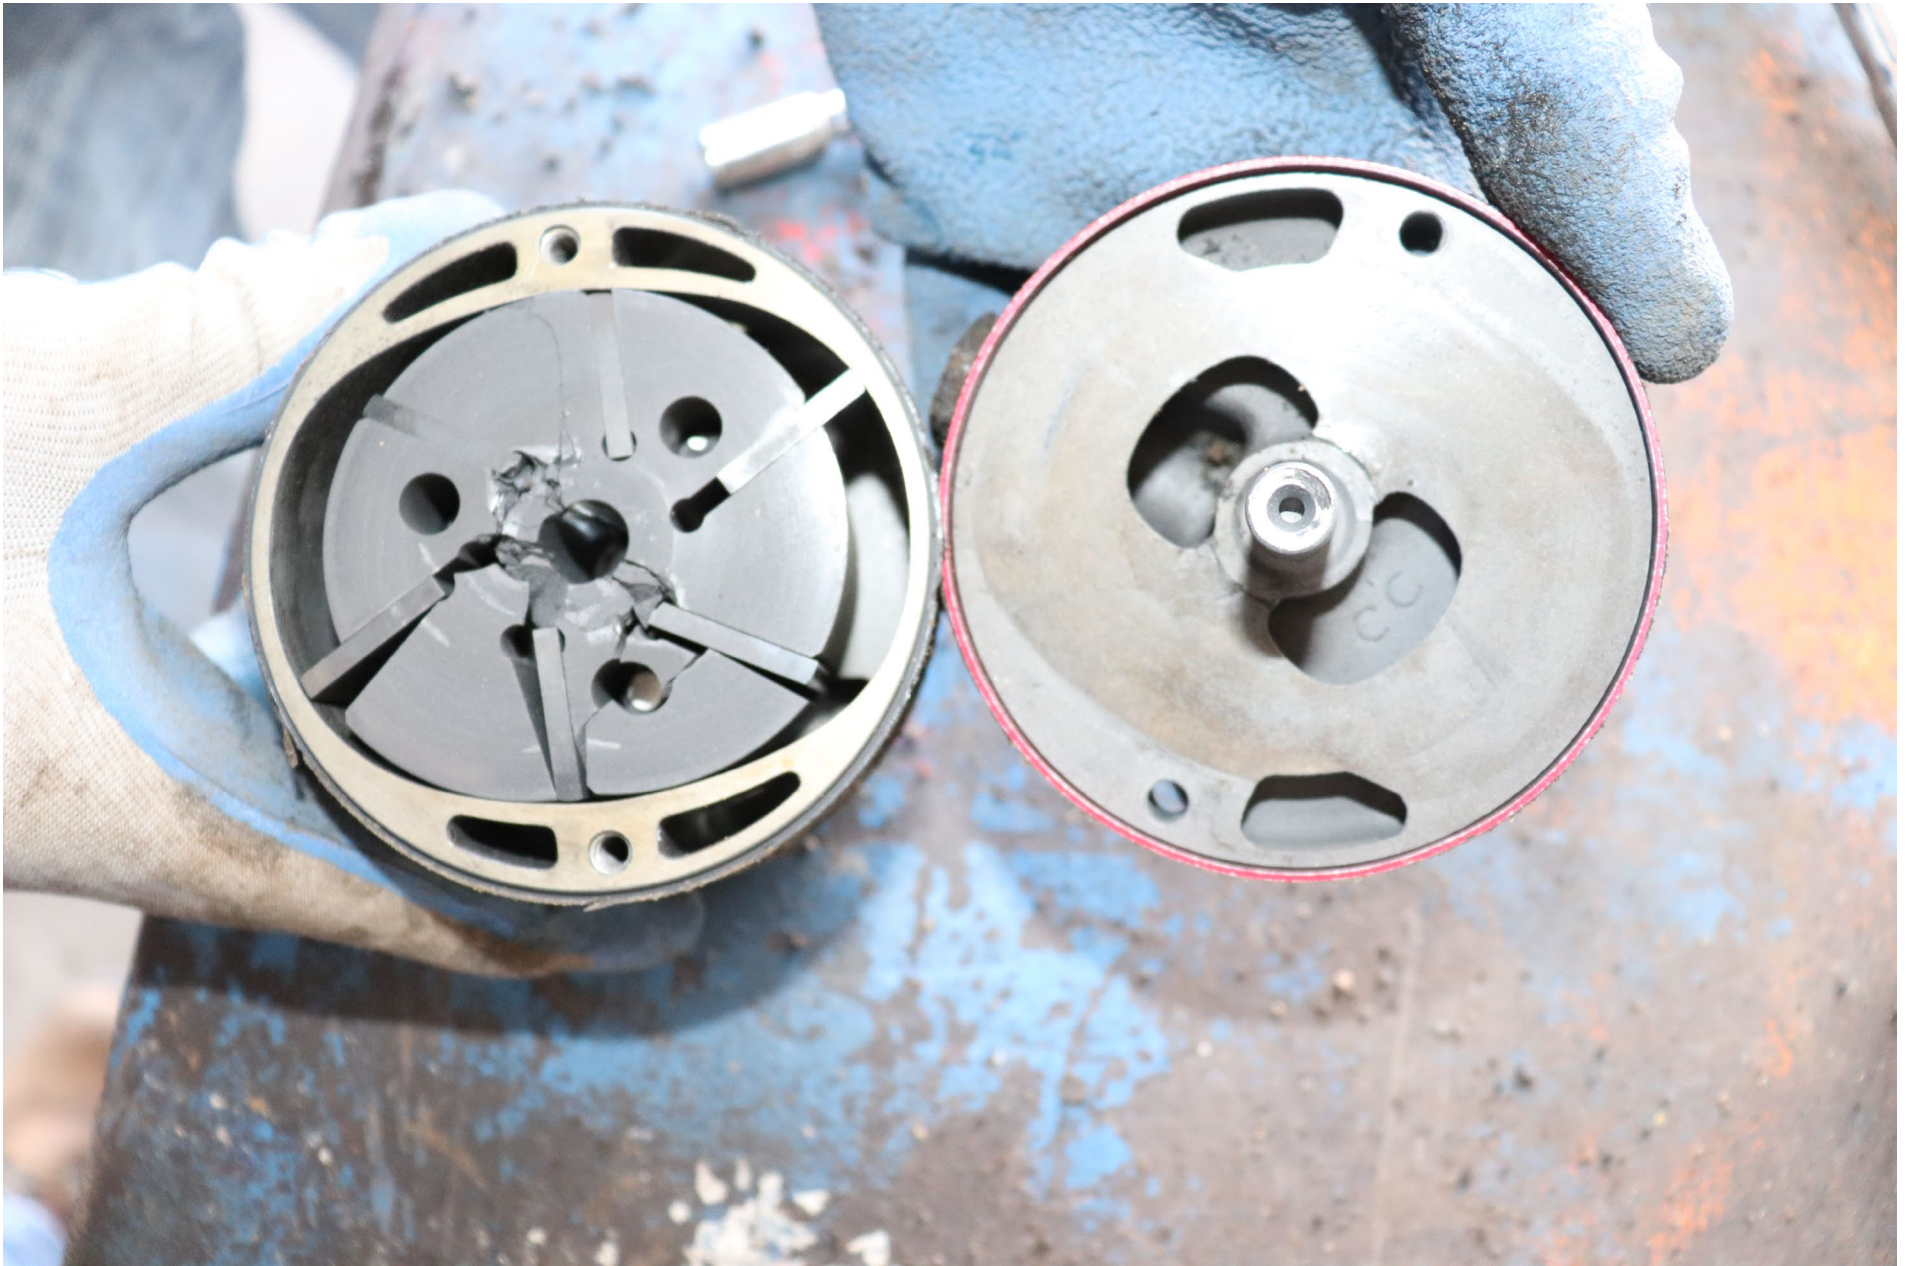
**Photo 6 – View of the internal components of the vacuum pump**

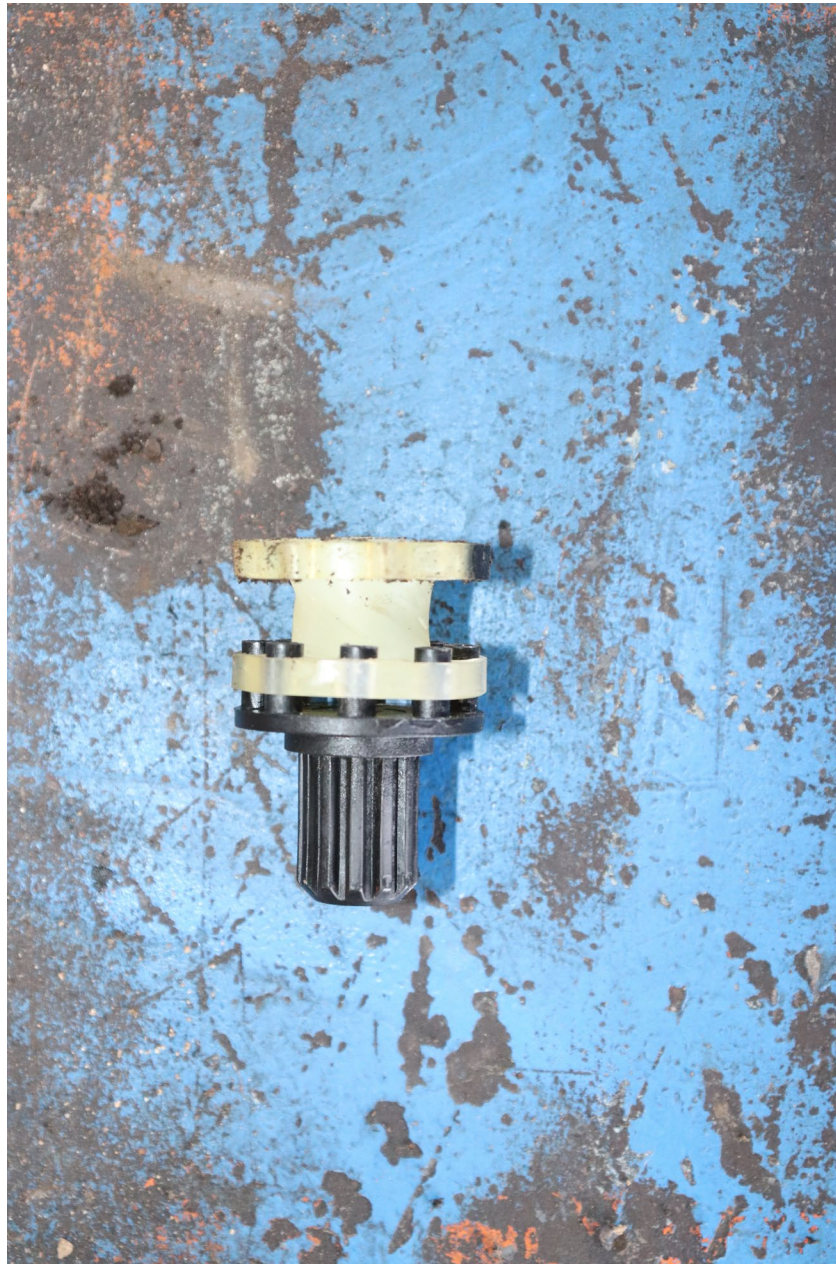
**Photo 7 - View of the vacuum pump drive shaft**

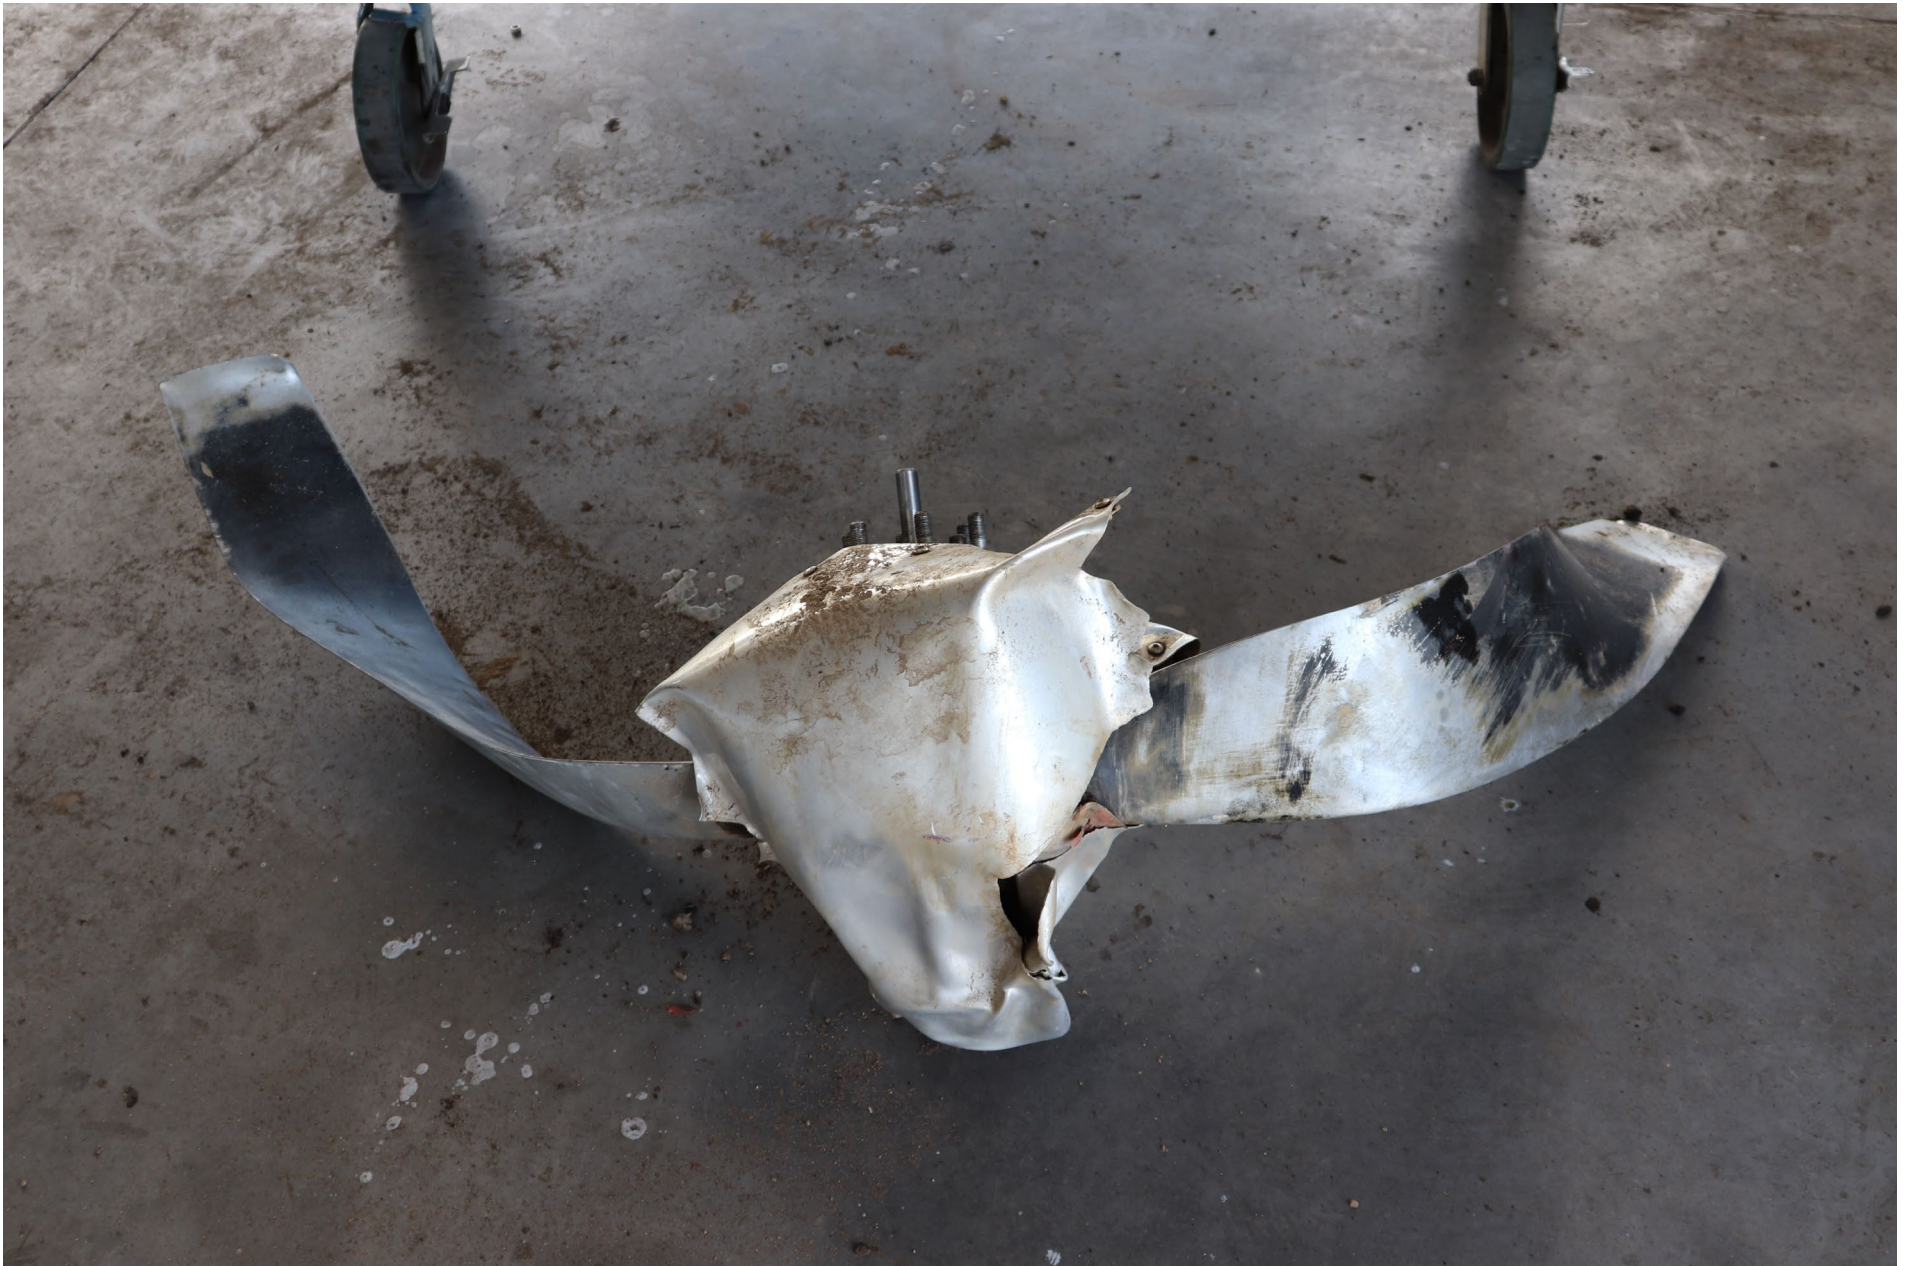
**Photo 8 – View of the propeller**

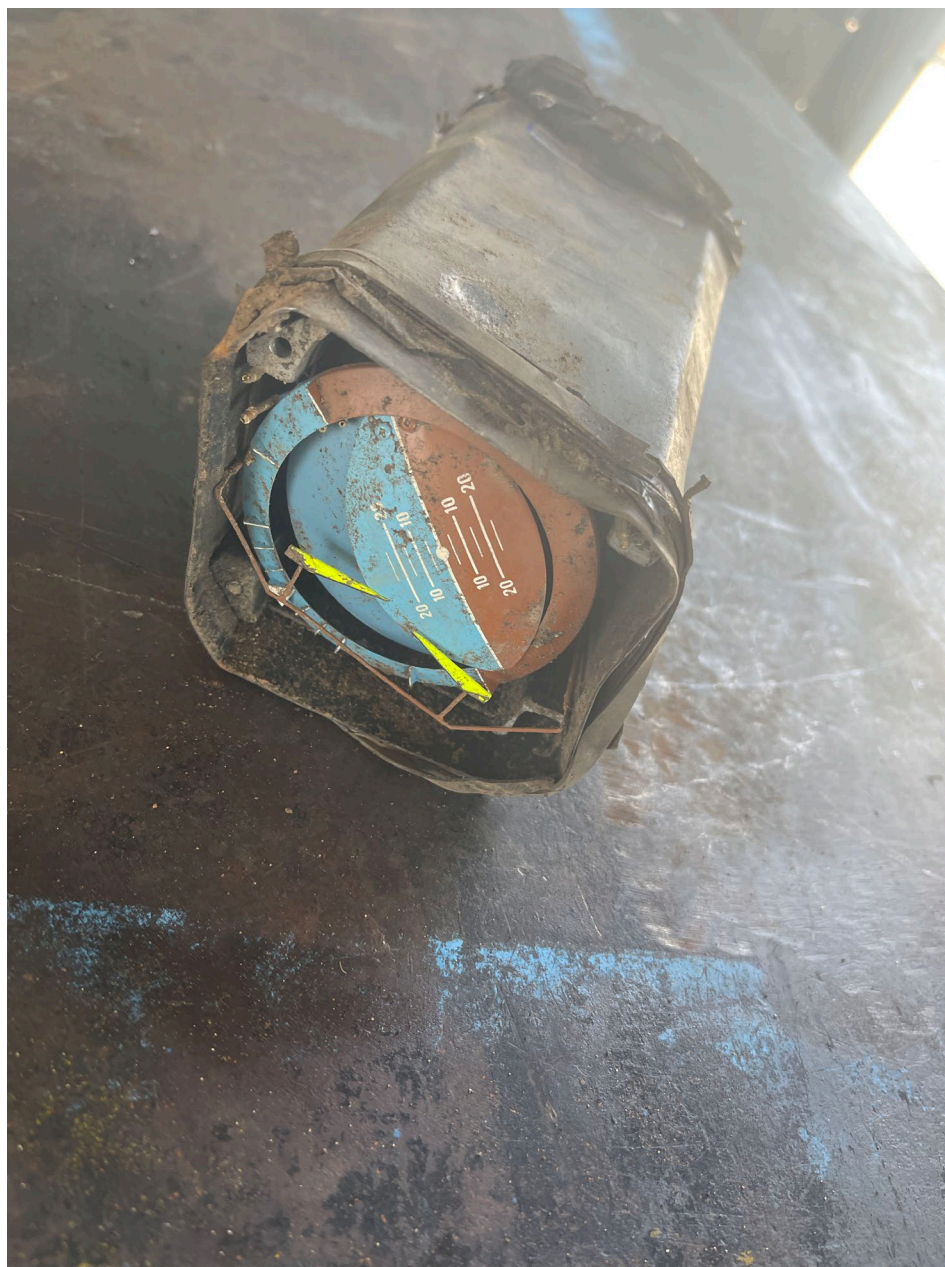
**Photo 9 – View of the damaged King KI-256**

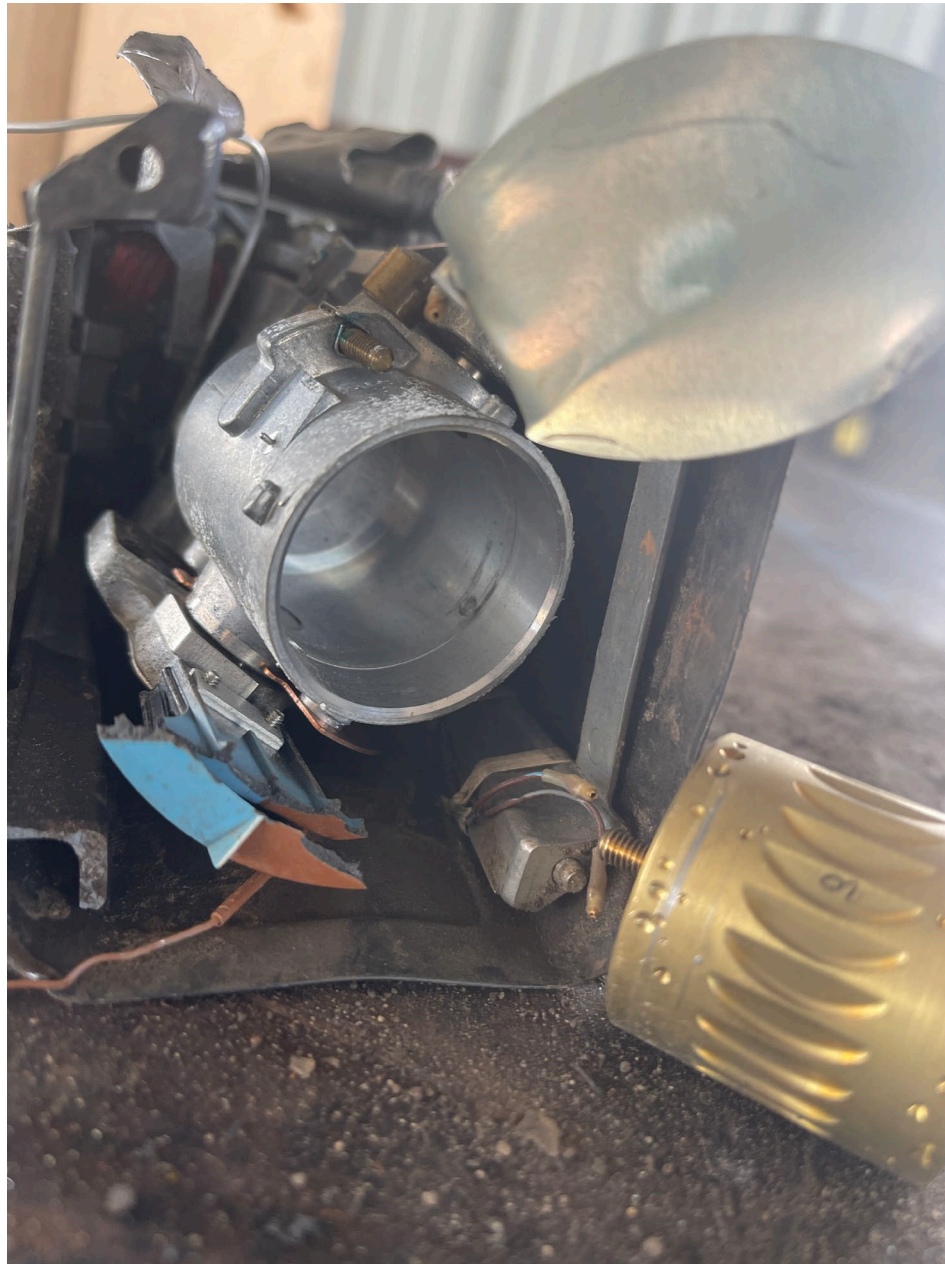
**Photo 10 - View of the King KI-256 gyro**
