## **NATIONAL TRANSPORTATION SAFETY BOARD**

### **ACCIDENT SITE / AIRFRAME / ENGINE EXAMINATION SUMMARY**

**WPR20FA108**

Location: Sylmar, California  
Date: March 13, 2020  
Aircraft: Mooney M20K, N777WP  
NTSB Investigator-in-Charge: Joshua Cawthra

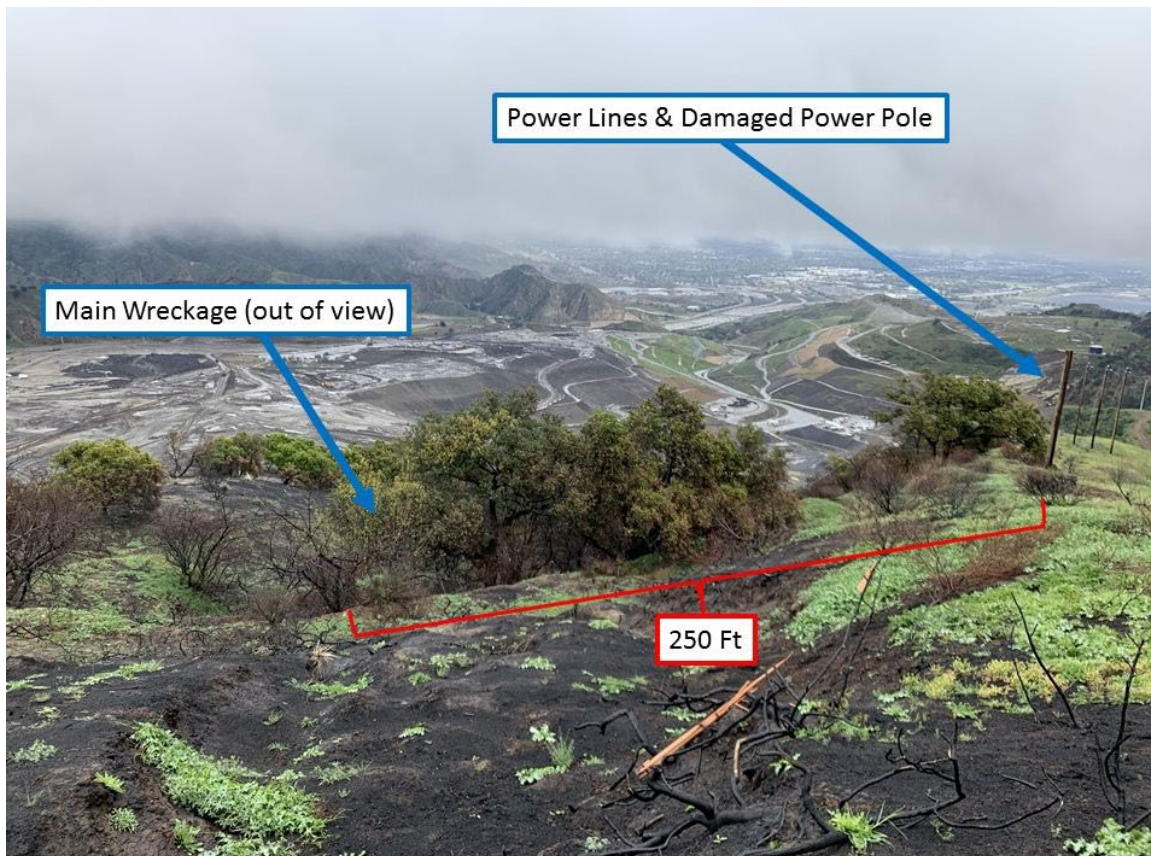
Examination of the accident site revealed that the airplane impacted power lines, which were about 50 ft in height, on a heading of about 064° before impacting terrain about 250 ft east and downslope of the powerlines. The fuselage came to rest inverted on heading of about 014° magnetic in a canyon surrounded by mountainous tree covered terrain at an elevation of about 2,315 ft mean sea level (msl). The wreckage debris path was measured about 260 ft in length, oriented on a heading of about 064° magnetic.

Figure 1: Accident Site Diagram

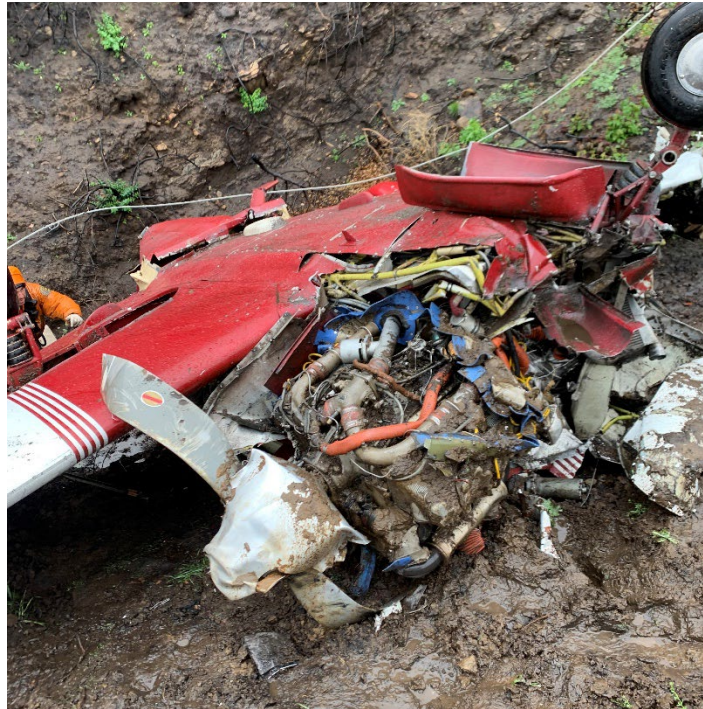
The fuselage was compressed throughout its length. The instrument panel was impact damaged with numerous instrument and radio separation observed. A portion of the right side of the fuselage was cut by first responders. The left side fuselage inspection cover was removed to turn off the emergency locator transmitter (was on, and functioning). The engine was displaced and partially attached to the fuselage. The induction system appeared to be intact. The propeller remained attached to the engine. One blade exhibited leading edge polishing, blade face polishing, and a portion of the propeller blade tip separated.

Figure 2: View of the engine, propeller, and portion of the fuselage and right wing.

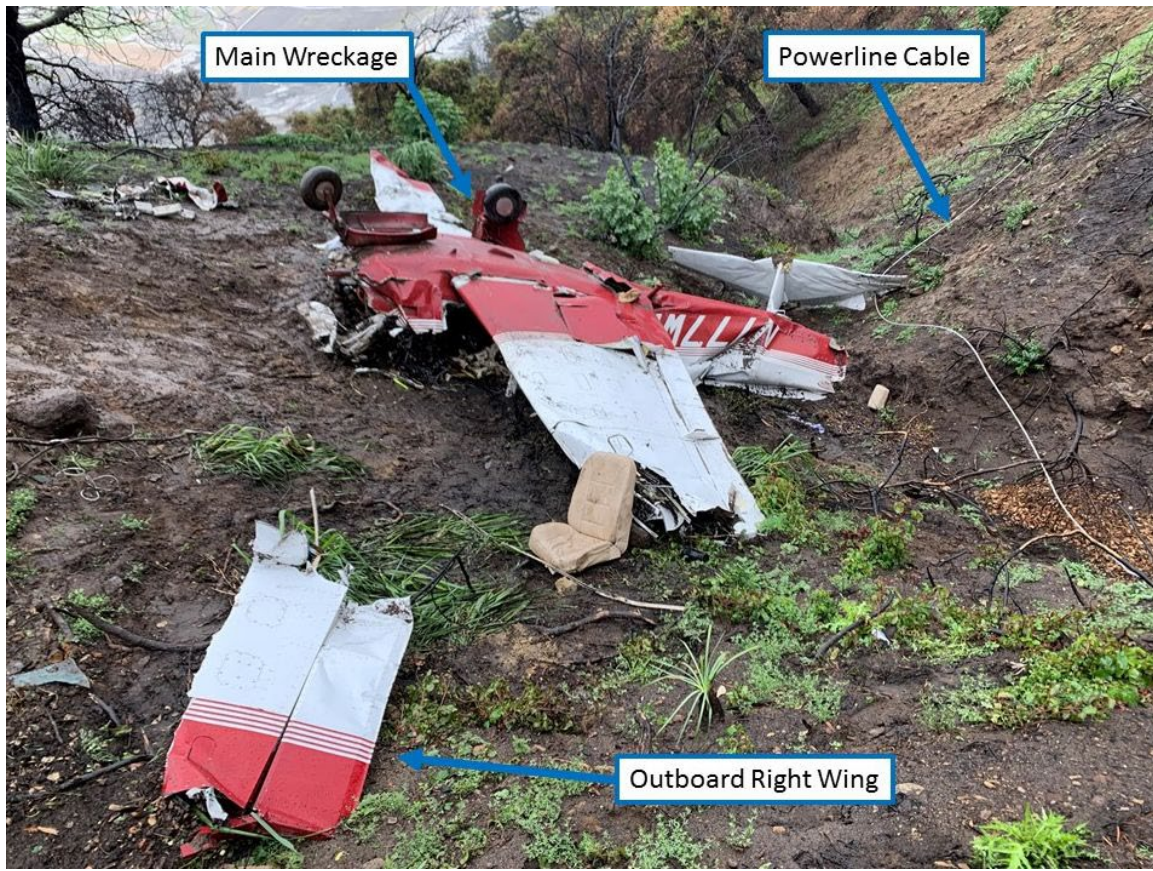
Both wings remained attached to the fuselage. The left main landing gear and nose wheel landing gear were in the extended position. The left wing was intact, and the flap and aileron remained attached via their mounts. The left wing exhibited bending and buckling throughout. The right wing was mostly intact, and bent and buckled throughout, with the exception of the outboard portion of the right wingtip and right aileron. The right flap remained attached via its mounts. The right main landing gear was retracted, and the right gear door exhibited a partial tear in the lower portion of the door and was bent and buckled. No wire marks were observed on the gear door.

Figure 3: Main Wreckage

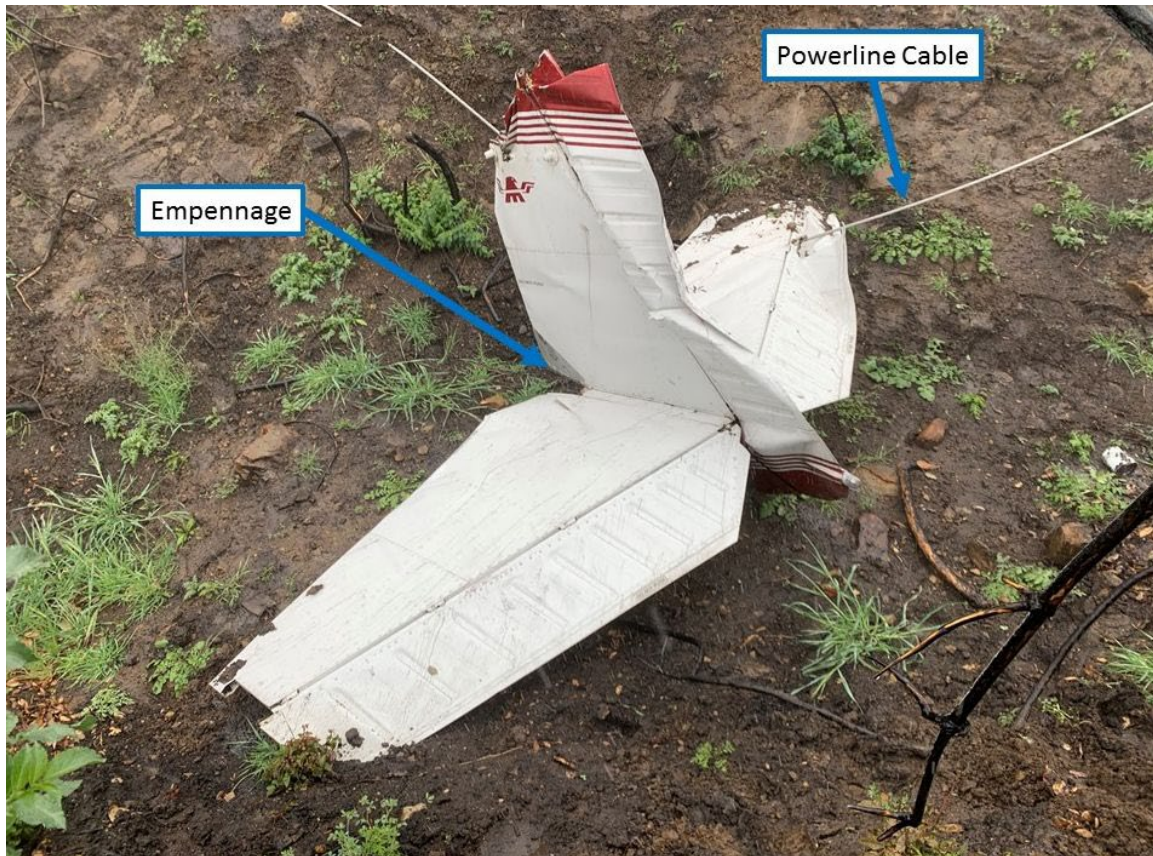
The empennage was separated from the fuselage just aft of the horizontal stabilizers. Both left and right horizontal stabilizers, elevators, vertical stabilizer, and rudder remained attached to the empennage. A portion of a braided power line remained entangled within the right elevator. The rudder exhibited a trailing edge indentation about mid height, that extended forward to just before the rudders spar. The upper portion of the rudder and vertical stabilizer was crushed downward.

Figure 4: Empennage

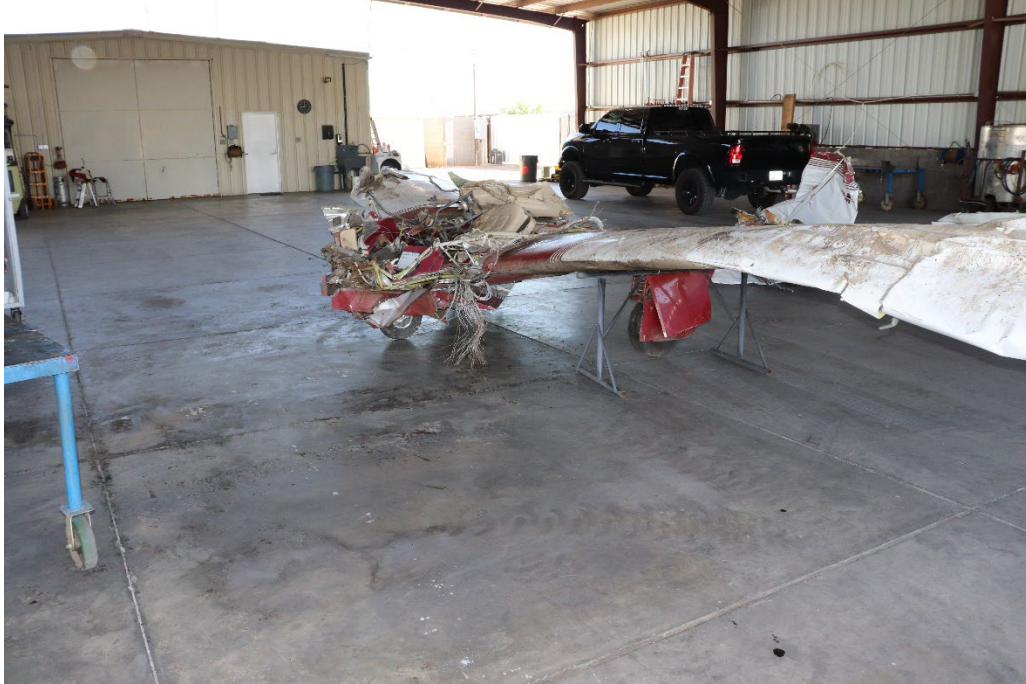
Examination of the recovered wreckage revealed that the cabin roof and aft fuselage structure, and engine were separated by wreckage recovery personnel to facilitate wreckage recovery.

Figure 5: View of the recovered wreckage.

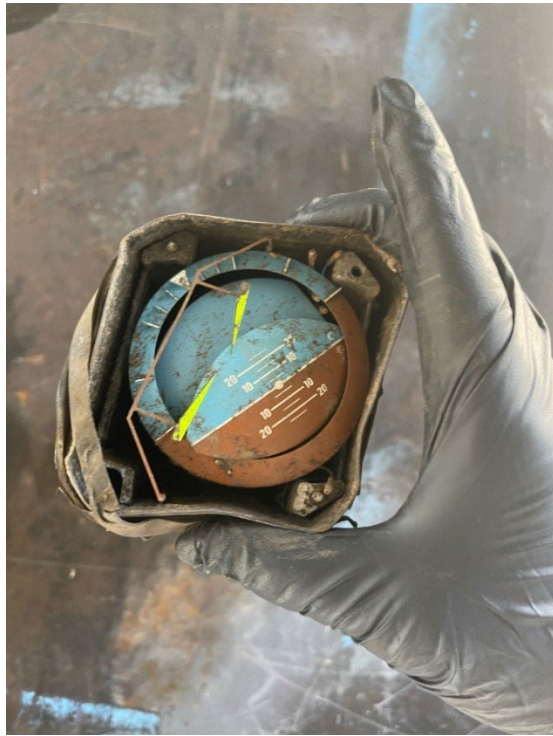
Figure 6: King KI-256

The King KI-256 instrument was impact damaged, which precluded functional testing. The gyro gimble was removed and disassembled. The gyro exhibited some rotational scoring

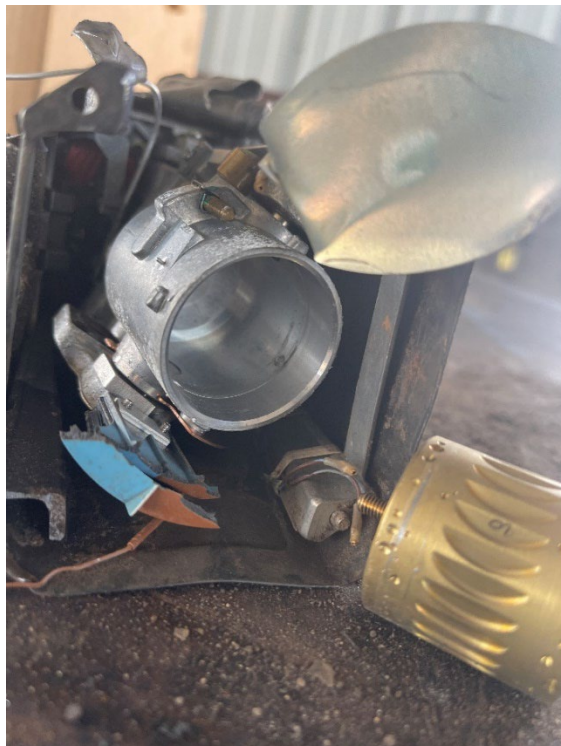
Figure 7: King KI-256 Gyro
