## **NATIONAL TRANSPORTATION SAFETY BOARD**

# **AIRFRAME AND ENGINE EXAMINATION**

**WPR20LA007**

Location: Susanville, California  
Date: October 13, 2019  
Aircraft: N131HA / Hiller UH-12E  
NTSB IIC: Fabian Salazar

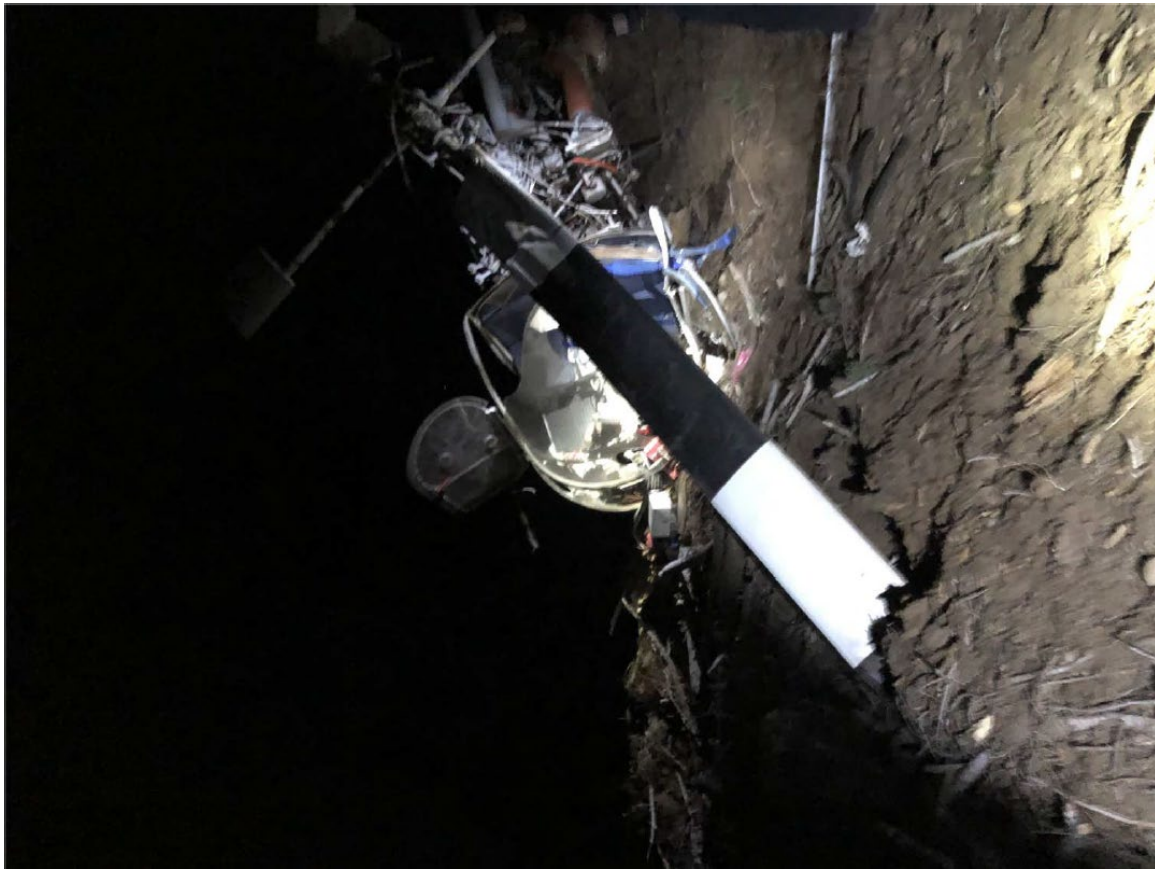
Figure 1. N131HA at the accident site. Photo courtesy of the operator.

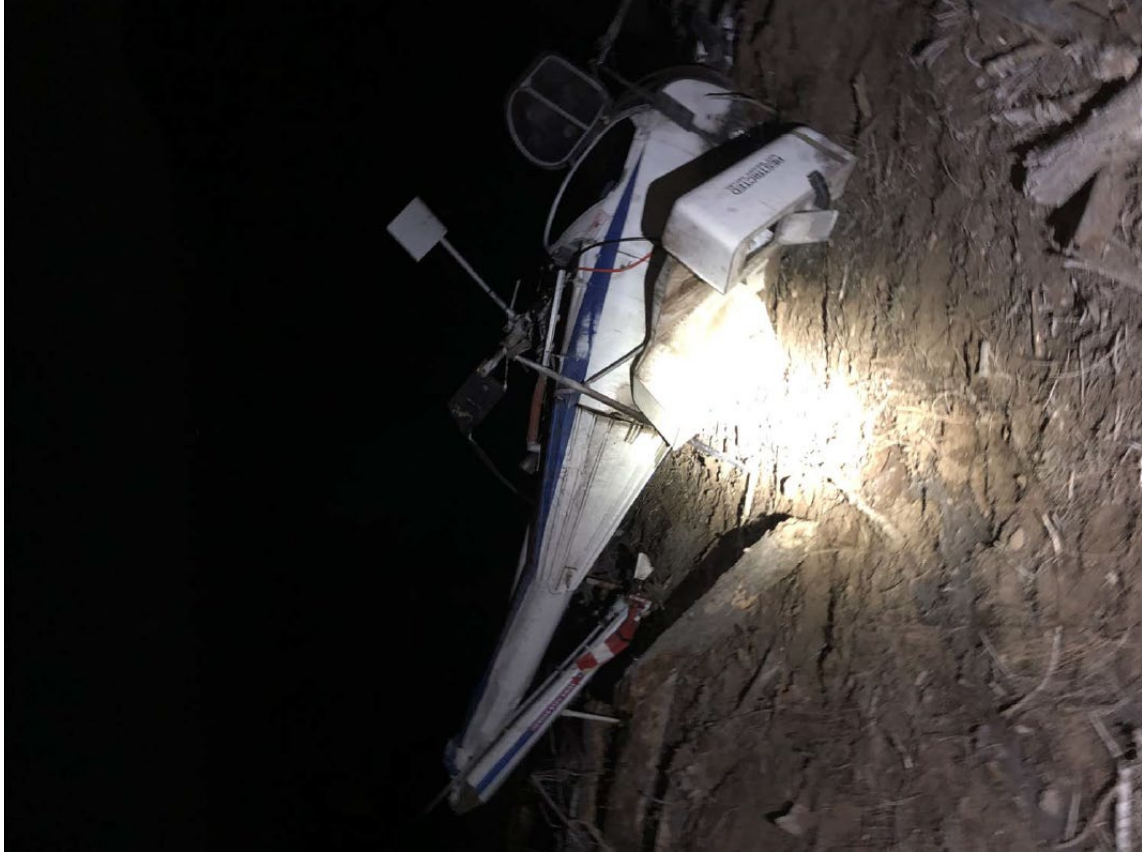
Fuselage. Examination of the fuselage started from the right side and worked around to the left side. The right-side door was removed during recovery. The right underside just aft of the rear cross tube exhibited a large dent. The right skid was removed for recovery, and the fore and aft cross tubes remained attached. The cross tubes exhibited normal appearance. The tailboom exhibited upward bending beginning near the driveshaft intermediate gearbox. The tailboom separated near the intermediate gearbox. The separated section of the tailboom was about 72 inches in length. The left side of the tailboom exhibited similar damage as the right side. The left side of the fuselage exhibited damage to the underside. The fore cross tube was bent rearward,

Figure 2. Right-underside view. Photo courtesy of the operator.

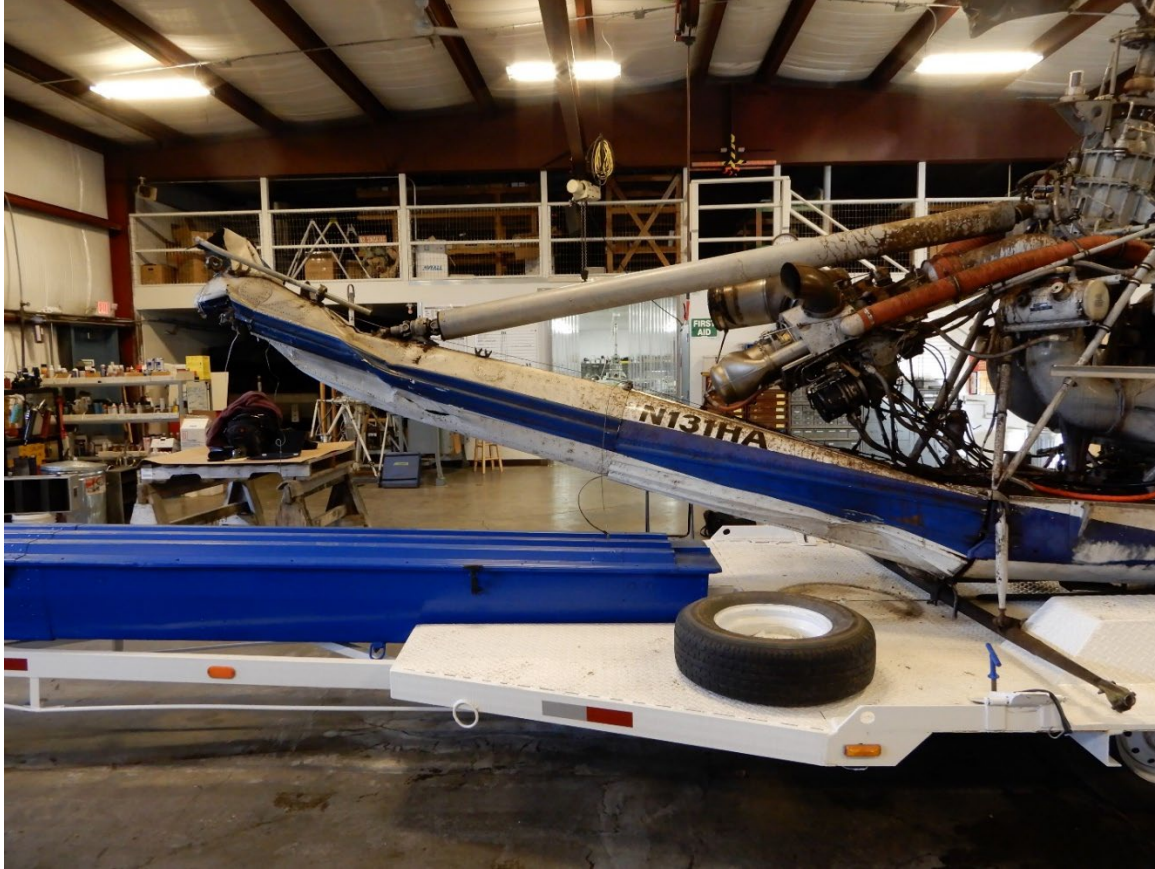
Figure 5. Right-side view showing damage to the tailboom. Photo NTSB.

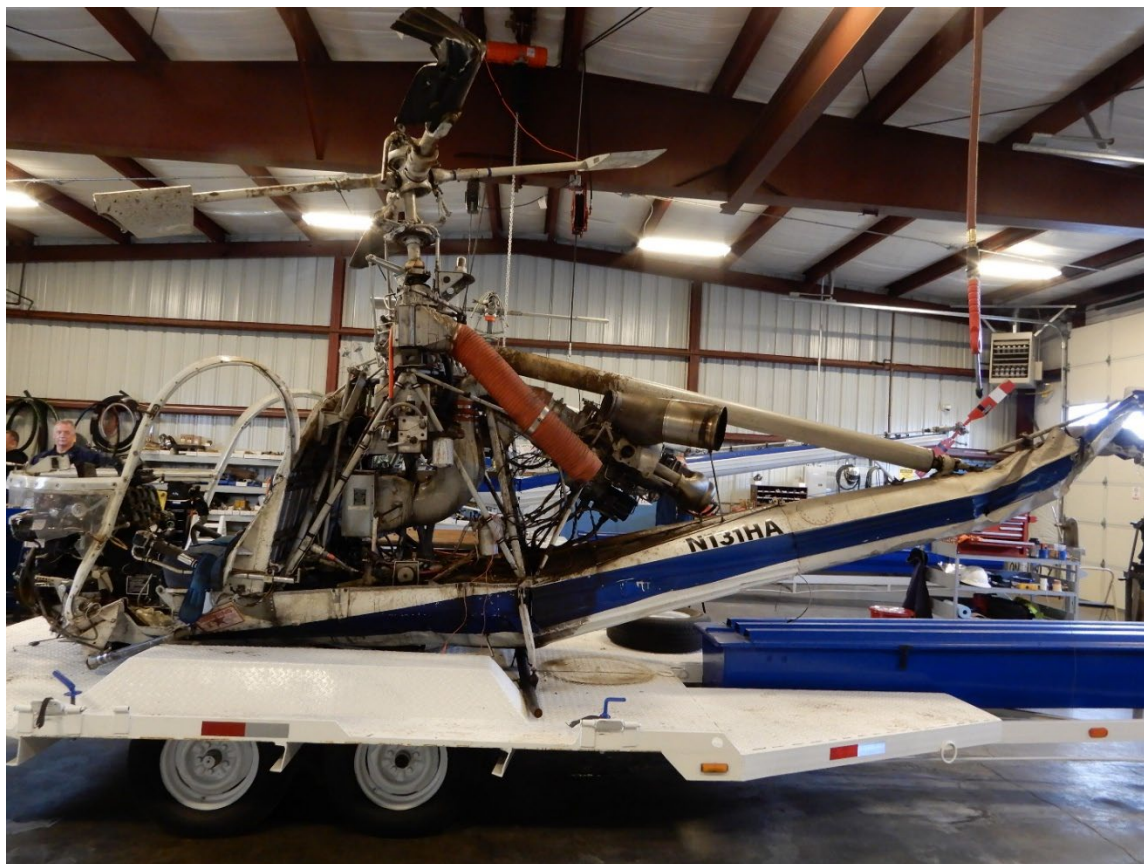
and the aft cross tube exhibited damage to the tip, with upward bending. The left side of the cockpit framework was bent inward and upward.

Figure 7. Left-side view. Photo NTSB.

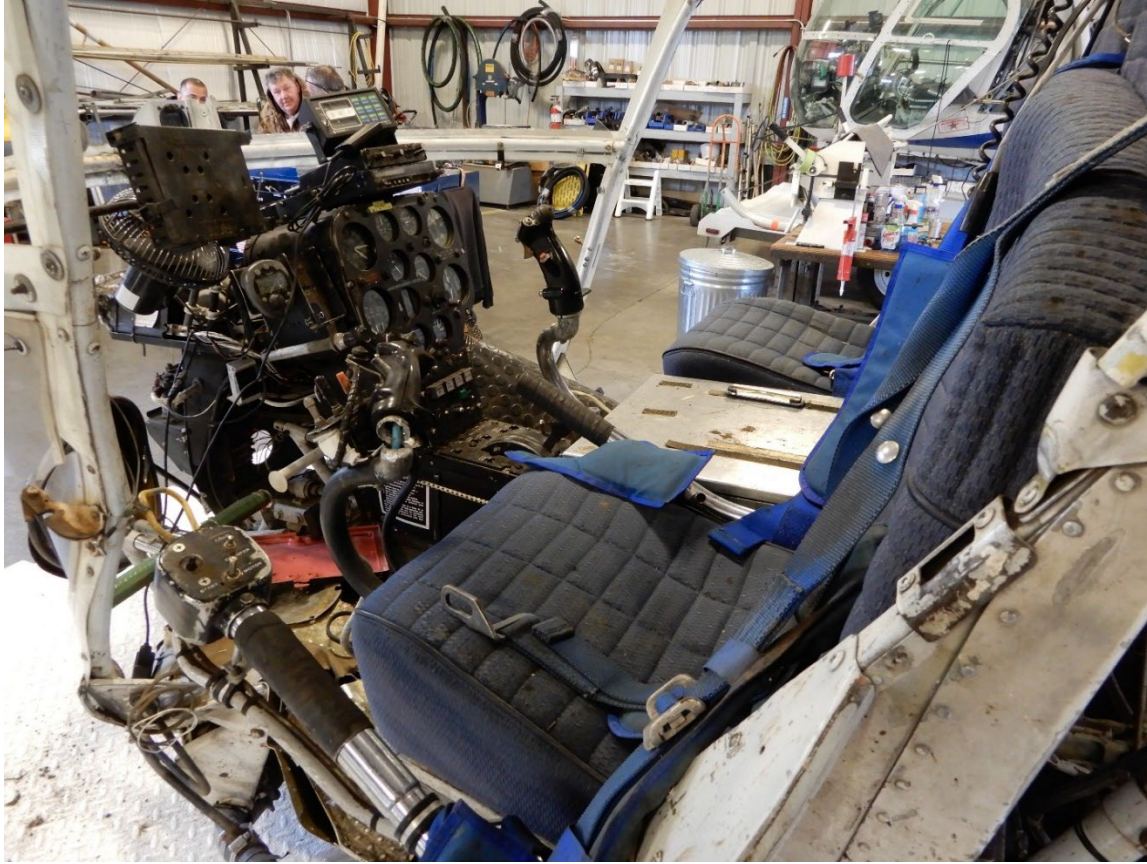
Figure 8. Left-side view of the cockpit. Photo NTSB.

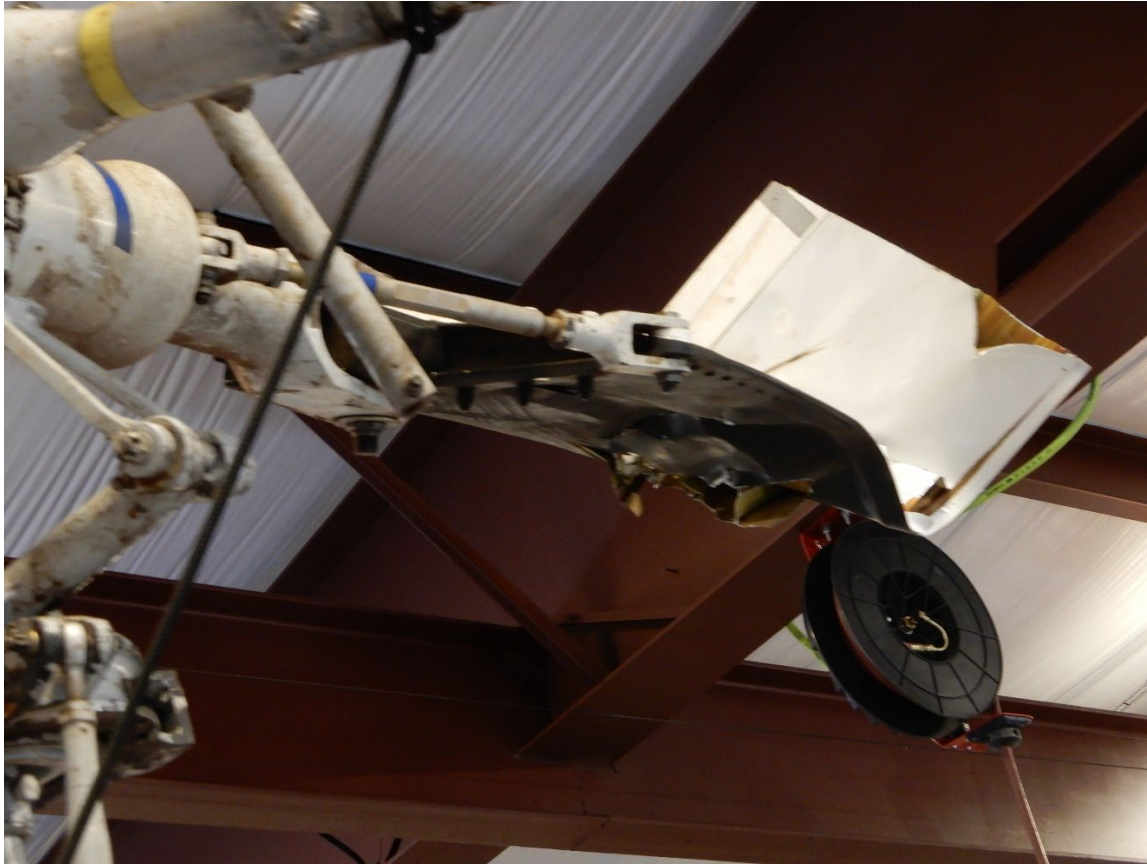
Main rotor system. The main rotor system remained attached to the mast and the transmission. One blade had yellow tape to identify its components and the other blade had blue tape to identify its components. The root, outboard to about 30 inches of the blue blade remained attached to the yoke and the blade grip. The blue rotor-matic paddle remained attached to the rotor assembly and exhibited no damage. The root, outboard to about 18 inches of the yellow blade remained attached to the yoke at the blade grip. The yellow rotor-matic paddle exhibited damage at its tip. The remaining sections of the main rotor blades were examined. Neither could be identified with a yellow or blue color, hence they were referred to as the A blade and the B blade. Both A and B blades exhibited damage throughout their spans. Both blades exhibited chord wise, aft, and upward bending and wrinkling of the skin.

Figure 9. View of the blue main rotor blade root. Photo NTSB.

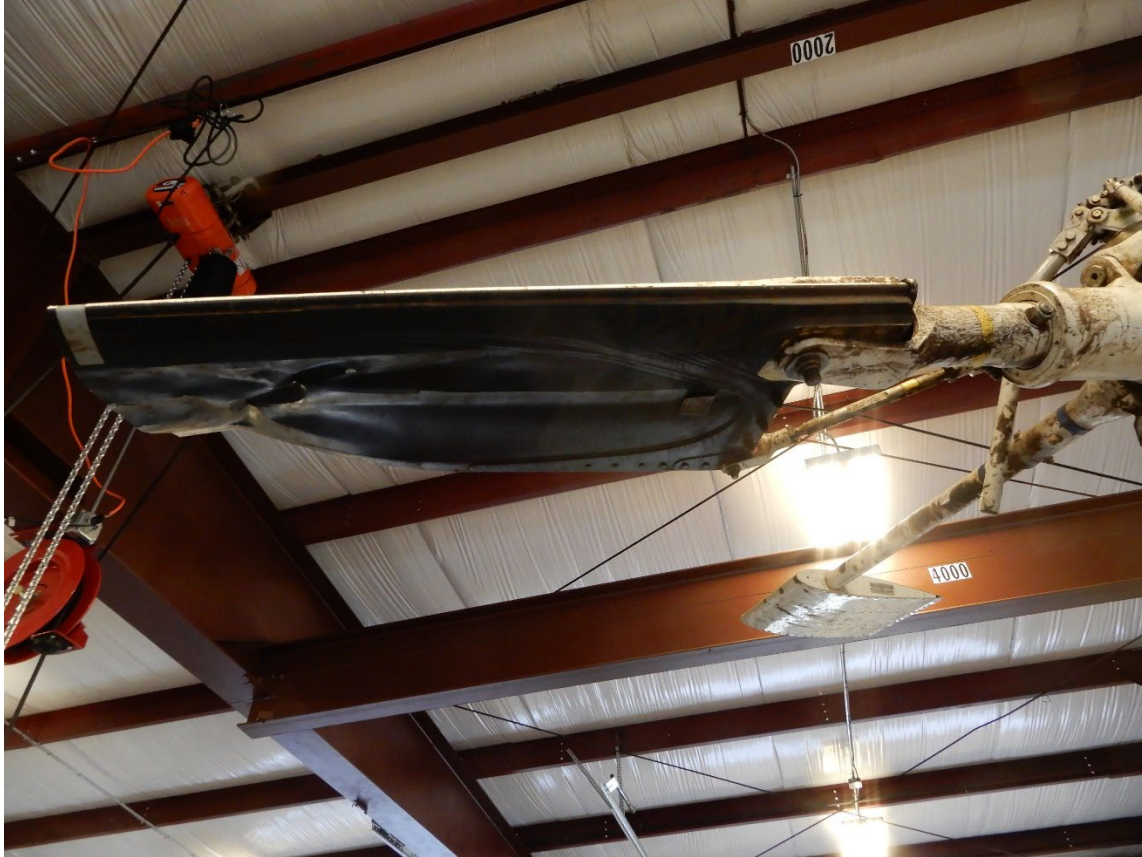
Figure 10. View of the yellow main rotor blade root. Photo NTSB.

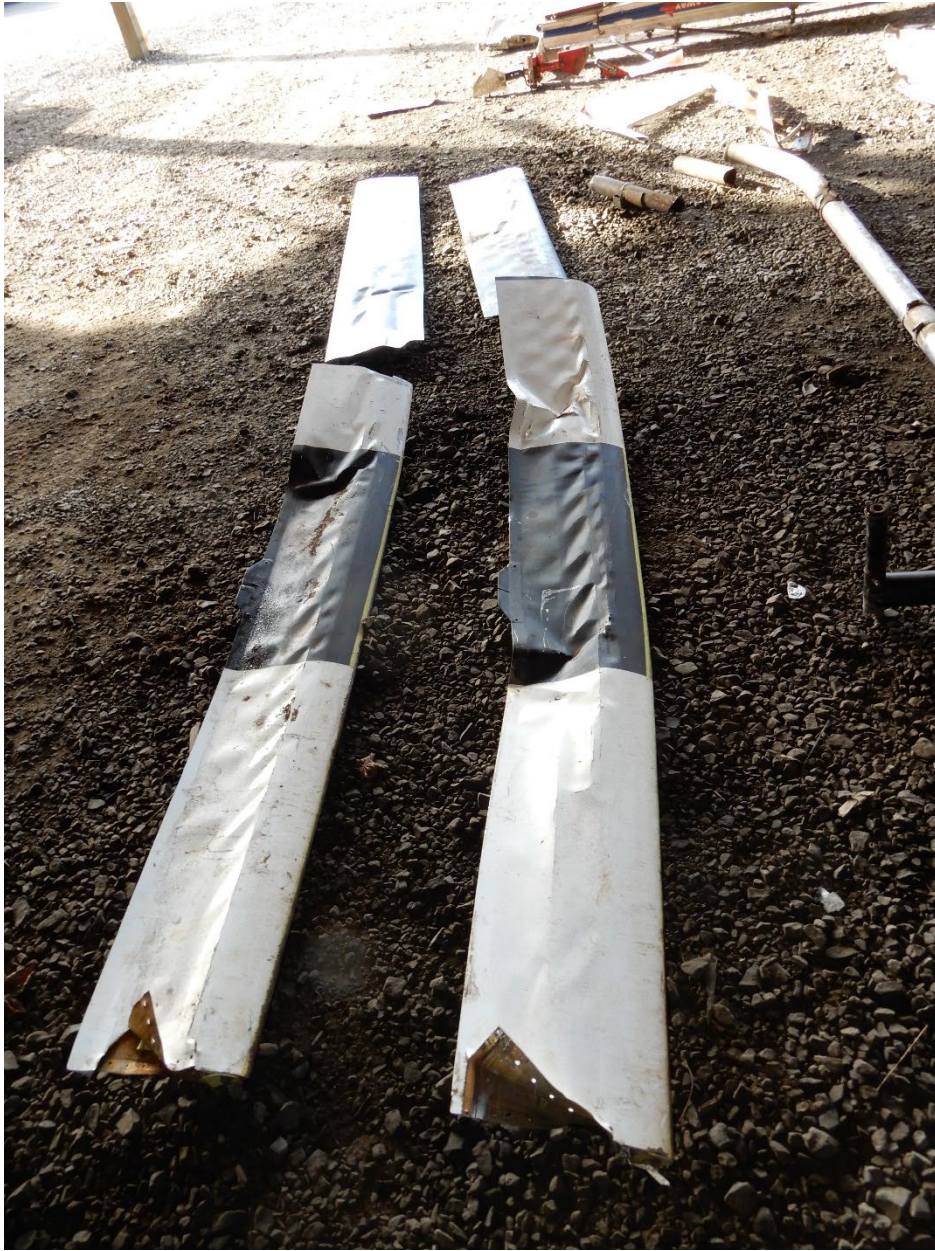
Figure 11. View of the main rotor blades, top side, with blade tops in the foreground. Photo NTSB.

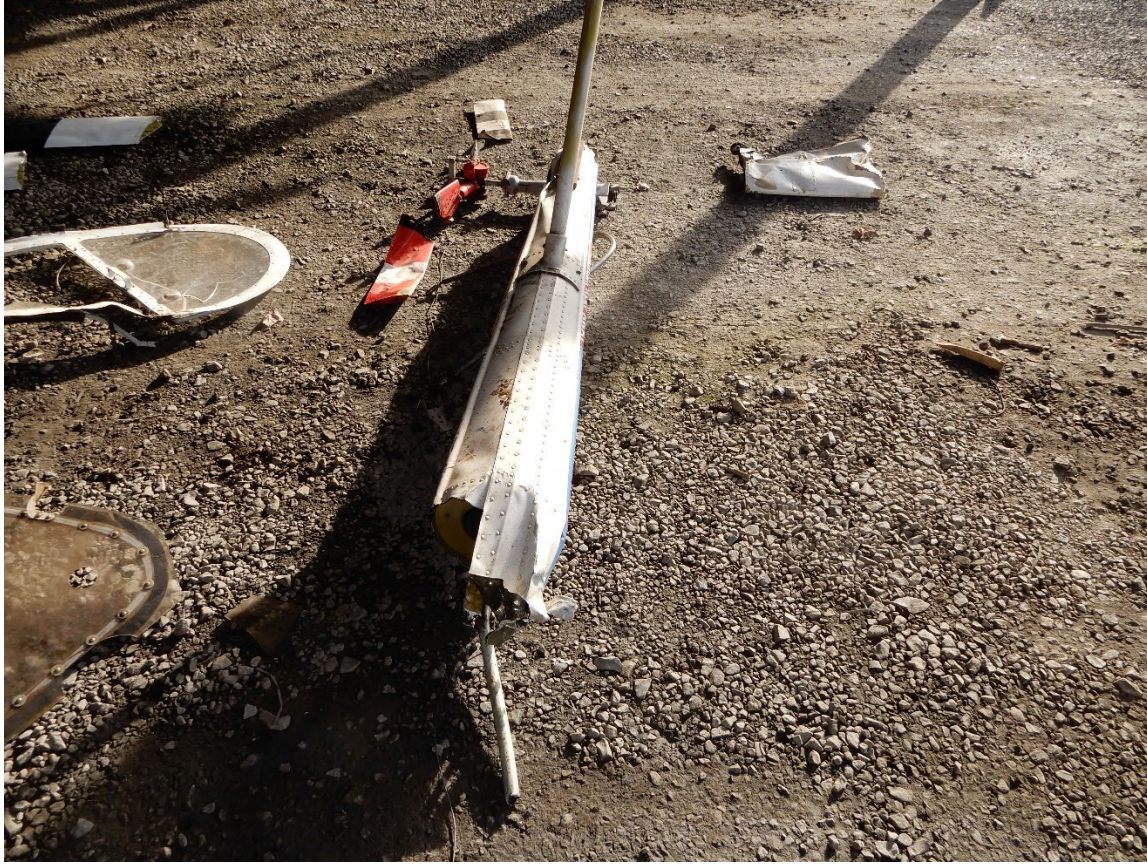
Tail Rotor assembly. The tail rotor assembly remained attached to the gearbox, which remained attached to the end of the tailboom. Both blades separated from the tail rotor assembly near the root at chord-wise fractures. Both separated blade sections departed the rotor system and exhibited wrinkles and dents of the skin. The tips of both blades retained their shape and exhibited only minor damage. The crosshead and pitch change links remained attached at both ends. The right -side tail rotor control cable exhibited a broom straw break just forward of the 1<sup>st</sup> hanger bearing. The large diameter drive shaft from the transmission to the intermediate gearbox remained secured at both ends with no damage noted. The small diameter tail rotor driveshaft located from the intermediate gearbox to the 90° gearbox was fractured and separated about 1 inch aft of the splines. A second break occurred about 14 inches aft of the splines. There was a disconnect of the driveshaft at the second hanger bearing.

Figure 12. View of the separated tailboom and tail rotor assembly. Photo NTSB.

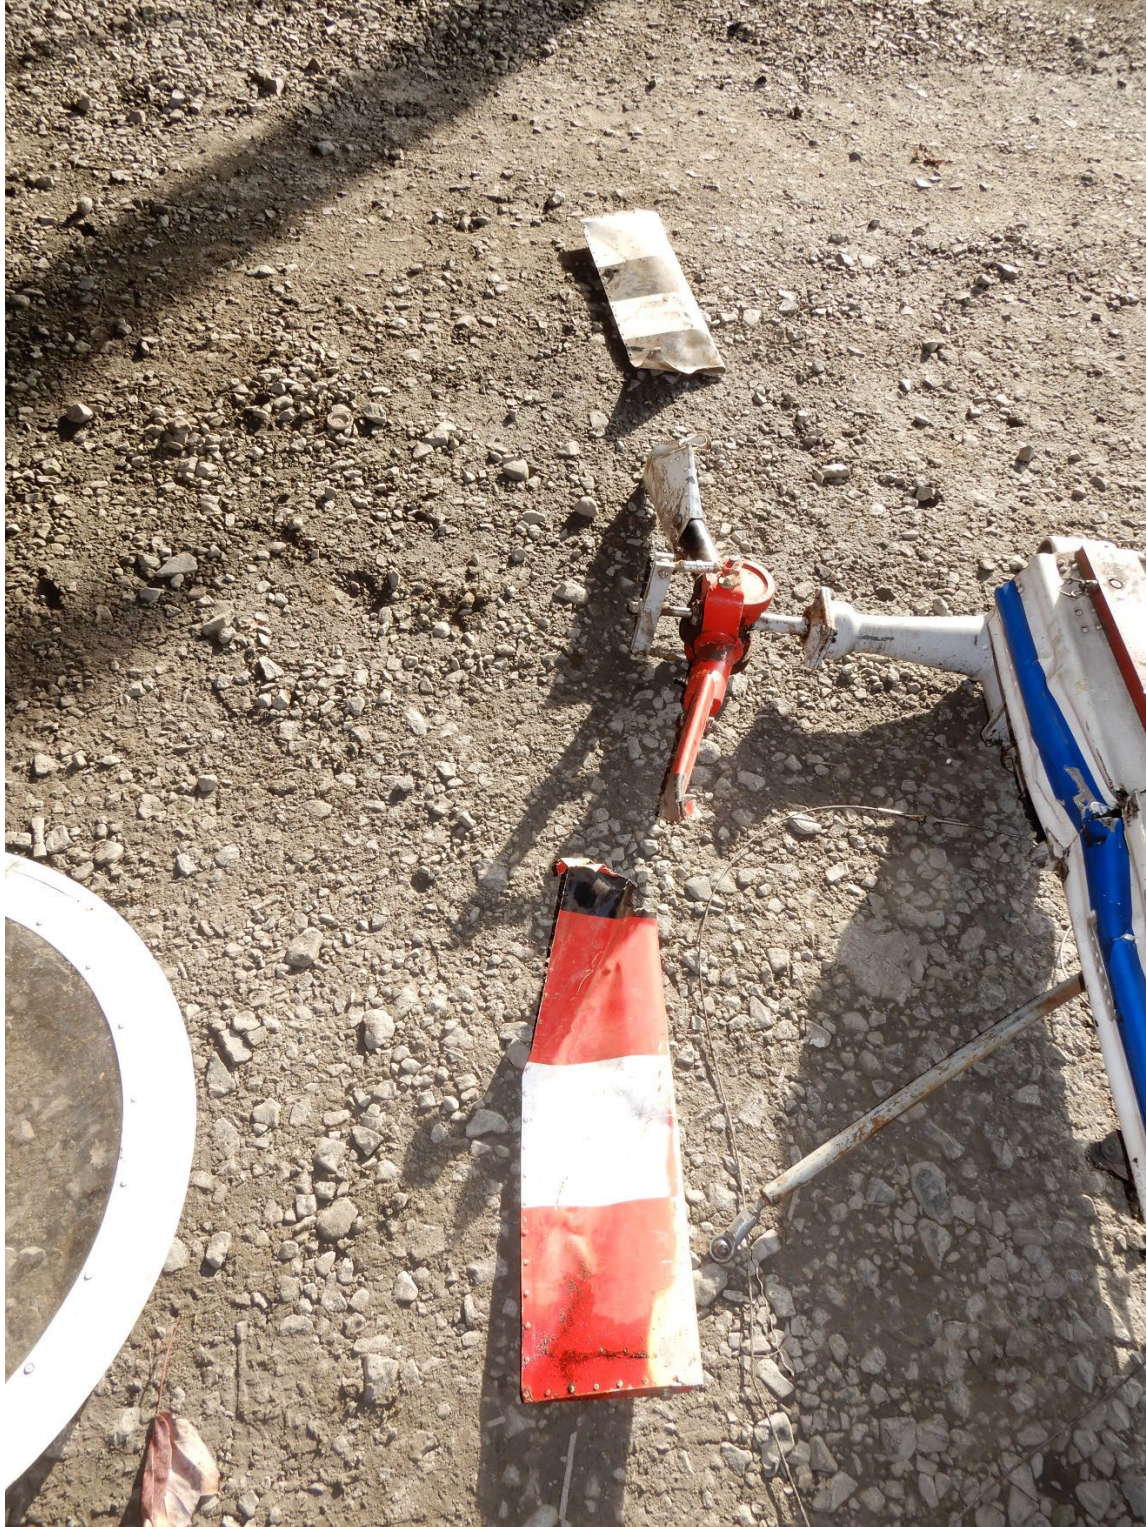
Figure 13. View of the tail rotor assembly and the 90° gearbox. Photo NTSB.

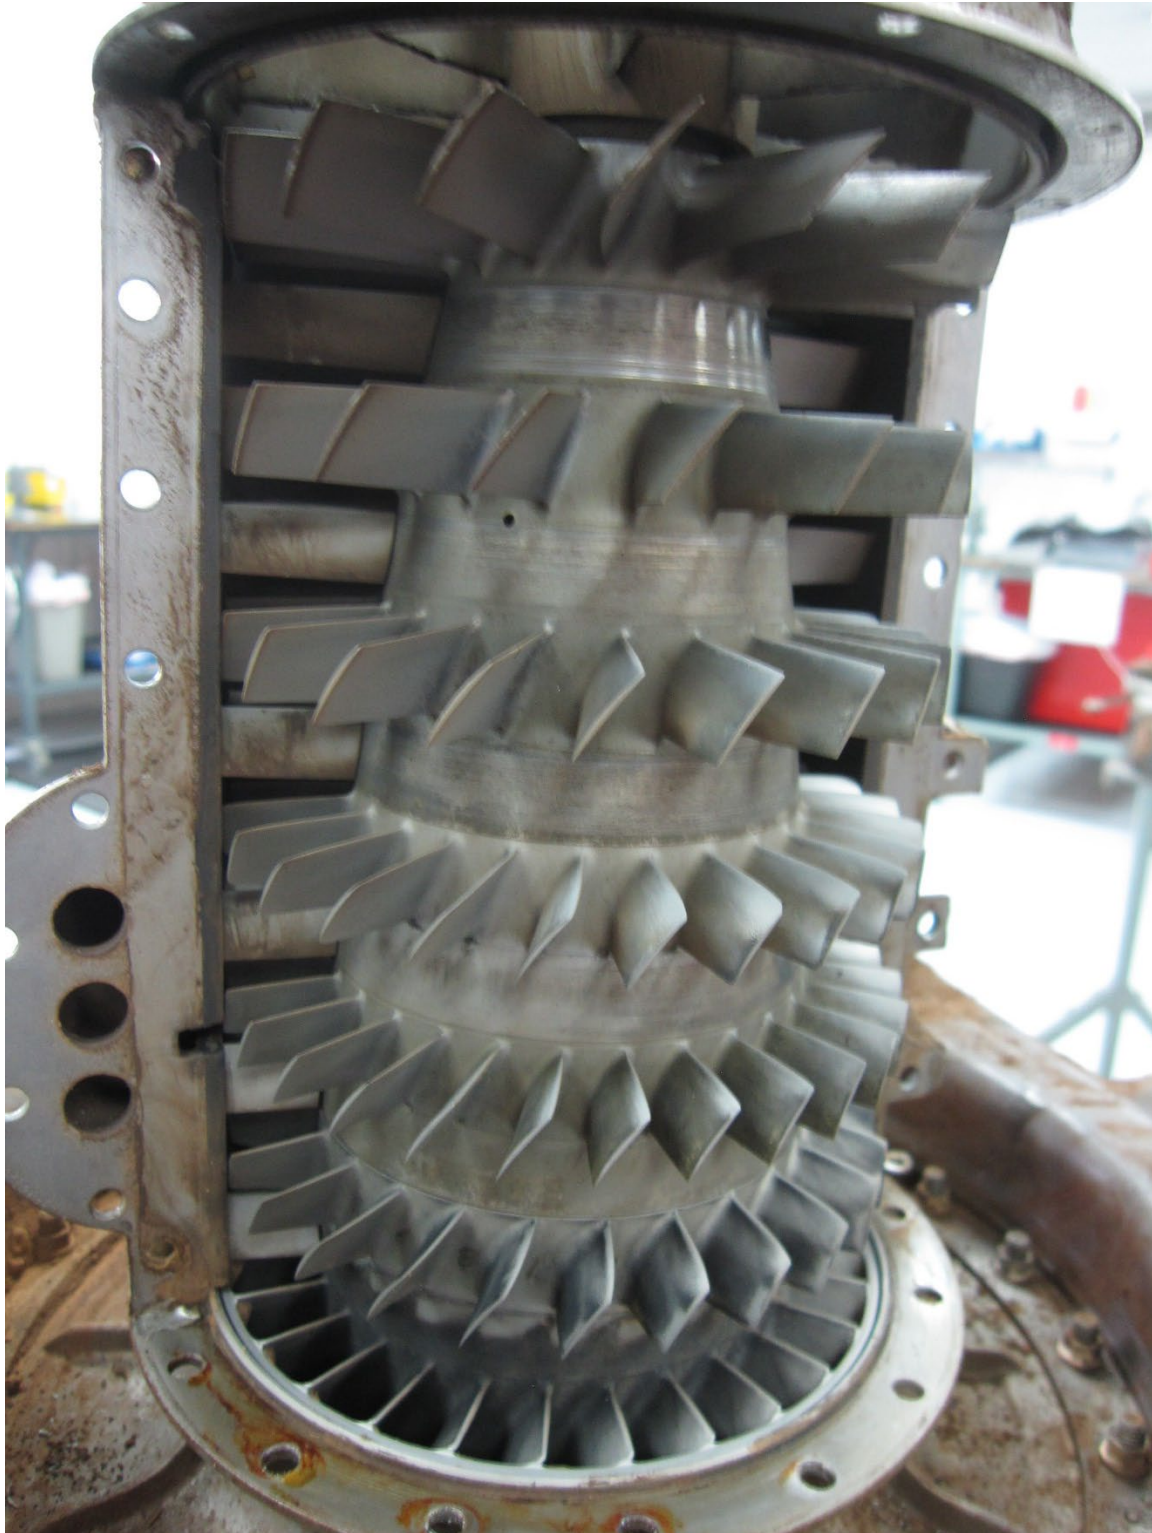
The compressor section was removed from the accessory gearbox. The compressor section was then opened exposing the six-stage centrifugal, single-stage axial compressor. The 6-stage compressor section. And the axial compressor section appeared normal with no apparent damage to the blades. Slight contact was made from the 1<sup>st</sup> stage guide vanes to the compressor assembly. A thickness check was performed on the 1<sup>st</sup>, 2<sup>nd</sup> and 3<sup>rd</sup> stage blades. All passed with sufficient thickness. The gap between the impeller and the number 2 bearing was checked and found at .012 inch, within acceptable tolerance (.010 to .012 inch).

Figure 17. The six-stage axial compressor. Photo Courtesy of Rolls-Royce.

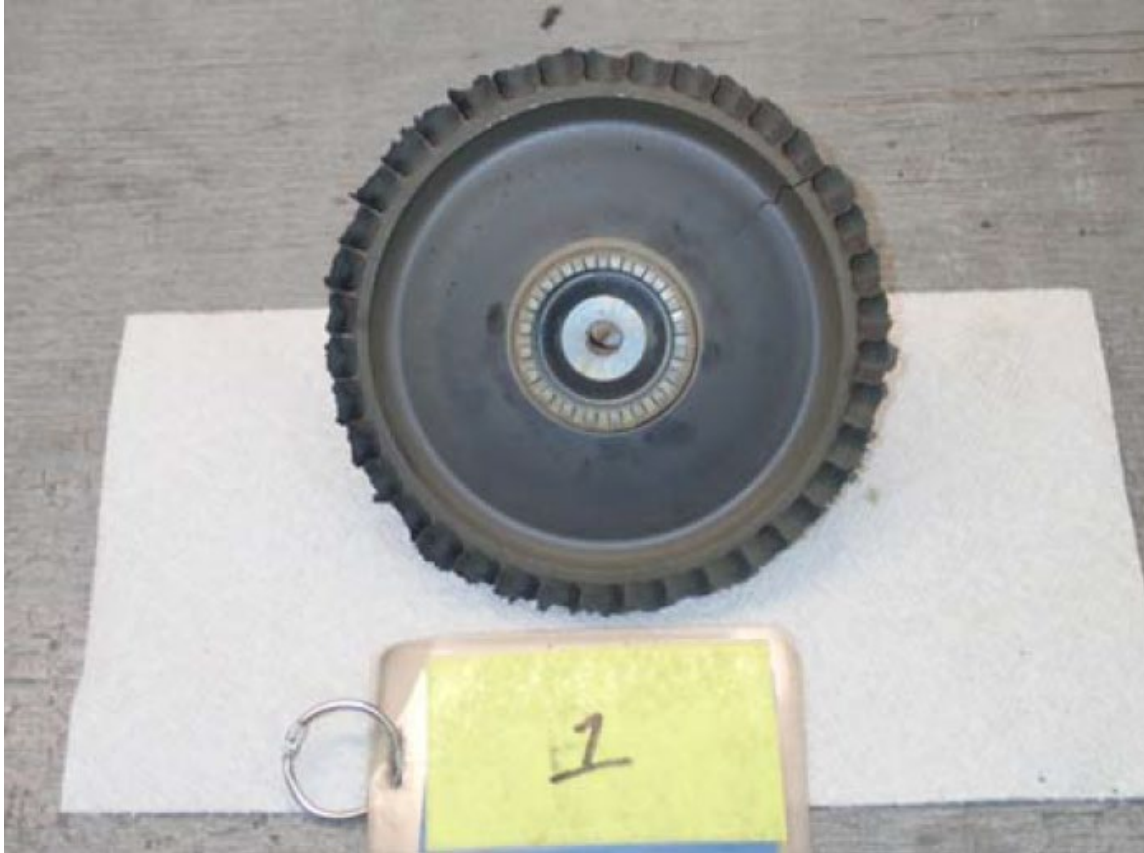
The stage 1 turbine wheel (1<sup>st</sup> stage gas producer) exhibited damage to all blades. All blade tips were eroded to about 40 to 50%. There was a crack running from the base of the turbine blades towards the center of rotation.

The stage 1 turbine wheel exhibited a crack extending radially inboard approximately 1.12 inches from the rim into the web. The crack initiated in the rim in thermal fatigue and transitioned to interdendritic fracture consistent with cracking expected after over-temperature operation. The interdendritic fracture exhibited two distinct regions consistent with it having formed from two separate over-temperature events.

Figure 18. Stage 1 turbine wheel, showing crack extending into the web. Photo courtesy of Rolls-Royce.

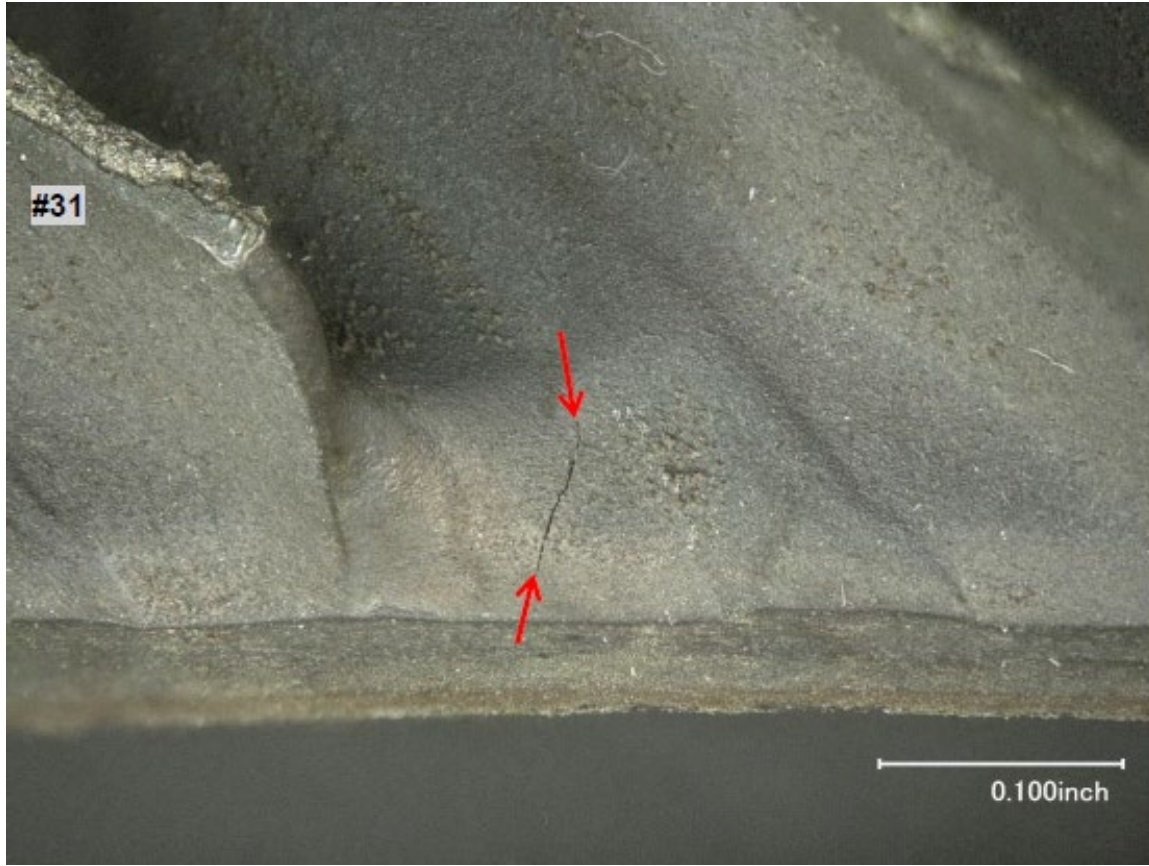
The stage 1 wheel exhibited 31 visually apparent rim cracks on the trailing edge side of the wheel and rim cracks in between every airfoil on the leading-edge side of the wheel. According to Rolls-Royce excessive rim cracking is indicative of the occurrence of an over temperature start.

Figure 19, Example of a rim crack on the first stage wheel. The red arrows point to the stark and stop of the crack. Photo courtesy of Rolls-Royce.

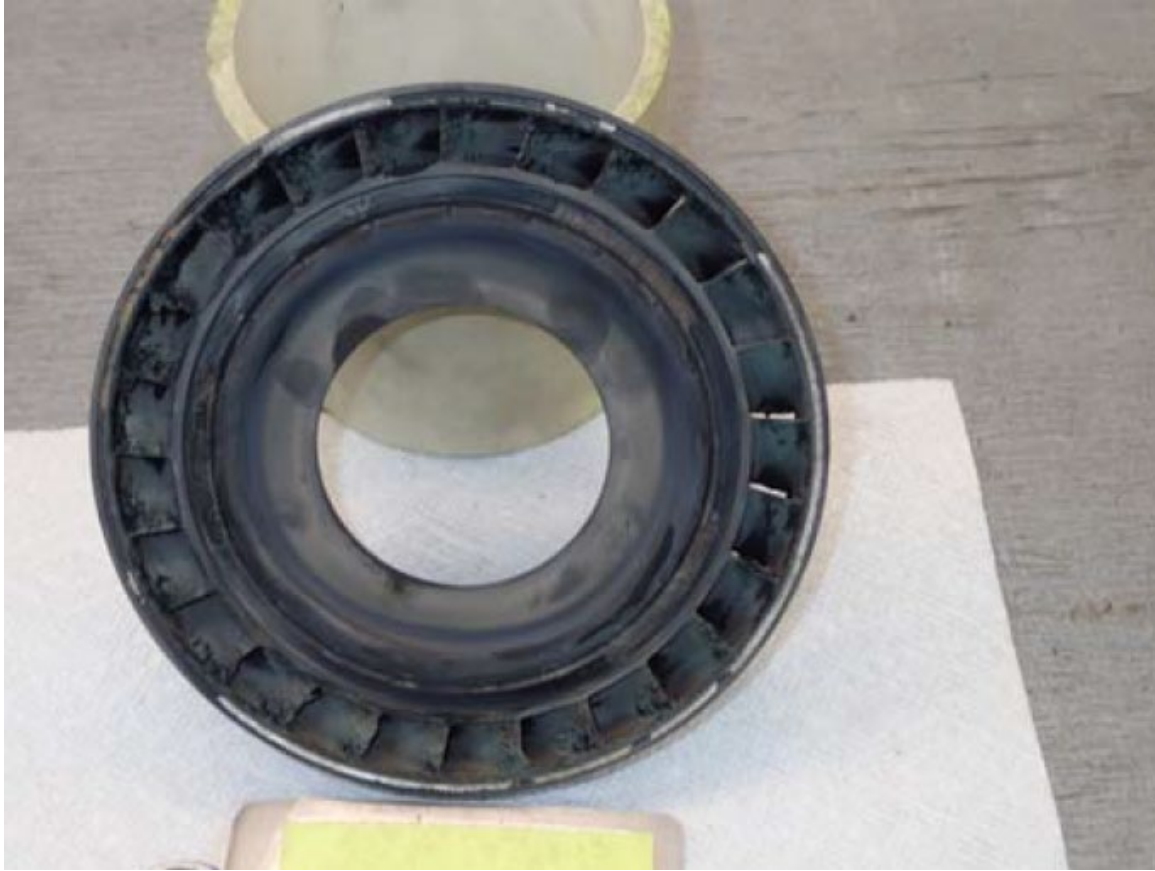
Figure 20. Stage 1 nozzle. Photo courtesy of Rolls-Royce. Photo courtesy of Rolls-Royce.

The stage 2 turbine wheel (2nd stage gas producer) exhibited damage to all blades. All blade tips were eroded away, about 15-20% of the blade. Both the first and second stage nozzles exhibited thermal damage with noted metal spatter and dirt throughout the gas path including the stage three and four nozzles and wheels.

The T1 [stage 1] and T2 [stage 2] wheels and nozzles exhibited evidence of thermal distress including burned airfoil tips, voiding, and plastic flow.

The T1 and T2 wheels and nozzles exhibited layers of deposited material on the gas flow path surfaces which were consistent with deposits of T1 and T2 wheel material due to melting of the airfoils.

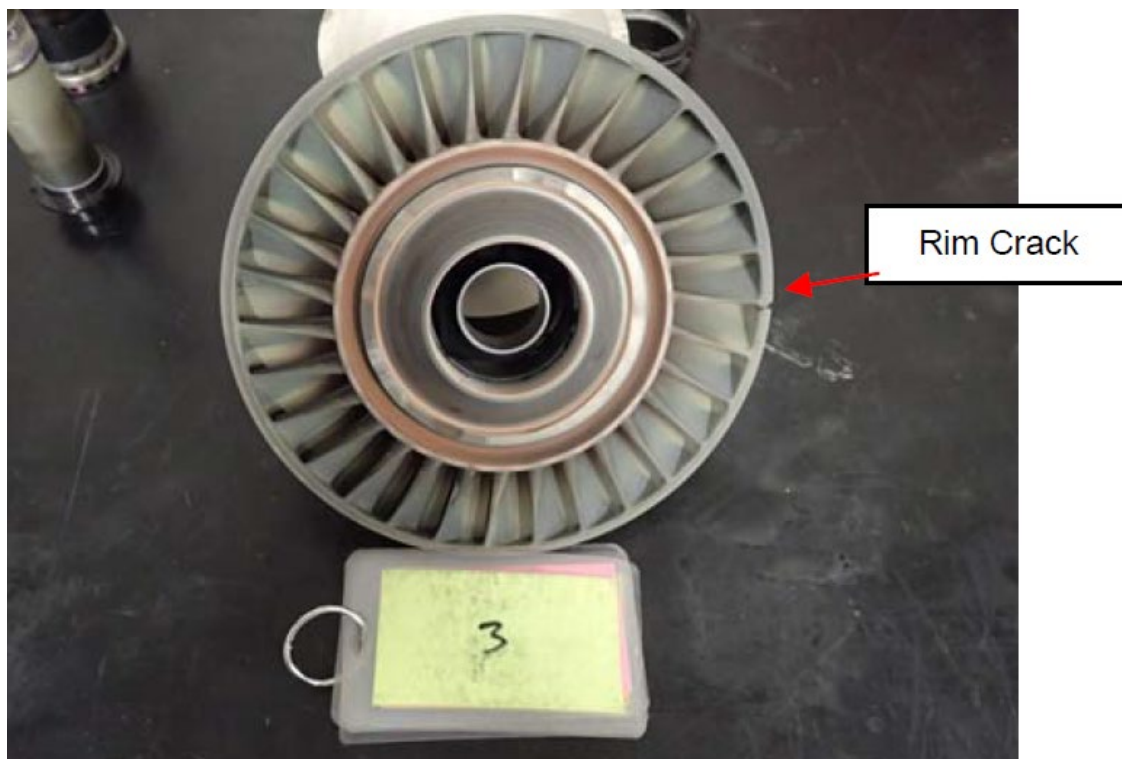
Figure 24. Stage 3 turbine. Photo courtesy of Rolls-Royce.

The stage 3 turbine wheel (1<sup>ST</sup> stage power turbine wheel) exhibited a crack at the outer diameter. No damage was observed at the stage 3 or stage 4 nozzles. The stage 4 power turbine wheel (2<sup>nd</sup> stage power turbine wheel). exhibited normal appearance.

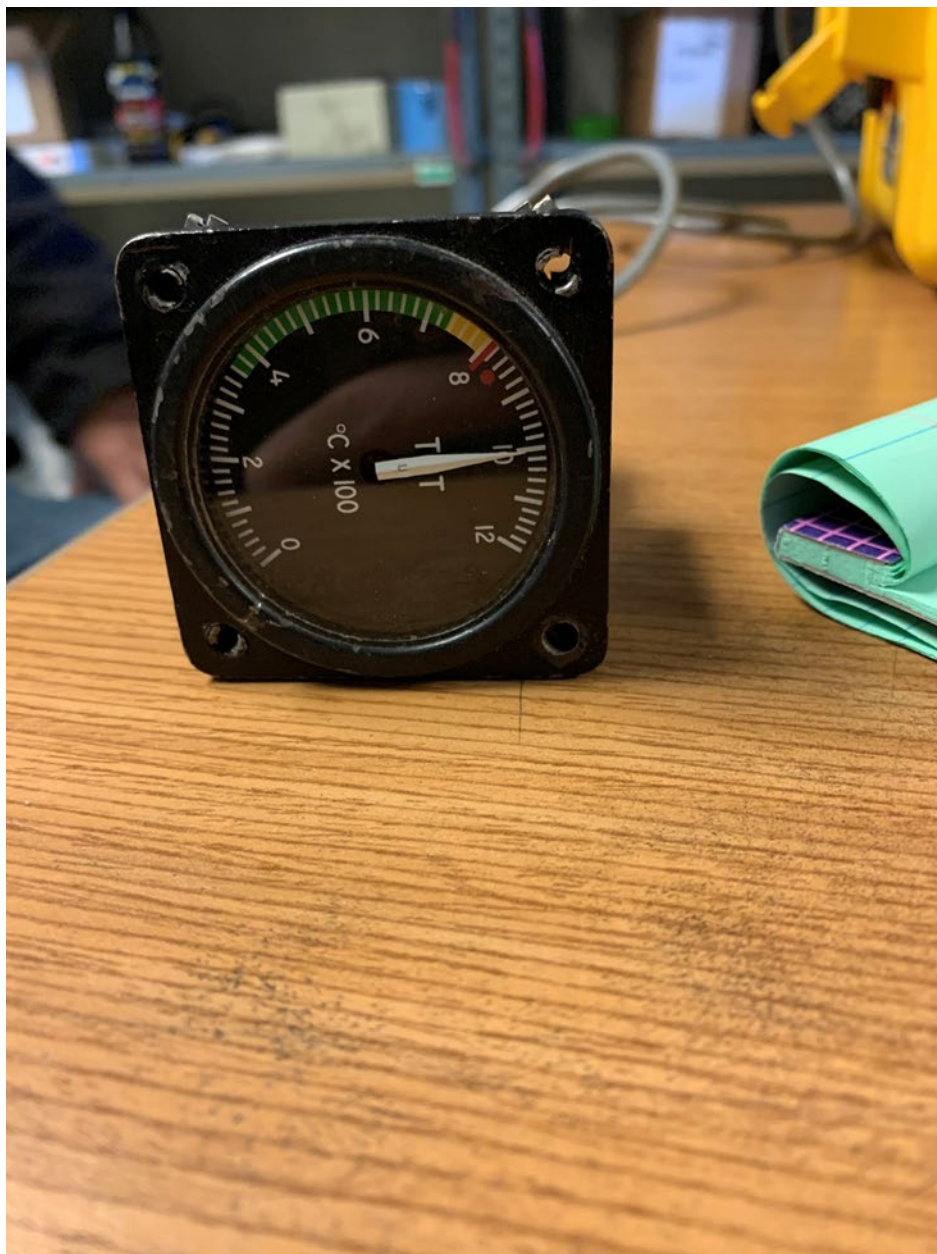
An examination of the turbine outlet temperature gauge from N131HA was conducted at a maintenance facility in West Jordan, Utah. The turbine outlet temperature gauge was connected to a Barfield TT1200A turbine temperature test set. Testing of the gauge resulted in the following values:

Figure 27. Turbine outlet temperature gauge from the accident helicopter.

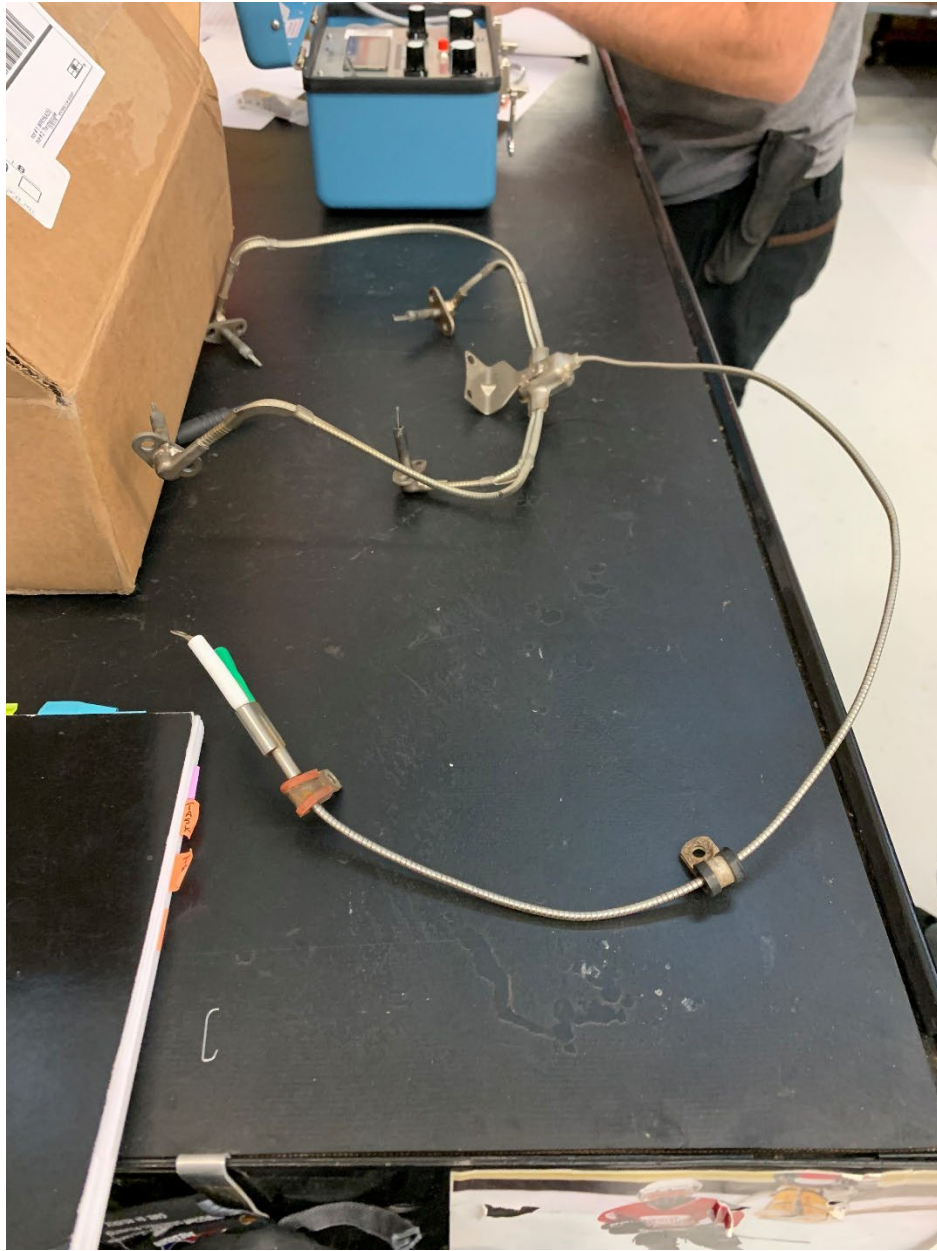
The thermocouple's internal resistance, at room temperature was .57 ohms. According to the Rolls-Royce M250-C20 series Operation and Maintenance Manual, for harness part number 23034926, the acceptable internal resistance is 0.50 to 0.60 ohms at room temperature.

Figure 29. Thermocouple from the accident engine. Photo NTSB.
