## **NATIONAL TRANSPORTATION SAFETY BOARD**

# **FUEL INJECTION SERVO EXAMINATION SUMMARY**

**WPR20LA009**

Location: Stockton, California  
Date: October 17, 2019  
Aircraft: Cessna 206H, N11379  
NTSB Investigator-in-Charge: Samantha Link

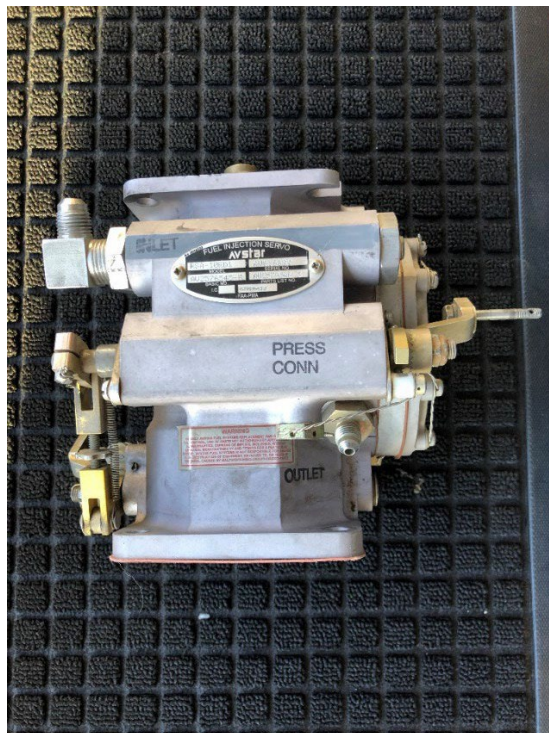
Figure 1: View of the fuel servo.

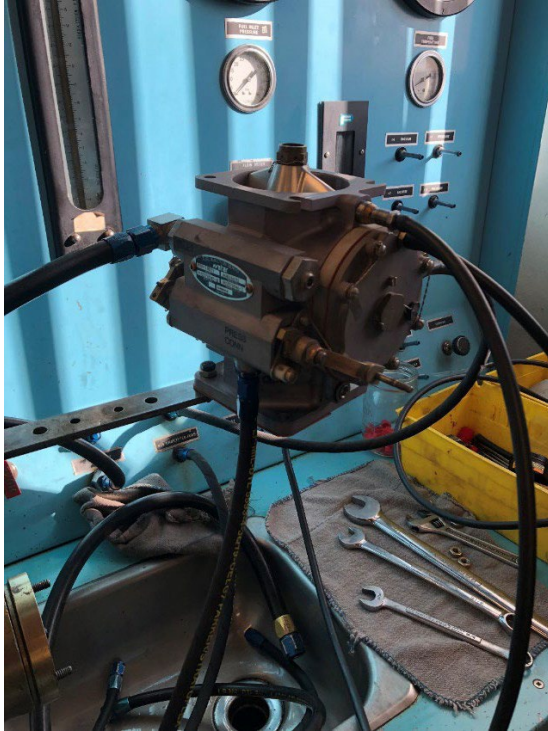
Work Scope: Flow test and inspect Fuel Injection Servo. Prior to performing a flow test, the Fuel Servo was inspected externally for any visual defects. No visual defects were found. Flow test data is attached below. The Fuel Servo flow rates were marginally below manufacture minimums. It is the opinion of the technical inspector that conducted the flow test, that the lower flow rates would not have effected engine performance. After flow test, the Fuel Servo was disassembled and inspected. Everything passed visual inspection with no abnormal visual wear or debris. The fuel screen was removed and found clean.

**Figure 2: View of the fuel servo on flow test stand**

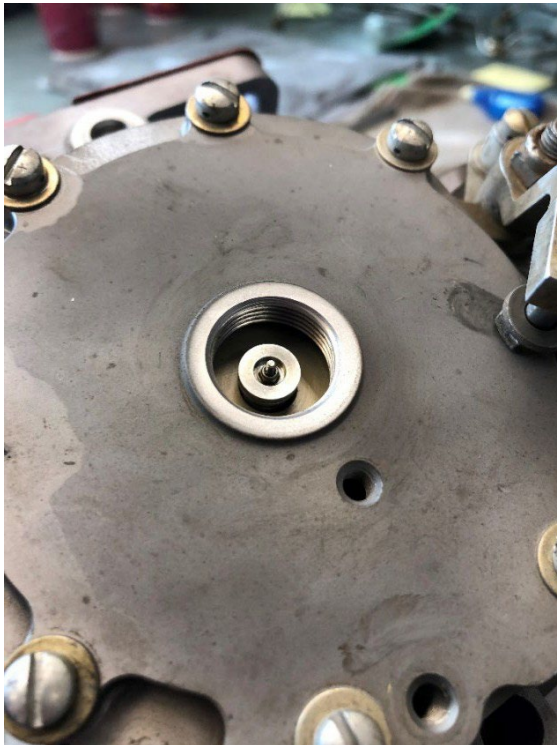
**Figure 3: View of the fuel servo.**

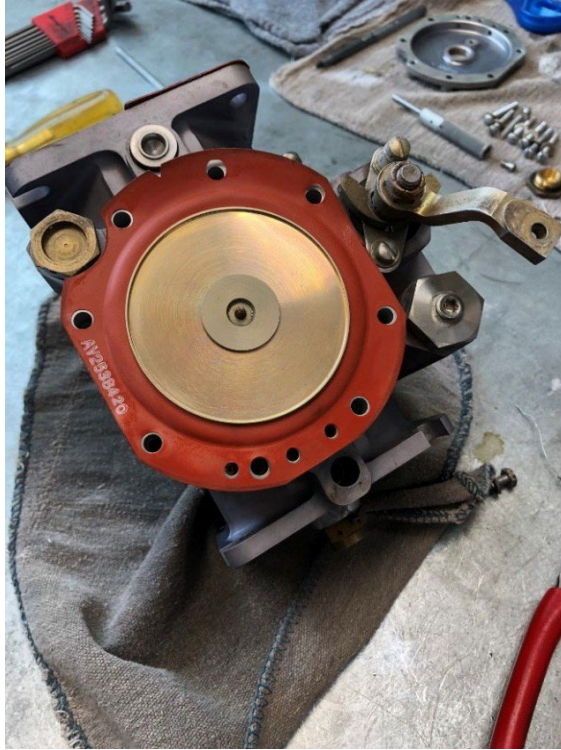
**Figure 4: View of the top cover removed above diaphragm.**

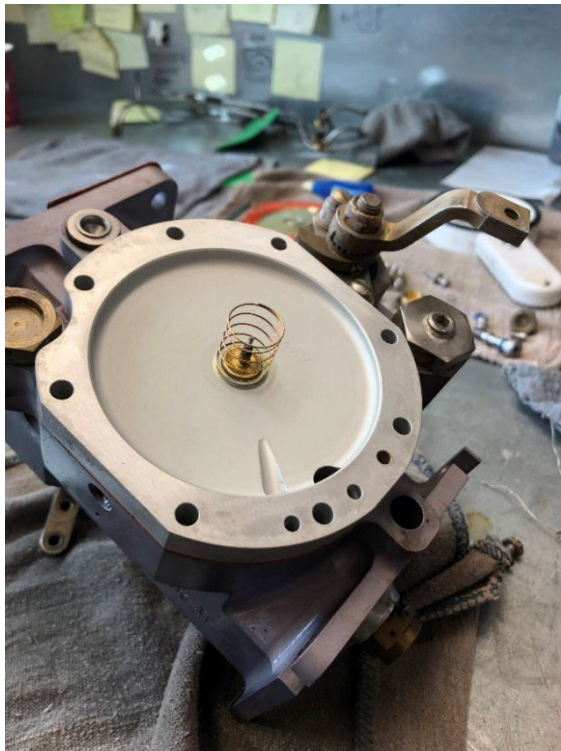
**Figure 5: View of the top cover and first diaphragm removed.**

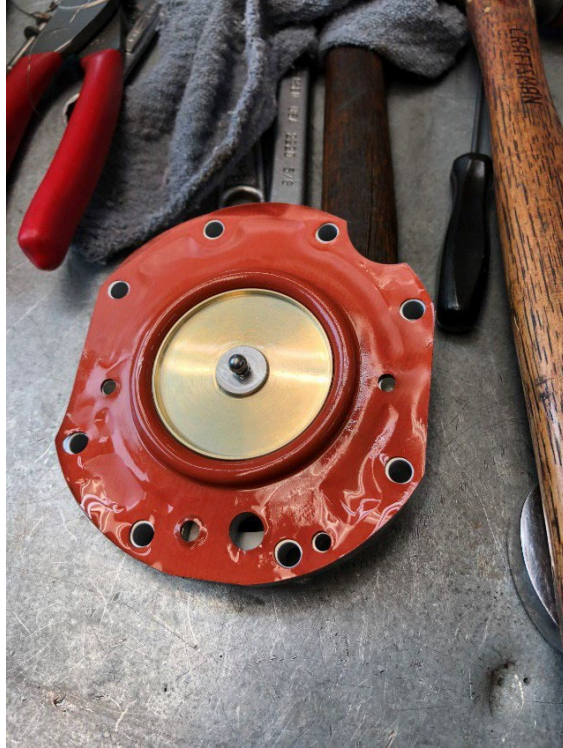
**Figure 6: View of the inside (second) fuel diaphragm.**

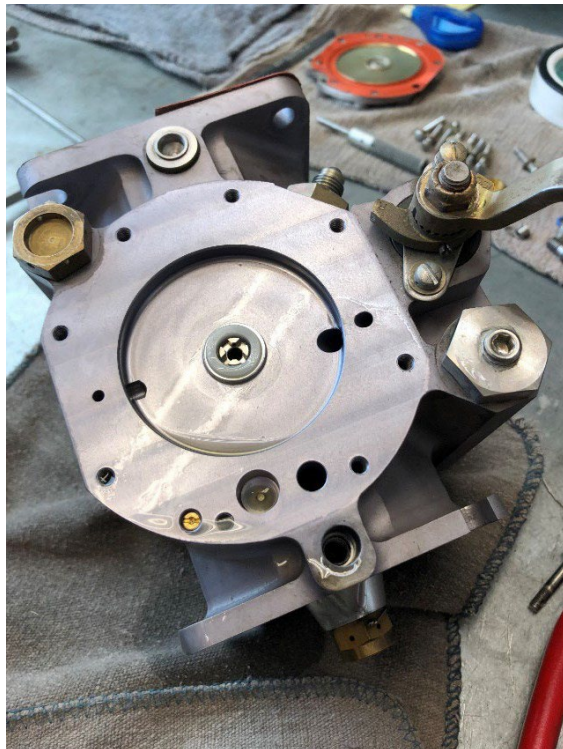
**Figure 7: View of the fuel servo with both fuel diaphragms removed.**

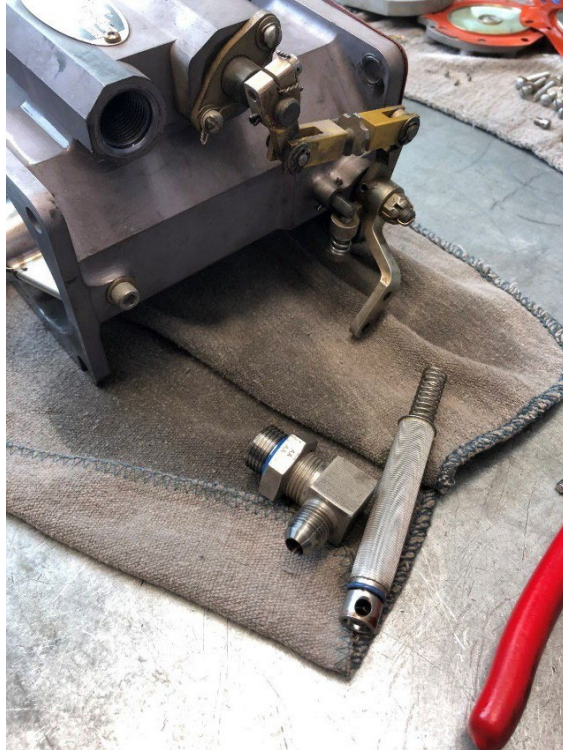
**Figure 8: View of the fuel servo filter.**
