## **NATIONAL TRANSPORTATION SAFETY BOARD**

# **AIRFRAME AND ENGINE EXAMINATION**

**WPR20LA012**

Aircraft: Czech Sport Aircraft Sportcruiser / N204BF

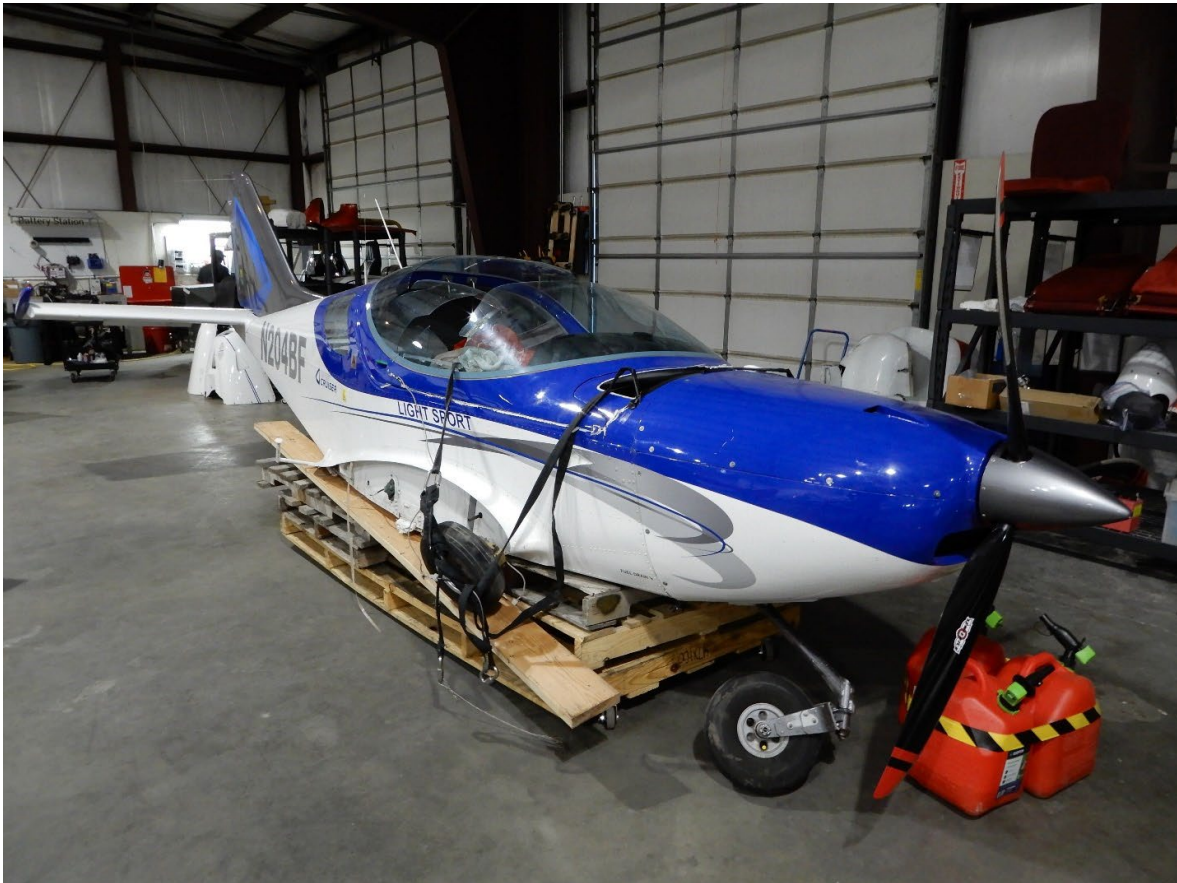
Fuselage right side. The right side of the fuselage was not damaged from the accident; however, there was visible damage to the composite material at the base of the canopy that began at the top of the fuselage, aft of the engine nacelle, and ran along the canopy side to about the aft section of the canopy, near the hand hold. The BRS right-aft suspension cable had created the damage to the composite material as it deployed. The right wing was not damaged including the flap and aileron. The right composite main landing gear had fractured and separated from the lower fuselage. The right-side fuselage, aft of the canopy to the empennage was undamaged. Empennage. The horizontal stabilizer exhibited no damage. The one-piece elevator exhibited a minor dent on the top right side. The right and left side of the vertical stabilizer and rudder were undamaged.

Figure 1. N204BF, Right-side view.

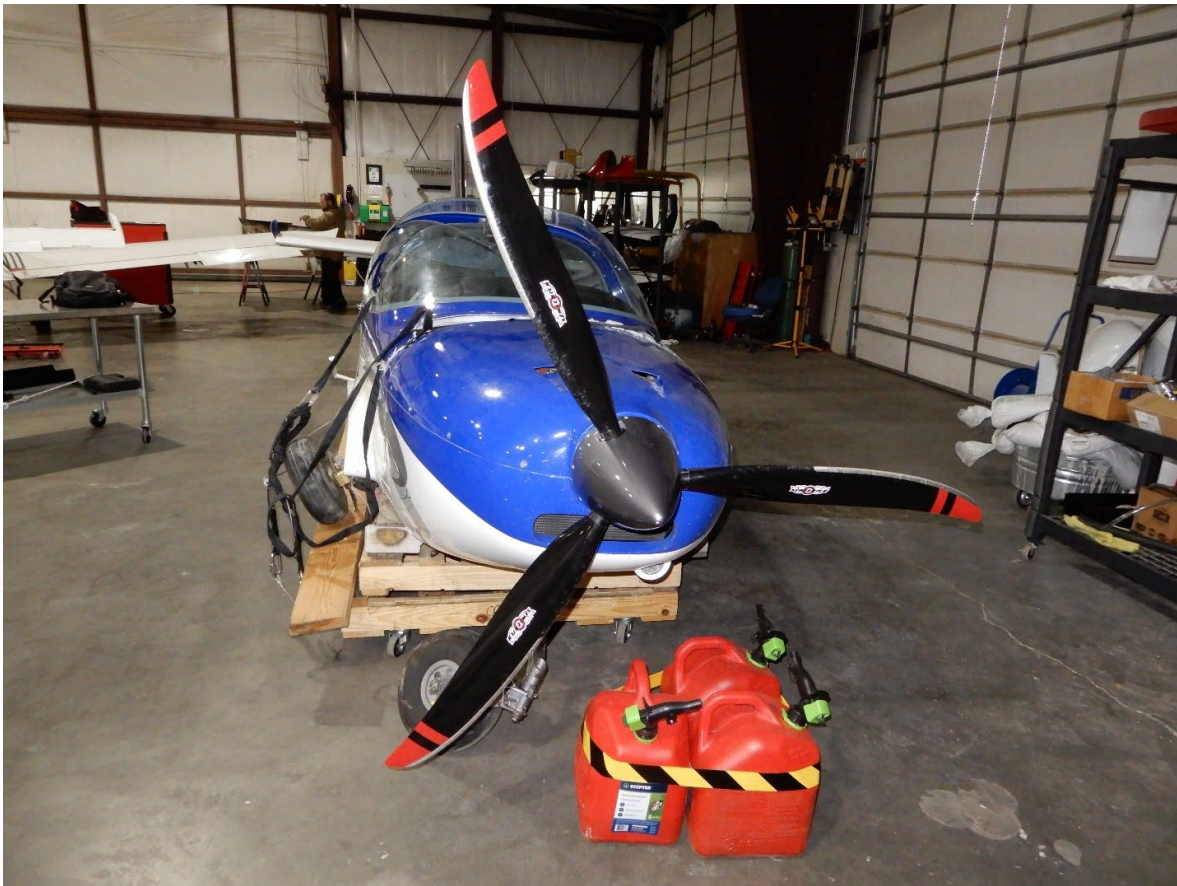
The engine cowling area was secure and undamaged. The three-bladed propeller was secure and undamaged. The spinner was undamaged. The nose gear remained attached to the underside of the fuselage and exhibited minor damage.

Figure 2. Front view.

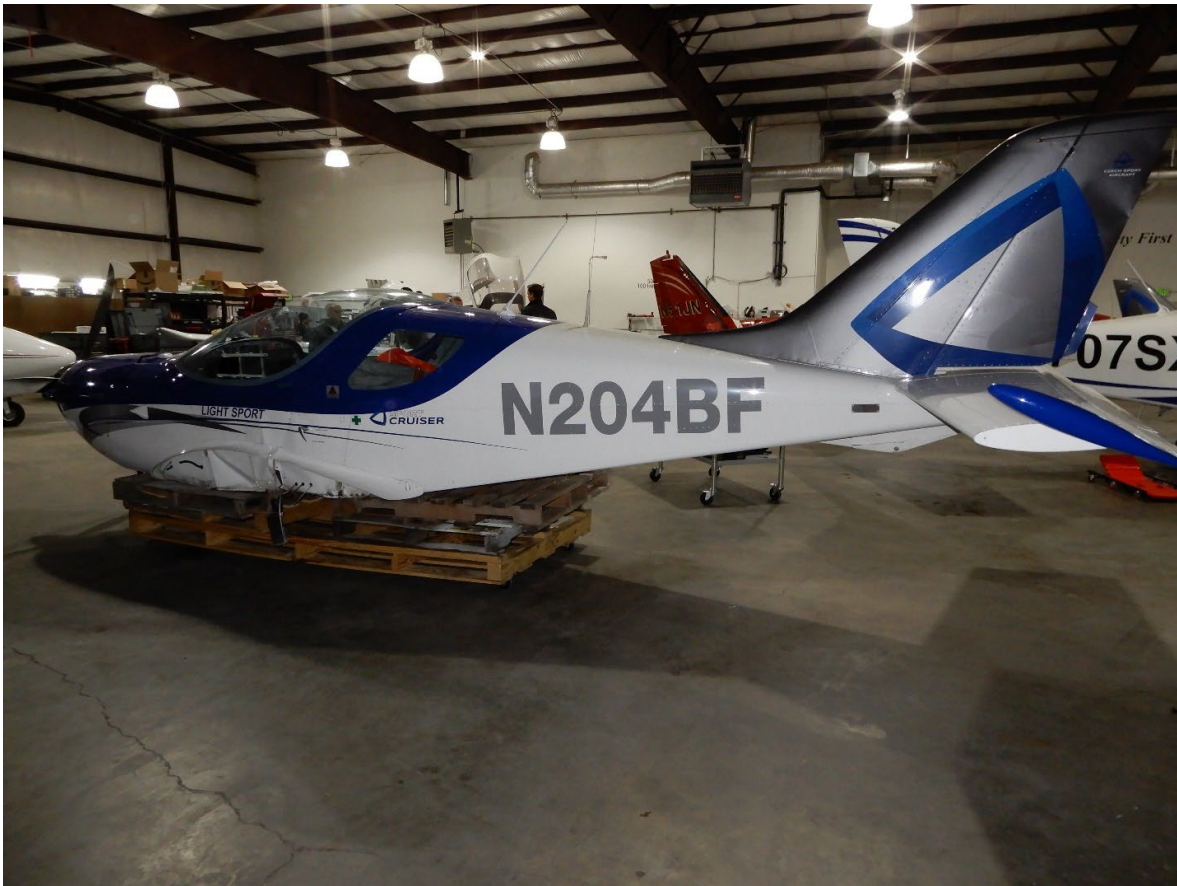
Fuselage left side. The left side of the fuselage, from the empennage to the canopy was undamaged. The fuselage sheet metal above the left wing exhibited wrinkling. There was no tear in the composite canopy from the left-side BRS suspension cable. The left wing exhibited substantial damage, with upward bending of the aileron and wing. The left main landing gear was fractured above the spindle. The left flap was undamaged.

Figure 3. Left-side view.

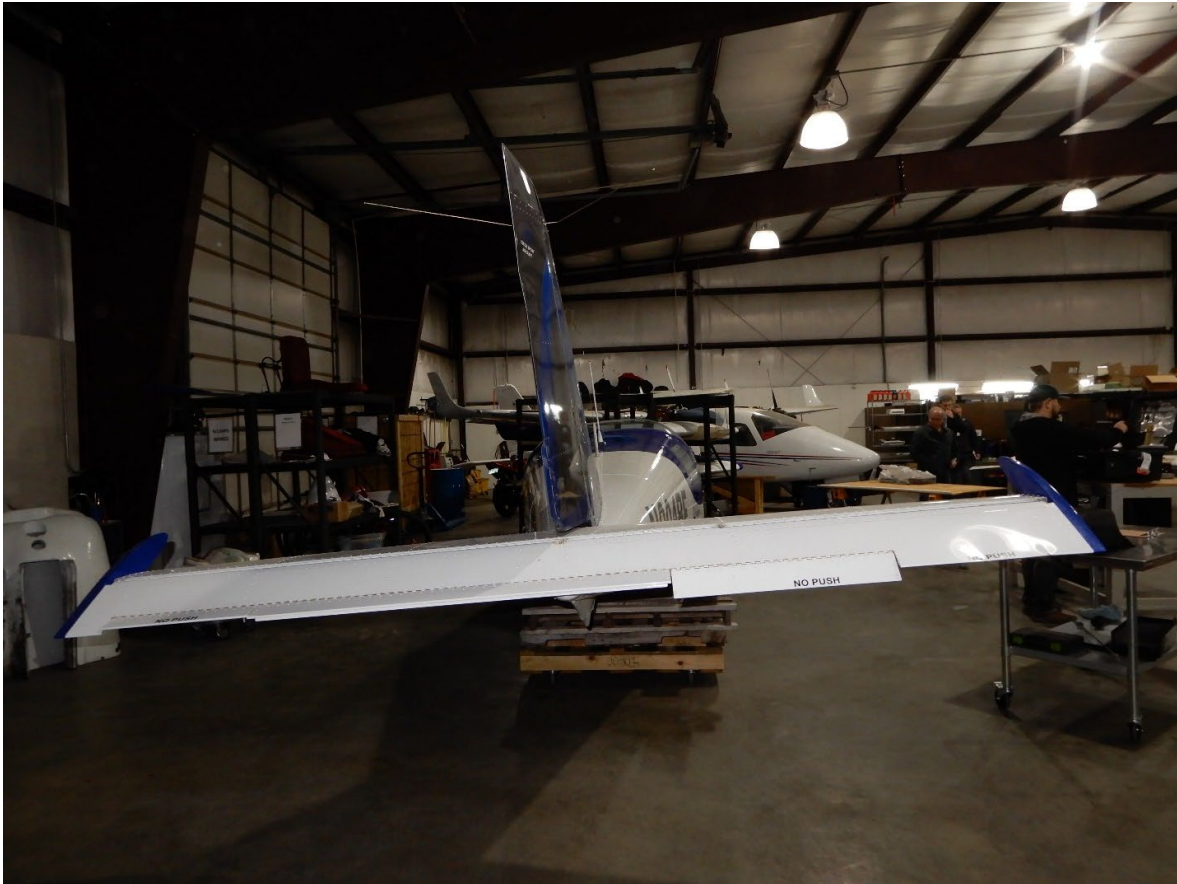
Figure 4. Rear view.

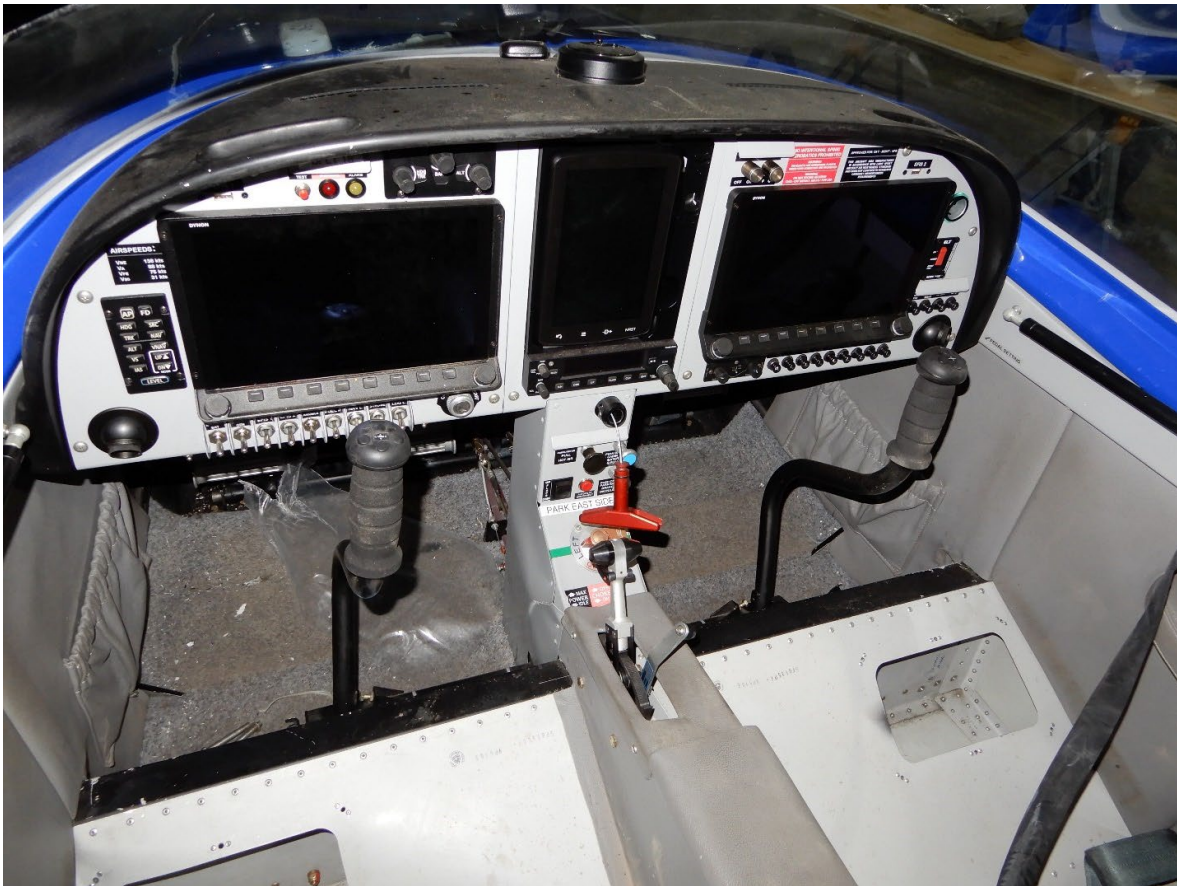
The airframe was examined by a party member representing the airframe manufacturer. The wings had been removed from the fuselage for recovery. The fuselage was placed on pallets and secured with straps. The straps were removed to facilitate examination of the interior of the cockpit. The cockpit canopy had a fracture to the acrylic, but the cockpit space was not compromised. The interior of the cockpit did not sustain damage. The three-screen electronic flight instrumentation system was secure. The ballistic recovery system handle was pulled out about 3 inches and suspended by the cable. The fuel selector system was positioned to the left tank.

Figure 5. Cockpit view.

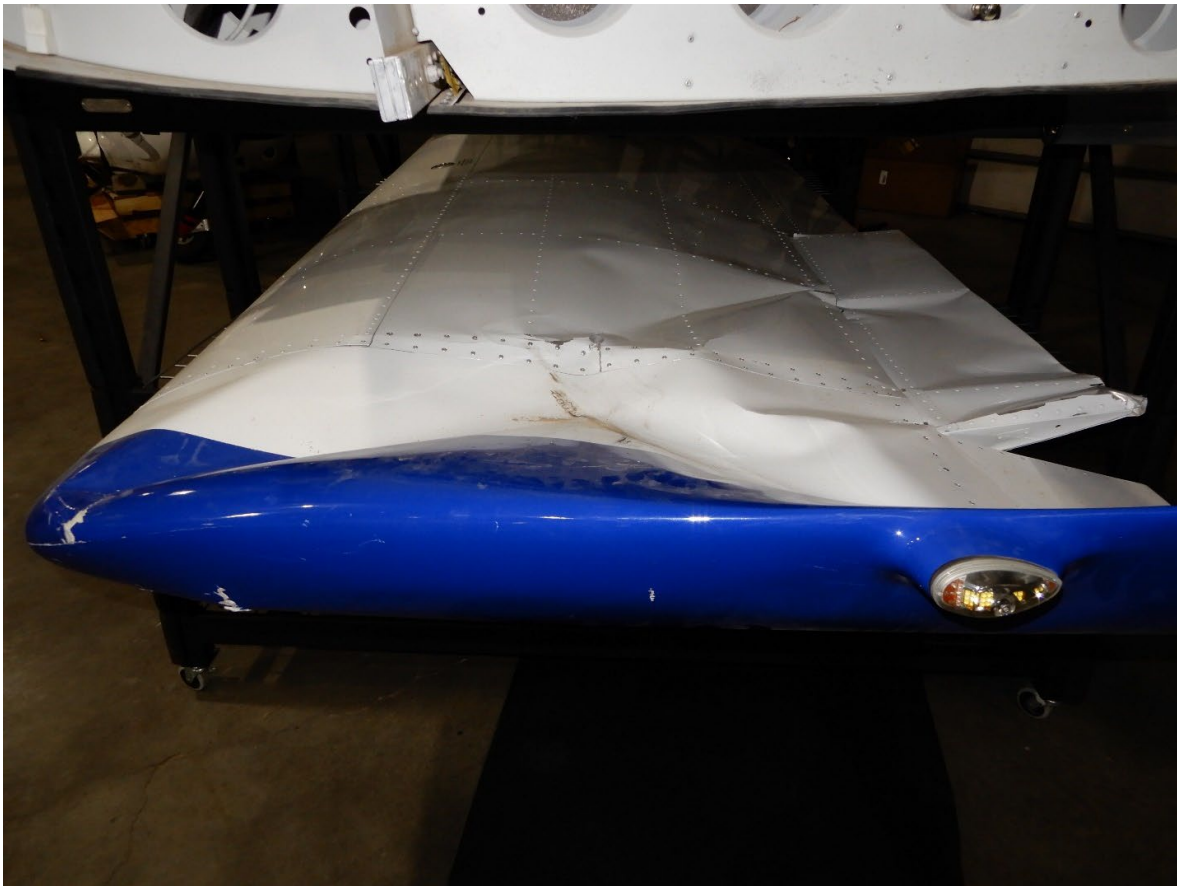
Figure 6. Left wing, showing substantial damage.

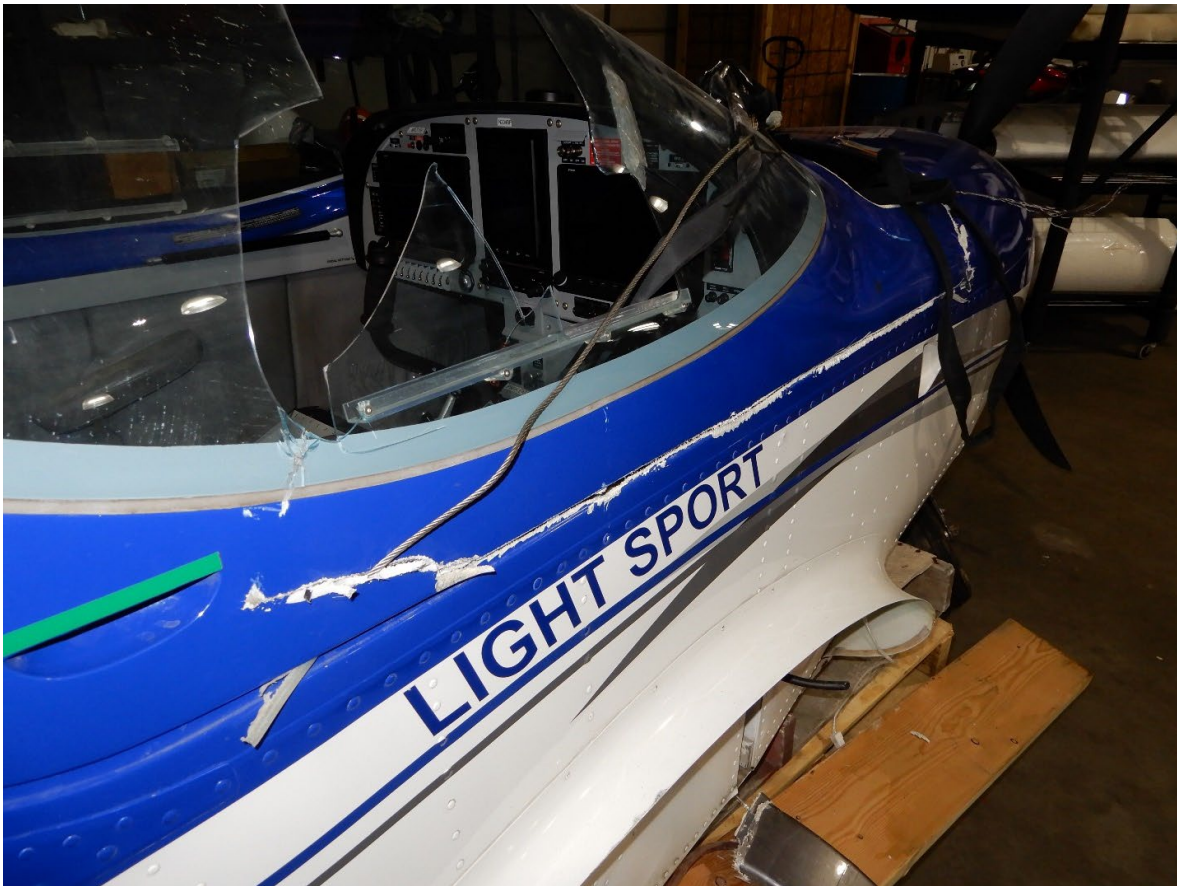
Figure 7. Right side, showing exemplar track for the BRS right-side suspension cable.

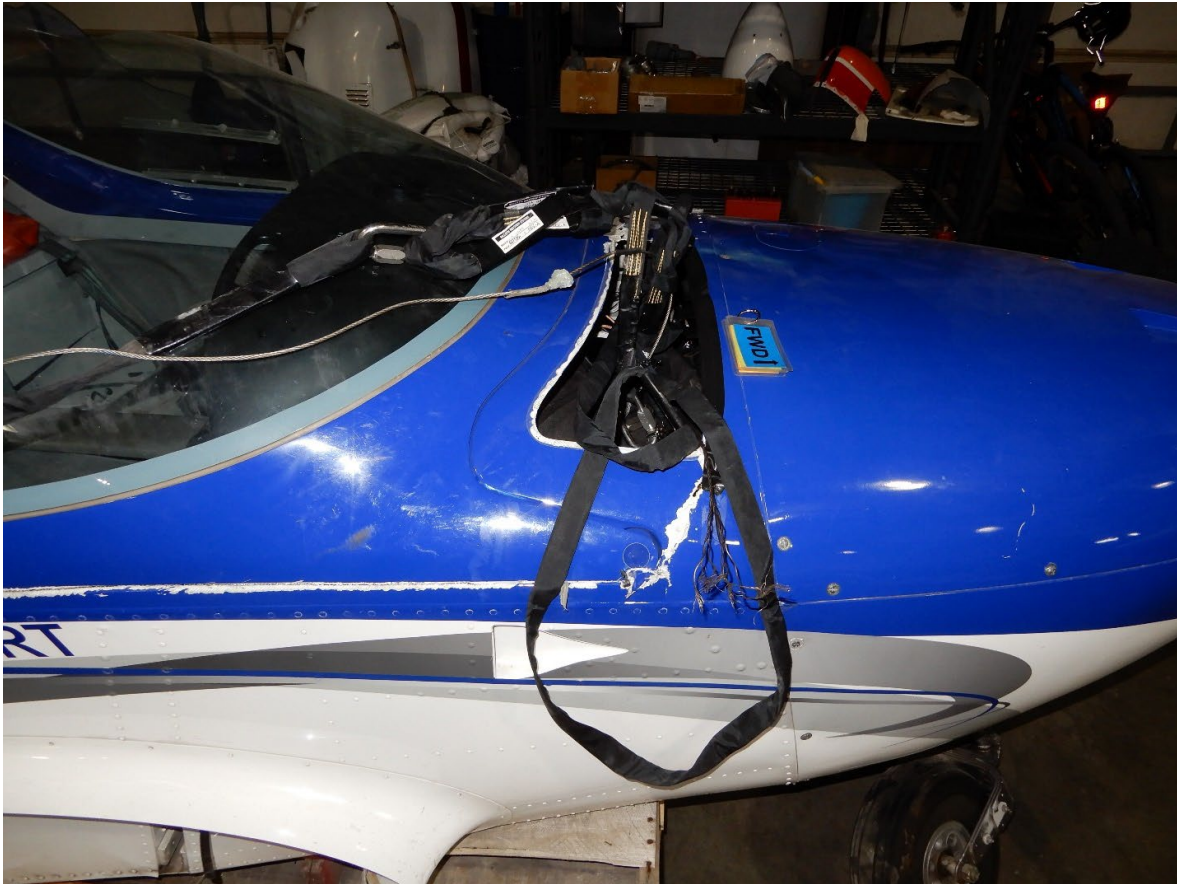
Figure 8. Right-side, forward view of the exemplar track for the BRS right-side suspension cable.

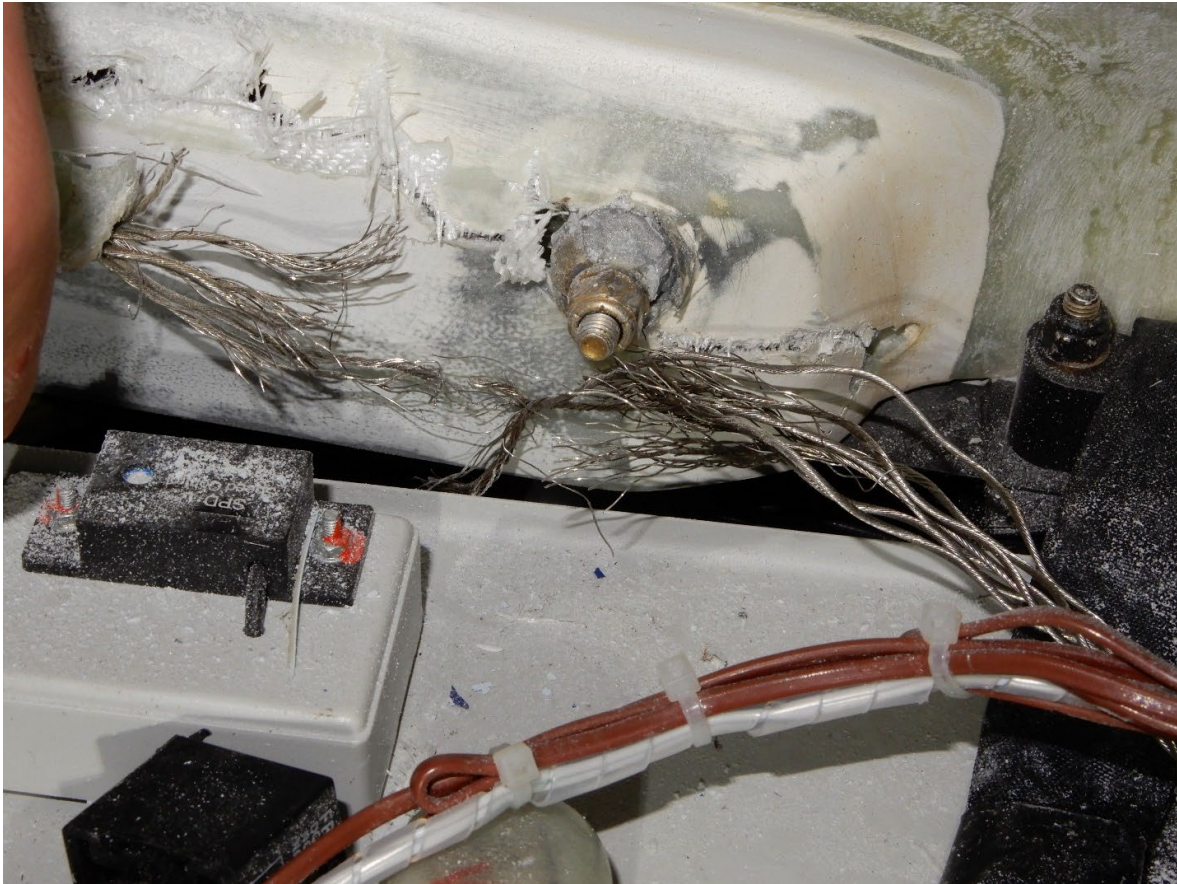
The BRS was examined by a party member representing BRS Inc. The parachute exhibited minor tearing only. The right-side rear suspension cable was intact and exhibited no damage. The right-side front fabric suspension strap was intact and exhibited no damage. The left-side front fabric suspension strap was intact and exhibited no damage. The left-side rear suspension cable was fractured near the left-side canopy hinge. The cable exhibited a frayed or broom-straw appearance. When placed near the canopy hinge, the cable break was abeam the hinge retention bolt. The left-side rear suspension cable had initially torn through the composite material at the top of the forward fuselage but stopped at the location of the canopy hinge. Beyond the separation, the cable extended to, and remained attached to the metal ring that secured the four suspension units to the parachute.

Figure 9. left-side internal view of the break in the left-side BRS suspension cable near the location of the canopy hinge bolt.

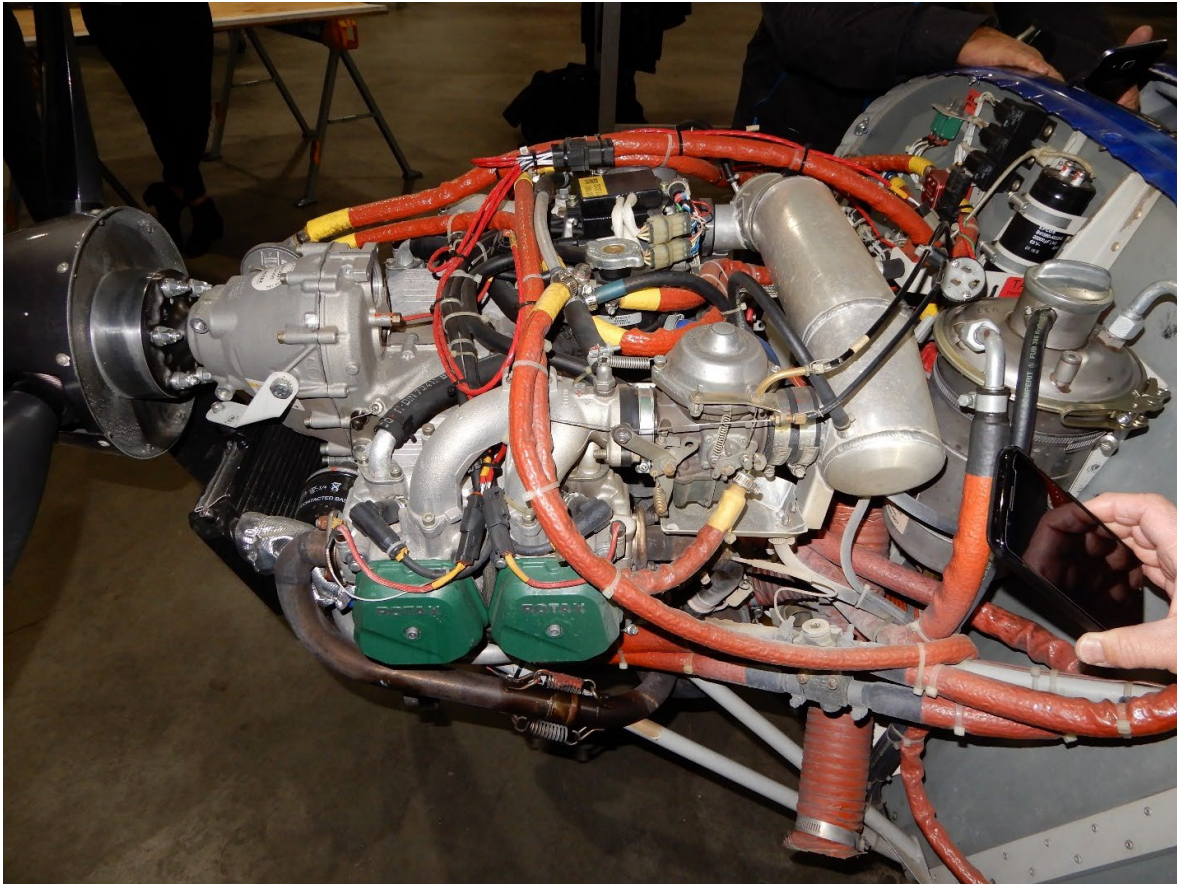
Figure 10. Left-side view of the engine, showing the number two and four-cylinders.

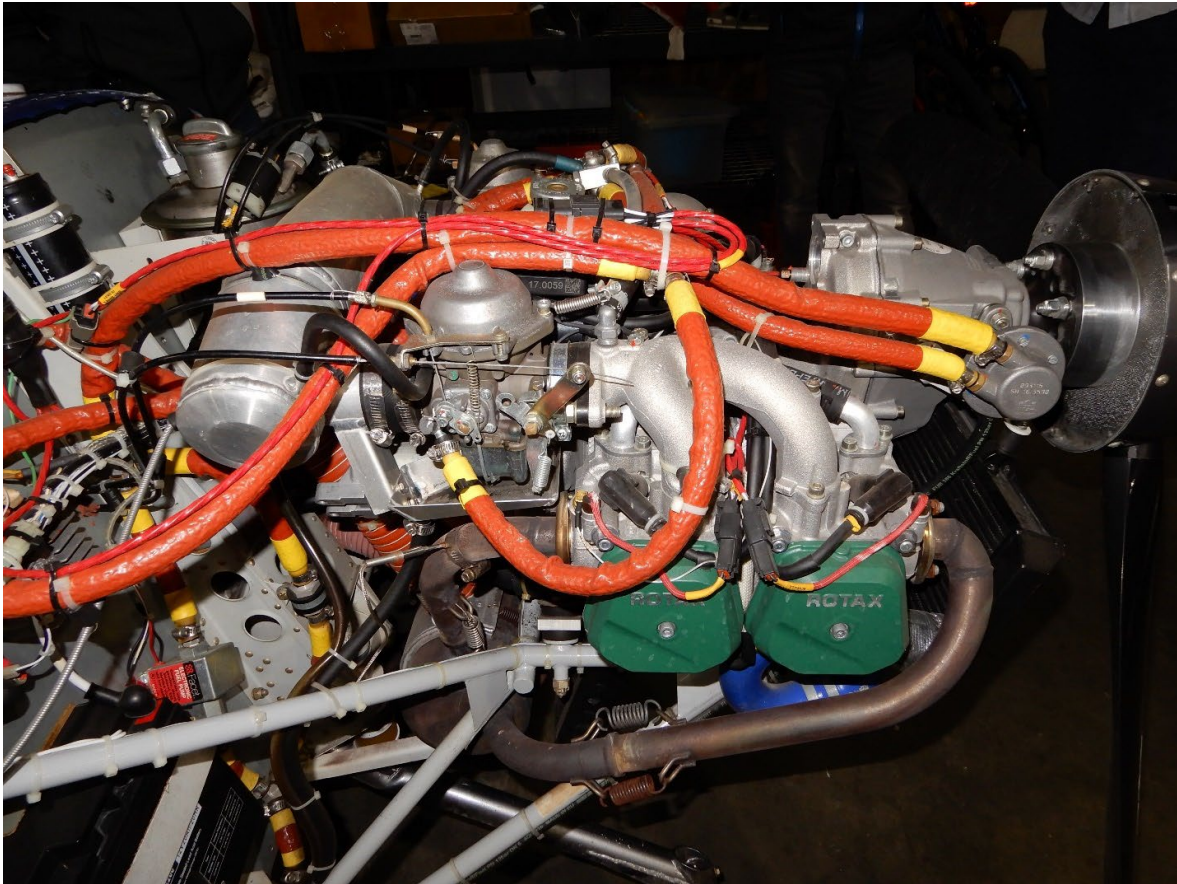
The number one-, three-, and four-cylinder assemblies were disassembled. No anomalies were found that would have precluded normal operations.

Figure 11. Right-side view of the engine, showing the number one and three-cylinders.

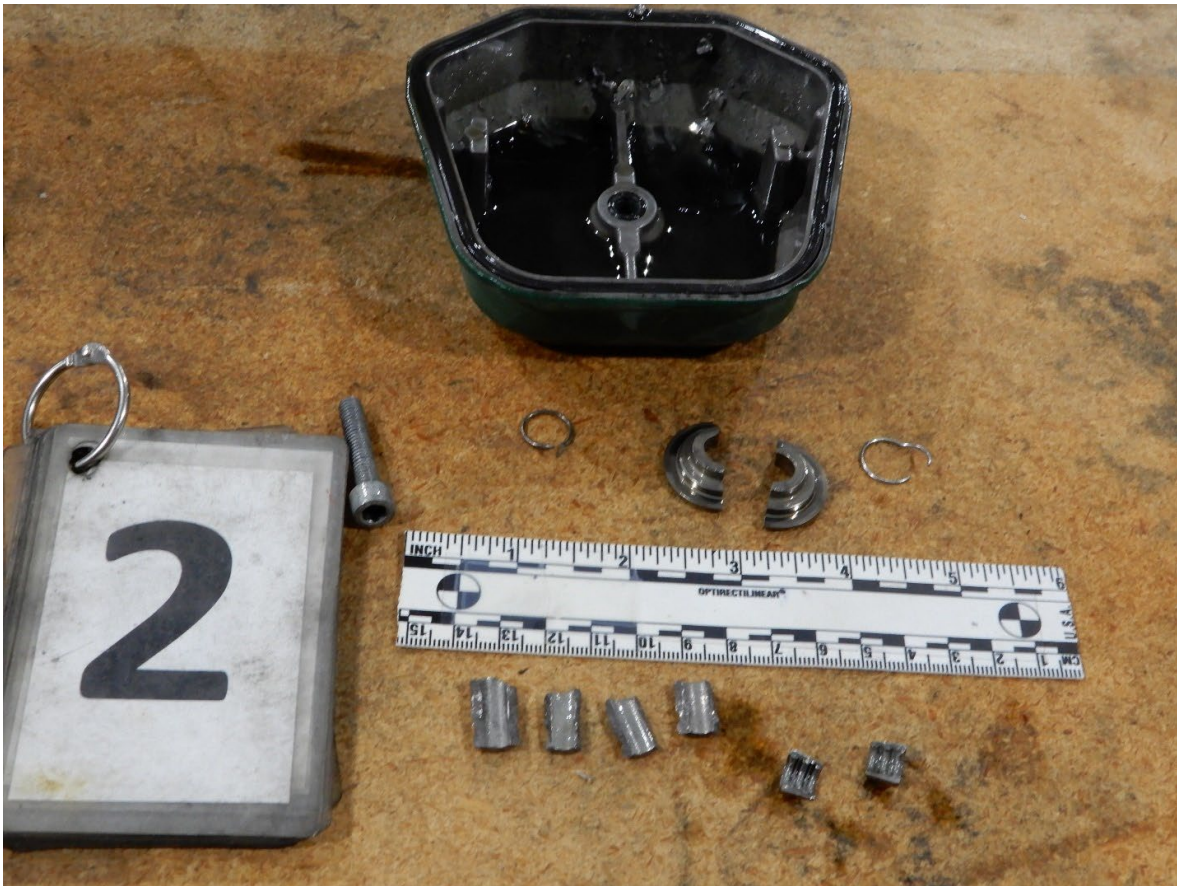
The engine was examined by a party member representing the engine manufacturer. The engine remained attached to the airframe at the undamaged mounts. When the number two-valve cover was removed, there were components of the valve train loose in the chamber. The intake rocker arm was displaced past the top of the valve spring. The valve spring retainer was absent and found in two halves in the rocker box chamber along with remnants of the valve guide. The top and bottom spark plugs were removed, exposing damaged electrodes. The number two-cylinder was removed exposing the top of the piston. The piston exhibited impact damage and a hole consistent with being struck by the side of the intake valve. The piston exhibited multiple fractures to the piston skirt. The number two-piston wrist pin had separated from the piston and lodged between the crankshaft and the wall of the number two-cylinder bore. The number two-intake valve lodged into the intake valve opening. The valve was inverted where the stem was pointing toward the piston and had a S-bend to it. The number two-cylinder exhibited multiple fractures of the cylinder skirt. The valve spring shim exhibited a circumferential indentation or wear mark. The chip detector was removed and exhibited multiple metallic metal shavings attached to it.

Examination of the engine by BRP-Rotax revealed the fracture area of the valve spring retainer had a fatigue break with pronounced vibration stripes. The breakage exit area was close to the upper edge (outer bore), but the exact breakage exit was in a destroyed or damaged condition.

Figure 12. Number two-rocker box cover and contents found in it upon removal.

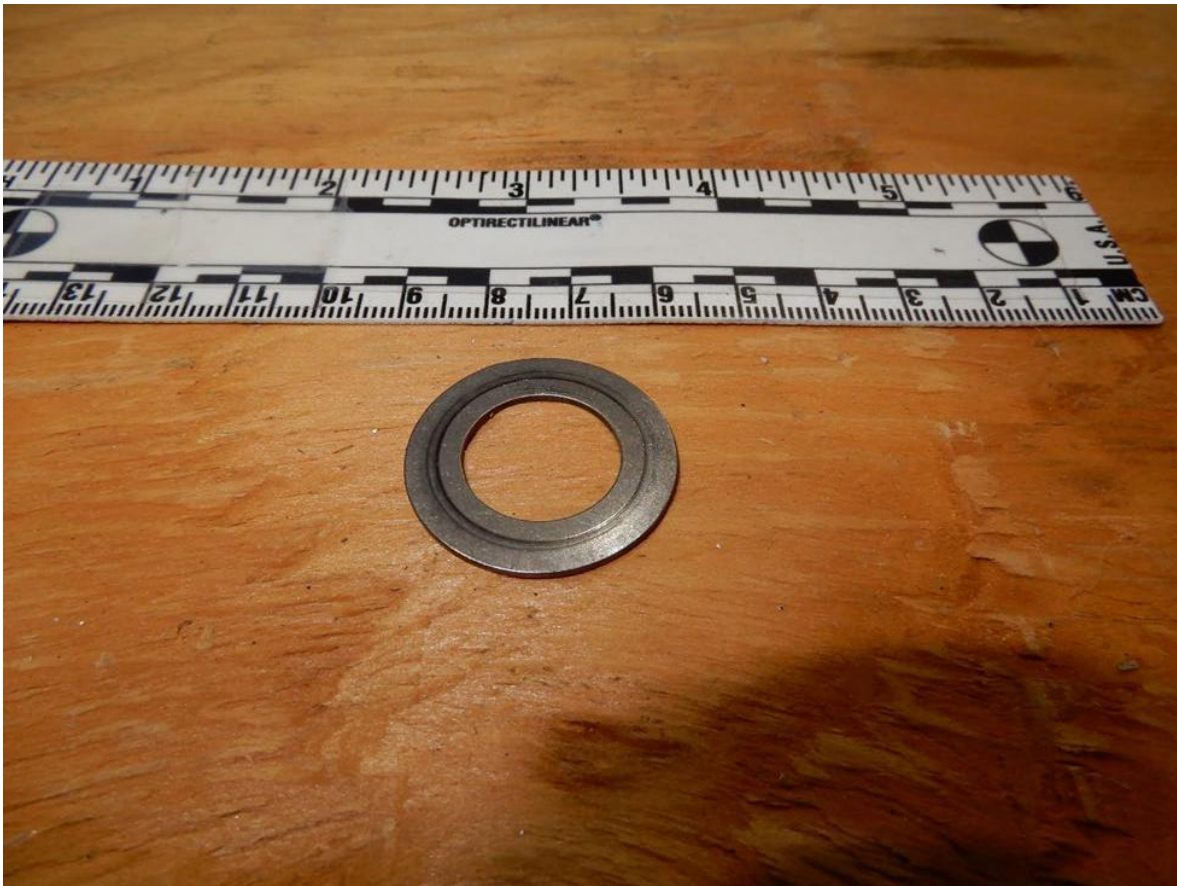
Figure 13. Number two-valve spring shim, showing a worn, circular groove.

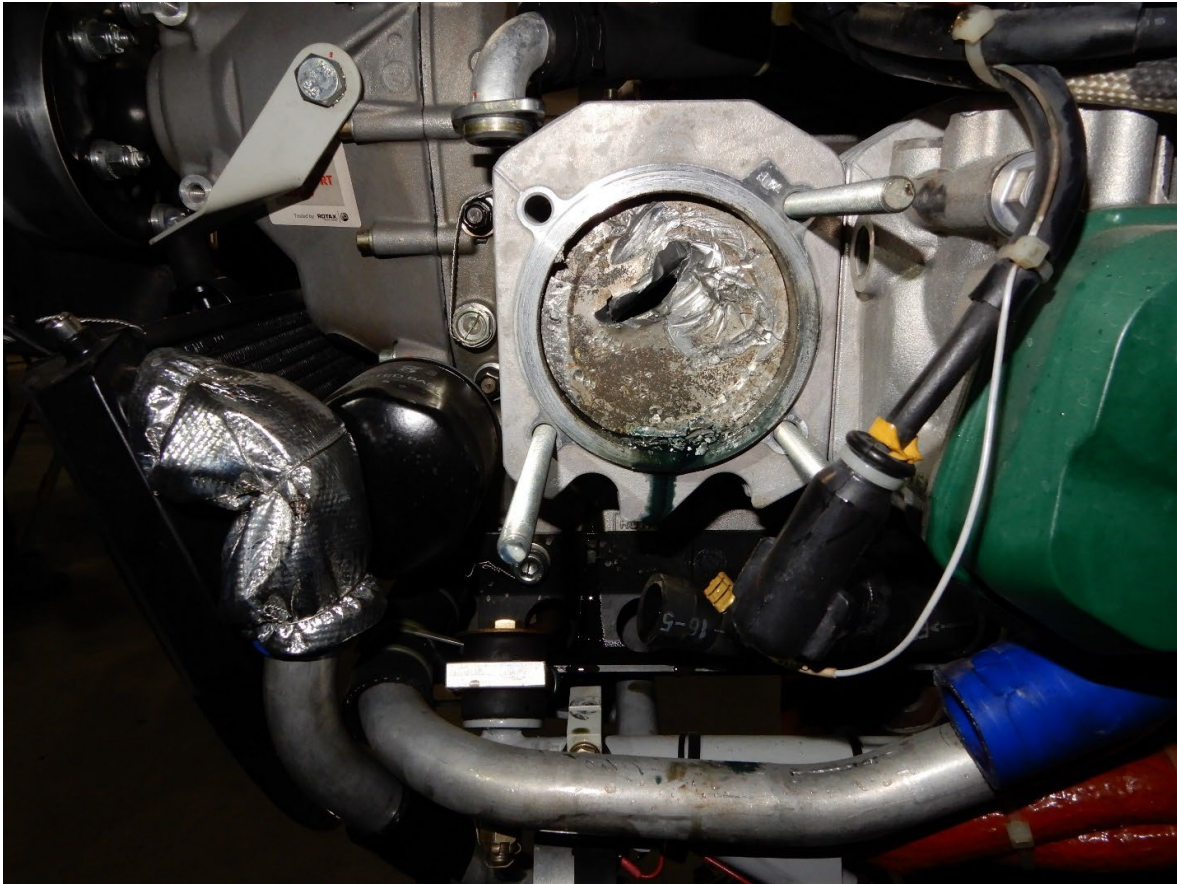
Figure 14. Number two-piston top.

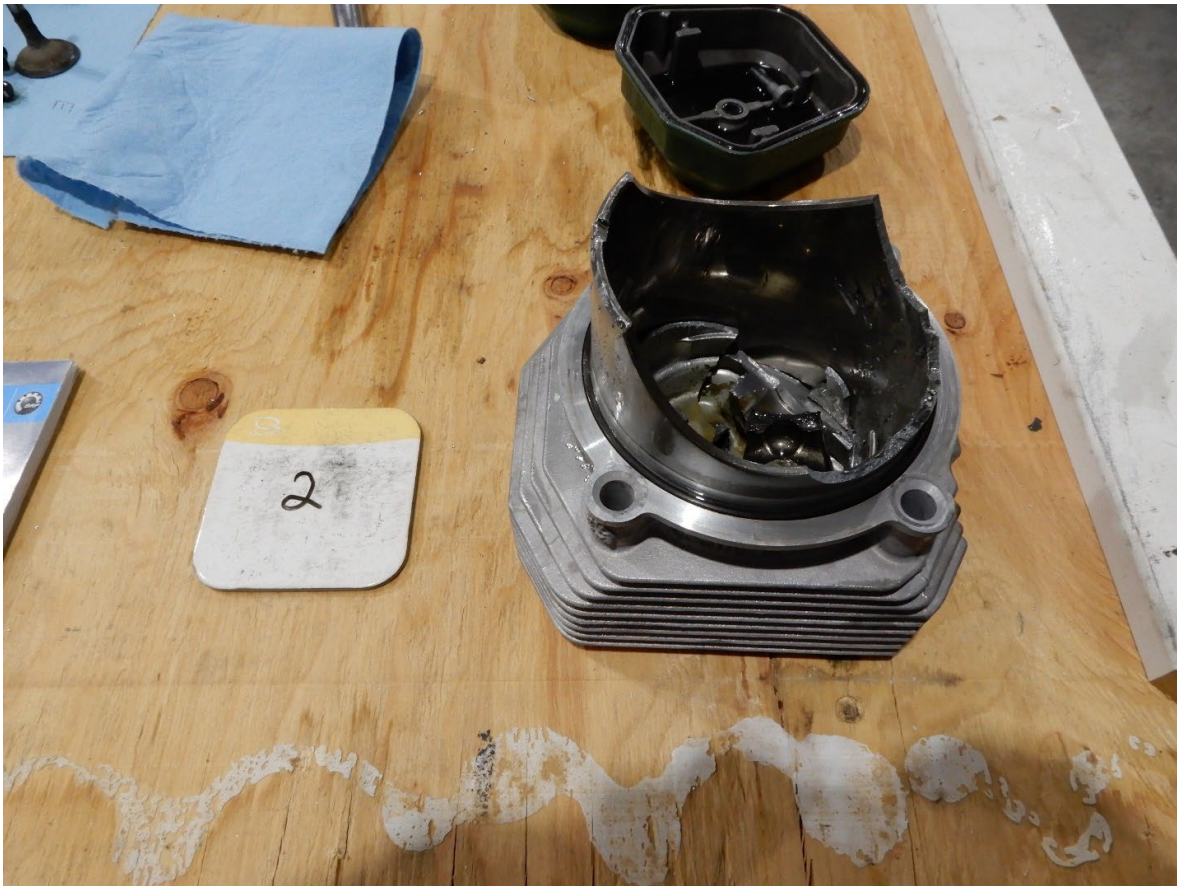
Figure 15. Number two-cylinder, bottom view, showing the fractured cylinder skirt. The fracture piston skirt is visible.

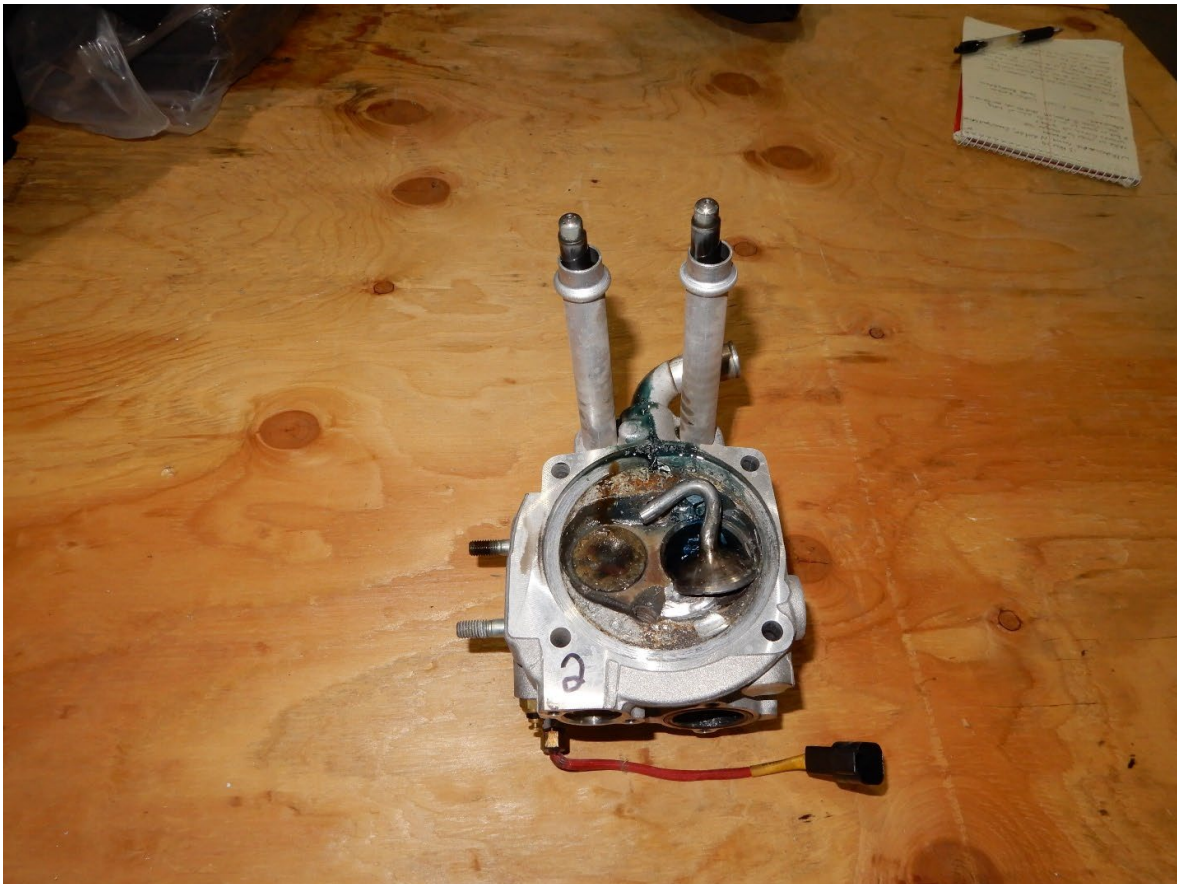
Figure 16. Number two-cylinder head, showing the intake valve displaced and lodged in the valve port.

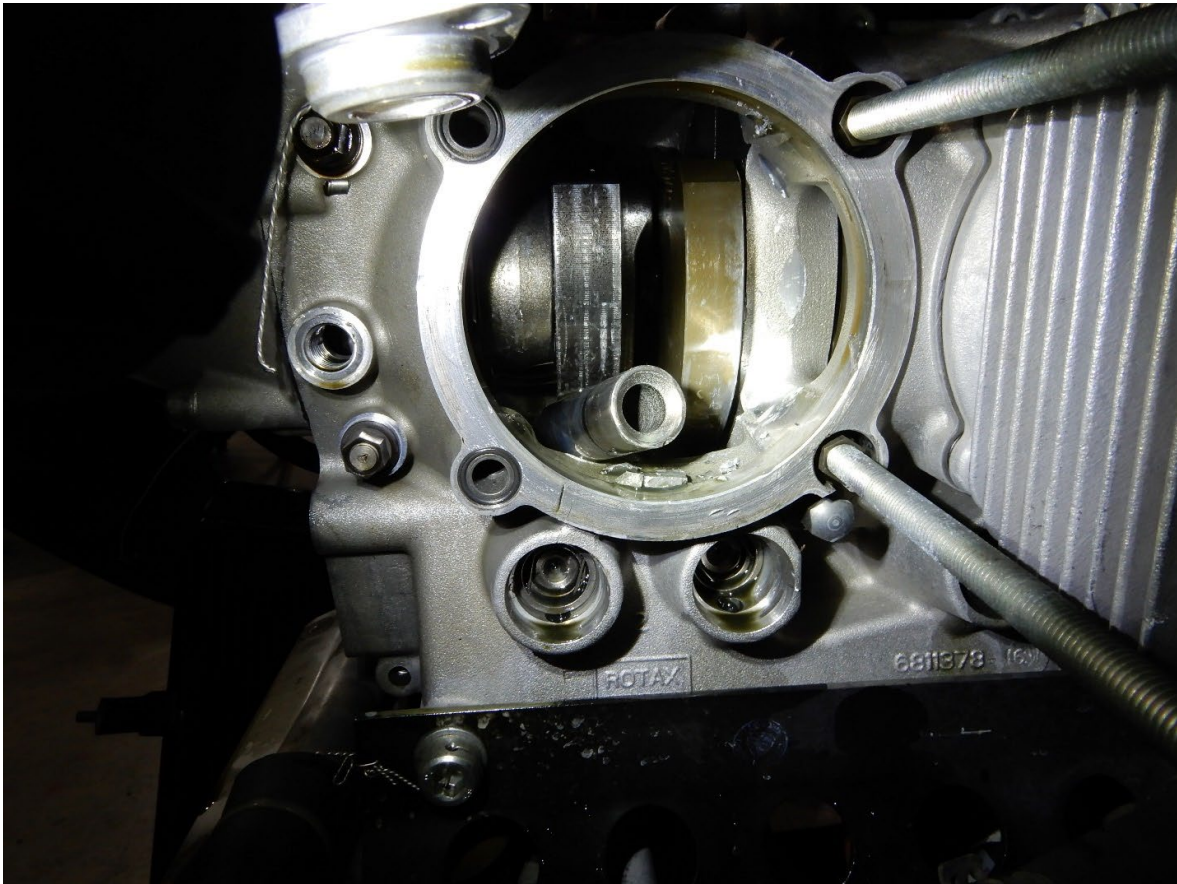
Figure 17. Number two-cylinder bore, showing the number two-piston wrist pin lodged between the crank shaft and the bore.

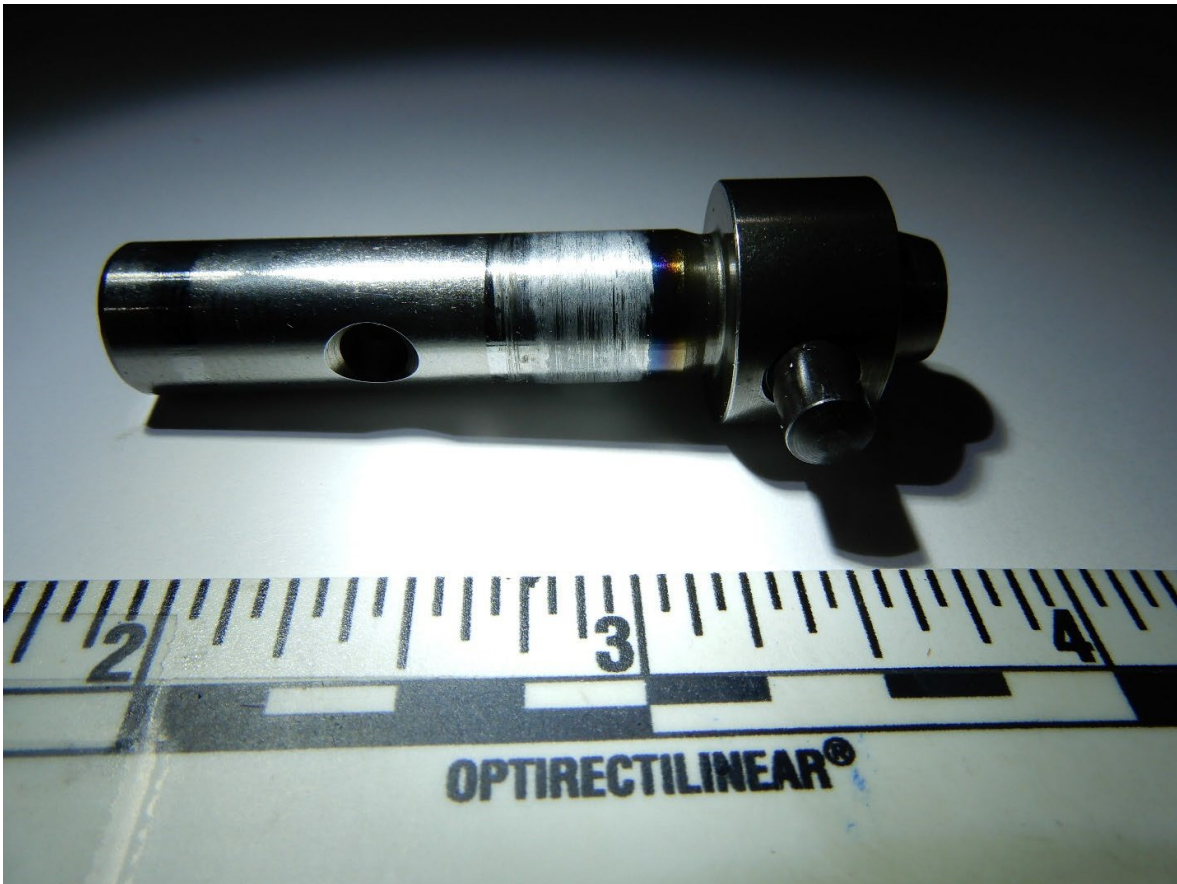
The oil pump was removed, and the pump shaft exhibited discoloration and galling.

Figure 18. Oil pump shaft, showing discoloration and galling.

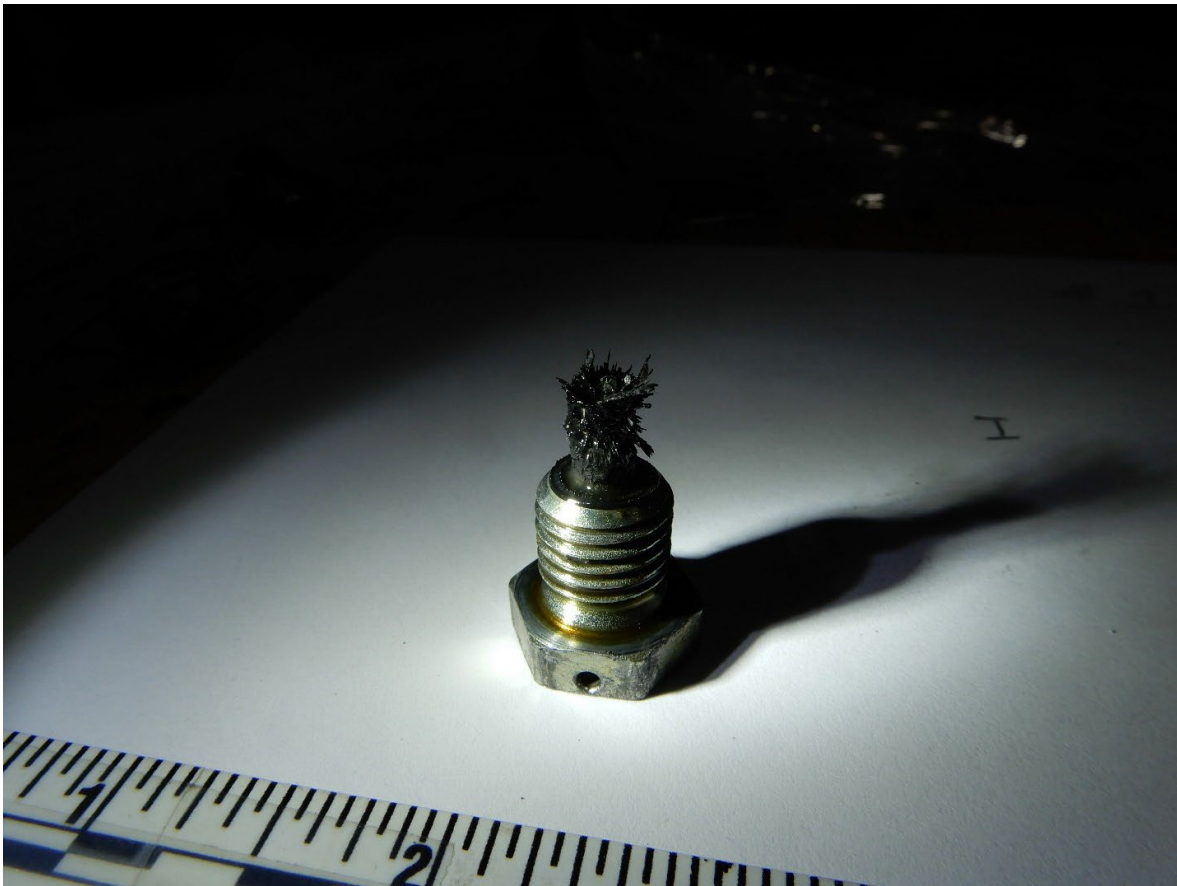
Figure 19. Magnetic chip detector, showing metal shaving attached.

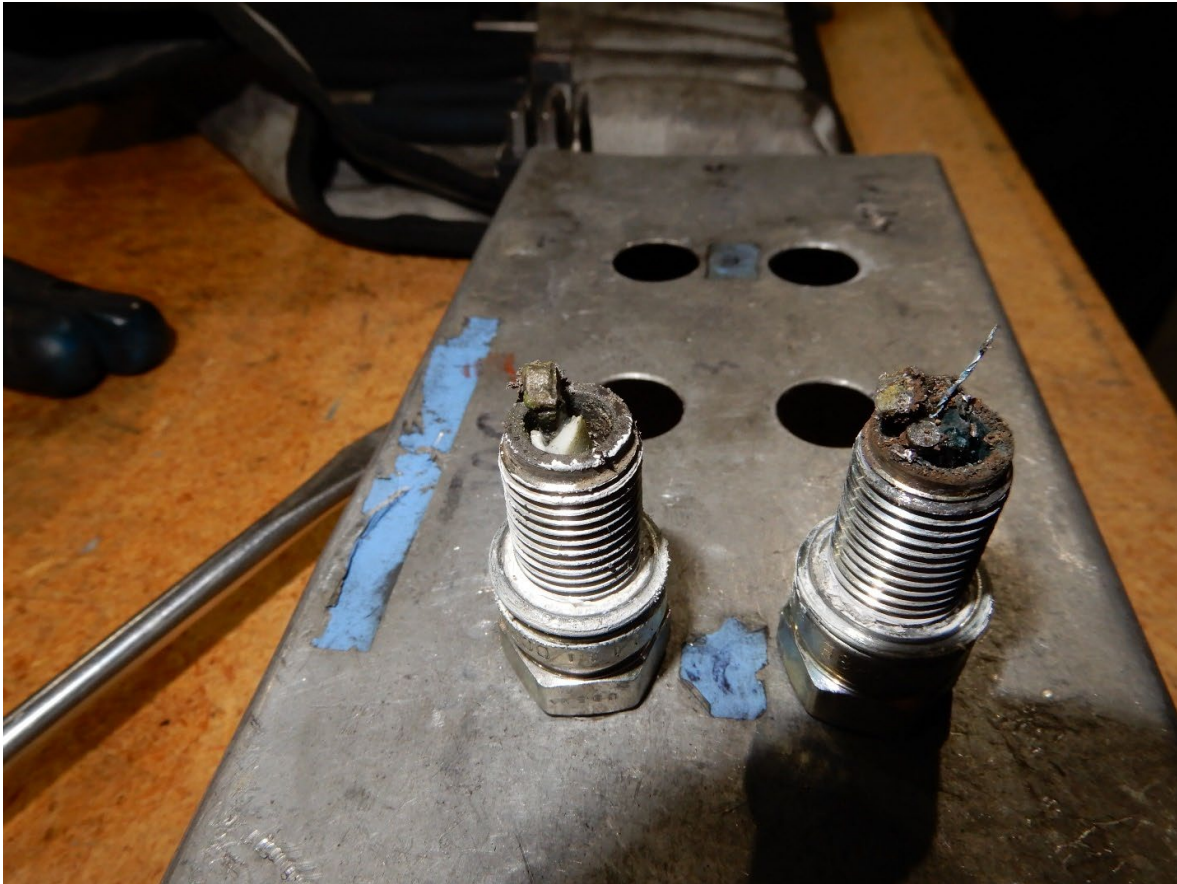
Figure 20. Number two-cylinder, top and bottom spark plugs.
