## **Memorandum for Record**

**NTSB Accident Number: WPR20LA012**  
**Aircraft Registration & Make/Model: N204BF / Czech Sport Aircraft, Sport Cruiser**  
**Accident Location: Holden, Utah**  
**Accident Date: October 22, 2019**  
**Subject: Ballistic Recovery System Examination**

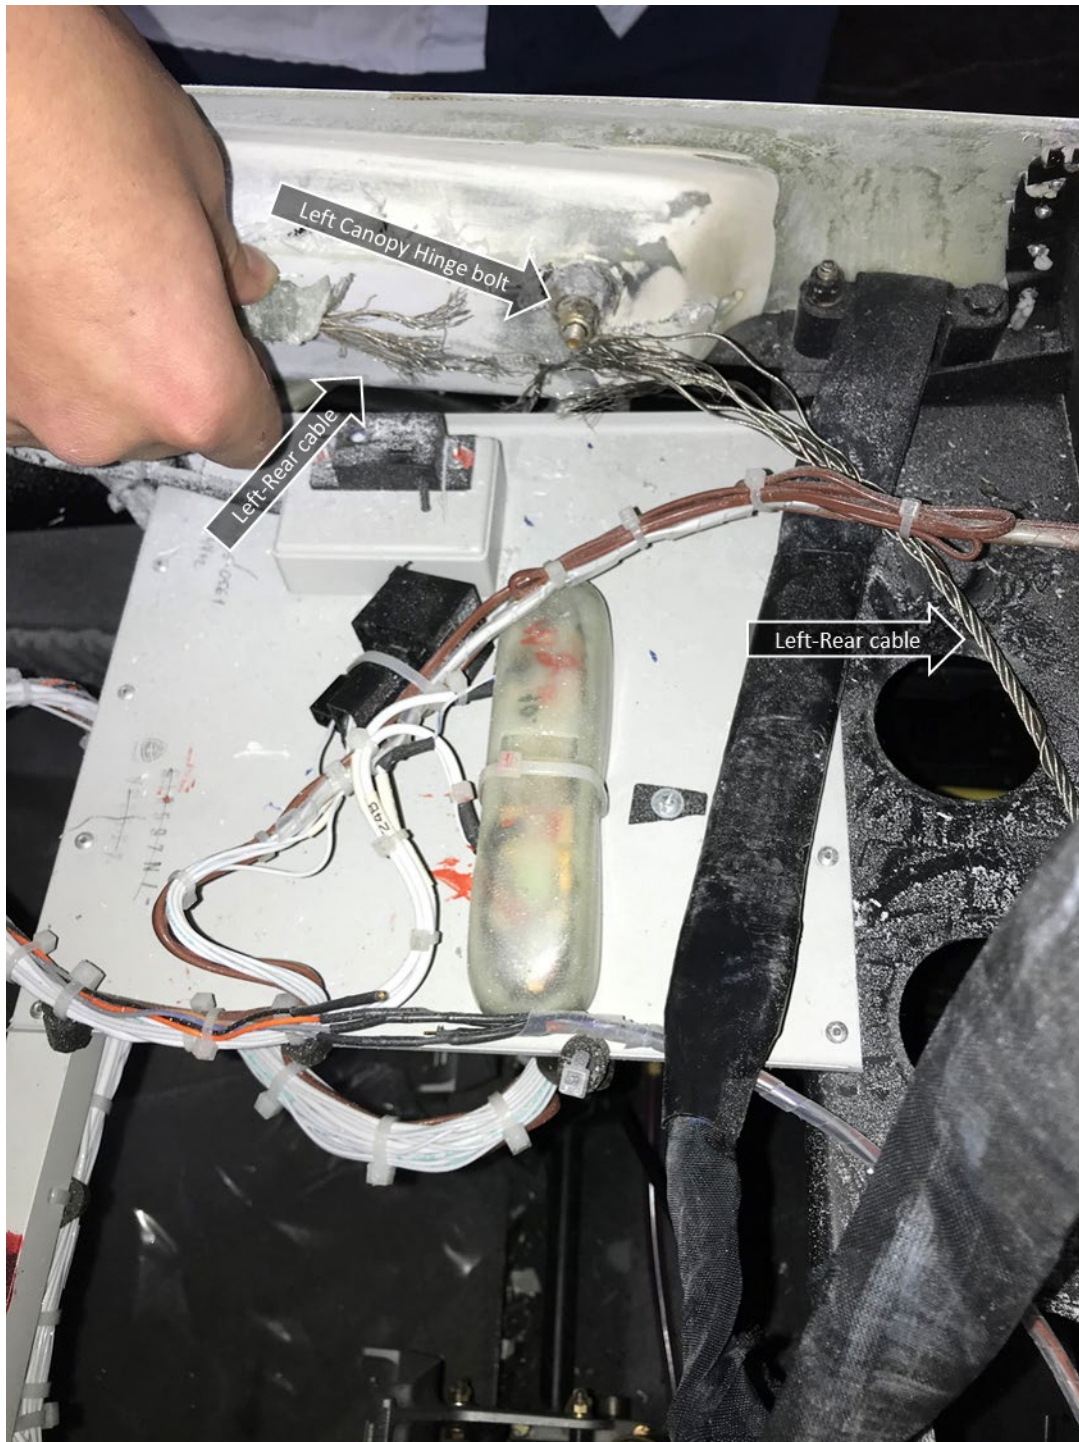
The left-rear steel suspension cable remained attached to the metal ring and the fuselage attachment point about mid-fuselage. The left-side cable exhibited a separation near the cockpit canopy left hinge bolt (Figures 1 and 2). The separated cable ends exhibited a frayed or broom

Figure 1 Photo showing both ends of the fractured left-side steel cable, and the left-side canopy hinge bolt and nut.

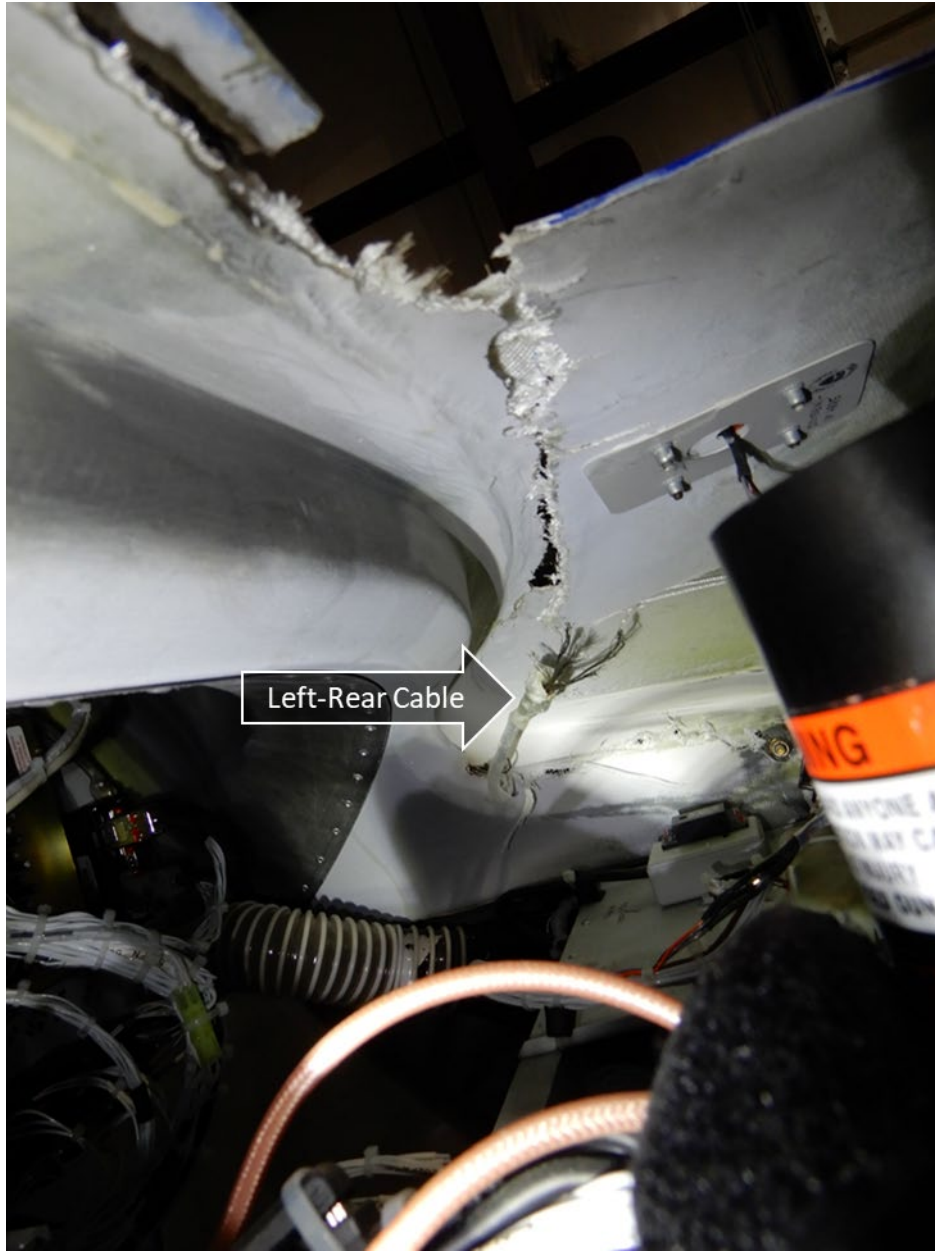
Figure 2. Photo showing the fractured left-side.

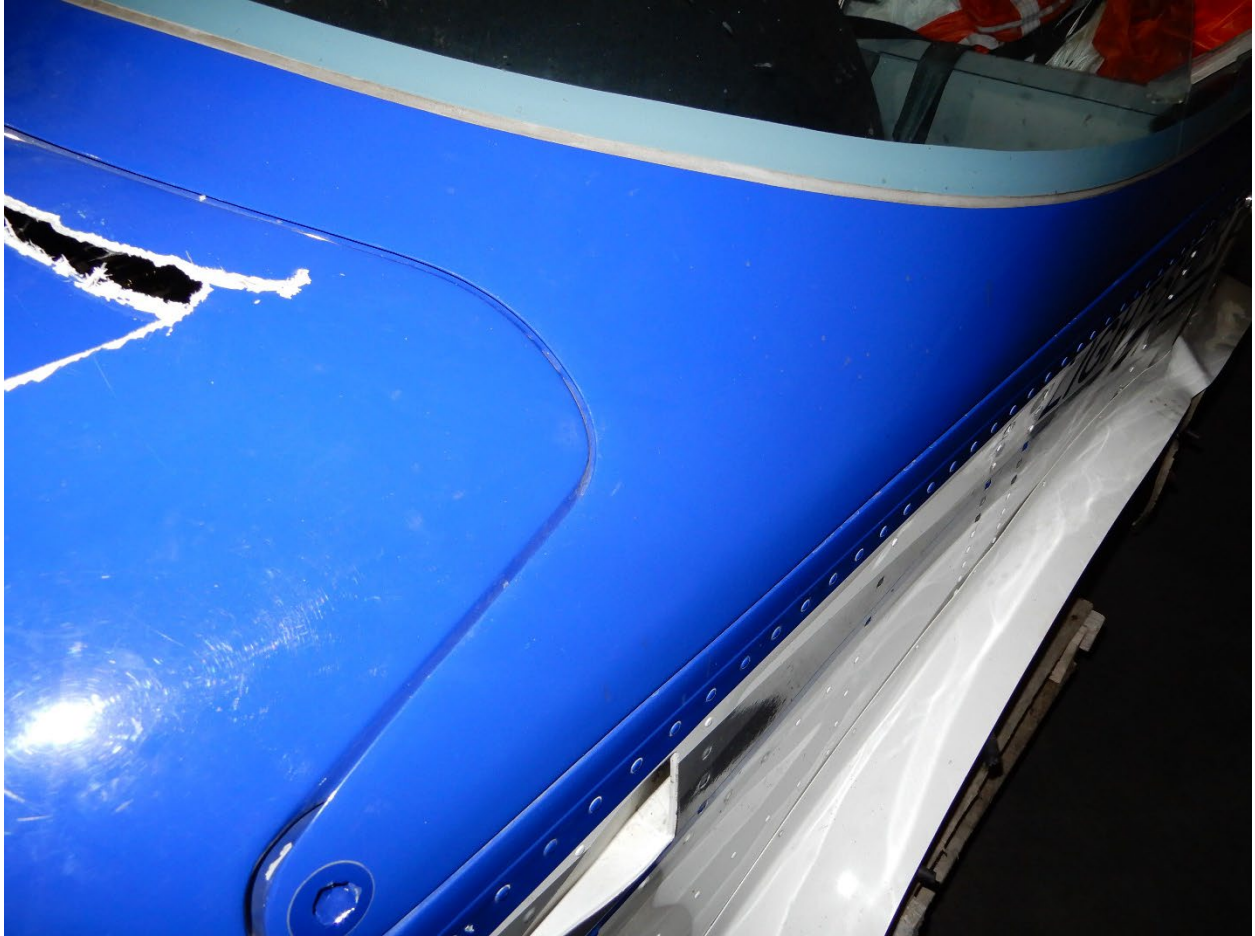
straw appearance. The steel cable did exit the nose compartment but aft of the canopy hinge bolt, the steel cable did not exit the composite material (Figure 3).

Figure 3. Photo showing the left-side suspension cable did not exit the forward nose compartment.

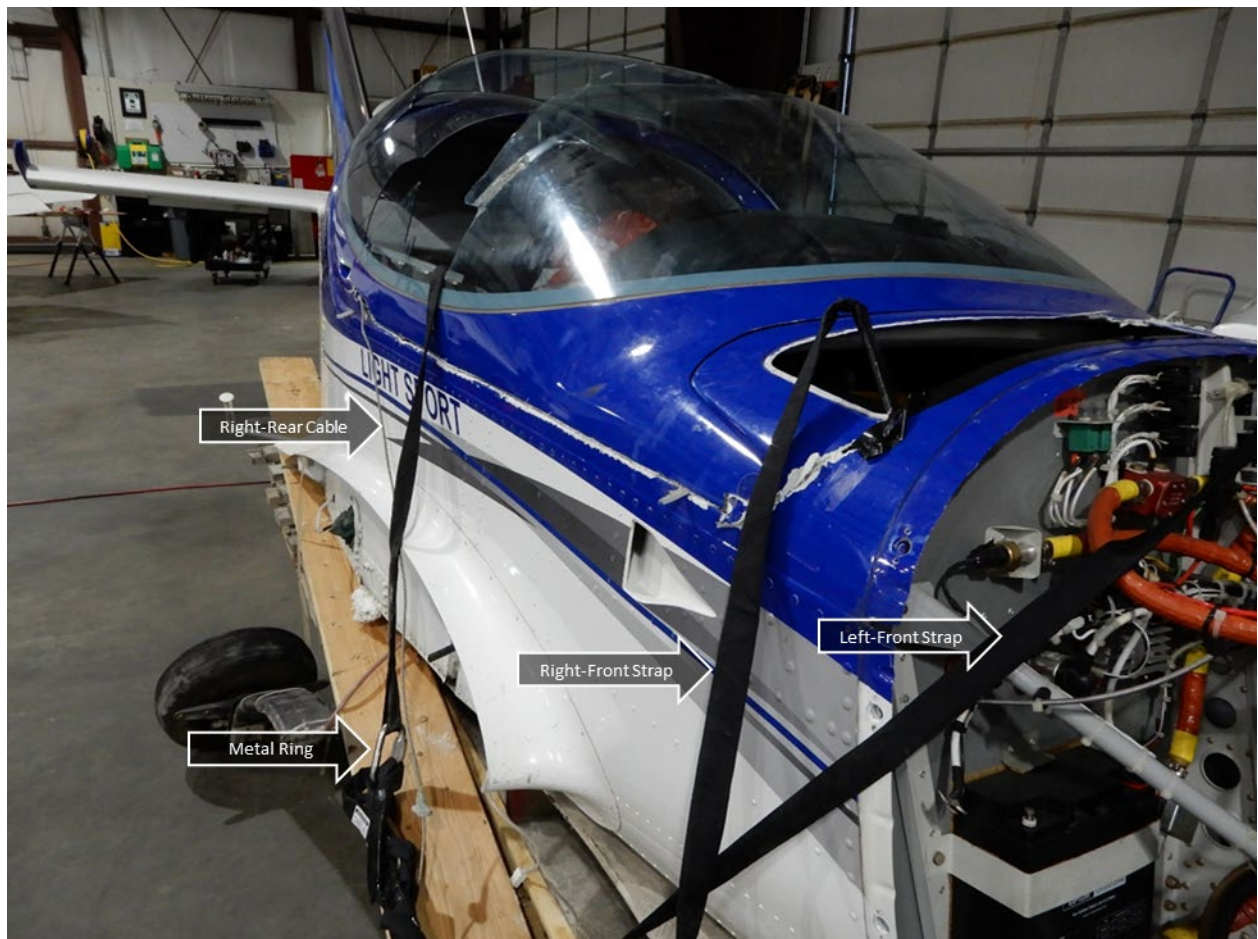
Examination of the right-side rear cable revealed that the cable remained attached at the metal ring and the fuselage attachment point about mid-fuselage. The cable exited the nose compartment, travelled under the right-side canopy hinge bolt, and then along the right side of the canopy's lower seam to the fuselage. The cable then tore into the canopy and stopped near the right-side handle. (Figures 4, 5, and 6).

Figure 4. Photo showing the two straps, the right-rear cable, and the metal ring.

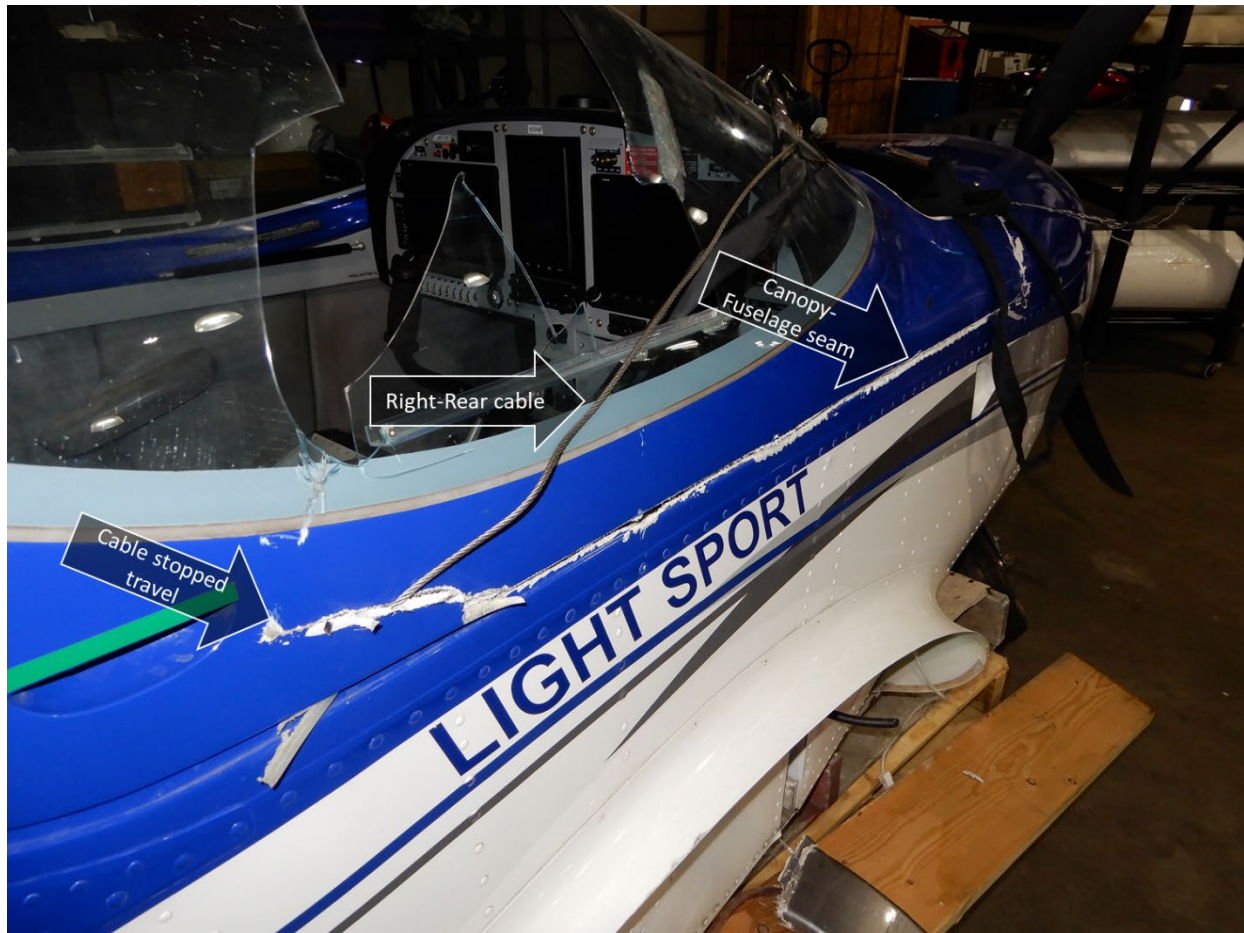
Figure 5. Photo showing the path of the right-rear cable.

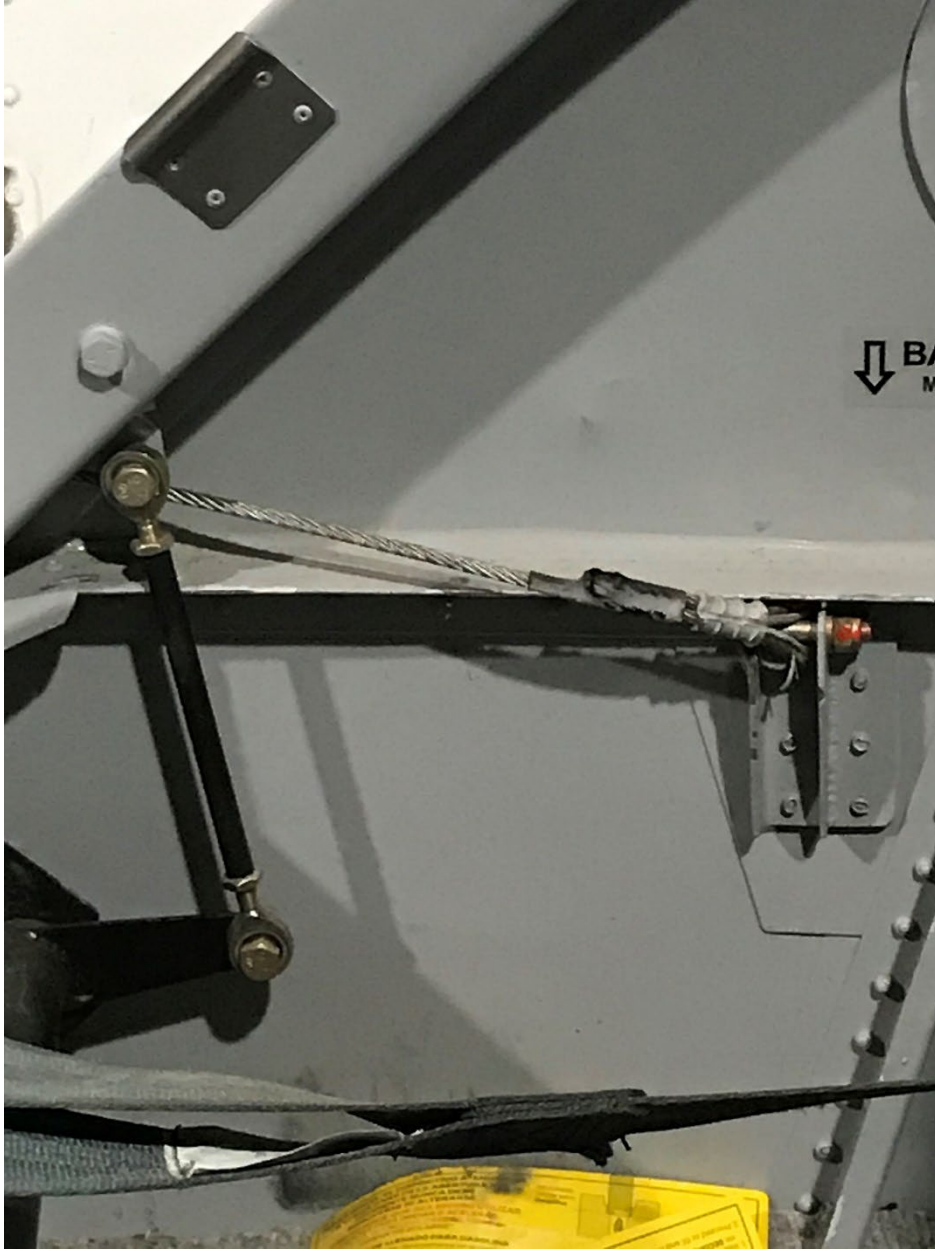
Figure 6. Photo showing the right-rear cable fuselage attachment point. This is typical for the left side.
