## RECORD OF CONVERSATION

**Date: December 6, 2019**  
**Person Contacted: Mr. Randy Weese (Federal Aviation Administration Inspector)**  
**NTSB Accident Number: WPR20LA022**

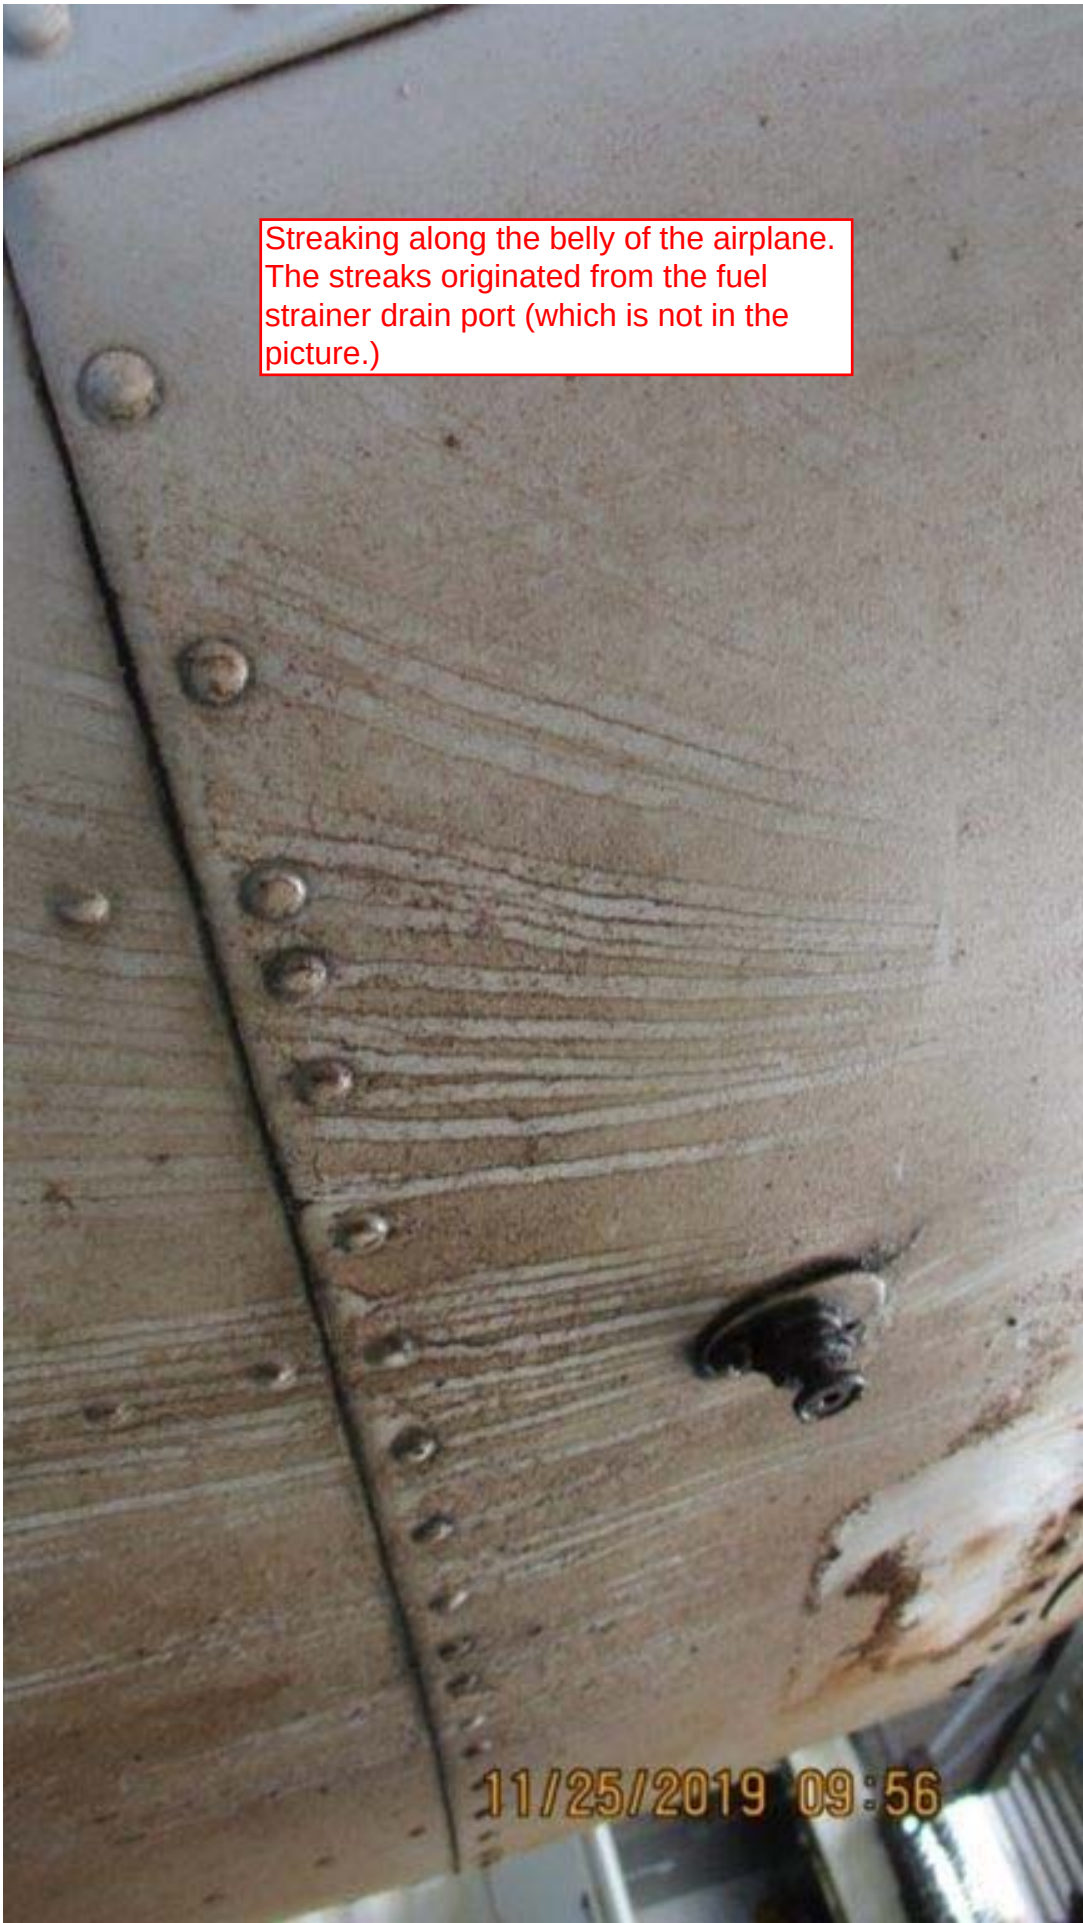
- Fuel streaking was observed on the belly of the airplane initiating from the sump drain port on the bottom of the cowling.
  - The handle was manipulated and operated normally.

Streaking along the belly of the airplane.  
The streaks originated from the fuel  
strainer drain port (which is not in the  
picture.)

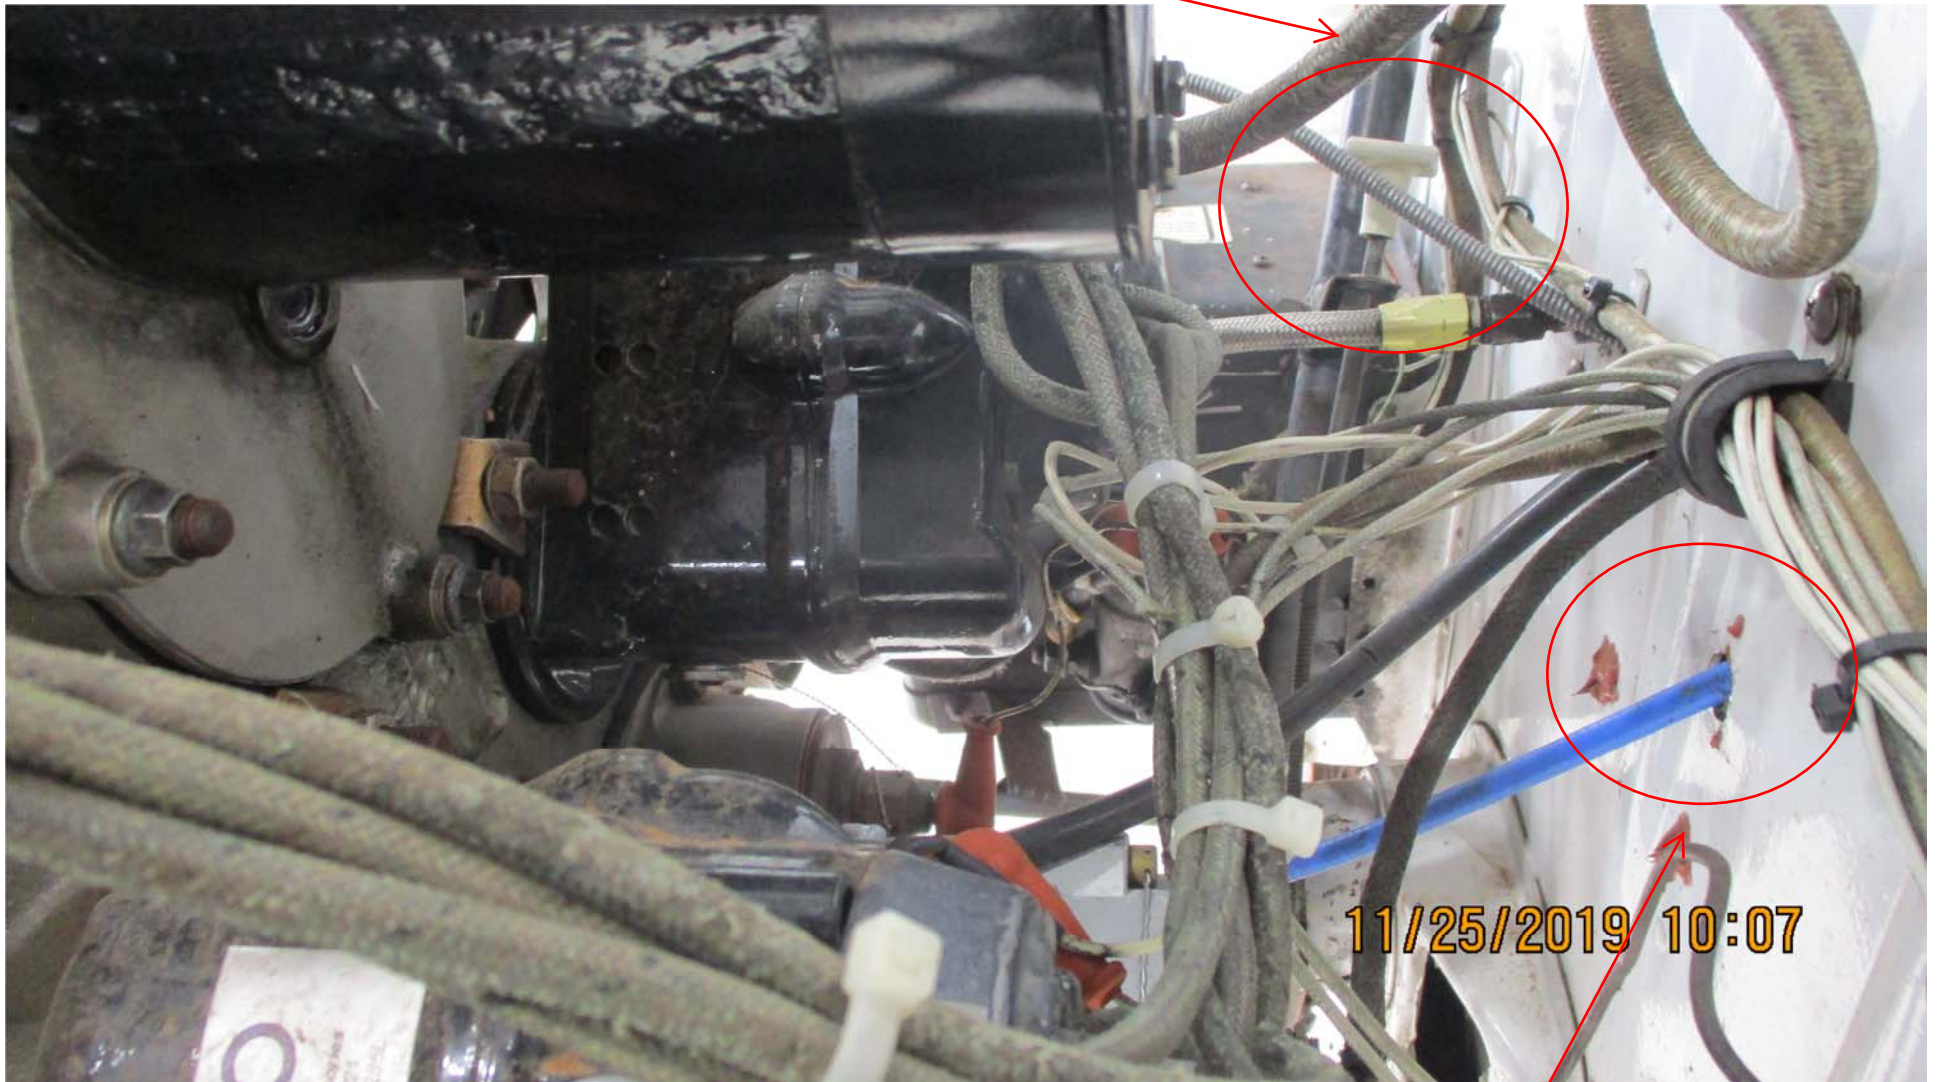
- The propeller was rotated by hand and thumb compression was established on all cylinders.
- The handle for the fuel strainer sump was found pulled up about ½ inch.

Fuel strainer drain handle.

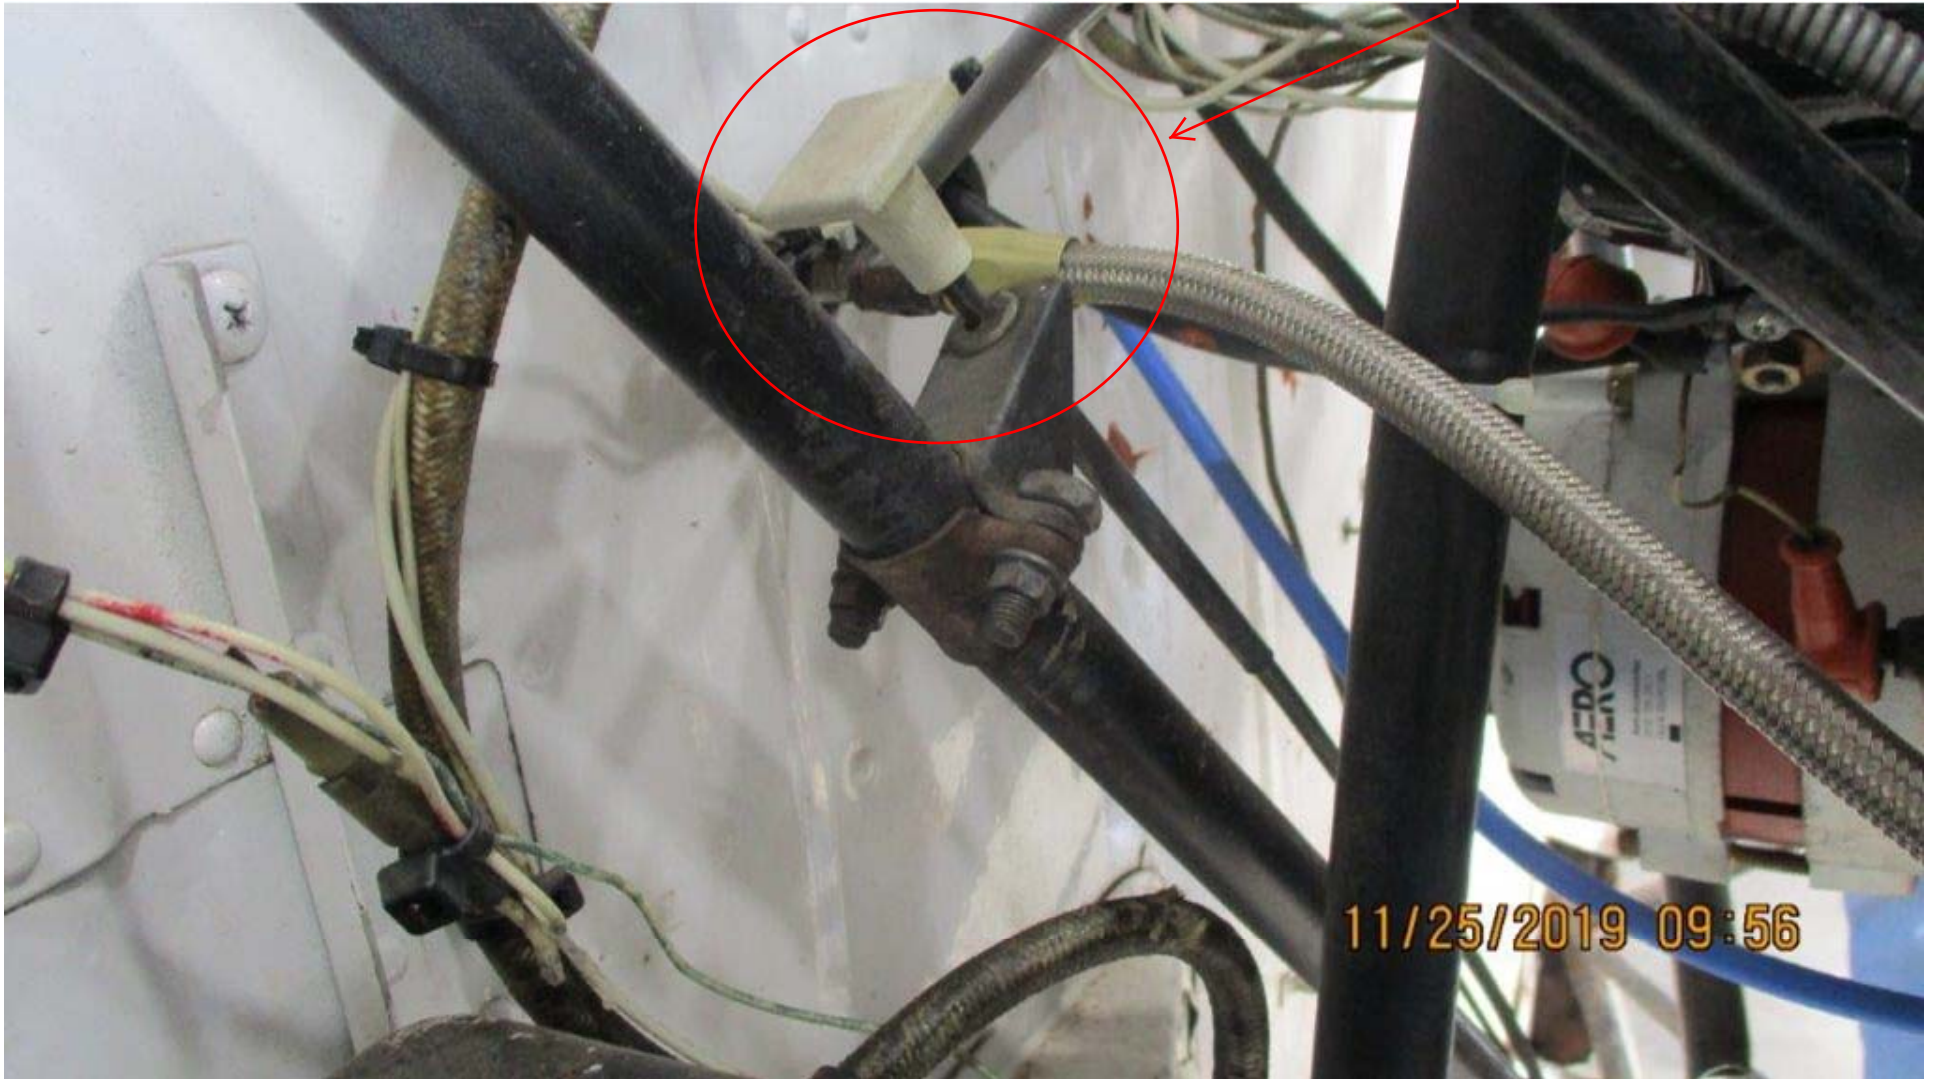
- It was noted that a grommet was not present around the throttle cable at the firewall. However, there was no wear on the throttle cable itself.
- The spark plugs were removed from the engine and were sooty, however, they were consistent with normal operating wear signatures.

No Grommet at the firewall for the throttle cable.

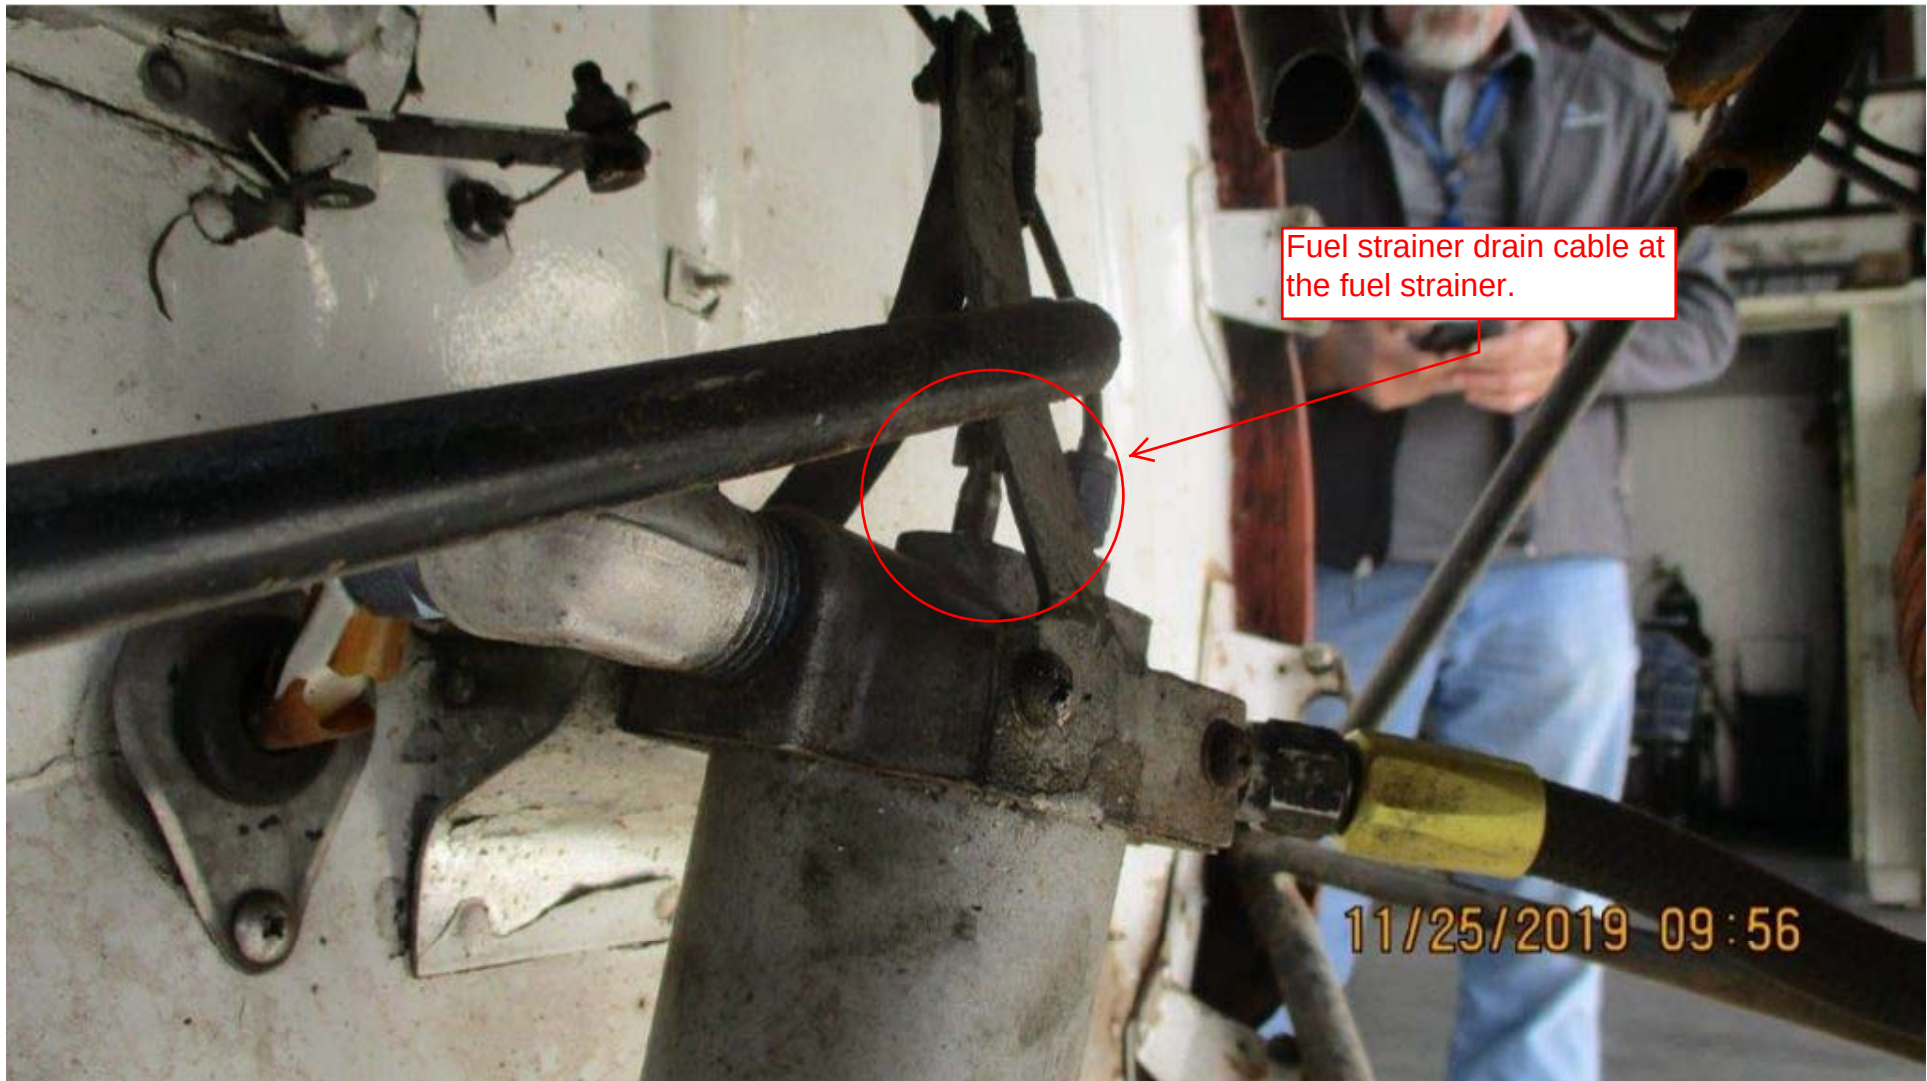
Another view of the fuel strainer  
drain handle. It was extended about  
1/2 inch. (Fully extended is about 1  
inch)

Fuel strainer drain cable at the fuel strainer.
