## **NATIONAL TRANSPORTATION SAFETY BOARD**

# **AIRFRAME AND ENGINE EXAMINATION**

**WPR20LA024**

Location: Ogden, Utah  
Date: November 17, 2019  
Aircraft: Piper Aircraft, PA 28R, N3206R  
NTSB IIC: Fabian Salazar

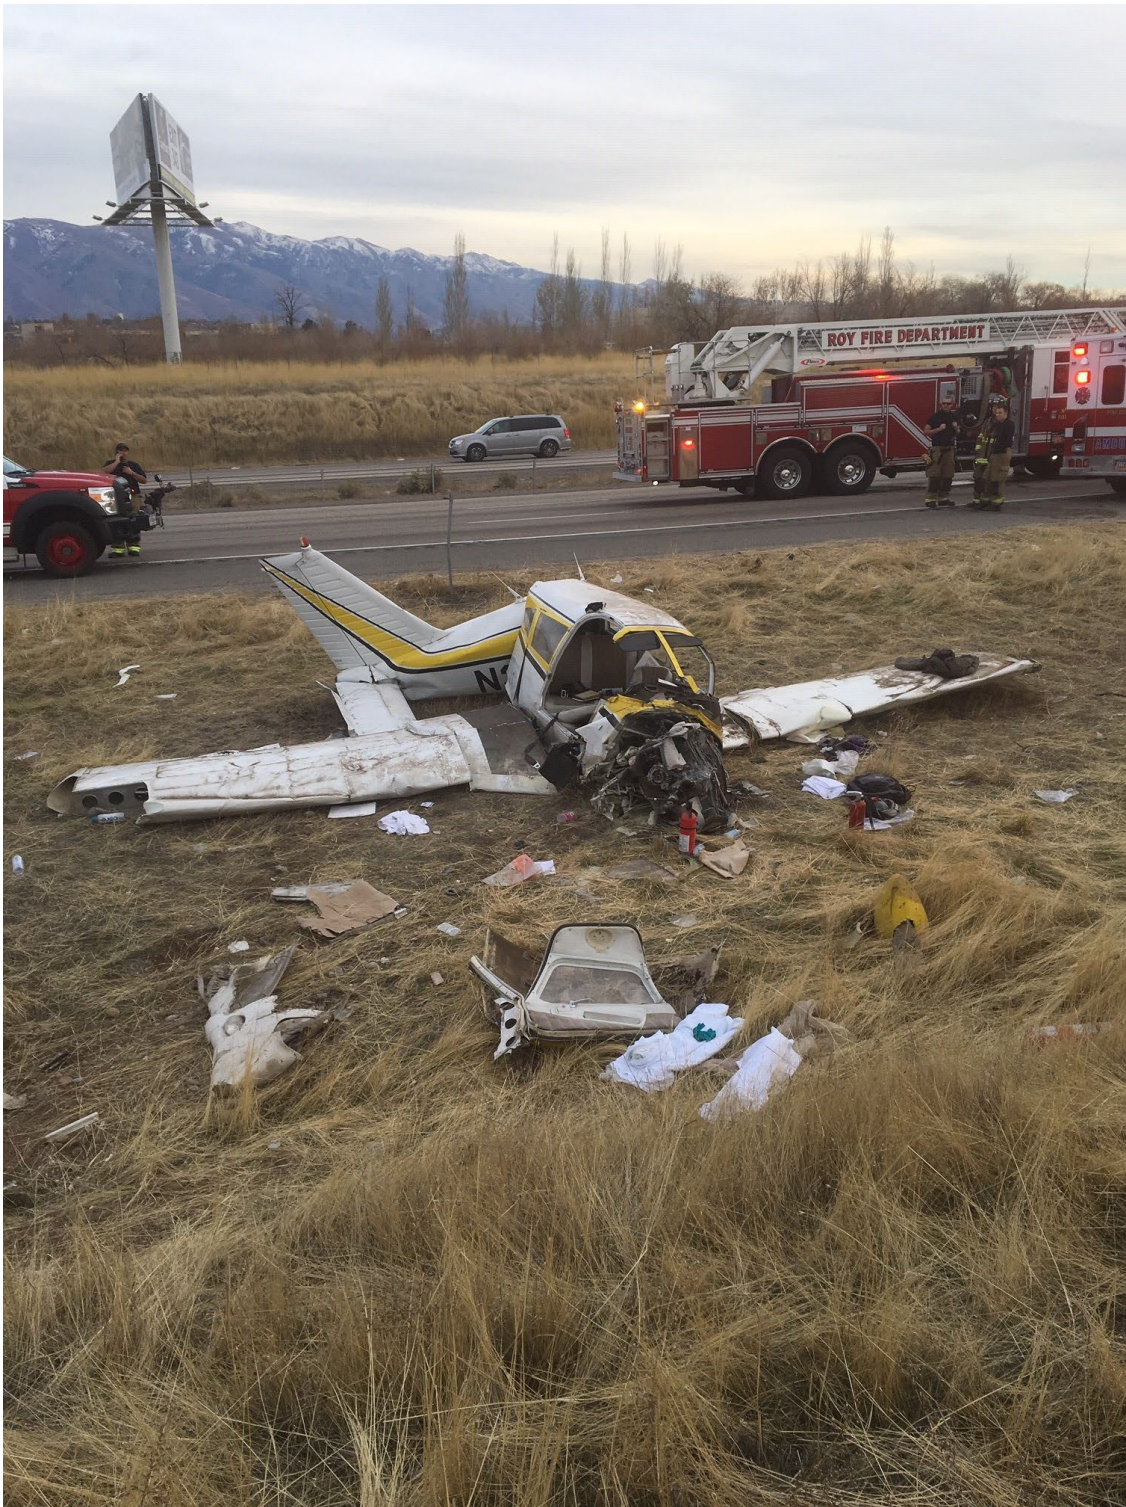
Figure 1. N3206R front view at the accident site: Photo courtesy of the FAA.

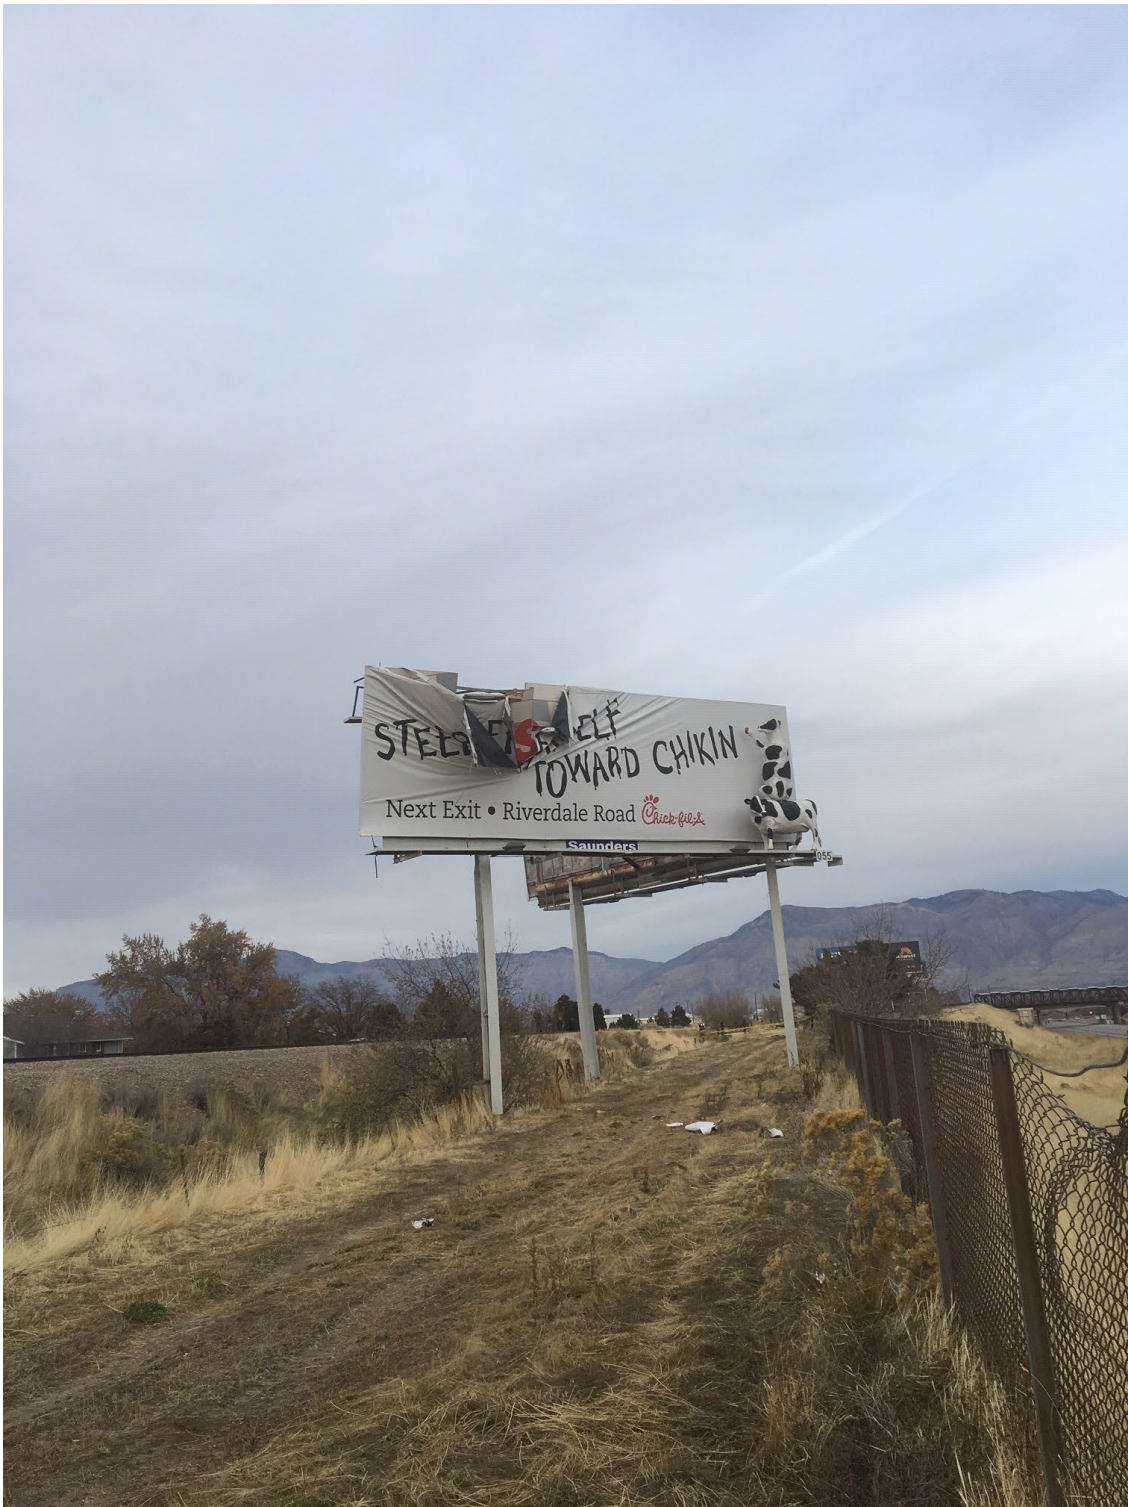
Figure 2. View of the billboard struck by N3206R. Photo courtesy of the FAA.

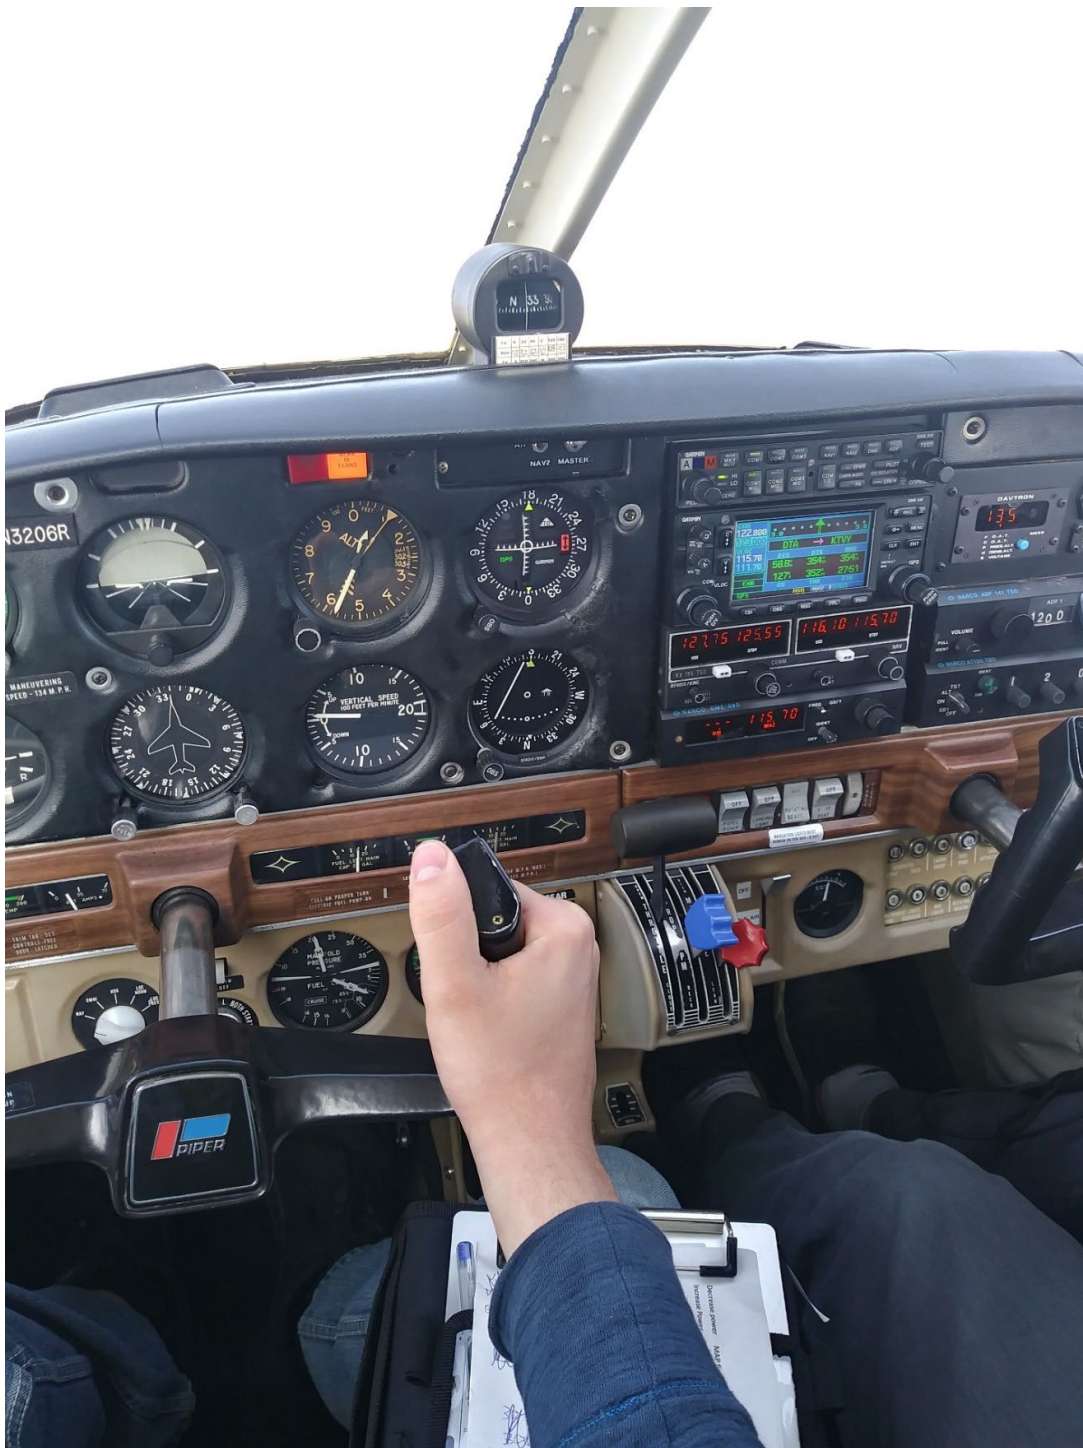
Figure 3. Photo taken from a previous flight showing the Gear in Transit light illuminated.

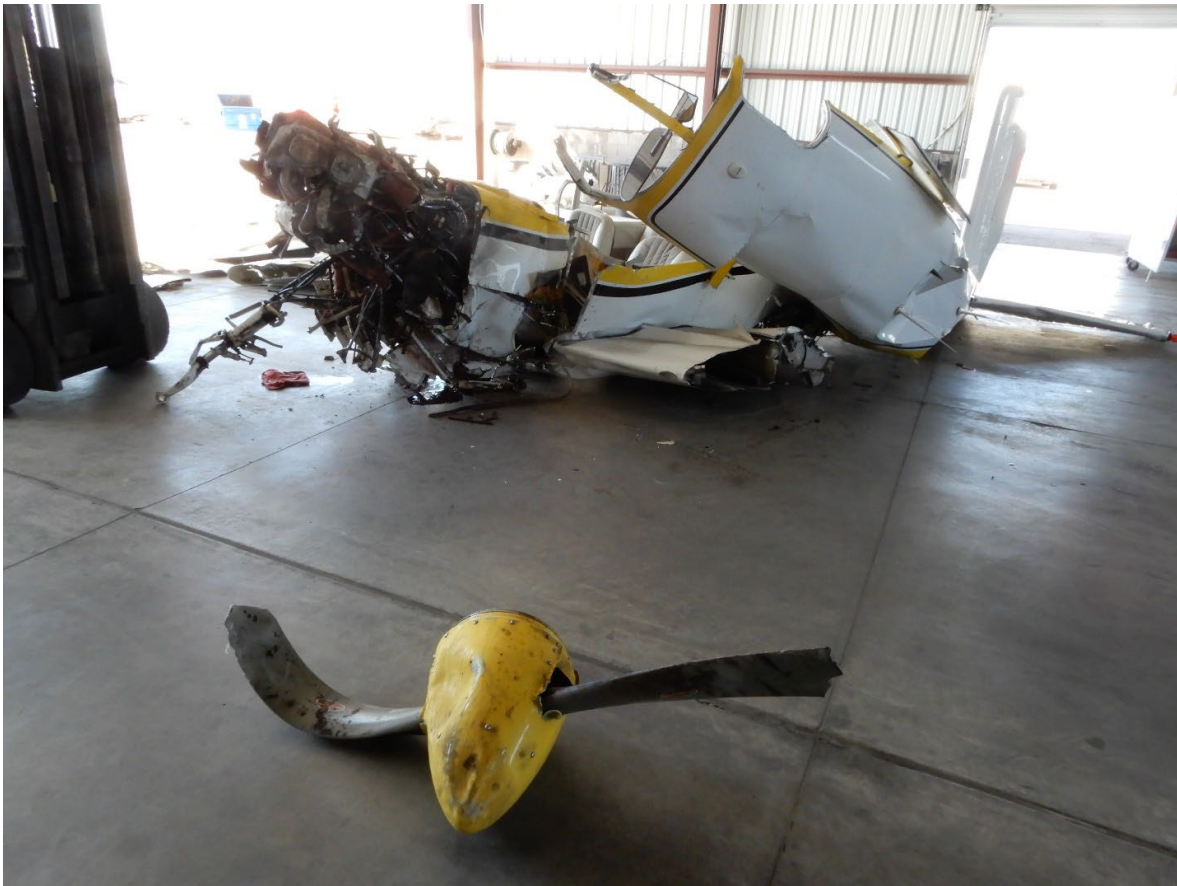
Figure 4. View of N3206R at the recovery site.

The Airframe was in two large halves connected by wiring and cables. The first half consisted of the engine nacelle area and floor back to the rear seat aft bulkhead. The second half consisted of the upper cabin roof and extended back to the empennage. The separation appeared to be mostly from the accident, but some cutting by first responders were present.

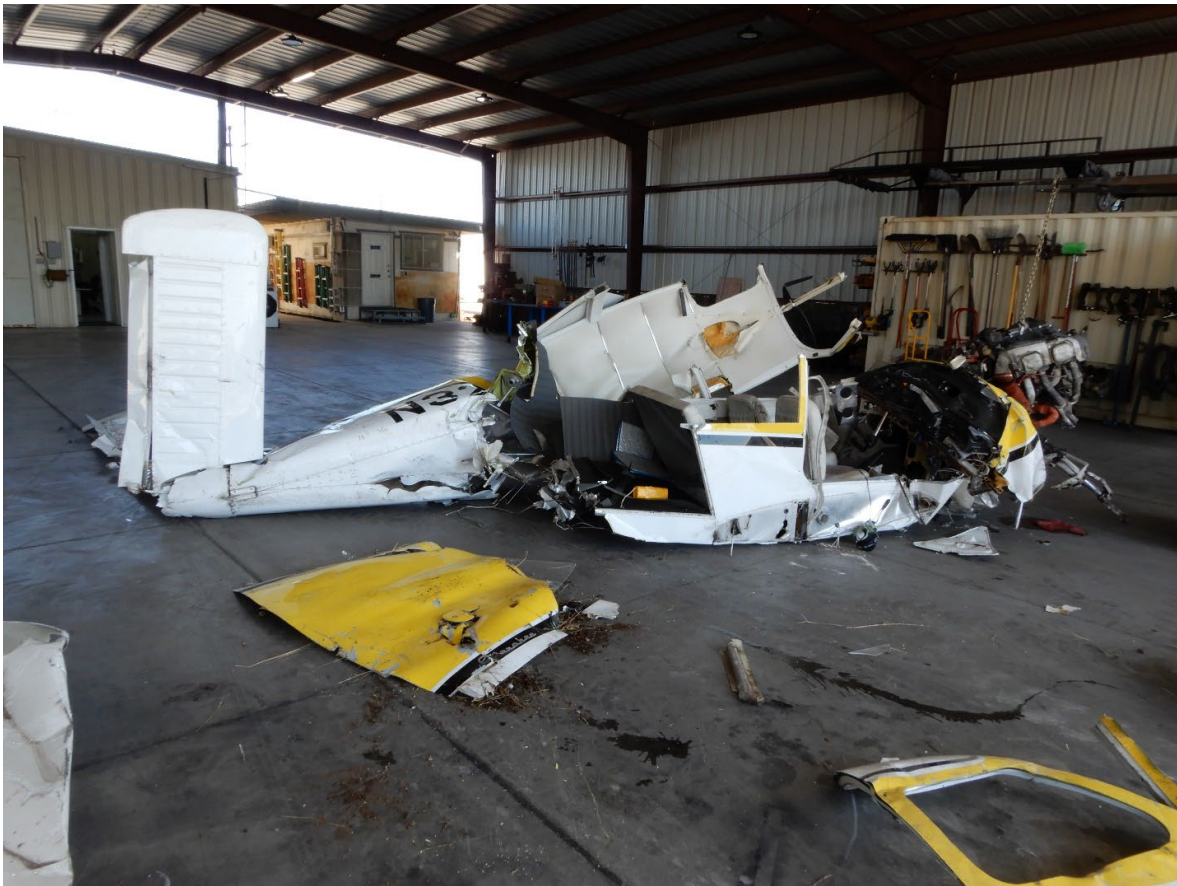
Figure 5. Right-side view.

Right side fuselage. The composite lower engine cowlings were flattened and fragmented. The upper composite engine cowlings separated from the airplane and were found with the wreckage. The rear fuselage, behind the aft seat bulkhead, on the underside, was damaged and fractured with upward deformation.

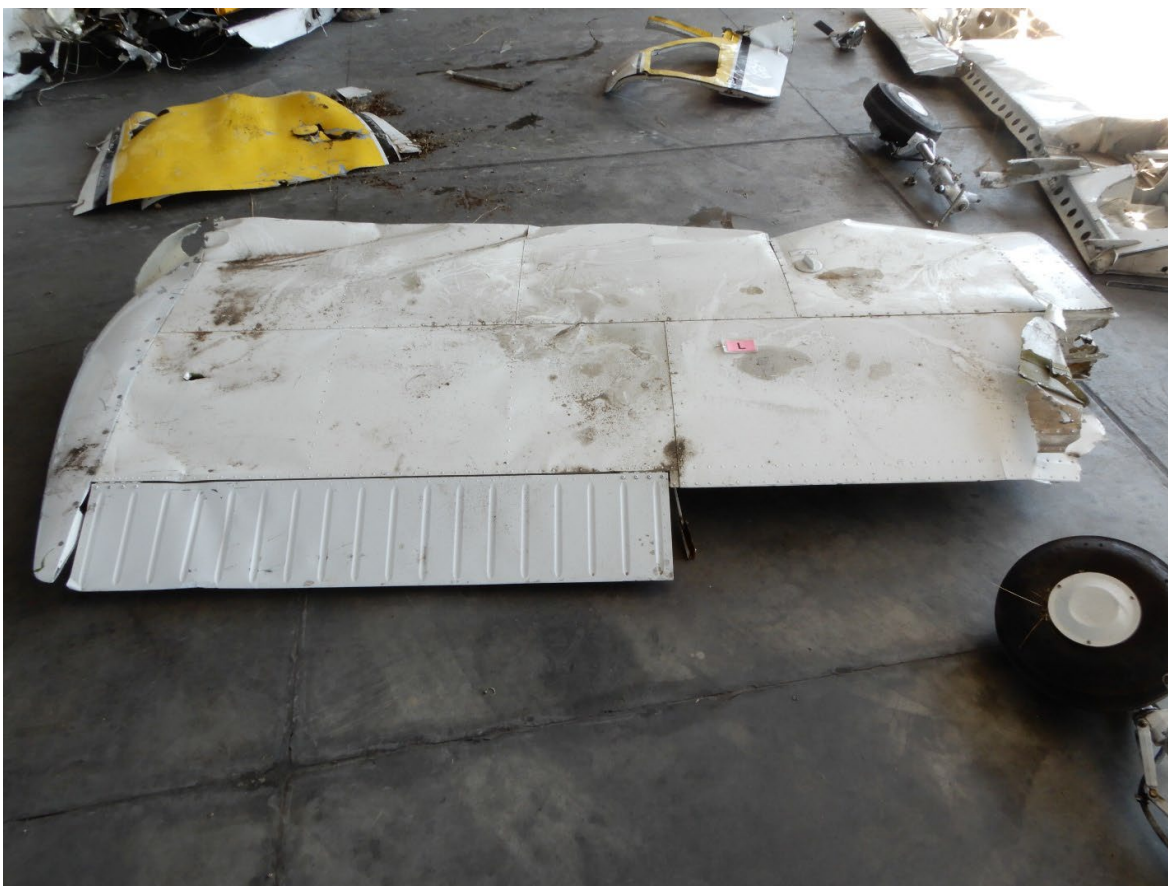
Figure 7. Left outboard wing section.

The left wing remained attached to the fuselage and was cut about 27 inches from the wing root for recovery. The left-wing root and 27 inches of the left wing remained attached to the fuselage. This section of the wing exhibited an upward bend. The wing tip exhibited a contact point at the leading edge that created a hole about 6 inches in diameter. A dented and wrinkled area near the trailing edge was present near the hole. The stall warning tab was bent aft. The pitot sensor was separated from the wing at the screws but retained to the wings by the tube. An area of dents and wrinkles pushed aft towards the trailing edge was exhibited about 90 inches from the wing tip. The aileron remained attached to the wing at the three hinges and exhibited minor damage. The flap was separated from the wing at the three attachment points and exhibited wrinkles and dents throughout its span.

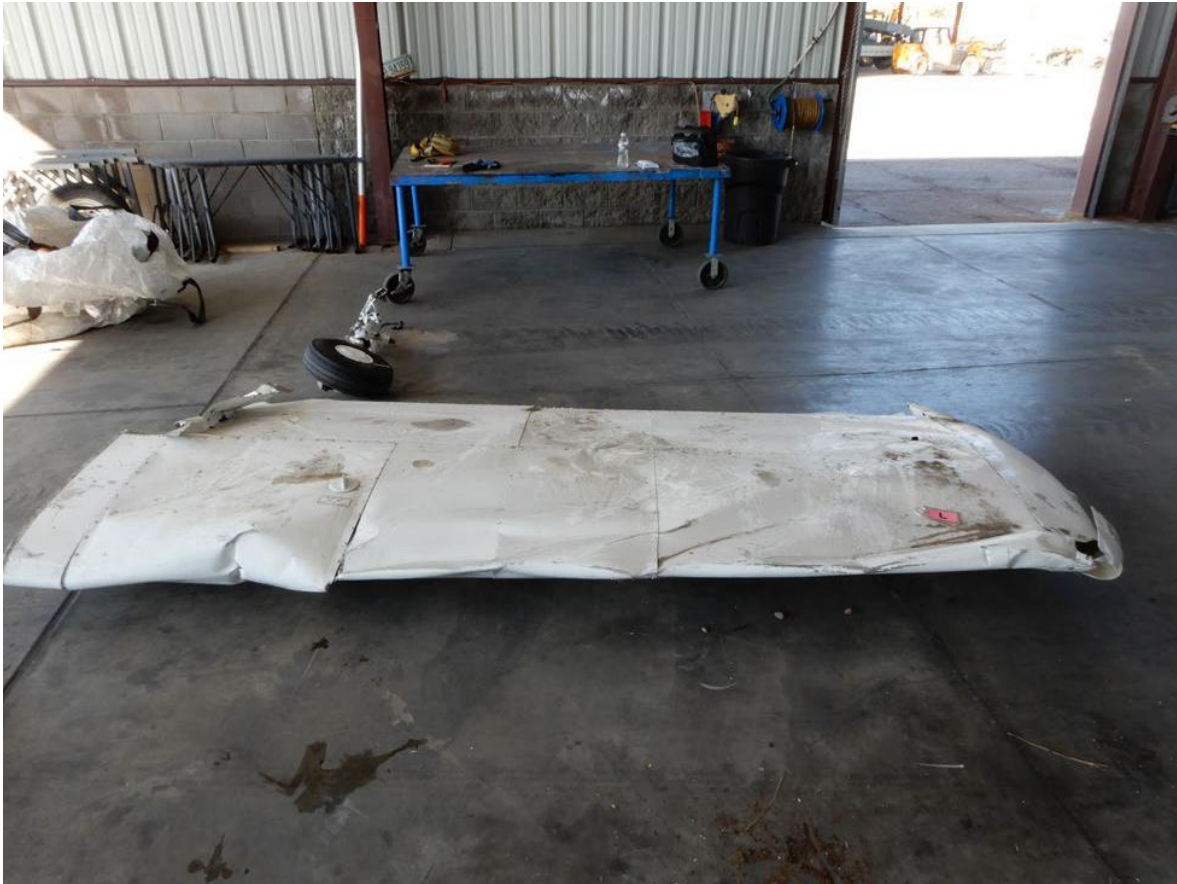
The left main landing gear separated from the underside of the wing at the attachment points. The landing gear was found in the wreckage area intact. The landing gear actuator was extended. The oleo strut was charged and extended. The brakes were intact and appeared normal. The brake line separated from the wing at the wing attachment point. The tire and wheel exhibited minor damage.

Figure 8. Outboard section of left wing and left main landing gear.

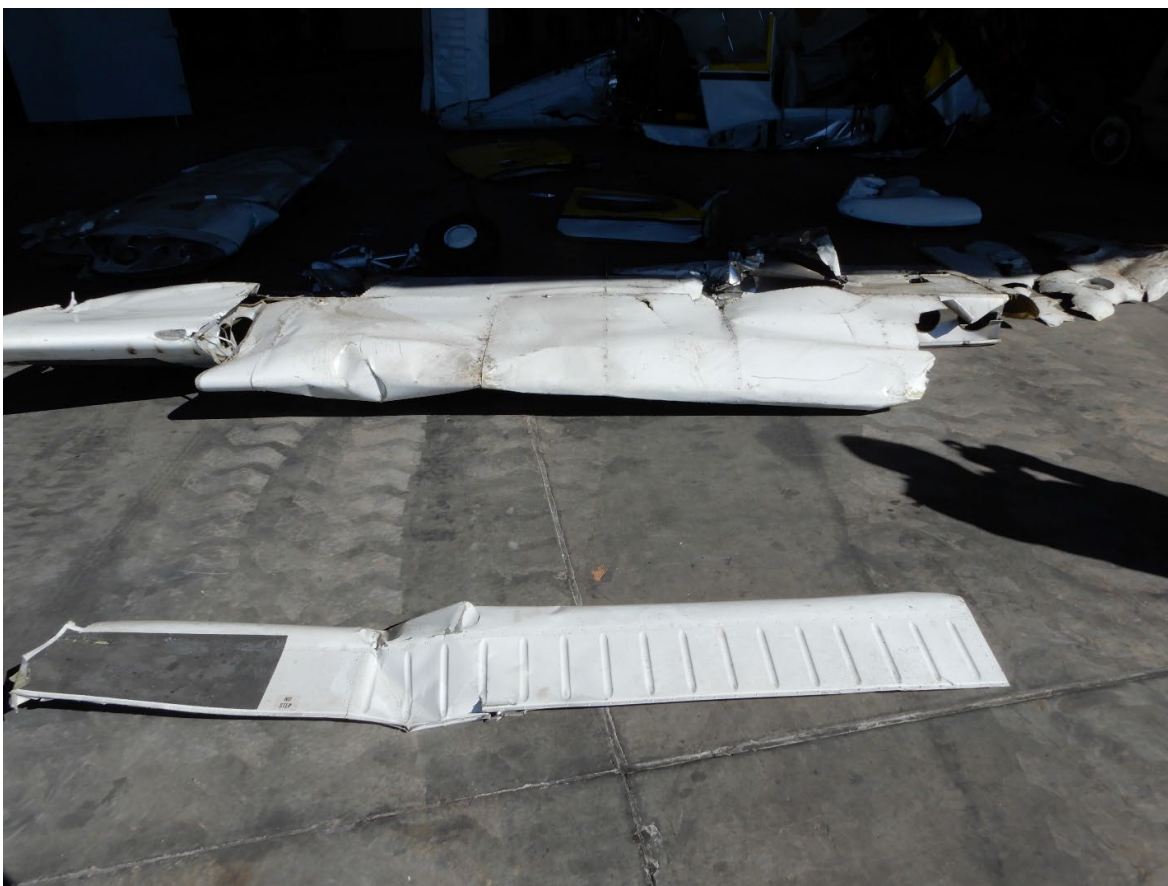
The right wing was removed from the fuselage for recovery. The main landing gear separated from the underside of the right wing. The flap separated from the right wing. The spar fractured at the root of the blade. A large section of the leading edge at the tip, inboard to about 30 inches separated from the wing. There were indications of contact with an object about 30 inches inboard of wing tip. A large gouge extended to the underside of the wing, ripped the sheet metal and structural components of the wing aft toward the trailing edge. The forward half of the wing separated at a seam line about 130 inches from the wing tip, forward of the main landing gear bay. The aileron remained attached to the wing at the three attachment points and exhibited damage directly in line of the large sheet metal rip in the underside of the wing. The flap separated from the wing at the attachment points and exhibited wrinkles and dents throughout its span.

Figure 11. Right wing and right flap.

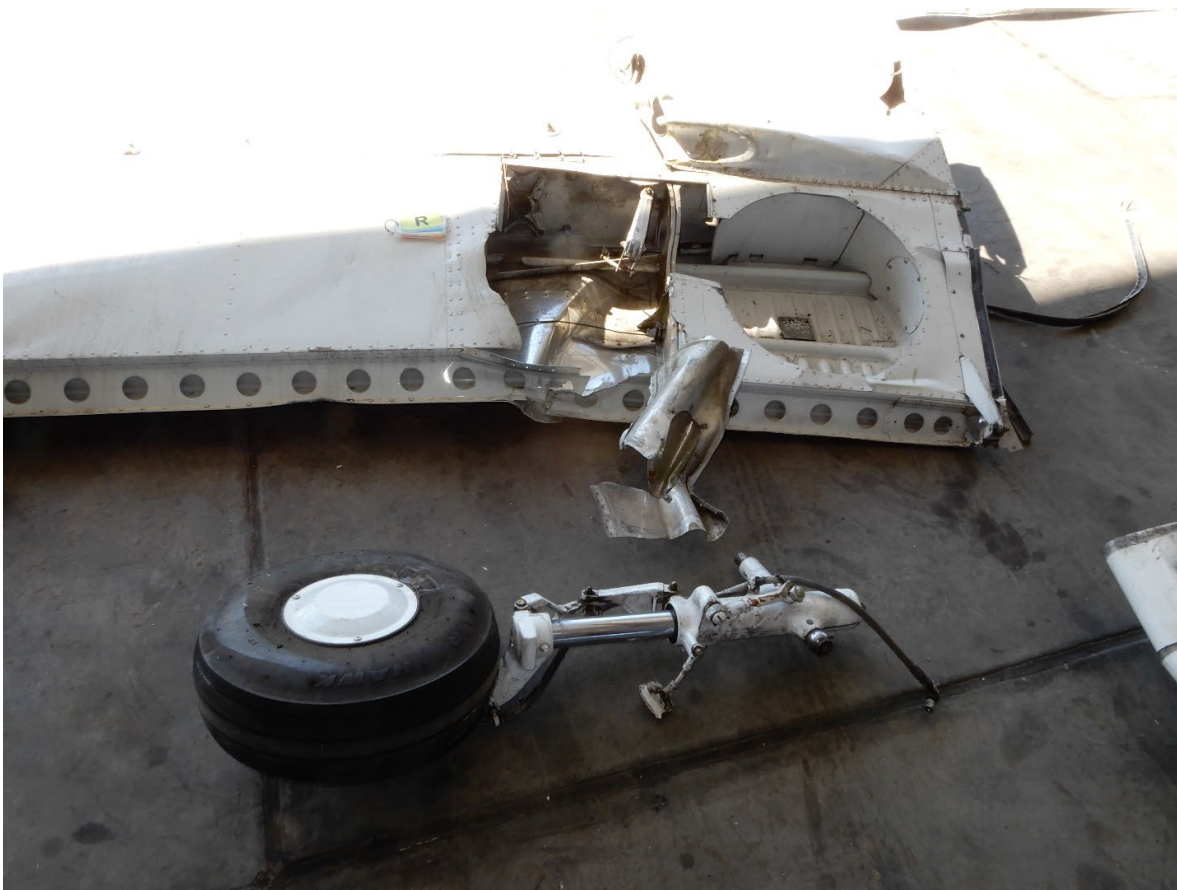
The right main landing gear separated from the underside of the wing at the attachment points and was in the wreckage area. The landing gear actuator was extended. The oleo strut was charged and extended. The brakes were intact and appeared normal. The brake line separated from the wing at the wing attachment point. The wheel and tire exhibited minor damage.

Figure 12. Underside of the right wing and right main landing gear.

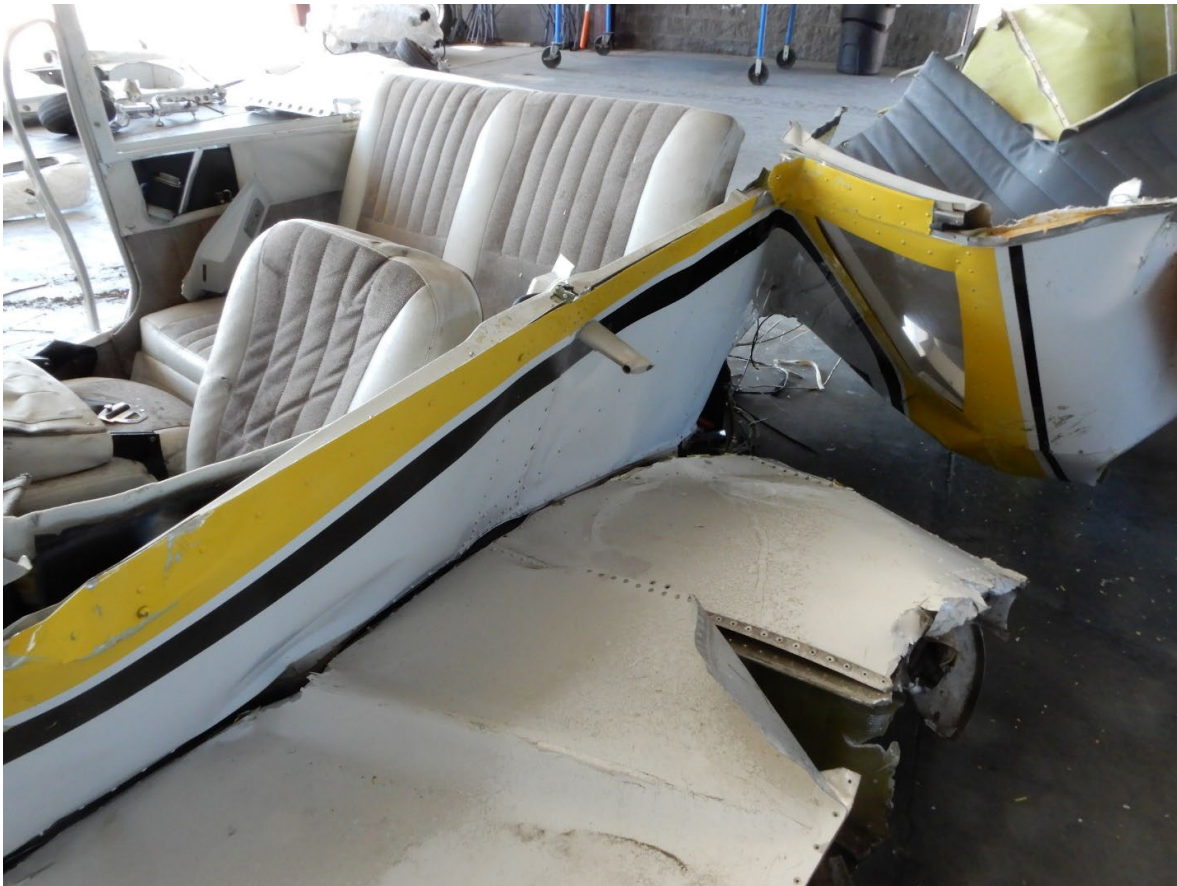
Figure 13. Left side of the fuselage showing the backup landing gear system pressure static head.

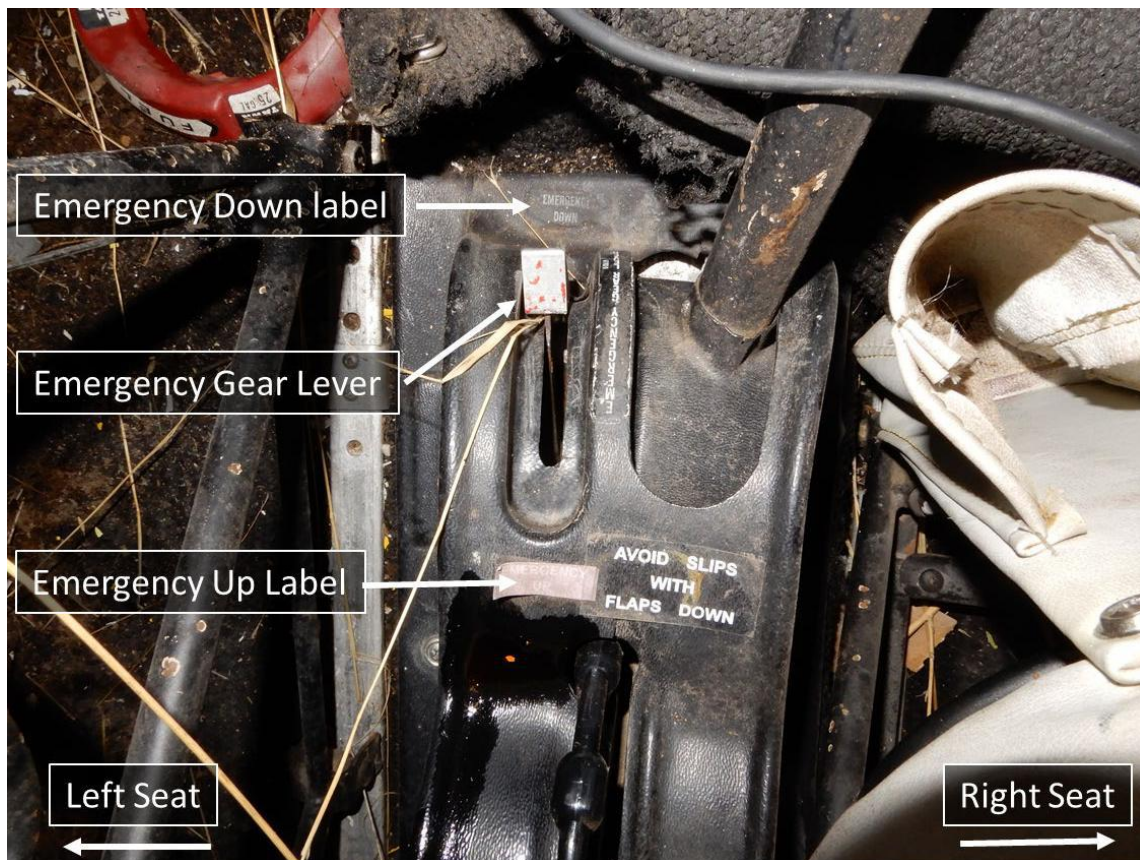
Figure 14. Emergency gear extension override lever.

Throttle: Mid-range  
Propeller: Mid-range  
Mixture: Mid-range  
Landing Gear selector: Up  
Flap Handle: 25°  
Emergency Gear extension override lever: Near the normal (non-override position).

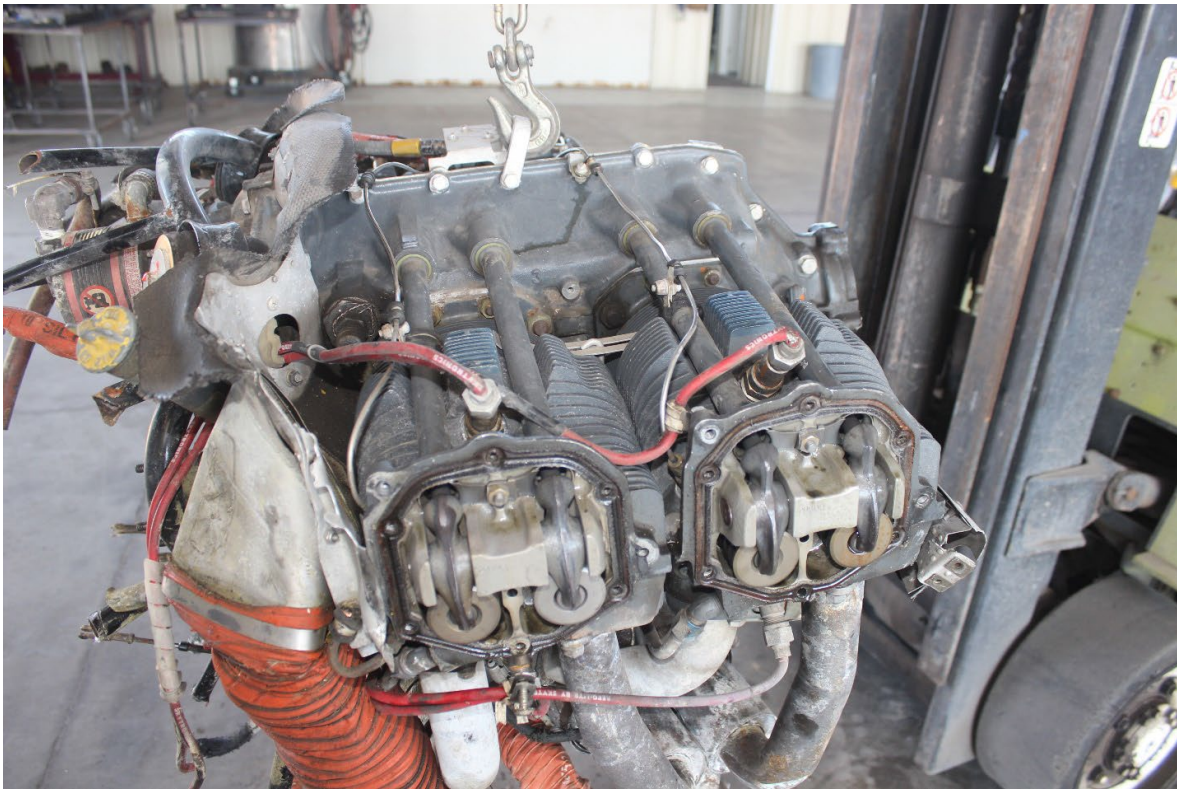
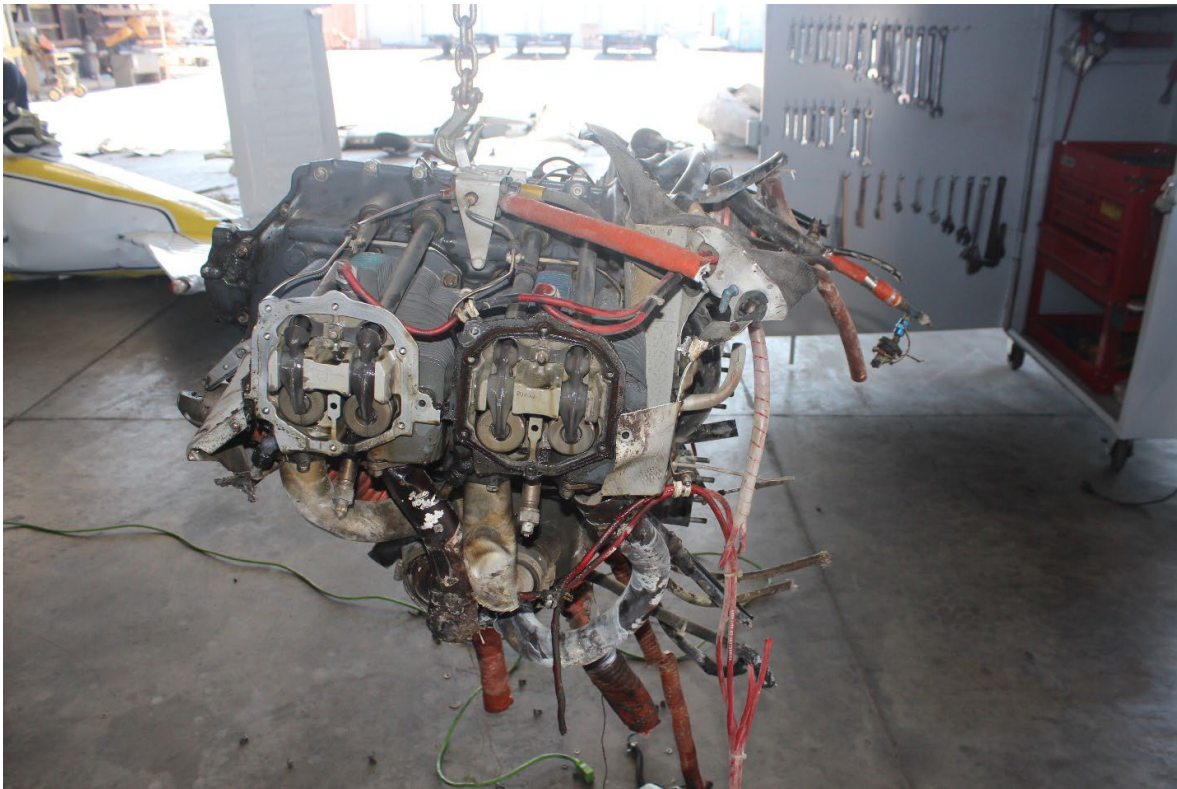
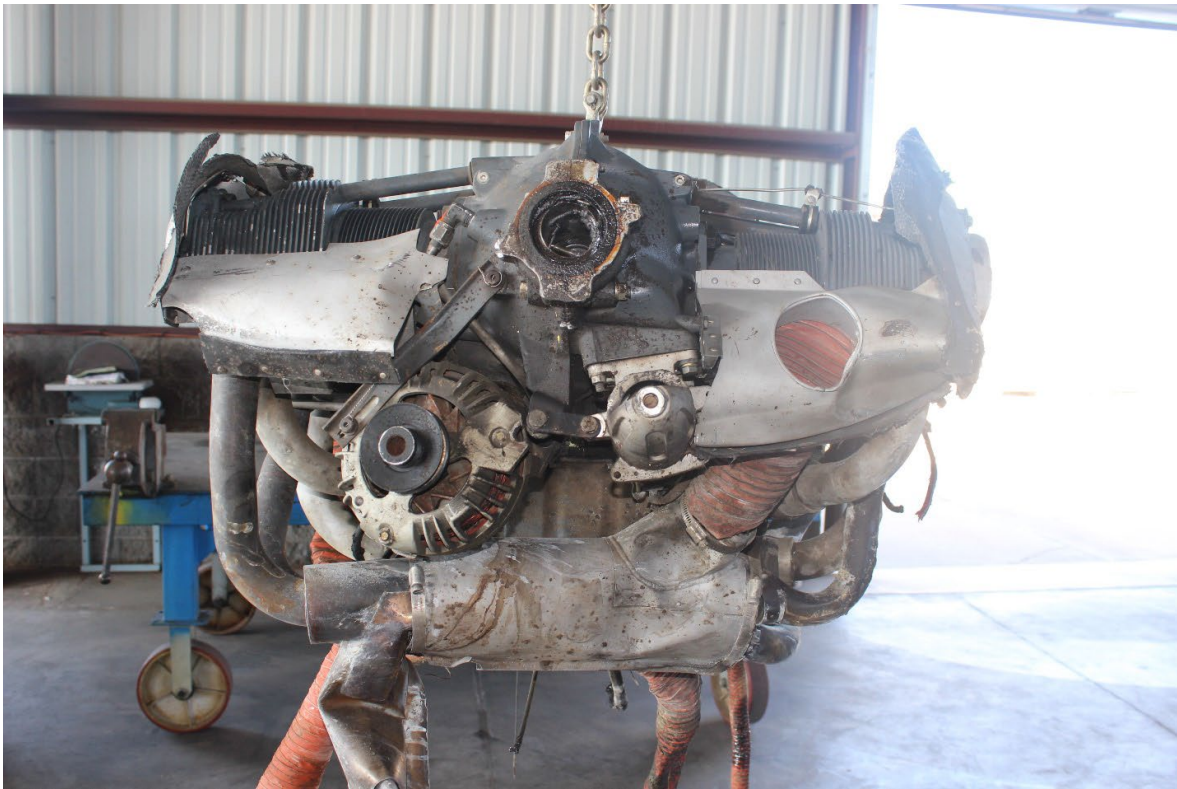
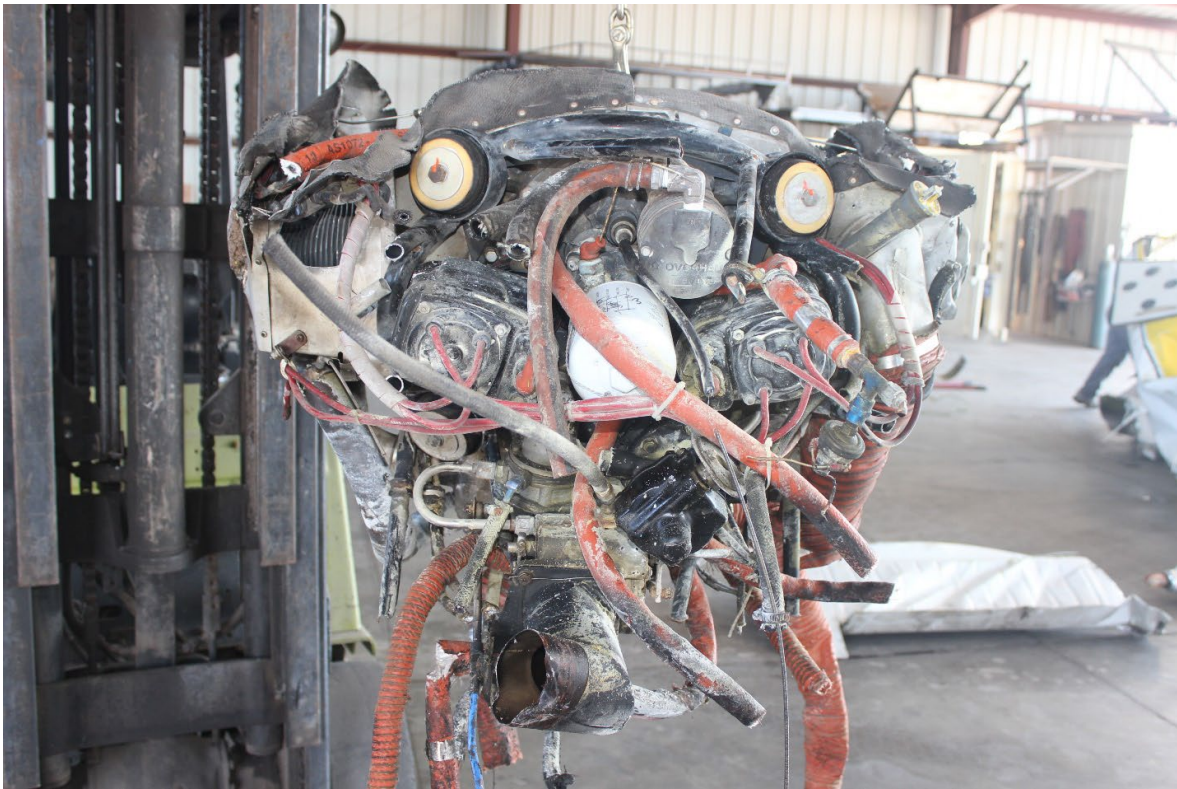
The engine remained partially attached to the airframe by the engine mounts. Mechanical continuity was established utilizing a drive tool at the propeller drive pad. Thumb compression was obtained in the proper firing order. All valves moved consistent with normal operation. All accessory gears and drives were observed to turn properly. Borescope examination of the cylinders found no evidence of foreign object ingestion or detonation.

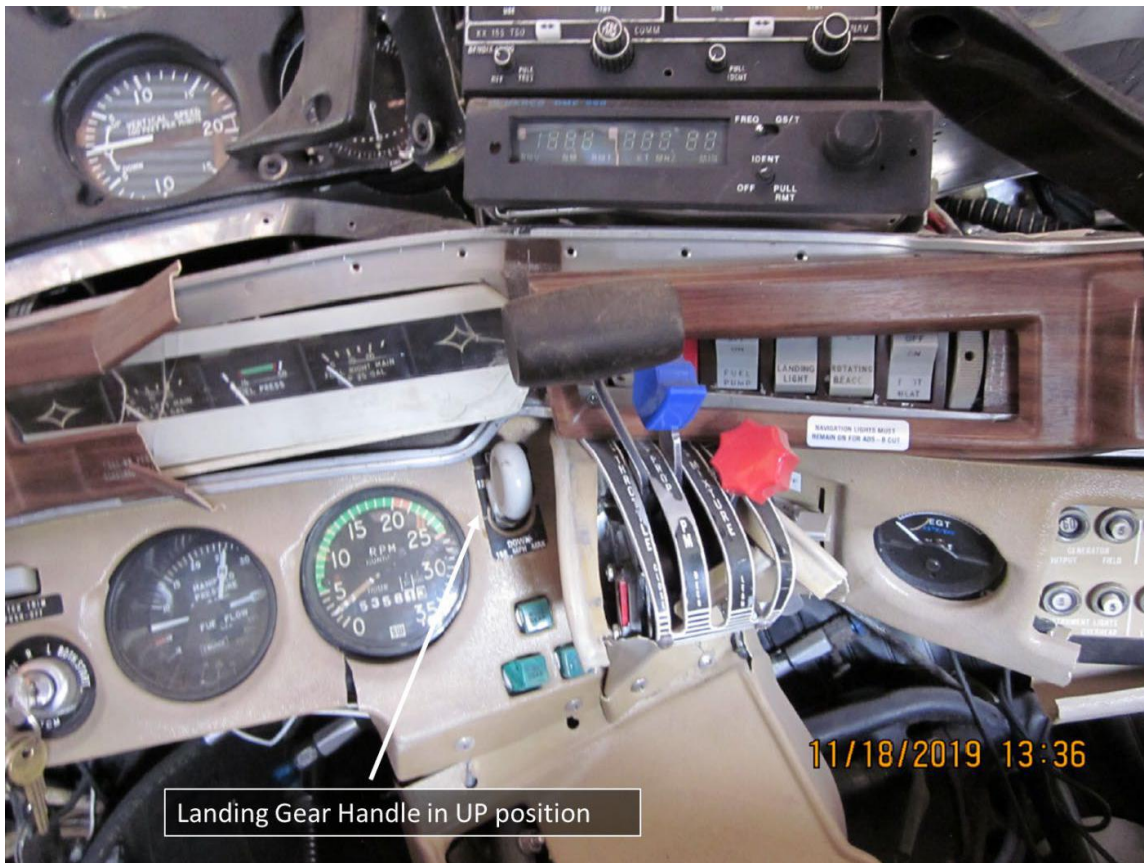
Figure 20. Image showing the main landing gear handle in the up position.
