## **NATIONAL TRANSPORTATION SAFETY BOARD**

# **TAILWHEEL TO RUDDER LINK ROD EXAMINATION**

**WPR20LA025**

Location: Heber City, Utah  
Date: November 16, 2019  
Aircraft: North American SNJ-4, N694US  
NTSB Investigator-in-Charge: Joshua Cawthra

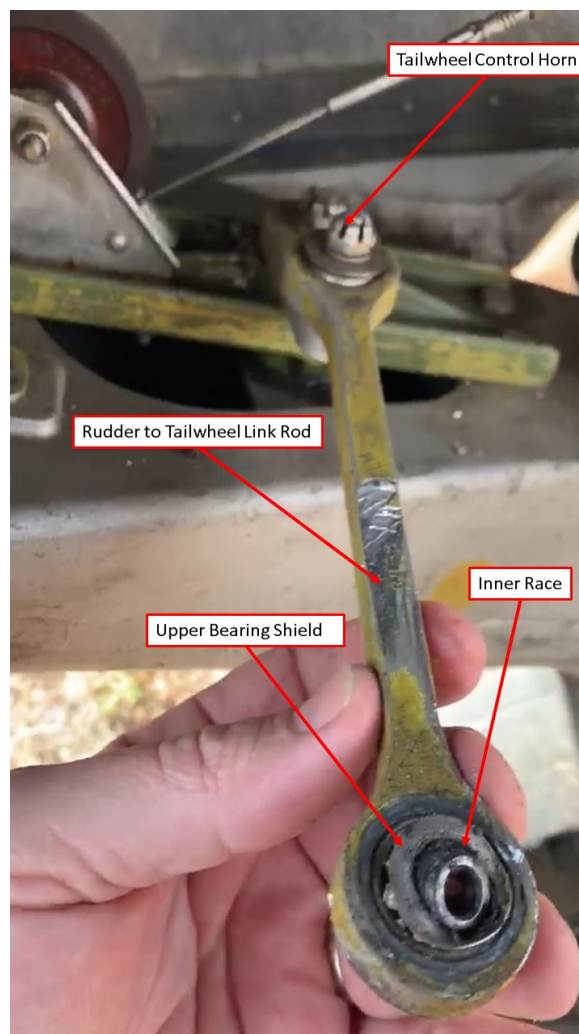
Figure 1: Excerpt from a video provided by the pilot, showing the tailwheel to rudder link rod and damage.

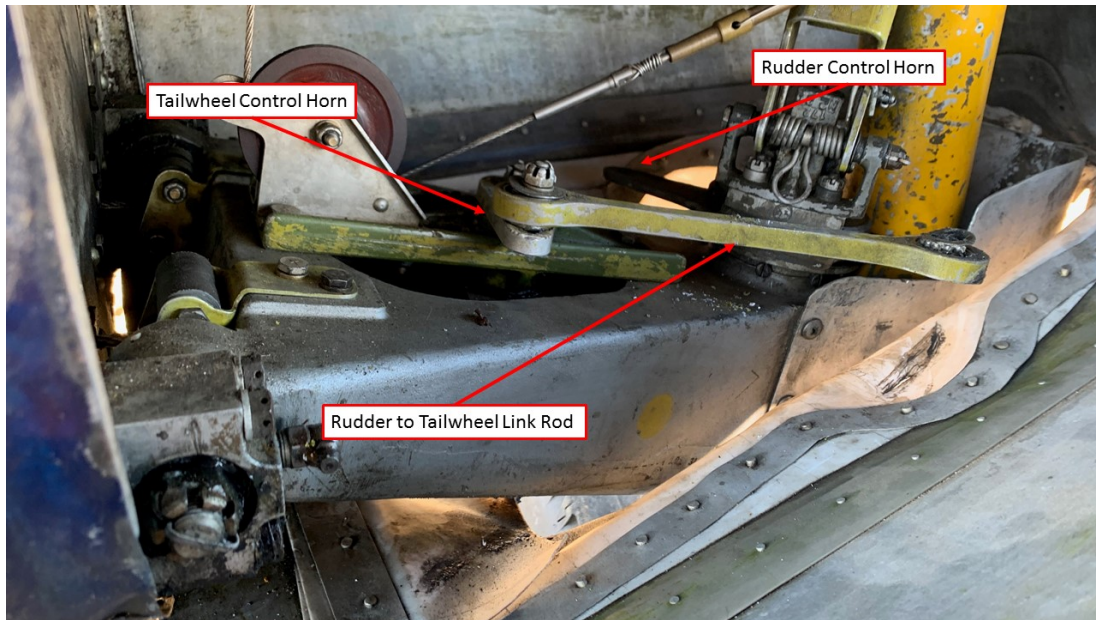
Figure 2: Photo provided by the pilot, showing the tailwheel to rudder link rod and damage.

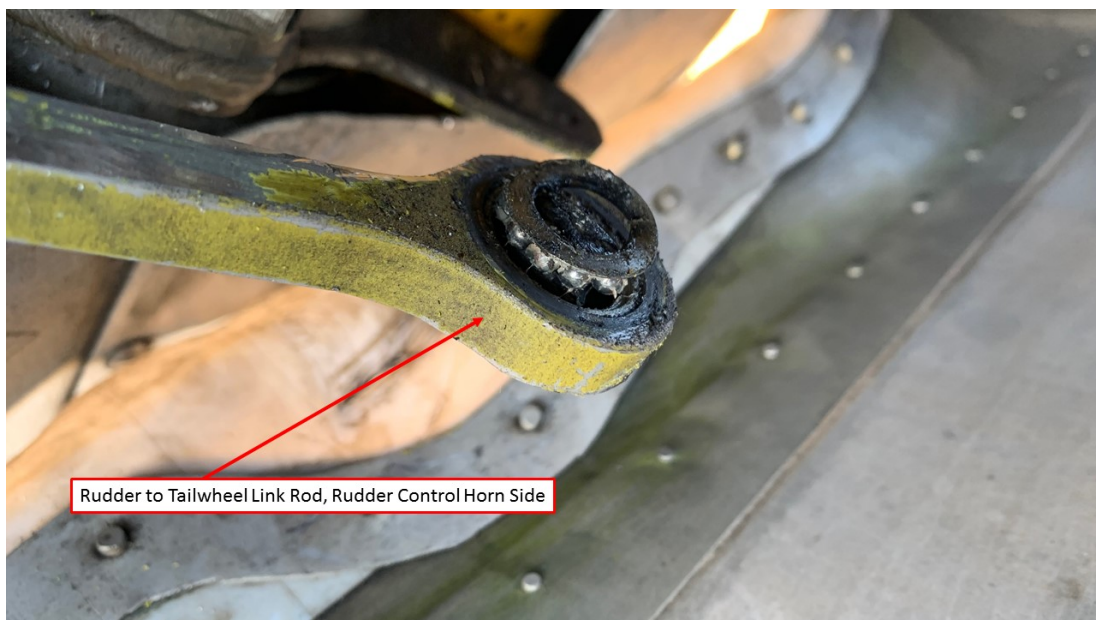
Figure 3: Photo provided by the pilot, showing the tailwheel to rudder link rod and damage.

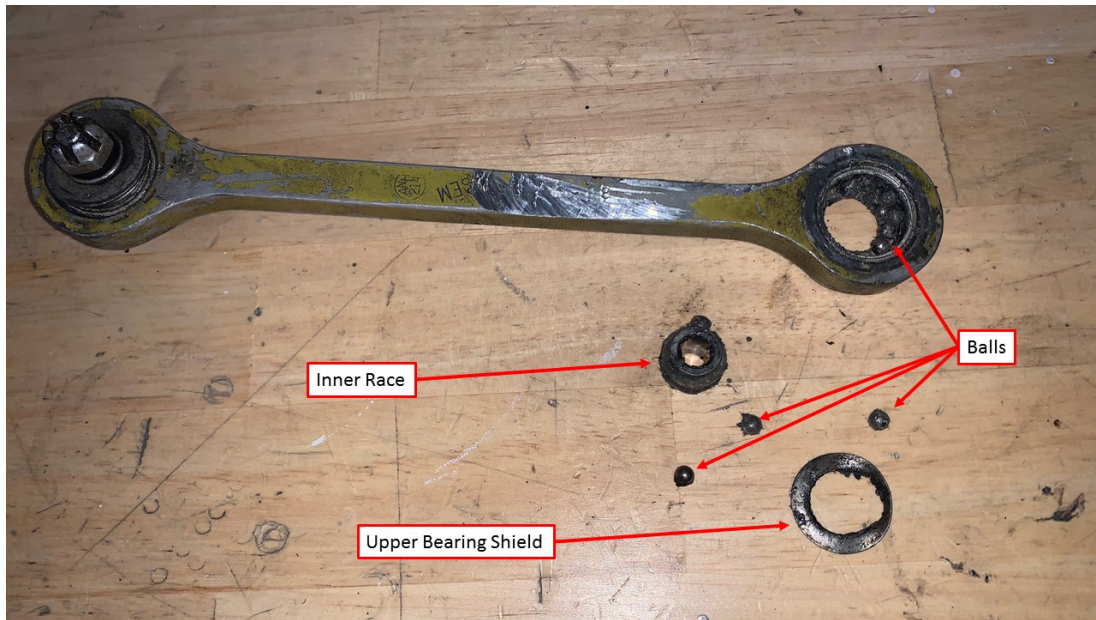
Figure 4: Tailwheel to rudder link rod.

The rudder control horn side ball bearing was damaged, and upper and lower bearing housing shields were elongated and exhibited an inward bend along a portion of both shields, about 180° opposite of one another. The inner race was intact. The bearing balls were mostly separated from the bearing assembly.

The pilot reported that the bolt, castellated nut, and cotter pin were not located.

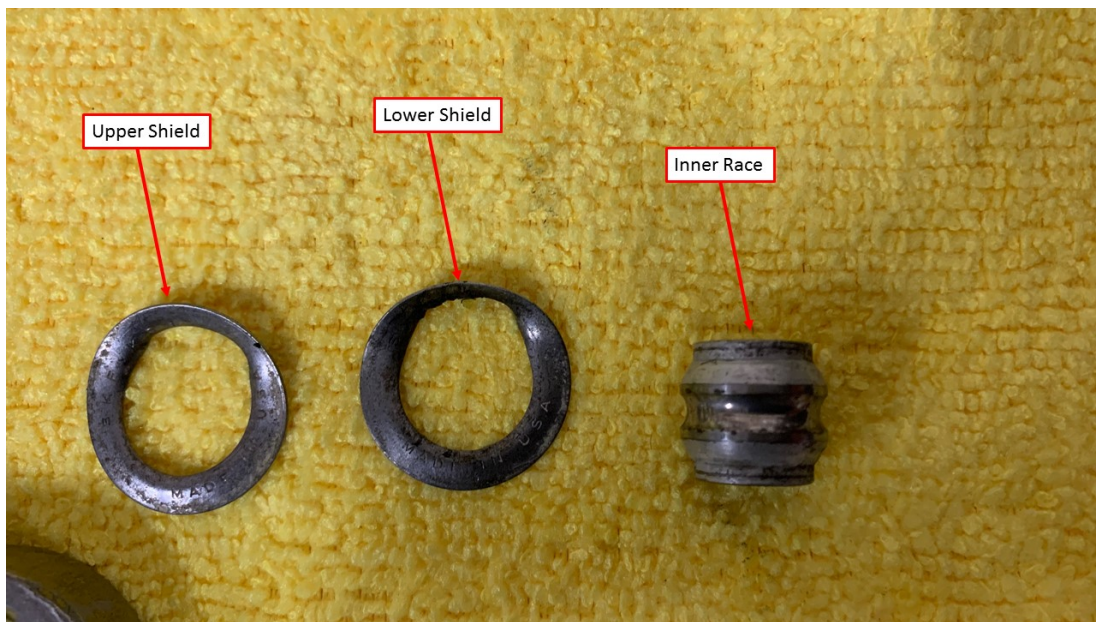
Figure 5: Upper and lower bearing shields and inner race.
