# NATIONAL TRANSPORTATION SAFETY BOARD

## MATERIALS LABORATORY FACTUAL REPORT

Report No. 21-025

Place : Spanish Fork, Utah  
Date : November 12, 2019  
Vehicle : Agusta 109SP, N271HC  
NTSB No. : WPR20LA029  
Investigator : Stephen Stein, AS-WPR

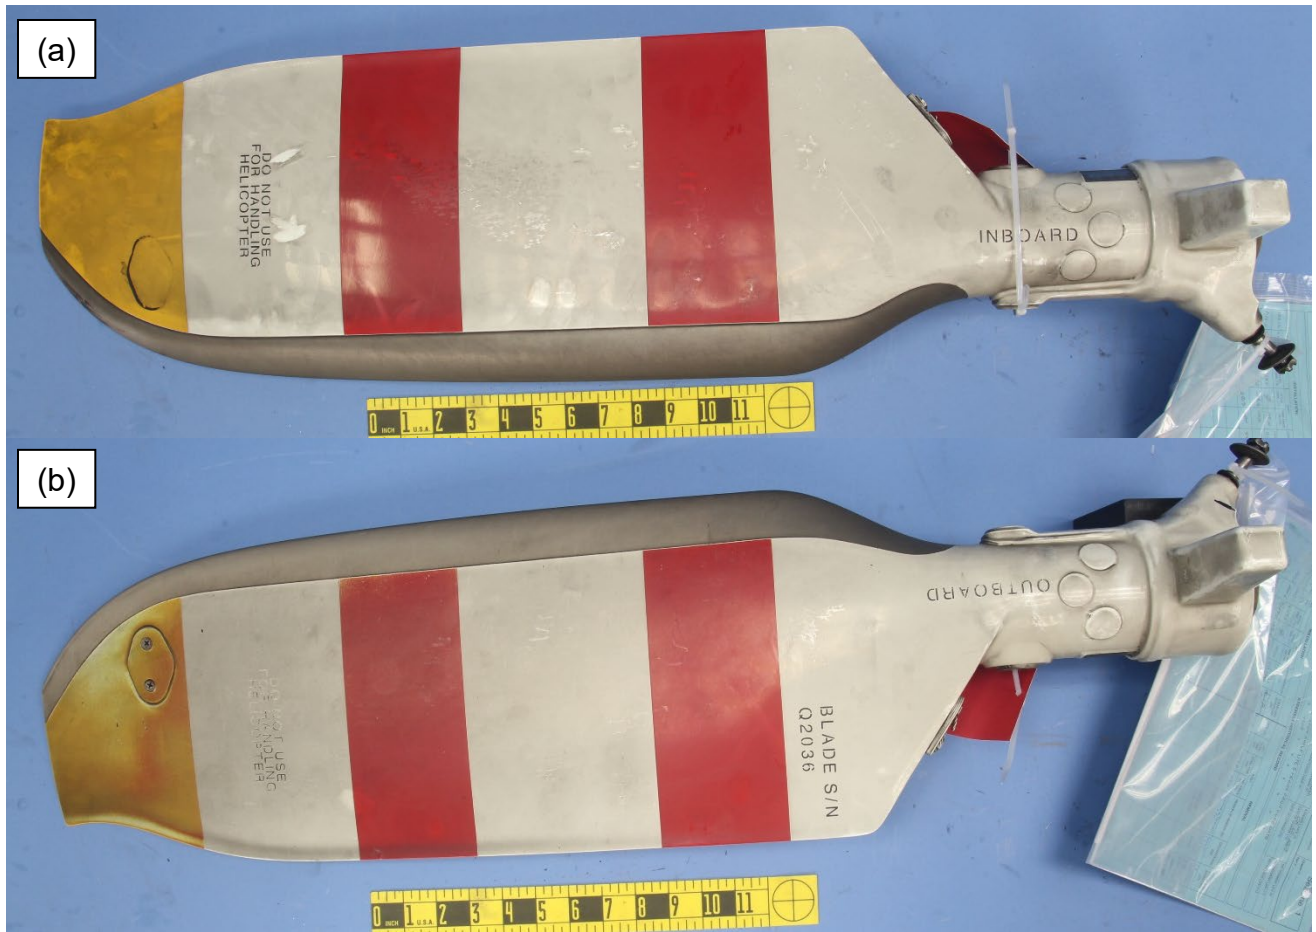
Both blades exhibited identical plate markings stating, "A0126 709-0160-48-101 109-5010-02-101". Each blade had a different serial number, with the blade in Figures 1 and 2 having "Q2036," and the blade in Figures 3 and 4 having "R2108."

Figure 1 – View of the tail rotor blade Q2036 from the (a) inboard and (b) outboard faces.

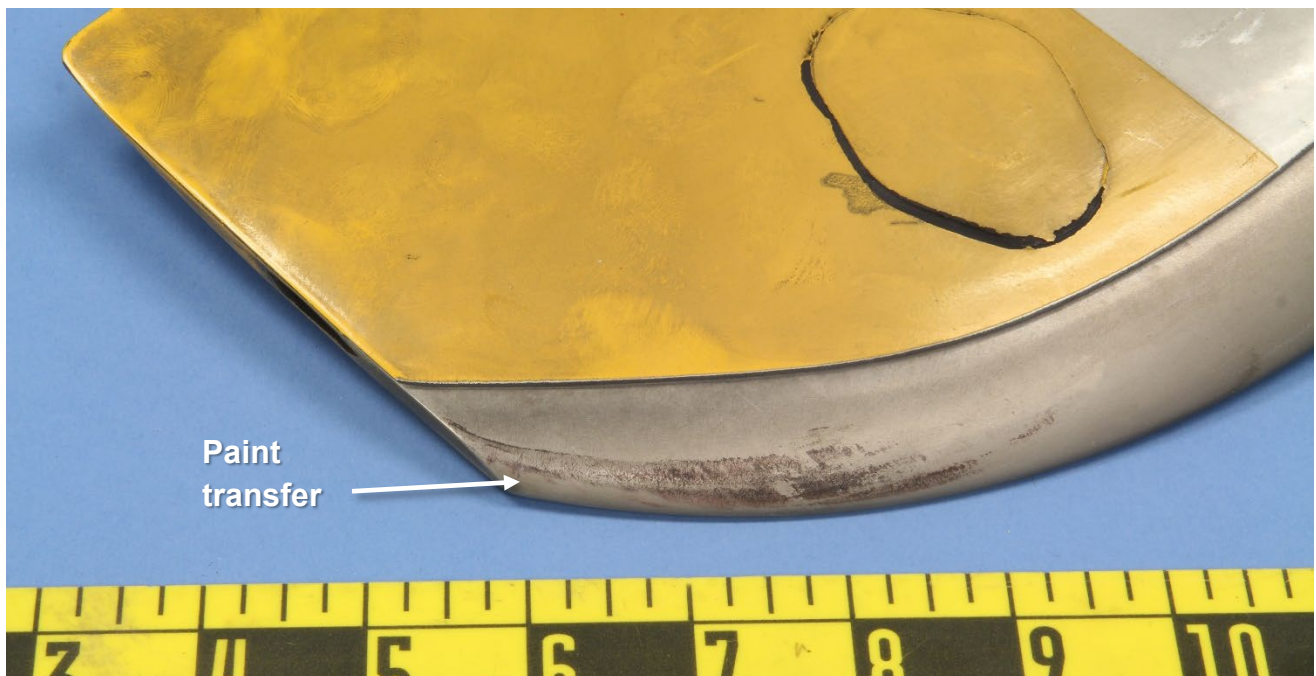
Neither tail rotor blade exhibited any indications of deformation, impact gouging, or cracking. The extent of the damage of both blades is illustrated on the blade tips of each in Figures 2 and 4. On the tips of the leading edge were 3-inch long and 0.5-inch-wide areas of a discoloration, exhibiting a dark gray hue with red undertones. These features were consistent with paint transfer to the leading edge of the tail rotor blade tips.

Figure 2 – The inboard face blade tip of Q2036, showing paint transfer marks.

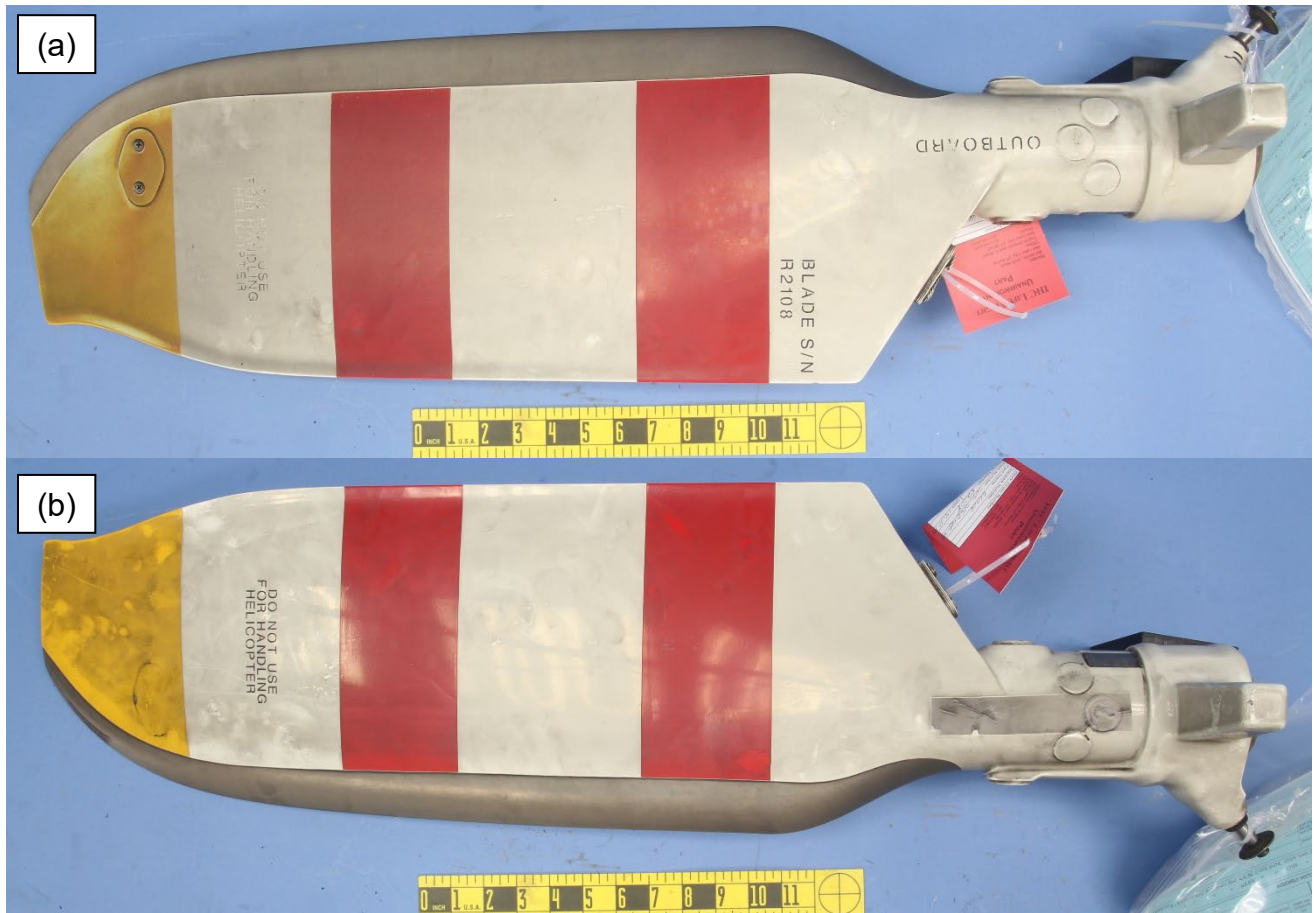
Figure 3 – View of the tail rotor blade R2108 from the (a) inboard and (b) outboard faces.

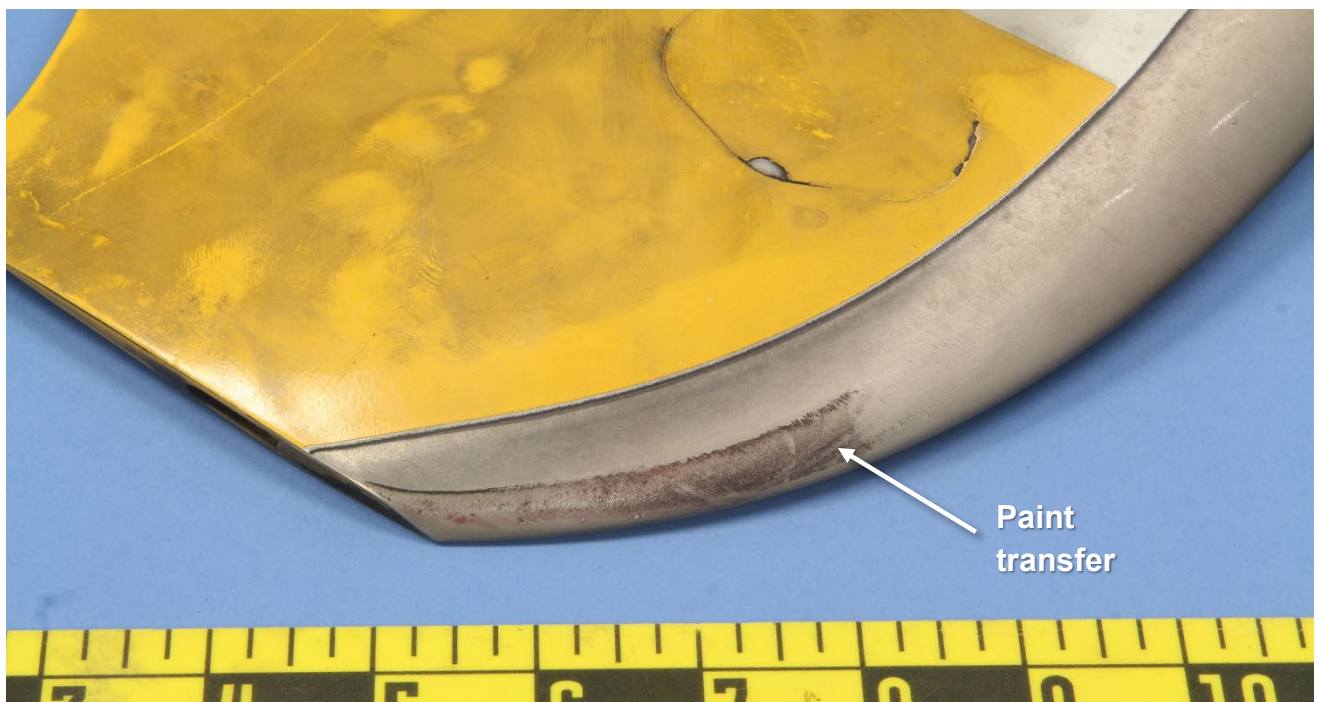
Figure 4 – The inboard face blade tip of R2108, showing paint transfer marks.

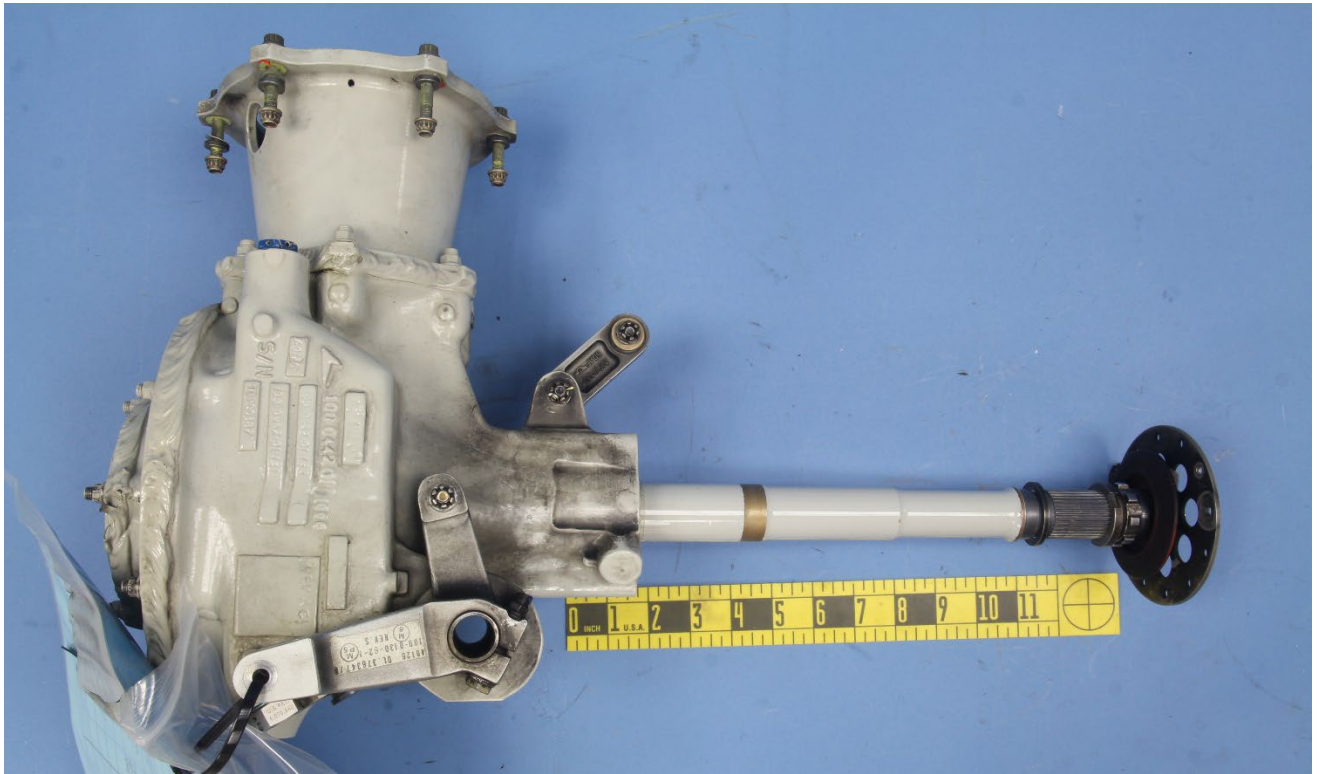
Figure 5 shows the tail rotor gear box, as received. The assembly consisted of a cast housing with an elongated output shaft (horizontal and to the right in the figure) and a shrouded input shaft (facing upward in the figure). The gear box was full of oil, which began to leak out when positioned as shown in Figure 5 (the leak occurred on the side opposite shown). The housing was painted white, and displayed the following markings on the housing:

Figure 5 – The tail rotor gear box 90°, as received.

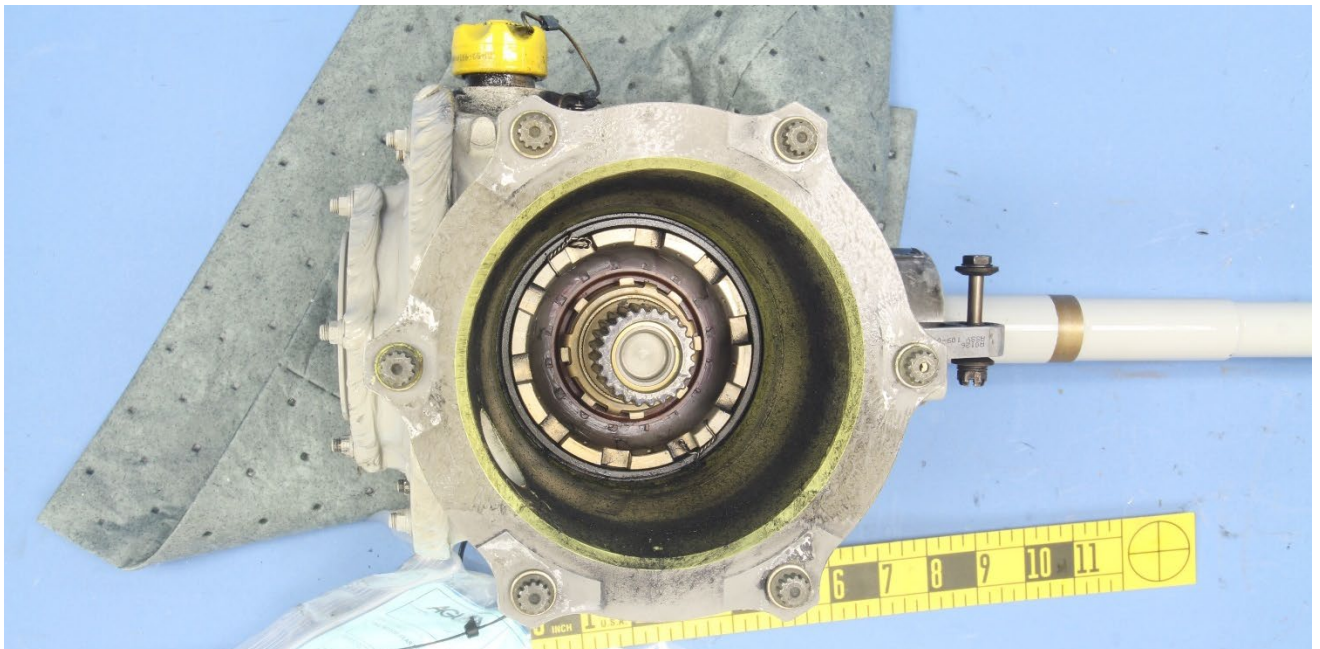
Figure 6 shows the splined input shaft of the tail rotor gear box. The shaft exhibited no indications of deformation or impact damage, and the splines were absent any typical indications of wear such as rounding or gouging. The interior coupling castellations likewise did not exhibit any indications of rounding or damage, and the exposed surfaces appeared smooth and reflective.

Figure 6 – The splined axial input drive shaft of the transmission from the gear box, as received.

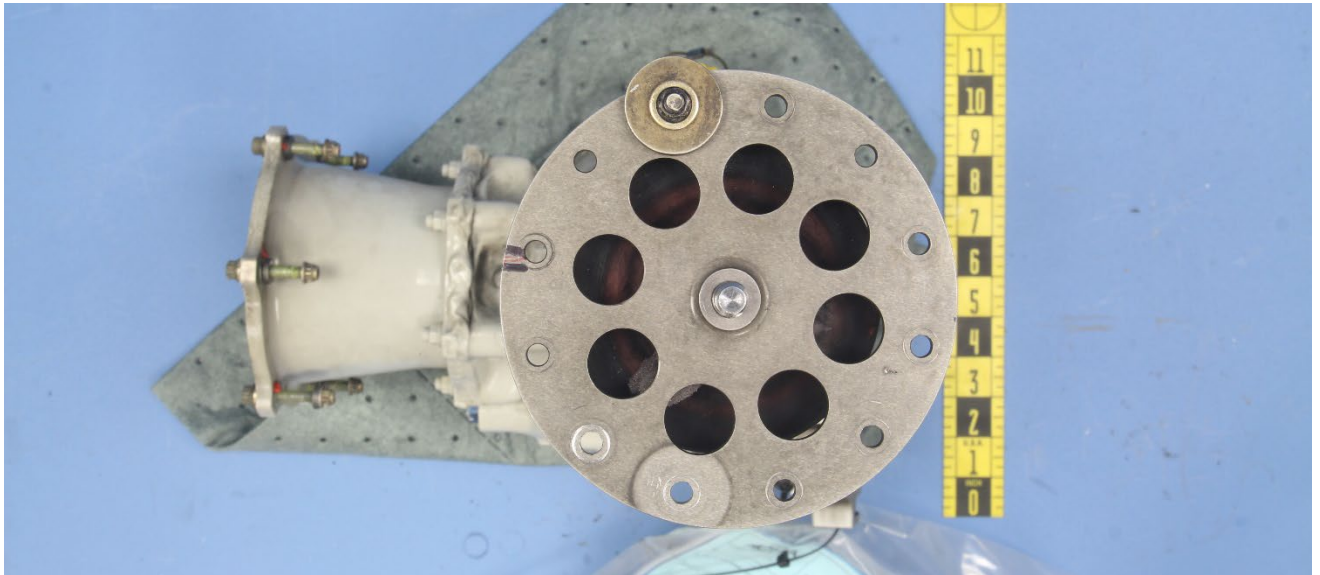
Areas of the output shaft are highlighted in Figures 7 and 8. Figure 7 shows the forward face of the balance flange at the end of the input shaft. Two of the bolt holes exhibited some circular marks, consistent with the location of the removed bolts and/or nuts. There was also a larger circular mark on the bottom of the figure, consistent with the location of a washer that had been removed (compare with the in-place washer on the top of the figure). The balance flange did not exhibit any indications of missing material or deformation, such as hole widening or chipping. The circular washer and bolt witness marks were consistent with marks made from bolted connections under typical service of helicopter components. This face was absent any indications of wear, impact, or deformation.

Figure 7 – View of the face of the balance flange on the input shaft arm of the tail rotor gear box output.

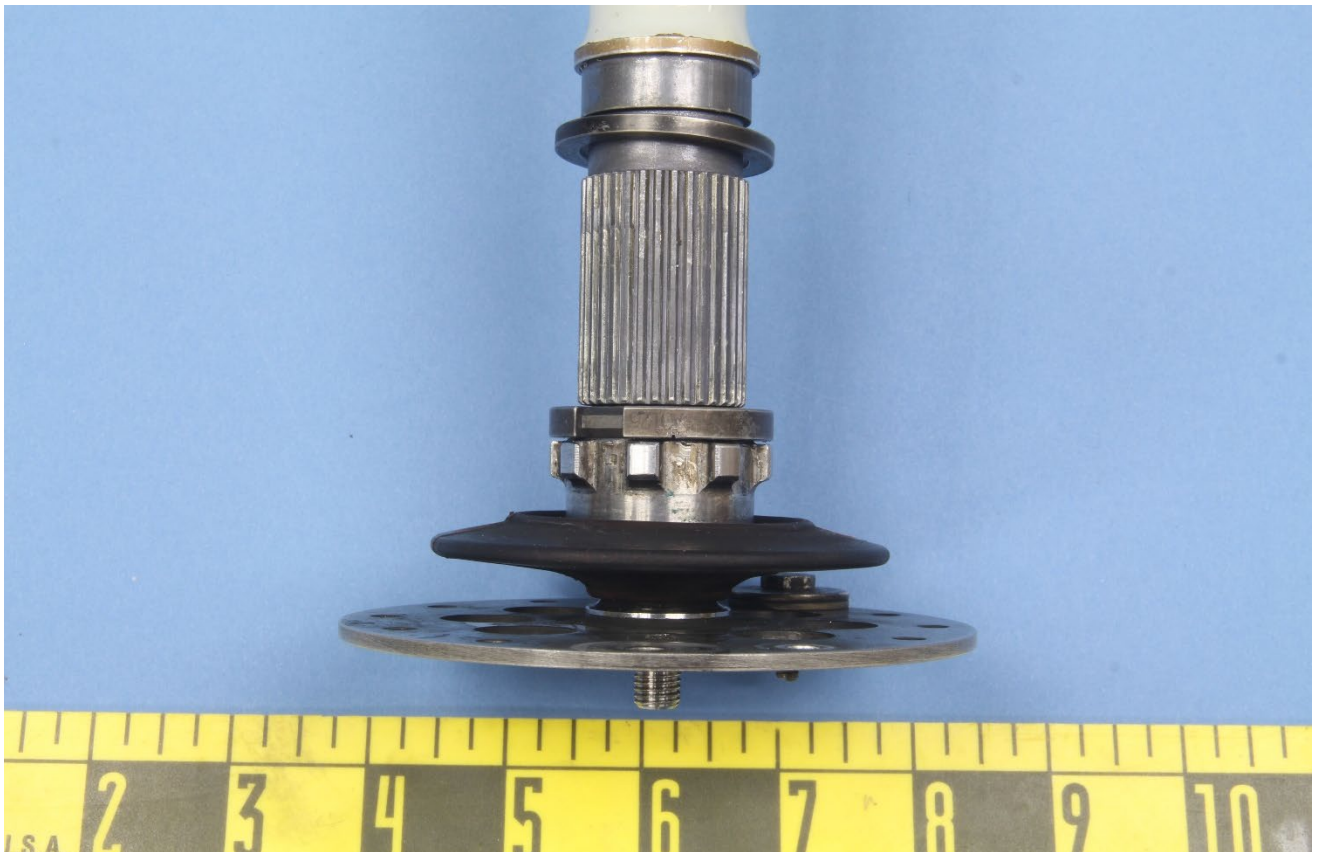
Figure 8 shows the splined portion of the output shaft of the gear box, towards the forward end (near the mounting sleeve). Like the splines in the input shaft, these splines did not exhibit any indications of rounding or wear and were absent deformation or cracking. There was a loose washer on the shaft, located aft of the splined area. This washer did not exhibit any witness marks on the faces and was absent any wear marks or similar damage.

Figure 8 – Side view of the arm from Figure 7, showing the splined area of the shaft and the washer (loose on the shaft).

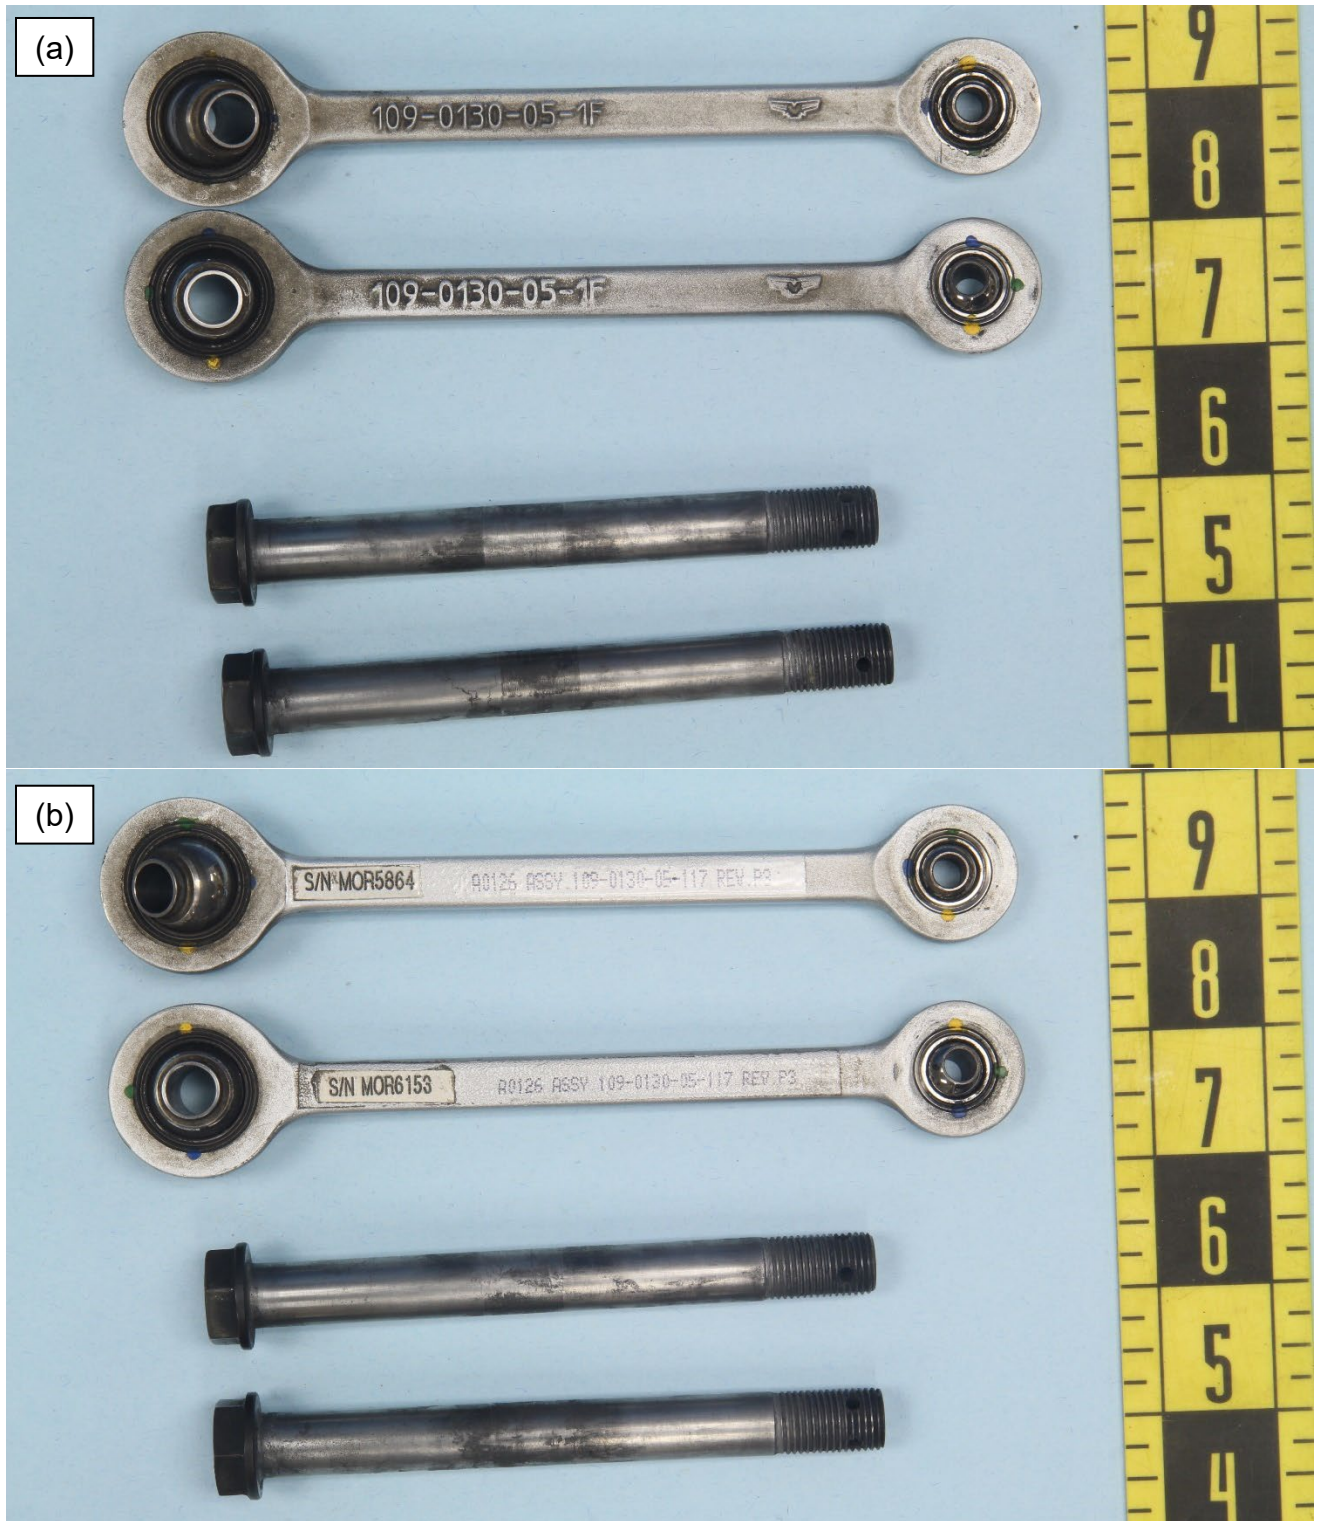
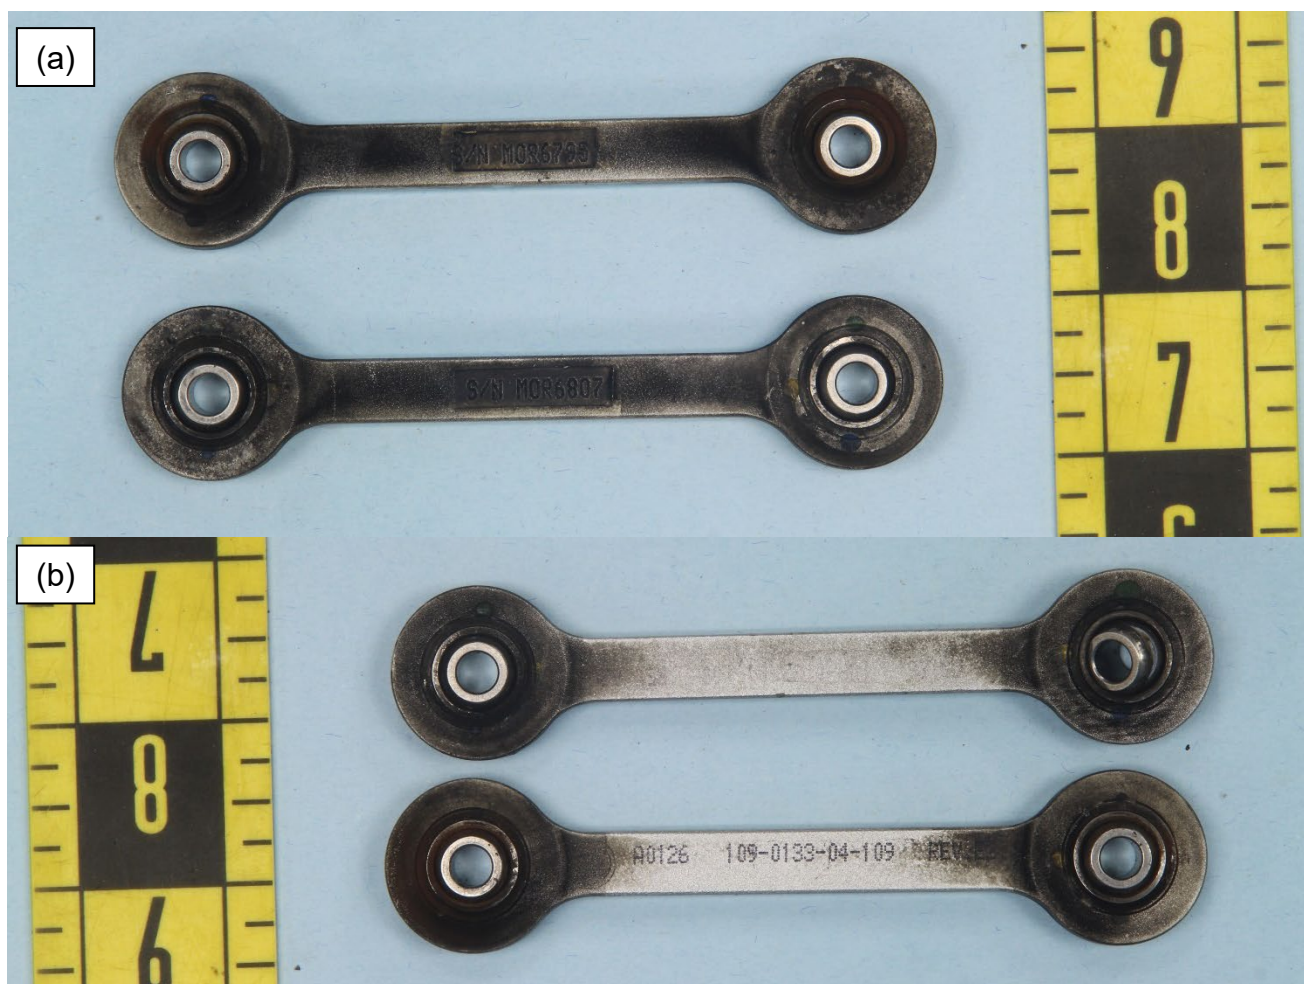
Figures 9 and 10 show the submitted links and bolts, as received. While these links exhibited areas of darker color, these were found to be consistent with accumulated dirt and oils and were inconsistent with any exposure to elevated temperatures. The bolts showed cylindrical contact marks, which were consistent with typical in-service contact between bolted parts. No indications of deformation or wear were found on any of these components. The markings for the links in Figure 9 stated "109-0130-05-1F" on one side, and "A0126 ASSY.109-0130-05-117 REV.P3" on the other. The link serial numbers were "MOR5864" and "MOR6153". The serial numbers for the links in Figure 10 were "MOR6795" and "MOR6807". The link with S/N MOR6807 had marking on the reverse side stating, "A0126 109-0133-04-109 REV.E2"; the other link had no markings on its reverse side.

Figure 9 – One set of links and bolts from (a) the obverse and (b) reverse sides.

Figure 10 – The second set of links viewed from (a) the obverse and (b) reverse sides.

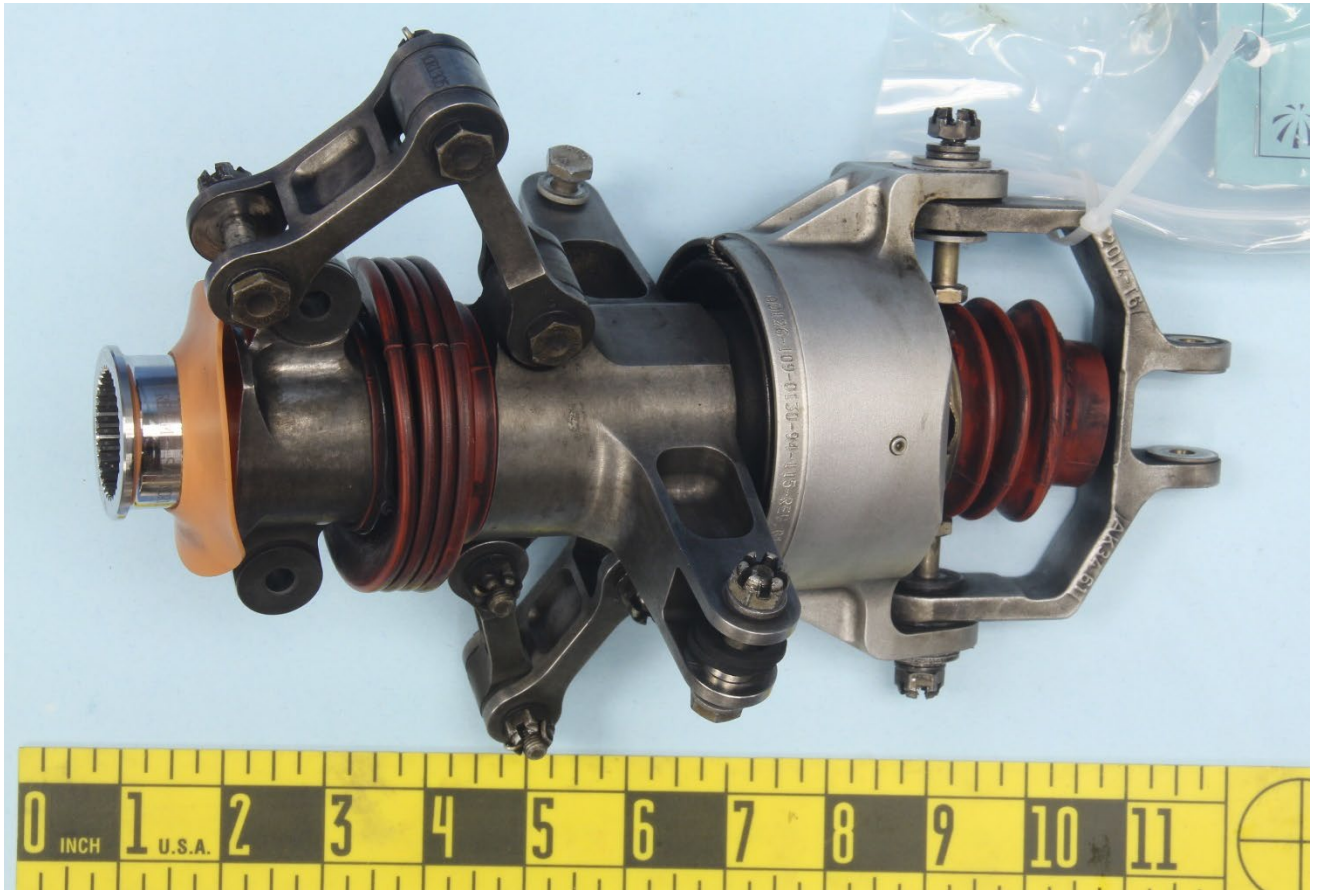
Figure 11 shows the pitch change slider assembly, as received. This assembly was able to be actuated without excessive force or interruption. No indications of damage were observed along the body, and none of the bolted connections were loose, or absent cotter pins where applied. The markings on the main body of the pitch change slider assembly were, "A0126-109-0130-94-115-REV.G1 S/N MOR0683".

Figure 11 – The pitch change slider assembly, as received.

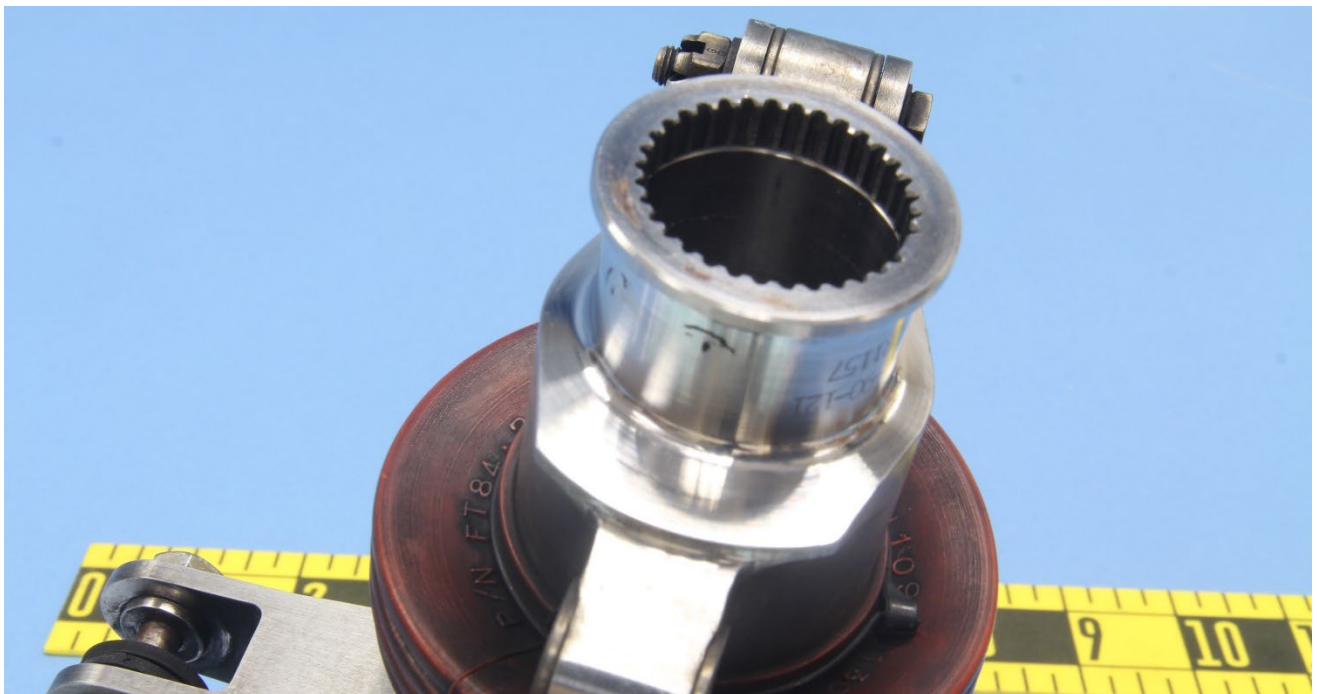
Figure 12 shows the interior splined driven connection on the inboard side of the slider assembly. The exterior surface exhibited markings stating, "A0126-109-0130-90-121 Rev.M – S/N MOR1157". The splines exhibited some rounding on the edge near the inboard face, but no such wear along the interior spline edges. The inboard face of the flange exhibited some scuff marks, but no indications of gouging or deformation.

Figure 12 – View of the splined driven connection of the slider assembly in Figure 11.

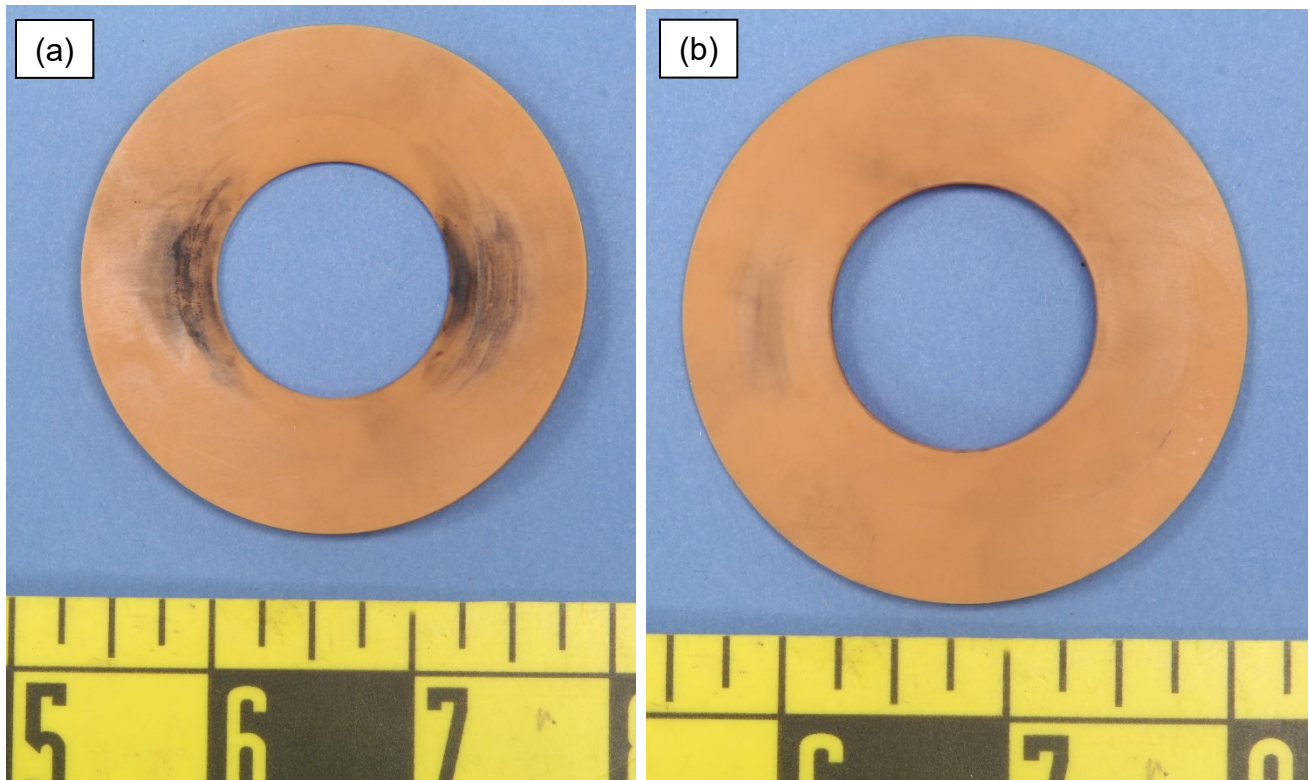
Figure 13 shows the rubber gasket or bumper from the slider assembly, viewed from both sides. The color of the part was consistent with having been cleaned after the accident but prior to receipt. While the face in Figure 13b was absent any features, the obverse face in 13a exhibited two opposite-facing dark-colored areas of circular rubbing.

Figure 13 – The rubber bumper from the pitch change slider assembly from (a) the face exhibiting witness marks and (b) the reverse side.

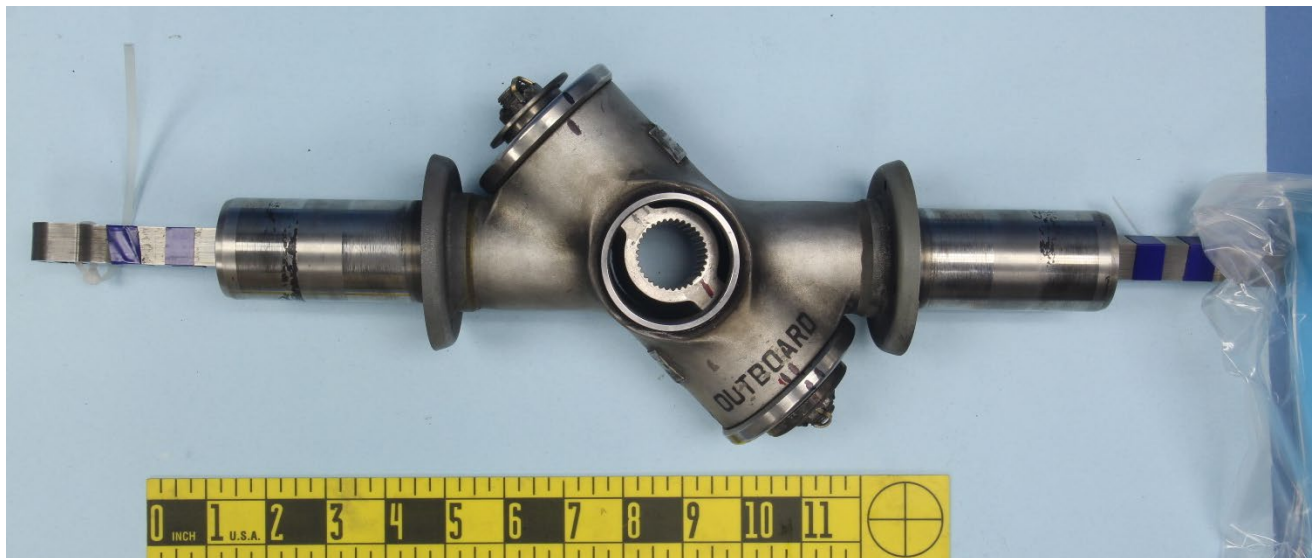
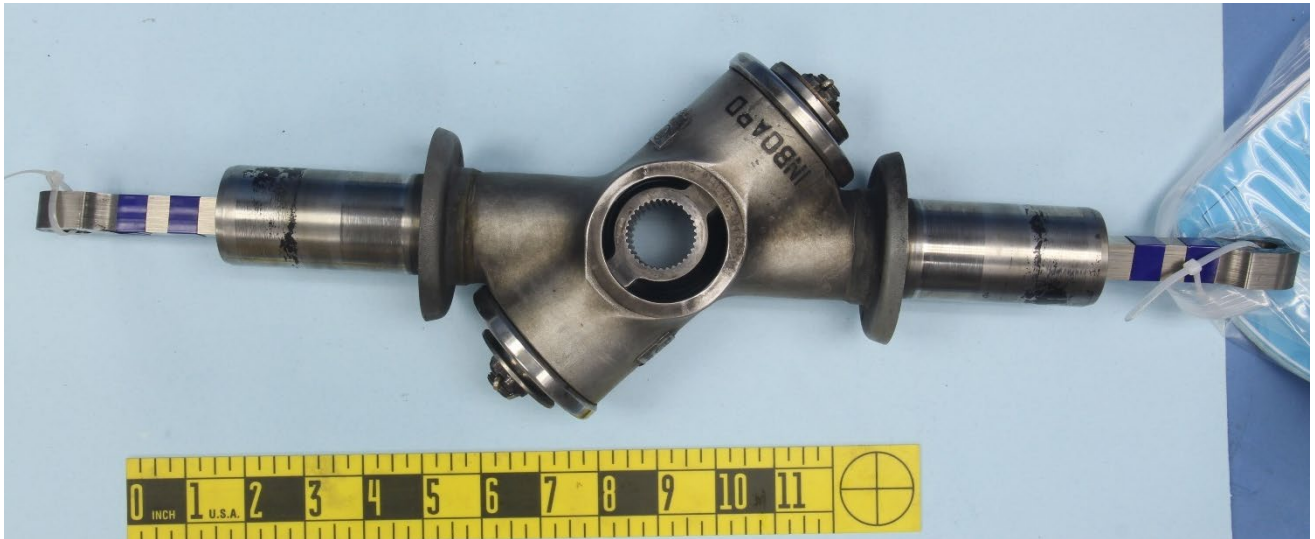
Figure 14 and Figure 15 show the tail rotor hub assembly, with the internal trunnion and retention strap bundles still attached inside. The strap bundles had been tied together with plastic ties. Figure 16 shows the internal splined trunnion of the hub from both sides. The inboard face exhibited some discoloration marks (left in the figures). However, there were no indications of wear, rounding, or deformation of the splines.

Figure 14 – The tail rotor hub assembly, from the outboard side.

Figure 15 – The tail rotor hub and blade assembly, viewed from the inboard side.

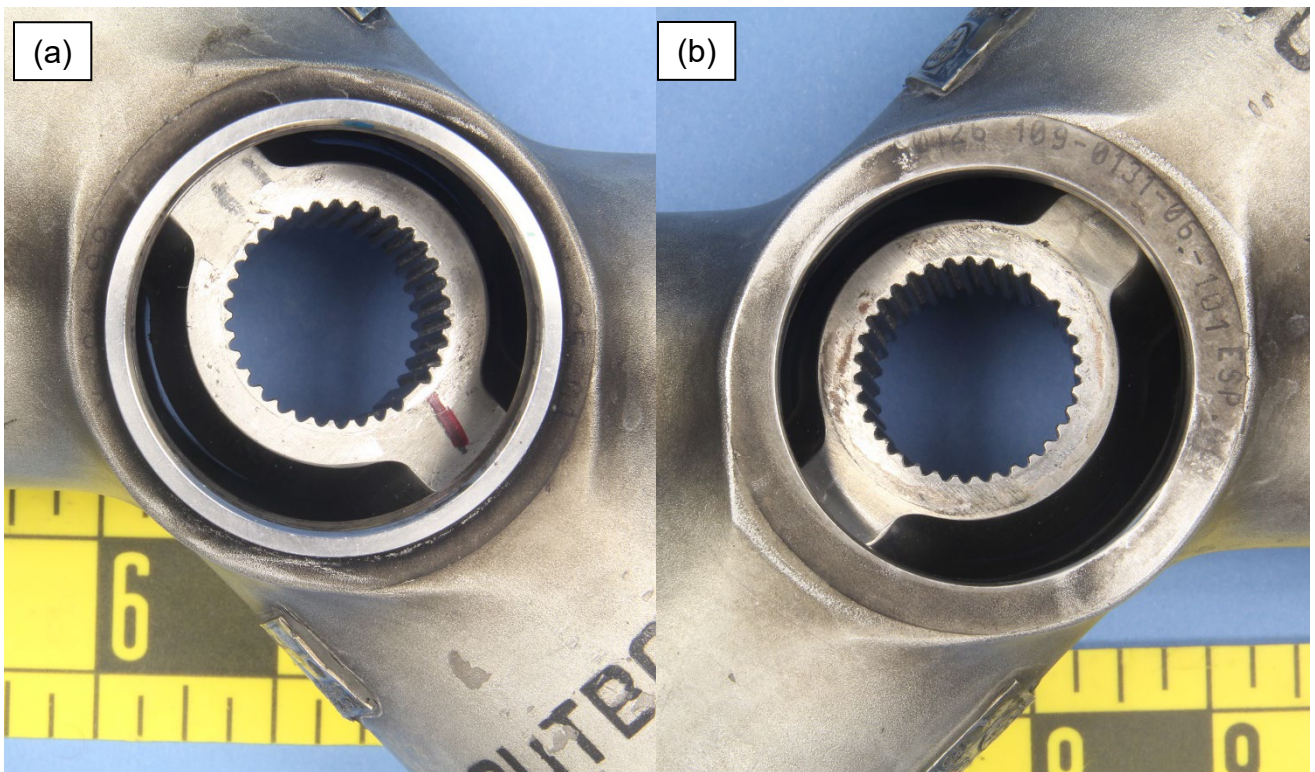
Figure 16 – The internal splined trunnion of the hub, viewed from (a) the outboard side and the (b) inboard side.
