## **NATIONAL TRANSPORTATION SAFETY BOARD**

### **Helicopter Specialist Factual Report**

# **AIRWORTHINESS**

WPR20LA029

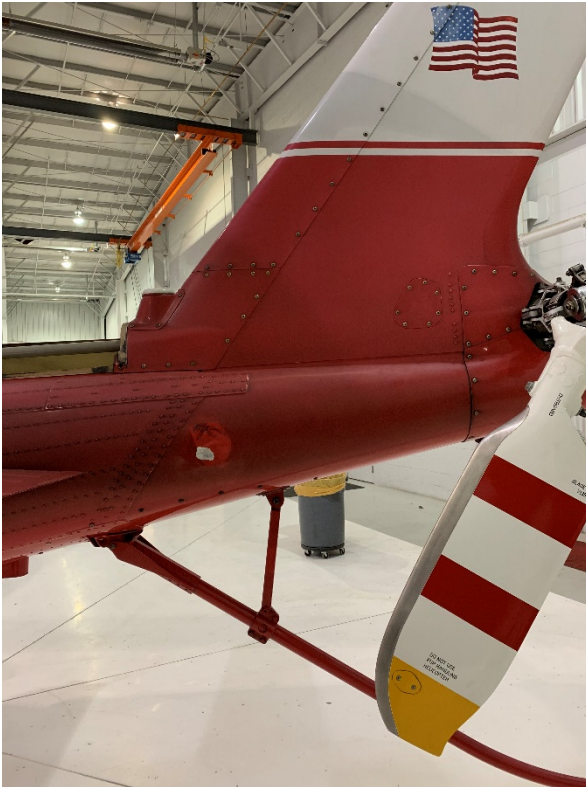
*Photo 1 - Tail section showing tail rotor blade tip strike on the empennage.*

Safety Board investigators did not physically examine the helicopter or the damage to the empennage. The operator provided photo documentation of the damage, which are included here (photos 1 & 2). The damage was located in the vicinity of the tail rotor's tip path, a witness mark where a discolored area and a paint chip were evident on the empennage.

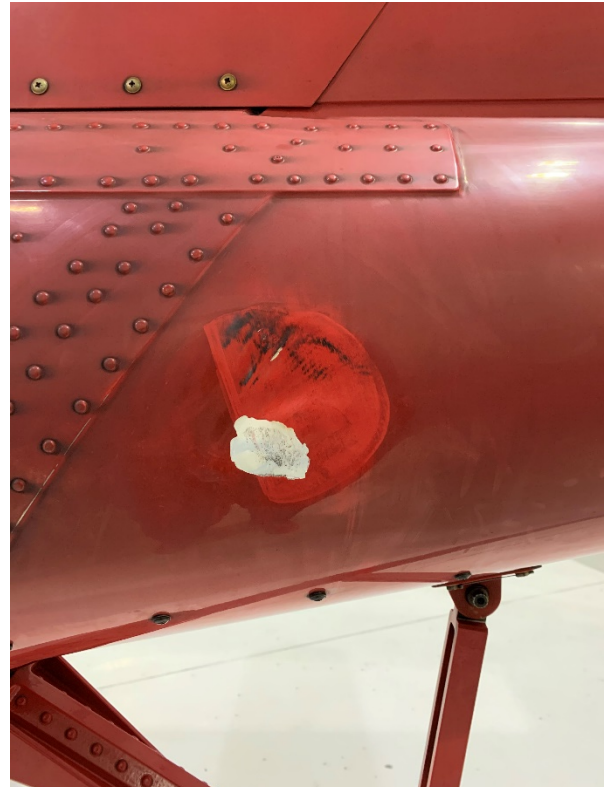
*Photo 2 - Close-up view of strike damage to empennage.*

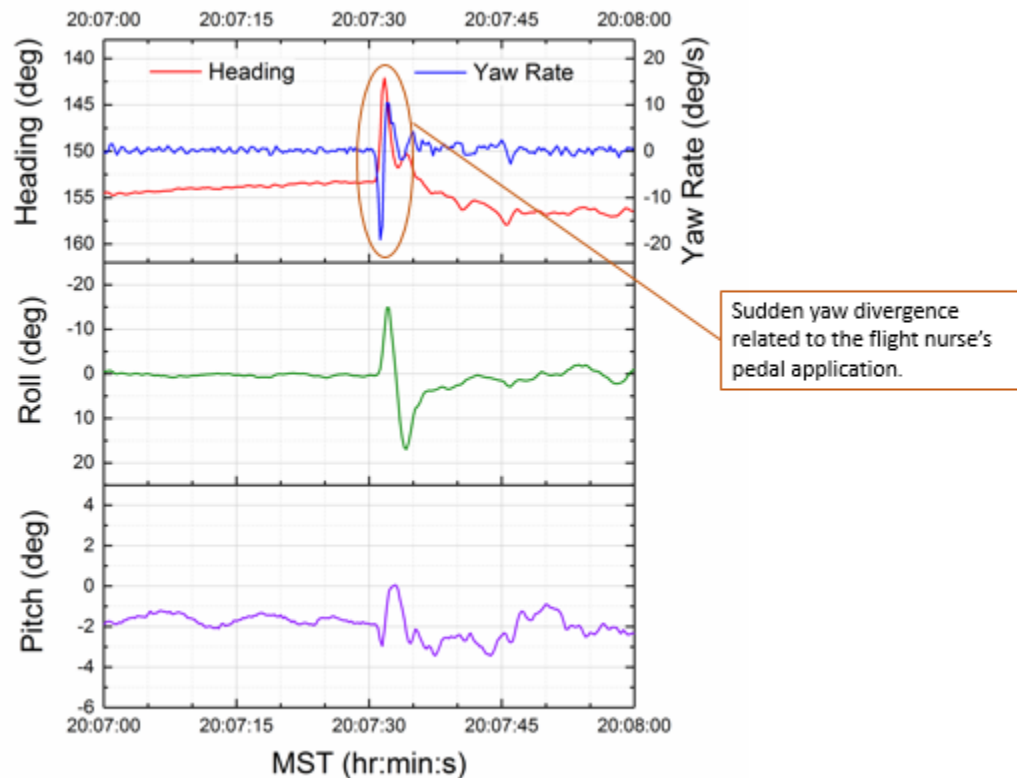
Figure 2- Graphic time plots of pitch, yaw, and roll around the time of the divergence event.

The helicopter was flying at 7,500 ft msl and a groundspeed of 150 kts when the pilot reported the flight nurse accidentally stepped on the left tail rotor pedal. Onboard data recorded that at 20:07:30.5 the helicopter rapidly turned left from a heading of 153° to 142° in 1.25 seconds, a yaw rate of nearly 20 deg/s. The pilot reported immediately countering which is reflected in the data as the helicopter returned to 151°. The helicopter also responded by rolling left then right from -15° to 15° and pitching up 2° before returning to its original attitude.

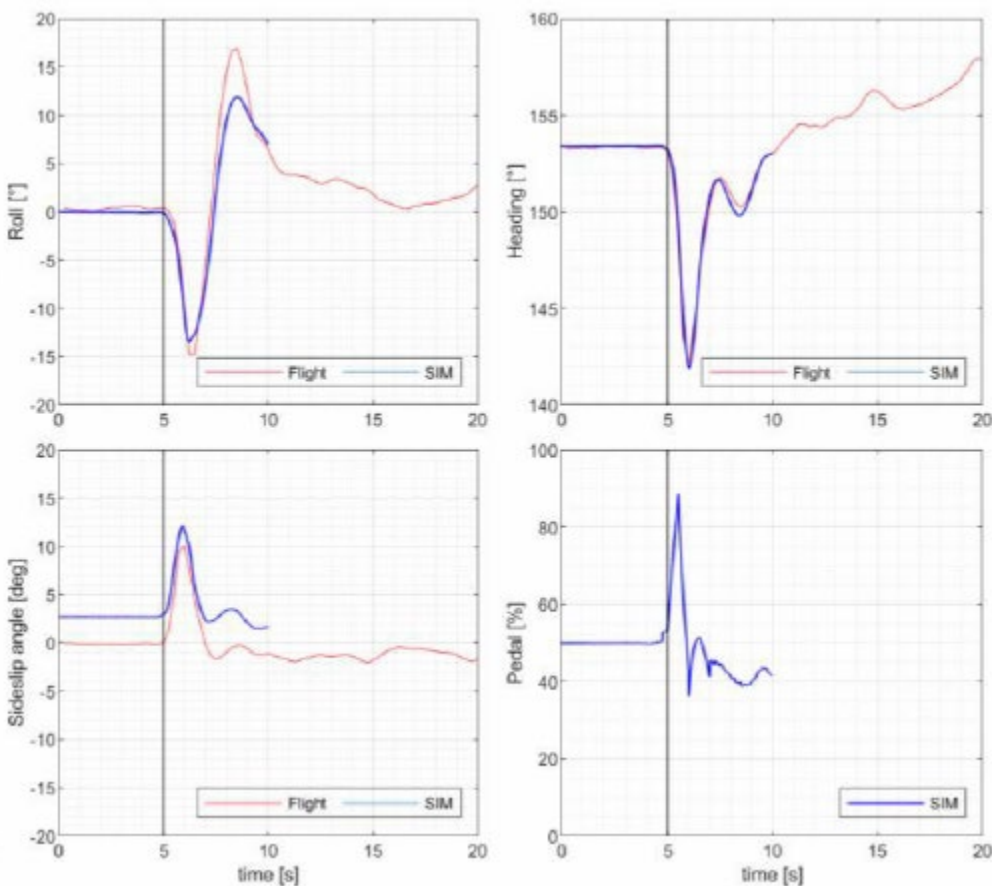
Figure 3 - Plots compare simulated and flight data for sideslip, roll, heading, and pitch parameters.

By matching the accident event heading and roll change over the same period of time, the simulation illustrates that the required left pedal pulse input would be 40% (90% pedal position).

Comparing the pedal input applied during the accident event and pedal input shape used during the dynamic stability is useful. During certification of the A109SP dynamic stability test performed at  $0.9V_h$ , were limited to 15% pedal input, resulting between  $6^\circ$  deg/s to  $15^\circ$  deg/s sideslip deviation. The accident event resulted in a  $20^\circ$  deg/s deviation which was much more extreme than parameters tested for during certification.
