| Report number: <b>ML467211</b> | |
| <p><i>Powering Aircraft Since 1929</i></p> <p><b>METALLURGICAL REPORT</b></p> | <p><u>Distribution</u><br/>Phillip Grice</p> |
| Subject: Crankshaft from engine serial 467211, Cessna 182P N182EF | |

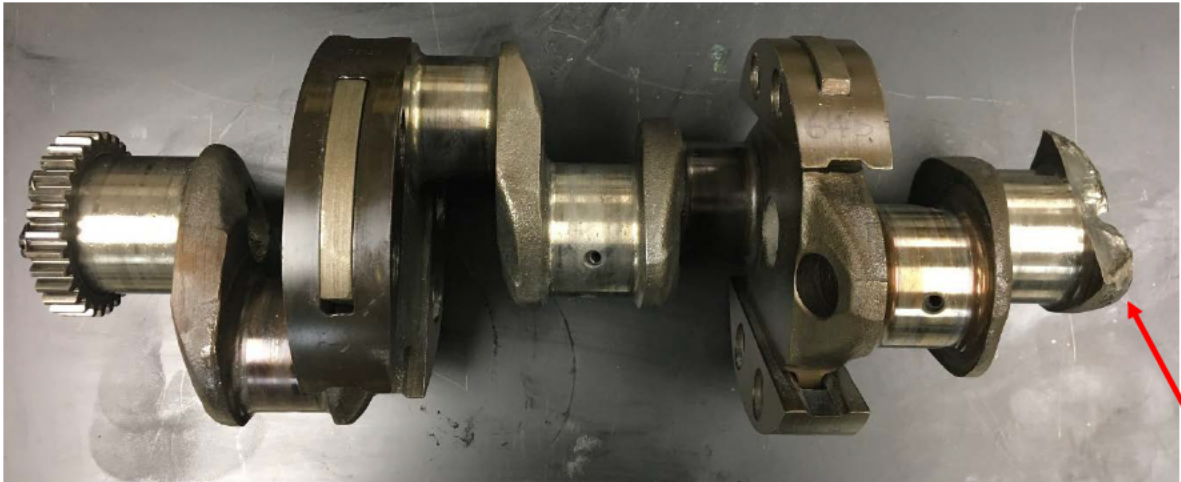
Figure 1 shows the crankshaft fracture location at the third main and fifth rod bearing. Inspection of the fracture surface shows the initiation below the surface, as shown in figure 2. Crack arrest lines or beach marks radiate from the origin below the surface. The nitride case appears normal and can also be seen in figure 2.

*Figure 1 Fractured aft portion of the crankshaft (arrow to fracture surface)*

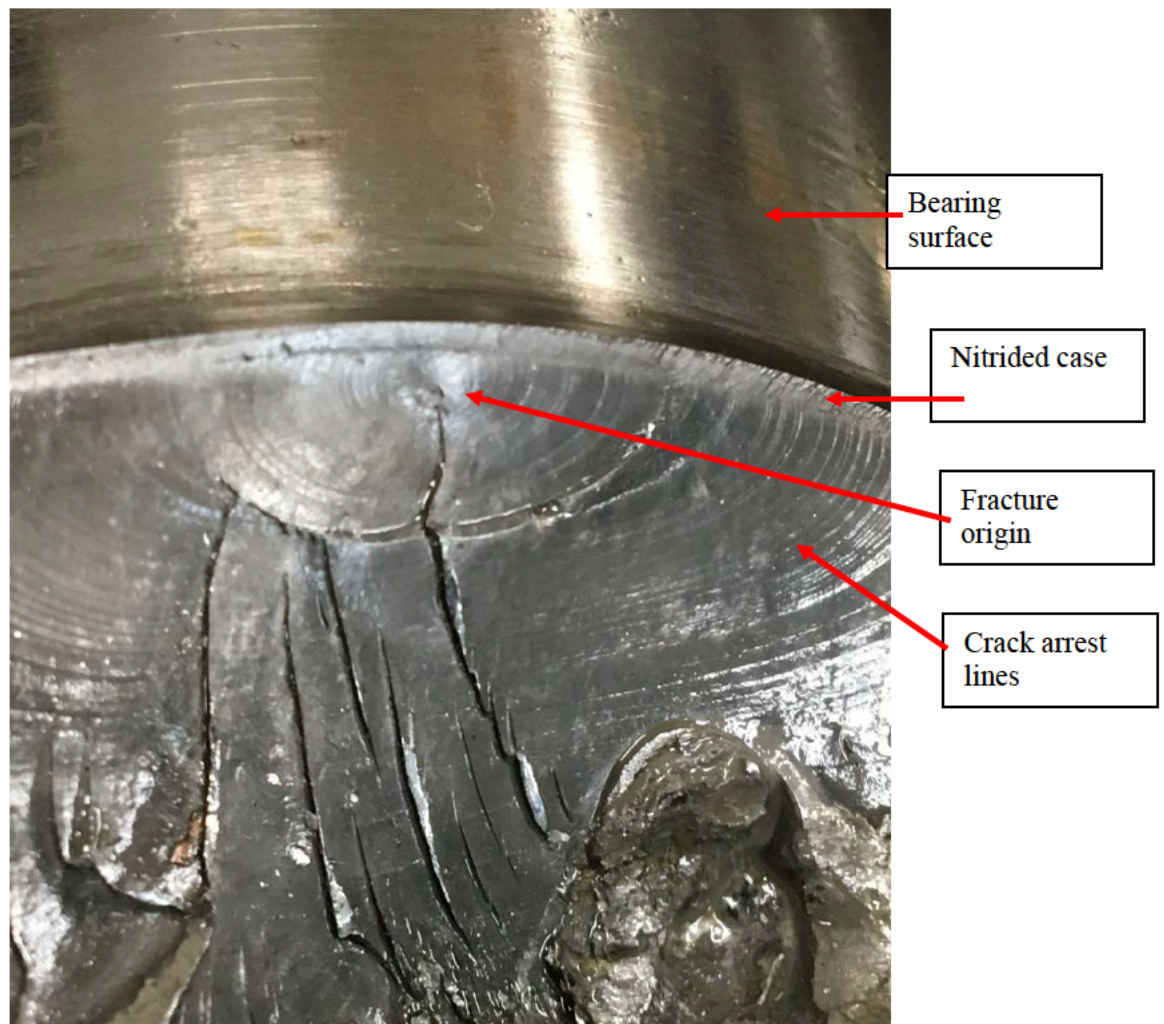
- 1] The fracture initiated below the surface, originating near an oxide inclusion within the metal.
- 2] Contributors to increased stress include
  - A. The addition of a super charger
  - B. The larger cylinders in the conversion
  - C. The inclusions naturally occurring in the non-VAR steel

*Figure 2 Fracture surface showing subsurface crack origin*

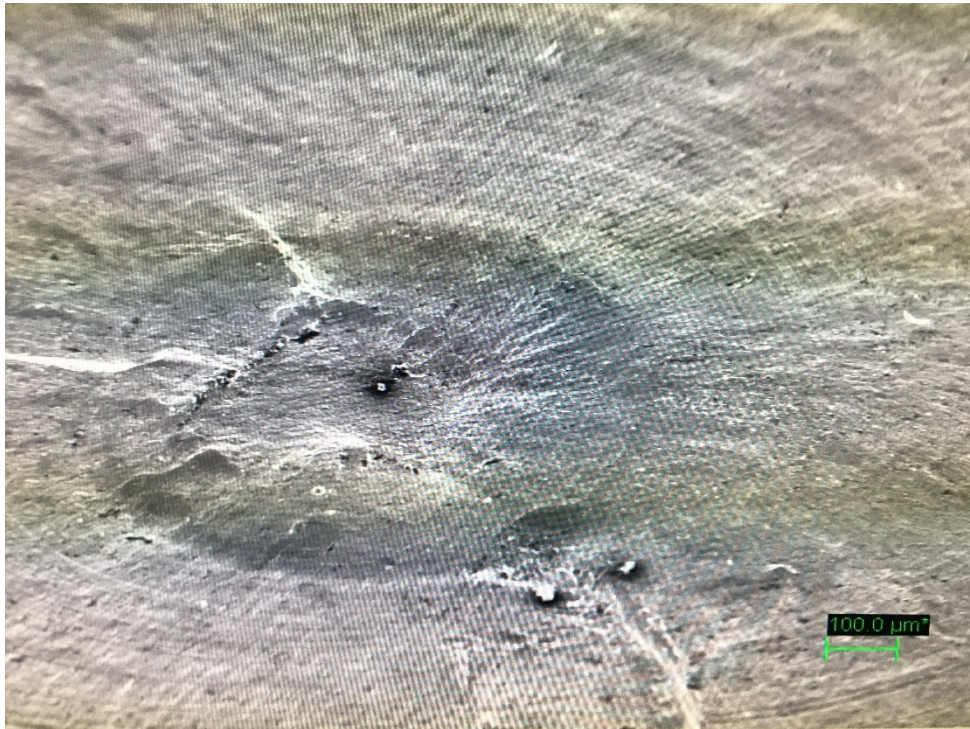
Figures 3 and 4 show the origin area using a scanning electron microscope with an energy dispersive spectrometer. There are oxide inclusions in the area of fracture origin, as is shown in figure 4.

*Figure 3 Scanning electron image of fracture origin*

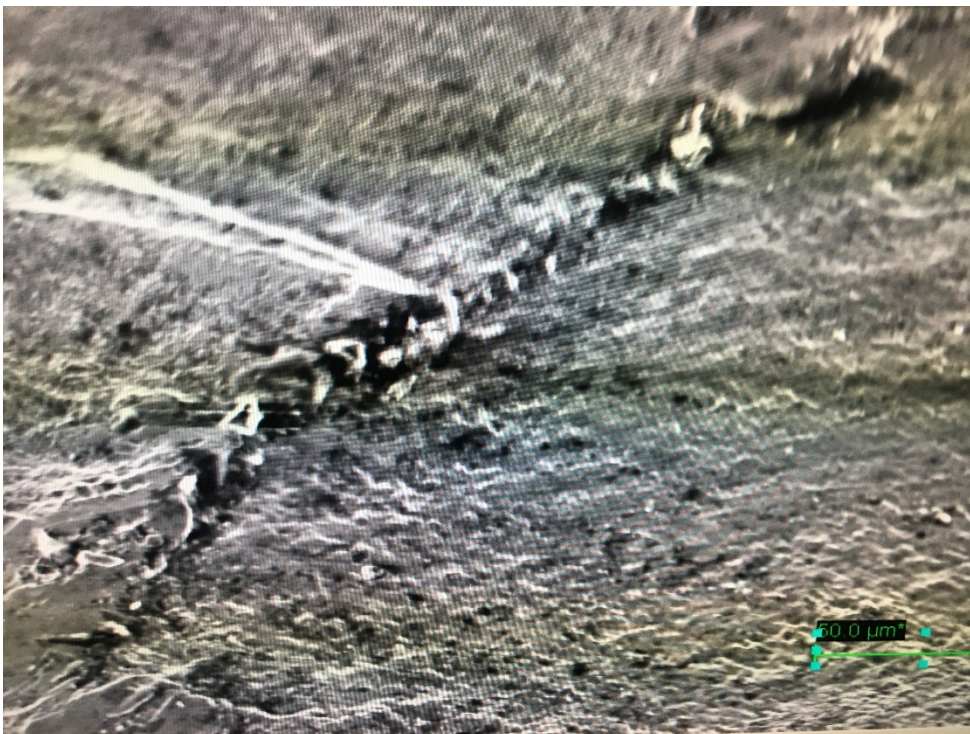
*Figure 4 Oxide inclusions near fracture origin*
