## **NATIONAL TRANSPORTATION SAFETY BOARD**

### **ENGINE EXAMINATION SUMMARY**

**WPR20LA042**

Location: Carlsbad, California  
Date: December 12, 2019, at 1315 PST  
Aircraft: Cessna 182-P  
NTSB IIC: Andrew Swick

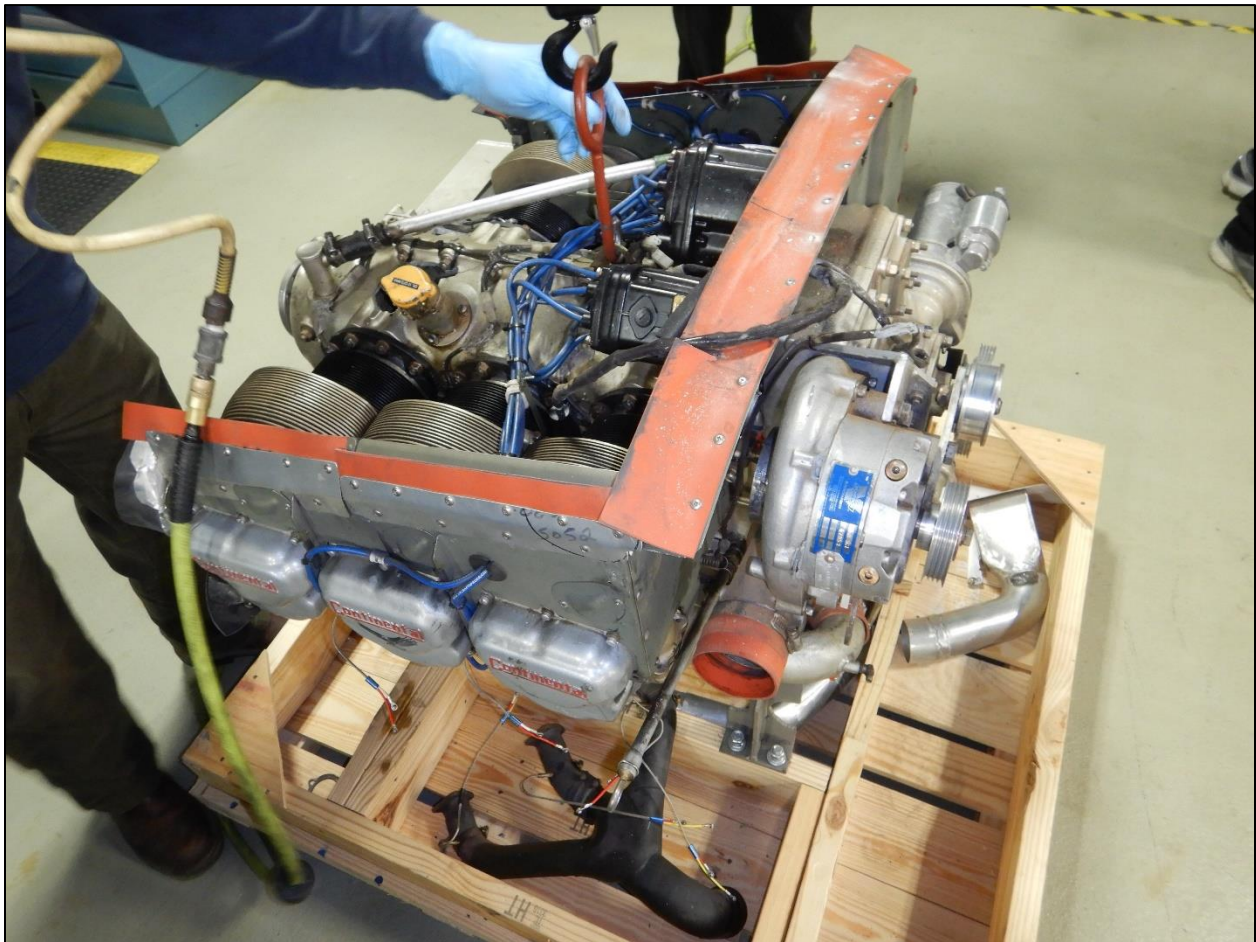
*Figure 1-Engine and lower side of engine crate.*

Internal surfaces were visible through two holes in the crankcase and were thermally damaged.

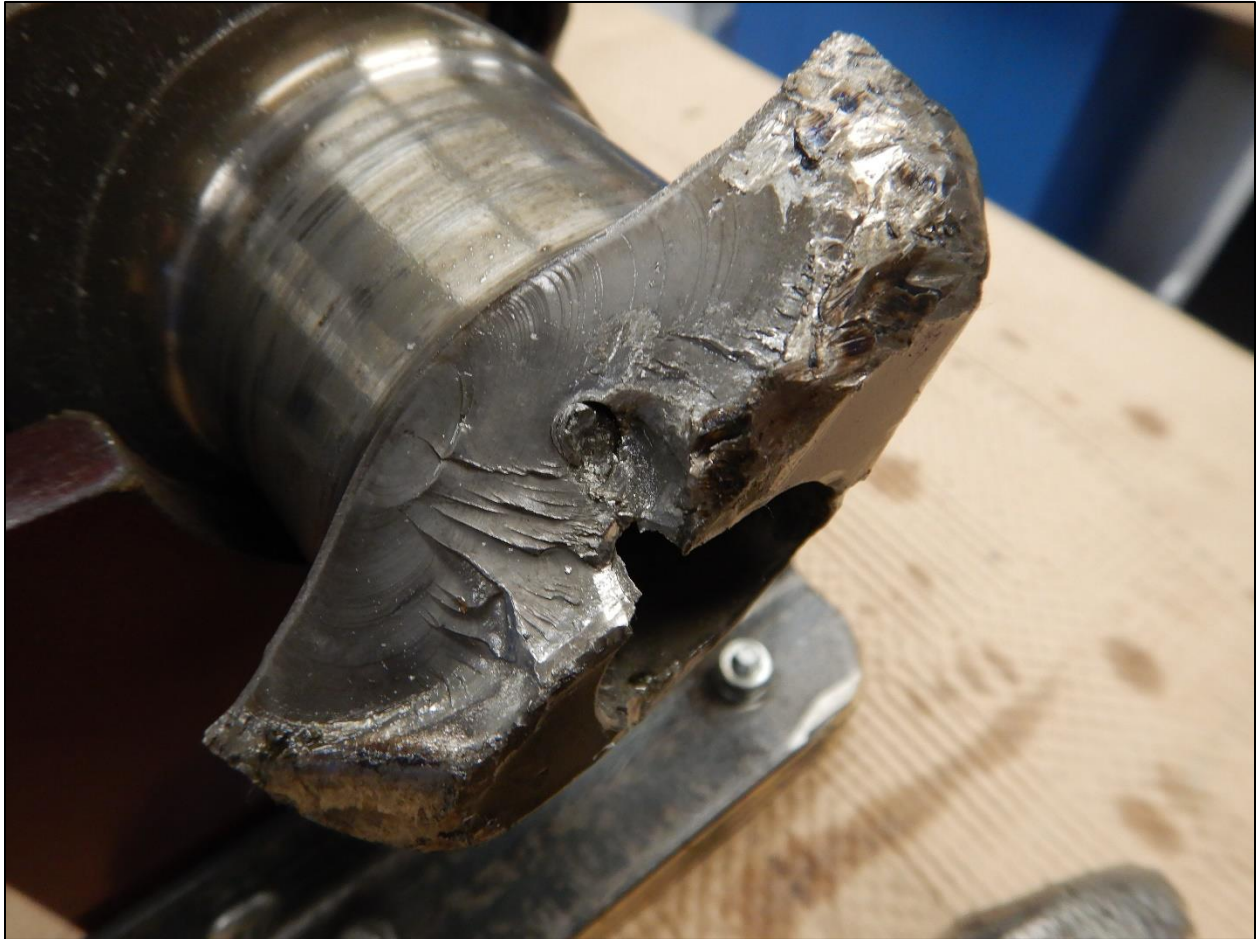
Examination of the recovered engine was conducted on February 4, 2020, at a facilities of Continental Aerospace Technologies-Analytical Department, Mobile, Alabama. The crankshaft was found in three sections near the No. 5 and 6 cylinders. The separation surface at the No. 3 crankshaft main bearing journal forward cheek showed signatures of fatigue.

The oil sump had a hole and ping marks from the inside. The No. 5 and 6 connecting rods separated from the crankshaft. Connecting rod parts and metal fragments were found in the oil sump. The crankshaft was found in three sections. The crankshaft cheek forward and adjacent to the No. 3 bearing journal separated. It was consistent with fatigue type signatures (beach marks) on the separation surface. According to the CAT initial metallurgical exam, the stress riser appeared to initiate below the nitride layer with beach marks prorogating from the center and ratcheting marks. A CAT Metallurgical Examination Report will be prepared for the investigation.

*Figure 2-Crankshaft separation surface near the No. 3 main bearing journal.*

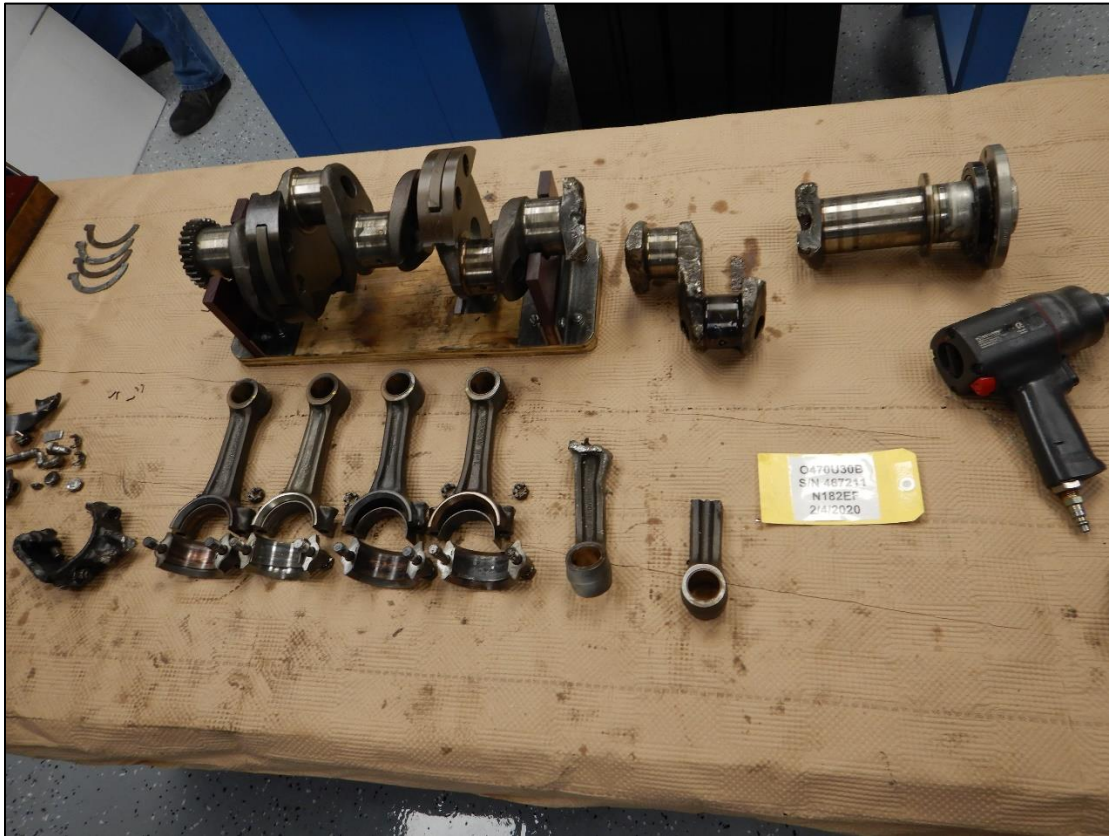
*Figure 3-Crankshaft (3 sections) and connecting rods.*
