From: [REDACTED]  
To: [REDACTED]  
Subject: Re: WPR20LA097 Baker City, OR-Engine Examination  
Date: Friday, July 3, 2020 9:53:54 AM

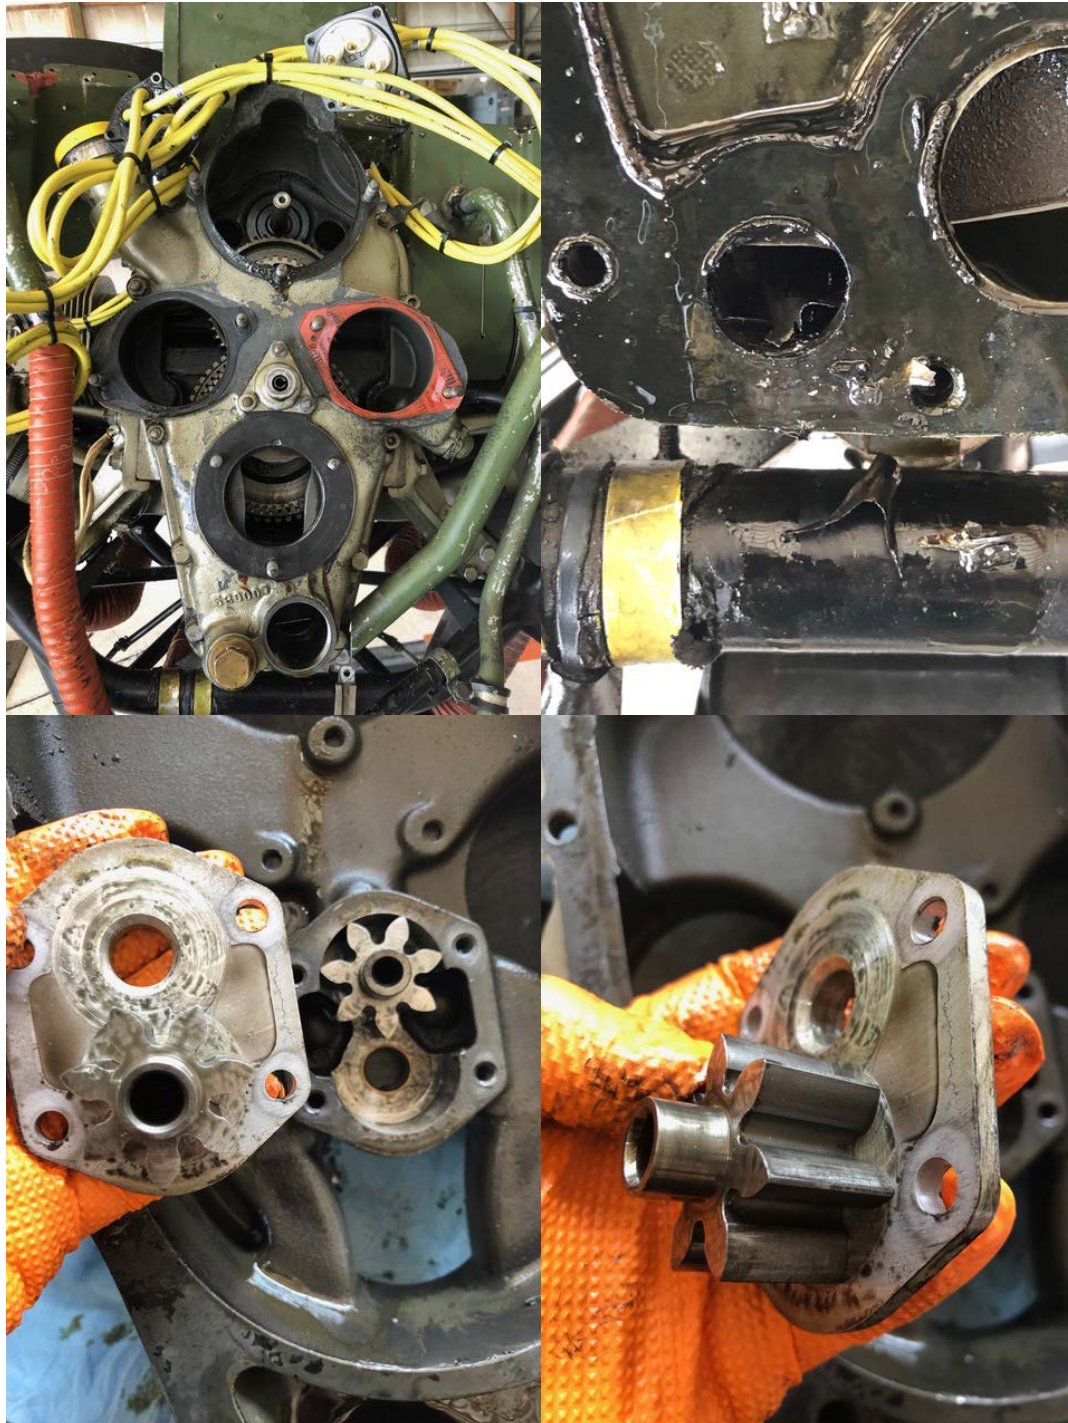
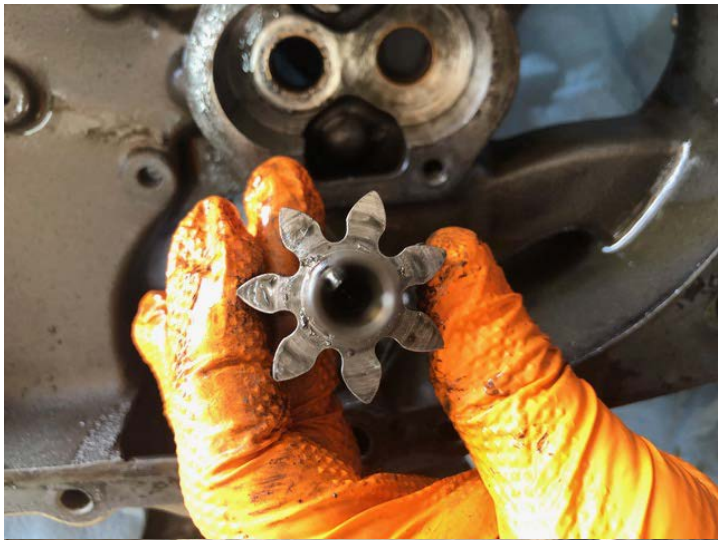
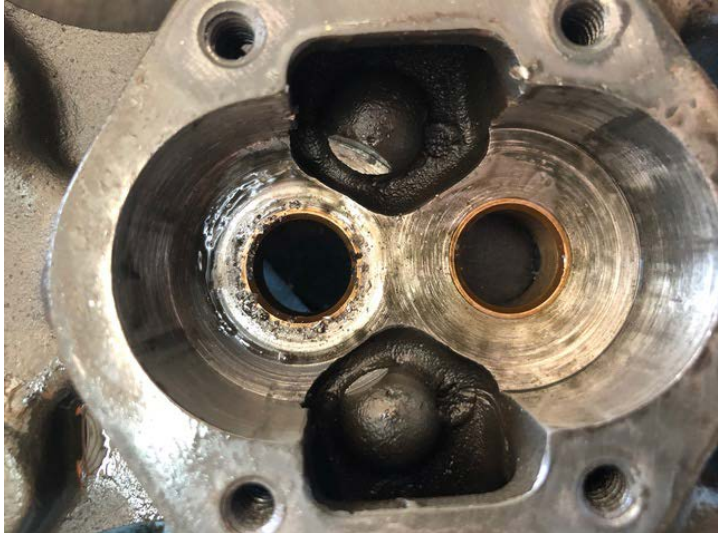
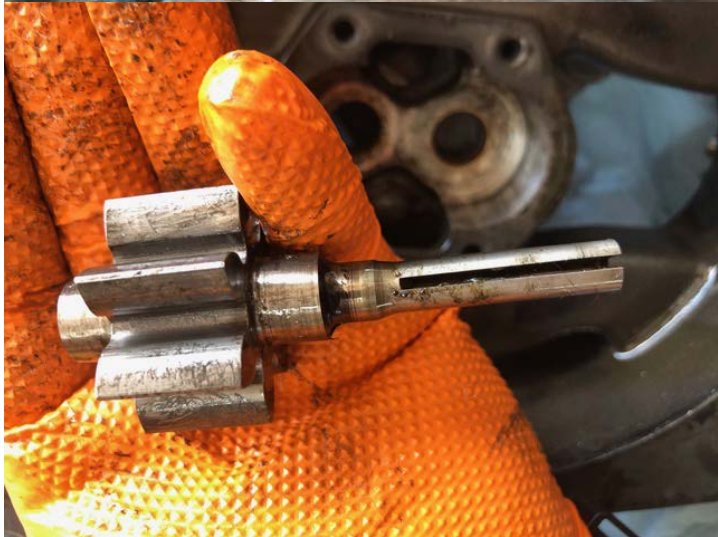
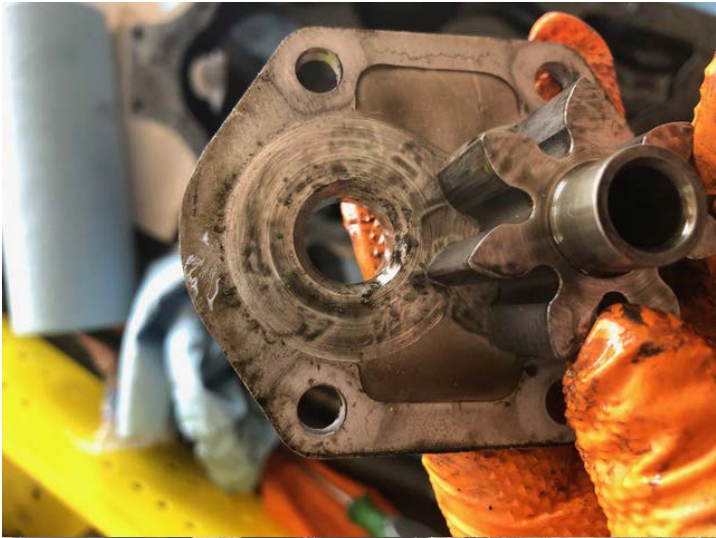
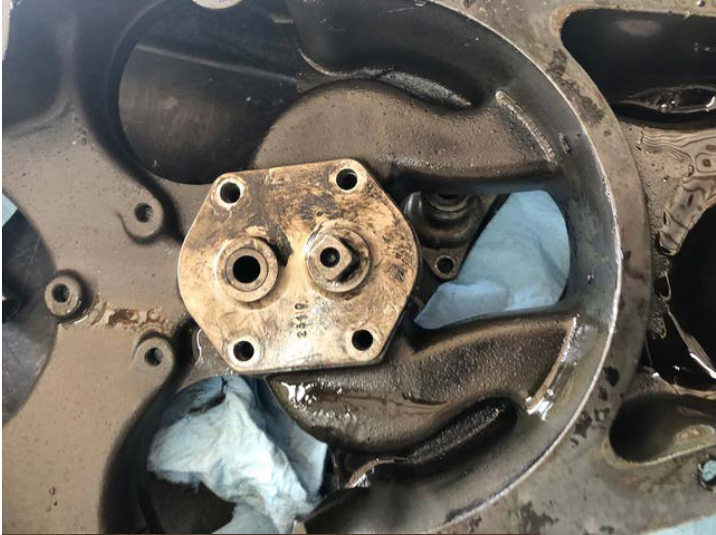
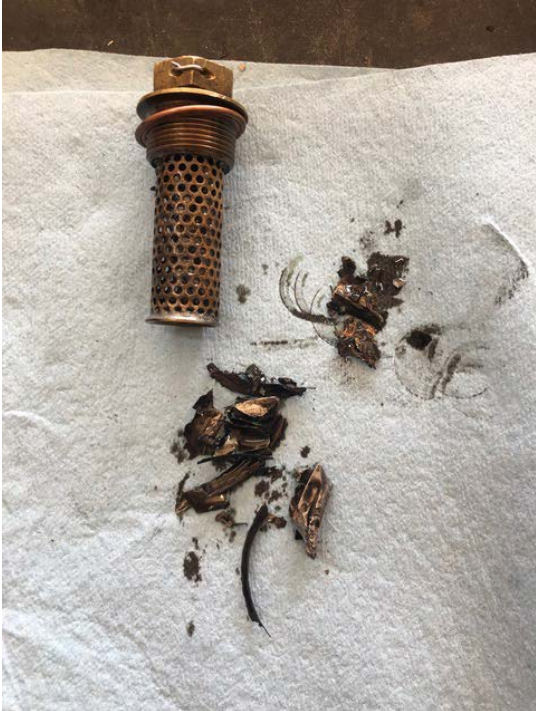
Attached are the photos of the accessory case and oil pump disassembly. The oil pump felt gritty when turned by hand, but for the most part didn't exhibit any signs of major damage. As I mentioned before there was no oil flow when the prop was motored. The suction screen had a significant accumulation of large debris. Most of which appeared to be from machined parts.
