## **NATIONAL TRANSPORTATION SAFETY BOARD**

# **PHOTO EXAMINATION REPORT**

**WPR20LA097**

Location: Baker City, Oregon  
Date: February 27, 2020  
Aircraft: N5478C  
NTSB IIC: Andrew Swick

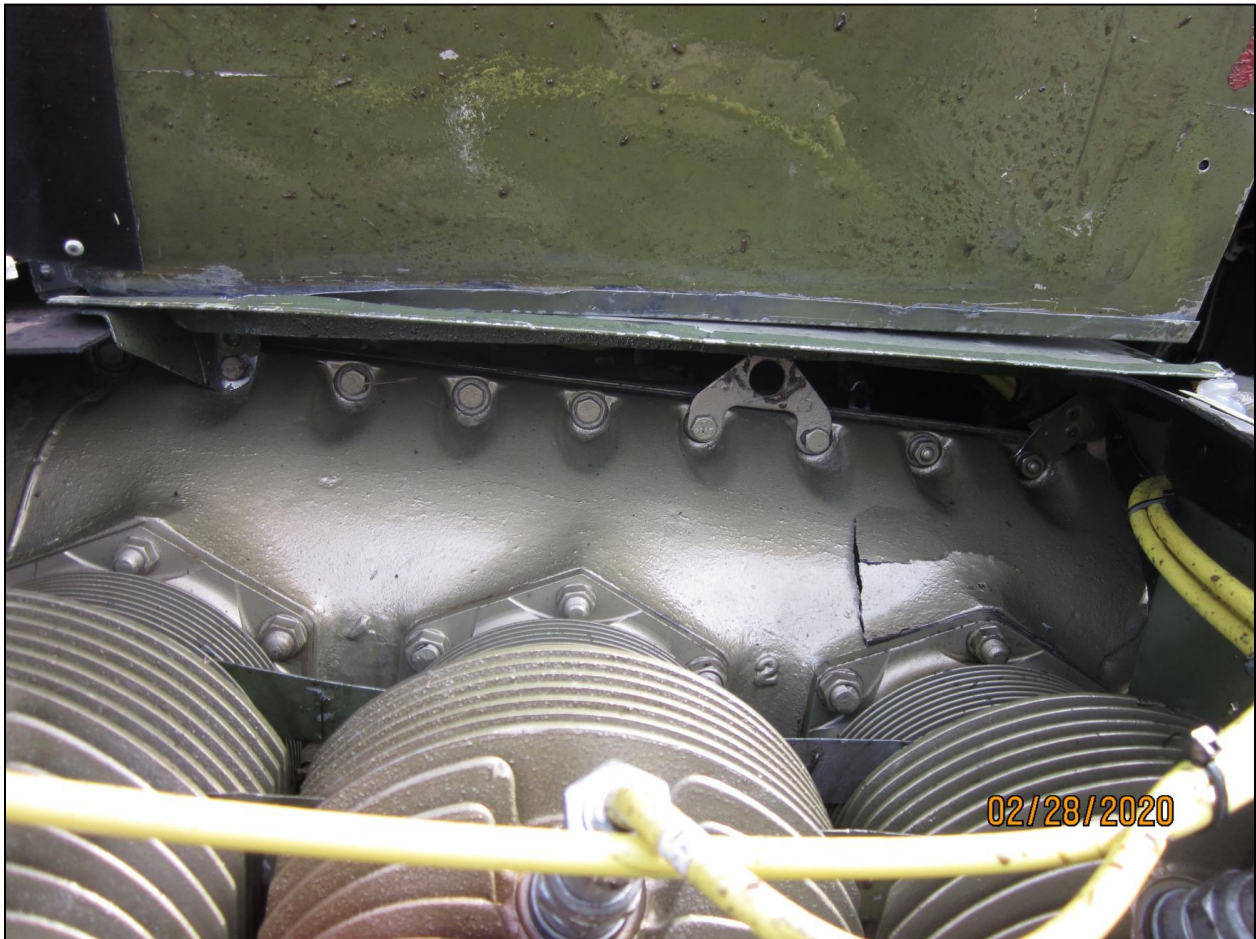
The examination was performed by a hired mechanic who supplied the NTSB with photographs and notes. The engine cowling was removed, and the crankcase had impact damage between cylinders No. 5 and 6.

Figure 1-View of the engine from the left side.

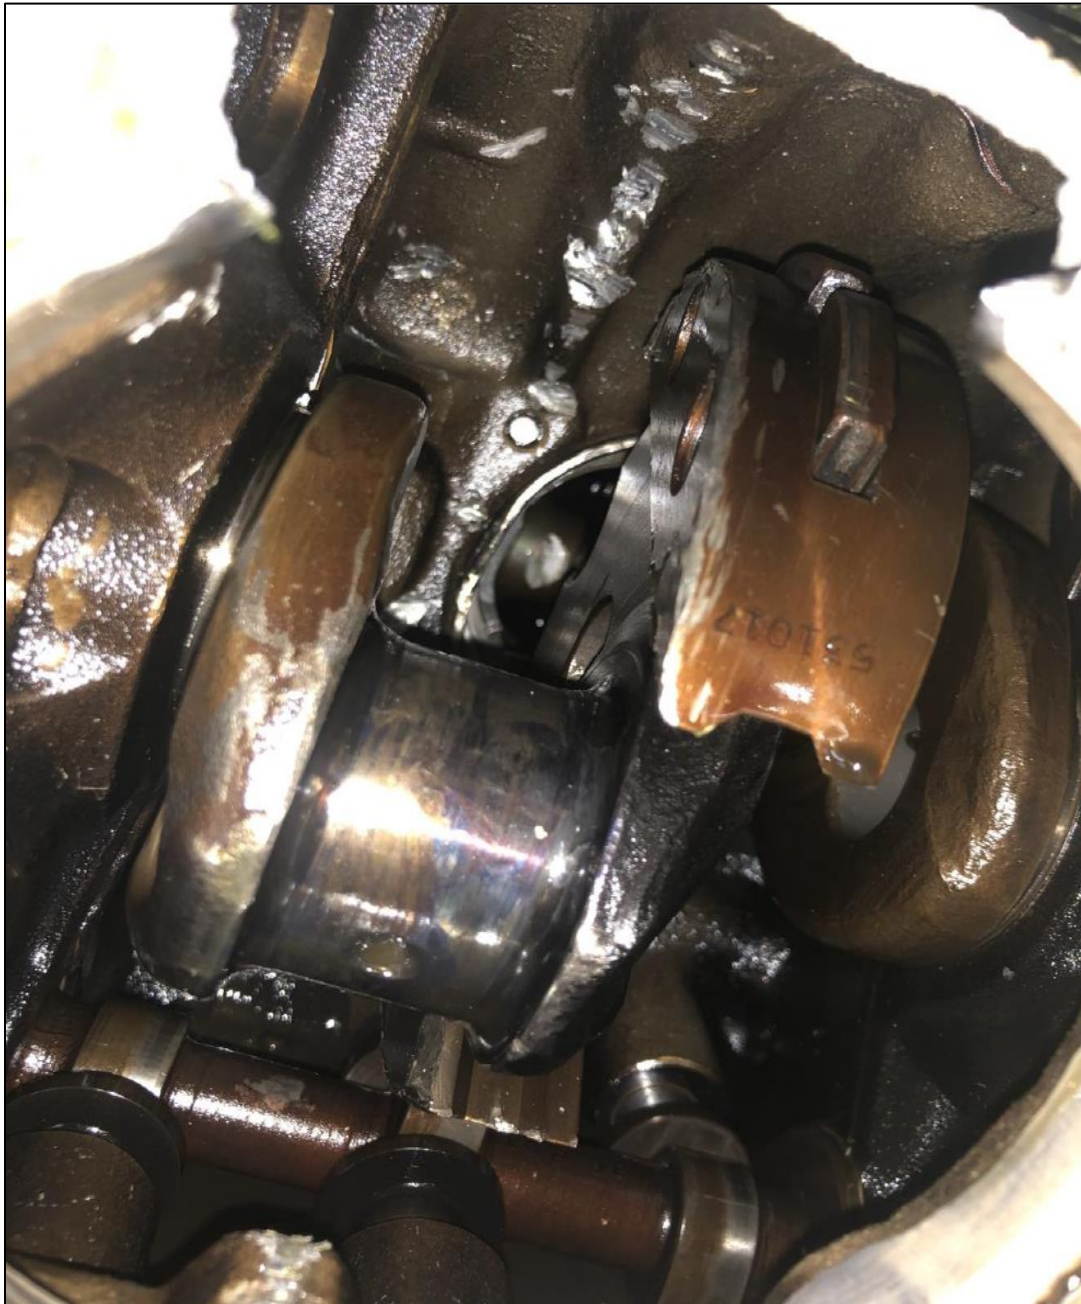
The No. 2 cylinder was removed from the engine and had mechanical damage to the cylinder skirt. The No. 2 connecting rod separated from the crankshaft and the No. 2 crankshaft journal displayed signatures consistent with heat distress. Mechanical damage was notes to the adjacent counterweight and internal crankcase surface areas.

Figure 2-The crankshaft No. 2 connecting rod journal.

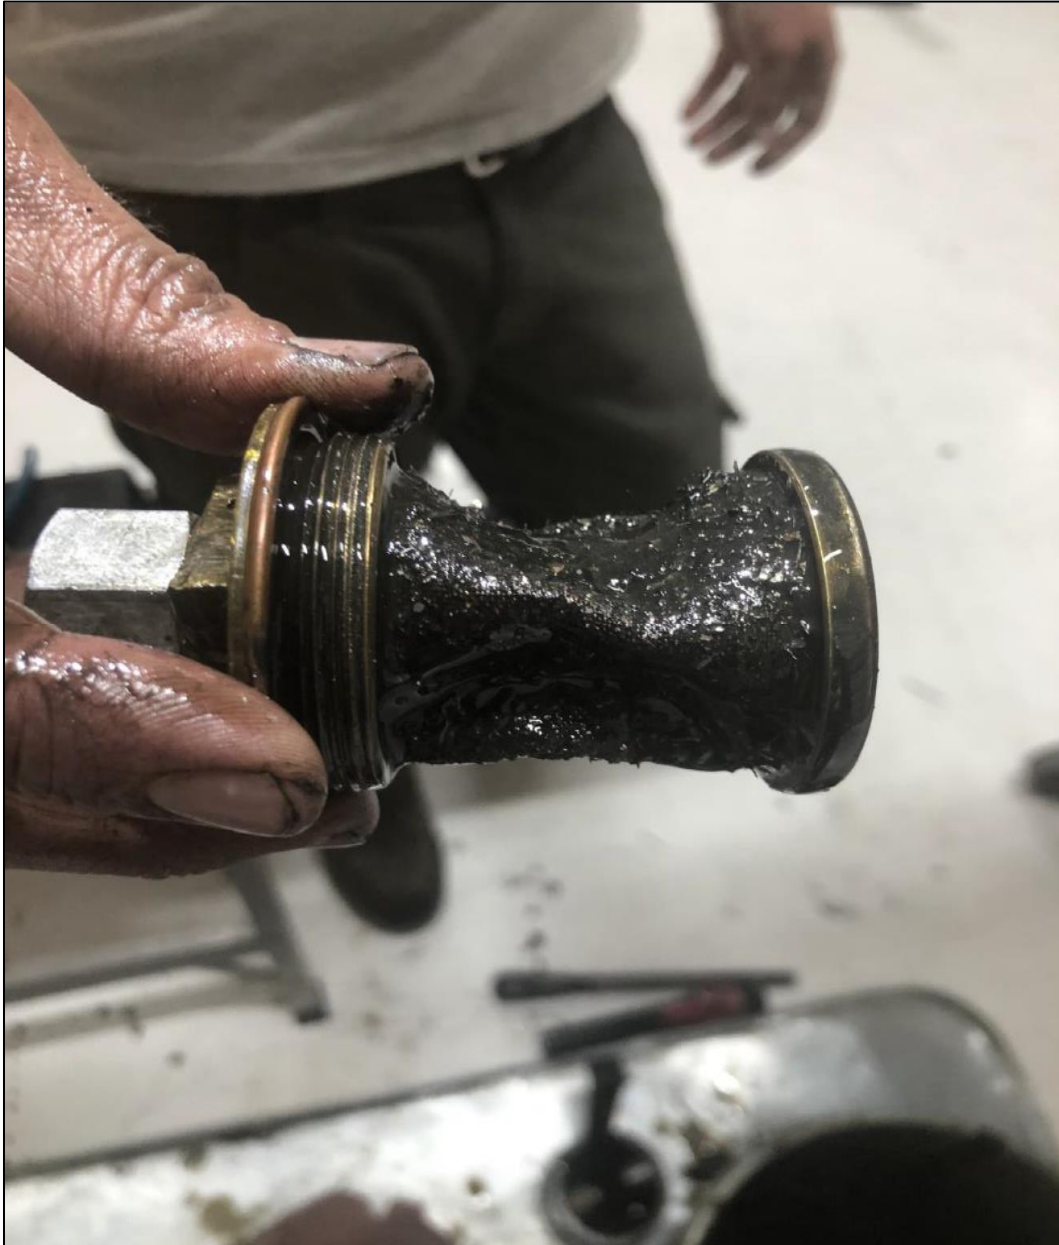
The No. 2 piston moved freely in the cylinder and the connecting rod wrist pin moved freely in the piston. The No. 2 cylinder intake and exhaust valves were undamaged. The No. 2 crankshaft journal had thermal discoloration and mechanical damage. The oil filter screen was removed from the engine, and the cylindrical filter screen was collapsed. The screen was covered in metal shavings and dark thick oil.

Figure 3-Oil filter screen.

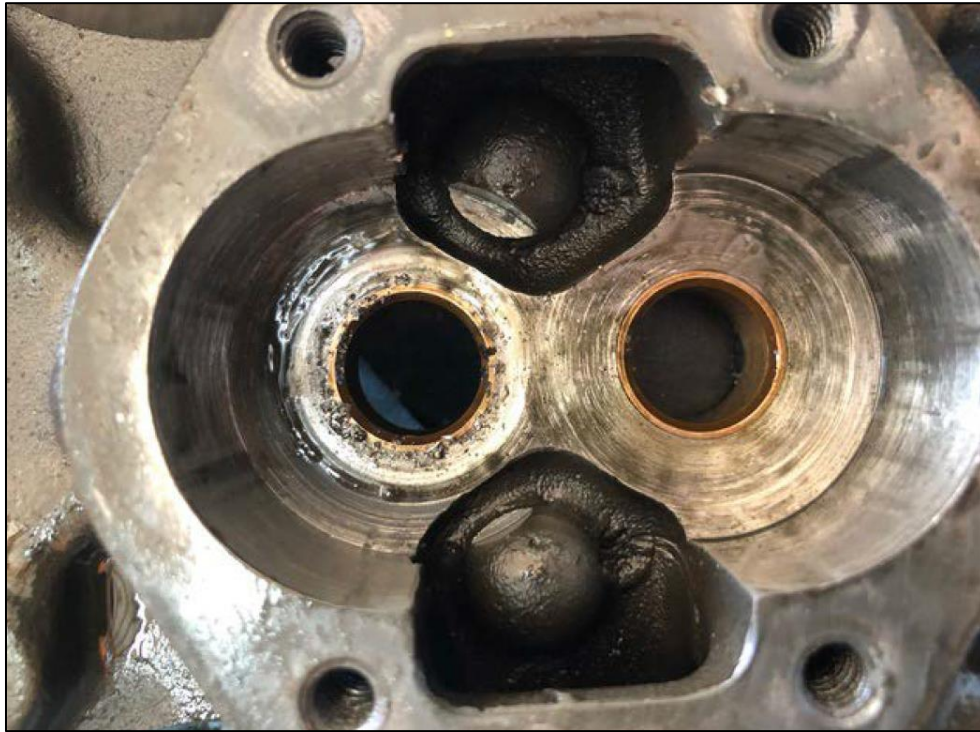
The oil pump was removed and shows signatures of hard particle passage. The oil sump pickup screen and the accessory section cover were removed from the engine. Large metal bearing fragments were found in the area of the pickup screen position.

Figure 4-Oil pump gear cavity.

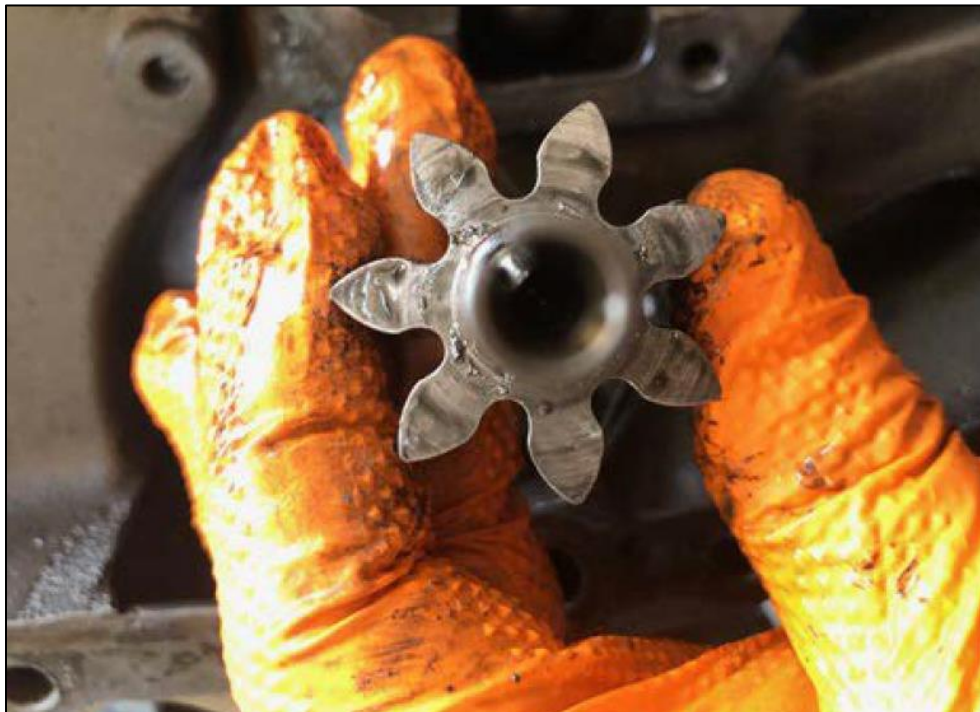
Figure 5-Oil pump drive gear.

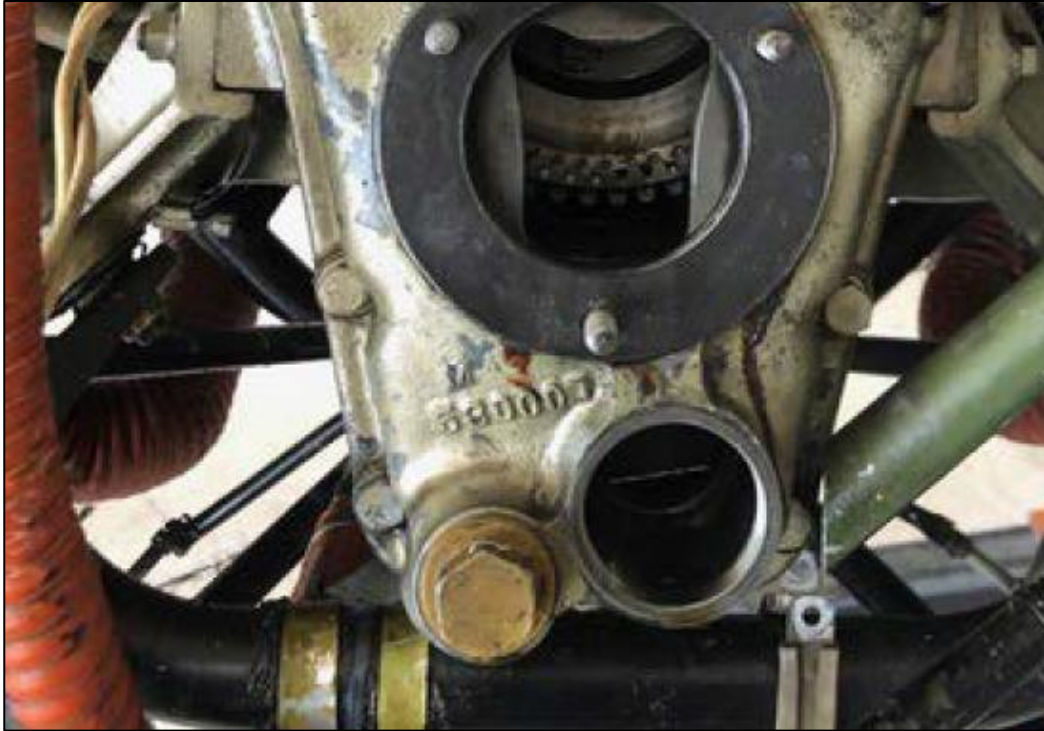
Figure 6-Accessory section and oil pickup screen location.

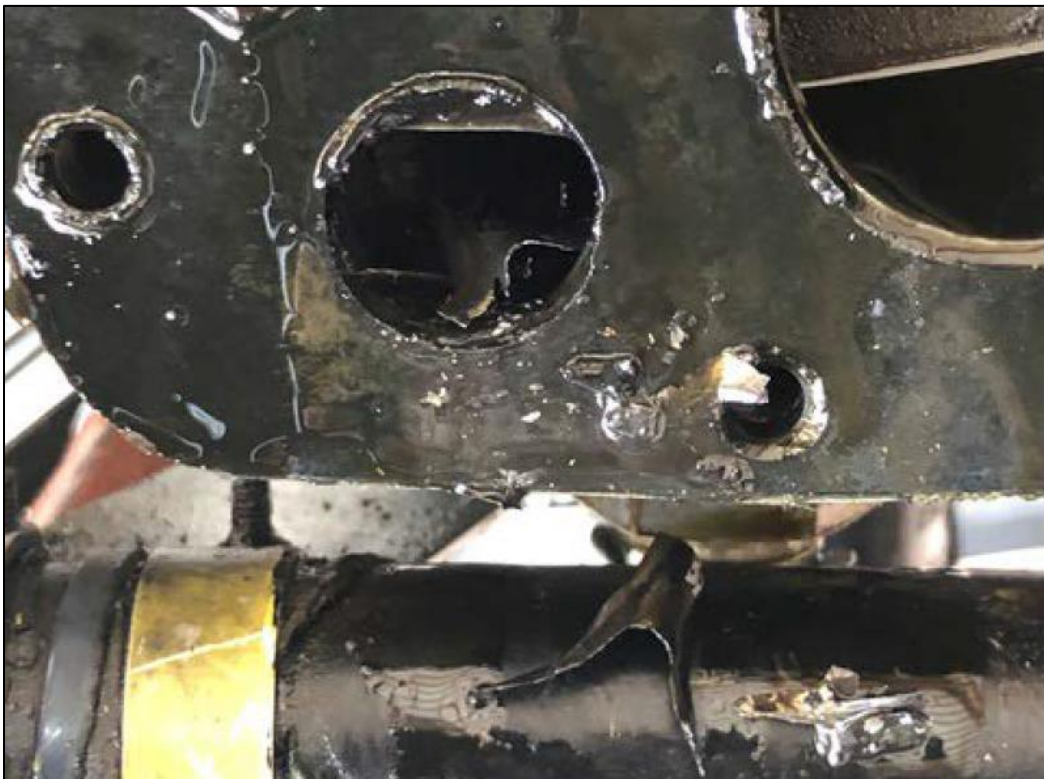
Figure 7-Oil pickup screen location and metal fragments.

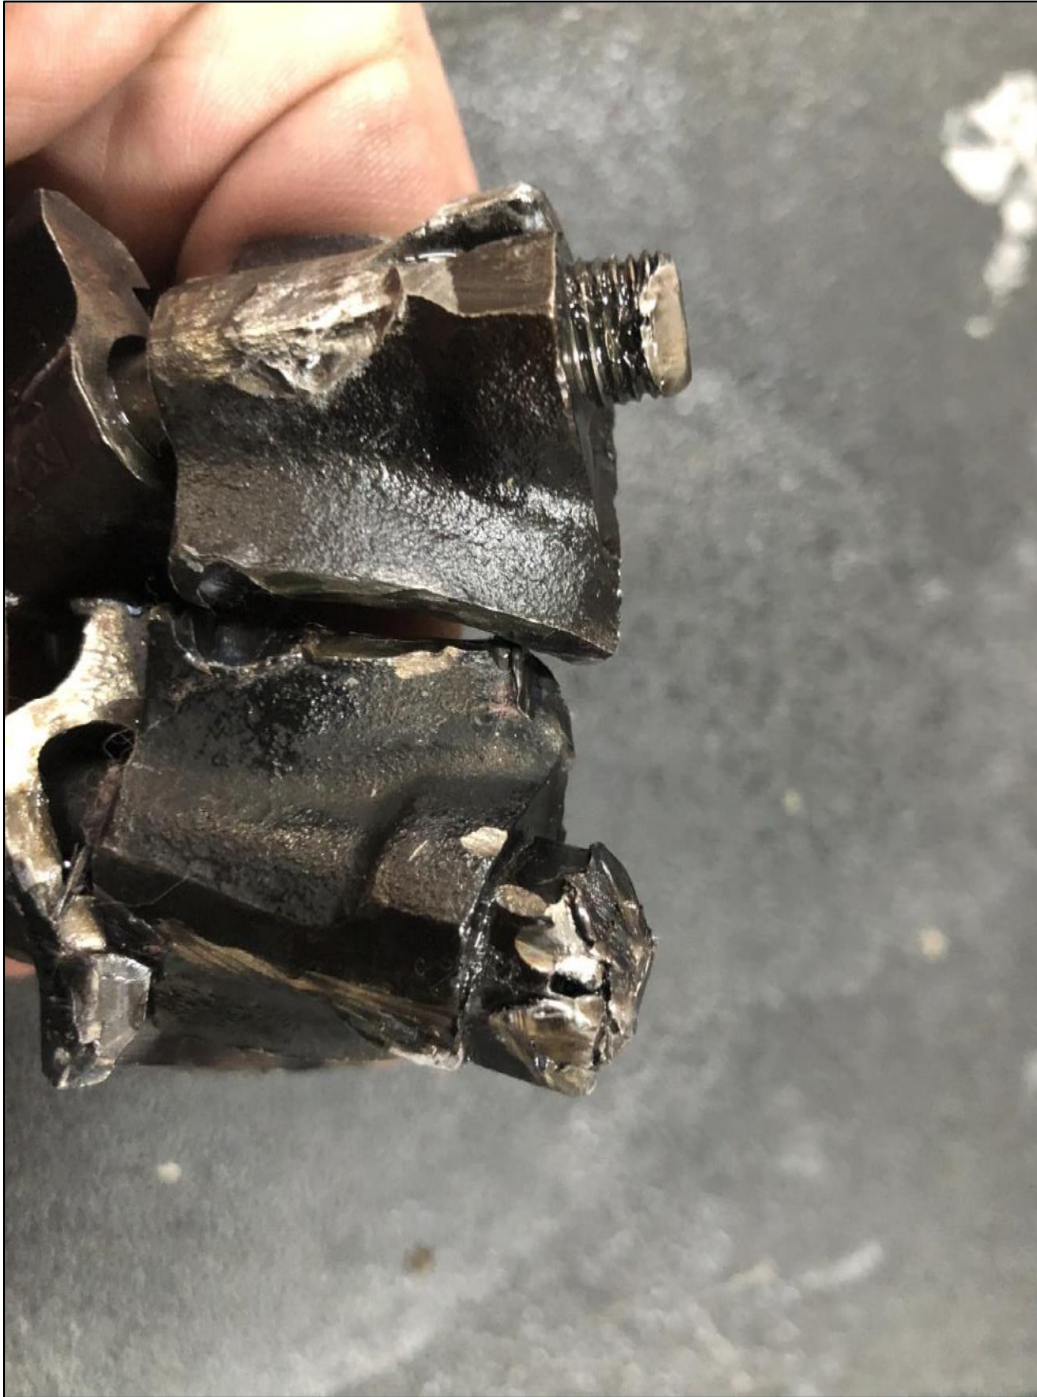
The oil sump was removed. The No. 2 connecting rod yoke end sections and cap end were found in the oil sump. The connecting rod end cap was found in two pieces. The yoke ends remained attached to their respective cap end pieces. The bolts remained intact and the nut from one bolt separated and was found broken in the sump. The cotter pin was not found during the examination.

Figure 8-The No. 2 connecting rod end cap and yoke end sections.

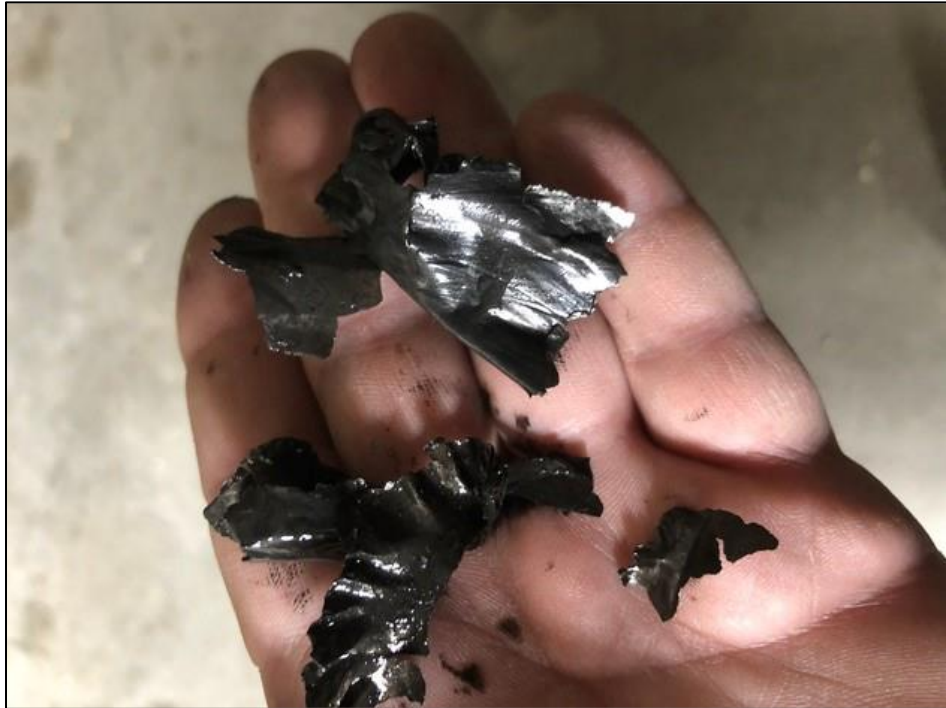
The No. 2 crankshaft connecting rod bearing material was found in pieces in the oil sump. The pieces exhibited thermal distress and deformation.

Figure 9-Oil sump debris.

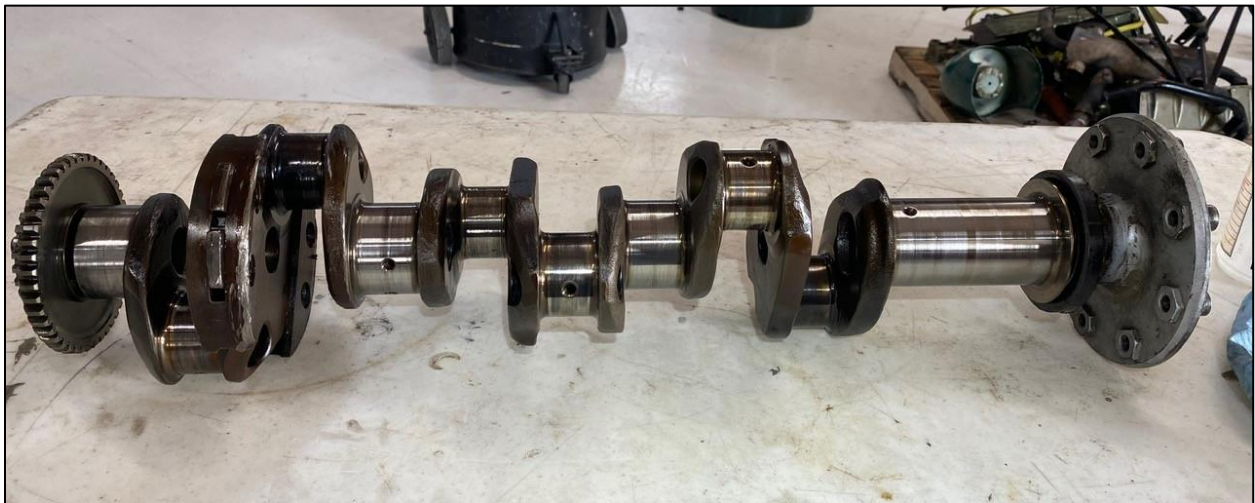
Figure 10-Crankshaft.

The engine was disassembled, and the crankshaft was removed. The No. 2 connecting rod journal and adjacent cheeks had mechanical damage. The remaining connecting rod journals had thermal discoloration. The main bearings had thermal discoloration and bearing wear. The connecting rod bearings had thermal discoloration and wear revealing the copper layer below.

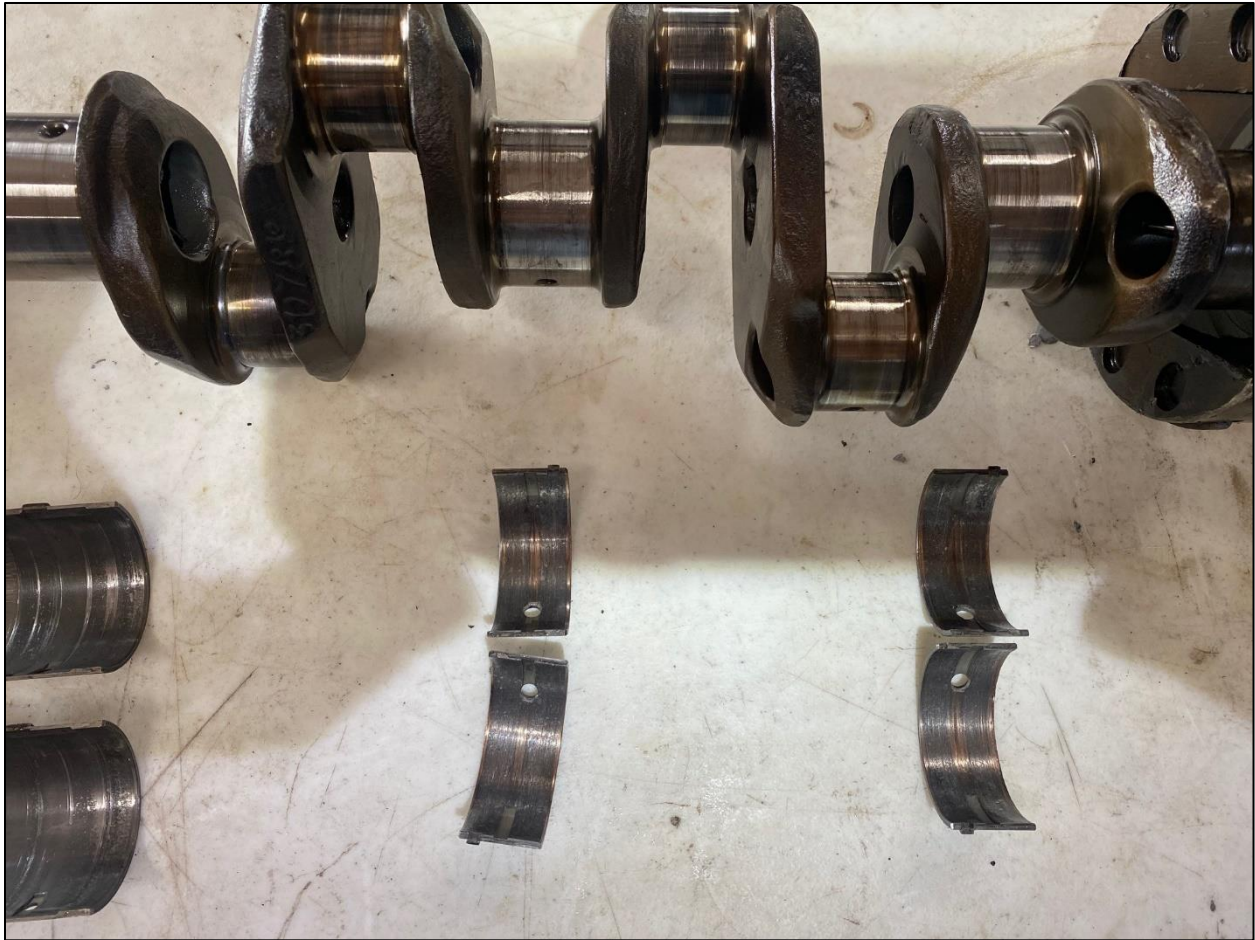
Figure 11-Crankshaft and connecting rod bearings (forward main bearing-left side of photo).
