## **NATIONAL TRANSPORTATION SAFETY BOARD**

# **AIRFRAME EXAMINATION SUMMARY**

**WPR20LA099**

| Aircraft: | Cessna 182A, N4031D |

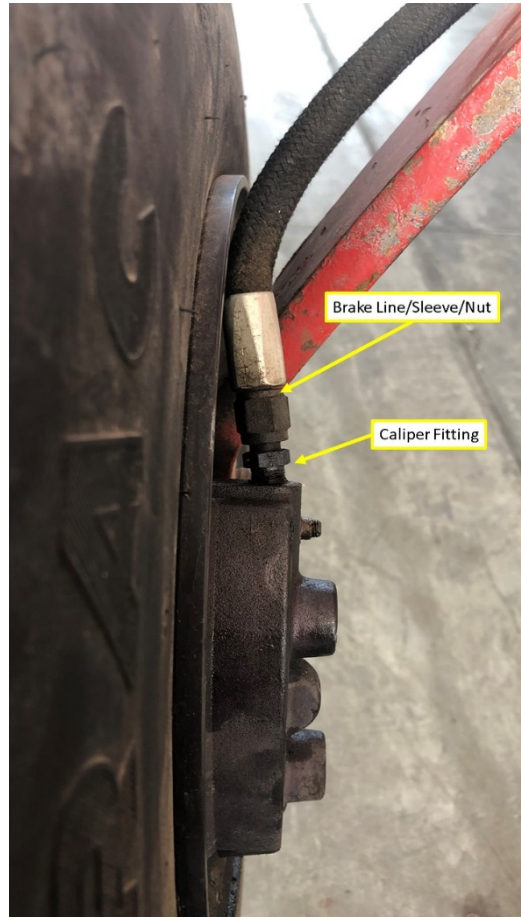
Examination of the recovered airframe was conducted by an airframe and powerplant mechanic under the supervision of a National Transportation Safety Board investigator. The examination revealed that the fitting on the upper portion of the brake caliper was slightly bent outward, toward the wheel assembly, which allowed for a portion of the brake line attached to the fitting to contact the inner wheel assembly, as seen in figure 1.

**Figure 1: View of the right main landing gear brake assembly.**

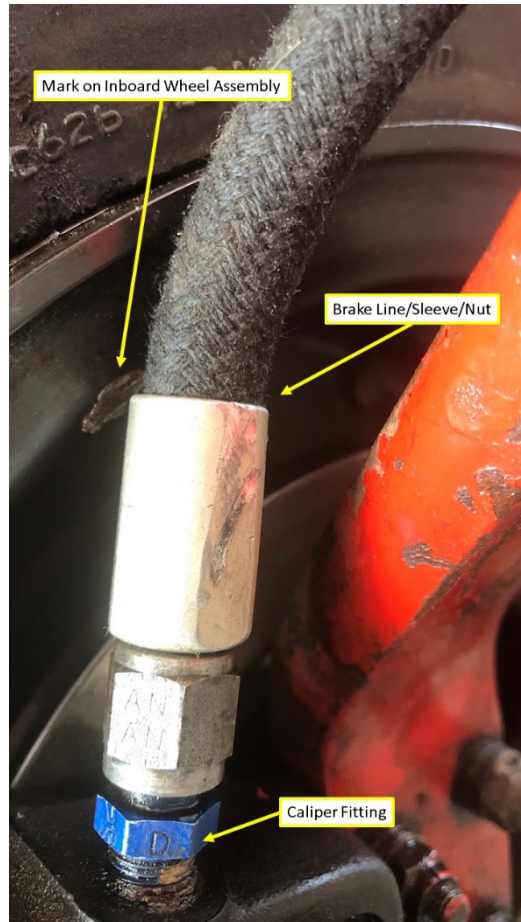
An area of scratched/displaced paint that was about 3/4 to 1 inch wide and 1/4 inch tall observed on the wheel assembly. No additional damage was noted on the inboard portion of the wheel assembly. Additional damage was observed on the inboard side of the brake line sleeve fitting, as seen in figure 2.

**Figure 2: View of the right main landing gear brake assembly.**

The brake caliper and rotor were found unremarkable. When the brake line was pulled away from the wheel assembly, the wheel rotated freely by hand and was not restricted. However, when the brake line was not pulled away from the wheel assembly, it contacted the wheel assembly and rotated slightly before it stopped.
