## **NATIONAL TRANSPORTATION SAFETY BOARD**

# **AIRFRAME AND ENGINE EXAMINATION SUMMARY**

**WPR20LA110**

Location: Pinedale, Wyoming  
Date: March 16, 2020  
Aircraft: N4837Z; Piper PA-22-108  
NTSB Investigator-in-Charge: Andrew Swick

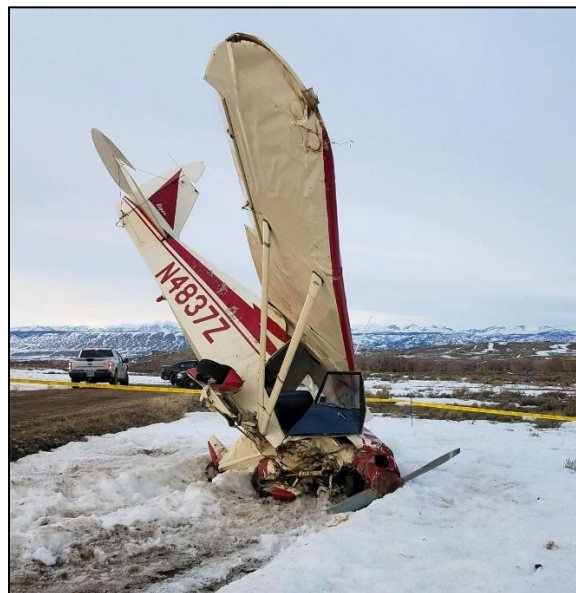
Figure 1-Accident Site

A post-accident examination of the airplane revealed damage to both wings and fuselage. The airplane was recovered to a secure location for further examination.

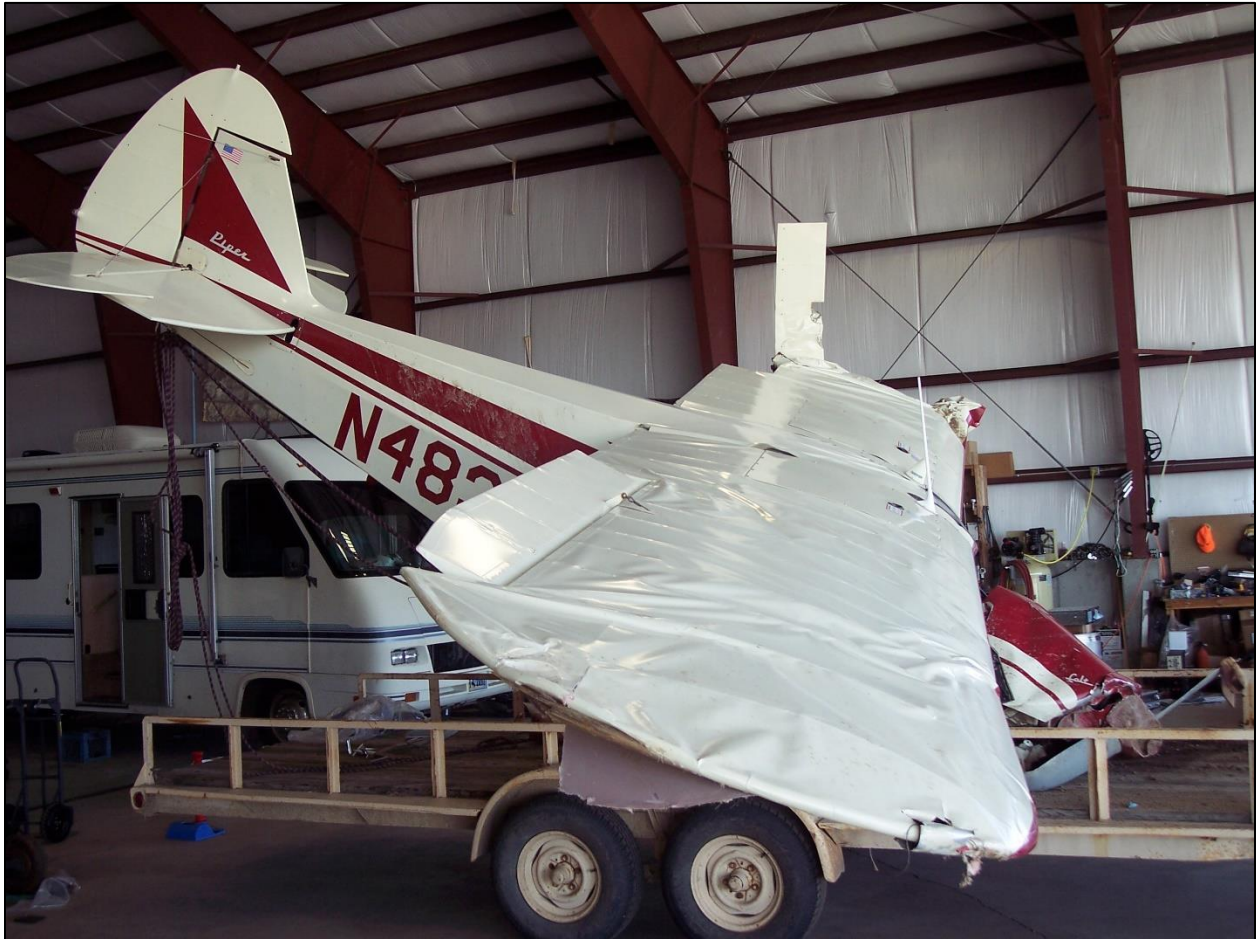
Figure 2-Follow-up Examination, Main Wreckage

The airplane was relocated to a secured location for further examination. The wings were not removed during the relocation of the wreckage. Examination of the recovered airframe revealed impact damage to both wings, fuselage and engine mount. The left wing, from the side strut to the tip was partially separated due to the impact with the ground during the accident sequence. The left main landing gear collapsed underneath the cabin area and the right main landing gear collapsed. The forward fuselage including the engine mount was crushed upwards and to the left. The engine and propeller remained partially attached to the main wreckage. The windscreen separated and was found in several pieces at the accident site. A tachometer timing box that was reportedly on the airplane during the accident, was found at the accident site which was thrown from the wreckage during the accident sequence. A portion of the instrument panel-mounted tachometer housing was found between the rudder pedal and the firewall. It was determined that the instrument panel-mounted tachometer gauge had impact damage as a result of the accident.

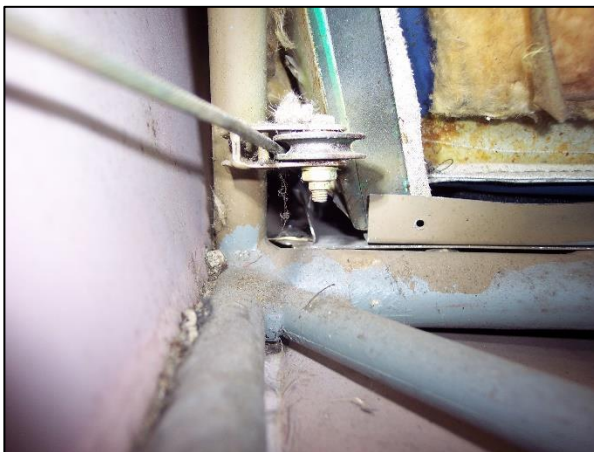
**Figure 4-Left Rudder Cable and Pulley**

According to the hired mechanic, the airplane's flight control cables were intact. The rudder cable pulleys were unable to be rotated freely by hand. The pulley showed wear in the area where the cable passes next to. The cable moved freely past the seized pulley with little resistance. During another follow-up examination on May 18, 2020, a closer look at the rudder cables revealed they were undamaged, and the pulleys were stiff when rotated by hand. The cables and pulleys were free of any binding.

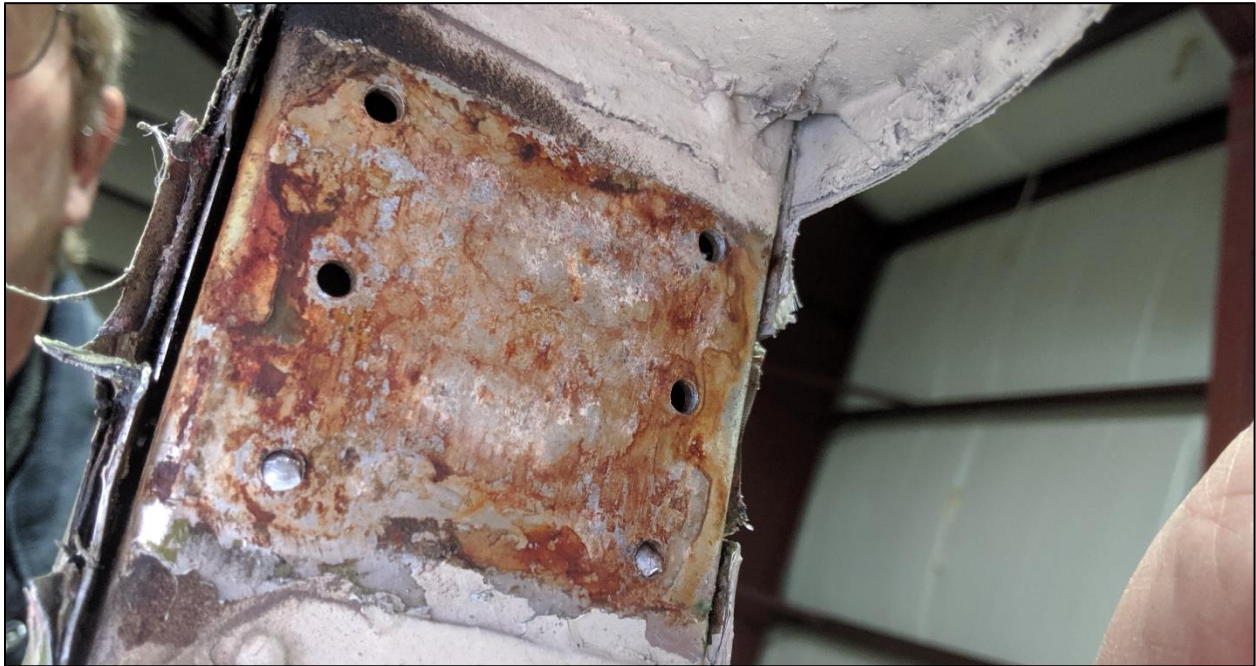
**Figure 6-Left Aileron Inboard Bracket Attachment**

The left aileron inboard attachment bracket separated from the left aileron bellcrank. Corrosion was noted between the aileron bracket and aileron bellcrank mounting surfaces. The remaining rivet material left in the aileron and bellcrank bracket exhibited overload necking signatures.
