**On Scene Photos**  
Courtesy of Local Law Enforcement

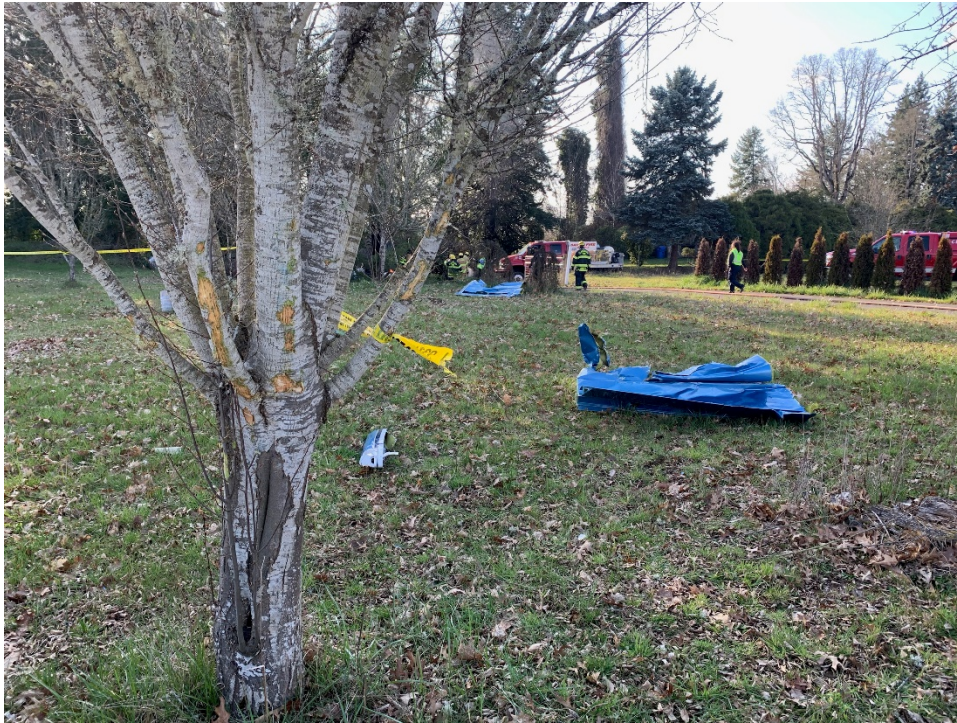
*Figure 1: Wreckage Debris Path*

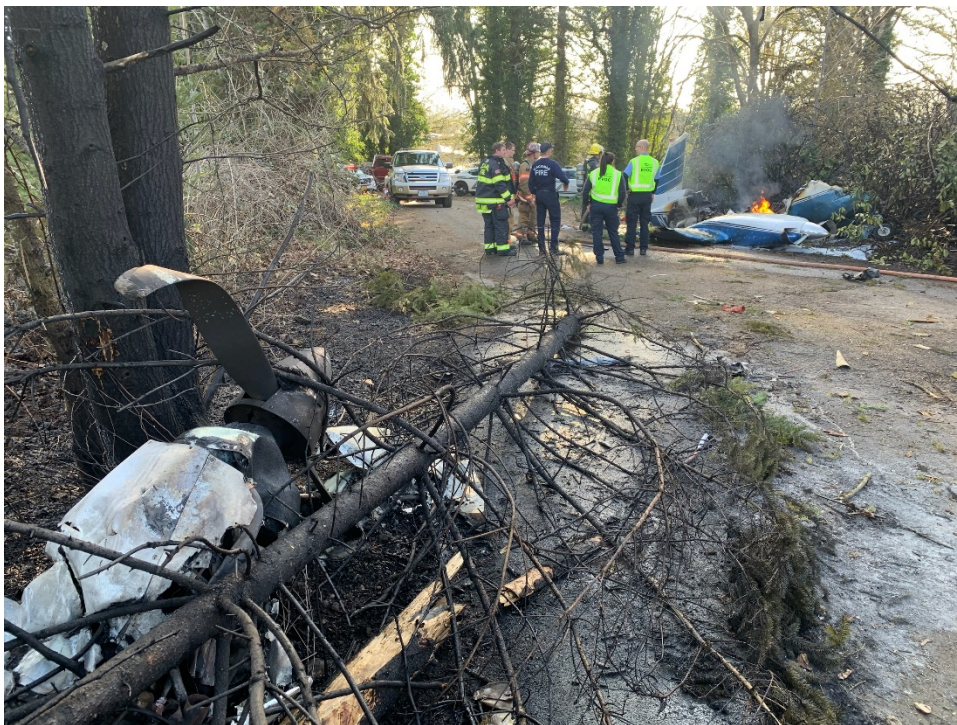
*Figure 2: Left Engine and Main Wreckage*

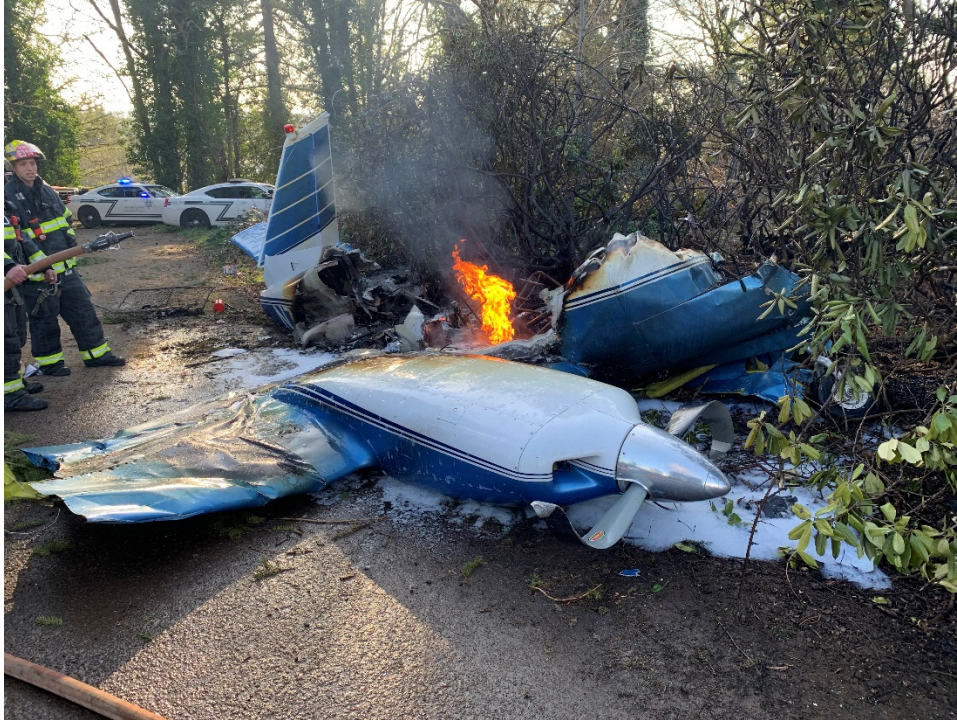
*Figure 3: Main Wreckage*

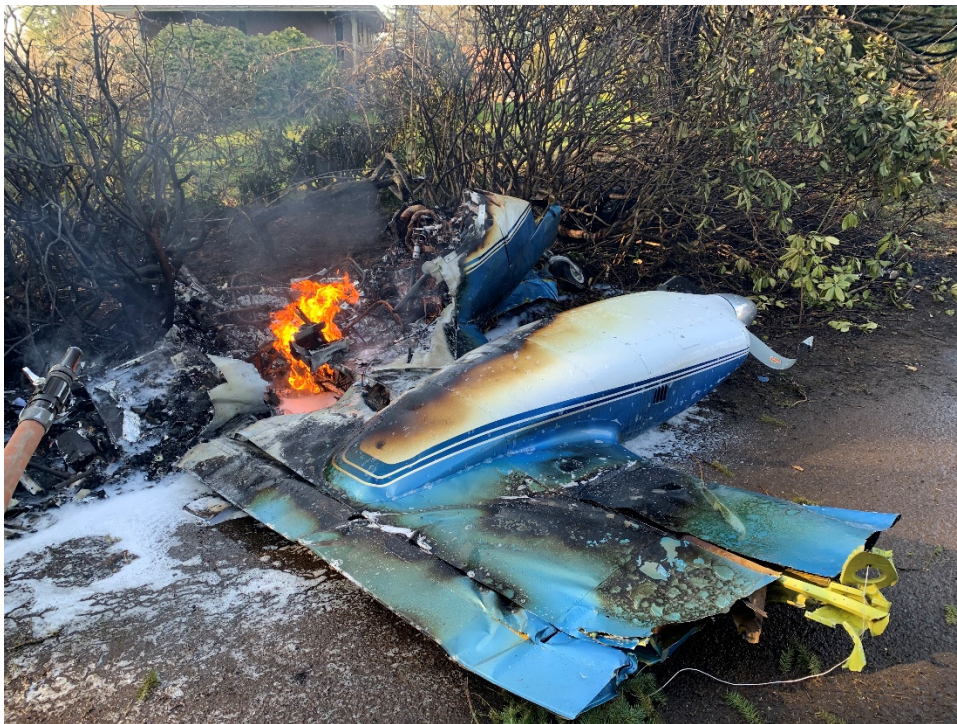
*Figure 4: The Main Wreckage was Thermally Damaged*

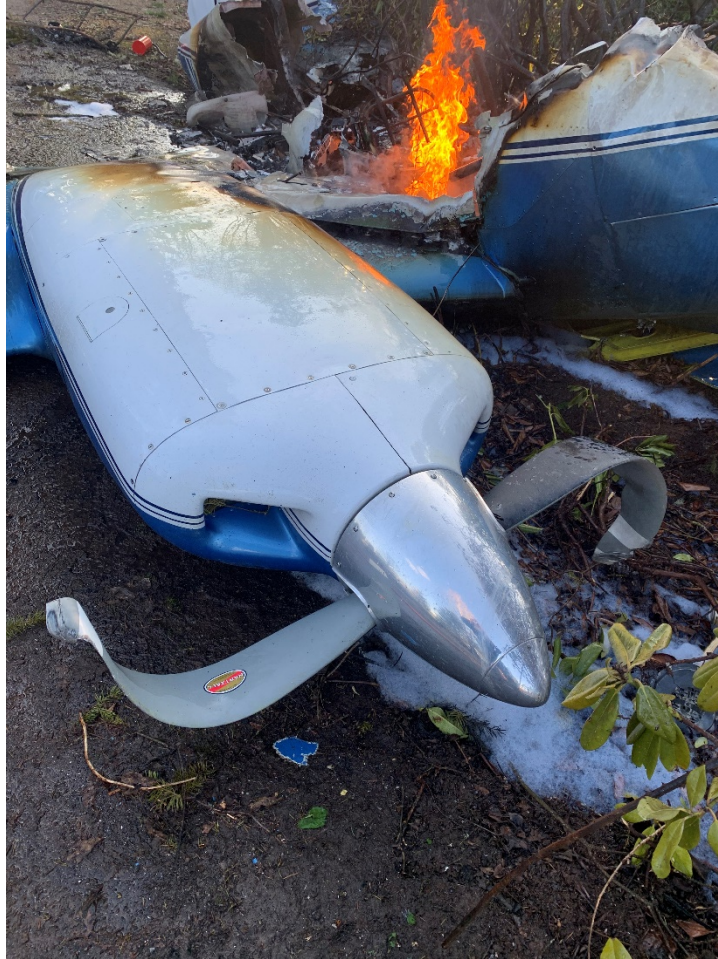
*Figure 5: Right Engine*
