## **RECORD OF CONVERSATION**

**Samantha Link**  
**Aviation Accident Investigator**  
**Western Pacific Region**

**Date: March 25, 2020**  
**Person Contacted: Mr. Jason Lawver (Federal Aviation Administration)**  
**NTSB Accident Number: WPR20LA111**

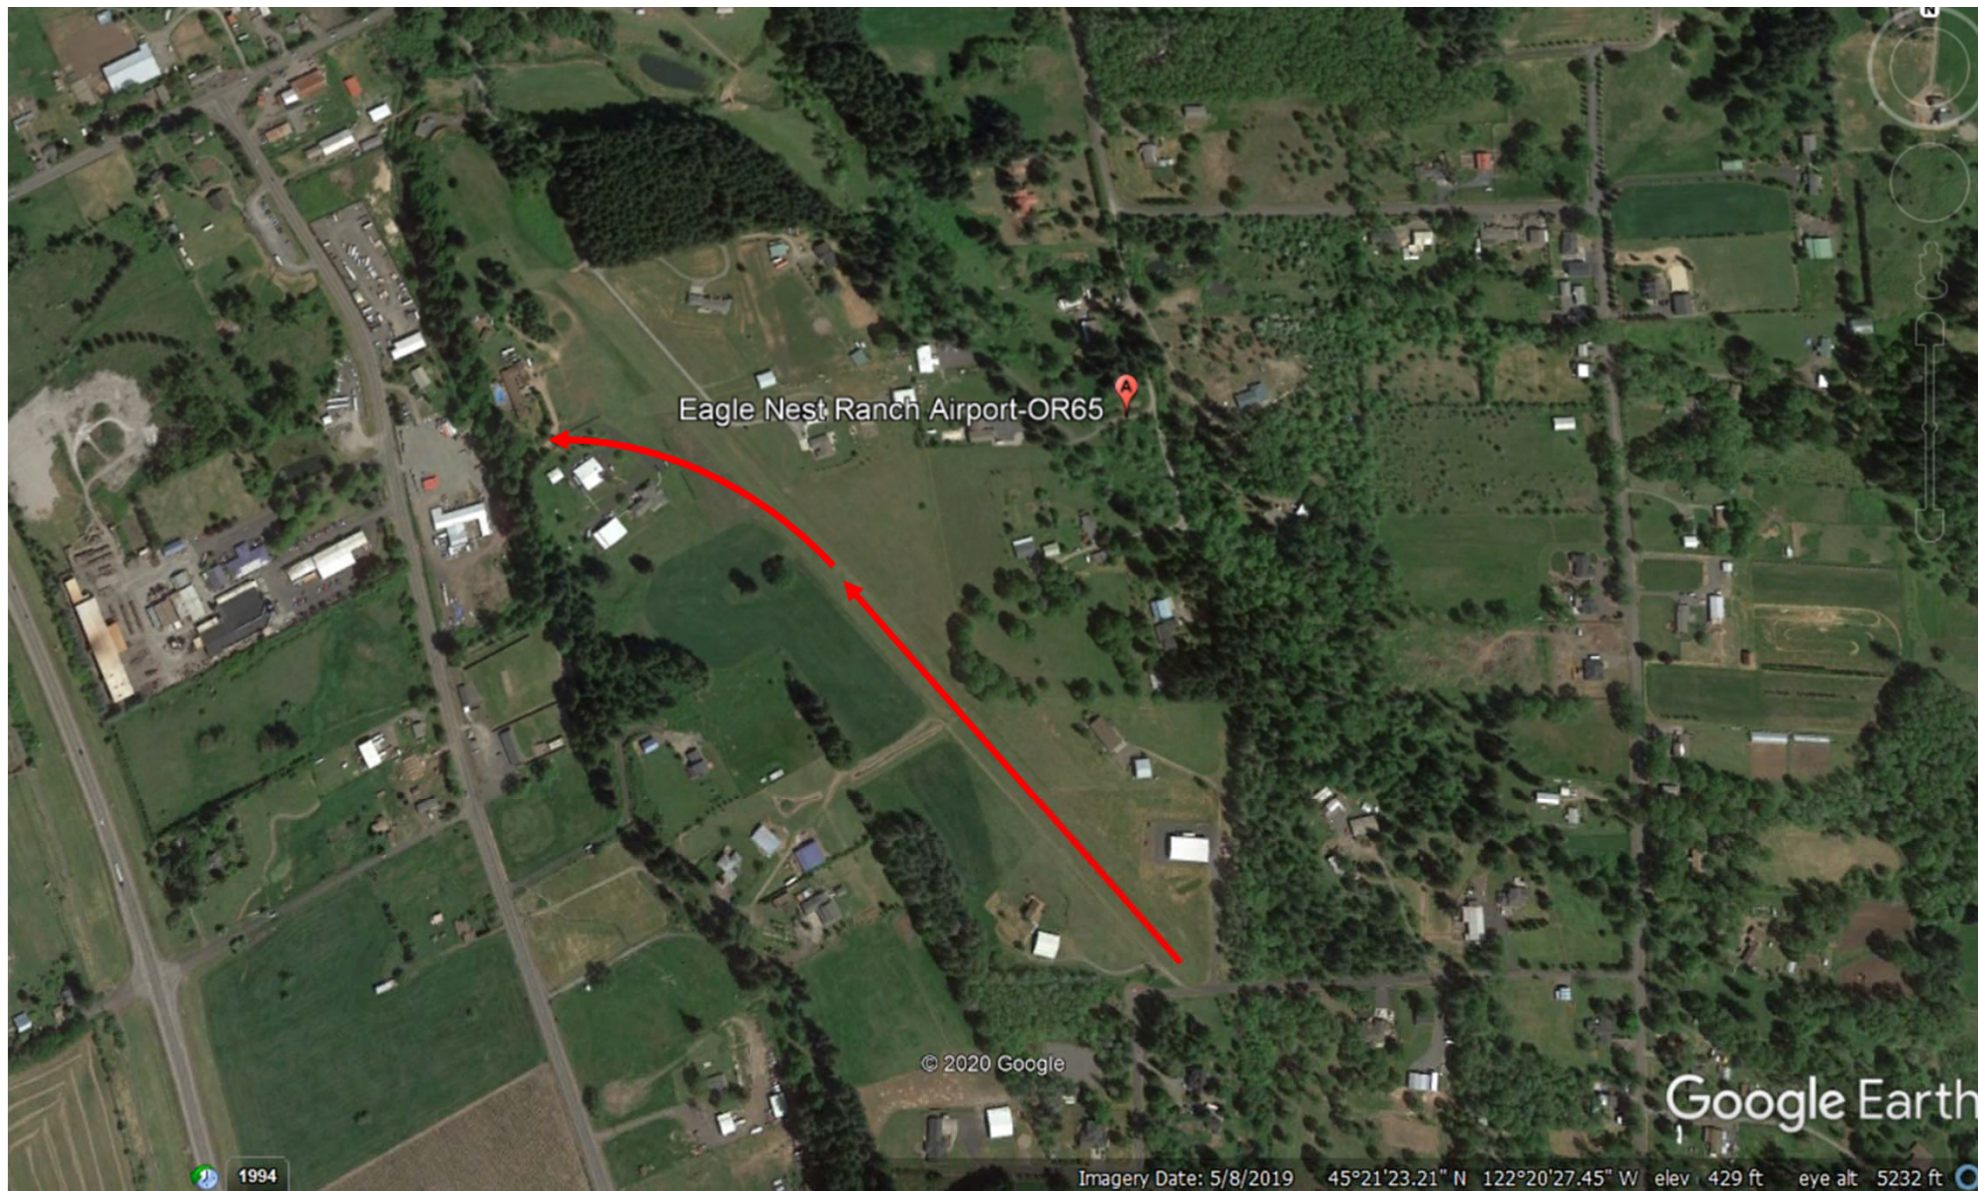
Eagle Nest Ranch Airport-OR65

On scene examination by the Federal Aviation Administration Inspector revealed the debris path was about 150 feet long. The airplane was heavily fragmented, and several portions exhibited thermal damage. The first identified point of impact was a tree located about 300 southwest of the runway. The next pieces of debris were the left wingtip, outboard left wing, and outboard right wing. Continuing along the debris path was the left engine, which came to rest against trees and a post impact fire ensued. The main wreckage was the last major piece of debris; it included the cabin, right inboard wing and right engine, and the empennage. The main wreckage exhibited extensive thermal damage from a post impact fire.
