# NATIONAL TRANSPORTATION SAFETY BOARD

## MATERIALS LABORATORY FACTUAL REPORT

Report No. 20-039

Place : Hillsboro, Oregon  
Date : April 6, 2020  
Vehicle : Robinson R44 II, N725GT  
NTSB No. : WPR20LA119  
Investigator : Maja Smith, ASI-WPR

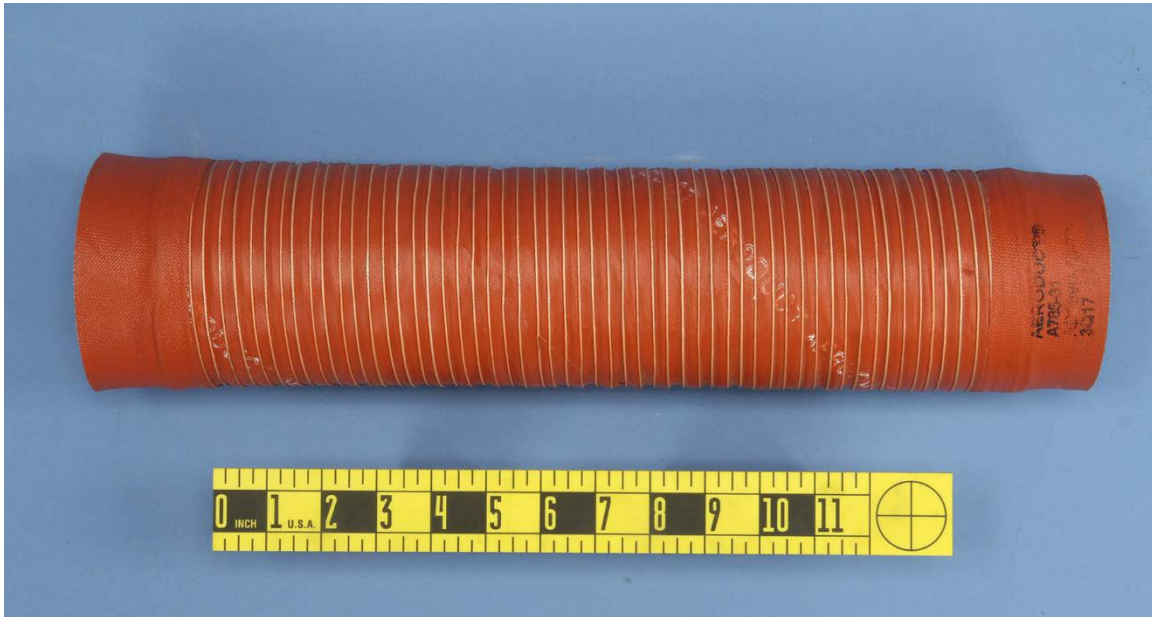
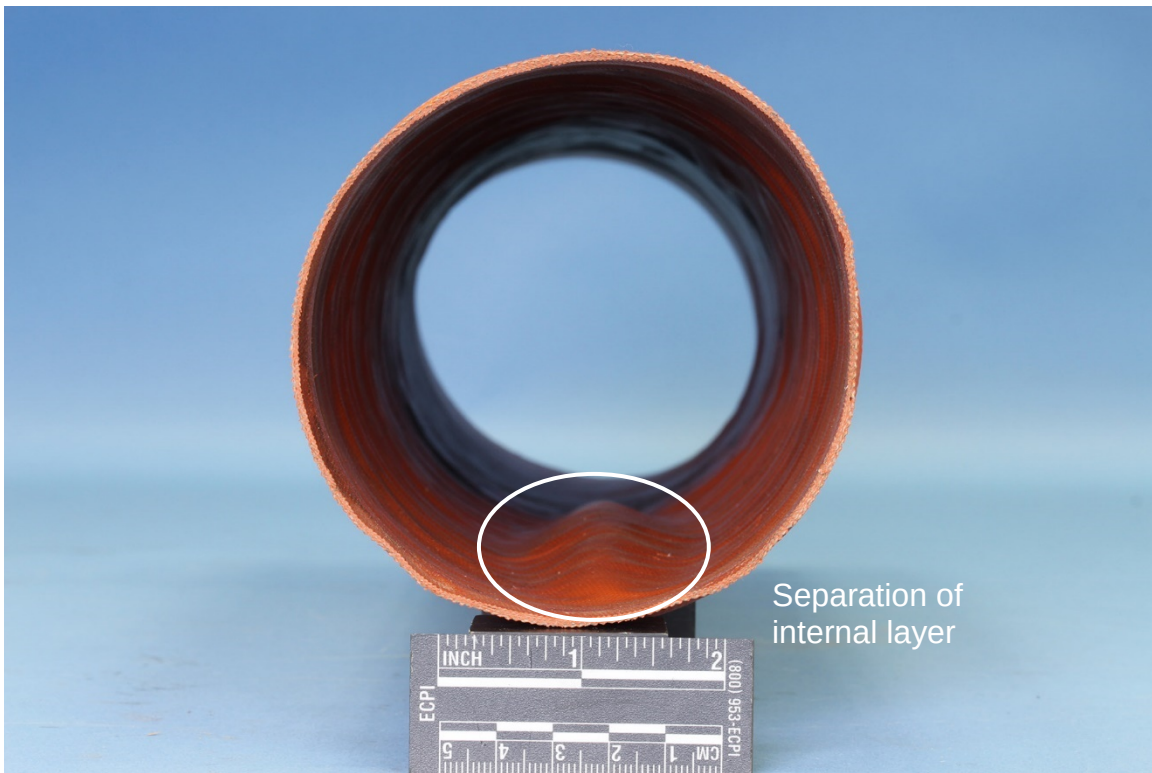
An air intake duct tube from the aircraft referenced above was sent to the NTSB Materials Laboratory for examination as shown below in figures 1a and 1b. The on-scene examination of the tube had revealed that the inner rubberized fabric liner collapsed, obstructing the interior volume of the tube. The tube was sent to Robinson Helicopters for an on-wing test to reproduce the collapse and subsequent shut down of the engine prior to being sent to the NTSB Materials Laboratory for examination.

Examination of the accident tube revealed a region where the inner layer was protruding into the internal volume of the tube, as indicated in figures 1b and 3a. The region extended approximately 8.25 inch along the length of the tube starting near the cuff on one end. Further examination revealed internal surface wrinkles and smaller unbonded regions as shown in figures 3a – 3d.

Separation of  
internal layer

**Figure 1:** Images of the air intake duct tube as received: a) side view and b) axial view.

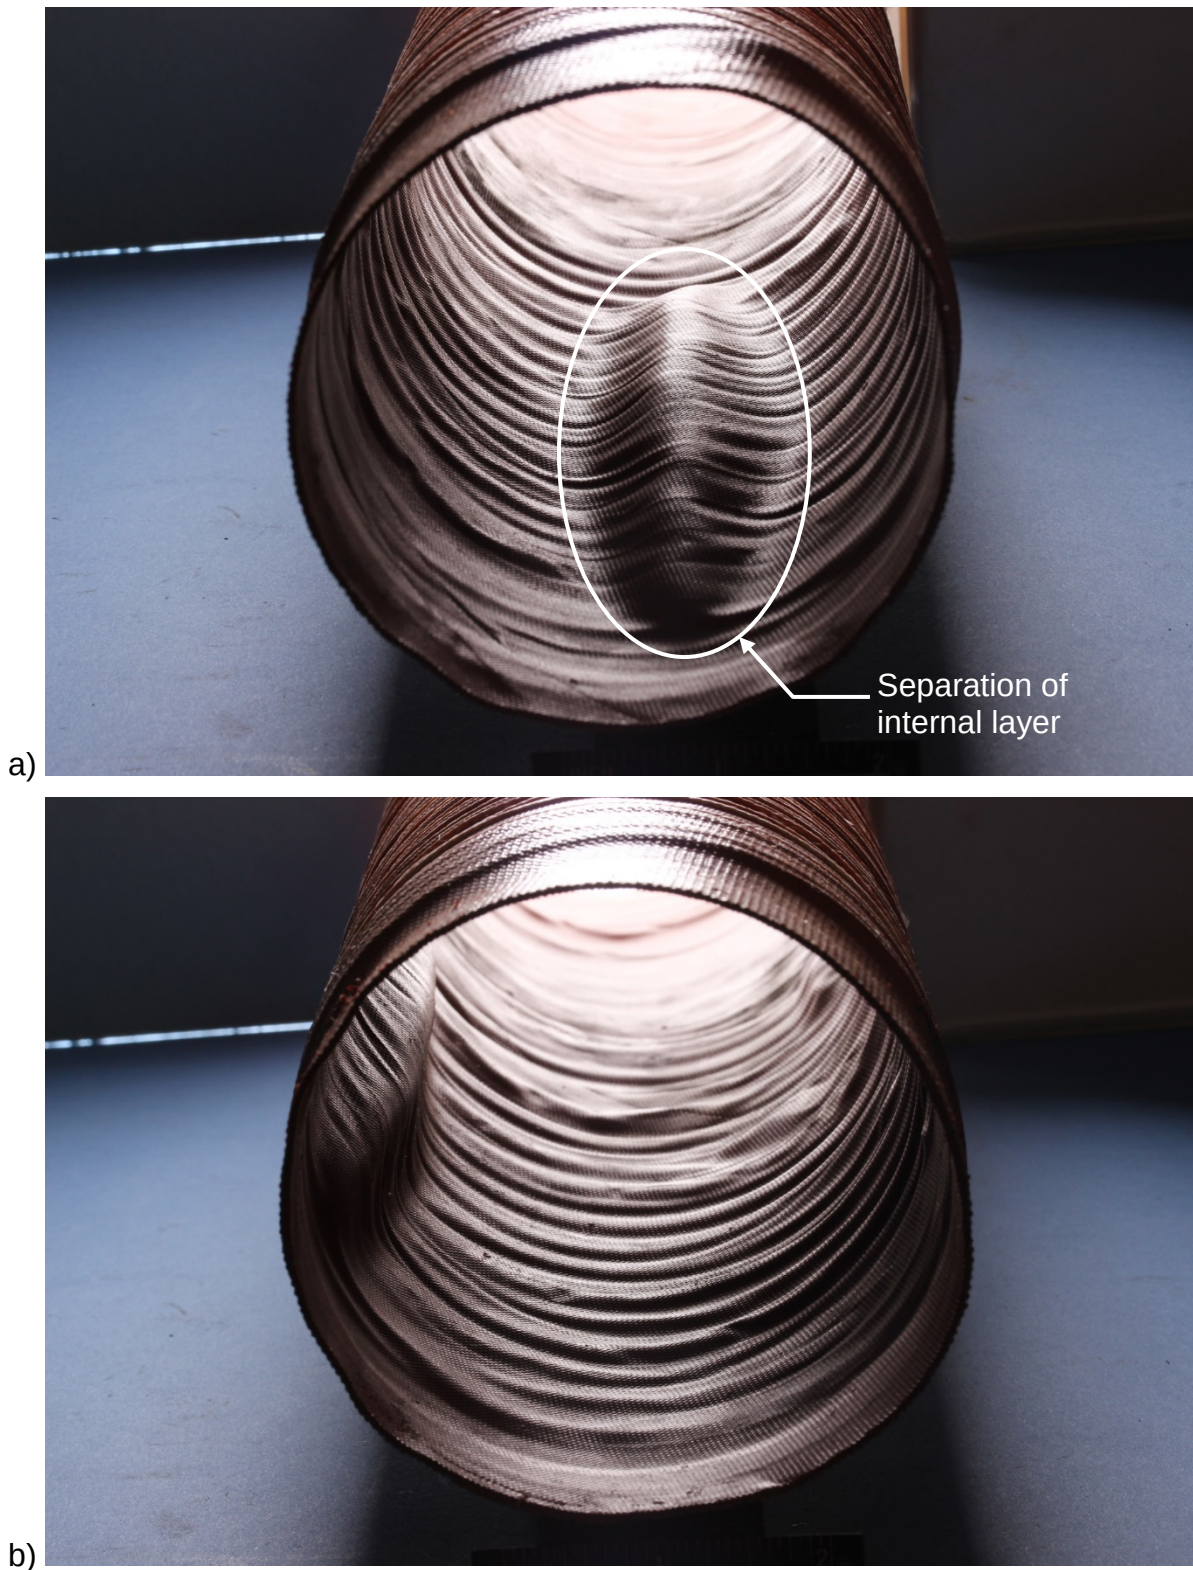
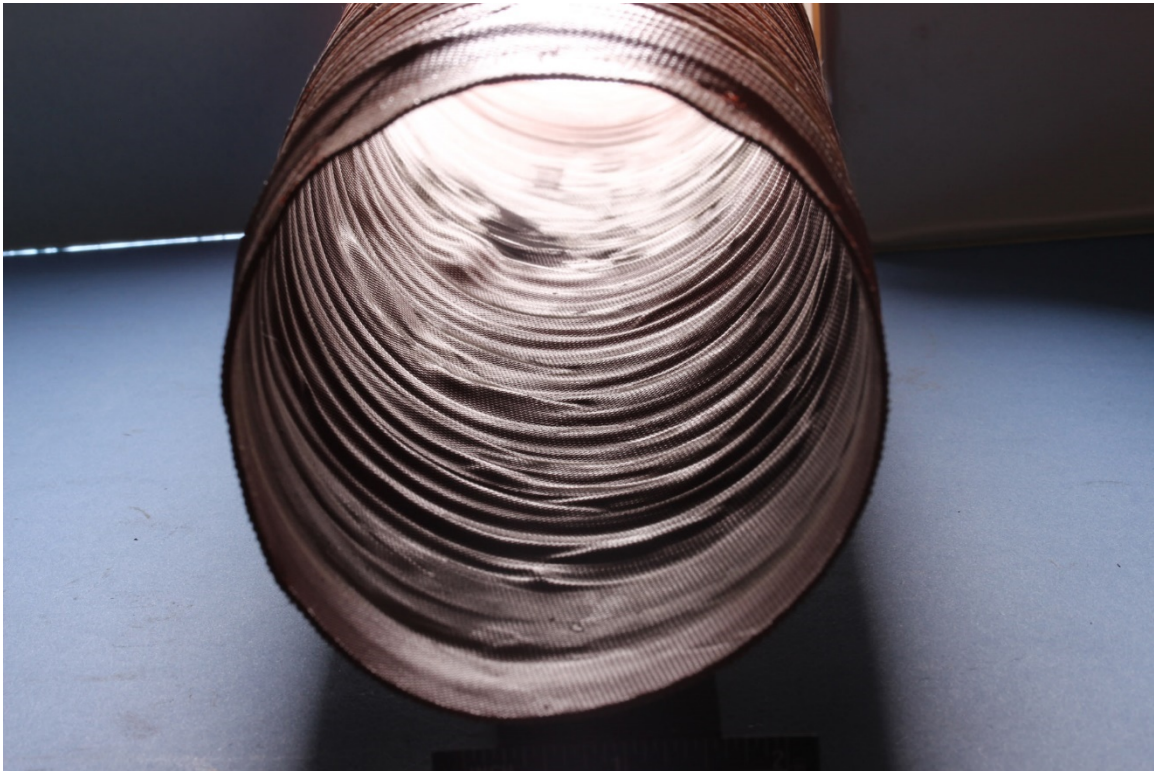
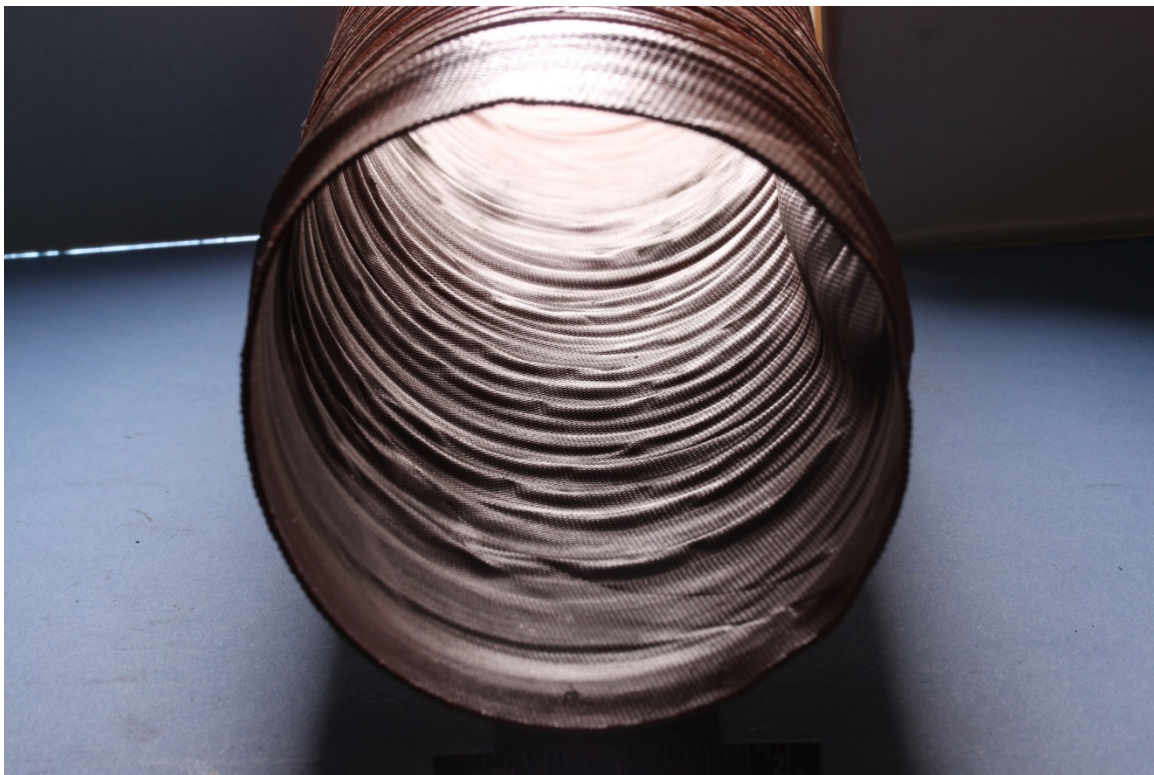
**Figure 3:** Images of the internal volume of the tube backlit to highlight separations and wrinkles: a) lower side as oriented in figure 1b; b) tube rotated clockwise 90° from part (a);

**Figure 3 (cont.):** c) tube rotated clockwise 90° from part (b); and d) tube rotated clockwise 90° from part (c).

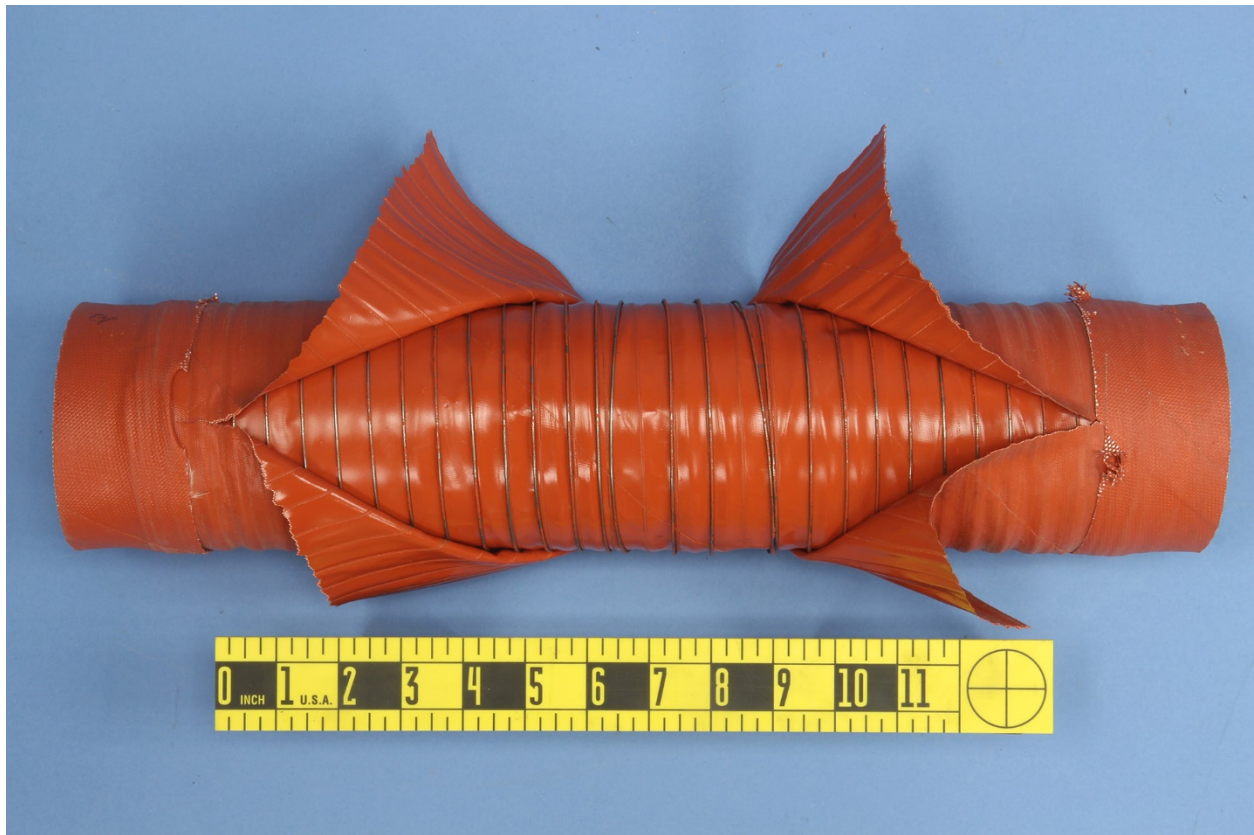
The tube was dissected to examine the condition of the internal surfaces of the inner and outer layers and the steel wire. A utility knife was used to cut the outer fiberglass cords. They were then unwound and removed from the tube. The outer layer was then cut using the utility knife, first circumferentially, and then in each longitudinal direction. The duct in its dissected condition is shown in figure 4.

**Figure 4:** Image of the duct tube after dissection.

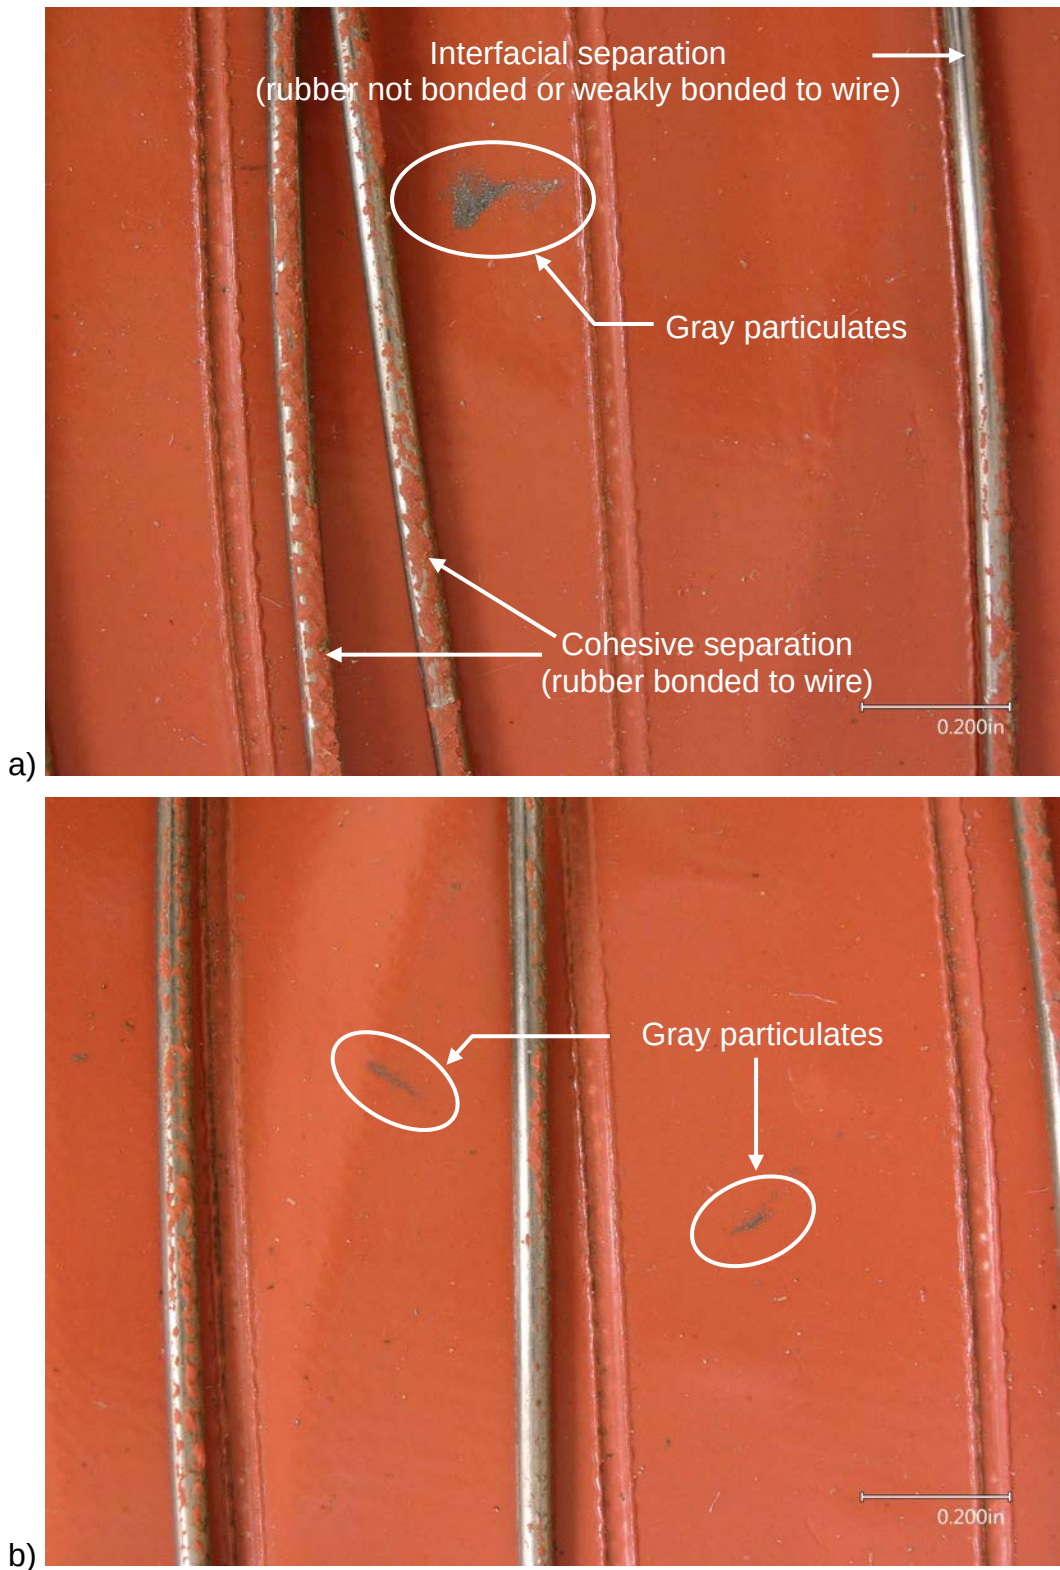
Visual examination of the internal surfaces indicated that there were few, if any, areas where the inner and outer layers had apparently co-cured to one another. As the outer layer was peeled back, it appeared to be bonded primarily to the helical wire. Examination of the exposed wire surfaces indicated that there were areas where the silicone rubber separated in a cohesive manner, leaving remnants of rubber on the wire, as indicated in the higher magnification image in figure 5a. Conversely, in some areas the separation occurred at the rubber/wire interface, consistent with either no bond or a weak bond between the rubber and the wire. The outer and inner layers had not co-cured to one another as indicated by the smooth appearance of the internal surfaces shown in figures 5a through 5c.

The inner and outer layer internal surfaces were examined with the aid of a binocular stereomicroscope and two unidentified substances were observed. One substance consisted of discrete spots of gray particulates, several examples of which are indicated in figures 5a and 5b. The spots ranged in size and aspect ratio but were on the order of 0.1 inch in the longest direction and were distributed at random across the internal surfaces. A second friable translucent substance was observed in some areas, typically in steel wire impressions in the rubber layer and adjacent tented regions, an example of which is shown in figure 5c.

**Figure 5:** Images of the inner layer internal surface and steel wire: a) indicated areas of cohesive separation where pieces of rubber remained attached to the wire, interfacial separation between rubber and wire, and a discrete area of gray particulates; b) a second image showing additional areas of particulates;

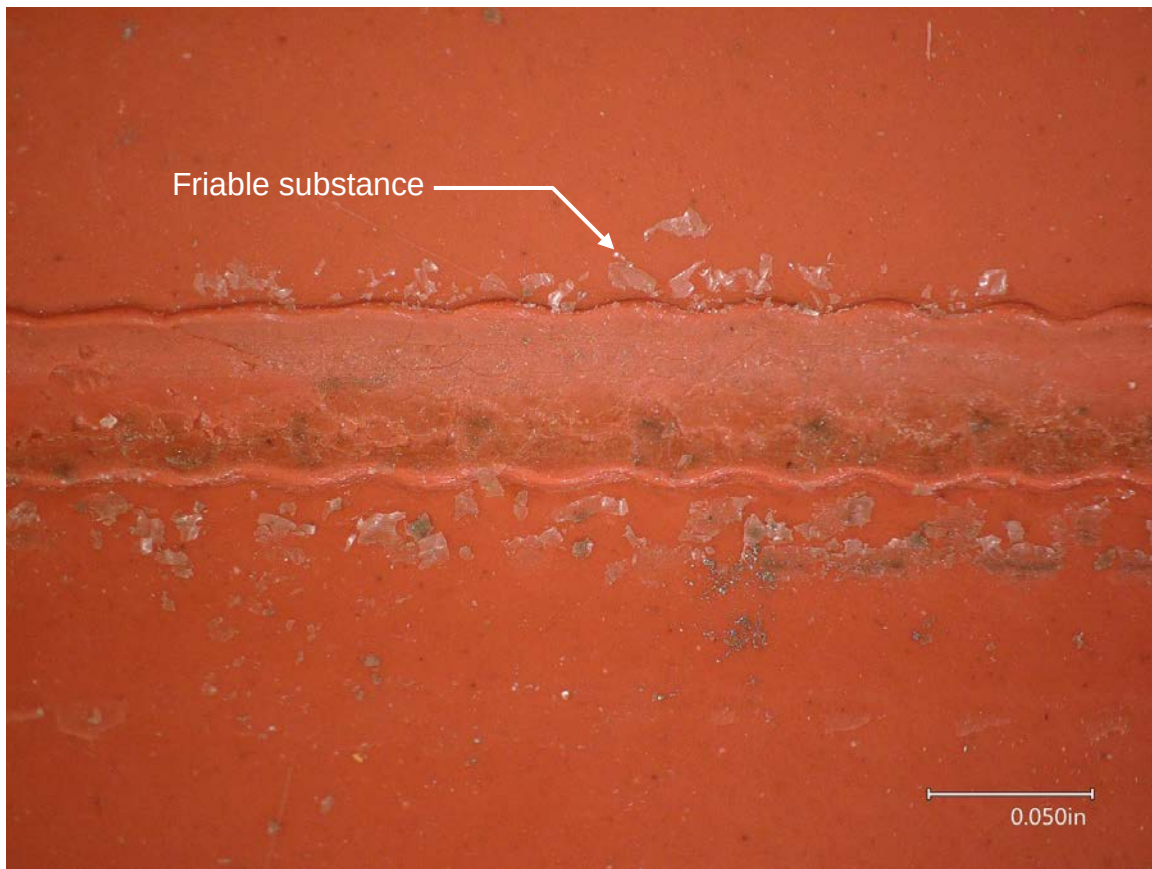
**Figure 5 (cont.):** and c) outer layer internal surface showing a friable translucent material in the wire impression and adjacent tented area.

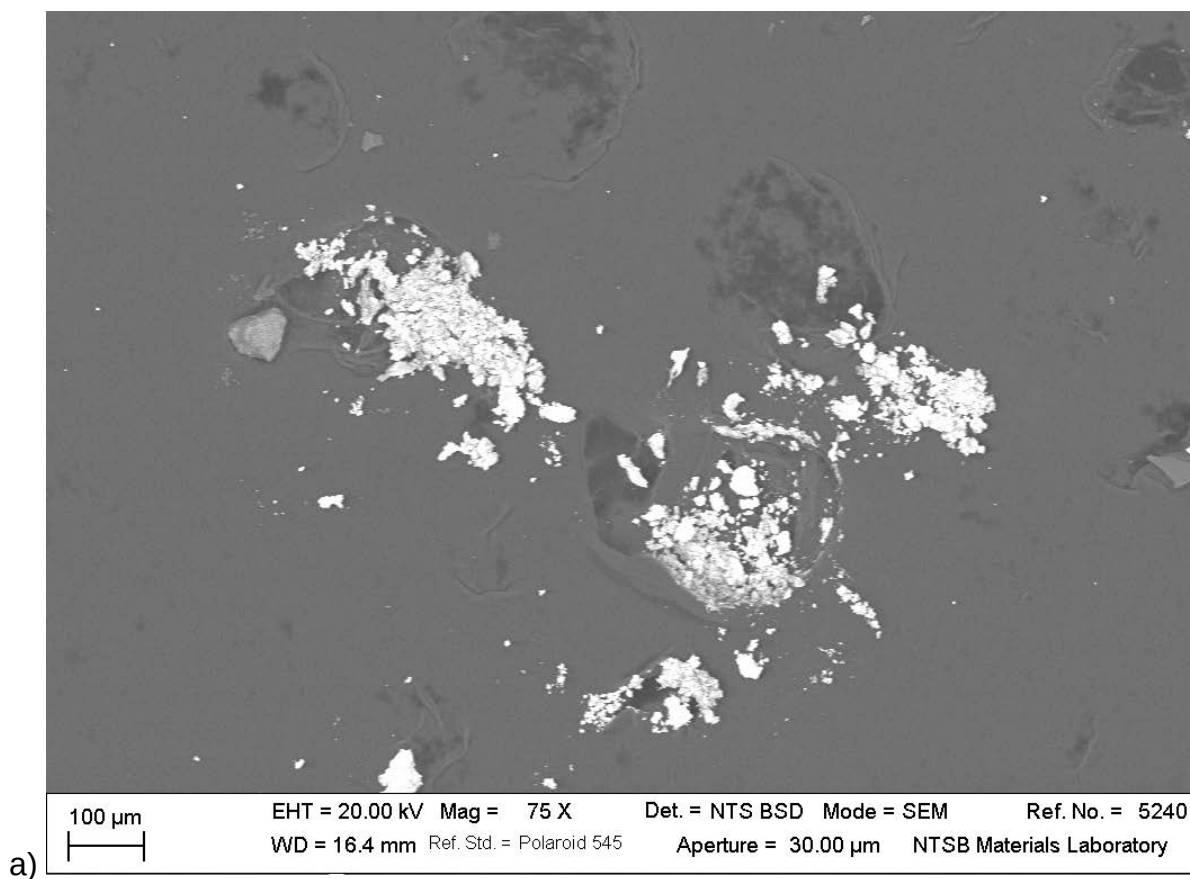
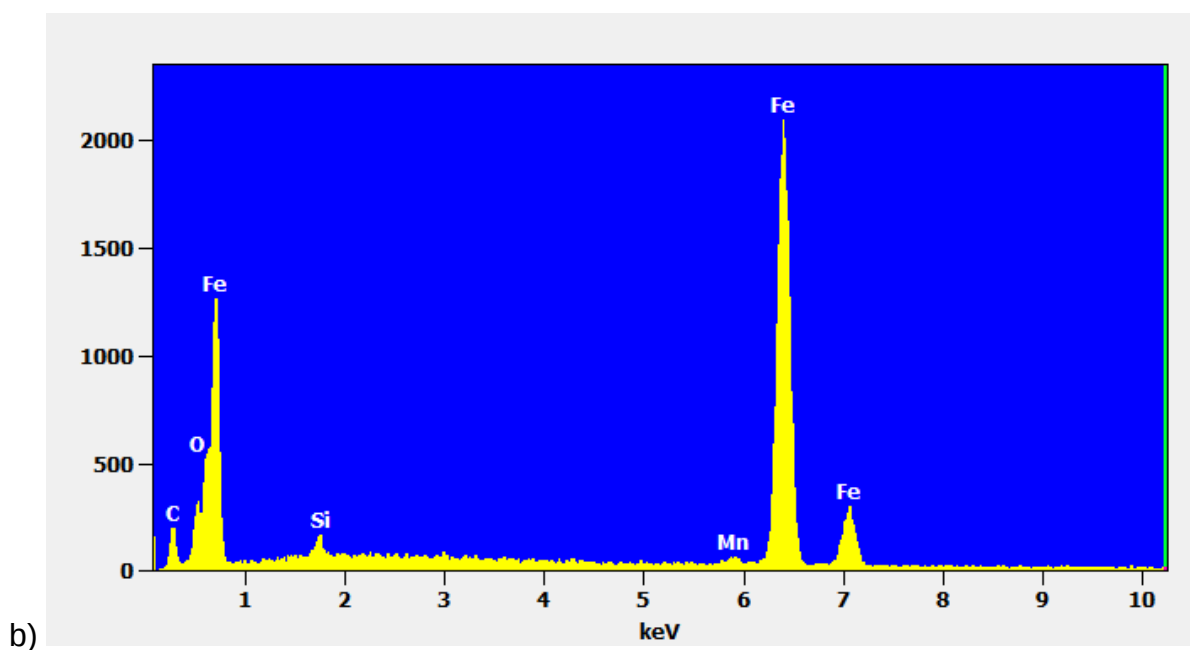
7c, respectively. The spectrum of the gray particulate sample, shown in figure 6b consisted primarily of iron (Fe) with traces of manganese (Mn), consistent with the composition of a low carbon steel. The pollutant from the interior passage of the duct exhibited two different spectra; the first spectrum, as shown in figure 7b, consisted of bromine (Br), lead (Pb), and silicon (Si). The presence of bromine and lead was consistent with engine exhaust residue. The second spectrum, as shown in figure 7c, exhibited primarily aluminum (Al), silicon (Si), and calcium (Ca) with traces of iron (Fe), consistent with primarily silicate minerals. No traces of bromine, lead, aluminum, or calcium were observed on the intralayer gray particulate sample.

**Figure 6:** a) SEM backscatter image of a sample of gray particulate residue taken from between the inner and outer layers and b) EDS spectrum of the particles indicating the presence of iron (Fe) and manganese (Mn), consistent with a low-carbon steel.

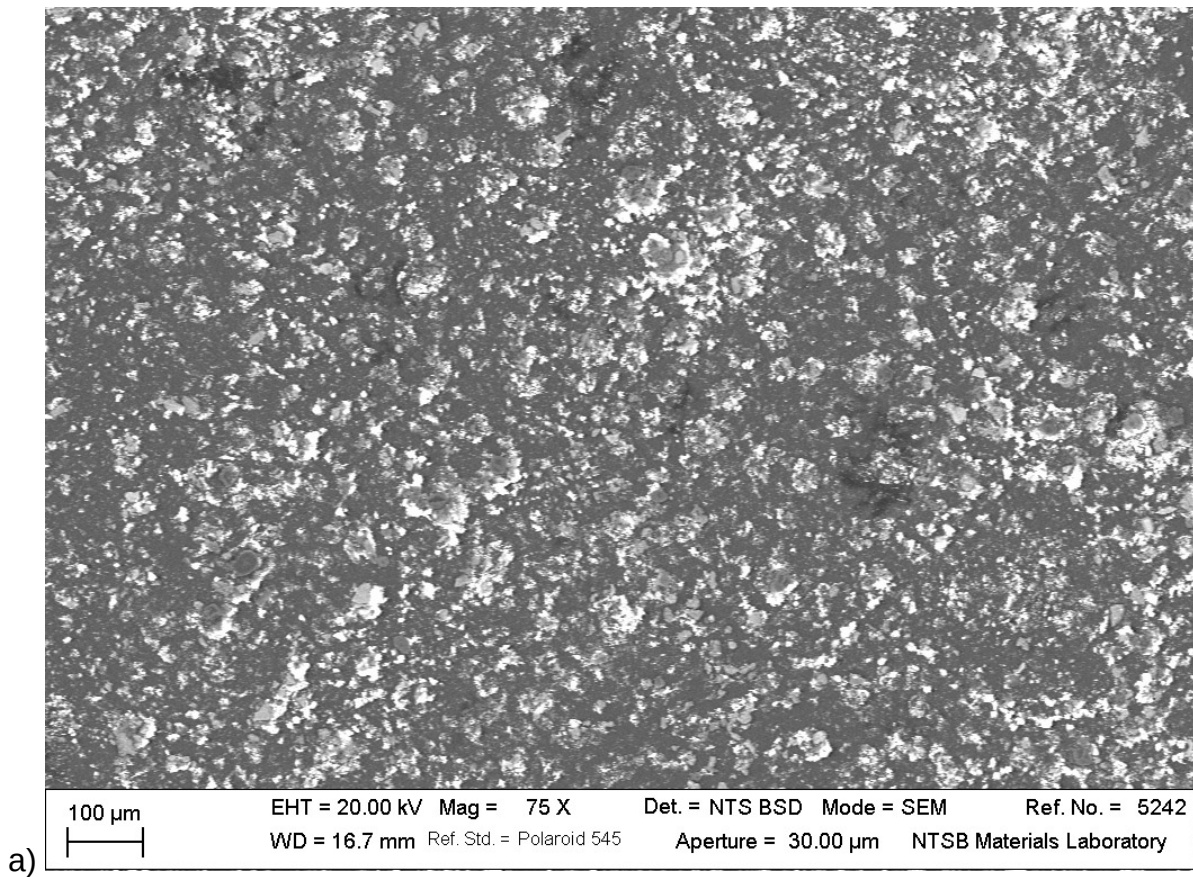
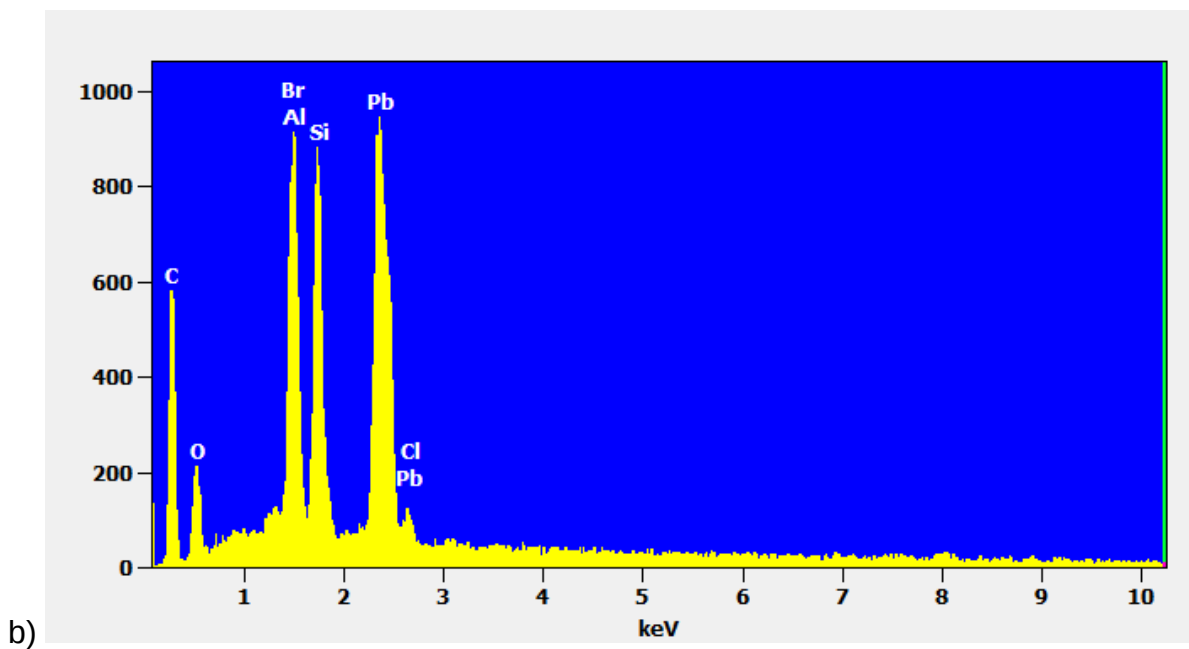
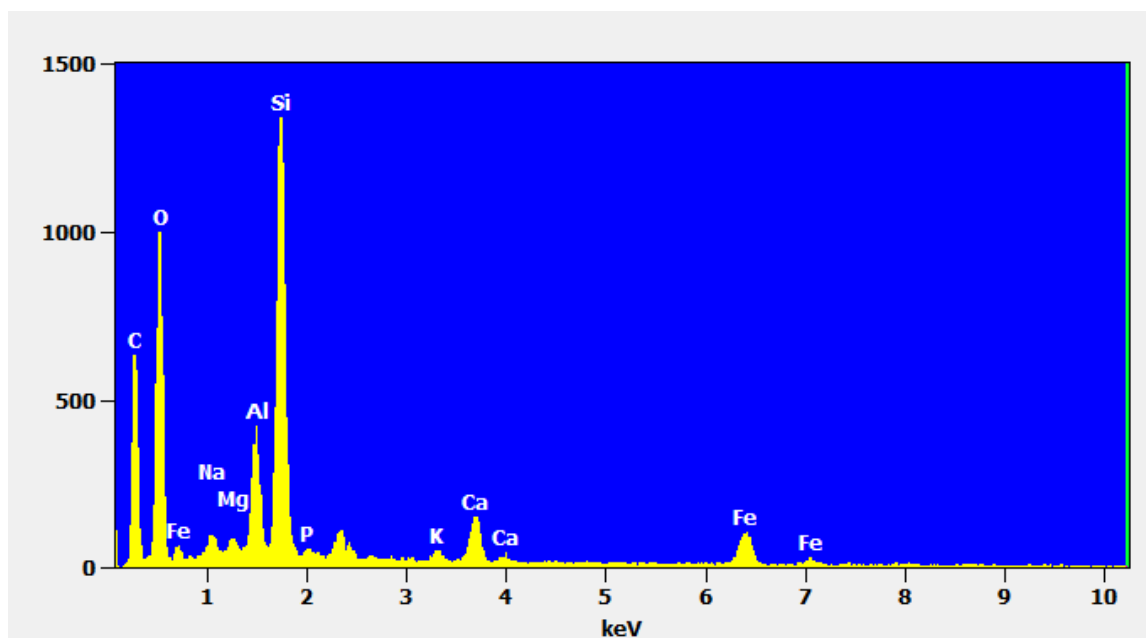
**Figure 7:** a) SEM backscatter image of a sample of pollution taken from the internal volume of the duct tube; b) EDS spectrum of one type of particle showing the presence of lead (Pb), bromine, (Br), aluminum (Al), and silicon (Si);

**Figure 7 (cont.):** and c) EDS spectrum of a second type of particle showing primarily the presence of aluminum (Al), silicon (Si), and calcium (Ca) with traces of iron (Fe).

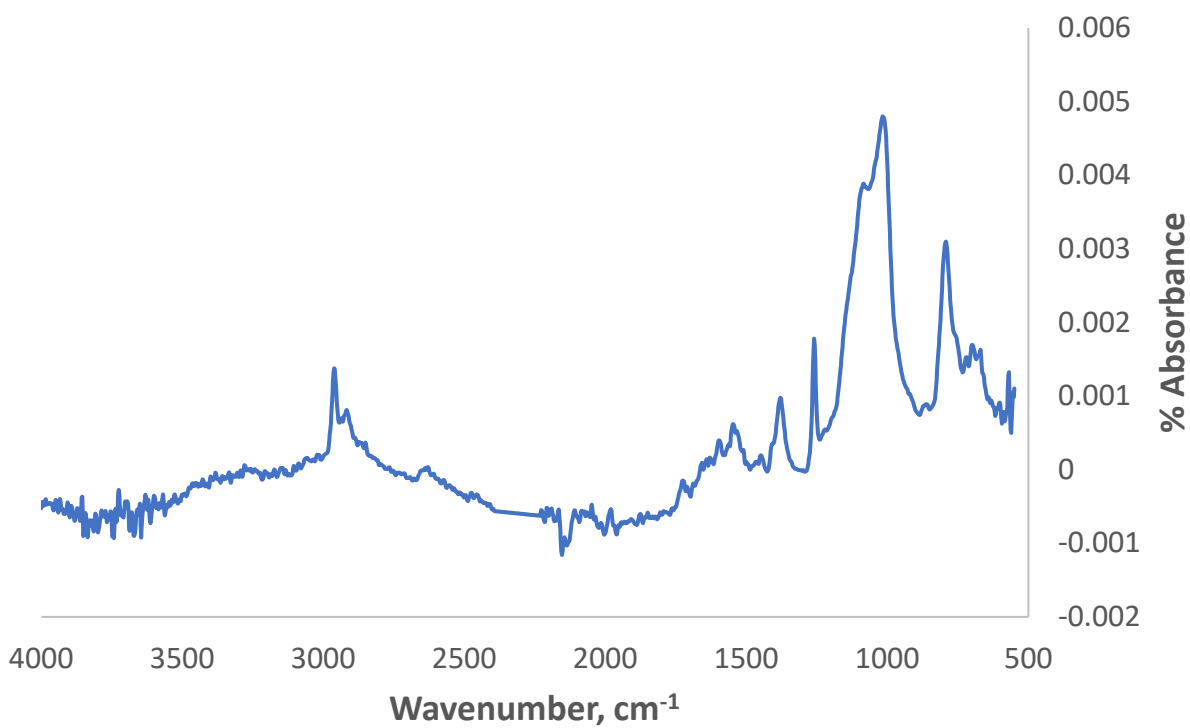
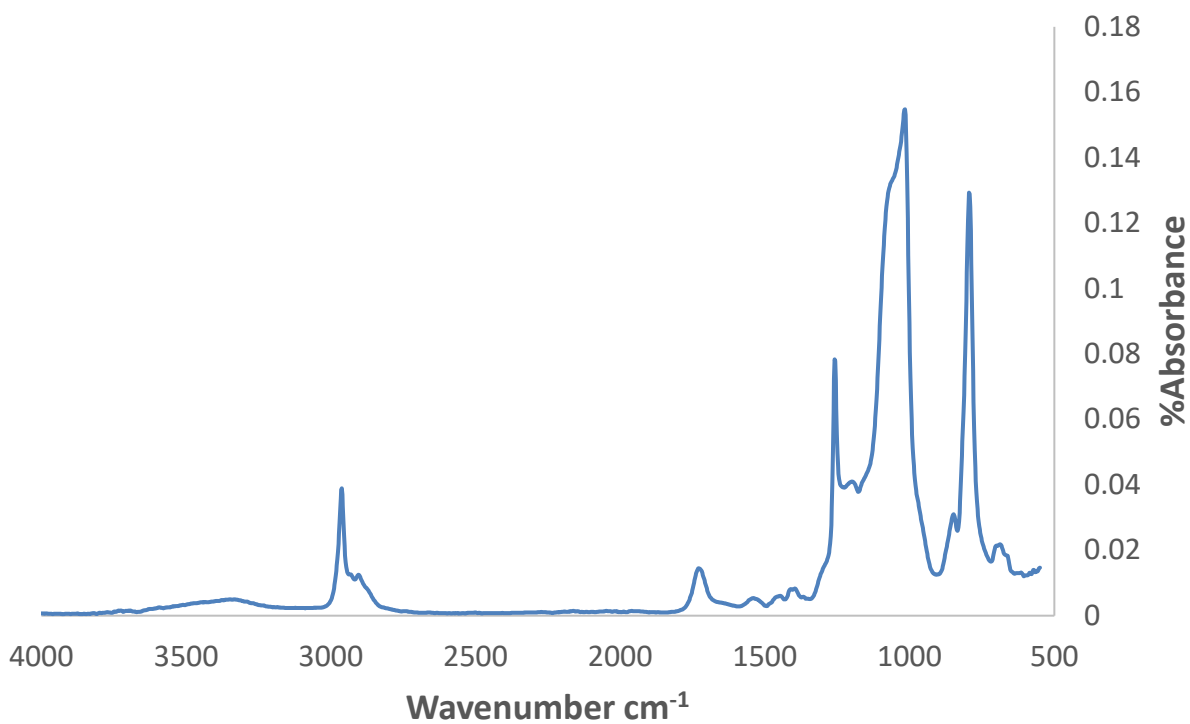
The friable translucent material was analyzed using Fourier-transform infrared spectroscopy (FTIR) on an attenuated total reflectance (ATR) bench accessory equipped with a single bounce diamond/ZnSe crystal. A metal blade was used to lift a sample of the translucent material from the rubber and transfer it to the crystal. The absorbance spectrum for the unknown substance is shown in figure 8a.<sup>1</sup> The spectrum was similar to that of a water-based mold release agent used by the manufacturer, as shown in figure 8b (NTSB, 2019). A spectral search using an online library of reference spectra returned matches for silicone-based materials.

**Figure 8:** FTIR/ATR spectra as follows: a) friable residue from accident duct and b) a sample of a water-based mold release agent used by the duct tube manufacturer.
