## N2112A Lycoming Field Notes

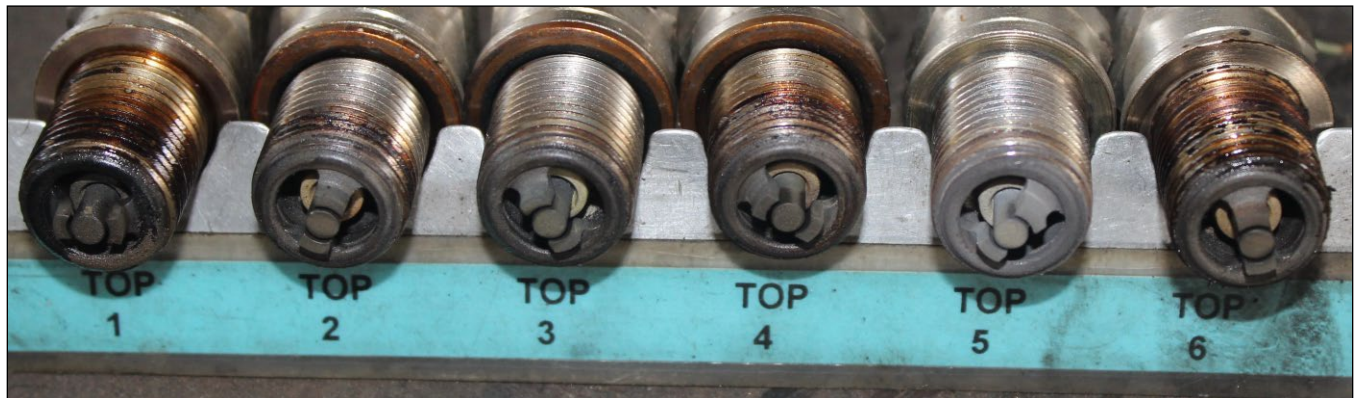
The spark plugs were secure at each position with their respective spark plug lead attached. The spark plugs were removed, examined and photographed. The spark plugs electrodes remained mechanically undamaged, and according to the Champion Spark Plugs Check-A-Plug chart AV-27, the spark plugs electrodes displayed coloration consistent with normal operation.

The top spark plugs were removed, examined and photographed.
