## RECORD OF CONVERSATION

**Date: April 22, 2020**  
**Person Contacted: Ms. Maria LeBlanc (Federal Aviation Administration)**  
**NTSB Accident Number: WPR20LA126**

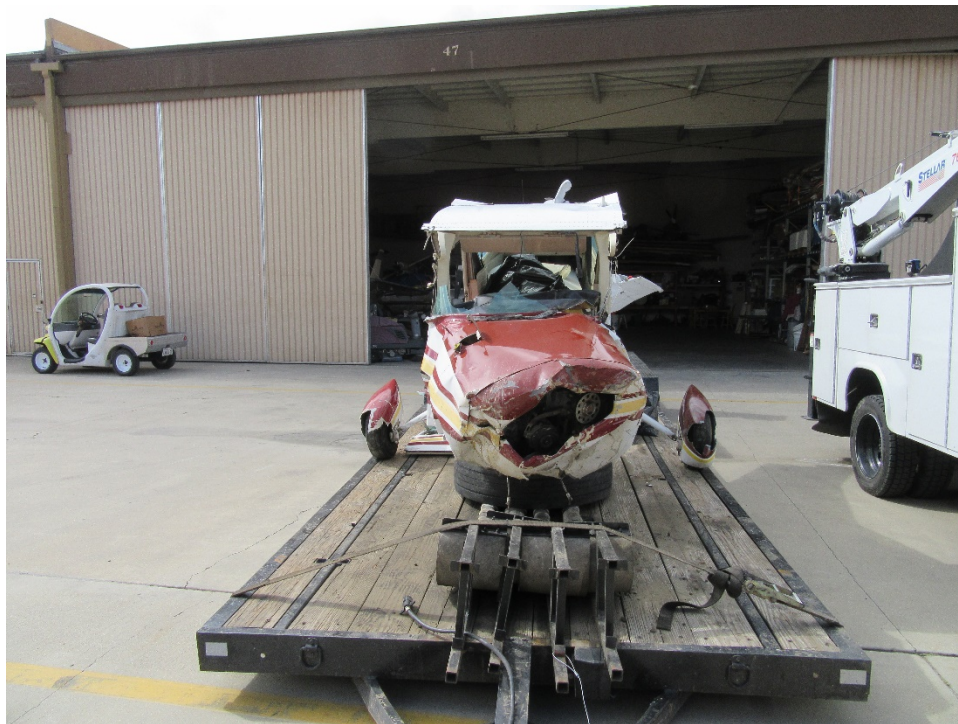
*Figure 1: Front of Airplane*

- Ms. LeBlanc went on scene and the first identified point of impact was a fence on top of a berm, followed by a fence lower on the berm, and then the roadway below. The airplane impacted the roadway nose low and the propeller and spinner were fracture separated. The airplane came to rest inverted. The engine and instrument panel were pushed up and aft into the cabin area. The wings and empennage exhibited extensive damage.

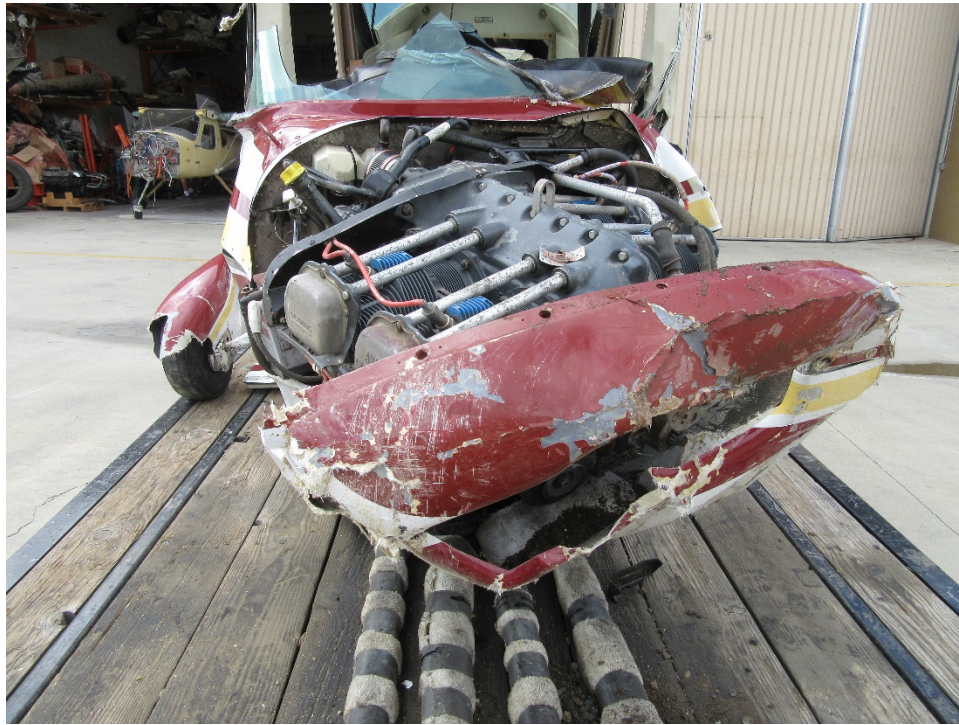
*Figure 2: Engine*

- o The airplane had 4.5 quarts of oil.
- Ms. LeBlanc went to the recovery facility on April 21, 2020 to conduct an examination of the airplane.
  - o The engine was bent aft and to the left about 30 degrees. It was removed from the airframe, there were no obvious signs of catastrophic mechanical failure.

- o The spark plugs were removed and were consistent with normal operations. The #3 cylinder spark plugs were oily.
  - o The engine was rotated, and thumb compression was established on all cylinders.

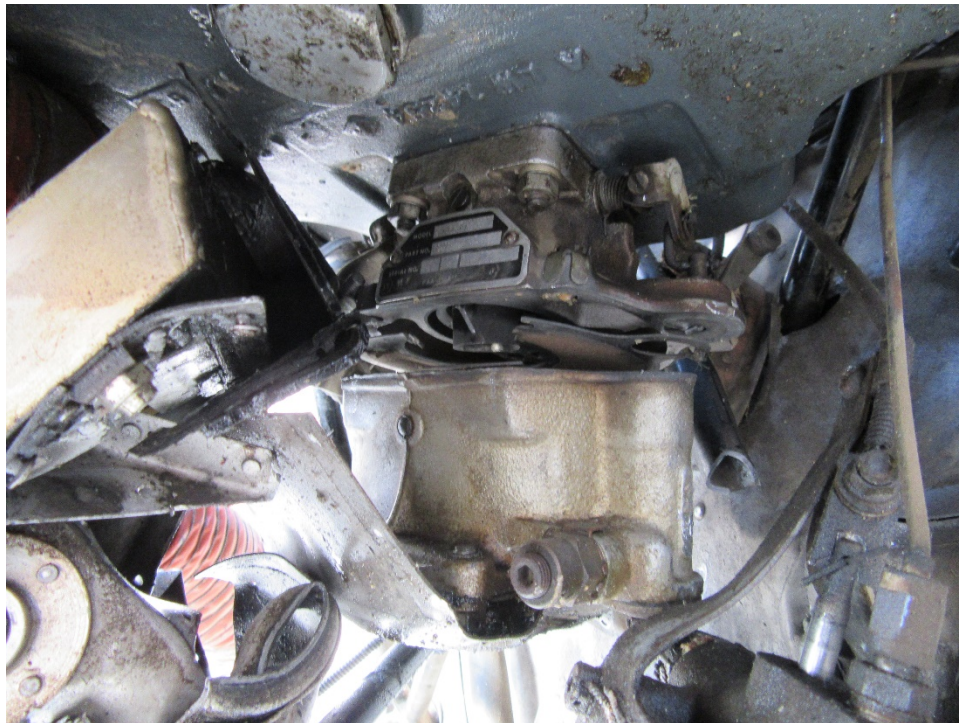
*Figure 3:Carburetor*

- o The magnetos were tested, and spark was obtained on all leads.
  - It was noted that the magnetos were quite new.
- o The carburetor bowl was found mostly fracture separated and was removed from the engine.

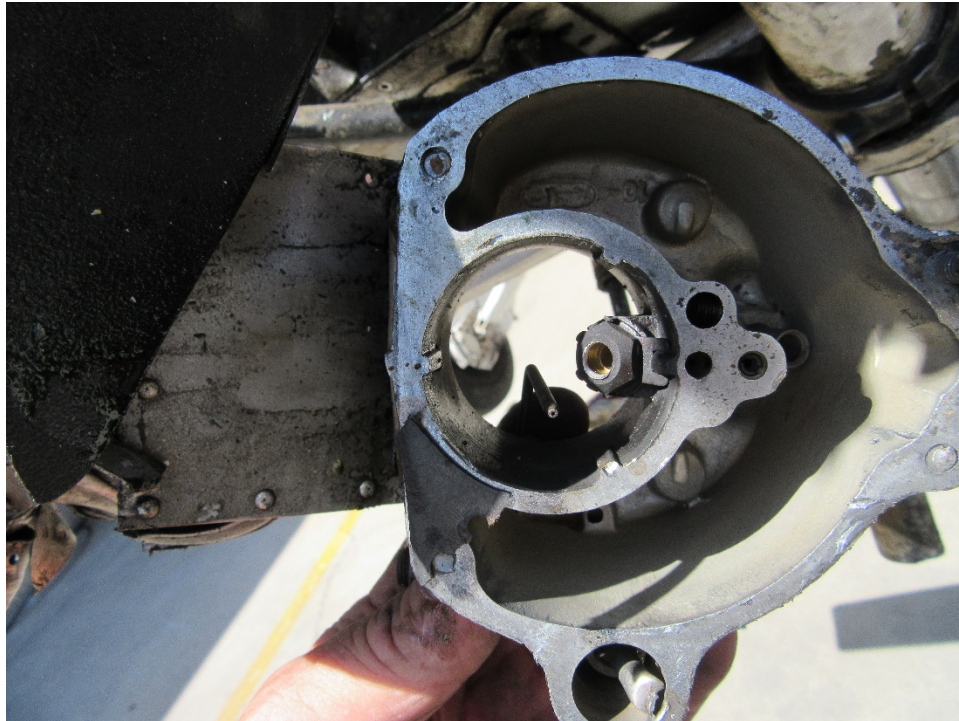
*Figure 4: Carburetor Bowl*

- The bowl was empty, and the floats were clear of liquid. There was no obvious distortion of the floats.
- o The fuel strainer exhibited corrosion on the top, and about a thimble of water was observed within the bowl.

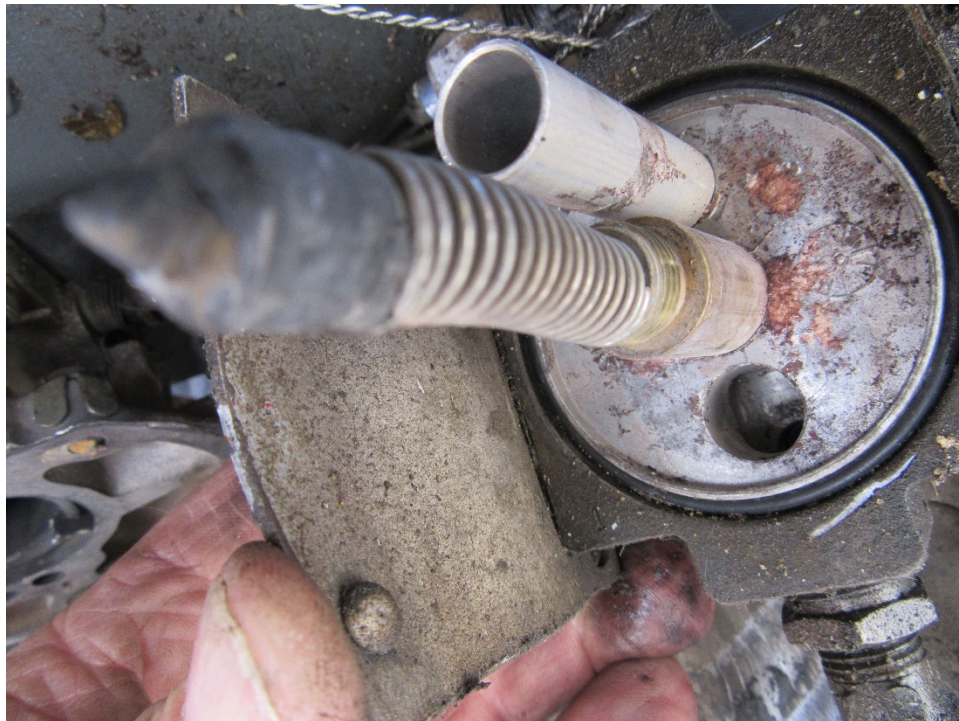
*Figure 5: Fuel Strainer*

- o If he had to guess, he would think the engine quit because of water in the fuel system.
  - o The airplane is not hangered and there has been a lot of rain in the area lately. On the previous flight he found water in the fuel tanks and the carburetor. Since he does not remember the accident flight, he does not recall if he drained the fuel tanks or not.
