**Date of Accident:** April 20, 2020

**NTSB File No.:** WPR20LA128

**Aircraft:** Piper PA-31T1 Cheyenne

**PROPELLER TEARDOWN REPORT**

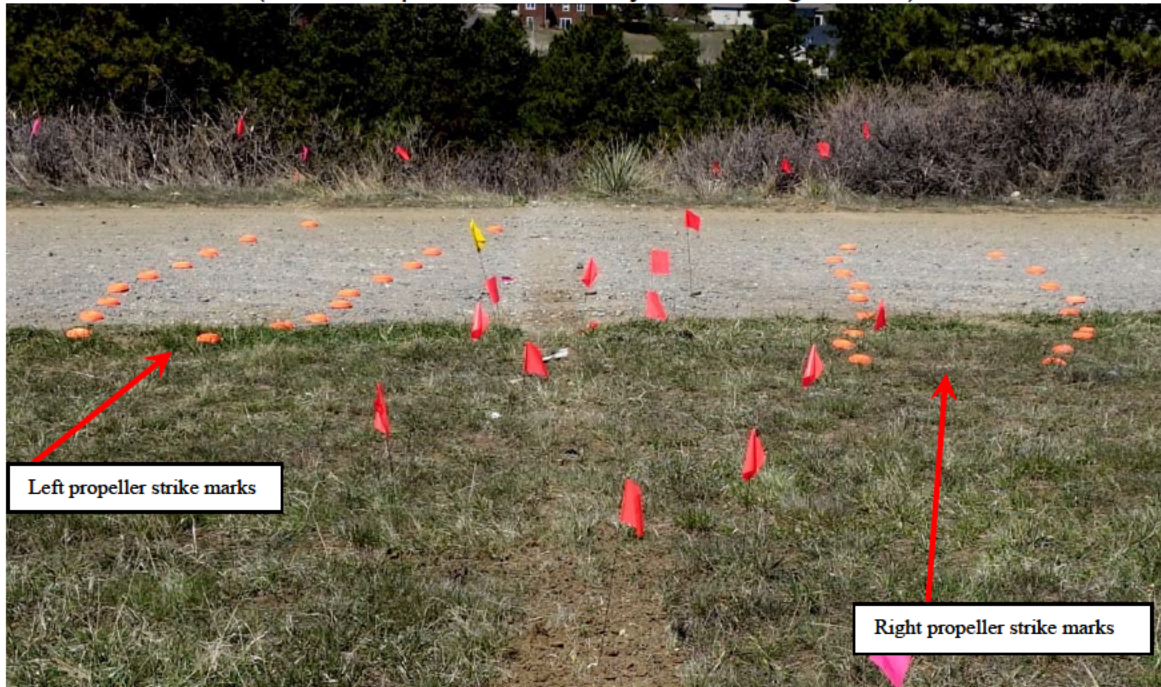
*Ground scars found near the top of a coulee consisted of the airplane's fuselage impact mark and symmetrical propeller strikes consistent with the airplane impacting the ground in a shallow, nose-up, wings-level attitude. The airplane then continued over the coulee about 410 ft, and about 75 ft down before impacting the side of the coulee where a postimpact fire ensued. All major structural components of the airplane were located within the debris field."*

As stated in the NTSB Preliminary Report, there were somewhat symmetrical propeller strike marks in the dry, hard-pack soil and gravel road at the initial point of impact (Photo #1).

Photo #1 – Symmetrical propeller strike marks – Piper ASI Photo  
(strike end points identified by small orange cones)

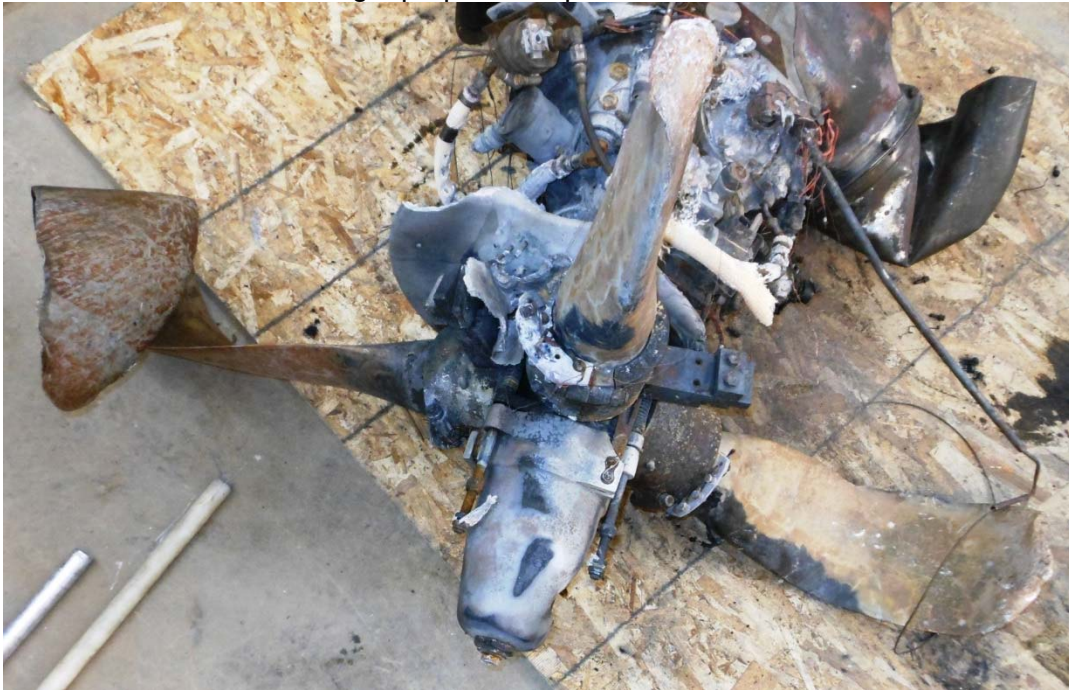
Photo #2 – Right propeller as-presented for examination

**“As Received” Condition:** The propeller was presented for examination while still attached to the engine propeller shaft flange as shown in Photo #2. All mounting hardware appeared intact and present. The beta arm was in the proper position under the guide pin and the beta block was in the beta ring. The de-ice slip ring potting compound was consumed and the slip rings were resting loose around the mounting flange area. No attempt was made to remove the propeller from the engine propeller flange. The piston was in the feathered position. The propeller exhibited extensive thermal damage. The beta guide ring was mostly consumed. The piston had a hole burned/melted through adjacent to R2. Blade R1 was thermally consumed ~13” outboard of the clamp and was in the feathered position. Blade R2 was thermally consumed ~21” outboard of the clamp and was in the feathered position. Blade R3 bent/curled aft and opposite rotation and also in the feathered position. Blade R3 had leading edge gouges and buckling wave bends along the trailing edge. There were no visible slip indicators on the clamps but blade R3 appears to have been forcibly slipped toward low pitch. All three link arms were present and attached at both the link screw and link pin locations. The beta guide rod collar was gouged by all three link arms in a similar fashion. The spinner dome was mostly consumed and all three counterweight assemblies were present and secure. Photo #7 shows the propeller prior to disassembly with components numbered.

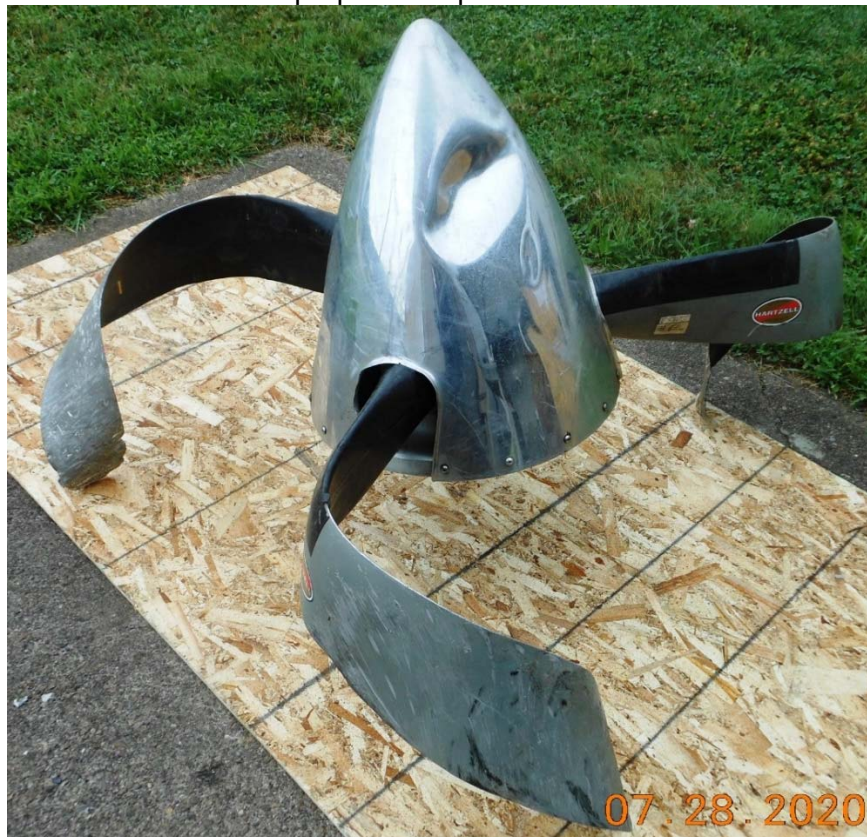
Photo #3 – Left propeller as-presented for examination

**“As Received” Condition:** The propeller fractured from the propeller shaft during the impact sequence, was recovered and shipped with the engines to PWC Engine Services in Bridgeport, WV for examination as shown in Photo #3. Because the propeller separated from the main wreckage it was not subjected to the post-crash fire as shown in the on-scene photos. The spinner dome was intact but dented. All three blades and clamps were in the feathered position. There were no slip indicators on the clamps. All three blades exhibited similar bending and twisting; curled aft, opposite rotation and toward low pitch. All three blades exhibited leading edge gouging and chordwise/rotational scoring on the camber side, outboard half of the blade. There were gouges in the guide collar from the link arm/link screws indicating forceful rotation toward low pitch. The beta ring was intact and all propeller mounting hardware was present and lockwired on the mount flange. The propeller is shown in Photo #17 with the spinner dome removed and components numbered prior to disassembly.

**Spinner Dome:** The spinner dome was intact but dented in some areas and torn on the forward side of one blade opening (see Photo #3). There was some pine/evergreen shrub debris around the propeller hub after removal of the dome. There was also some evidence of spiral scoring on the dome surface. There were no counterweight punctures or impressions in the dome that could aid in determination of blade angle.

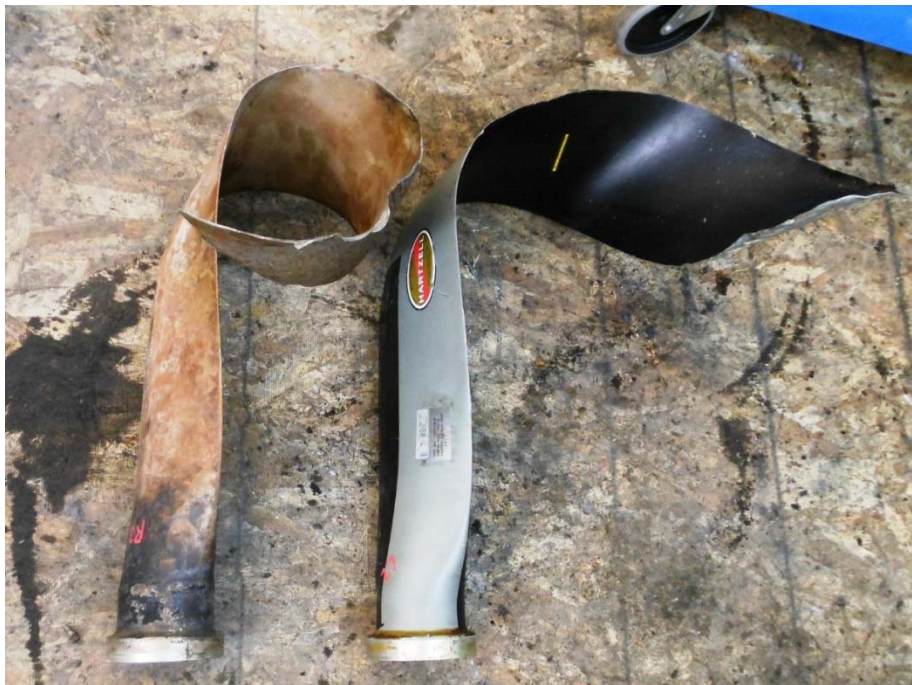
The cylinder and piston impact marks found were not useful in determining blade angle prior to impact and only indicated the propeller was forcefully rotated toward the low pitch/reverse stop at initial impact. There was no damage to indicate either propeller was feathered at the time of impact. All blades remained attached via the retention clamps. No pilot tubes were fractured and there were no blade fractures due to impact. Blade damage that included camber side chordwise/rotational scoring, bending aft, bending opposite rotation, leading edge gouging with most material deformation toward low pitch, and progressive compound bent/twisting towards low pitch was consistent with impact at a relatively shallow aircraft impact angle while rotating under power. The damage to blades and pitch change mechanisms indicated forceful rotation towards low pitch during the impact sequence. All damage was consistent with the blade tip region initially hitting terrain at a zero-to-negative section angle of attack. A comparison of blades L2 and R3 bend and twist also suggested some degree of power symmetry between left and right engines. Photo #4 shows the degree of bend and twist. Photo #5 shows the extent of bending opposite rotation is similar.

Photo #4 – Blades R3 and L2 relative bend and twist

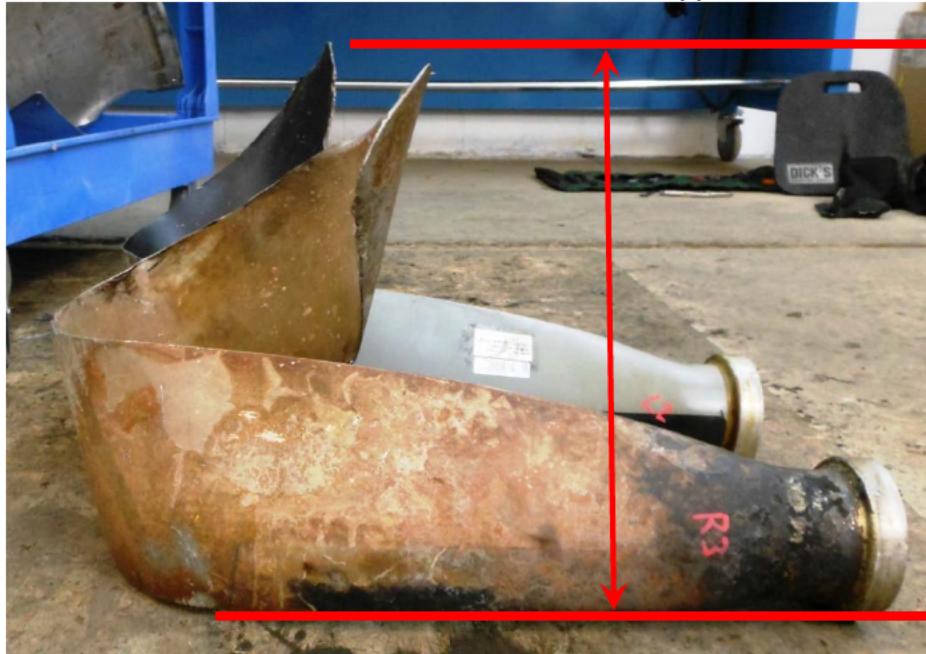
Photo #5 – Blades R3 and L2 amount of bend opposite rotation

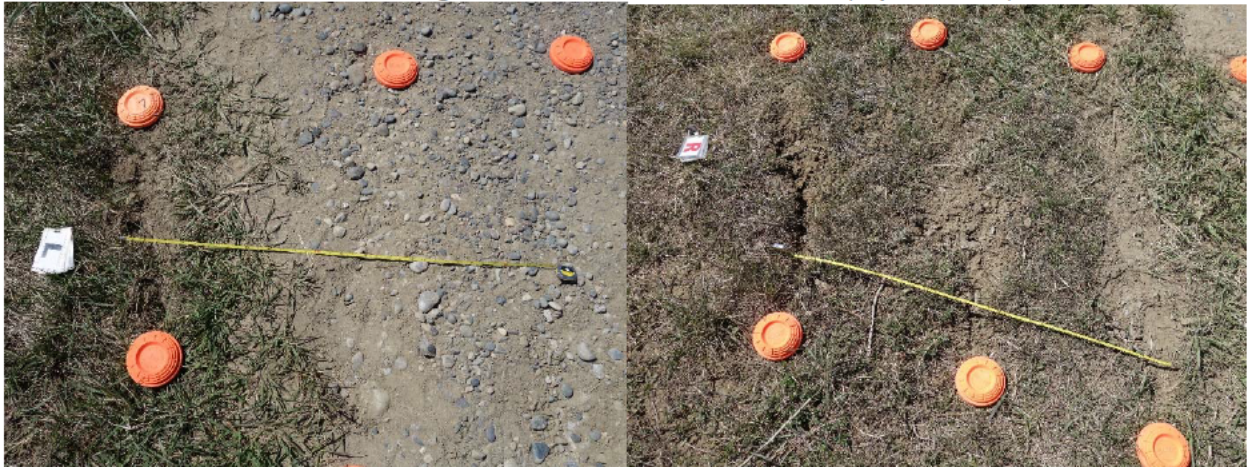
The propeller strike marks at the initial impact location were measured by the Piper Air Safety Investigator (Photo #6). The Investigator stated the first three strike marks for both the left and right propeller were equally spaced and approximately 1' apart. Calculations using the strike mark dimension and the estimated ground speed from radar/ADS-B data of approximately 65-70 Knots suggested an RPM between 2100-2300 at initial impact.

Photo #6 – Left and Right Strike Mark Measurements (Piper Photo)

Assuming the propellers were being governed at the 2200 RPM rating, the minimum possible blade angle range would be between the running flight idle blade angle of approximately 15.2° and the beta/low pitch angle of 20.2°. At 70 KGS (~84 KTAS with ~14 Kts. headwind) the power and thrust at 15.2° blade angle would be approximately 152 Hp and 388 lbs. At 20.2° blade angle the power and thrust would be approximately 340 Hp and 956 lbs. of thrust. For comparison, the blade angle at takeoff rated power of 500 Hp and 2200 RPM is approximately 23.3° producing 1302 lbs. of thrust.

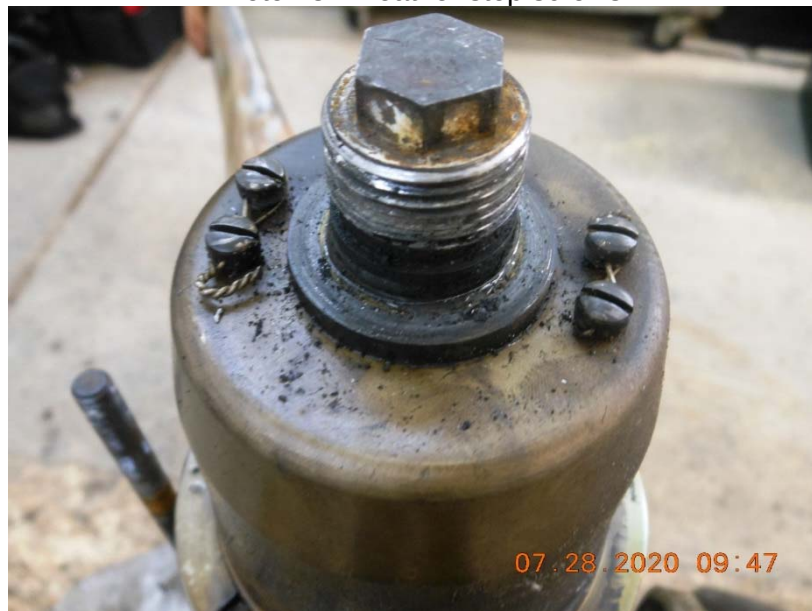
**Feather Stop Screws:** The feather stop screws appeared intact and undamaged but were charred/sooted. (see Photo #8).

Photo #8 – Feather stop screws

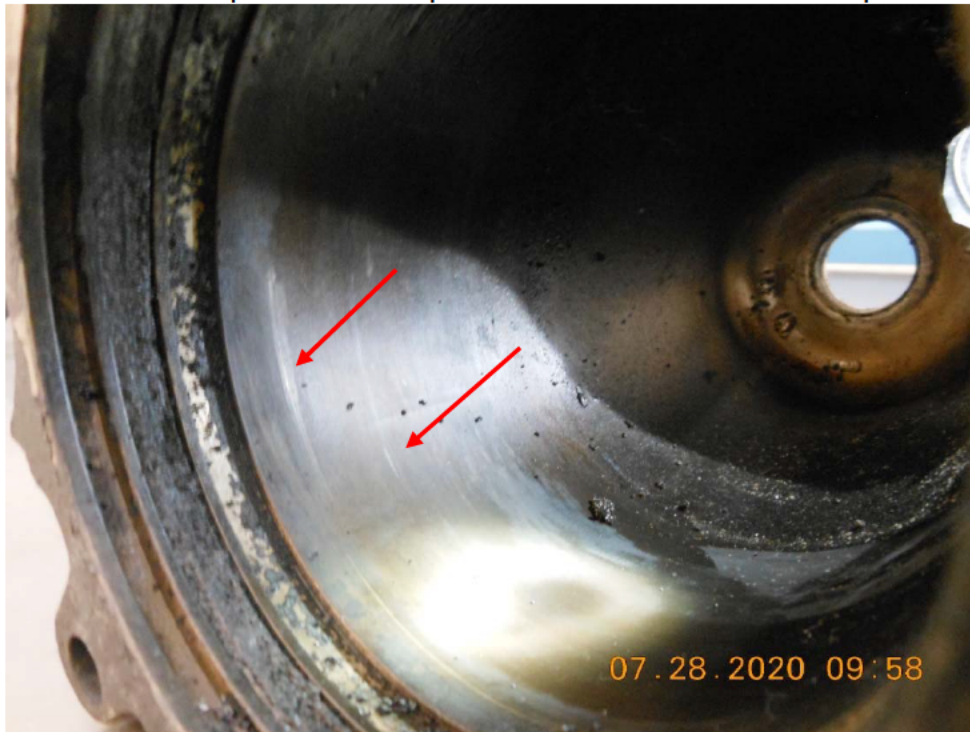
**Piston:** The piston was in the feathered position when presented for examination with a hole burned through the piston wall adjacent to blade R2. The piston nut was intact but loose. There were a few circumferential marks on the internal surface likely made by contact with the top corner of the cylinder during initial impact and following impact sequence (see Photo #9). The marks measurements and interpretation are presented in the following Table #1.

| Internal Marks from Bottom Piston Edge | Approximate Equivalent Blade Angle | Pre-impact Confidence Level / Why? |
|---|---|---|
| 1.47" | < reverse stop | Low – location suggests it was made after initial forceful rotation to low pitch |
| 2.13" | 7° | Medium –below the running flight idle blade angle of ~15° so likely made after initial impact |

Photo #9 – Representative impact marks on internal surface of piston

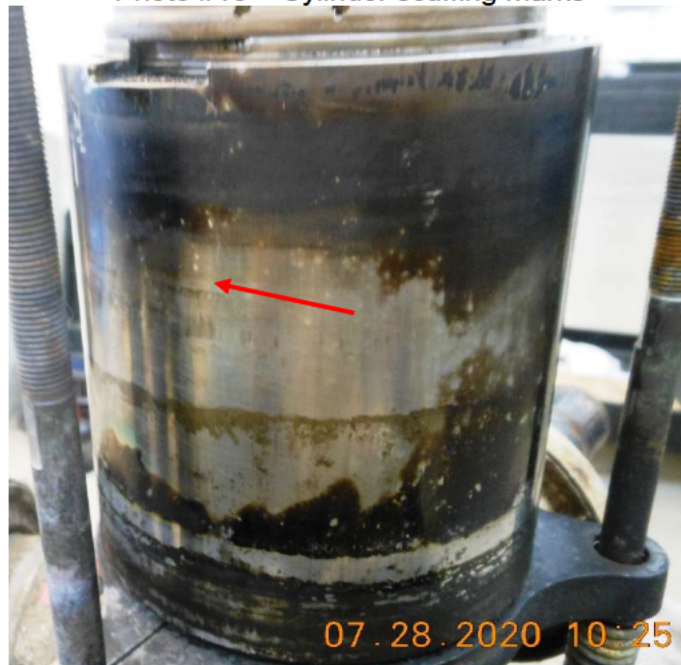
**Cylinder:** The cylinder was not removed from the hub during the examination and was charred/sooted from heat exposure. There were scuff marks on the cylinder wall at approximately 1.44" and 1.63" from the top corner (Photo #10).

Photo #10 – Cylinder scuffing marks

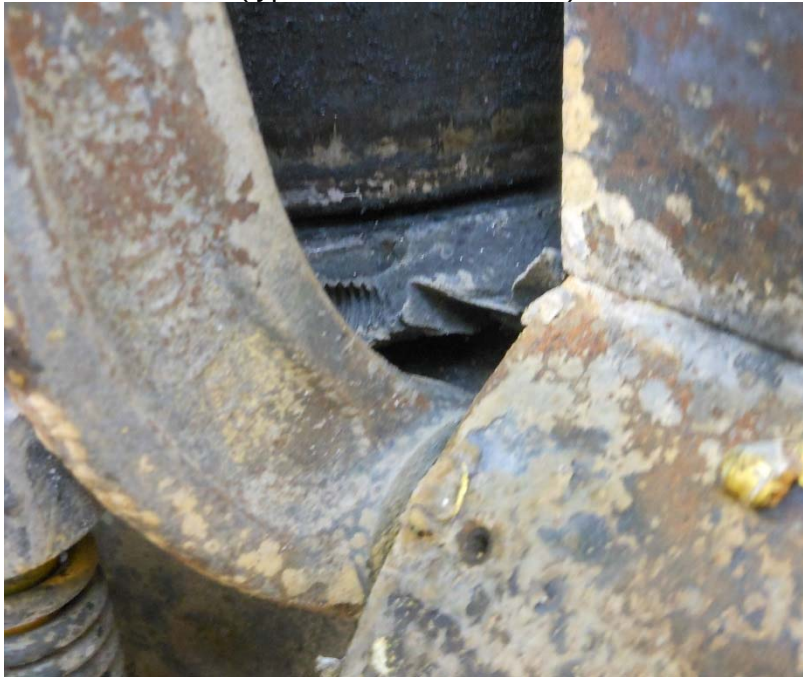
**Link Arms:** All three link arms remained attached at their link screw and link pin attach points. All three link arms contacted the beta guide collar (Photo #11).

Photo #11 - Right prop gouge in guide collar  
(typical all three locations)

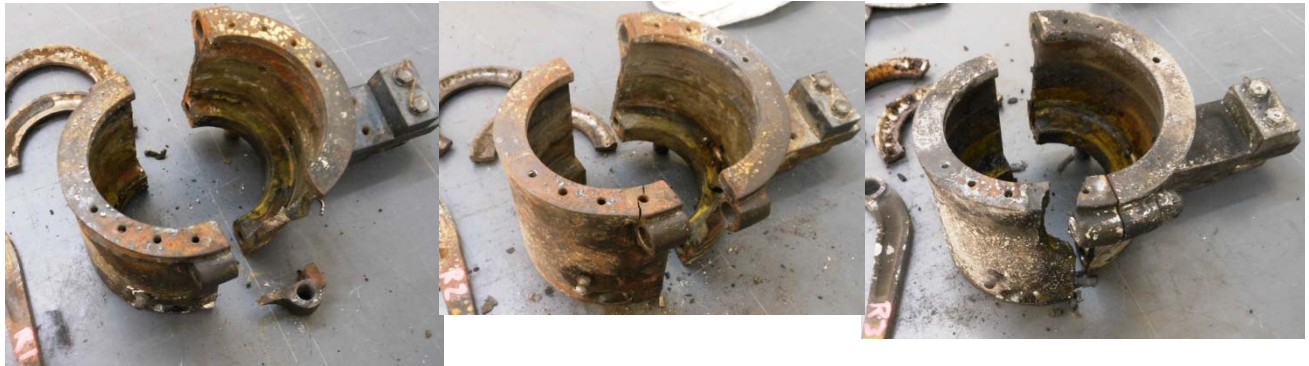
**Clamps and Counterweights:** (see Photo #12) All three link screws appeared undamaged.

| Clamp Pos. | Clamp S/N | Clamp Condition | Counterweight Condition |
|---|---|---|---|
| R1 | EK2463 | Charred/sooted, outboard lead-edge camber-side bolt ear fractured | Intact |
| R2 | EK2299 | Charred/sooted, outboard lead-edge face-side bolt ear fractured | Intact |
| R3 | EE844 | Charred/sooted, outboard lead-edge face-side bolt ear fractured | Intact |

Photo #12 – Blade retention clamps

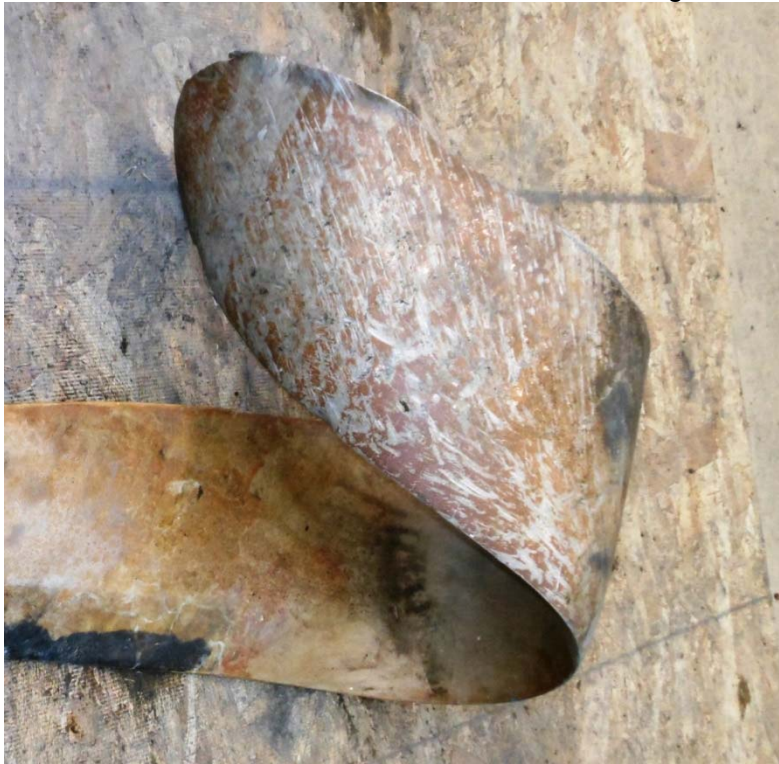
| Camber side | Chordwise/rotational scoring outboard half of blade |
| Bend | Aft and opposite rotation curling |
| Twist | Curled toward low pitch |
| Lead edge damage | Gouging, material deformation neutral/toward low pitch |
| Trail edge damage | Gouged, torn, dented, buckling-type wave bends |

Photo #13 – Blade #R3 camber-side scoring

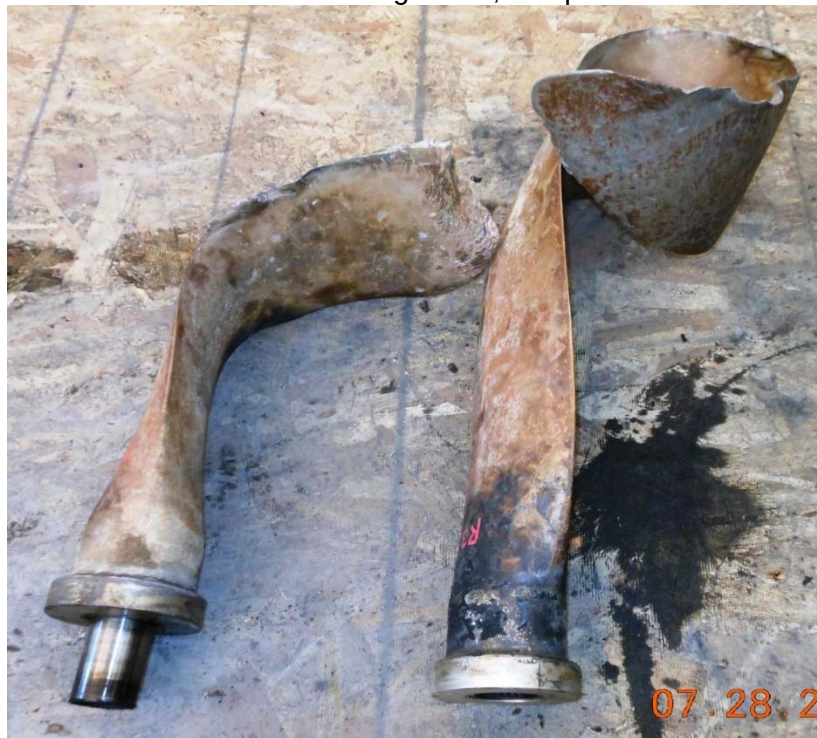
| Bend | Aft |
| Twist | Toward low pitch |

Photo #14 – R2 and R3 trail-edge view, compound bend and twist

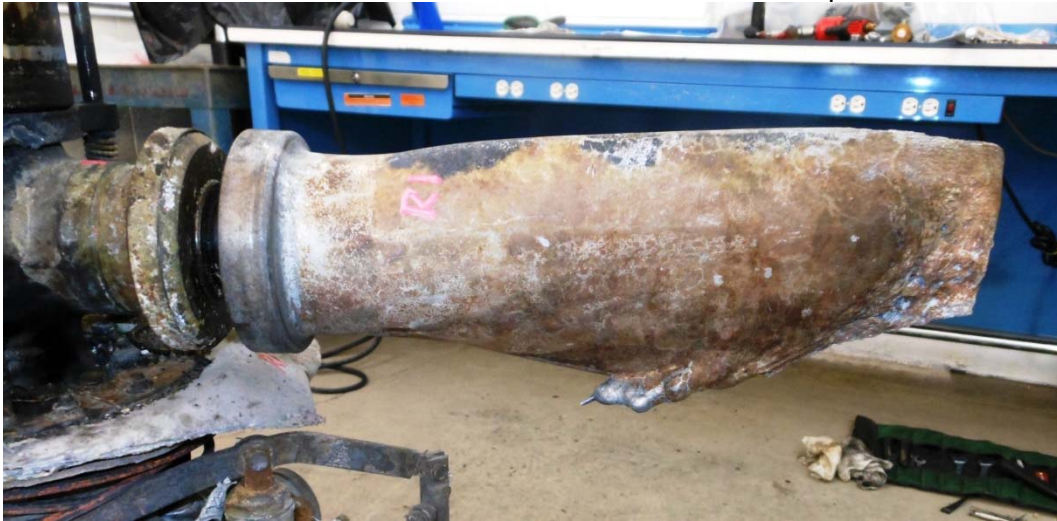
**Hub Unit:** The hub unit/spider remained intact but was heavily charred/sooted. The R1 blade could not be entirely removed from the hub. It appears the R1 pilot tube was being pulled from the hub during removal of the blade before movement stopped and prevented complete removal. The R2 pilot tube pulled from the hub during blade removal and remained lodged in the blade bore. The R3 pilot tube remained intact in the hub. The cylinder was intact and remained attached to the hub but was charred/sooted. The guide collar was intact but exhibited impact gouges at each of the three link arm/link screw locations due to forceful rotation to low pitch. The forward spring cup, pitch change rod and spring appeared intact and was not removed.

Blade # R1 – blade outboard of 14” from butt consumed/melted, blade could not be removed from hub

Photo #15 – Blade R1 could not be removed from hub/pilot tube

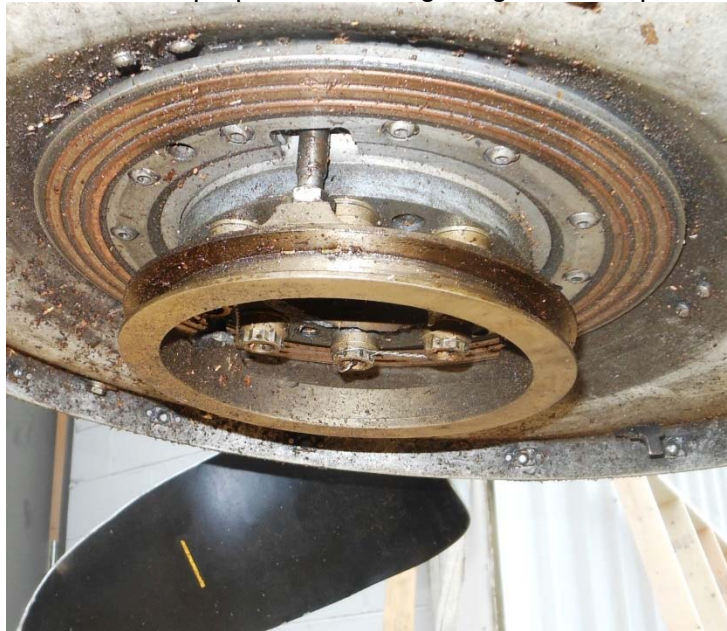
**Engine/Propeller Mounting:** (see Photo #16) The engine shaft flange fractured from the engine shaft and remained attached to the propeller. The propeller mounting hardware was present and lockwired. No attempt was made to remove the engine shaft flange.

Photo #16 – Left propeller mounting flange area as-presented

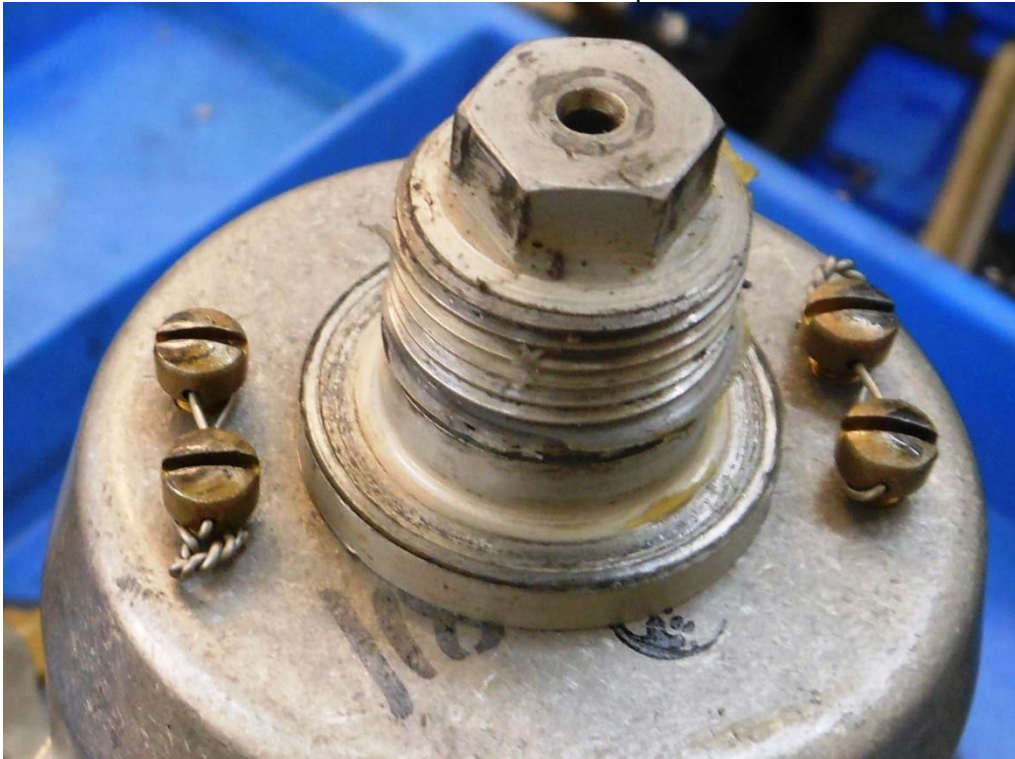
**Feather Stop Screws:** The feather stop screws appeared intact and undamaged (not smashed/bent). (see Photo #18).

Photo #18 – Left feather stop screws

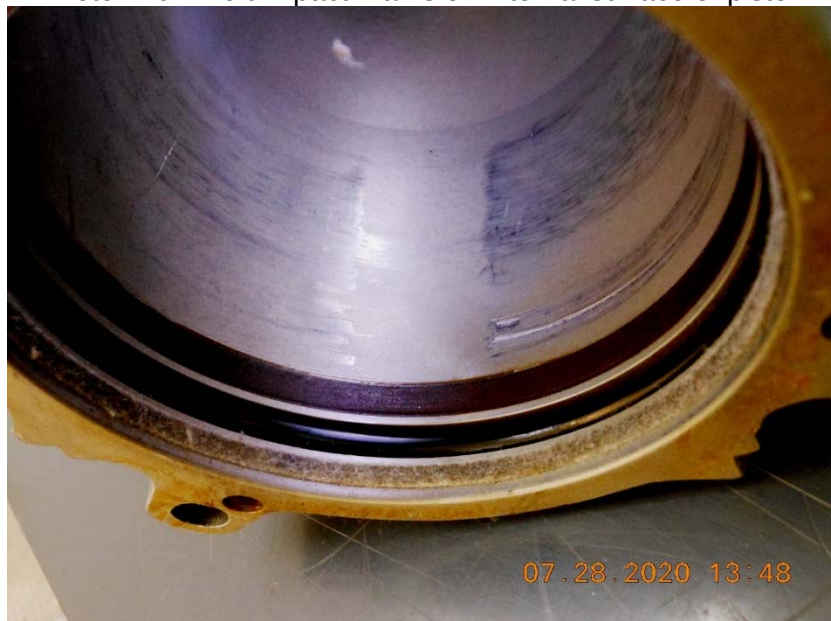
**Piston:** The piston external surface appeared intact and undamaged. It was removed without difficulty. The piston nut was intact and tight. There were several circumferential and scuff/drag marks on the internal surface made by contact with the top corner of the cylinder during the impact sequence (see Photos #19 and #20). The mark measurements and interpretation are presented in the following Table #2.

| Internal Marks from<br>Bottom Piston Edge | Approximate<br>Equivalent<br>Blade Angle | Pre-impact Confidence Level / Why? |
|---|---|---|
| 1.44" through | Lower than<br>reverse<br>stop | Low – location suggests it was made after initial forceful rotation to low pitch |
| 1.69" | -8.5° | Low – location suggests it was made after initial forceful rotation to low pitch |

Photo #19 – Left impact marks on internal surface of piston

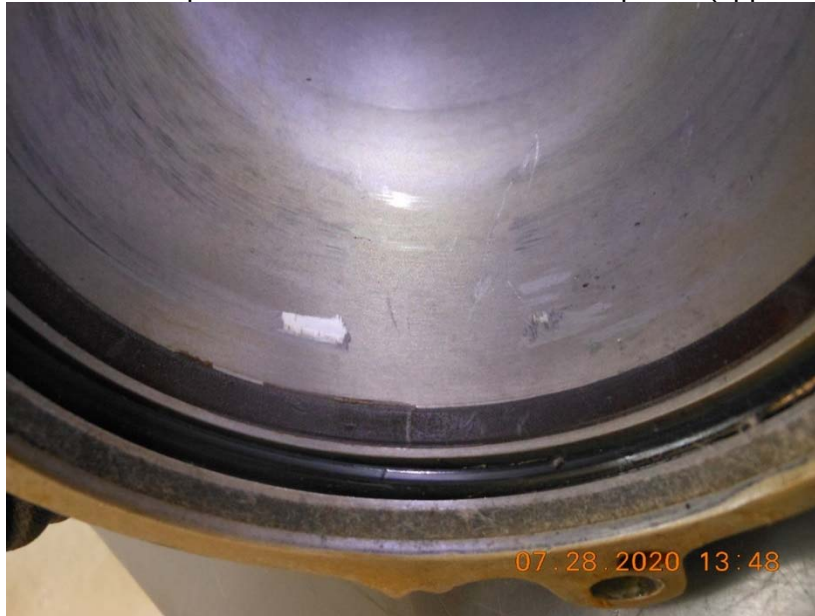
Photo #20 – Left impact marks on internal surface of piston (opposite side)

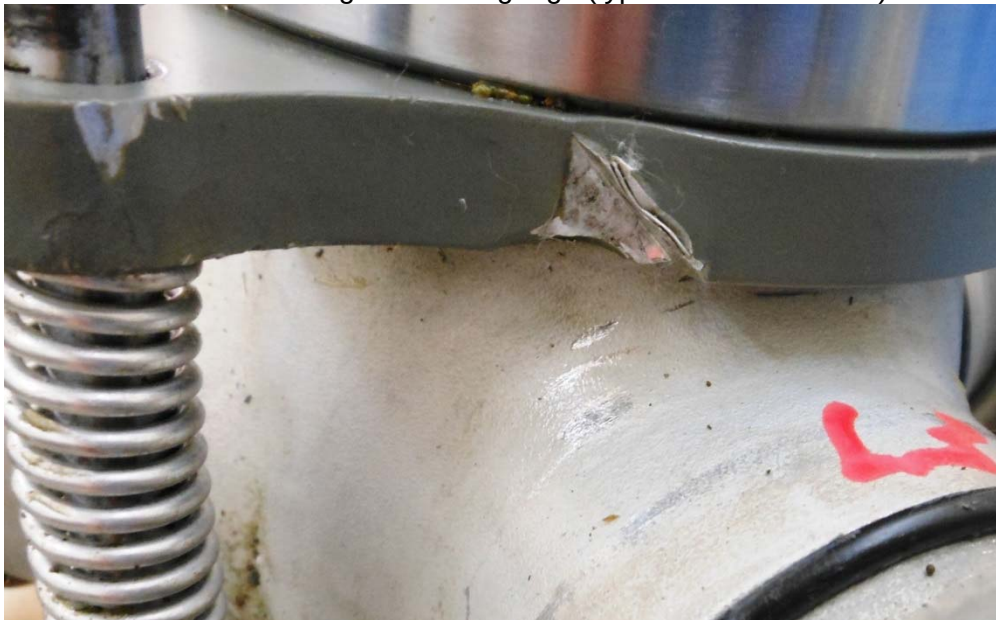
**Link Arms:** All three link arms remained attached at their link screw and link pin attach points preventing any clamp rotation prior to disassembly. The cotter pin was intact at the link screw connection. Each link arm contacted the guide collar in a similar fashion as shown in Photo #21

Photo #21 - Left guide collar gouge (typical three locations)

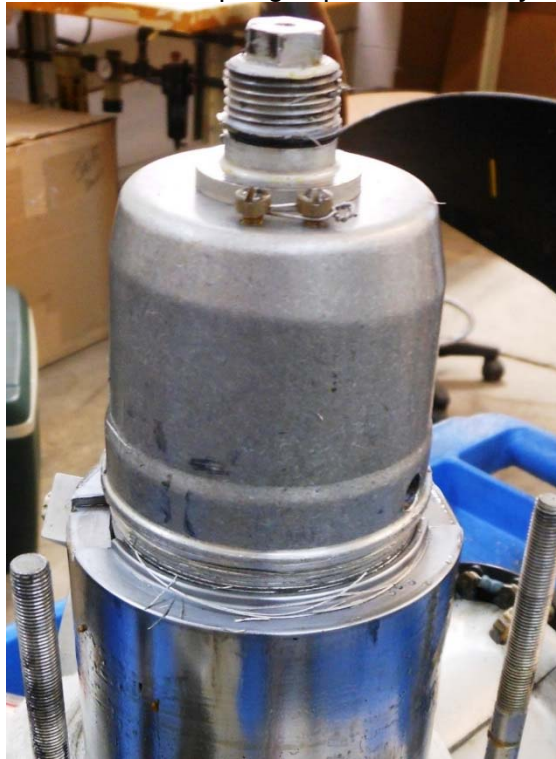
**Feathering Spring Assembly:** The feathering spring forward retainer cup was forcefully pushed out of the cylinder attachment damaging the threads and leaving thread whiskers (see Photo #22). The feathering spring assembly was completely removed from the cylinder during this examination and appeared intact and undamaged other than the forward cup threads. The spring was intact with the rear spring keepers in place (Photo #25).

Photo #22 – Left forward spring cup forced from cylinder mount

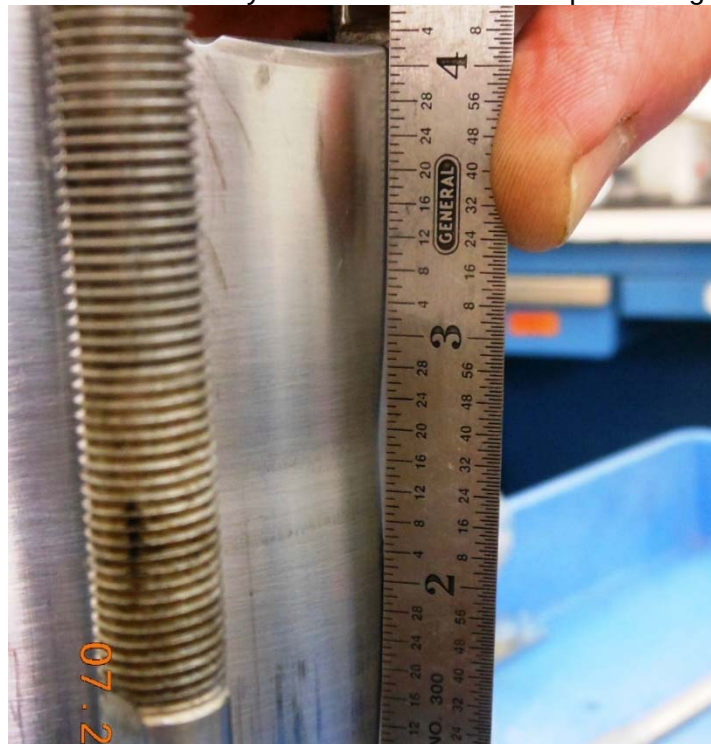
**Cylinder:** The cylinder remained attached to the hub and was not removed from the hub during the examination. There was a crease/dent in the cylinder made by the bottom edge of the piston at approximately 1.63" from the top corner (see Photo #23).

Photo #23 – Left cylinder crease/dent from piston edge

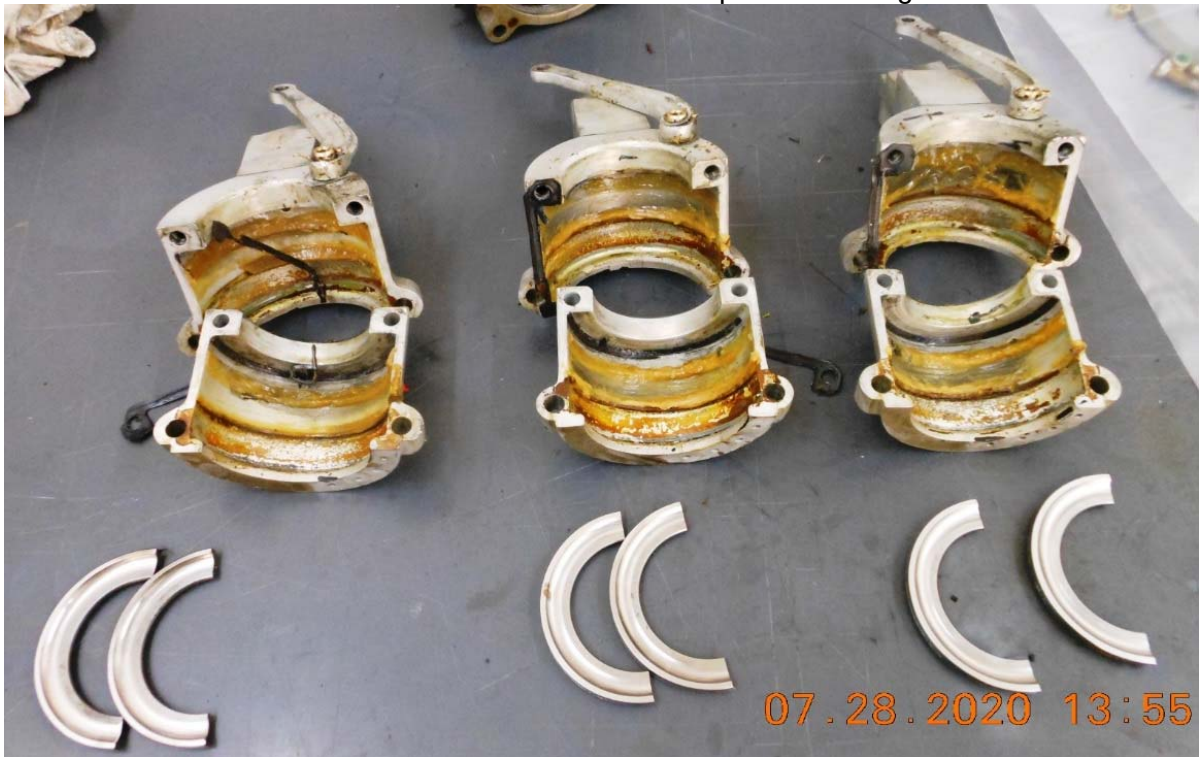
**Clamps and Counterweights:** (see Photo #24) All clamp bolts were present, secure and safetied.

| Clamp Pos. | Clamp S/N | Clamp Condition | Counterweight Condition |
|---|---|---|---|
| L1 | EE3979 | Intact, link screw slightly marred/deformed on low pitch side | Intact |
| L2 | EL456 | Intact, link screw slightly marred/deformed on low pitch side | Intact |
| L3 | EE4149 | Intact, link screw slightly marred/deformed on low pitch side | Intact |

Photo #24 – Left blade retention clamps and bearings

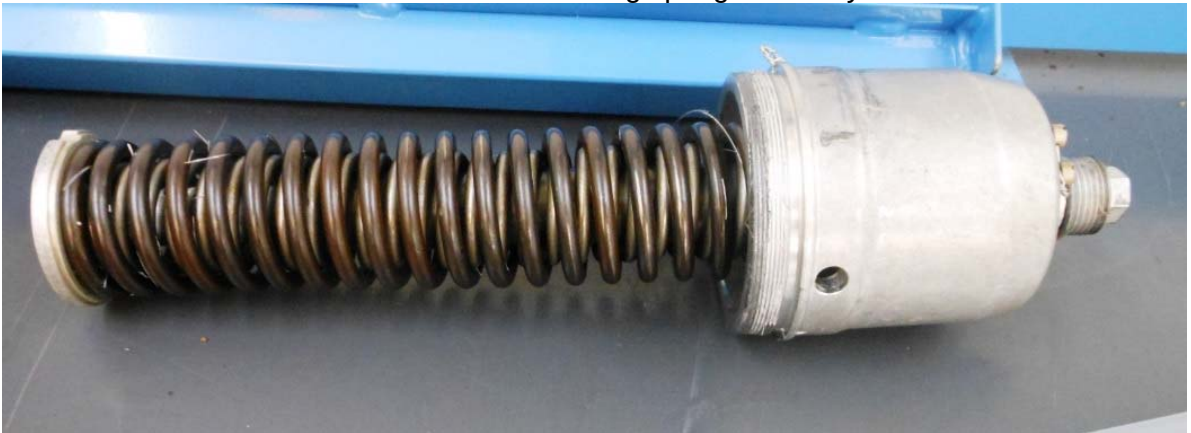
**Pitch Change Rod:** The pitch change rod appeared intact and undamaged and no attempt was made to remove it from the spring assembly (See Photo #25).

Photo #25 - Left feathering spring assembly

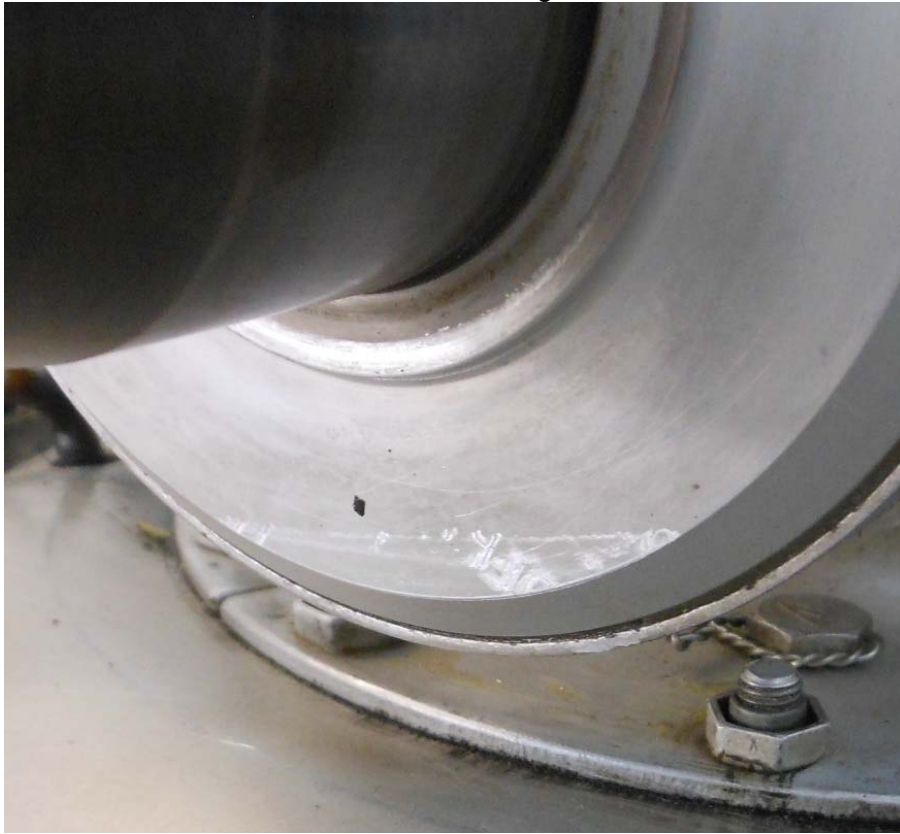
**Hub Unit:** The hub unit/spider was intact. All three pilot tubes were intact and remained in the hub. All three blades were removed without difficulty. The cylinder remained attached to the hub. There was only one impression mark on a blade arm flange at blade #L1 (see Photo #26) corresponding to the "DEP" in the word "DEPTH" stamping on the blade butt. That mark was located on the face-side leading edge quadrant and indicated the blade was in a low pitch position at the time the mark was made. There were also clamp-to-hub impact marks on the trailing edge side of each blade arm. There were also contact marks on the blade arm where the link arm contacted from forceful rotation to low pitch.

| Butt/shank impact marks | "DEP" letter transfer, pilot tube shoulder impact mark |

Photo #26 - Blade L1 hub arm flange letter transfer mark

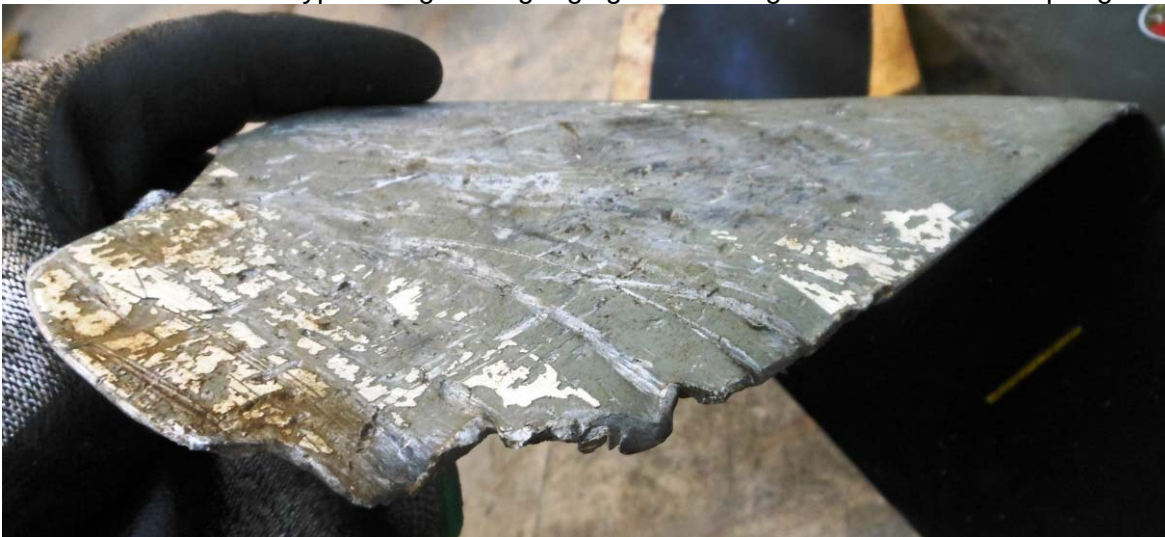
| Camber side | Chordwise/rotational scoring |
| Lead edge damage | Gouges with material deformation neutral/toward low pitch |
| Trail edge damage | Dents, gouges and tearing |

Photo #27 – Blade L3 typical degree of gouging and scoring on camber side of tip region

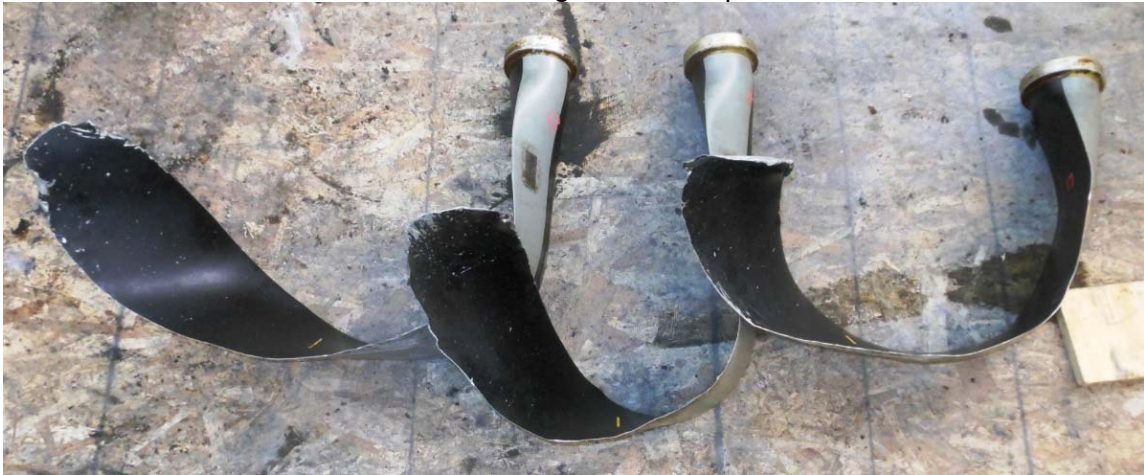
| Bend | Aft and opposite rotation |
| Twist | Curled toward low pitch |

Photo #28 – Left blades trail-edge view, compound bend and twist

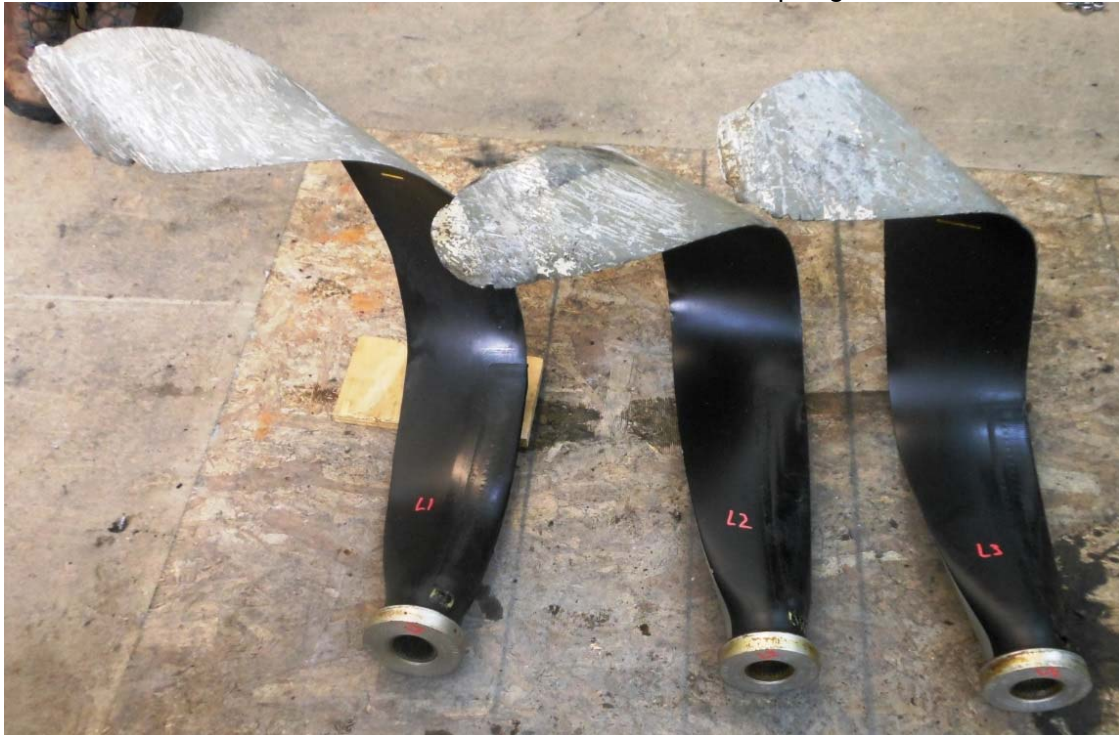
| Camber side | Chordwise/rotational scoring |

Photo #29 – Left blades camber side of tip region

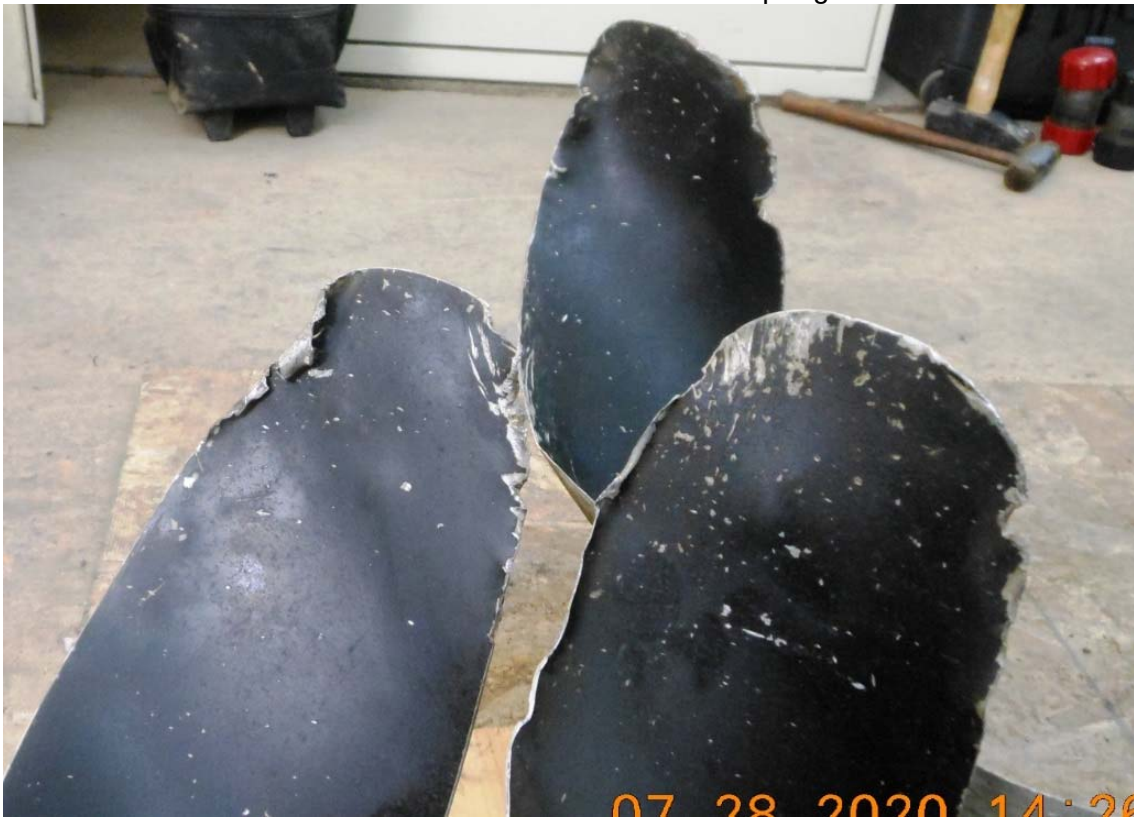
Photo #30 – Left blades face side of tip region
