**Report No.: 20-042**

**FMR Aviation LLC  
Piper PA-31T1, Aircraft Registration No. N926K  
Billings, Montana  
April 20, 2020  
PT6A-11  
Left Engine Serial No. 10234  
Right Engine Serial No. 10239**

**NTSB Identification: WPR20LA128**  
**TSB Identification: A20F0083**  
**P&WC File No.: 20-042**  
**RFA No.: 20SIE00091**

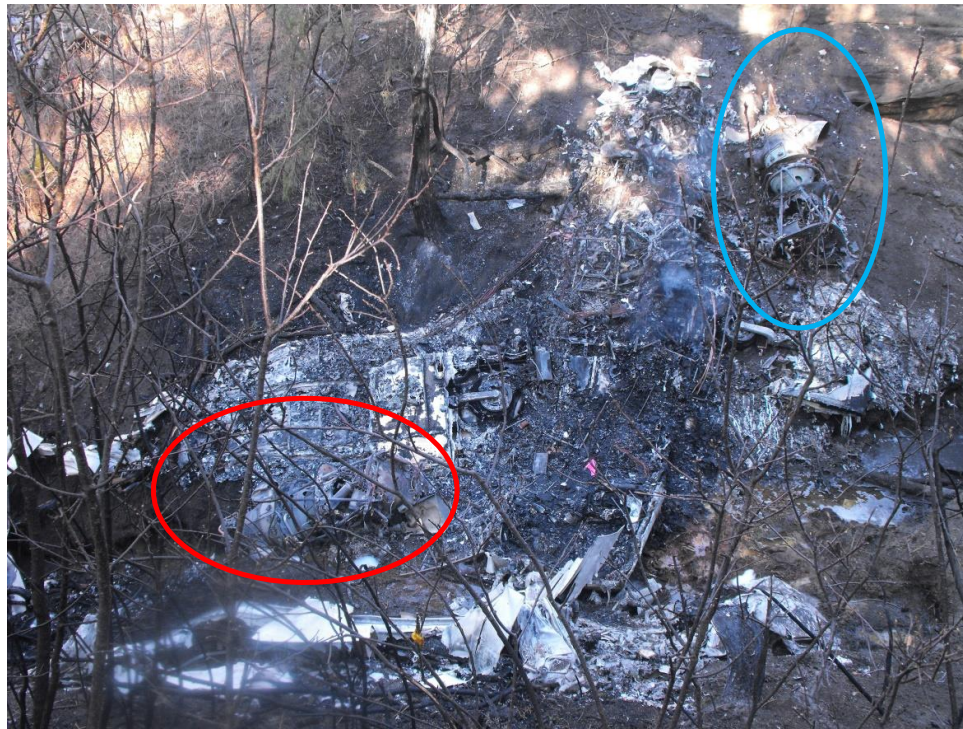
Photo No. 1, courtesy of the FAA

An overview of the accident site shows that left hand engine was orientated approximately 90 degrees opposite the directional orientation of the aircraft, suggesting it was most likely impact separated (Ref. Photo No. 1, red oval). The right hand engine was orientated in the same direction as the aircraft (Ref. Photo No. 1, blue oval). The left hand engine was situated in an upright orientation (Ref. Photo No. 2). The engine and propeller were received in a sealed shipping container (Ref. Photo No. 3). The exterior of the engine exhibited impact damage and thermal damage from the post impact fire (Ref. Photo No. 4). The propeller shaft was impact fractured, separating the propeller from the engine. All three propeller blades were bent and the exterior of the propeller did not exhibit any thermal damage (Ref. Photo No. 5). The bottom portion of the front reduction gearbox housing was partially consumed by the post impact fire. The accessory gearbox housings and portions of the inlet case were consumed by the post impact fire. The heater, fuel control housing and portions of the fuel pump were consumed by the post impact fire. The fire had separated the engine data plate from the inlet case. The data plate showed the engine was a PT6A-11 and the serial number was PC-E 10234 (Ref. Photo No. 6).

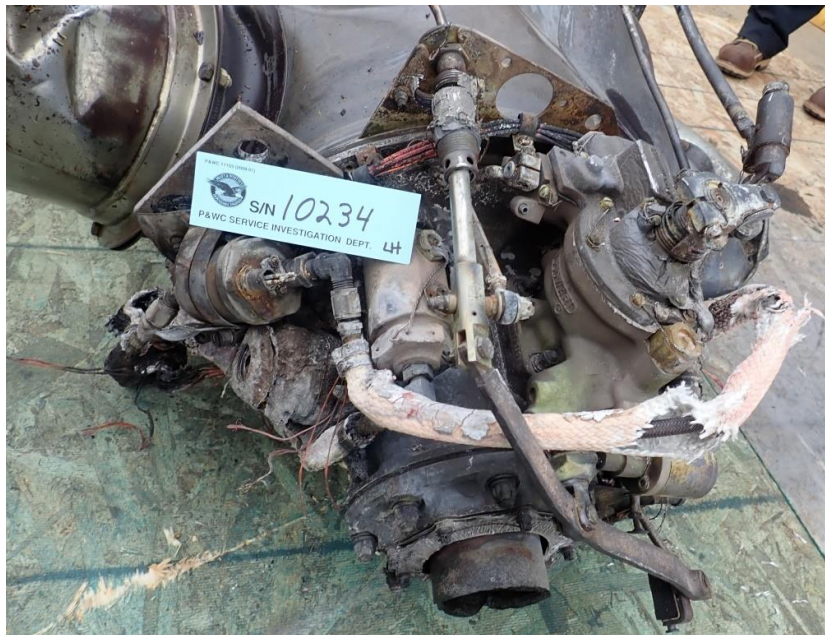
Photo No. 7

**Reduction Gearbox (RGB):** The propeller shaft was impact fractured and the gearbox mounted accessories were thermally damaged from exposure to the post impact fire (Ref. Photo No. 7). The bottom section of the gearbox was burned exposing several of the internal components (Ref. Photo No. 8).

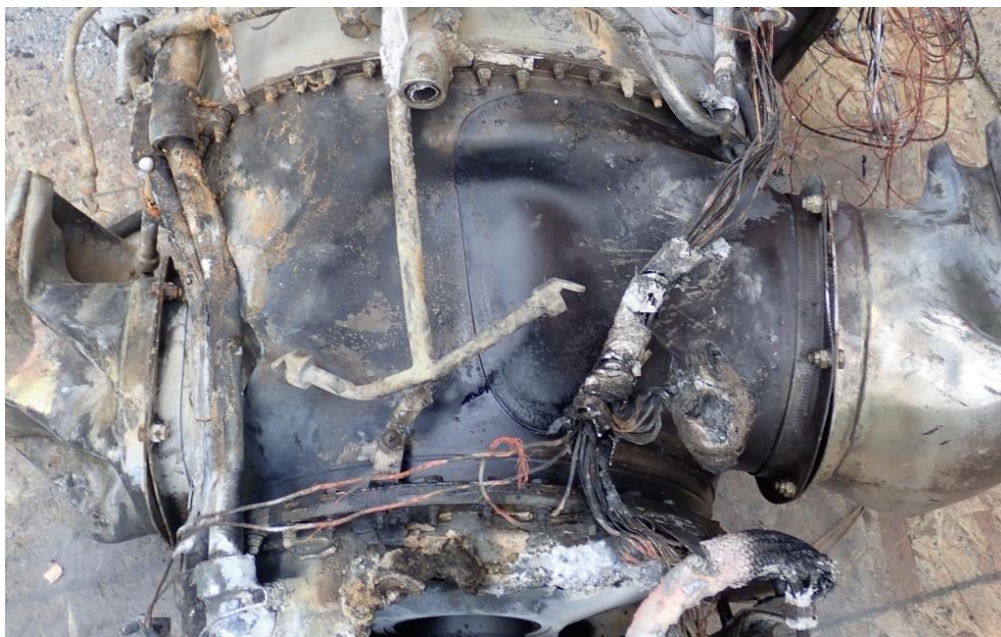
Photo No. 10

**Exhaust Duct:** The duct was partially coated in soot, was impact compressed, and it exhibited a crack at the 12 o'clock position along a creased region (Ref. Photos No. 9, red arrow & 10).

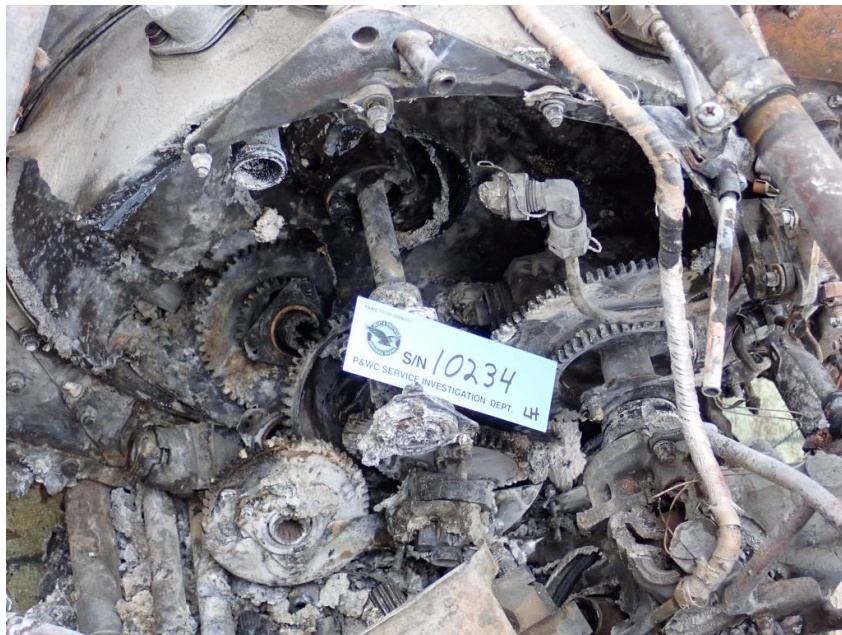
Photo No. 13

**Accessory Gearbox (AGB) and Inlet Case:** The gearbox housings were consumed by the fire, exposing the internal spur gears and pump gears (Ref. Photo No. 13). Portions of the inlet case were consumed by the fire and the inlet struts were all fractured or consumed by the fire.

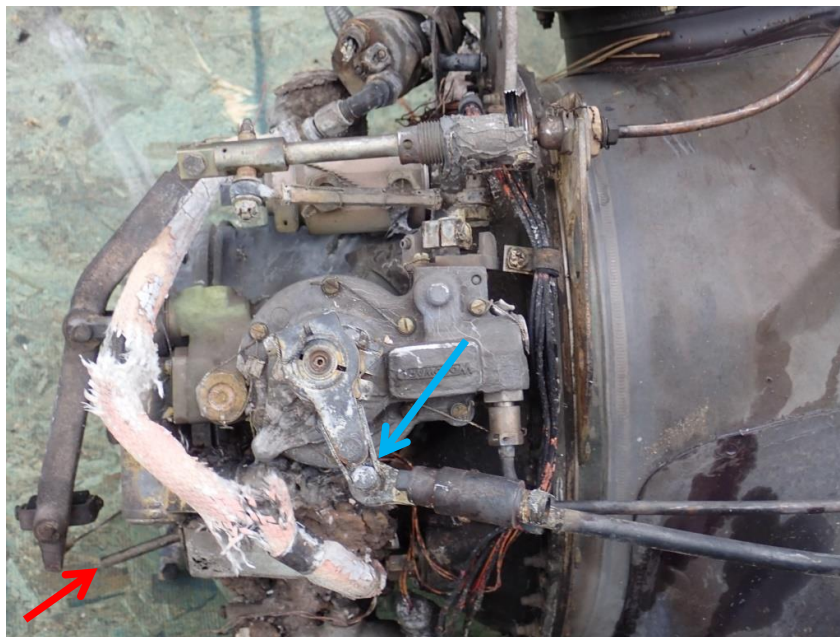
- 3.1.2 **Power Control Linkage and Reversing Linkage:** The reversing lever guide pin was bent (Ref. Photo No. 14, red arrow). The end airframe cable was attached to the propeller speed control lever (Ref. Photo No. 14, blue arrow). The low pitch stop adjuster was thermally damaged partially separating the front push-pull swivel joint casing from the low pitch adjusting stop reversing mechanism (Ref. Photo No. 15, red arrow). The wire rope was in place and the remaining linkage was in place and secure. The CAM box was discoloured from corrosion due to heat exposure (Ref. Photo No. 16, red arrow). The airframe power control cable was attached to the CAM lever (Ref. Photo No. 16, blue arrow). The connecting rod between the CAM and the fuel control arm was in place (Ref. Photo No. 17). A comparison between Photo No. 14 that was taken during the engine examination to Photo No. 18 that was taken at the accident site, show the propeller speed control had moved during the engine recovery and/or handling for shipment. A comparison between Photo No. 16 that was taken during the engine examination to Photo No. 19 that was taken at the accident site, show the CAM box components are in slightly different positions.

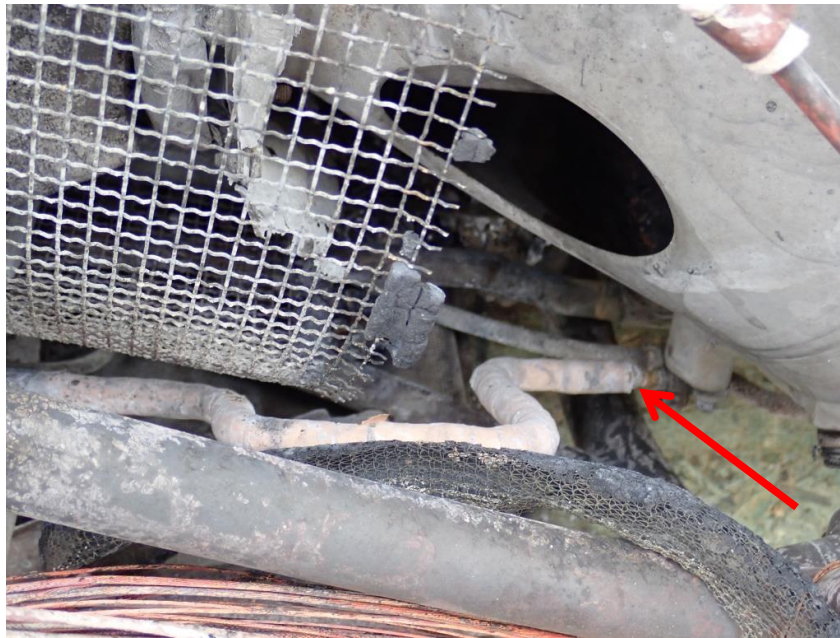
Photo No. 20

**Compressor Discharge Air (P3):** The exterior coating was burned off of the insulated section. The line was in place from the fuel control fitting to the gas generator case port (Ref. Photos No. 20 & 21, red arrows).

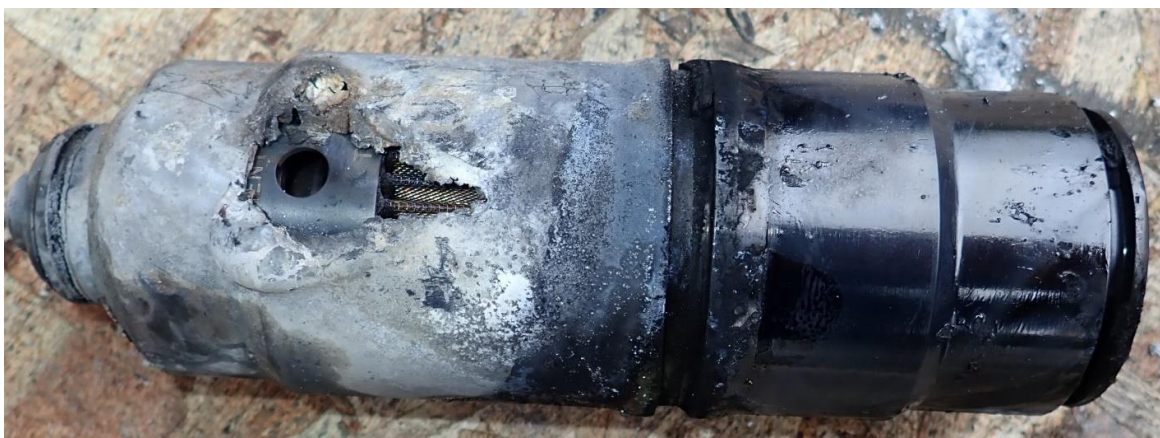
Photo No. 24

**Oil Filter:** The filter exhibited thermal damage and was not removed from the filter housing for the purpose of this investigation (Ref. Photos No. 24 & 25).

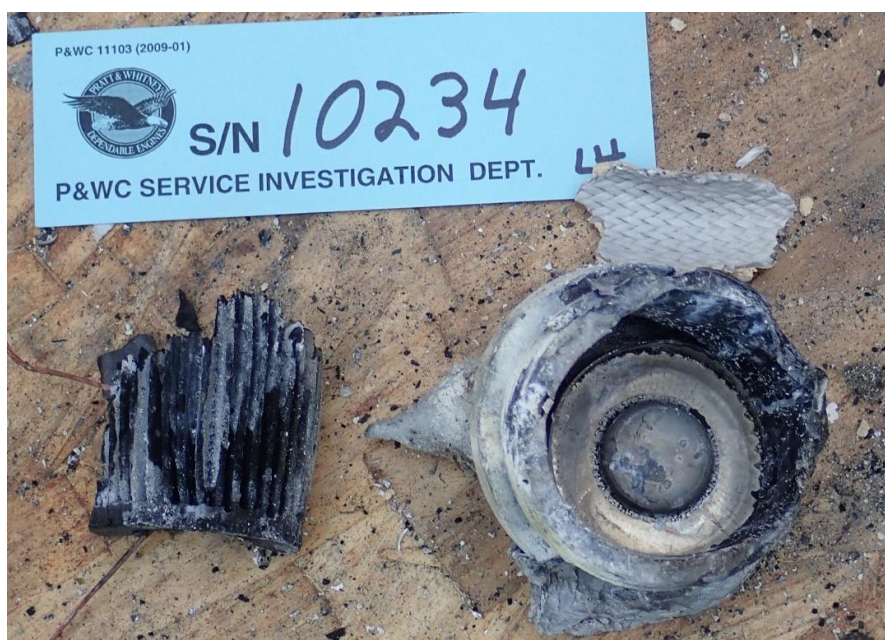
Photo No. 26

**Fuel Filter:** The filter exhibited thermal damage from the post impact fire (Ref. Photo No. 26).

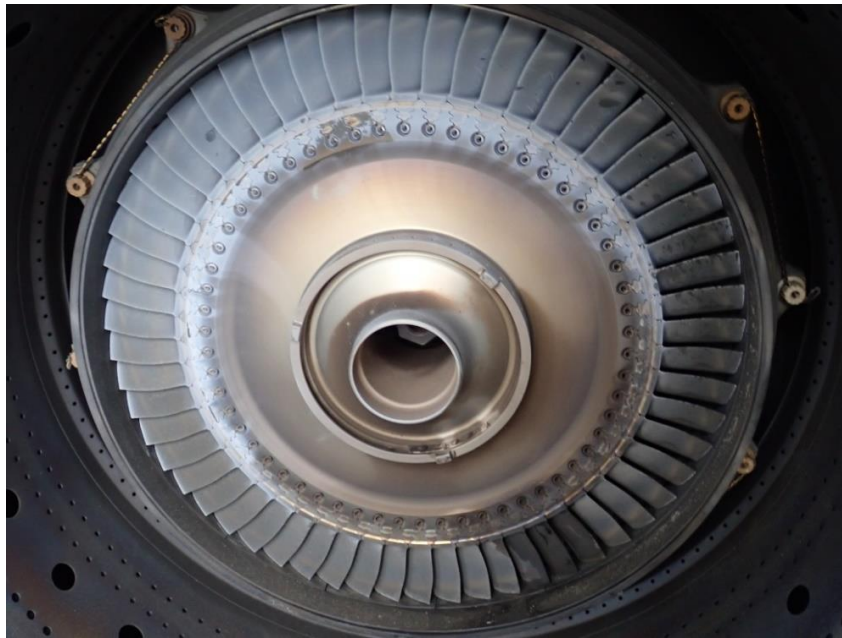
Photo No. 27, view of the downstream side

**Compressor Turbine:** The downstream side of the compressor turbine disc and blades exhibited circumferential scoring from contact with the power turbine vane (Ref. Photo No. 27 & 28). The hub adjacent to the retention bolt bore was rubbed from contact with the lip of the inner baffle (Ref. Photo No. 29). The upstream side of the turbine did not exhibit any visible damage (Ref. Photo No. 30). The blade tips exhibited some polished regions from contact with their respective shroud (Ref. Photo No. 31).

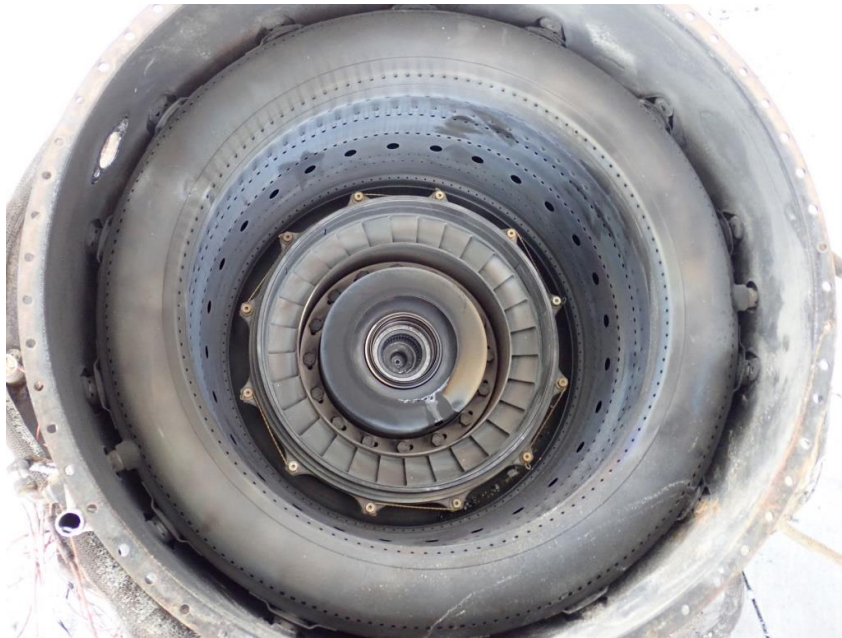
Photo No. 34

**Combustion Chamber Liner:** The liner was not removed for the purpose of this investigation. The visible section of the liner exhibited operational staining (Ref. Photo No. 34). The large exit and small exit ducts were not accessed for the purpose of this investigation.

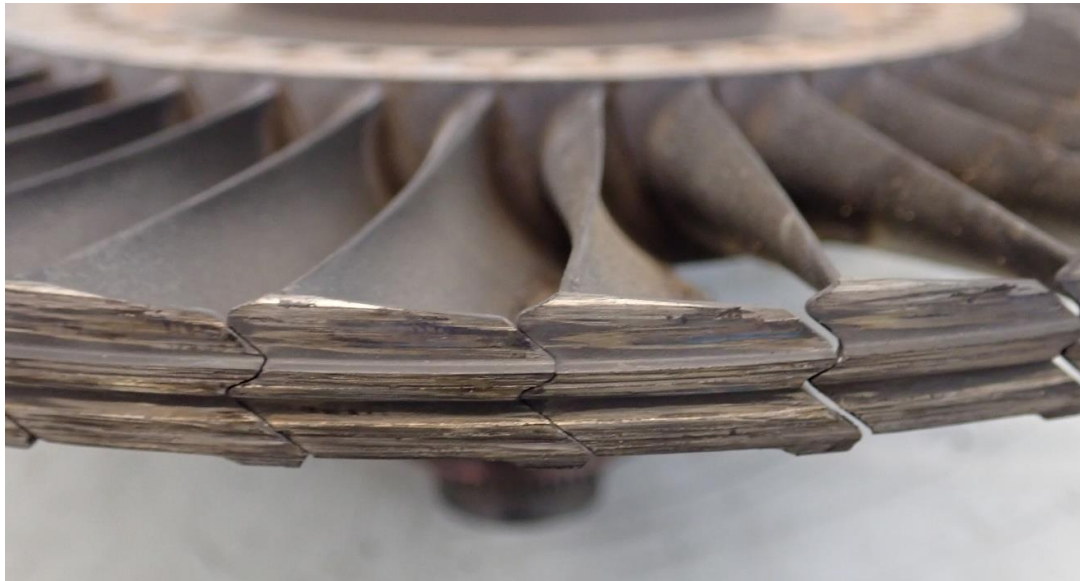
Photo No. 50

**Power Turbine:** The majority of the turbine blades exhibited some discolouration and some soot/debris buildup adhered to their surfaces (Ref. Photo No. 44 & 46). The exhaust duct was distorted resulting in a region where the turbine blades were positioned aft of their respective shroud (Ref. Photo No. 45). The upstream side of several of the blade platforms exhibited circumferential rubs from rotational contact with the power turbine vane baffle (Ref. Photos No. 46 & 47, red arrows). The disc hub adjacent to the retention bolt bore exhibited circumferential rubbing from contact with the lip of the inner baffle (Ref. Photo No. 48). The downstream side of the turbine was unremarkable except for discoloration (Ref. Photo No. 49). The blade tips exhibited rubs from contact with their respective shroud and the leading edge tips from contact with the power turbine vane (Ref. Photo No. 50).

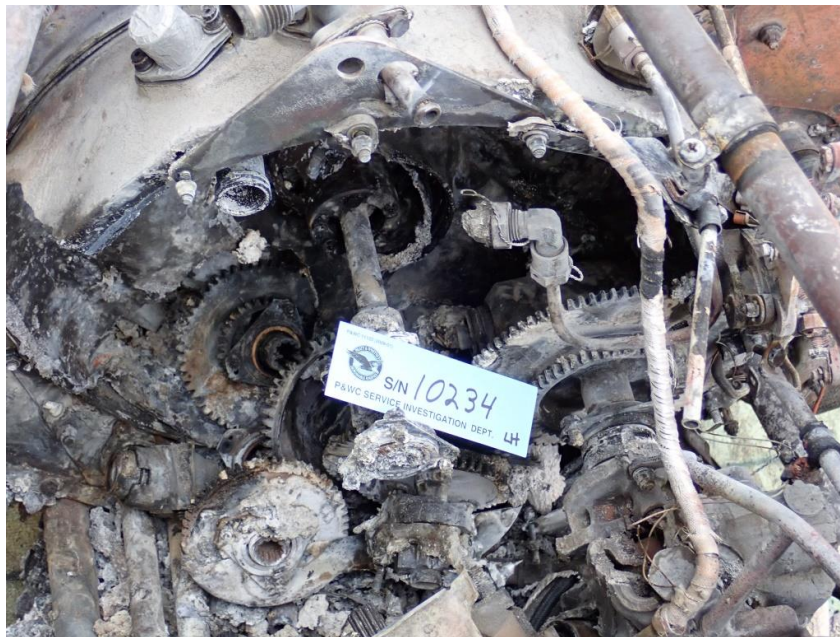
Photo No. 61

The gearbox housings were consumed by the post impact fire, exposing the spur gears, bearings and the oil pump gears (Ref. Photos No. 61 & 62). The inlet case struts were either fractured or burned away (Ref. Photos No. 63). The lower section of the oil tank was consumed in the fire (Ref. Photo No. 64, red arrows).

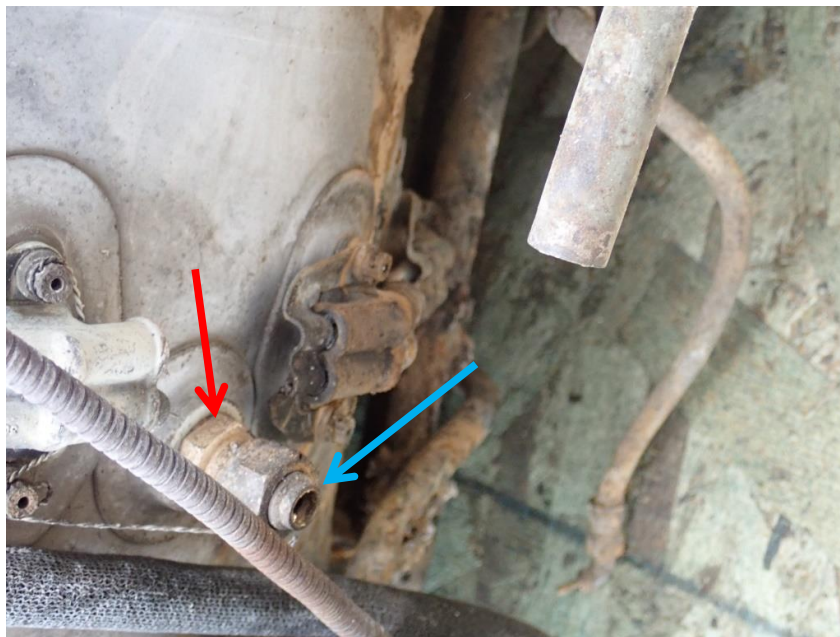
**Ignition Plugs:** Both plugs were in place but were not removed for the purpose of this investigation (Ref. Photos No. 65 & 66, red arrows).

**Ignition Leads:** The left hand lead was fractured and both leads were thermally and impact damaged (Ref. Photo No. 65 & 66, blue arrows).

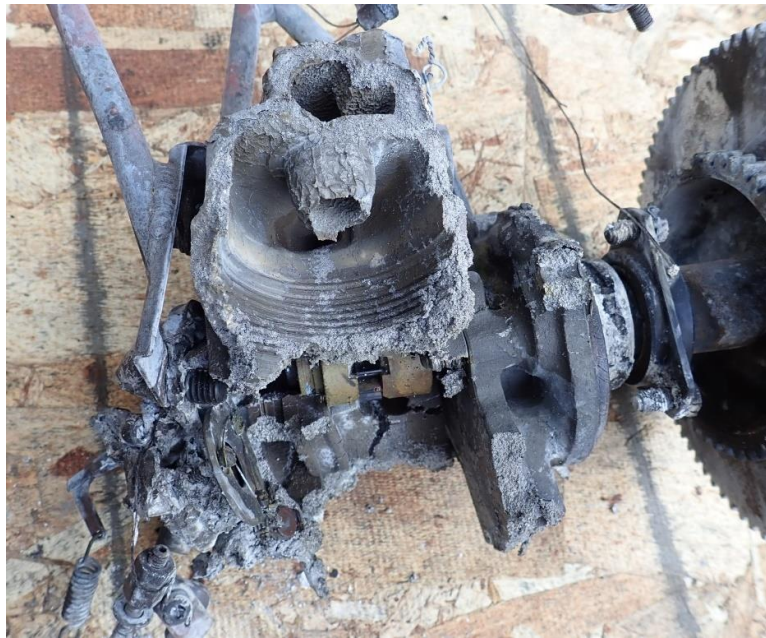
Photo No. 67

**Fuel Pump:** The majority of the pump was consumed in the post impact fire (Ref. Photo No. 67).

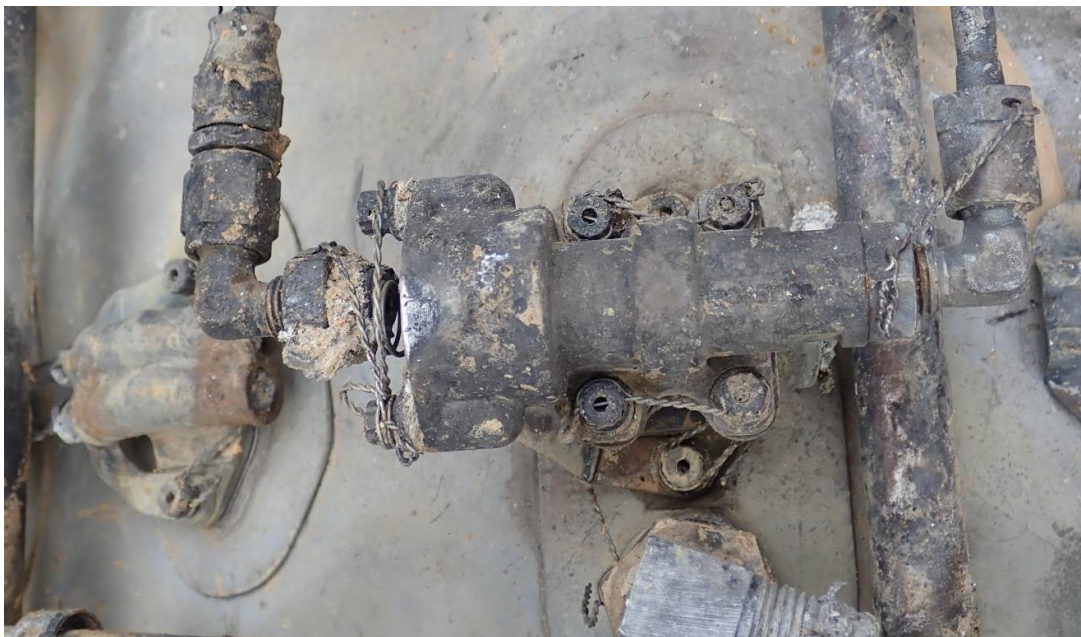
Photo No. 68

**Flow Divider Valve (FDV):** The valve was mounted to the inlet fuel nozzle but was thermally damaged (Ref. Photo No. 68).

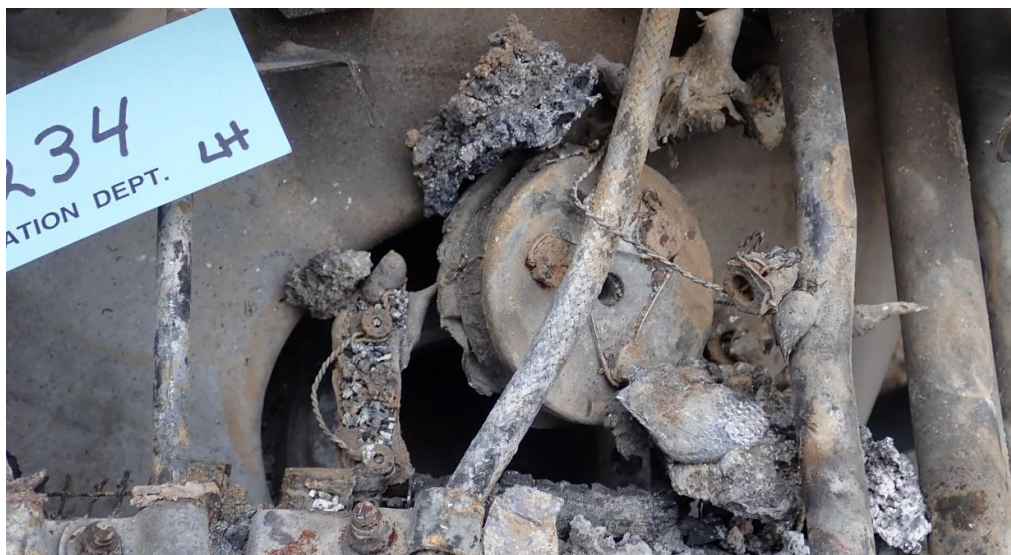
Photo No. 70

**Compressor Bleed Valve (BOV):** The majority of the valve was consumed in the post impact fire (Ref. Photo No. 70).

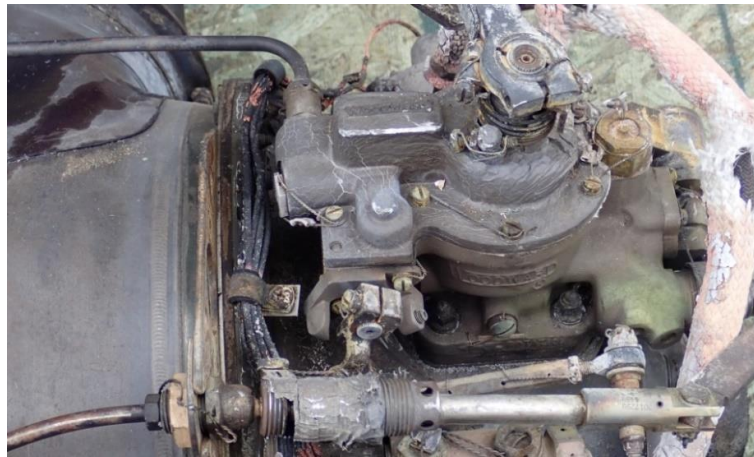
Photo No. 71

**Propeller Governor (CSU):** The governor was mounted on its respective pad on the reduction gearbox and the housing was thermally damaged (Ref. Photo No. 71).

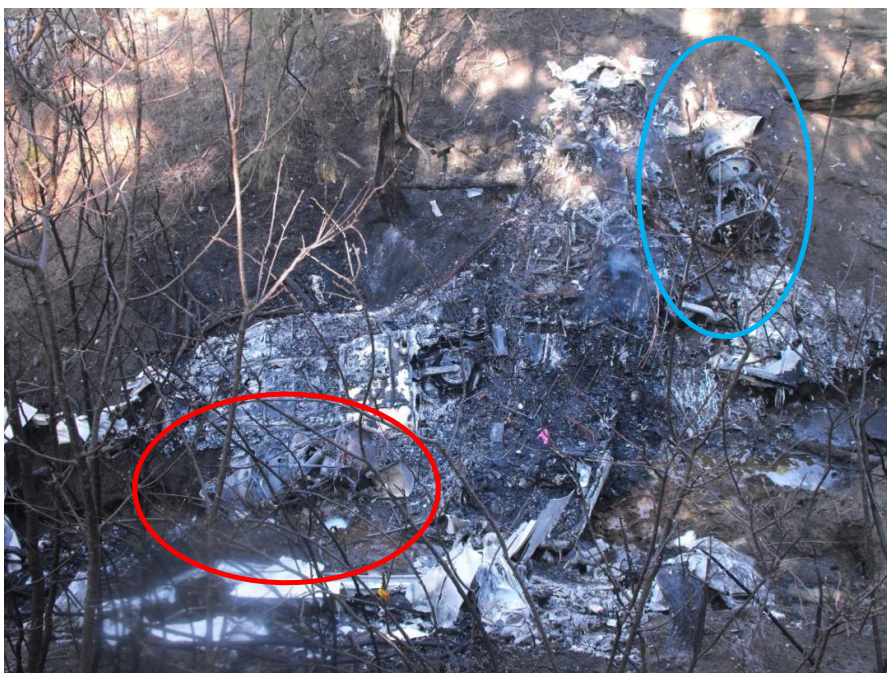
Photo No. 73, courtesy of the FAA

An overview of the accident site shows that the right hand engine was orientated in the same direction as the aircraft (Ref. Photo No. 73, blue oval). The left hand engine was orientated approximately 90 degrees opposite the directional orientation of the aircraft, suggesting it was most likely impact separated (Ref. Photo No. 73, red oval). The right hand engine was positioned in an upright position but it was tilted toward the left hand side at the accident site (Ref. Photo No. 74). The engine and propeller were received in a sealed shipping container (Ref. Photo No. 75). The exterior of the engine exhibited thermal damage from the post impact fire (Ref. Photo No. 76). The propeller blades exhibited thermal and impact damage (Ref. Photo No. 77). The accessory gearbox housings and portions of the inlet case were consumed by the post impact fire. The heater, fuel control housing and portions of the fuel pump were consumed by the post impact fire. The engine data plate showed the engine was a PT6A-11 and the serial number was PC-E 10239 (Ref. Photo No. 78).

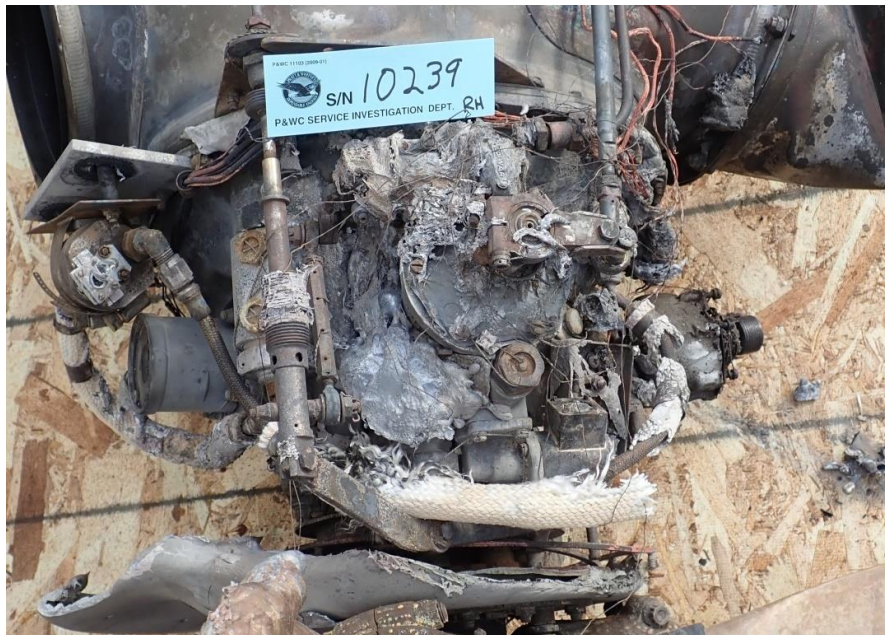
Photo No. 79

**Reduction Gearbox (RGB):** The gearbox mounted accessories were thermally damaged from exposure to the post impact fire and melted airframe material was adhered to the housing (Ref. Photo No. 79). The bottom of the housing was discoloured (Photo No. 81, blue arrow).

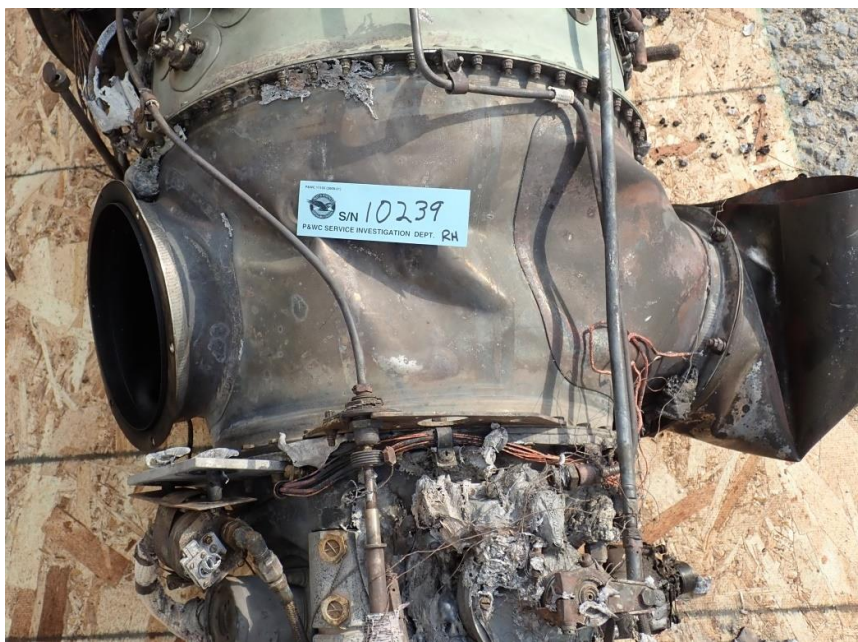
**Exhaust Duct:** The duct was partially coated in soot and was impact compressed (Ref. Photo No. 80 & 81, red arrow).

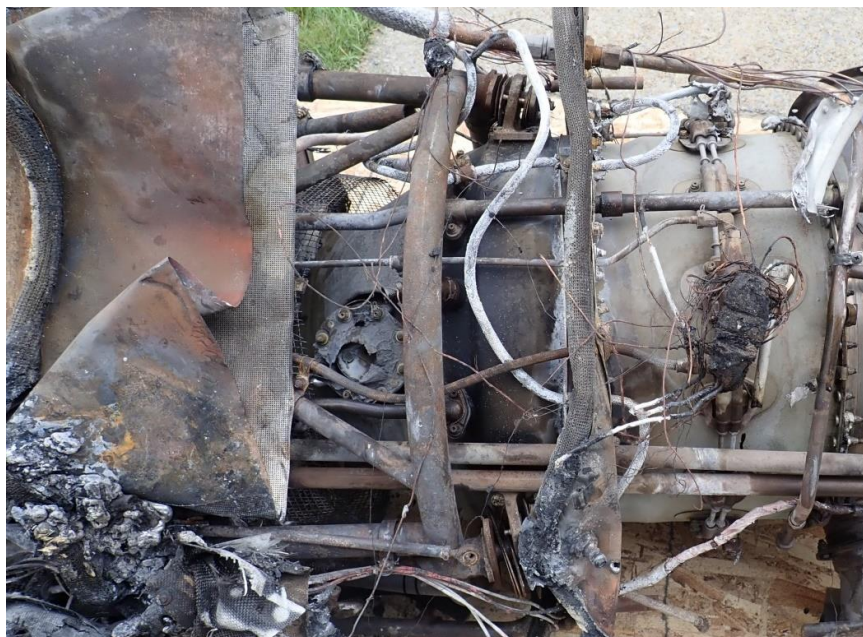
Photo No. 83

**Gas Generator Case (GGC):** The external components and engine mounts were thermally damaged and the case exhibited a bent region adjacent to the right hand engine mount (Ref. Photos No. 82 & 83).

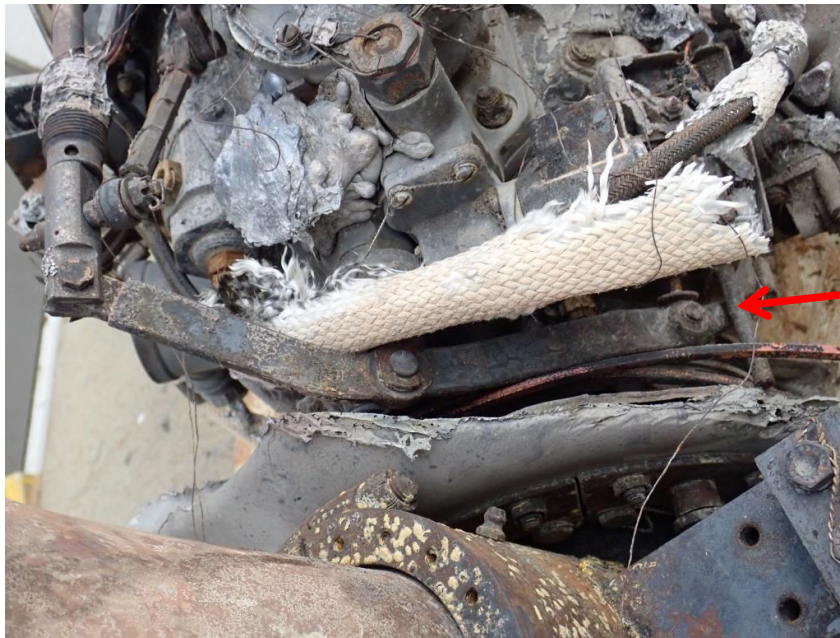
Photo No. 85

The end of the reversing lever was in position under the guide pin (Ref. Photo No. 85, red arrow). The end airframe cable was attached to the propeller speed control lever (Ref. Photo No. 86, blue arrow). The low pitch stop adjuster was consumed separating the front push-pull swivel joint casing from the low pitch adjusting stop reversing mechanism (Ref. Photo No. 86, red arrow). The wire rope was in place and the remaining linkage was in place and secure. The CAM box was discoloured from corrosion due to heat exposure (Ref. Photo No. 87, red arrow). The airframe power control cable was attached to the CAM lever (Ref. Photo No. 87, blue arrow). The connecting rod between the CAM and the fuel control arm was in place (Ref. Photo No. 88, red arrow). A comparison between Photo No. 86 that was taken during the engine examination to Photo No. 89 that was taken at the accident site show the propeller speed control appears to be in the same position. A comparison between Photo No. 87 that was taken during the engine examination to Photo No. 90 that was taken at the accident site, show the CAM box components appear to be in the same position.

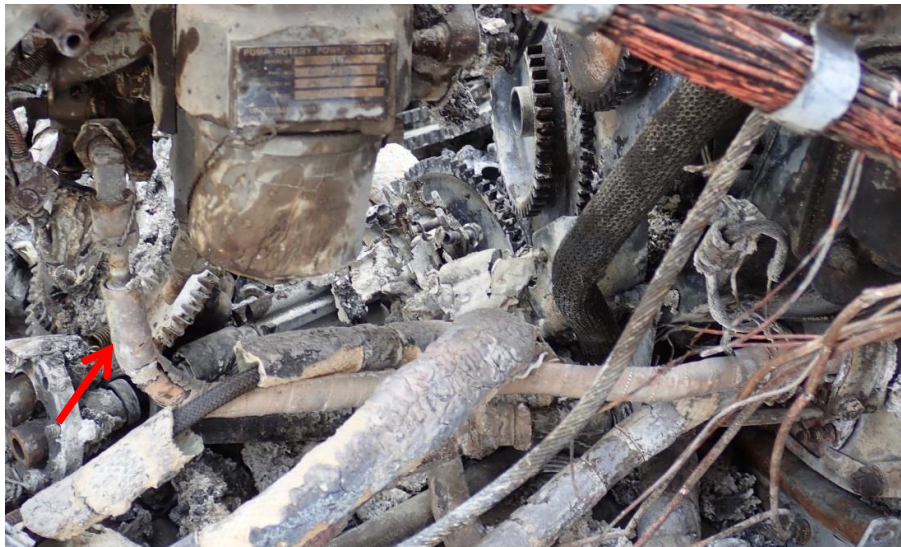
Photo No. 91

**Compressor Discharge Air (P3):** The exterior coating was burned off of the insulated section. The line was in place from the fuel control fitting to the gas generator case port (Ref. Photos No. 91 & 92, red arrows).

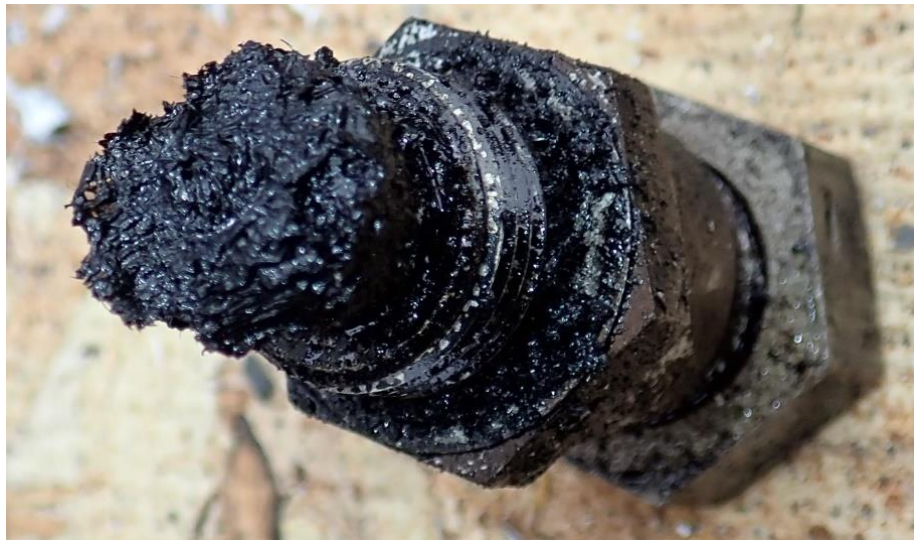
Photo No. 95

**Chip Detector(s):** The detector's magnetic poles were completely covered by the melted potting material (Ref. Photo No. 95).

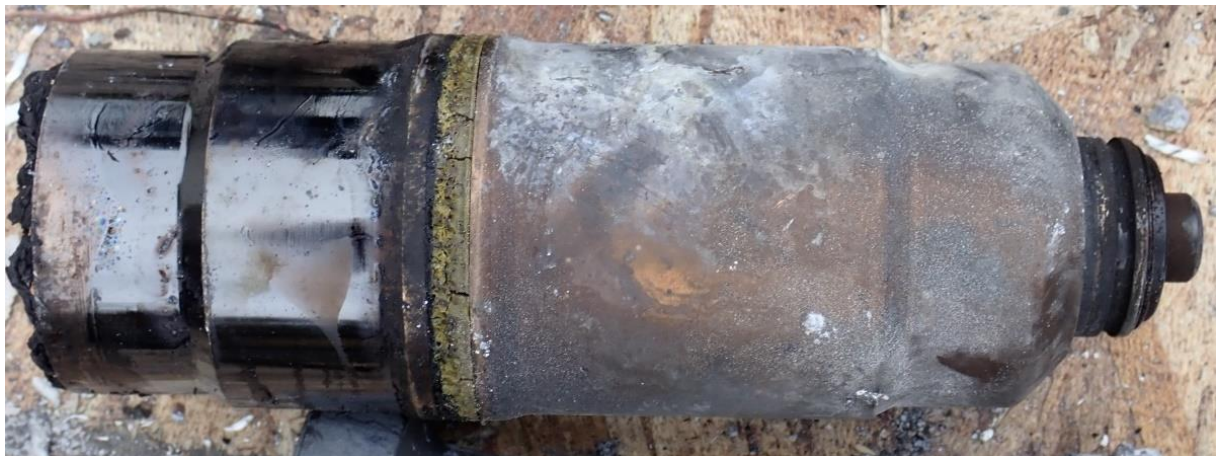
Photo No. 96

**Oil Filter:** Melted material from the packing and the filter were extruding between the filter housing and the filter element (Ref. Photos 96 & 97). The filter was not removed from the filter housing for the purpose of this investigation.

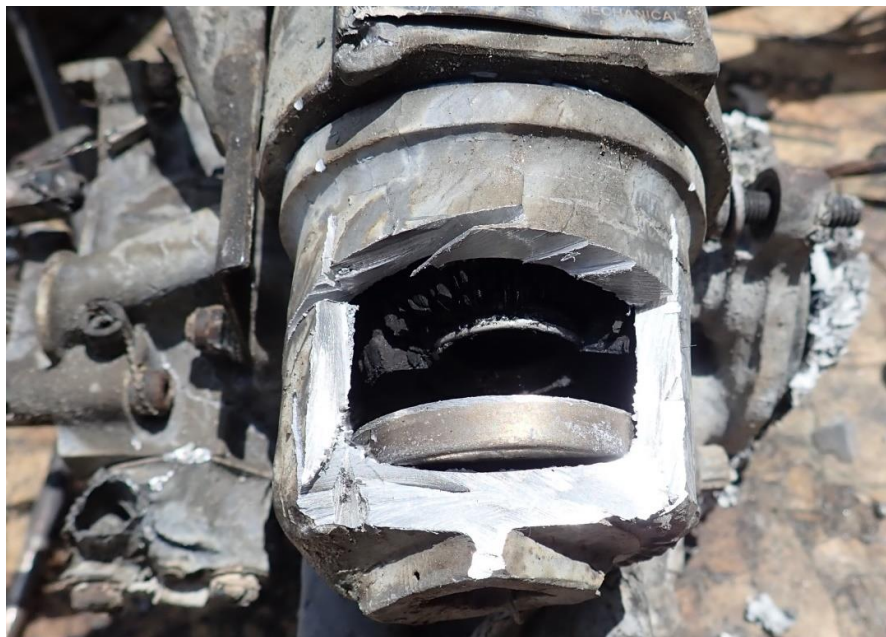
Photo No. 98

**Fuel Filter:** The filter housing was sectioned to view the filter. The filter was thermally damaged (Ref. Photo No. 98).

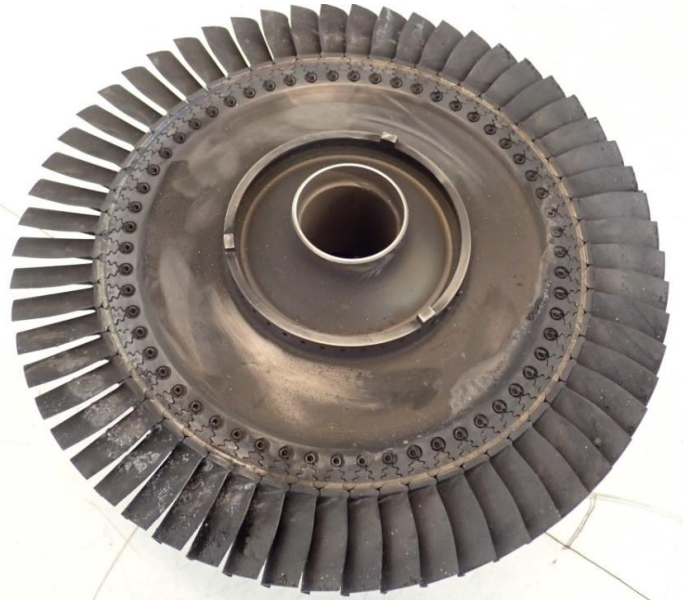
Photo No. 99, view of the downstream side

**Compressor Turbine:** The downstream side of the compressor turbine disc and blades exhibited circumferential scoring from contact with the power turbine vane (Ref. Photo No. 99 & 100). The hub adjacent to the retention bolt bore exhibited some localized score marks from contact with the lip of the inner baffle (Ref. Photo No. 101). The upstream side of the turbine did not exhibit any visible damage (Ref. Photo No. 102). The blade tips exhibited some polished regions from contact with their respective shroud (Ref. Photo No. 103).

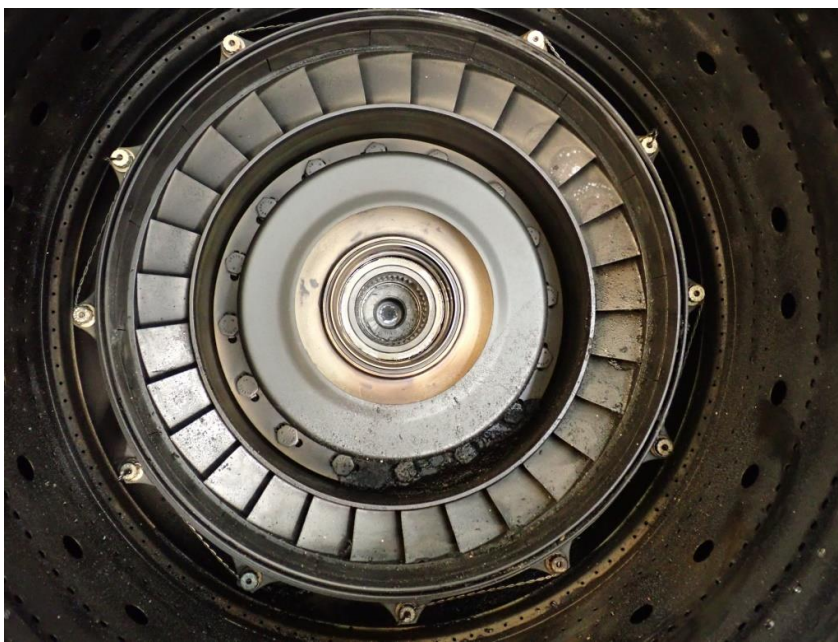
Photo No. 104, view of the downstream side

**Compressor Turbine Vane:** The vane was not removed for the purpose of this investigation. The visible section of the vane did not exhibit any visible damage (Ref. Photo No. 104).

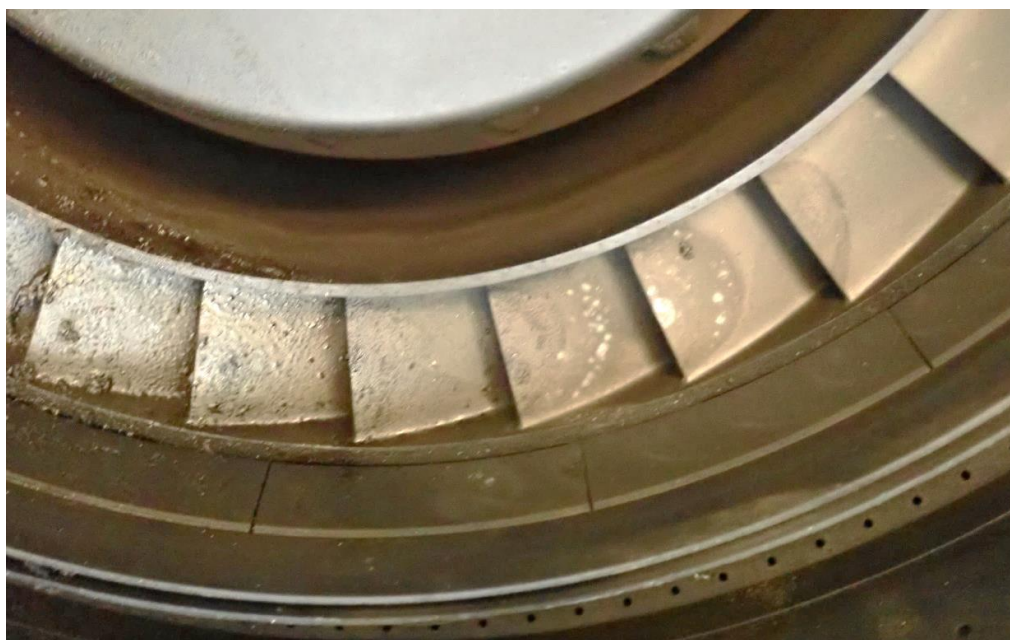
Photo No. 105

**Compressor Turbine Shroud:** The shroud exhibited some rubbing as viewed through the soot buildup coating the surface (Ref. Photo No. 105).

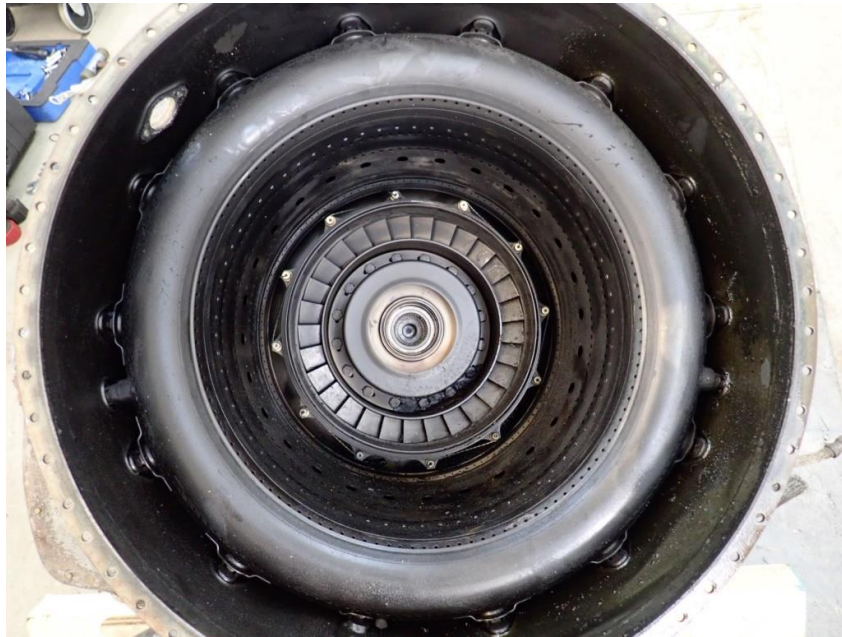
Photo No. 106

The liner was not removed for the purpose of this investigation. The visible section of the liner exhibited staining, and was partially coated with oil residue, ingested debris and dirt (Ref. Photo No. 106). The large exit and small exit ducts were not accessed for the purpose of this investigation.

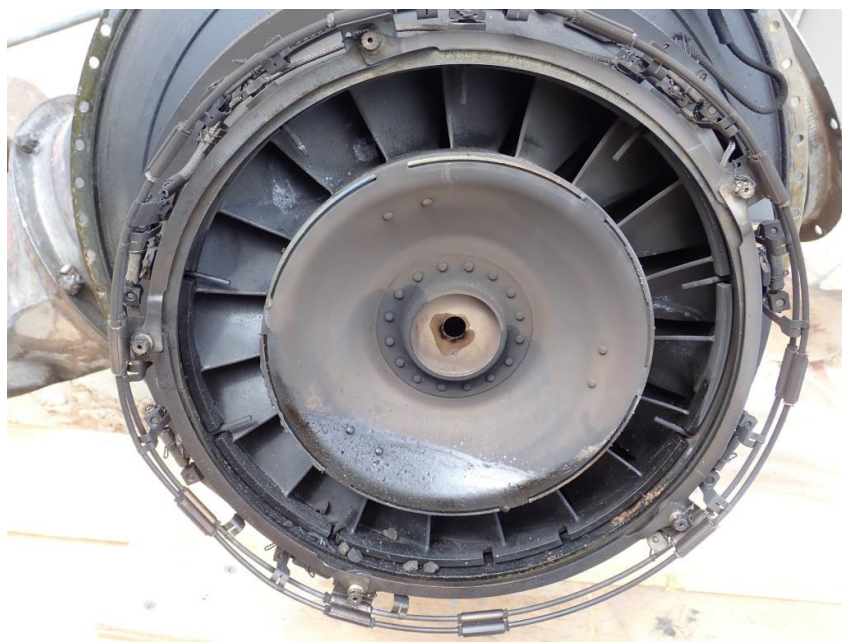
Photo No. 108

**Inter Turbine Temperature Probes, Busbar, and Harness:** The probes, busbar, and harness were in place and no visible damage was evident (Ref. Photos No. 107 & 108).

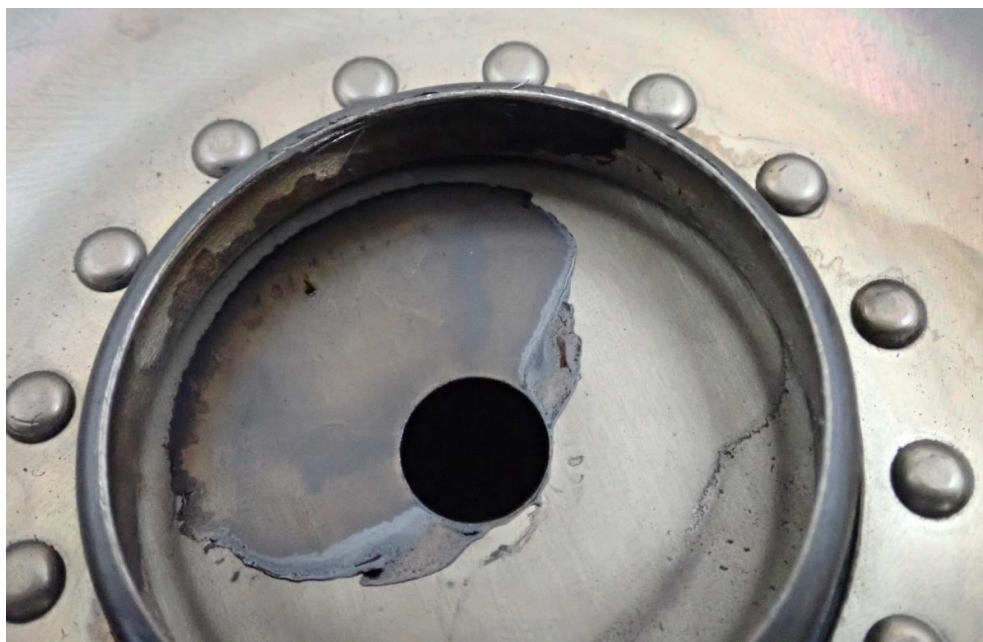
Photo No. 115, view of the downstream side

**Power Turbine Vane and Baffle:** The upstream side of the vane inner rim and baffle exhibited circumferential scoring from contact with the compressor turbine (Ref. Photos No. 109, red arrows & 110). The inner baffle on the upstream side exhibited circumferential scoring from contact with the compressor turbine disk (Ref. Photo No. 111, red arrow). The downstream side of the baffle exhibited light circumferential rubbing from contact with the power turbine (Ref. Photo No. 112 & 113, red arrow). The baffle also exhibited static imprints of the power turbine blade platforms (Ref. Photo No. 113, blue arrow). The upper portion of the outer rim exhibited localized rubbing from contact with the blade tips (Ref. Photo No. 114, red arrow). The outer rim also exhibited static imprint marks from contact with the power turbine blade tips (Ref. Photo No. 114, blue arrow). The downstream side of the inner baffle exhibited circumferential scoring on the lip (Ref. Photo No. 115).

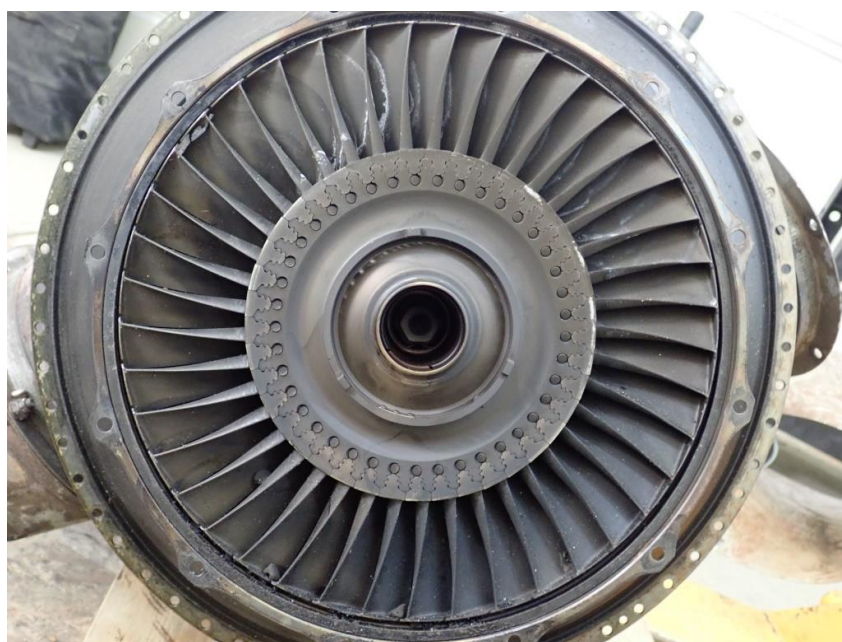
Photo No. 116, view of the upstream side

**Power Turbine:** The majority of the turbine blades exhibited some discolouration with soot/debris buildup adhered to their surfaces (Ref. Photo No. 116). The exhaust duct was distorted resulting in the turbine being loaded against the shroud at the 11 o'clock position (Ref. Photo No. 116). Photo No. 117 shows the gap between the blade tips and the shroud due to the exhaust duct distortion. The upstream side of several of the blade platforms exhibited circumferential rubs from rotational contact with the power turbine vane baffle (Ref. Photo No. 118, red arrows). The disc hub, adjacent to the retention bolt bore exhibited circumferential rubbing from contact with the lip of the inner baffle (Ref. Photo No. 119). The downstream side of the turbine was unremarkable except for discoloration (Ref. Photo No. 120). The blade tips exhibited rubs from contact with their respective shroud and the leading edge tips from contact with the power turbine vane (Ref. Photo No. 121).

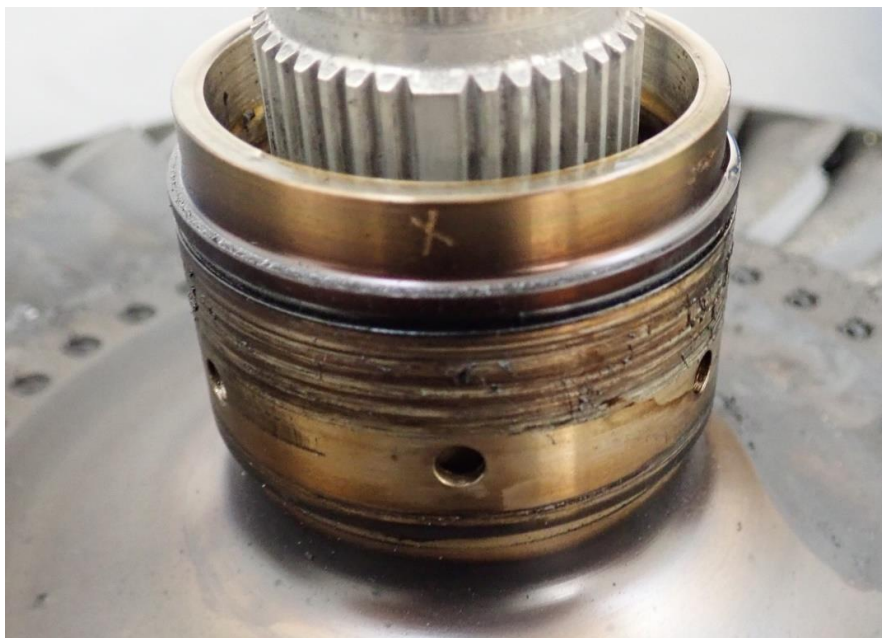
Photo No. 124

**Power Turbine Shaft and Housing:** The shaft and shaft housing were not accessed for the purpose of this investigation. The No. 3 bearing rotor air seal exhibited rubbing from contact with the No. 3 bearing stator air seal (Ref. Photo No. 124).
