**Report No.: 20-042**

**FMR Aviation LLC  
Piper PA-31T1, Aircraft Registration No. N926K  
Billings, Montana  
April 20, 2020  
PT6A-11  
Left Engine Serial No. 10234  
Right Engine Serial No. 10239**

**NTSB Identification: WPR20LA128**  
**TSB Identification: A20F0083**  
**P&WC File No.: 20-042**  
**RFA No.: 20SIE00091**

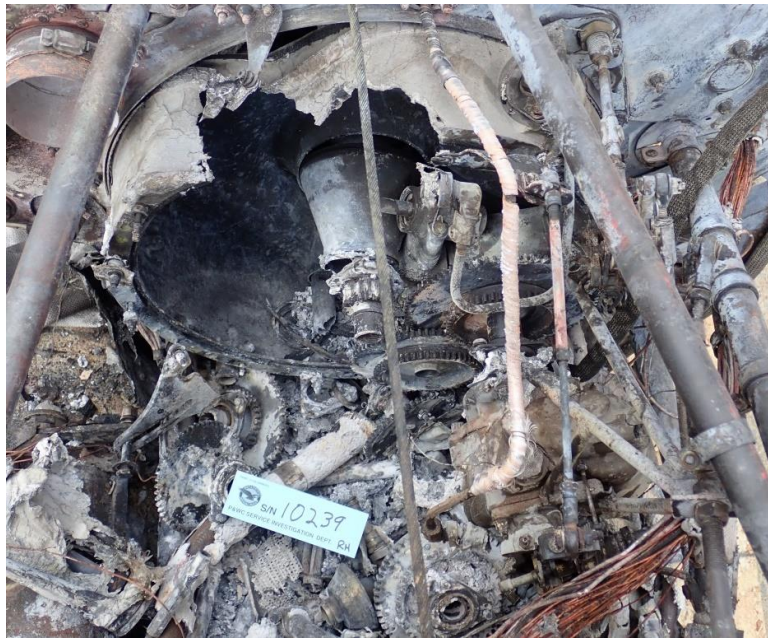
Photo No. 130

The gearbox housings were consumed by the post impact fire, exposing the spur gears, bearings and the scavenge oil pump gears (Ref. Photos No. 130 & 131). The inlet case struts were either fractured or burned away (Ref. Photos No. 132). The upper section and a portion of the lower wall of the oil tank were consumed in the fire (Ref. Photo No. 133, red arrows).

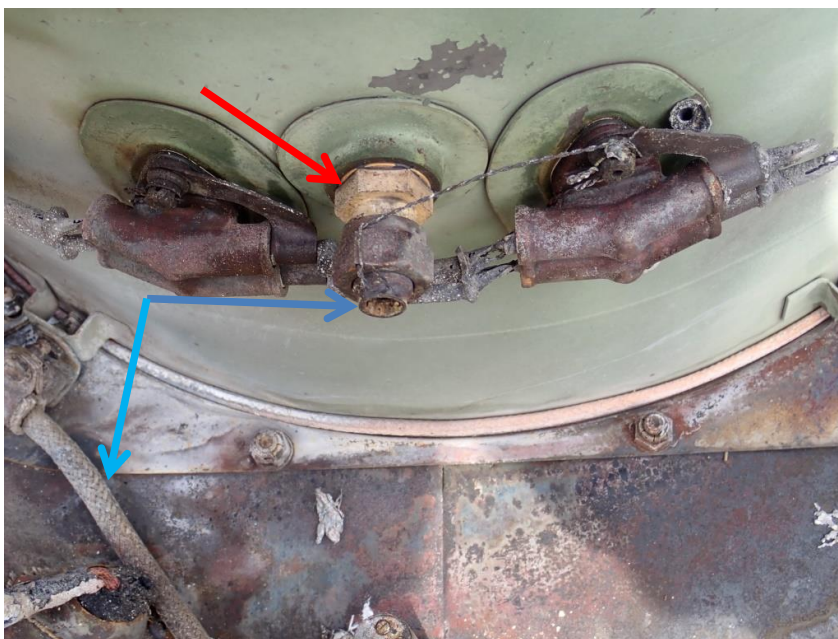
**Ignition Leads:** The left hand lead was fractured and both leads were thermally and impact damaged (Ref. Photo No. 134 & 135, blue arrows).

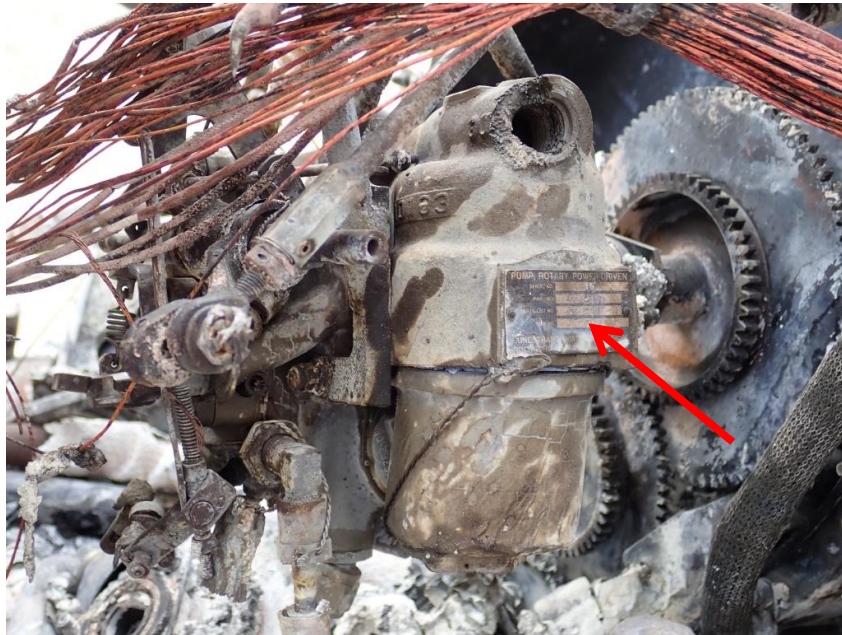
Photo No. 136

**Fuel Pump:** The majority of the pump housings were thermally damaged in the post impact fire (Ref. Photo No. 136, red arrow).

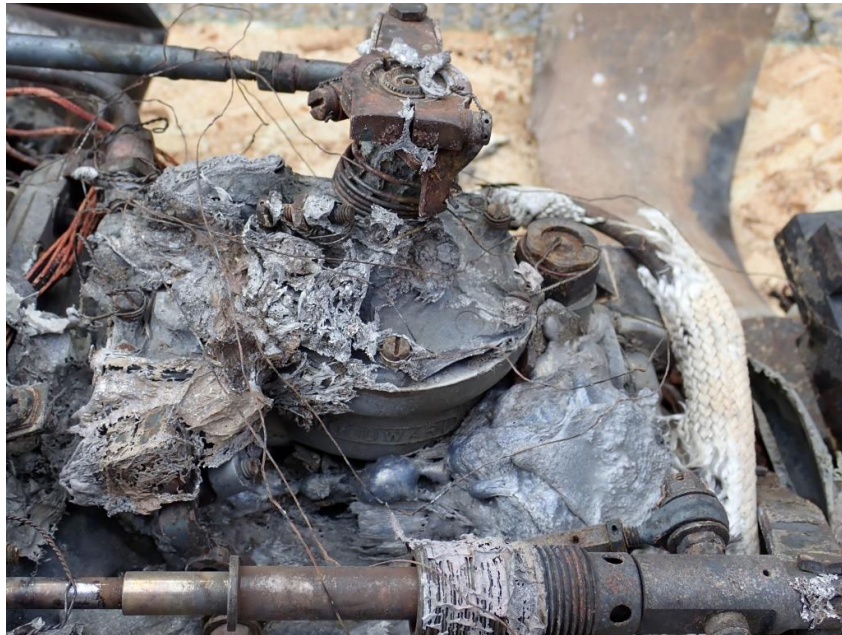
Photo No. 141

**Propeller Governor (CSU):** The governor was mounted on its respective pad on the reduction gearbox and the housing was thermally damaged (Ref. Photo No. 141).
