## **NATIONAL TRANSPORTATION SAFETY BOARD**

# **ENGINE EXAMINATION SUMMARY REPORT**

**WPR20LA131**

Location: Currie, NV  
Date: April 24, 2020  
Aircraft: N8743A  
NTSB IIC: Albert Nixon

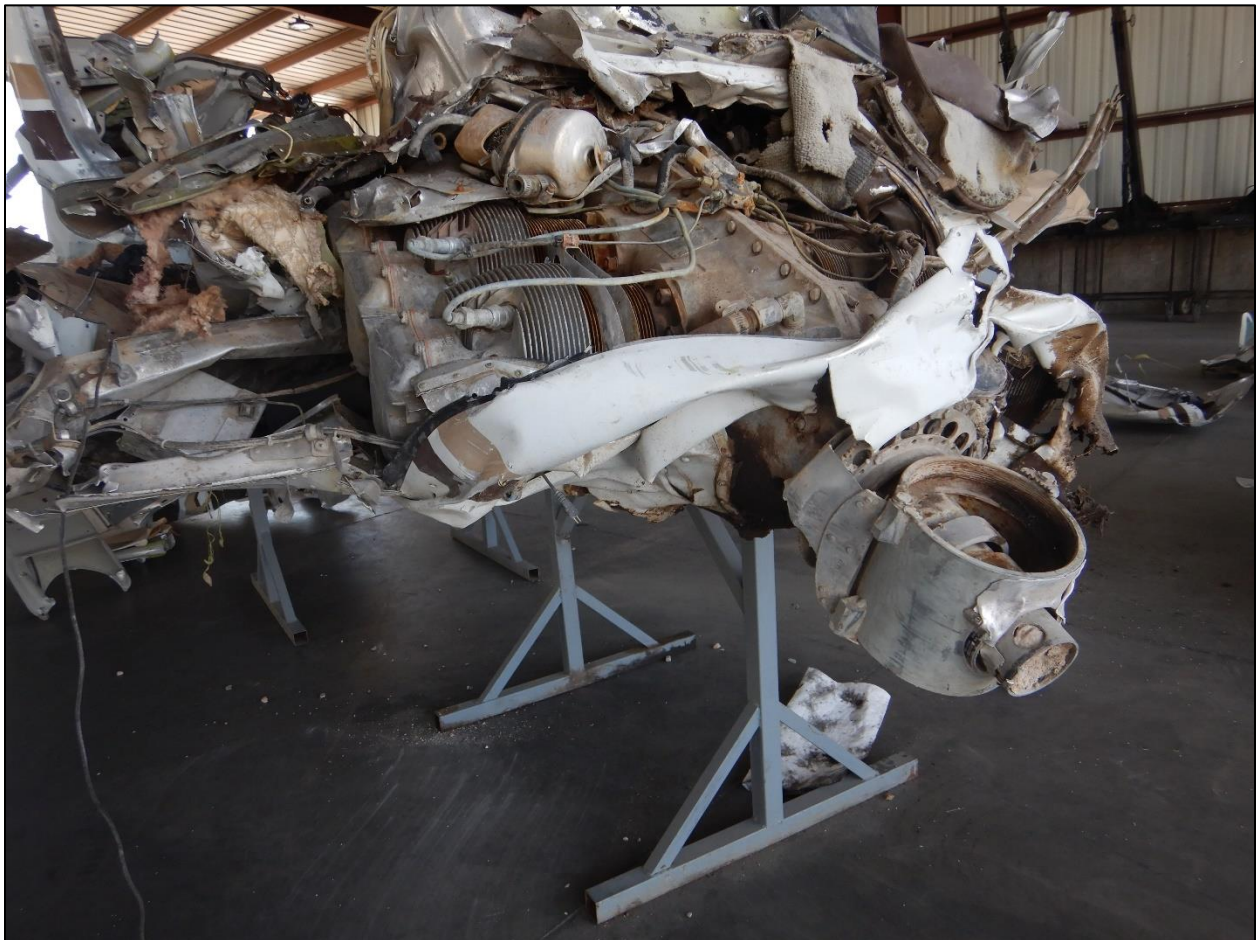
The engine remained partially attached to the airframe. The upper cowling separated revealing the top side of the engine. The forward cowling was crushed and remained partially attached. The glareshield and firewall had impact damage and covered the aft side of the engine and accessory section. The propeller blades separated from the hub which remained attached to the crankshaft. The pitch change assembly had impact damage. The engine was removed from the airframe and all four engine mount legs were crushed.

*Figure 1-Engine and airframe.*

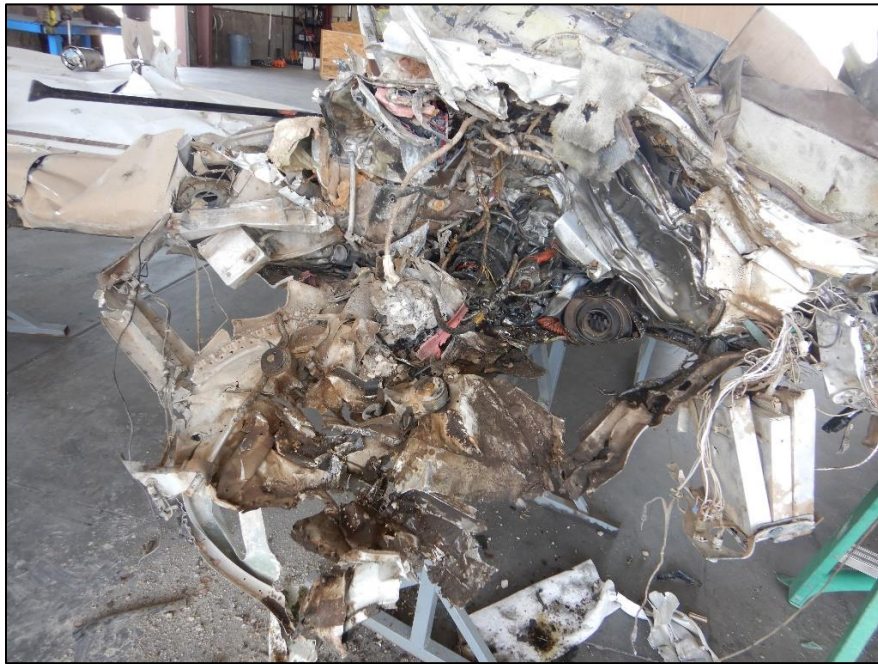
The lower cowling and engine mounting assembly were crushed. The carburetor and induction plenum/oil sump were crushed and remained in the lower cowling. The starter and fuel pump separated from the engine and were found near the firewall. The left exhaust muffler and both exhaust pipes were crushed and remained with the main wreckage. The No. 6 cylinder rocker cover had impact damage on its lower forward side. The accessory section had impact damage and was crushed forward. The engine's internal surfaces were visible. The surfaces were covered in residual oil and dark in color.

*Figure 2-Lower cowling and engine mounting assembly.*

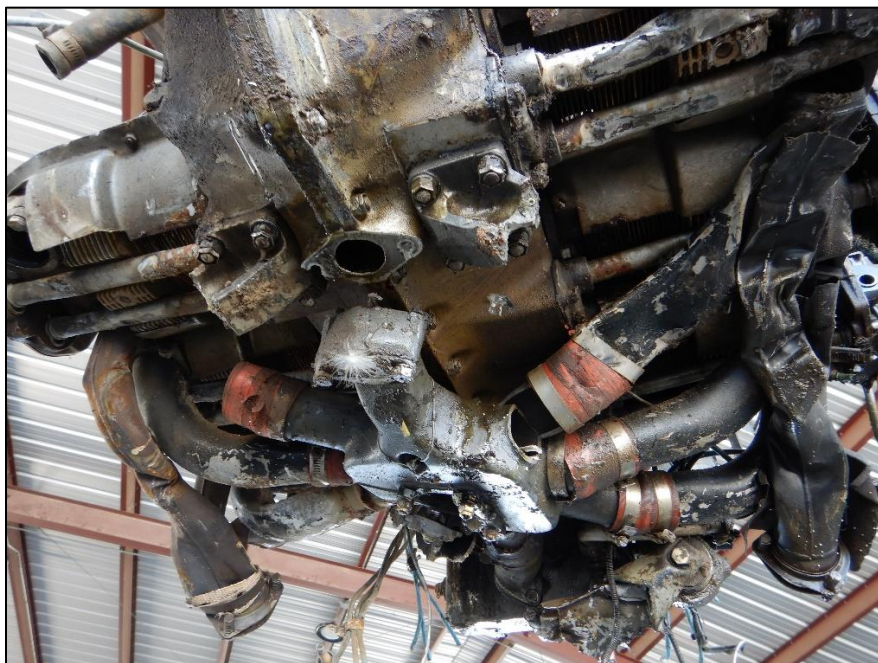
*Figure 3-Induction plenum and lower side of engine.*

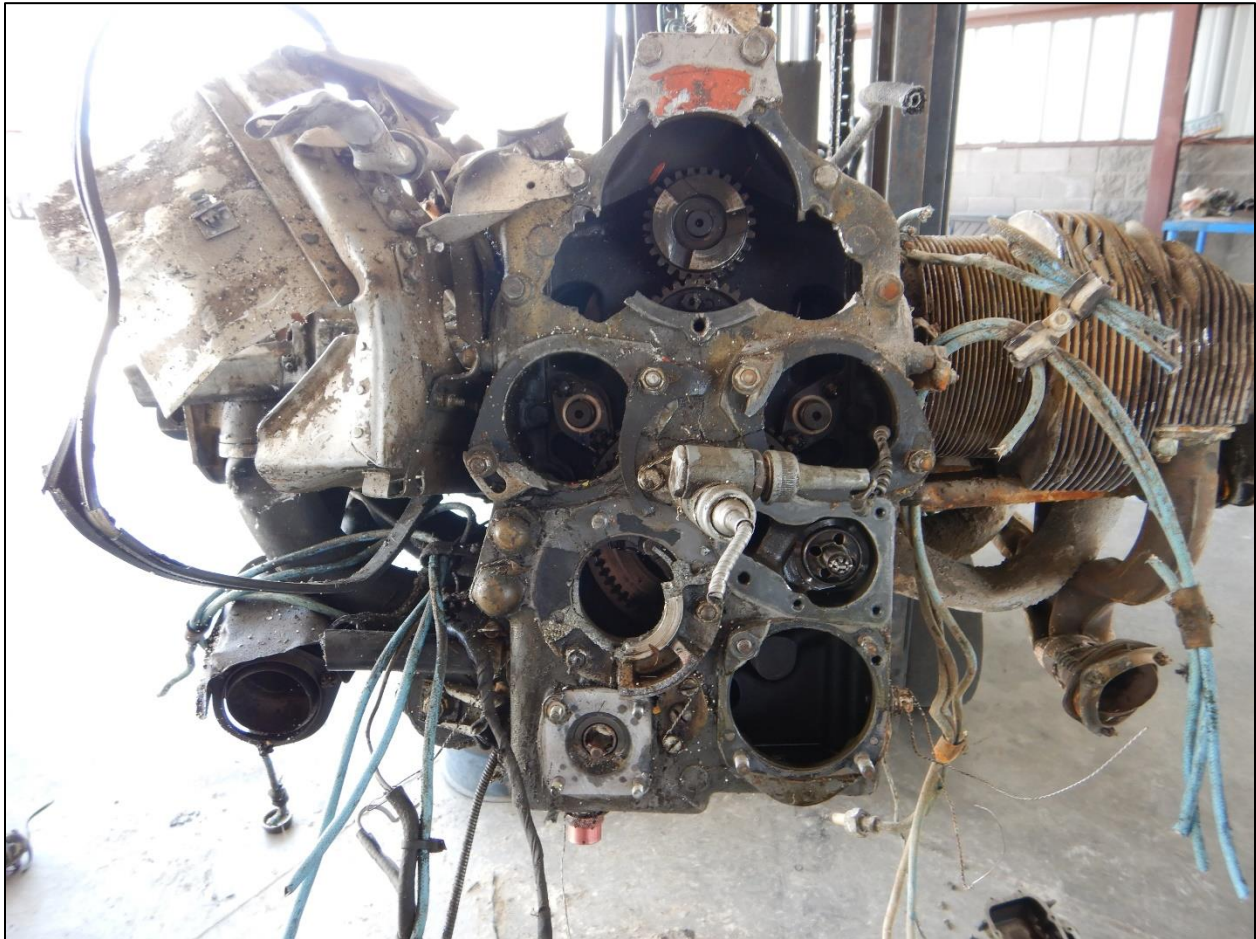
The accessory section had impact damage. A lighted borescope was used to examine the interior of the engine and no anomalies were noted. The accessory section was not removed from the engine during the examination.

*Figure 4-Accessory section.*

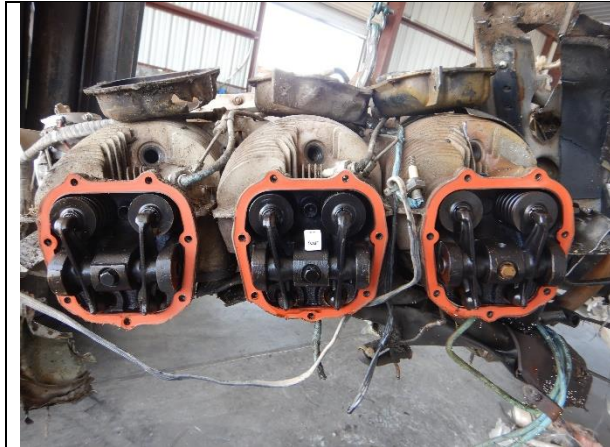
The cylinder rocker covers were removed, and the overhead components were black in color and covered in residual oil. The cylinders were undamaged.

*Figure 5-Left cylinder's overhead components.*

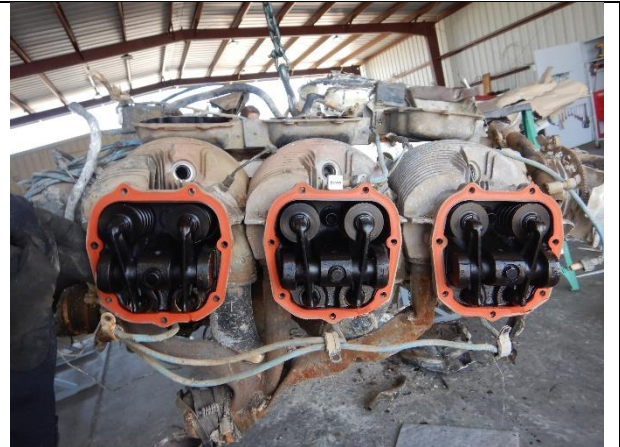
*Figure 6-Right cylinder's overhead components.*

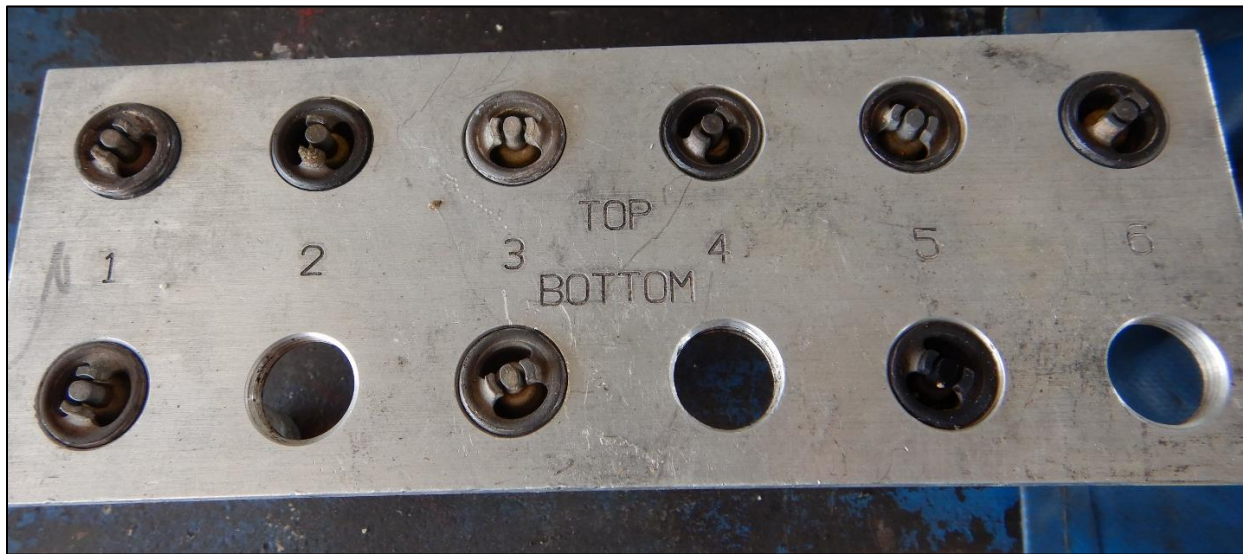
The upper sparkplugs and lower Nos. 1, 3, and 5 sparkplugs were removed and displayed in a rack. The sparkplugs had a normal amount of combustion deposits and the electrodes had normal wear. The lower No. 5 sparkplug electrode area was covered in black combustion deposits. The lower Nos. 2, 4, and 6 sparkplugs were not removed due to impact damage to the adjacent exhaust assembly. The sparkplug electrodes were later examined with a lighted borescope.

*Figure 7-Sparkplugs.*

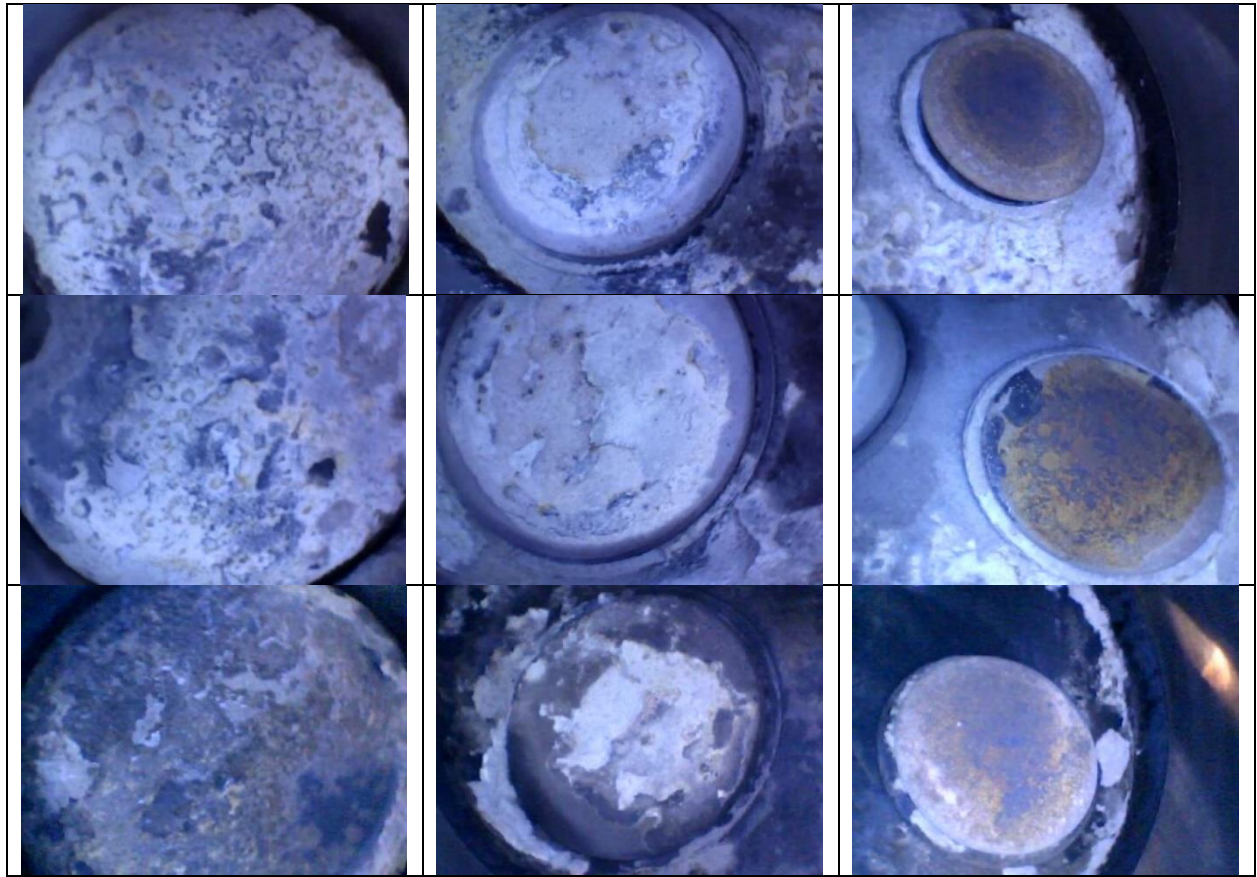
The cylinders were examined with a lighted borescoped and all cylinder combustion chambers were undamaged. The combustion chambers had a heavy amount of combustion deposits.

*Figure 8-Borescope examination of cylinder Nos. 1, 3, and 5 piston domes and valve heads.*

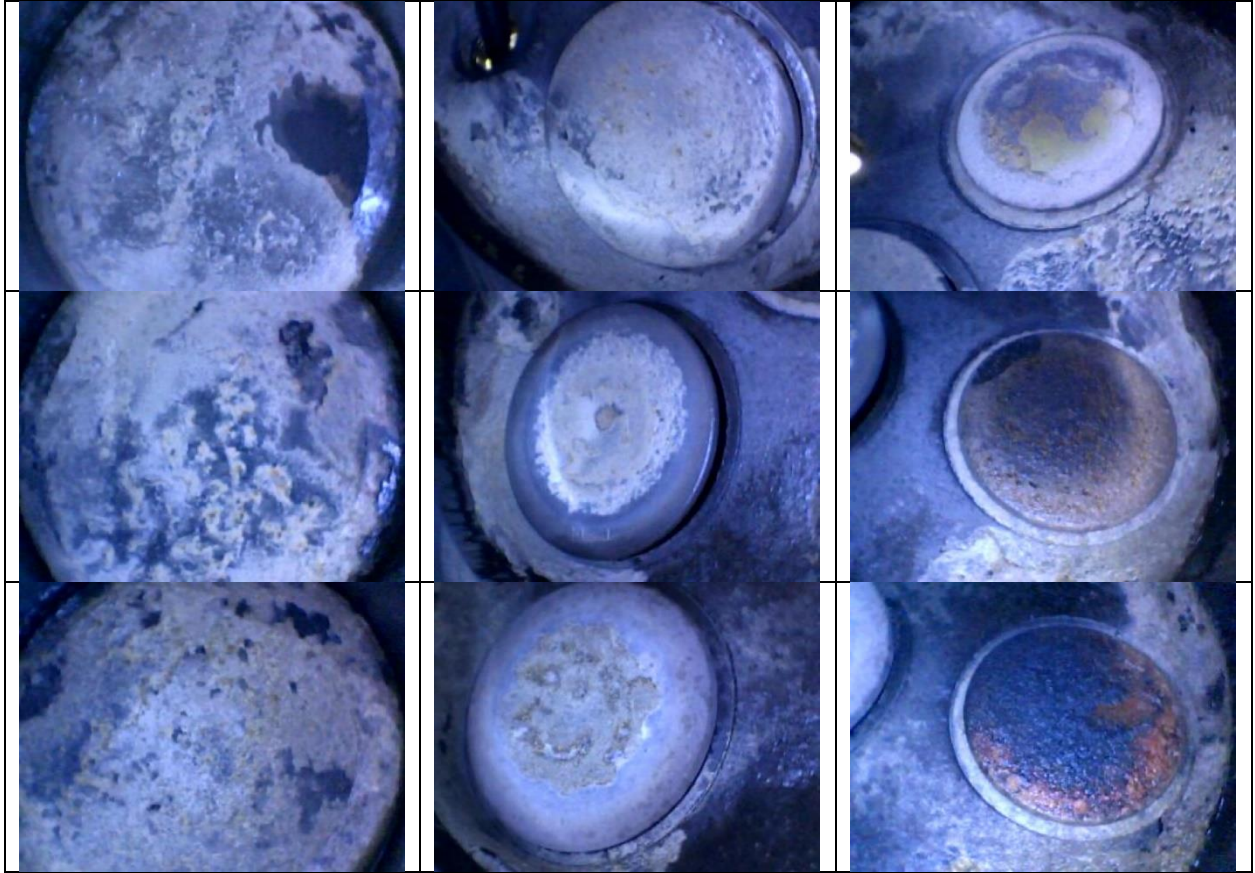
Figure 9-Borescope examination of cylinder Nos. 2, 4, and 6 piston domes and valve heads.

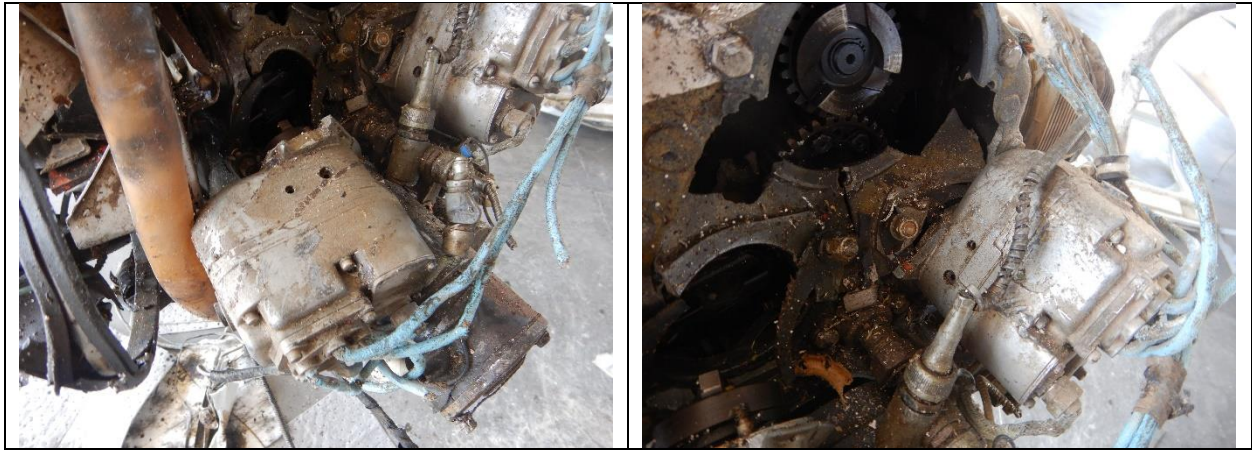
The left magneto had impact damage to its mounting flange and separated from its accessory mount. The right magneto had impact damage to its mounting flange and housing and was partially separated from its accessory mount. The ignition leads had impact damage.

*Figure 10-Magnetos.*

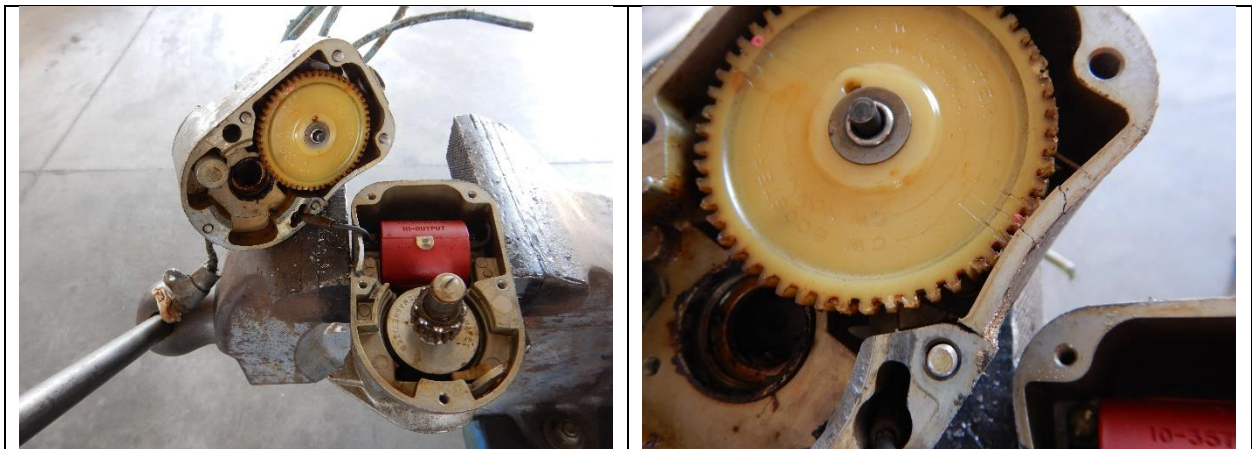
The magnetos were removed from the engine. The left magneto drive rotated, and spark was obtained from the damaged ignition leads. The right magneto had impact damage to its housing and the drive shaft had resistance when rotated by hand. The magneto was disassembled, and the plastic gear teeth were in contact with the side of the damaged housing. The magneto housing was hammered back, free of the gear, and the magneto was reassembled. The magneto drive rotated, and spark was observed at each of the damaged ignition lead ends.

*Figure 11-Right magneto disassembly and examination.*

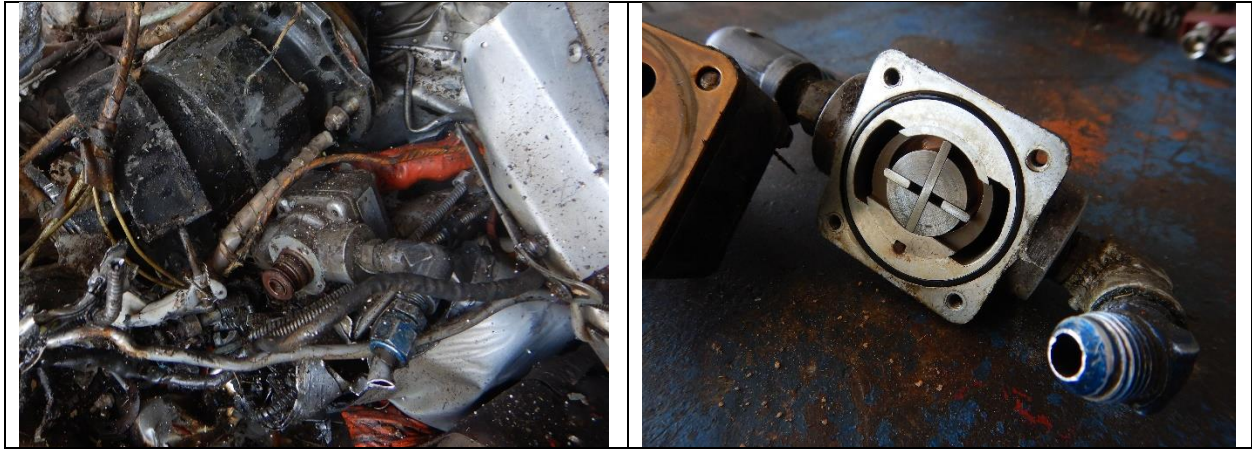
The fuel pump was removed from the firewall area and fuel line fittings were tight when removed. The fuel pump was disassembled, and no anomalies were noted.

*Figure 12-Fuel pump disassembly and examination.*

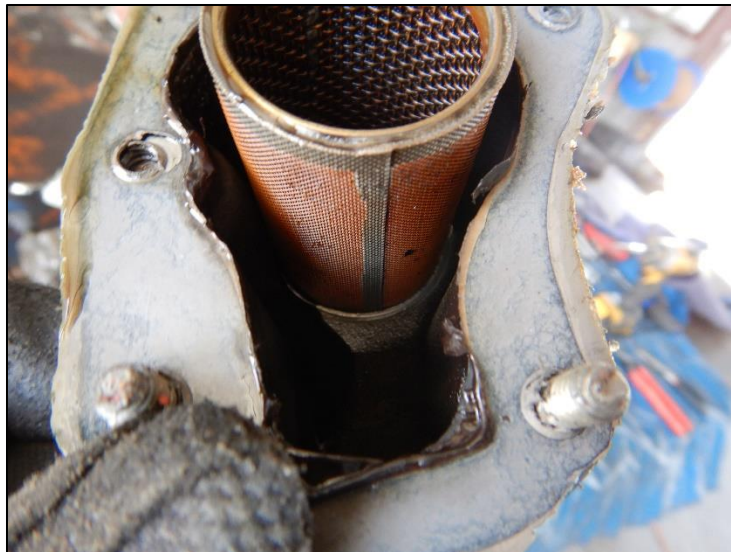
The oil pump gears were visible from the accessory section and no anomalies were noted. The oil filter screen was removed from the accessory section and was clear of debris.

*Figure 13-Oil filter housing and screen.*

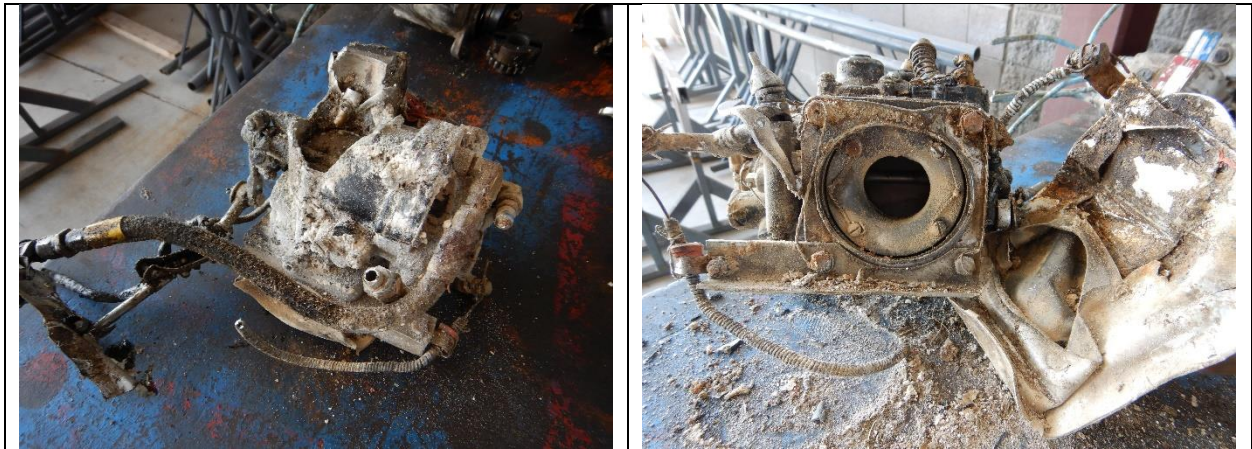
The throttle and mixture cables were cut, and the carburetor was removed from the lower cowl area. The carburetor had impact damage to several of its components and was covered in white corrosion deposits. The fittings attached to the carburetor were tight and secured. The inlet fuel screen was removed and contained a small amount of fibrous material. The carburetor mount fractured and separated from the carburetor. The throttle and mixture linkage remained attached and had impact damage. The throttle linkage moved slightly corresponding with movement from the throttle valve. The mixture linkage had impact damage and had limited movement. The induction air box was partially attached and was crushed.

Figure 14-Carburetor.

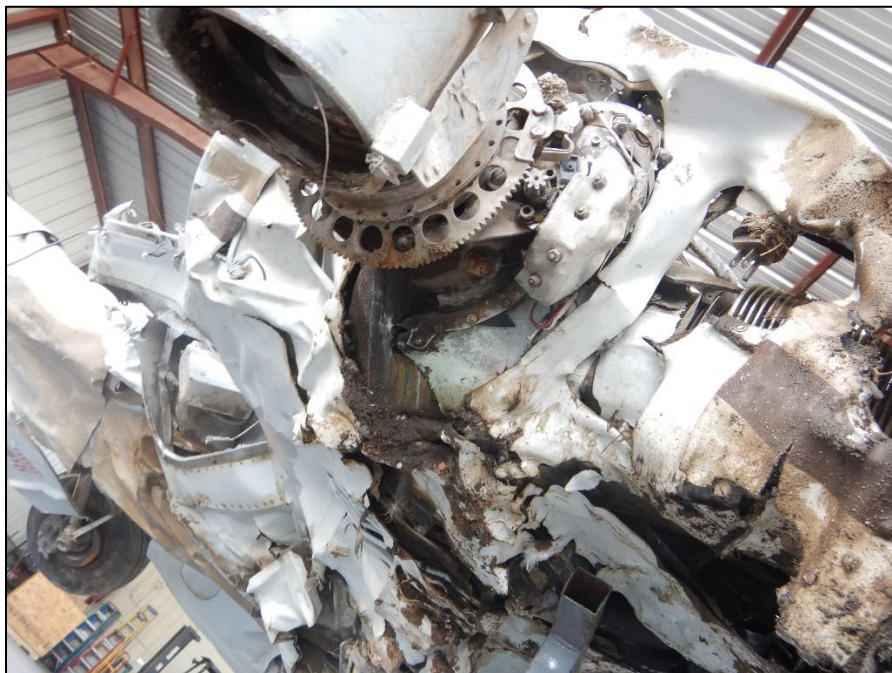
The propeller hub and pitch change assembly was removed from the engine and had impact damage. The motor's internal gearing was visible and covered in a heavy grease.
