# NATIONAL TRANSPORTATION SAFETY BOARD

## MATERIALS LABORATORY FACTUAL REPORT

Report No. 21-086

Place : Lodi, California  
Date : April 28, 2020  
Vehicle : Cessna 177, N3386T  
NTSB No. : WPR20LA133  
Investigator : Joshua Cawthra, AS-WPR

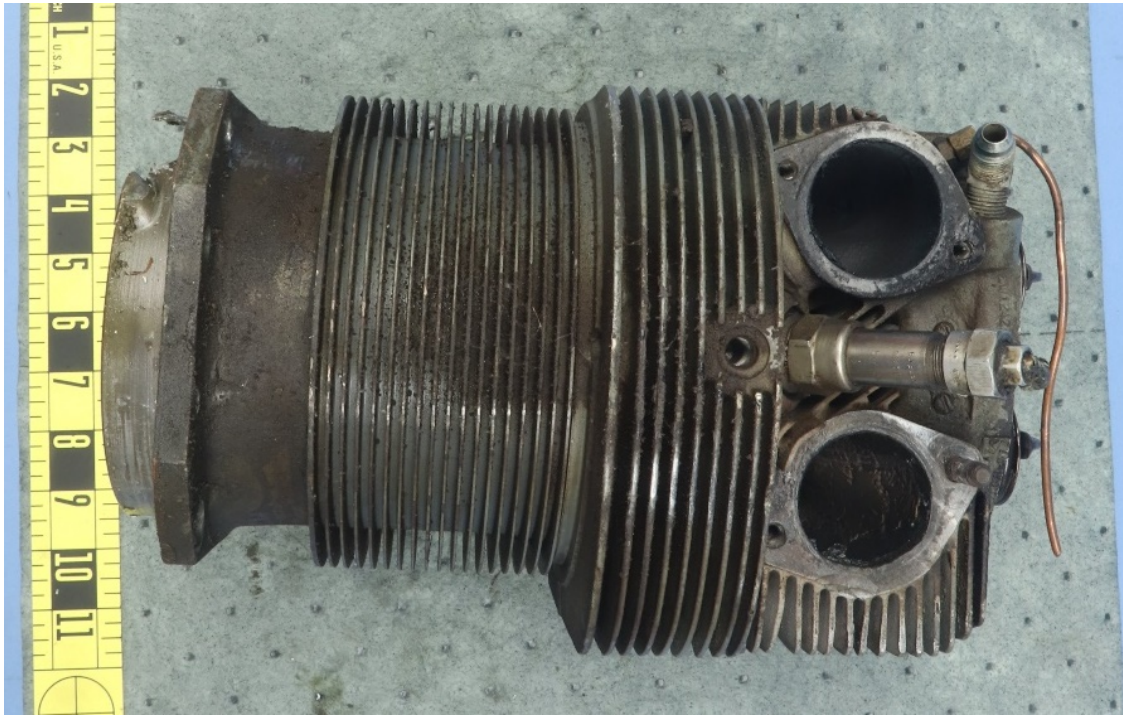
Figures 1 and 2 show different views of the #3 cylinder, as received. Much of the cylinder assembly, particularly on the exterior, exhibited damage consistent with that typically observed from being in service, including grayish discolorations on the exterior surfaces and oil deposits. However, as seen in the upper left of Figure 1 and the upper right of Figure 2b, the skirt of the cylinder was missing material, with the adjacent skirt material bent inward and with localized fractures and tears.

Figure 1 – View of the #3 cylinder, from the intake and exhaust manifold openings.

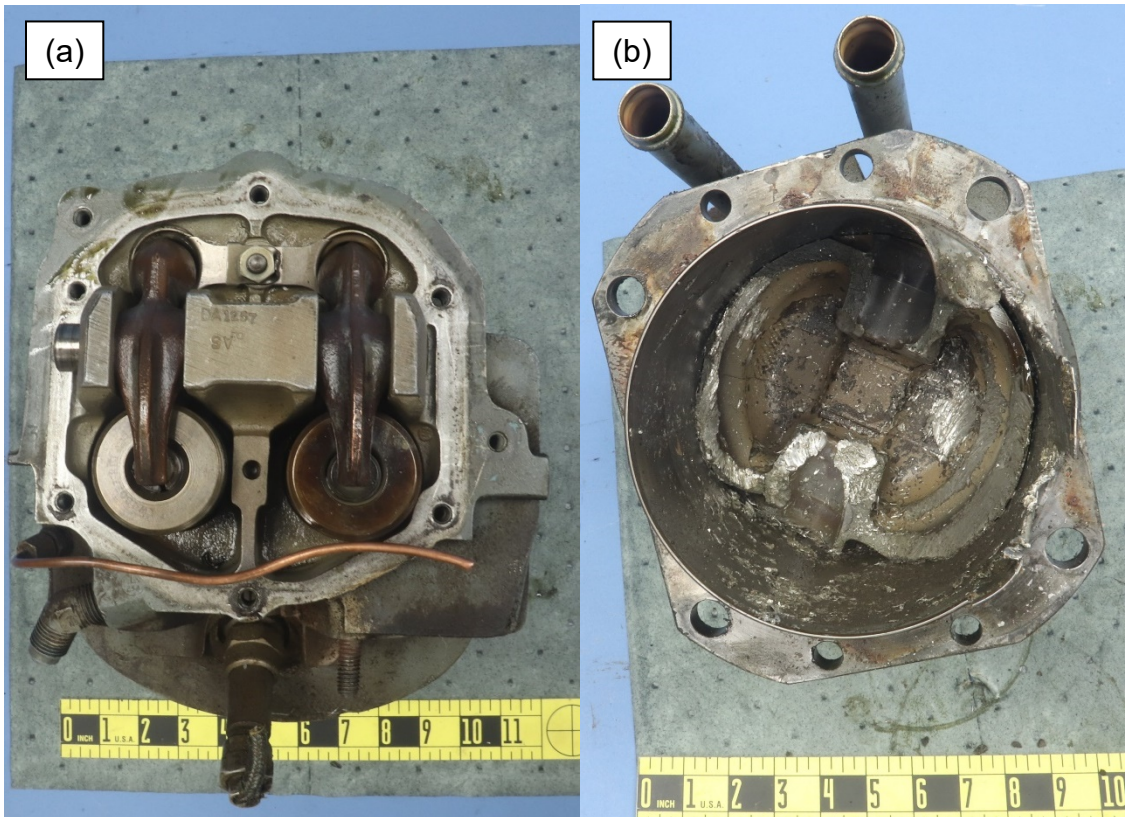
Also shown in Figure 2b was the underside of the piston still wedged inside the cylinder when received. While intact overall, the piston exhibited multiple fracture surfaces, consistent with areas containing the pin having broken downward. These fracture surfaces exhibited either rough dull features, or flat shiny and high directional features. These were consistent with fracture from overstress, and subsequent post-fracture smearing, respectively. There were no features consistent with progressive cracking or corrosive attack on this cylinder assembly.

Figure 2 – View of the #3 cylinder assembly from the (a) upper (rocker arm) position and (b) underside or piston position.

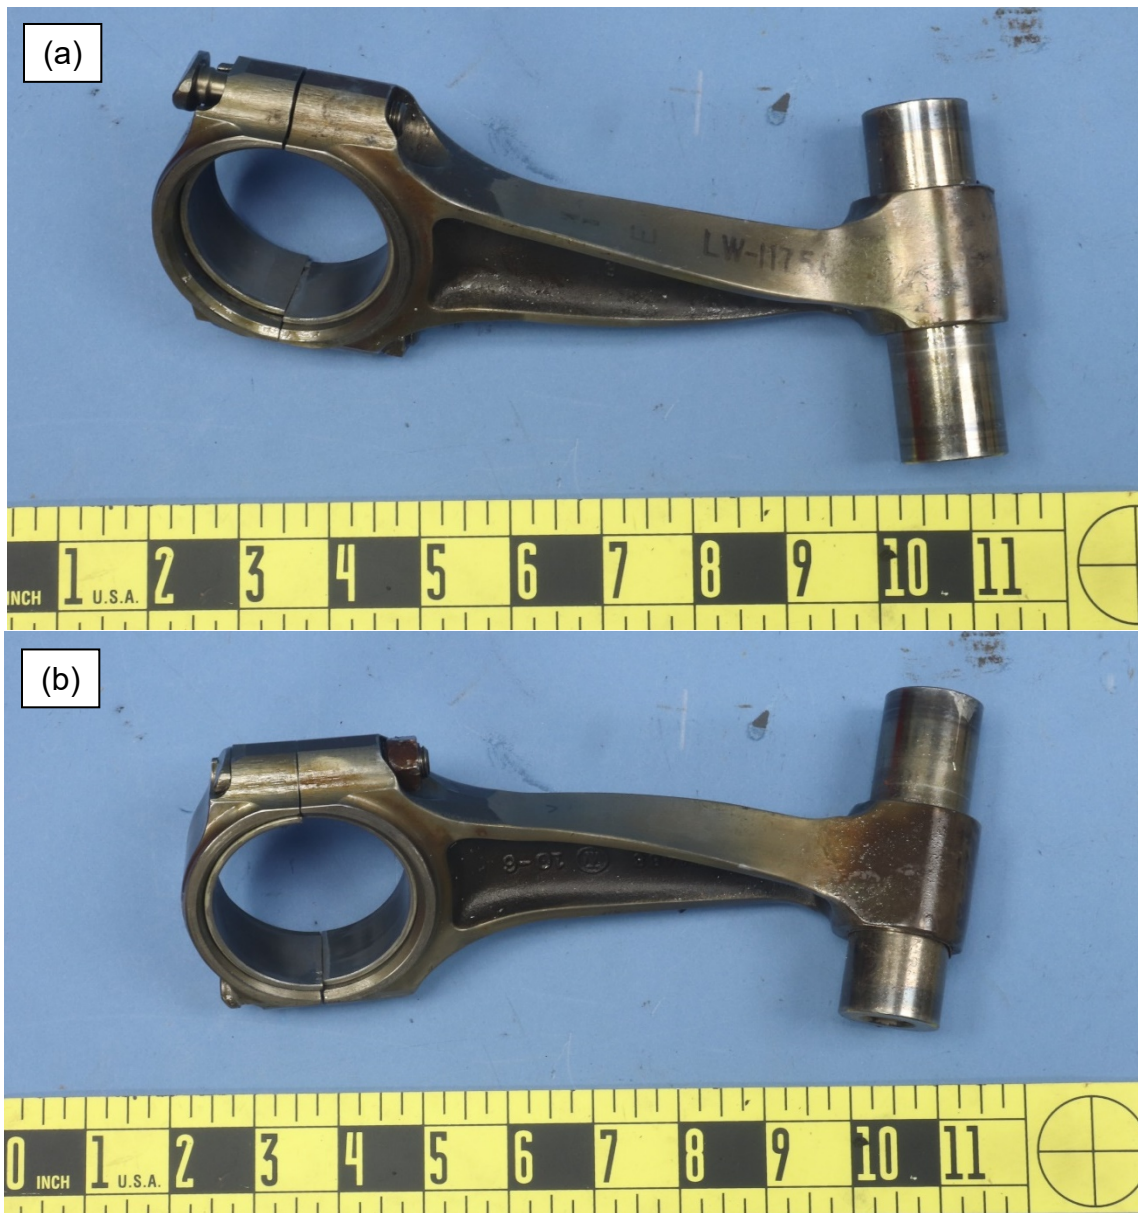
The connecting rod from this cylinder is shown from different web faces in Figure 4. The rod assembly had been disassembled from the engine and reassembled prior to receipt. The markings on the part flange stated "LW-11750" and in the web stated, "LW-11488 W 10-6". The neck of the connecting rod had been twisted approximately 90°, most pronounced near the piston pin bore. In addition, the rod exhibited more discoloration in this area, consistent with oil decomposition and subsequent deposits, typical of exposure to higher temperatures.

Figure 3 – View of the connecting rod recovered from the #3 cylinder, showing a 90° twist from (a) the marked flange face and (b) the opposite flange face.

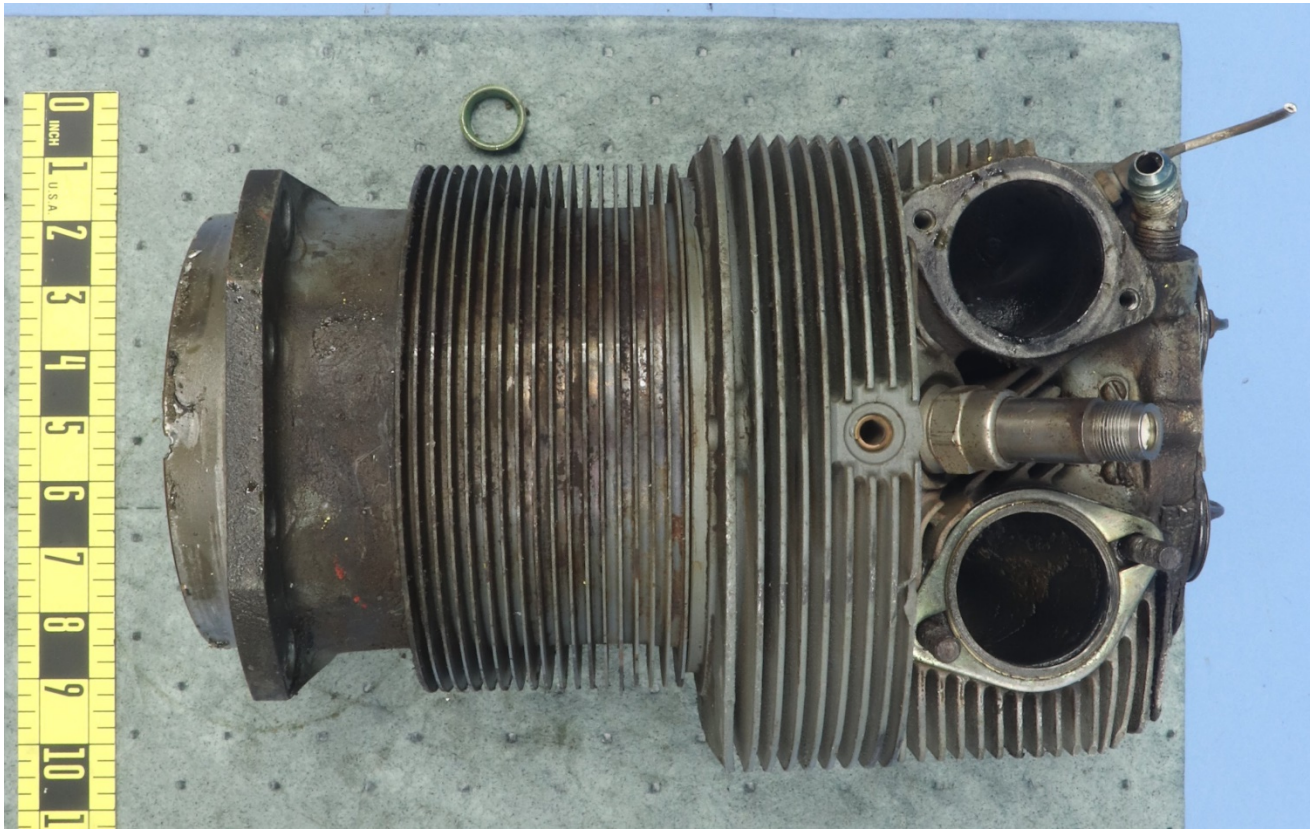
Figure 4 and Figure 5 show the #4 cylinder assembly from different locations. Figure 4 shows the side with the intake and exhaust manifolds, while the top of the cylinder with the rocker arms, retainers, and springs is depicted in Figure 2a. Figure 2b shows the underside of the piston, which had also been wedged against the walls of the cylinder. Unlike the other piston, this one was intact, with no fractures of the skirt or pin bore—the pin was still secure inside the piston, along with a remnant of the connecting rod. The recesses of the piston did exhibit shavings of metal, along with gouging on a corner of the skirt flange. These features were consistent with impact against a moving metallic object.

Figure 4 – View of the #4 cylinder assembly from the manifold side.

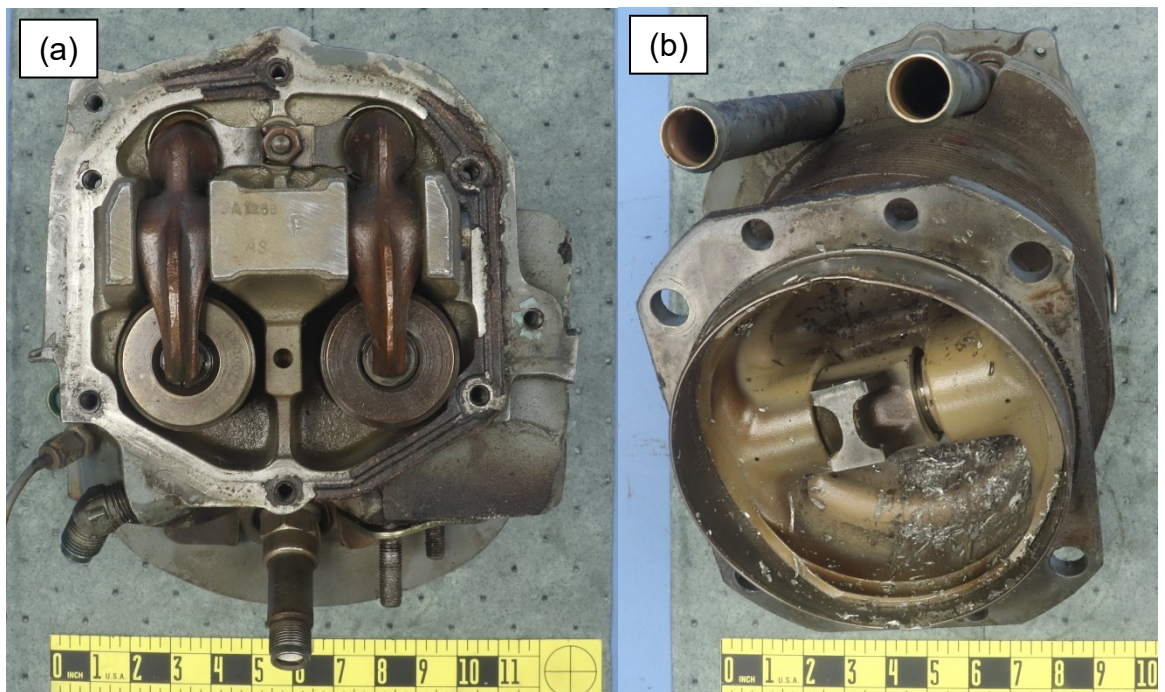
Figure 5 – The #4 cylinder assembly, as received, viewed from (a) the opened top section with the rocker arms and (b) the bottom piston position. The piston contained a remnant of the connecting rod secured by the piston pin.

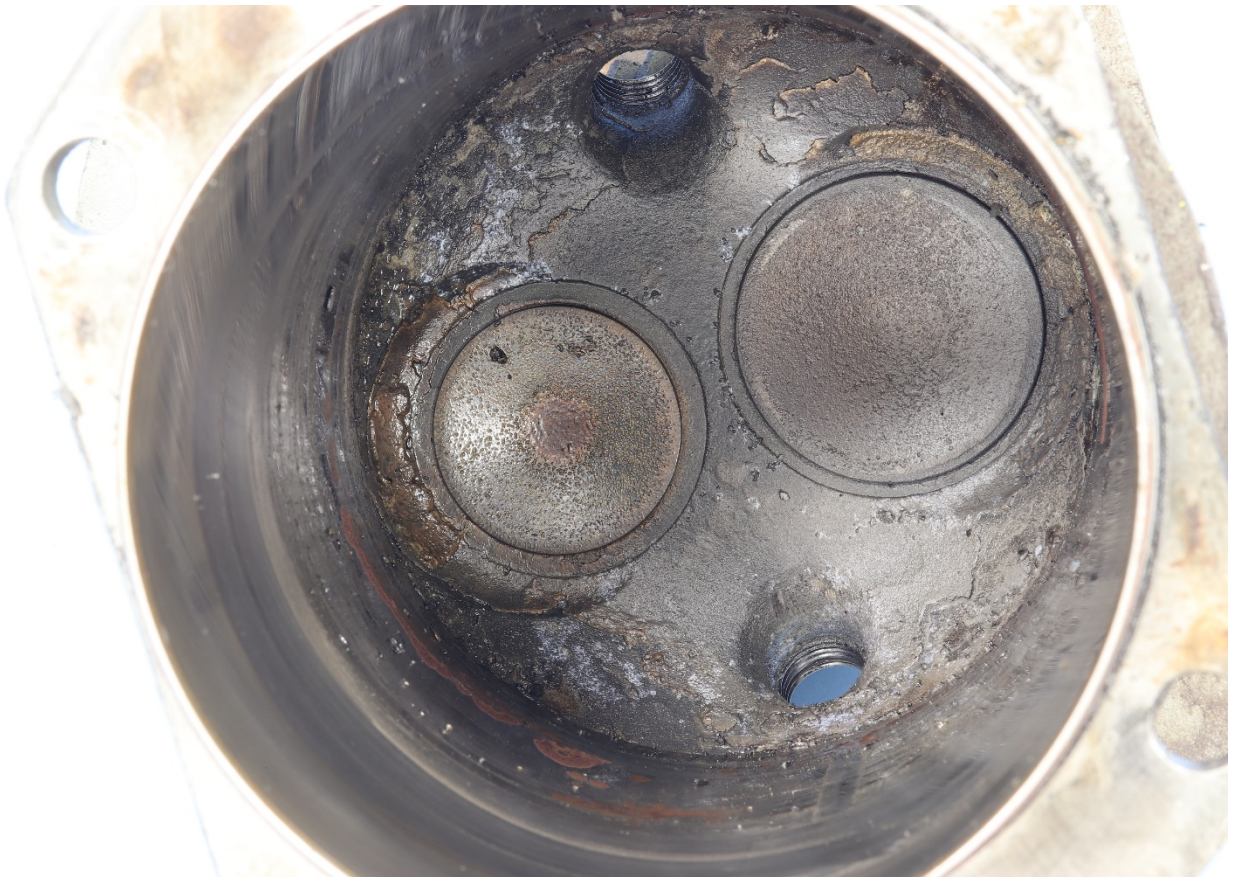
The spark plugs and piston assembly were removed from the cylinder, exposing the interior of the cylinder (shown in Figure 6). While there were no indications of impact, gouging, or spalling damage to the cylinder crown or valve seats, these surfaces did exhibit deposits thick enough to exhibit flaky layers. These deposits exhibited a reflective brown appearance, consistent with lead oxide-based compounds that buildup in reciprocating engines from deposits of combustion byproducts using avgas.

Figure 6 – View of the interior bore surfaces and valve seats of the #4 cylinder after removal of the piston and spark plugs.

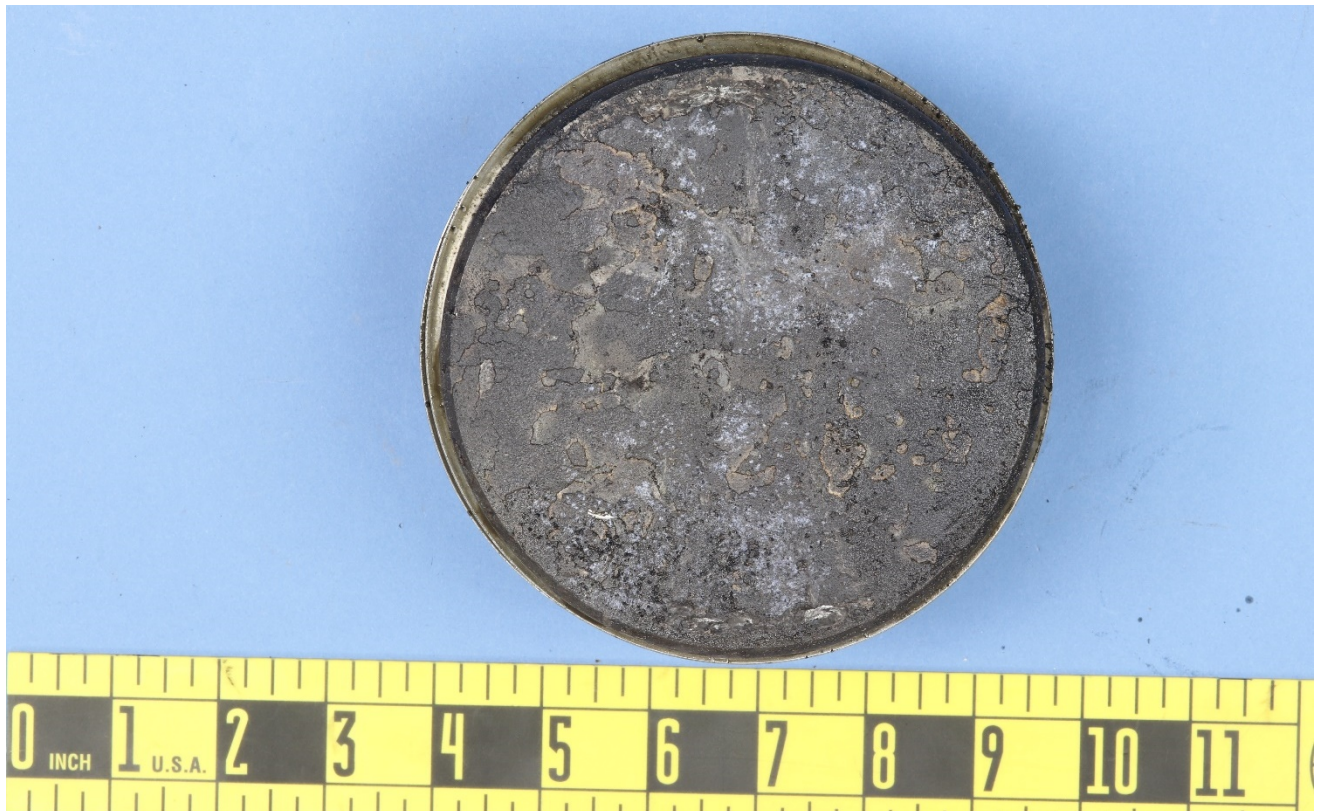
Similarly, the piston crown shown in Figure 7 exhibited these deposits, consisting of a mottled, flaky layered appearance, with brown and yellowish hues. One of the removed spark plugs, shown in Figure 8, also exhibited dark deposits on the electrode surfaces. However, the deposits on the spark plug were not thick enough to create contact between the electrodes on the spark plug head.

Figure 7 – View of the #4 piston crown, after removal. The surface exhibited deposits consistent with combustion products thick enough to begin spalling.

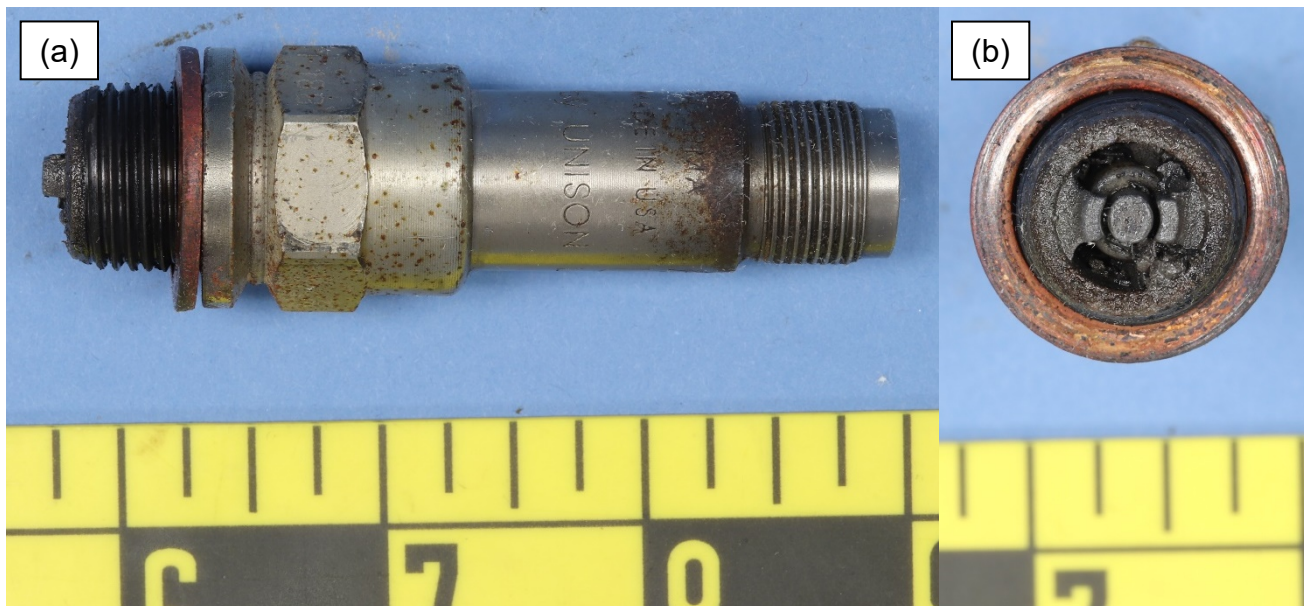
Figure 8 – View of the #4 spark plug after removal from (a) the side and (b) the electrode.

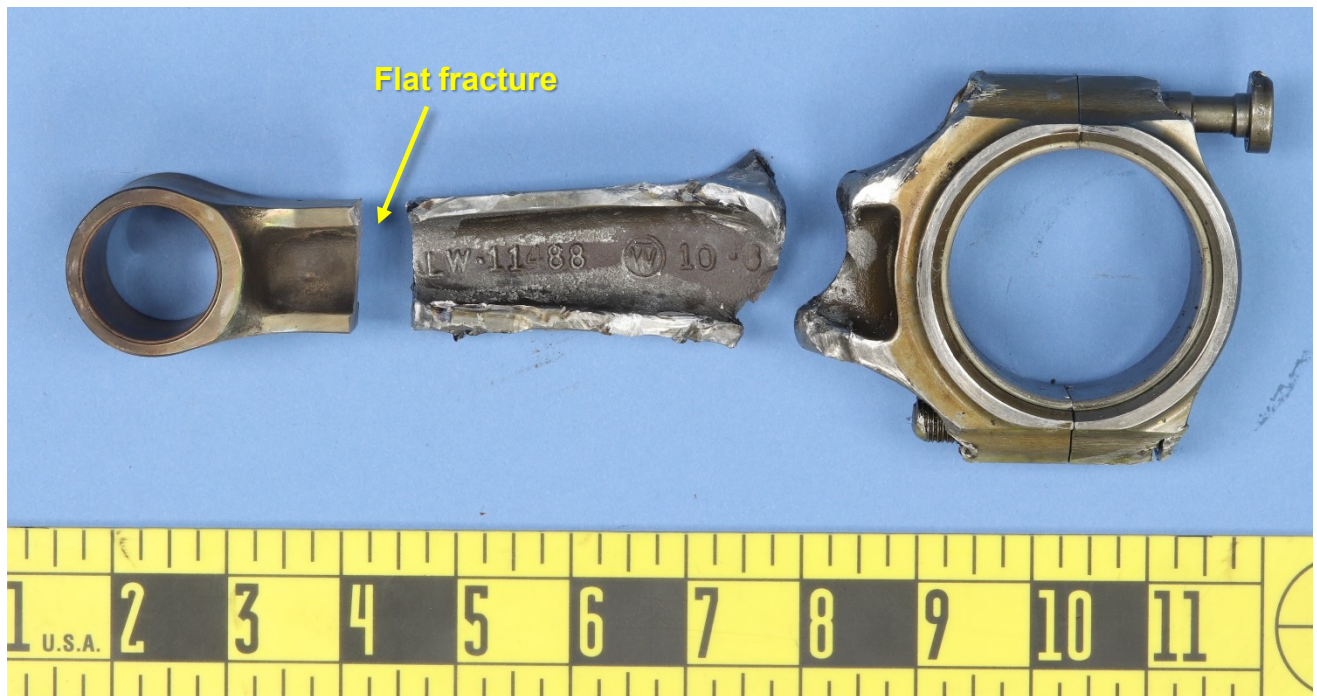
Figure 9 and Figure 10 show the fractured remnants of the connecting rod, after disassembly and positioning. The marking on the web stated "LW-11-88 W 10-3". The connecting rod had fractured in two locations, one adjacent to the yoke transition on the right of the figures, and the other 1.15 inches from the piston bore on the other side. The

remnant pictured on the left in the figures was the one that had been removed from inside the cylinder assembly. The total length from the end to the fracture surface was 2.41 inches.

The middle web section exhibited multiple areas of locally deformed material, mostly along the protruding flange surfaces. These features were consistent with this remnant having been impacted by adjacent components in multiple locations. The fracture surface between this remnant and the crankshaft bore surfaces exhibited a general rounded but perpendicular orientation in the upper half of Figure 9, but then a more angled orientation, with localized buckling on the flanges. This was consistent with bending towards that direction. The rough orientation and texture suggested overstress fracture, but the mating surfaces were damaged from post-fracture impact, with no discernible fracture features present.

Figure 9 – View of the #4 connecting rod remnants, positioned after removal of the pin remnant from the piston, viewed from the marked web side.

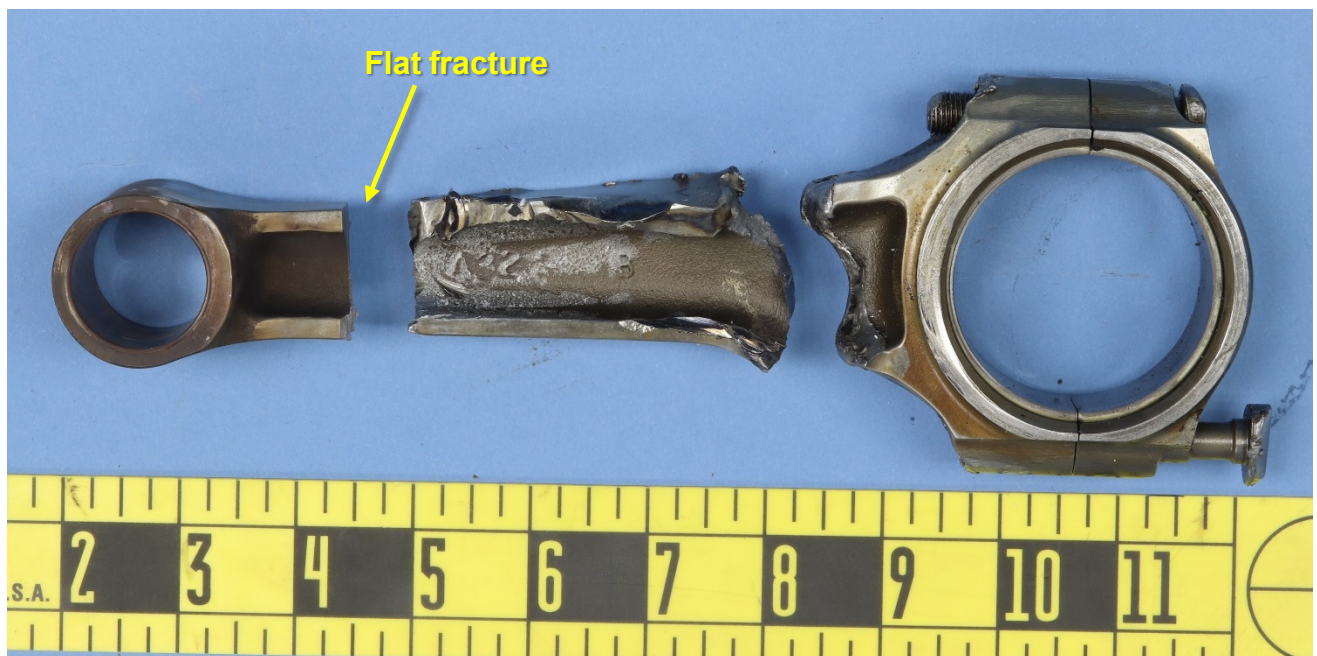
Figure 10 – View of the #4 connecting rod remnants, positioned after removal of the pin remnant from the piston, viewed opposite that in Figure 9.

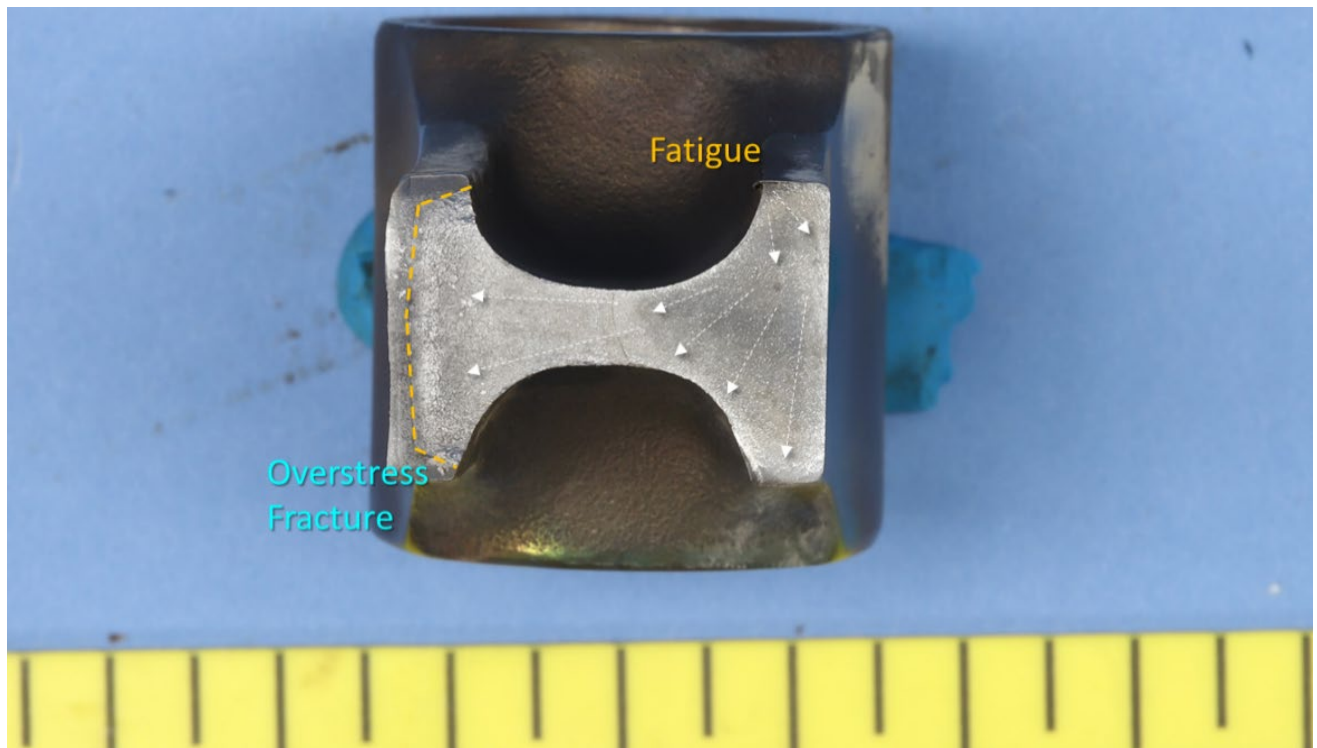
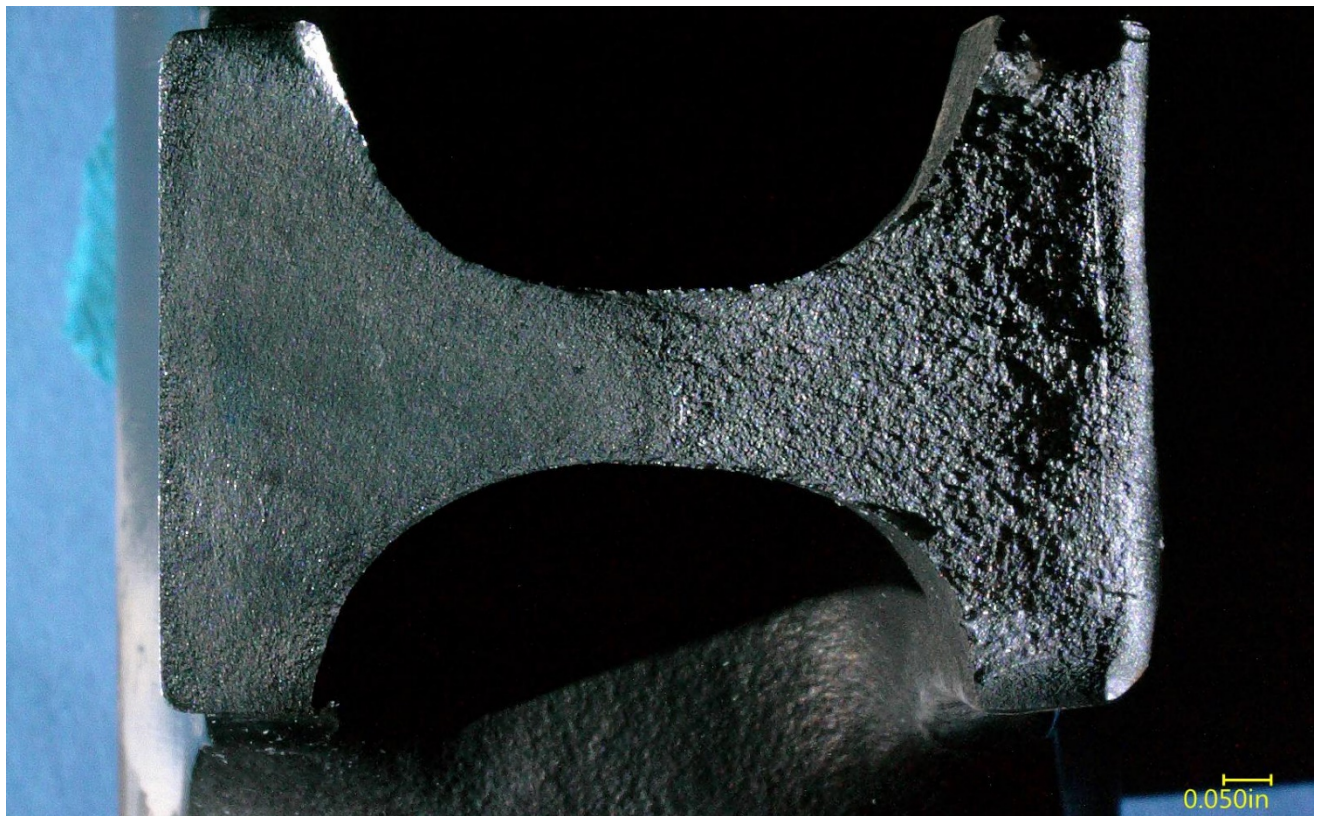
The other fracture surface of the connecting rod, towards the pin side, was relatively flat and oriented perpendicular to the rod longitudinal direction. The fracture on the pin side remnant was relatively smooth, exhibiting few elevated features. Figures 11 and 12 show more detailed views of the rod remnant fracture surface, with Figure 11 containing annotations. Most of the fracture surface, which was generally flat in orientation, exhibited crack arrest marks, indicative of progressive crack growth. Later examination of these regions found them to be consistent with fatigue. The last 0.04 to 0.07 inches of the fracture surface exhibited a rougher, more undulating surface texture—this area was consistent with subsequent overstress fracture. Therefore, the fatigue crack covered about 95% of the rod flange-to-flange cross section, measured as approximately 1.086 inches.

Figure 12 – Closer view of the fracture surface from Figure 11, using oblique lighting to highlight the surface features.

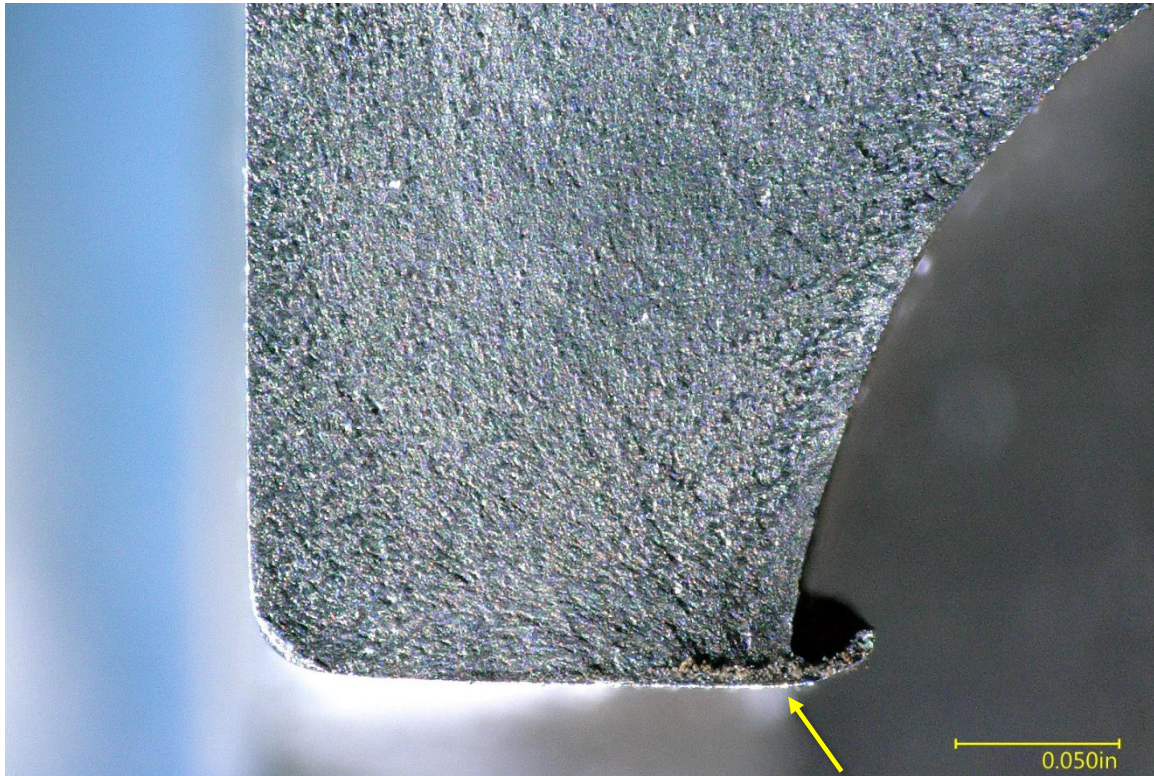
The lack of ratchet marks suggested a single initiation site, as shown in Figure 13. This site was located at the inside corner of a flange edge. The river patterns and crack arrest marks were consistent with having emanated from this feature. When viewed at an angle (Figure 14), the feature was collocated with an area of local plastic deformation and wear. As shown in the figure, the outer flange surface had been smoothed, and deformed over the side of the inner flange surface (Figure 15).

Figure 13 – View of the crack initiation site (arrow) of the fatigue crack on the connecting rod fracture surface.

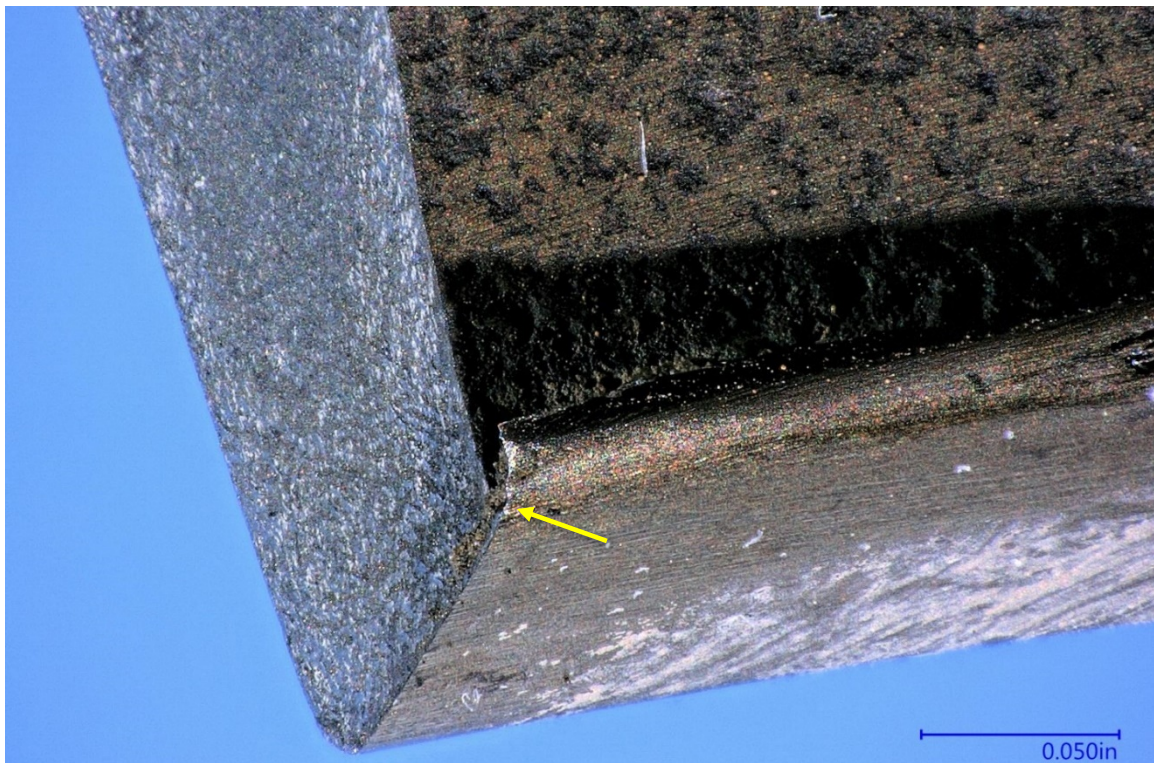
Figure 14 – Angled view of the crack initiation site (arrow), showing inward deformation of the flange side.

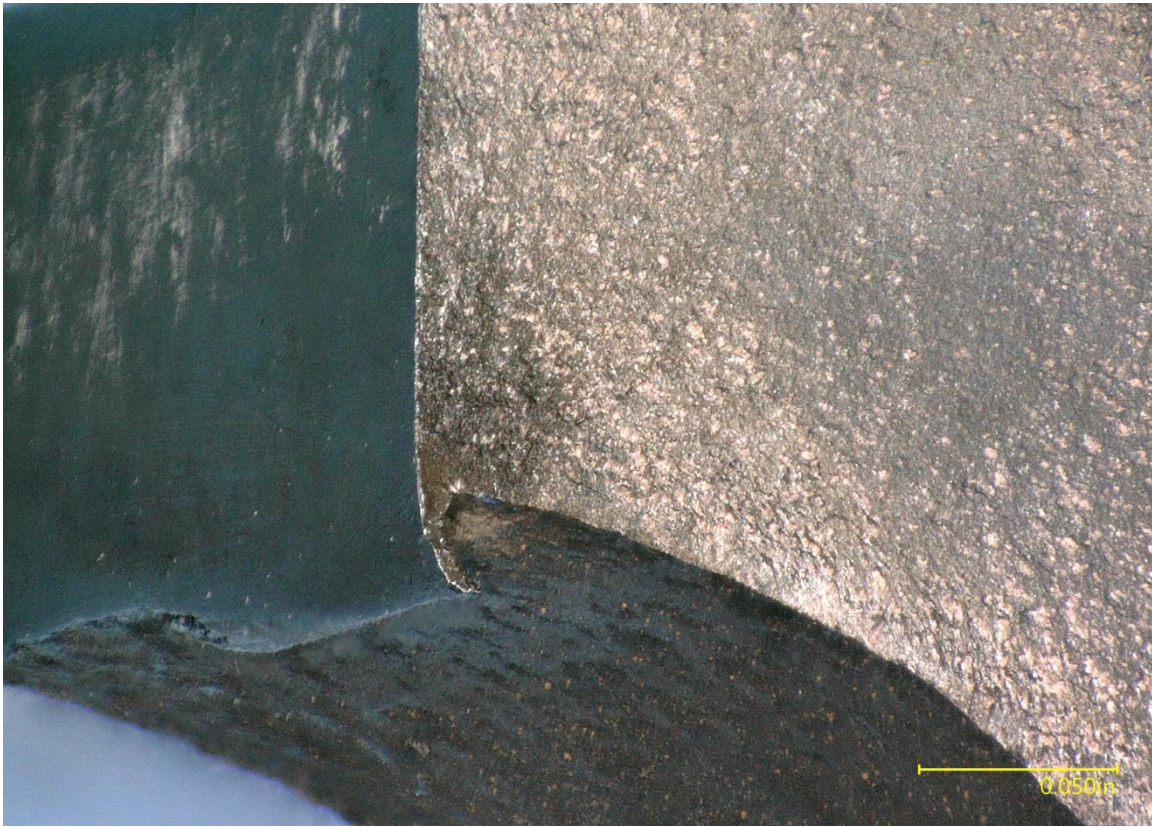
Figure 15 – Side angle view of the crack initiation site.

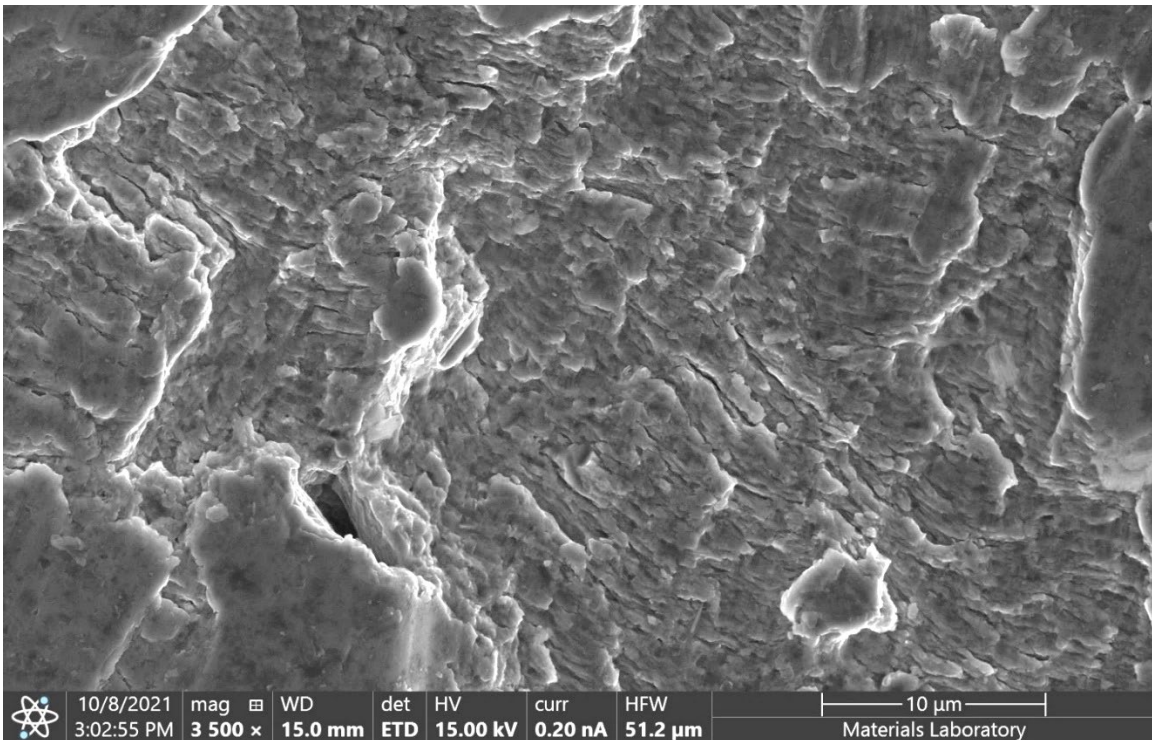
The connecting rod fracture surface was examined using a scanning electron microscope (SEM). As typified in Figure 16 located near the initiation site, the majority of the fracture surface exhibited fatigue striations, consistent with fatigue crack propagation. As exemplified in Figure 17, these striations exhibited both large and smaller features, consistent with spectrum loading typical of high rpm reciprocating engines.

Figure 16 – Secondary electron (SE) micrograph of fatigue striations near the initiation corner.

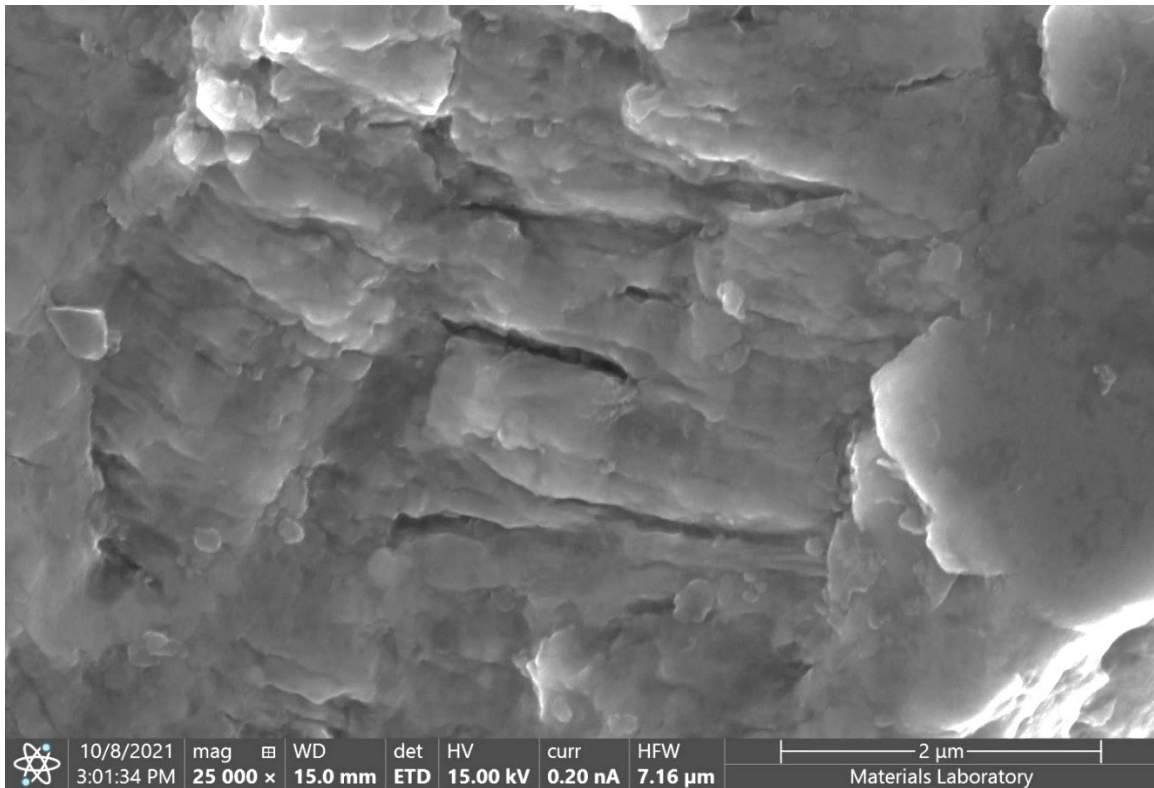
Figure 17 – SE micrograph of a closer view of the striations in Figure 16.

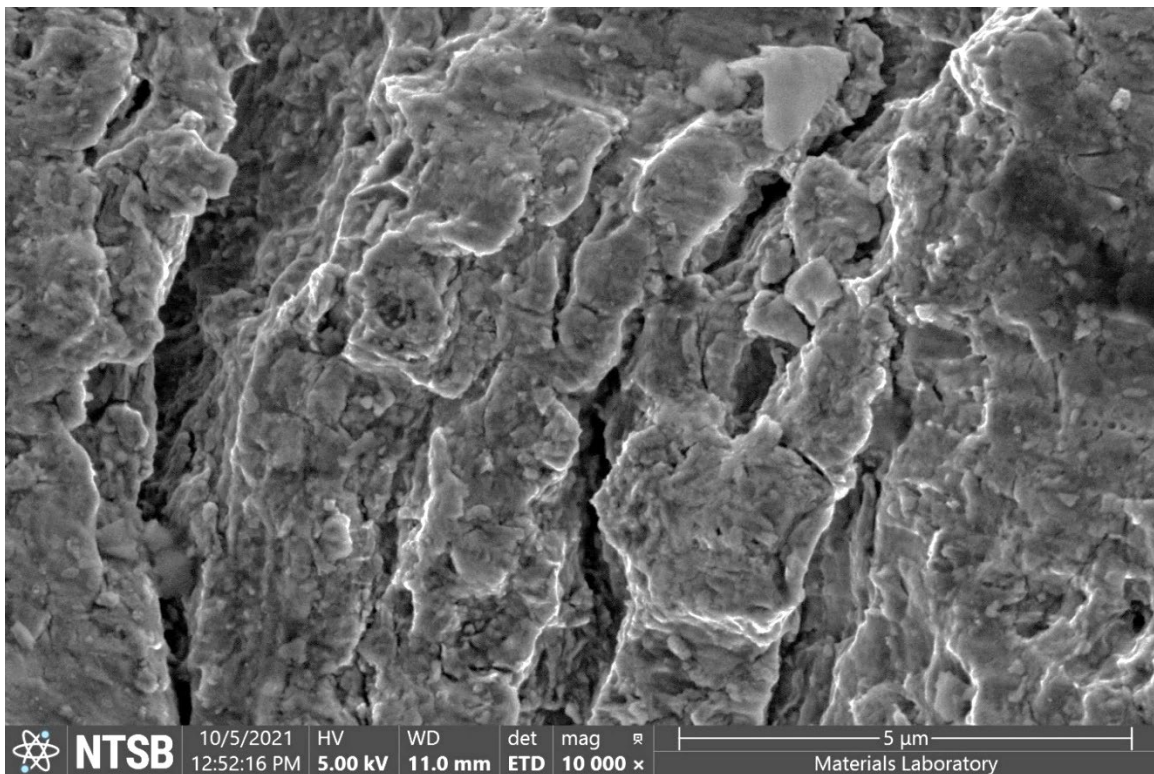
Towards the end of the fatigue crack, these striations became more unevenly spaced, with secondary cracking parallel to the striations, and tearing perpendicular to the striations (see Figure 18). These features were consistent with more rapid and unstable crack propagation at the end of the fracture sequence. The features on the fracture surface beyond the fatigue crack exhibited slanted dimpled rupture, consistent with subsequent tensile overstress in shear (Figure 19).

Figure 18 – SE micrograph of striations and secondary cracking at the end of the fatigue crack.

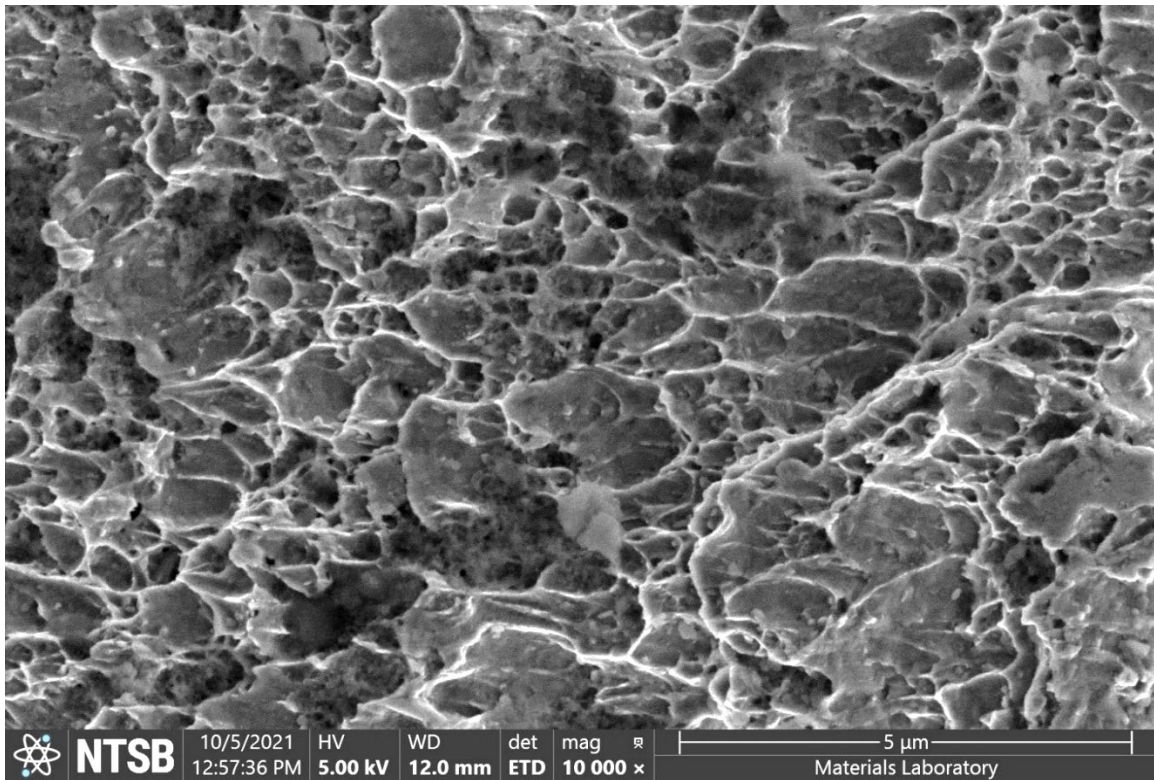
Figure 19 – SE micrograph of slanted dimpled rupture outside the fatigue crack.

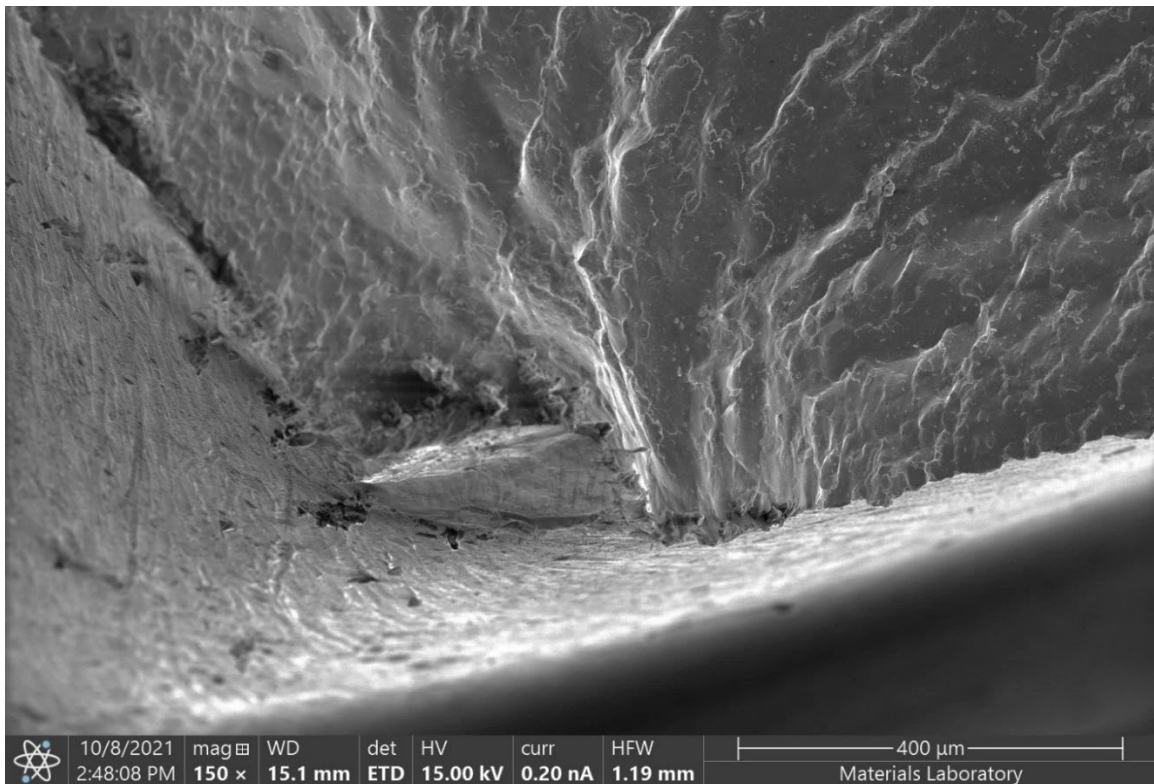
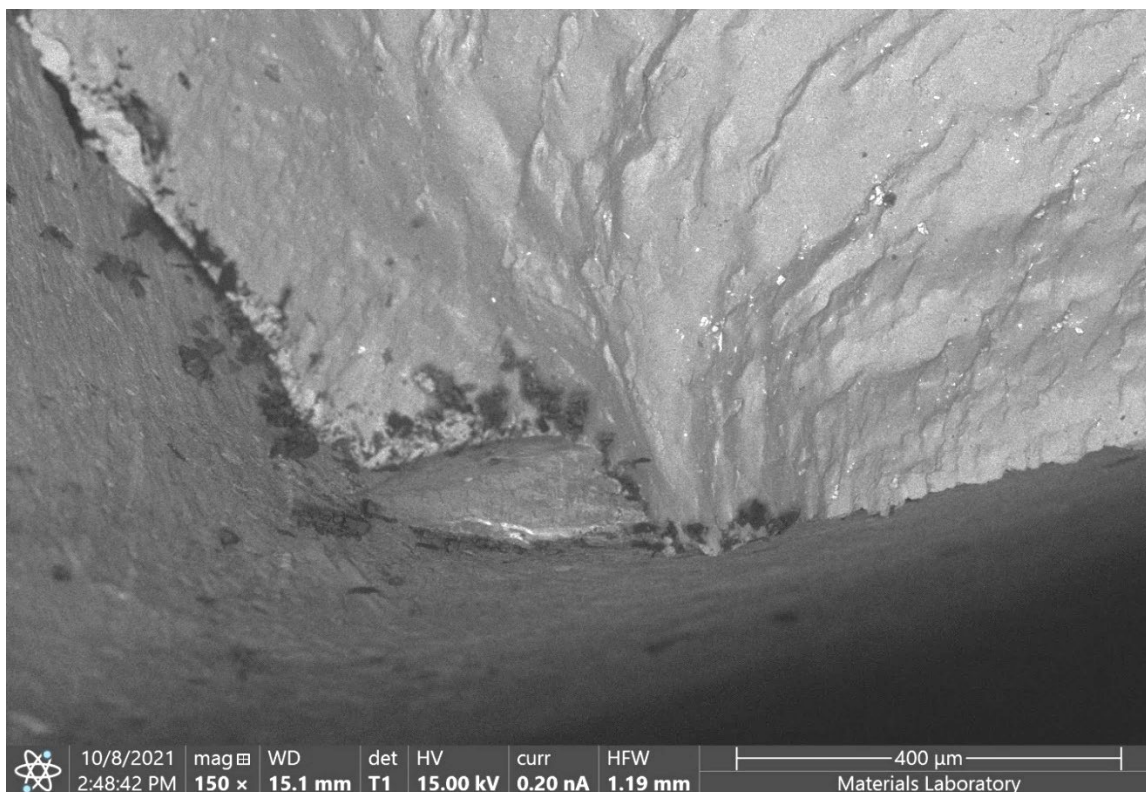
Figures 20 and 21 show closer views of the fatigue crack initiation site. These figures illustrate river patterns emanating from near the corner, which consisted of a flattened, angled feature. The backscattered micrograph showed material contrast consistent with the presence of lower atomic weight material.<sup>2</sup> This feature was examined using energy dispersive x-ray spectroscopy (EDS).

Figure 20 – SE micrograph of the fatigue crack initiation site.

Figure 21 – Backscattered electron (BE) micrograph of the fatigue crack initiation site.
