# NATIONAL TRANSPORTATION SAFETY BOARD

## MATERIALS LABORATORY FACTUAL REPORT

Report No. 21-086

Place : Lodi, California  
Date : April 28, 2020  
Vehicle : Cessna 177, N3386T  
NTSB No. : WPR20LA133  
Investigator : Joshua Cawthra, AS-WPR

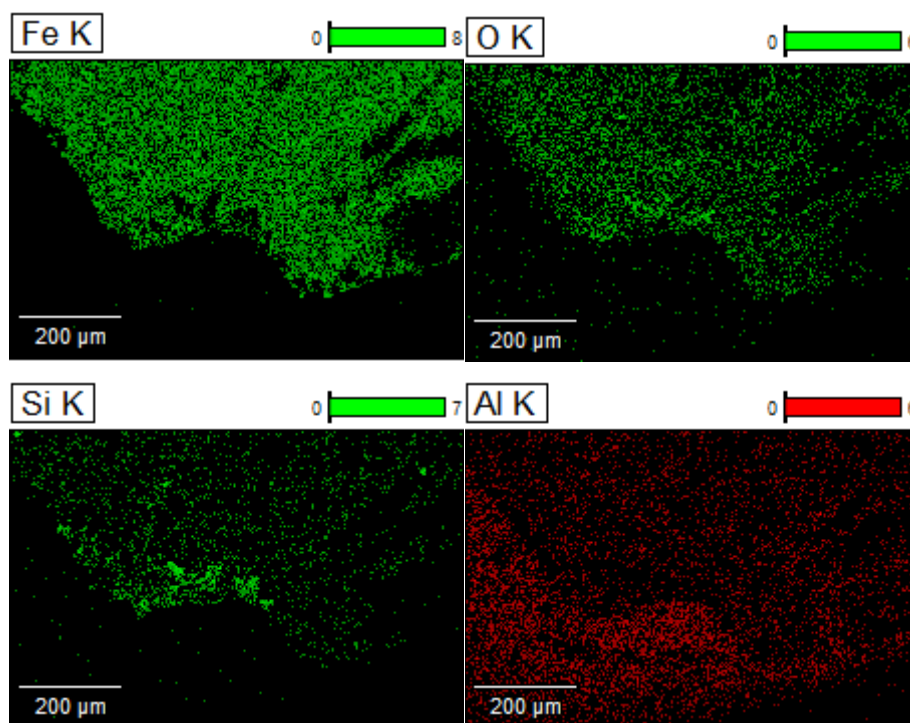
As compiled using x-ray maps in Figure 22, the area exhibited an absence of Fe and O, but exhibited elevated levels of Si and Al. As EDS data found the connecting rod remnant to exhibit a chemical composition consistent with an alloy steel (such as Type 4340), the presence of Si and Al would be consistent with impact against another metallic part. Figure 23 shows another closer view, exemplifying the material transfer at the crack initiation site. This figure also demonstrated the localized buckling, consistent with an impact depression in the rod flange corner. A typical EDS spectrum of the dissimilar material, showing large peaks of Al, Si, O, S, and Pb, is illustrated in Figure 24.

Figure 22 – X-ray maps of the initiation site in Figure 20, showing higher concentrations of Fe, O, Si, and Al, respectively.

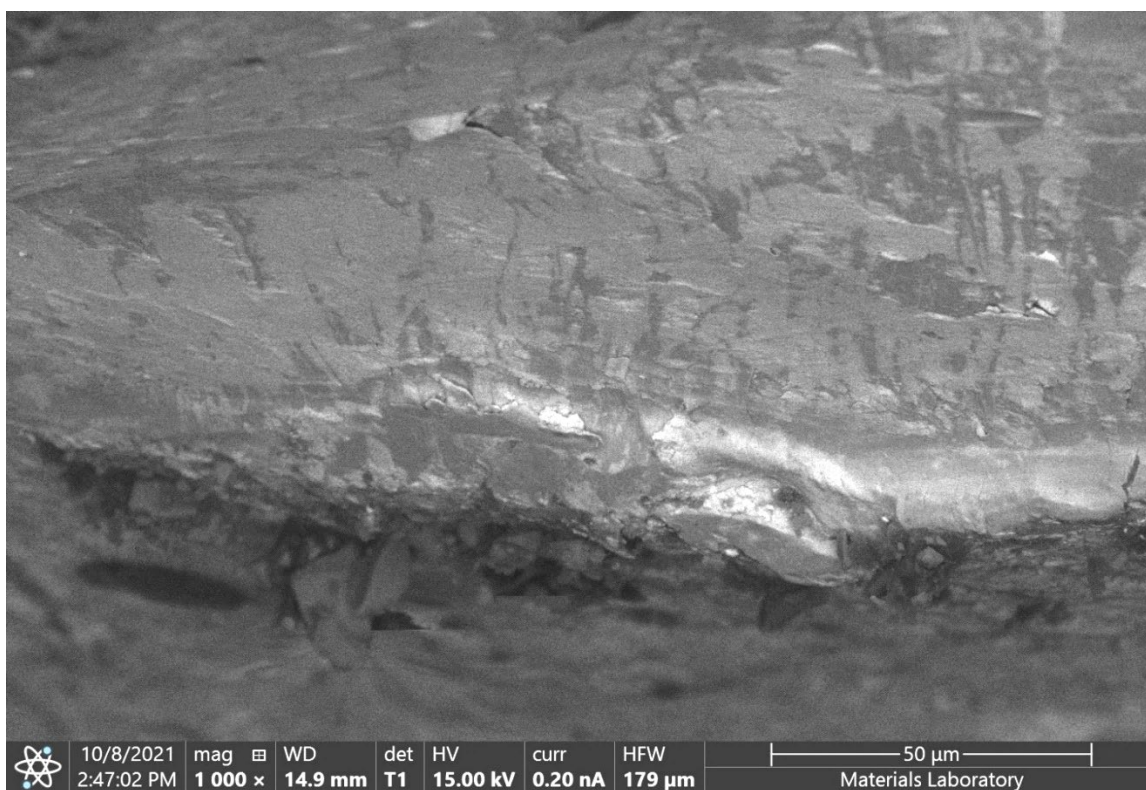
Figure 23 – BE micrograph of the crack initiation site, showing localized deformation and darker contrast material.

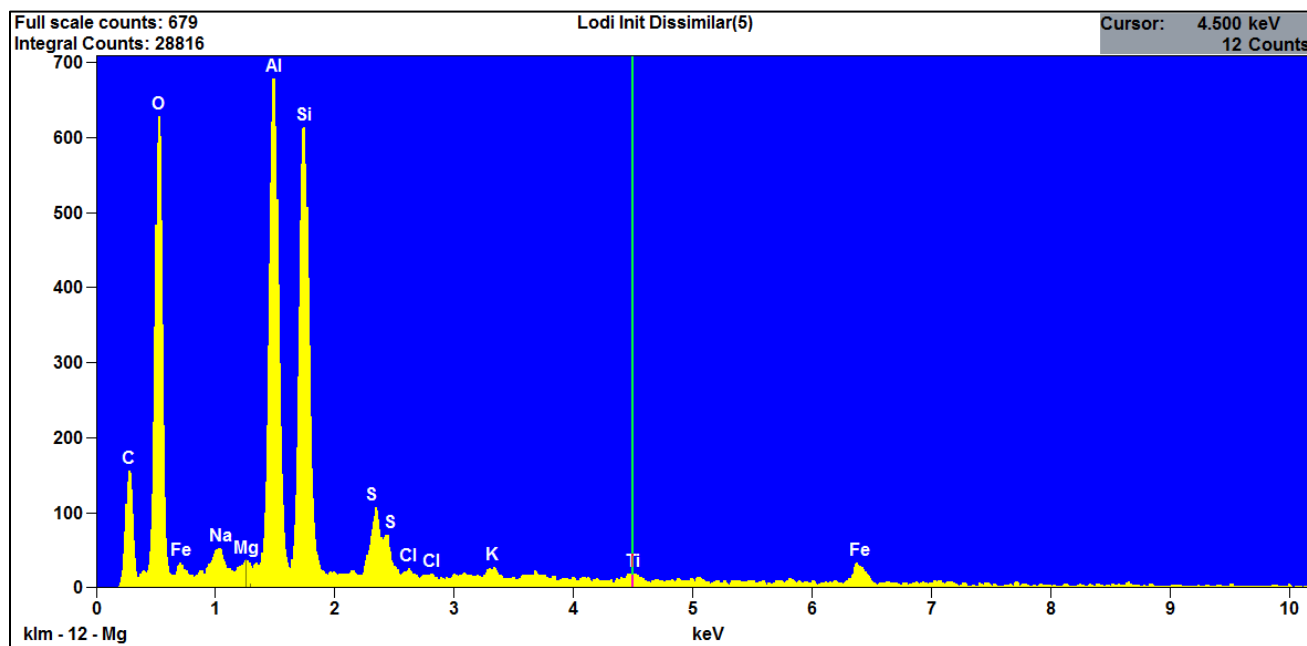
Figure 24 – EDS spectrum of the dissimilar material at the fatigue crack initiation site.

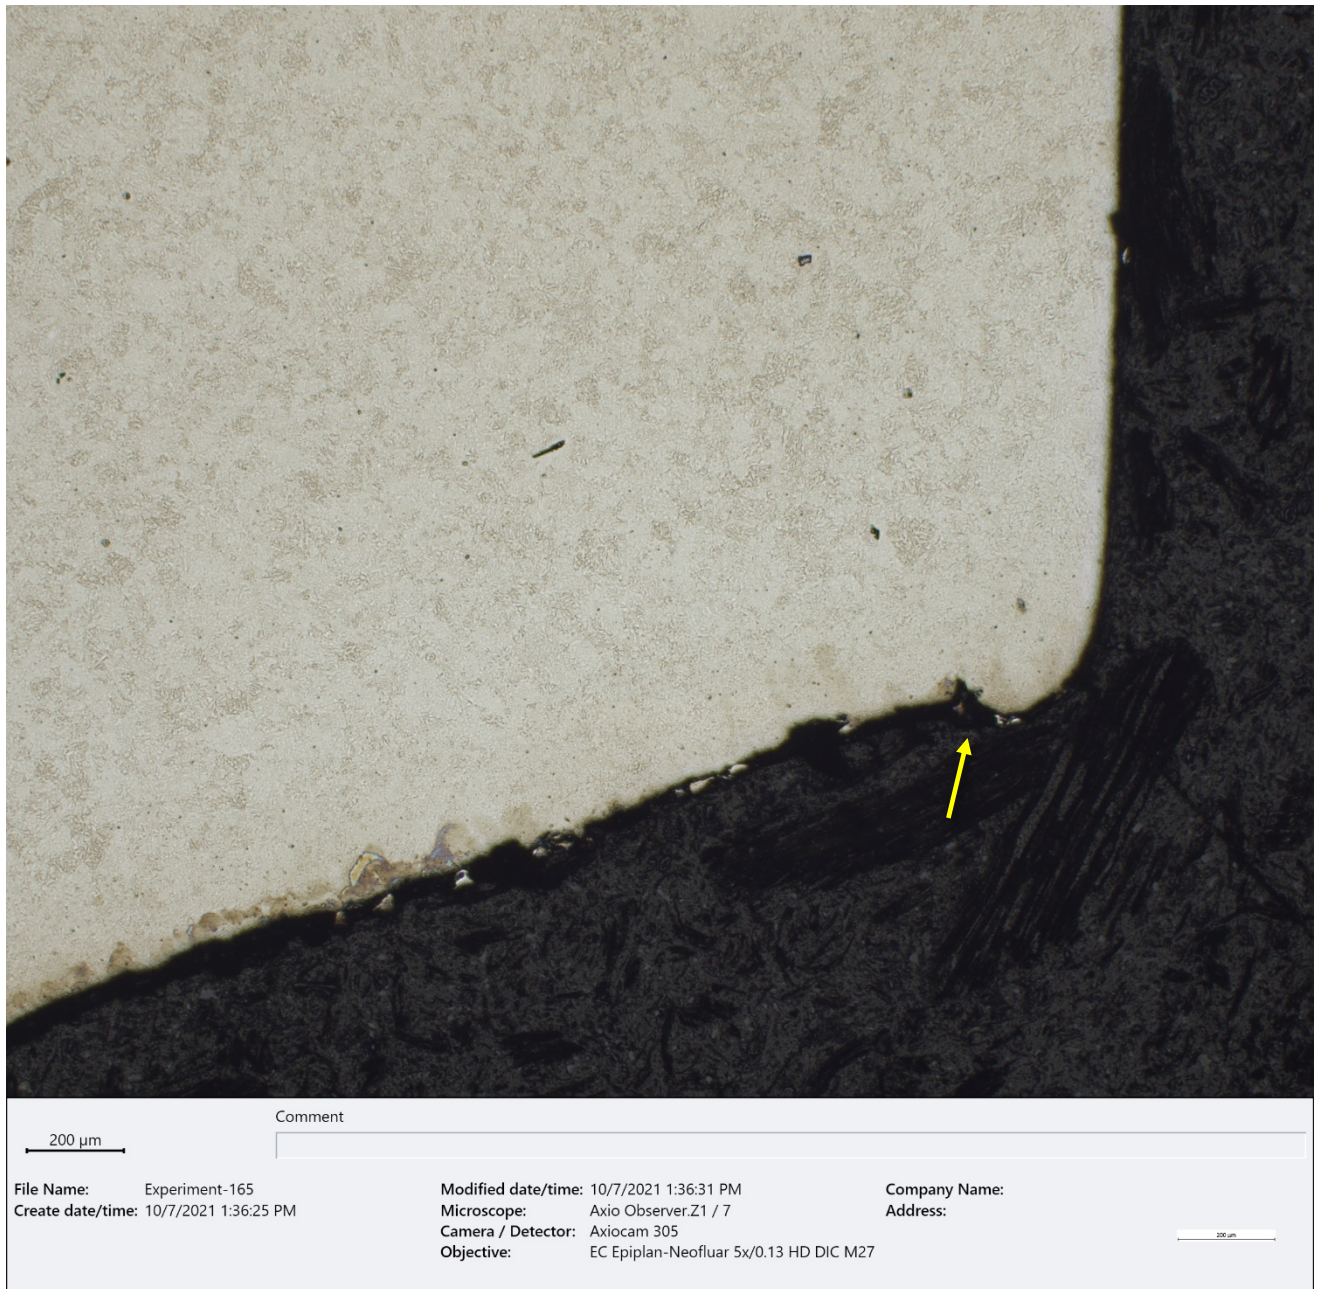
The remnant of the connecting rod was sectioned, cold epoxy mounted, polished, and etched using a 2% nital solution.<sup>3</sup> Figure 25 shows a cross section through the flange corner where the fatigue crack initiation site was located (arrow). The plastically deformed metal protrudes downward slightly in the figure (to the right of the arrow). A closer view in Figure 26 shows damage to the location, as well as the remnants of dissimilar material on the surface. Examination using EDS found the dissimilar material to be consistent with that shown in Figure 24. This initiation site also exhibited more inward damage and localized folds or cracks, consistent with stress risers that typically initiate fatigue cracks under cyclic stresses.

Figure 25 – Bright-field (BF) optical micrograph of the cross section through the crack initiation site (~50X, etched 2% Nital).

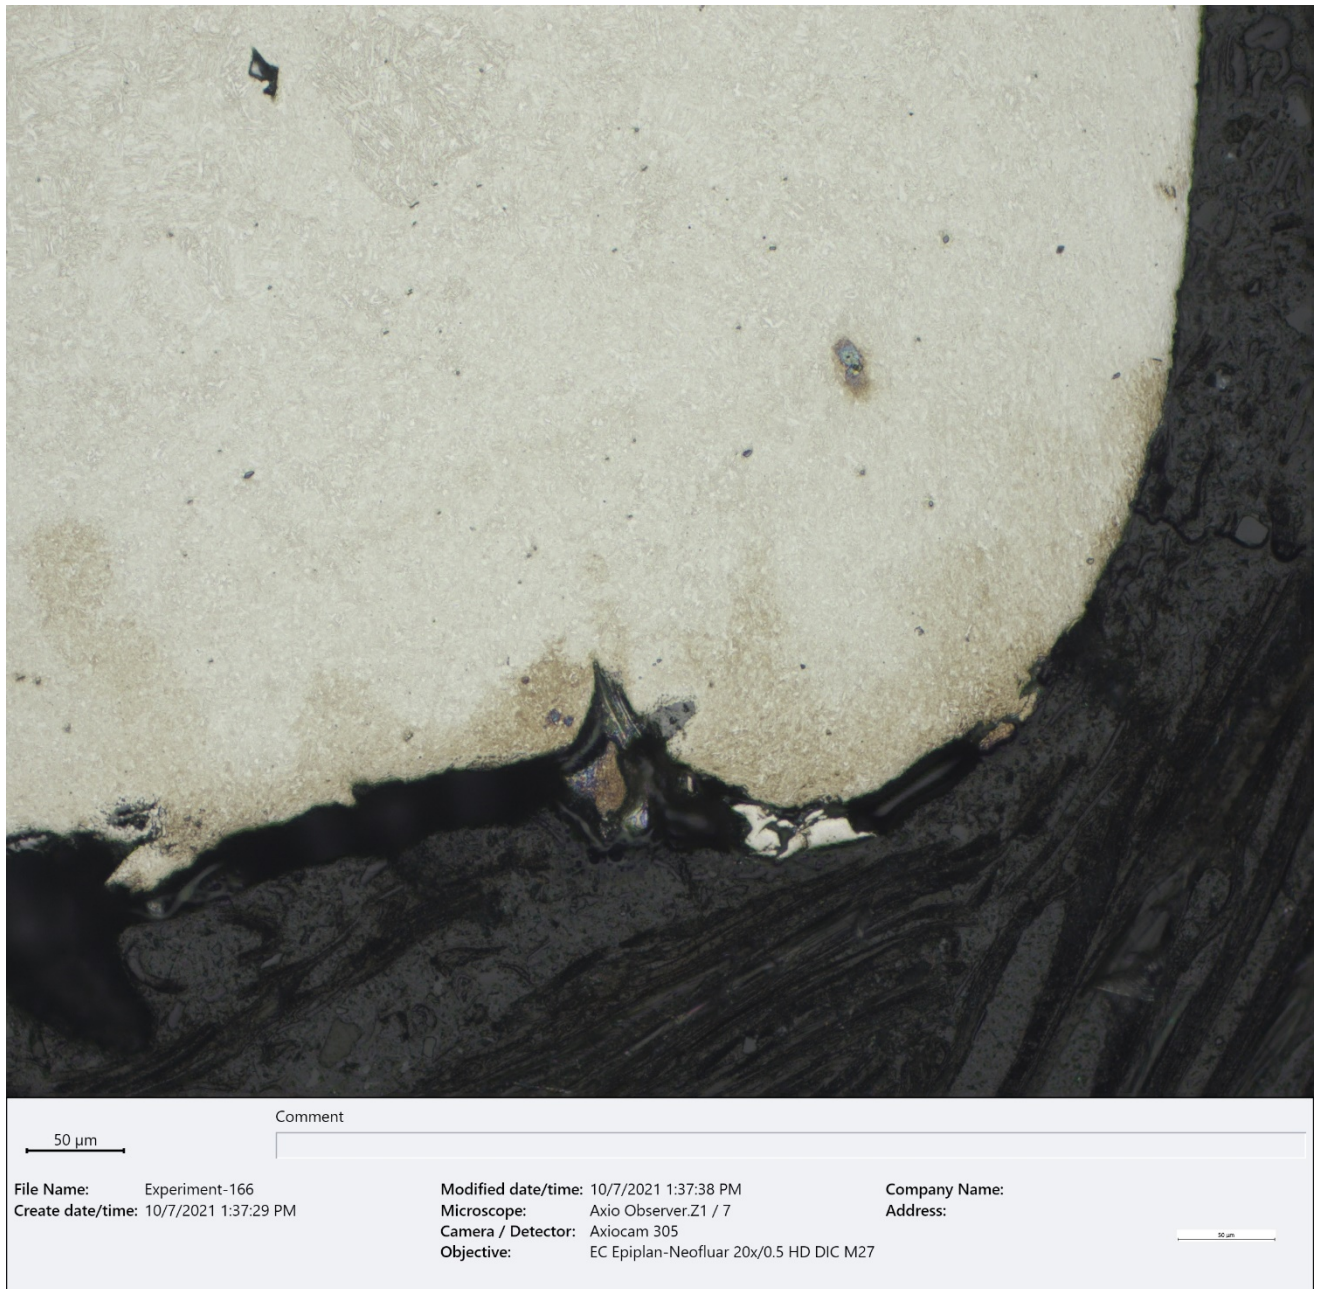
Figure 26 – BF micrograph of a closer view of the initiation site corner (~200X, etched 2% Nital).

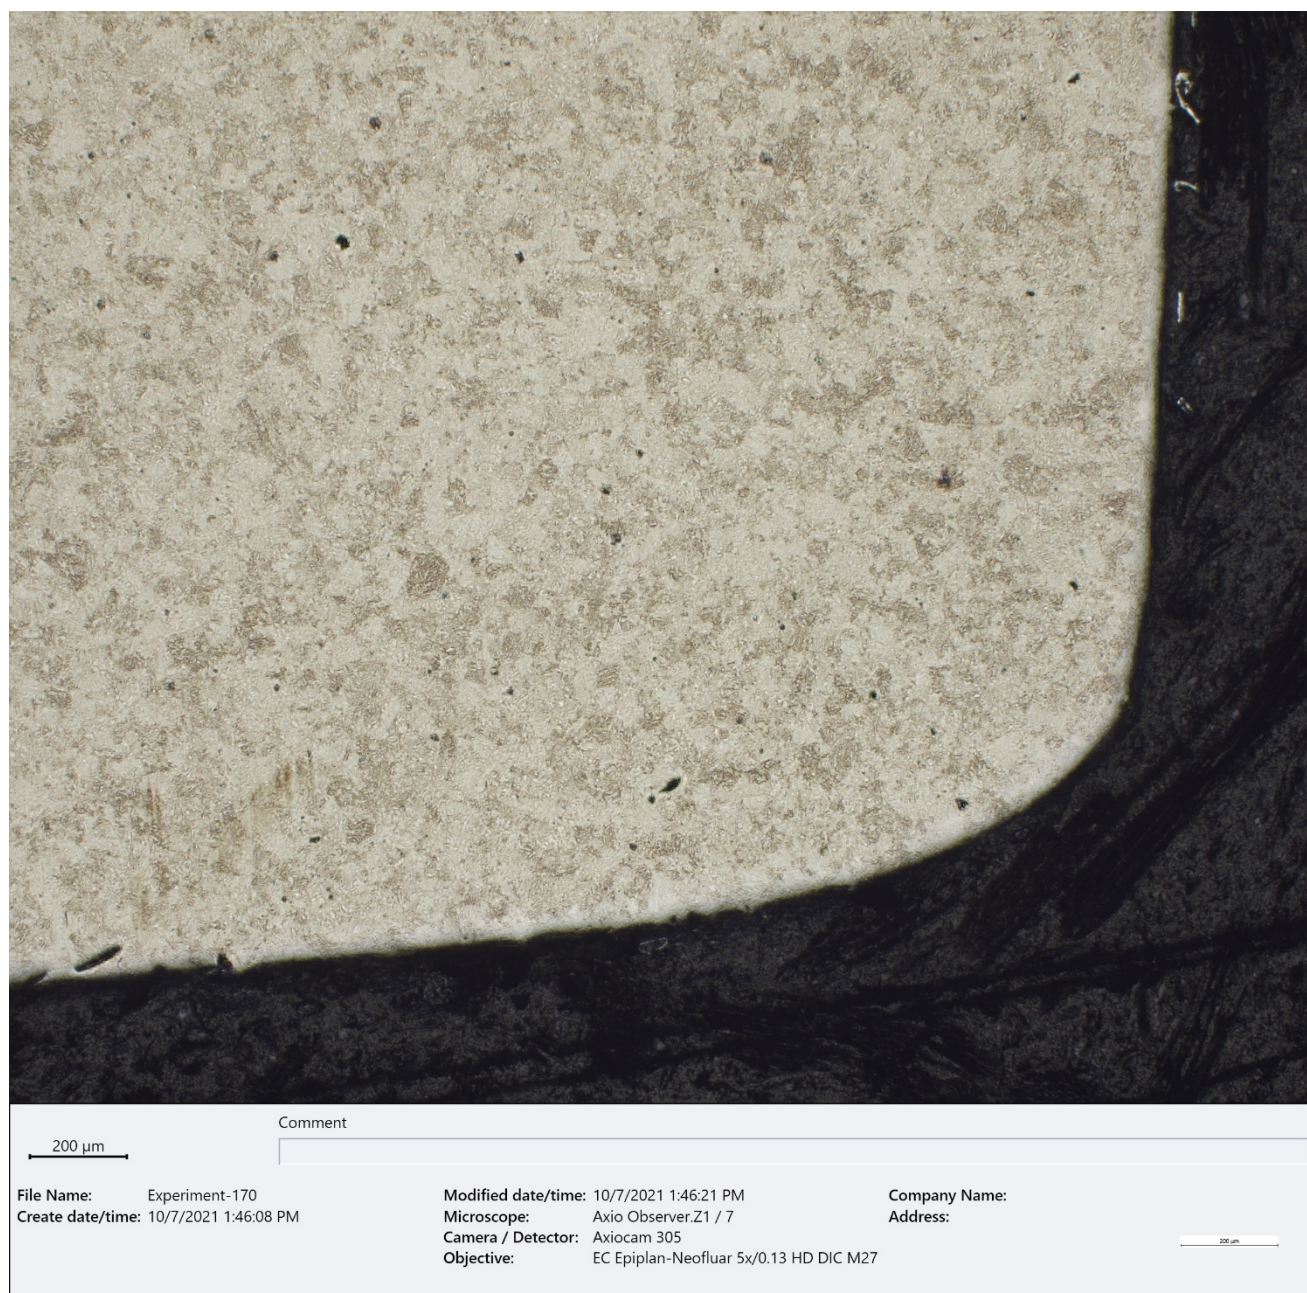
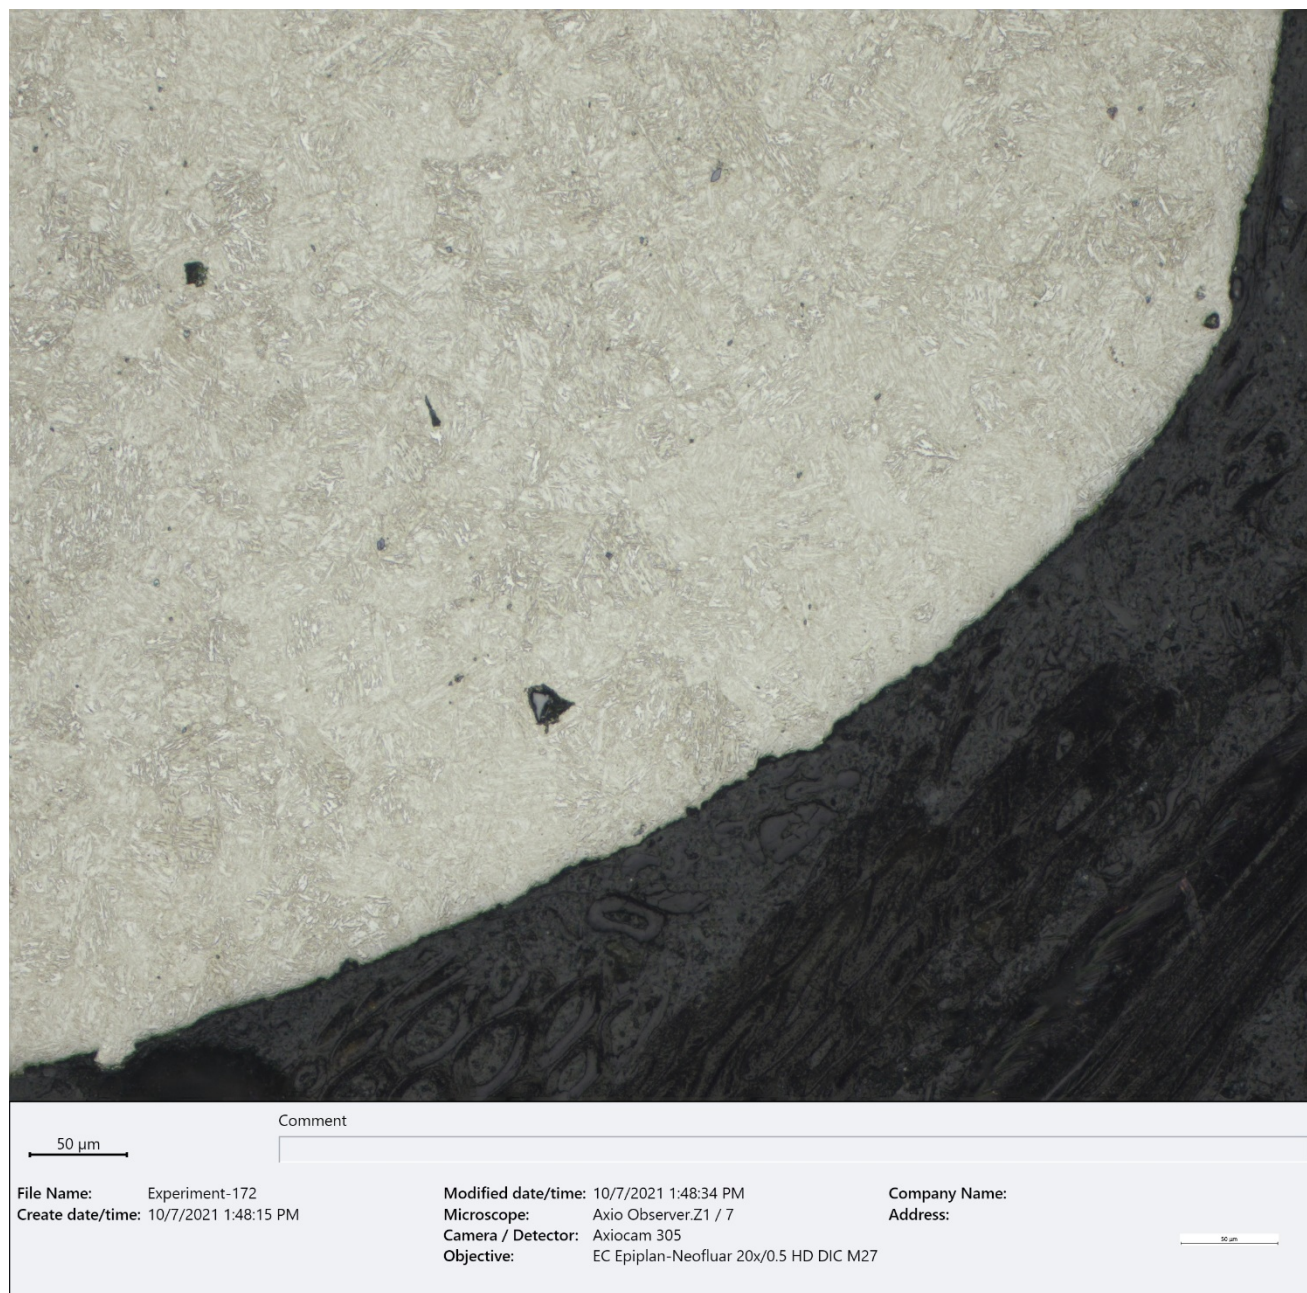
In contrast, Figures 27 and 28 show the opposite corner of the connecting rod (rotated to be a similar orientation to Figure 23). This corner exhibited a relatively smooth transition, with no indications of impact damage. The closer view in Figure 28 showed a relatively smooth surface, with no sharp peaks or valleys in the cross section. There was no visible dissimilar material present at or along the surface.

The hardness of the connecting rod cross section was examined per ASTM E18.<sup>4</sup> The hardness of the connecting rod core averaged 32 HRC, typical of this material and tempered martensite microstructure as shown in Figure 28.

Figure 27 – BF optical micrograph of the lower opposite corner of the connecting rod (~50X, etched 2% Nital).

Figure 28 – BF optical micrograph of the corner in (~200X, etched 2% Nital).
