# NATIONAL TRANSPORTATION SAFETY BOARD

## MATERIALS LABORATORY FACTUAL REPORT

Report No. 21-002

Place : Hemet, California  
Date : April 30, 2020  
Vehicle : Piper PA-23-250, N6521Y  
NTSB No. : WPR20LA135  
Investigator : Fabian Salazar, AS-WPR

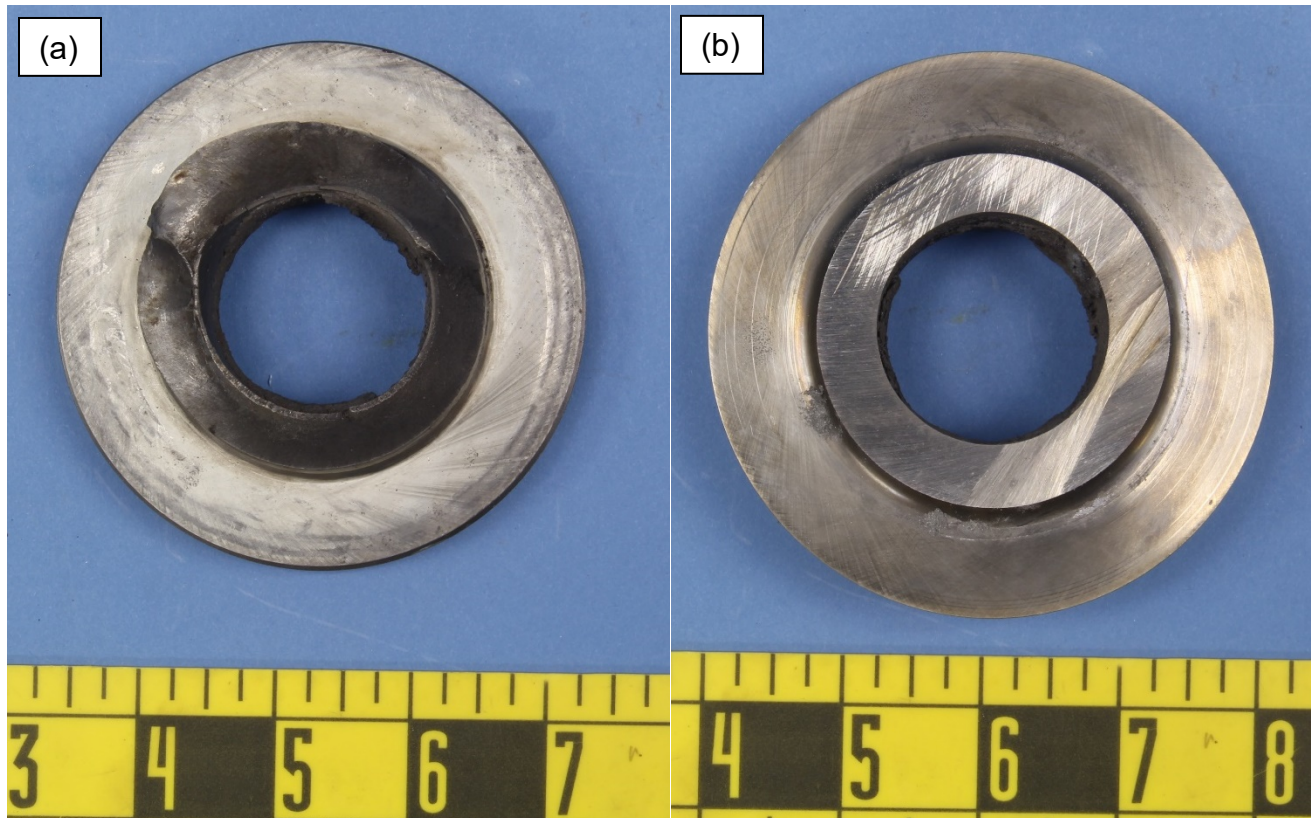
Figure 1 shows the remnant of the propeller mounting flange, as received. The flange remnant had been sectioned close to the flange (as shown in Figure 1b), and it exhibited a circular fracture surface on the opposite side, as shown in Figure 1a. Figure 2 shows the flange remnant viewed from an angle. The sides of the remnant consisted of two parallel circular flanges with a groove for a cable.

The fracture surface exhibited an angled orientation, as illustrated in Figure 2. The river patterns exhibited a rotational quality, consistent with the fracture surface orientation. There was a small ridge or lip (seen in the upper left of Figures 1a and 2). The fracture surface was rough in texture, with a dull, fibrous appearance. These features were consistent with fracture from torsional overstress.

Figure 1 – Closer view of the propeller mounting flange, viewed from (a) the fractured side and (b) the reverse side.

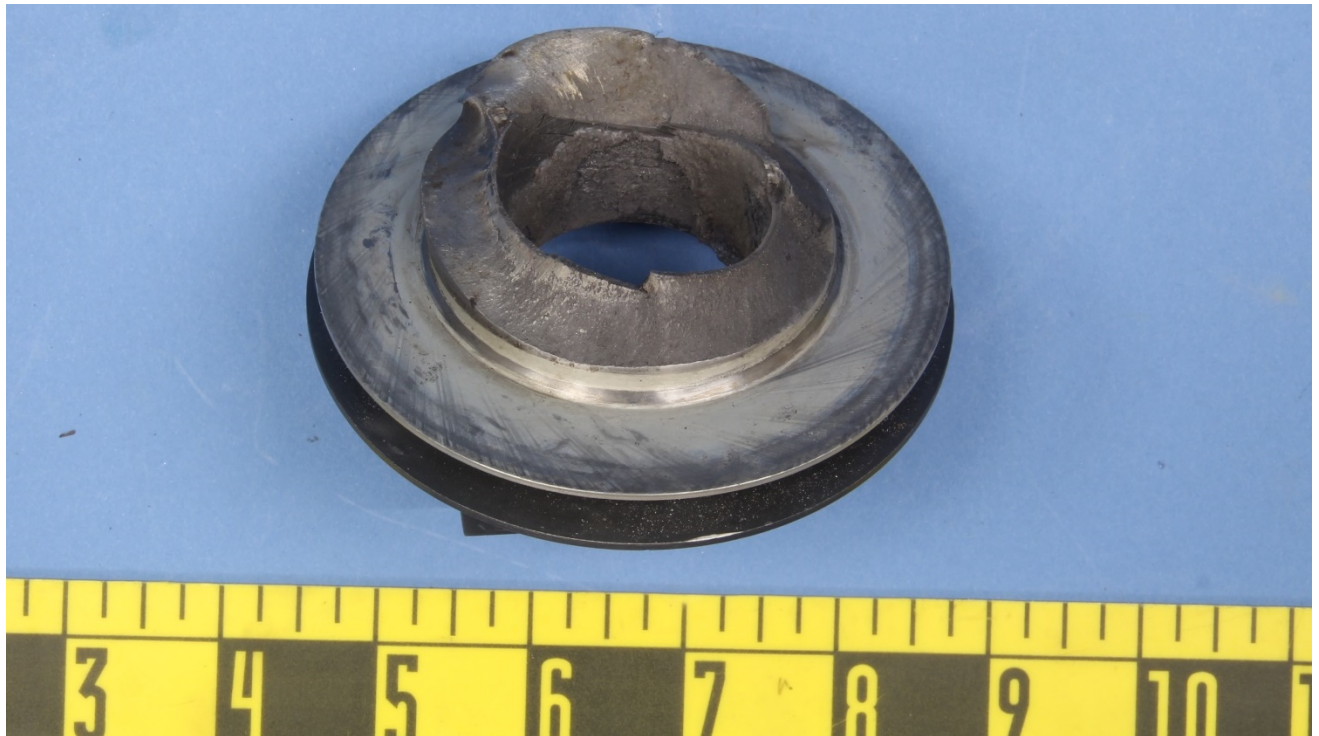
Figure 2 – The flange remnant, viewed from an angle, showing the angled fracture surface.

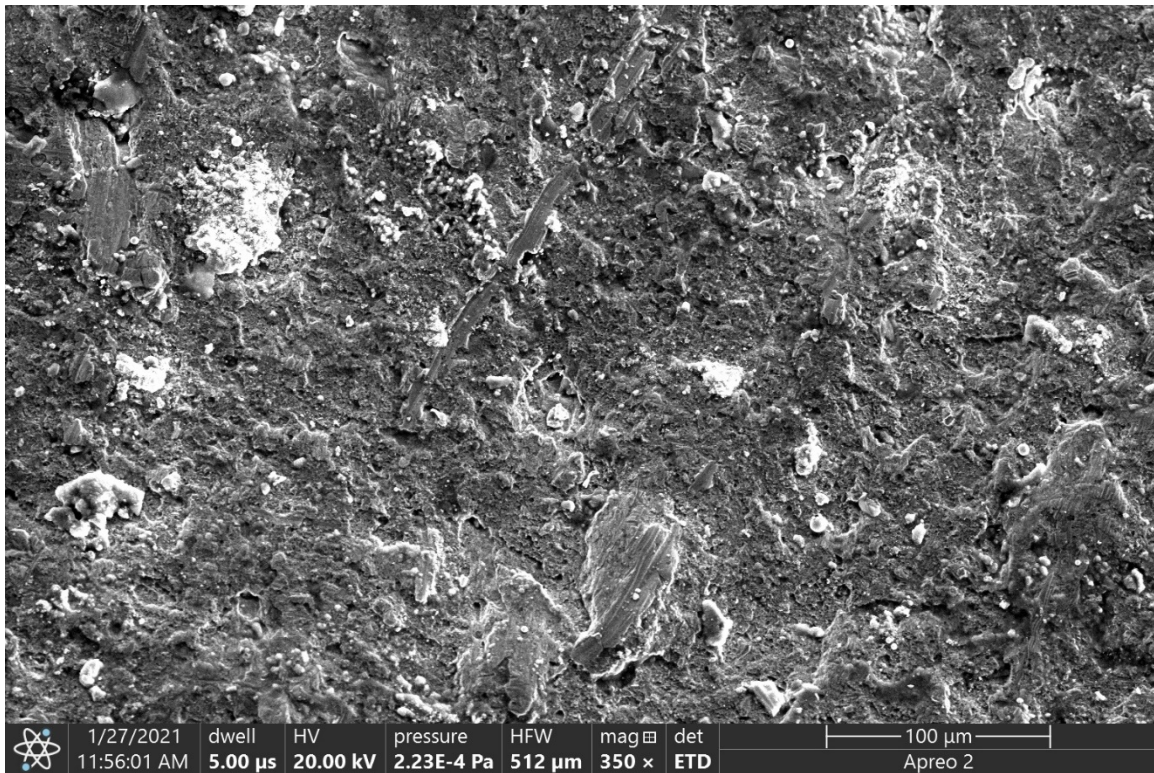
A portion of the remnant fracture surface was examined using a scanning electron microscope (SEM). As seen in Figure 3, much of the fracture surface exhibited smoothed and streaky features consistent with smearing, a form of post-fracture damage. Closer examination of the undamaged regions of the pulley fracture surface, such as typified in Figure 4, revealed dimpled rupture, consistent with overstress fracture. There were no other indications of other fracture modes on this fracture surface. These features were consistent with fracture of the flange in torsional overstress.

Figure 3 – Secondary electron (SE) micrograph of the remnant fracture surface, showing post-fracture damage and smearing.

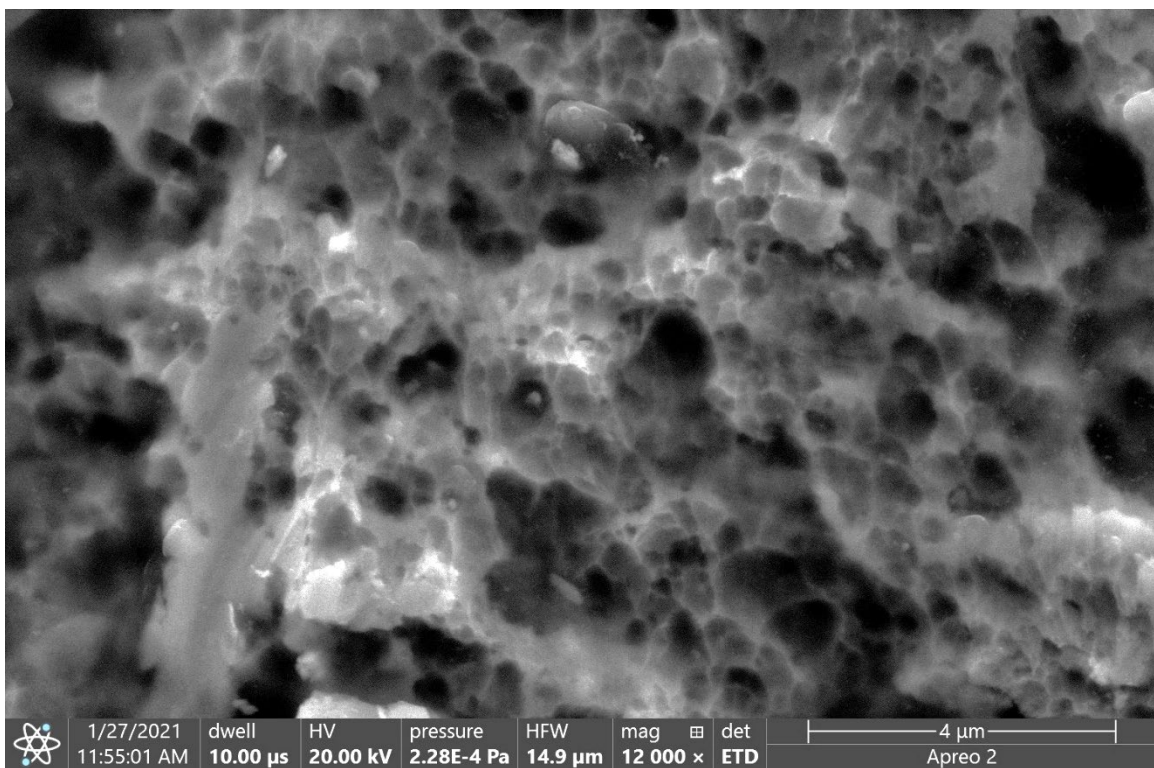
Figure 4 – SE micrograph of the remnant fracture surface, showing dimpled rupture.

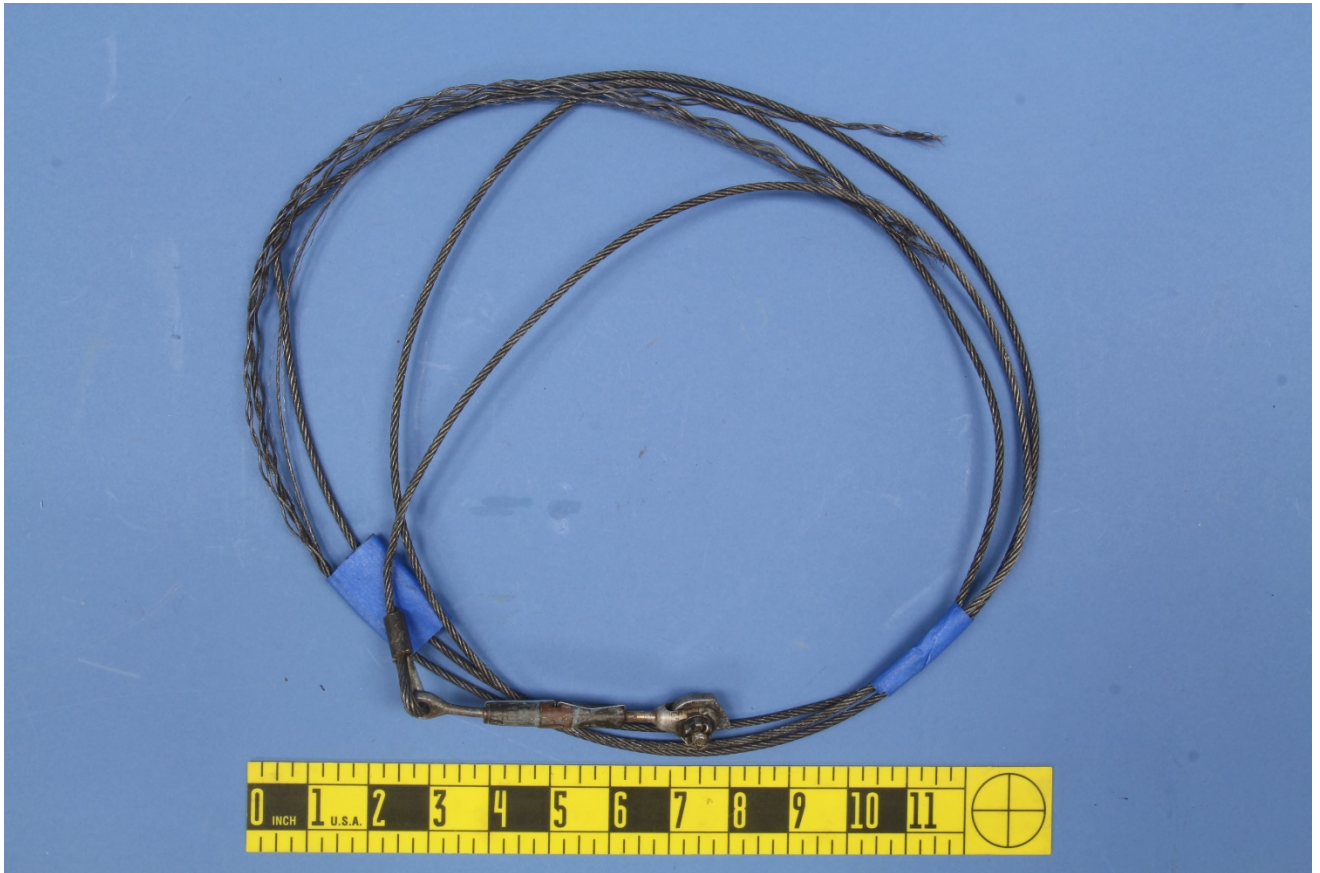
Figure 5 shows the remnant of the control cable, as received. The control cable measured approximately 123 inches (10.25 ft.) long. As shown in the upper right of Figure 5, and highlighted in Figure 6 and 7, the cable had fractured on one end. The cable consisted of six strands of wires wrapped about a central core strand. All the strands had fractured in approximately the same location, perpendicular to the cable direction. In looking at Figure 7, two of the strands exhibited little fraying of the wires, whereas the other four exhibited local fraying upwards of 0.5 inch from the fracture surfaces. The core strand exhibited fraying several inches from the fracture surface.

Figure 5 – The control cable remnant, as received.

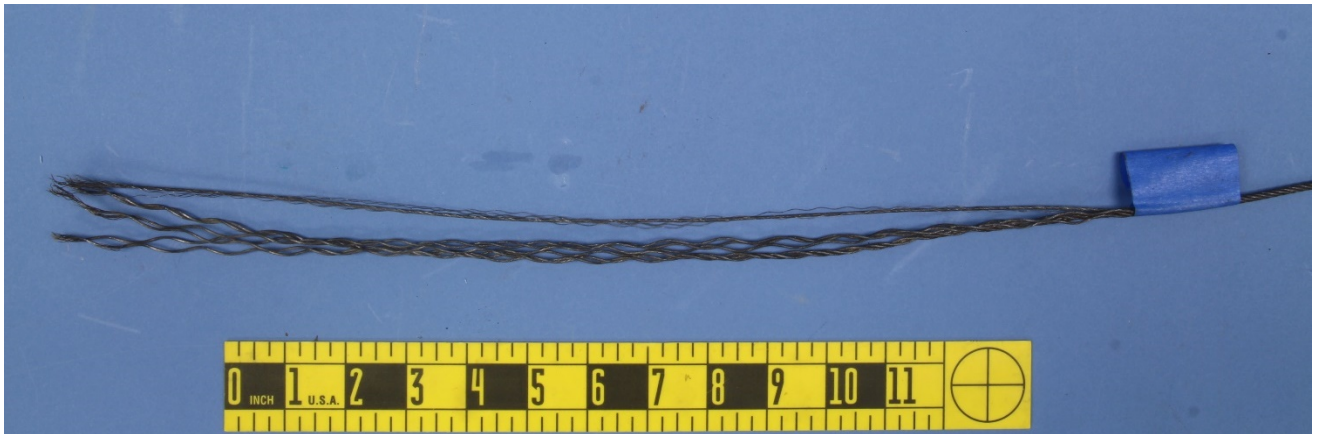
Figure 6 – View of the fractured end of the control cable remnant.

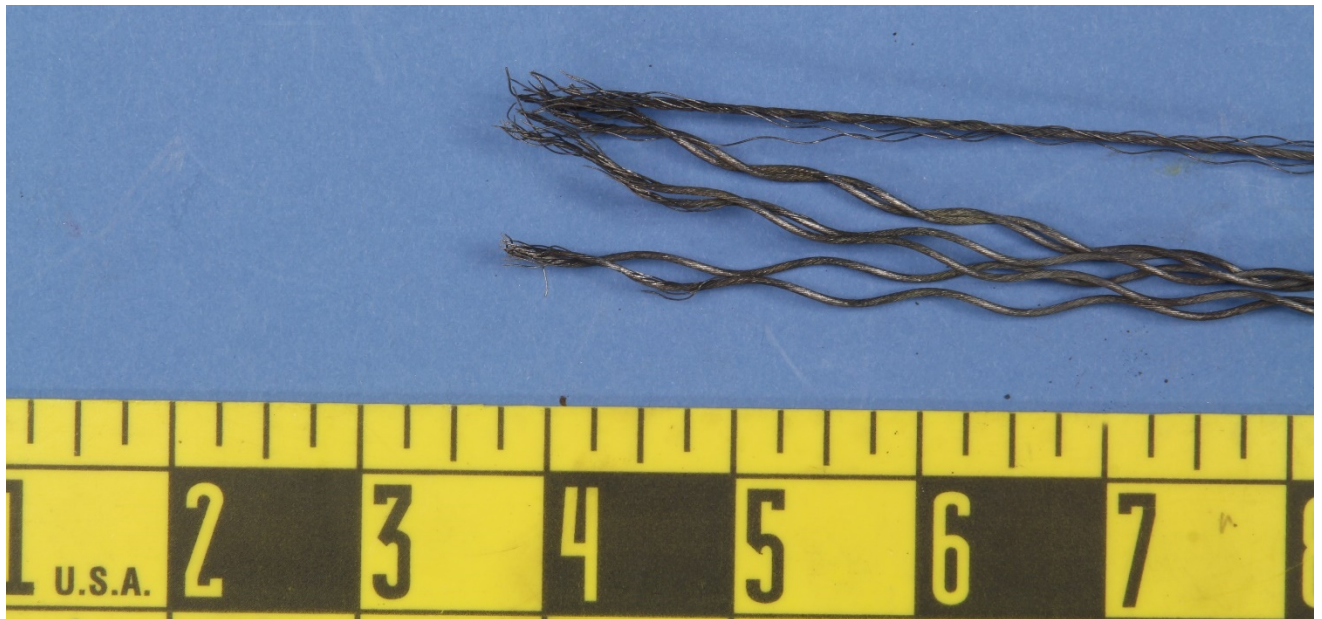
Figure 7 – View of the fractured control cable strands.

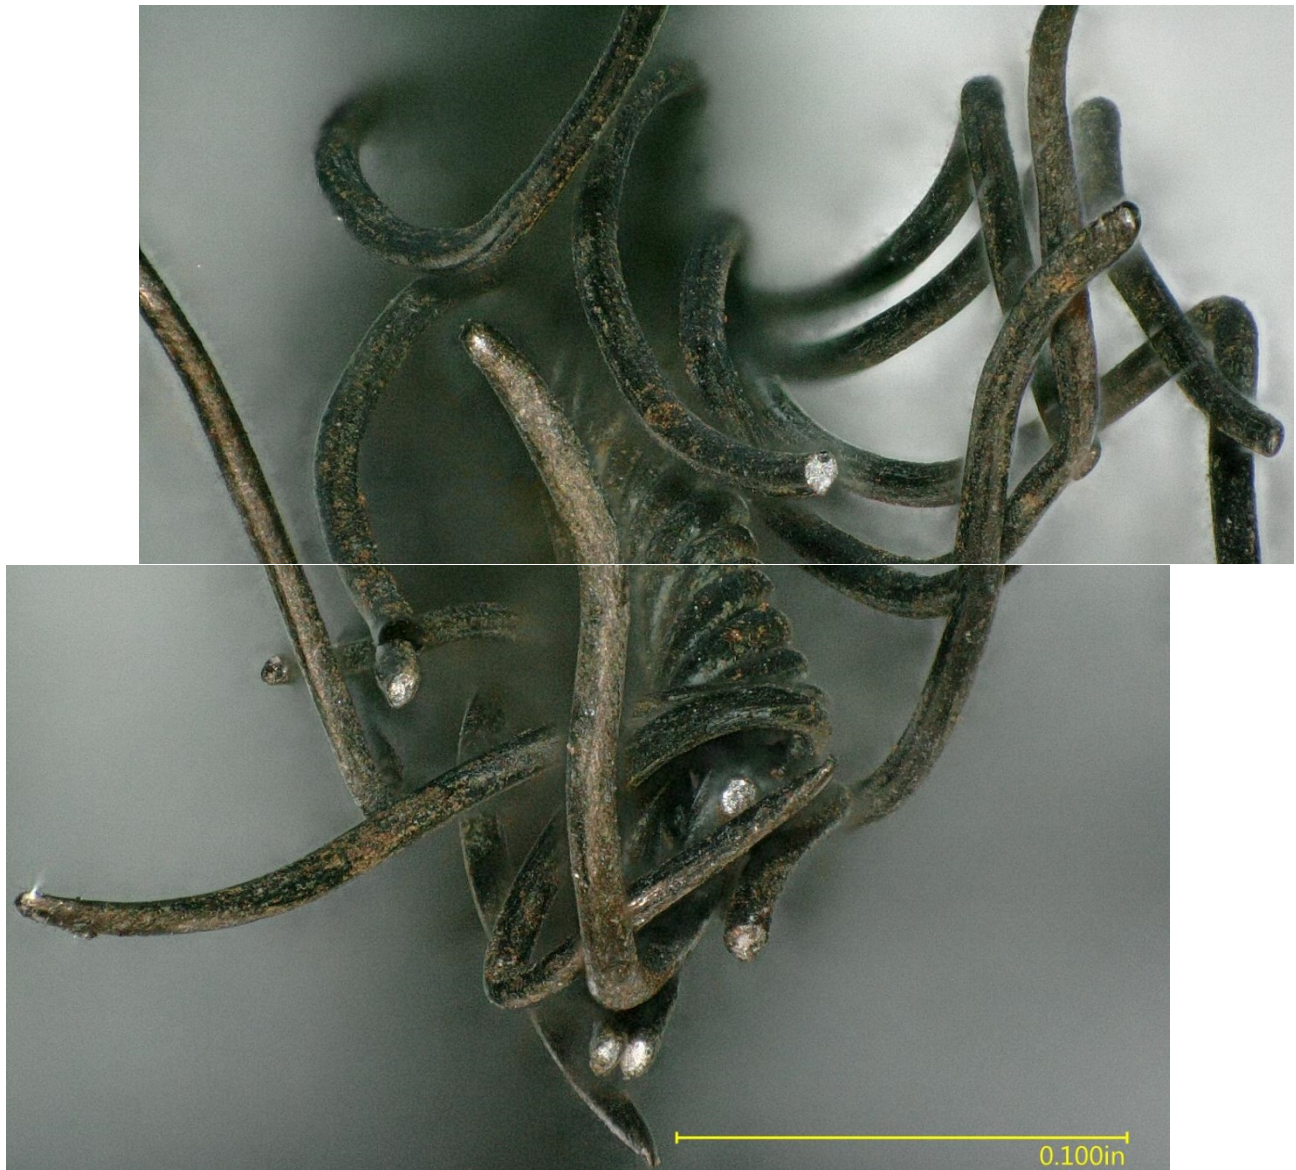
Figure 8 shows a montage of microscopic Z-stack photos of one of the frayed strands. The fractured wires showed several different fracture surface orientations. Most exhibited a slanted orientation, with some localized necking near the fracture. Others had necked and were completely rounded, consistent with some post-fracture damage. There were also three fractured wires with flat fracture surfaces oriented perpendicular to the wire direction.

Figure 8 – View of some of the fractured wires from the frayed strand of the cable fracture.

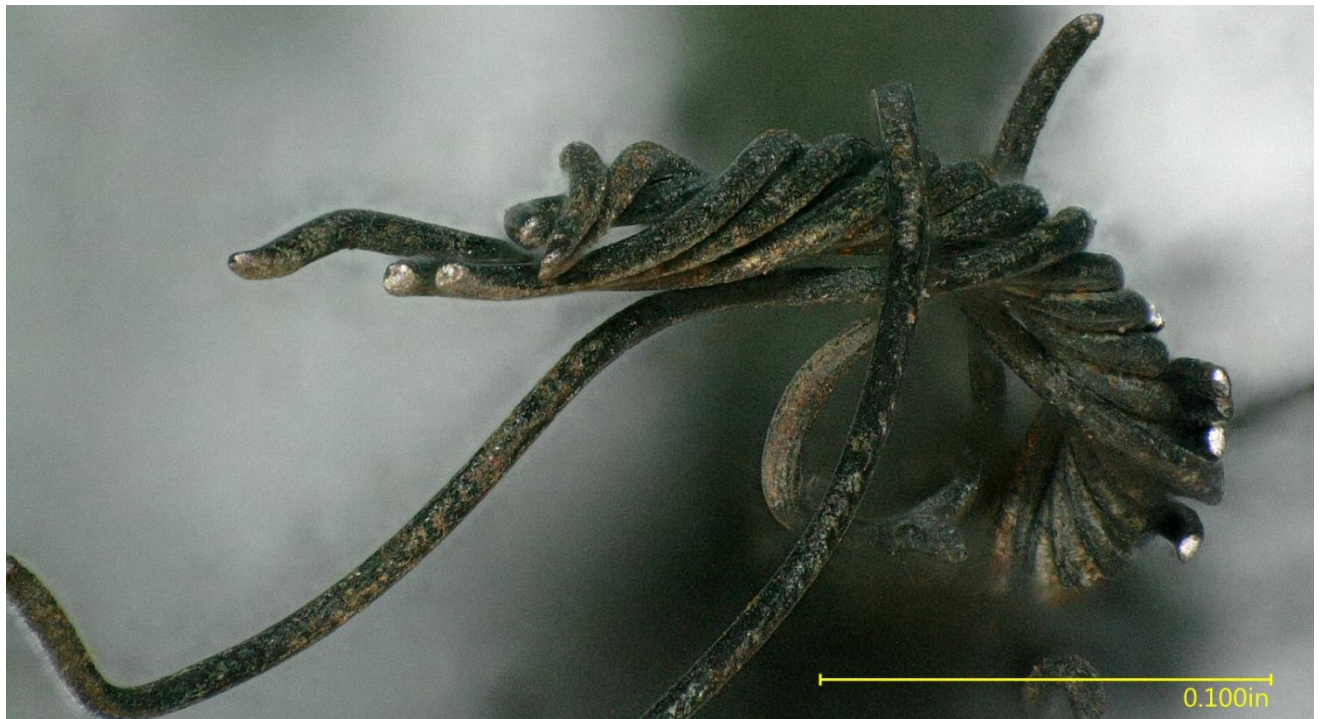
Figure 9 and 10 show microscopic images of two other frayed strands. These wires were mostly necked or thinned near the fracture surface. Several others exhibited a flat fracture surface, along with an ovoid or oblong wire shape adjacent to the fracture. The wires that have frayed out the most from the main strand exhibited rounding absent a fracture surface—these wires were consistent with having undergone some post-fracture damage or wear after breaking.

Figure 9 – View of the second strand of frayed wires on the fractured cable.

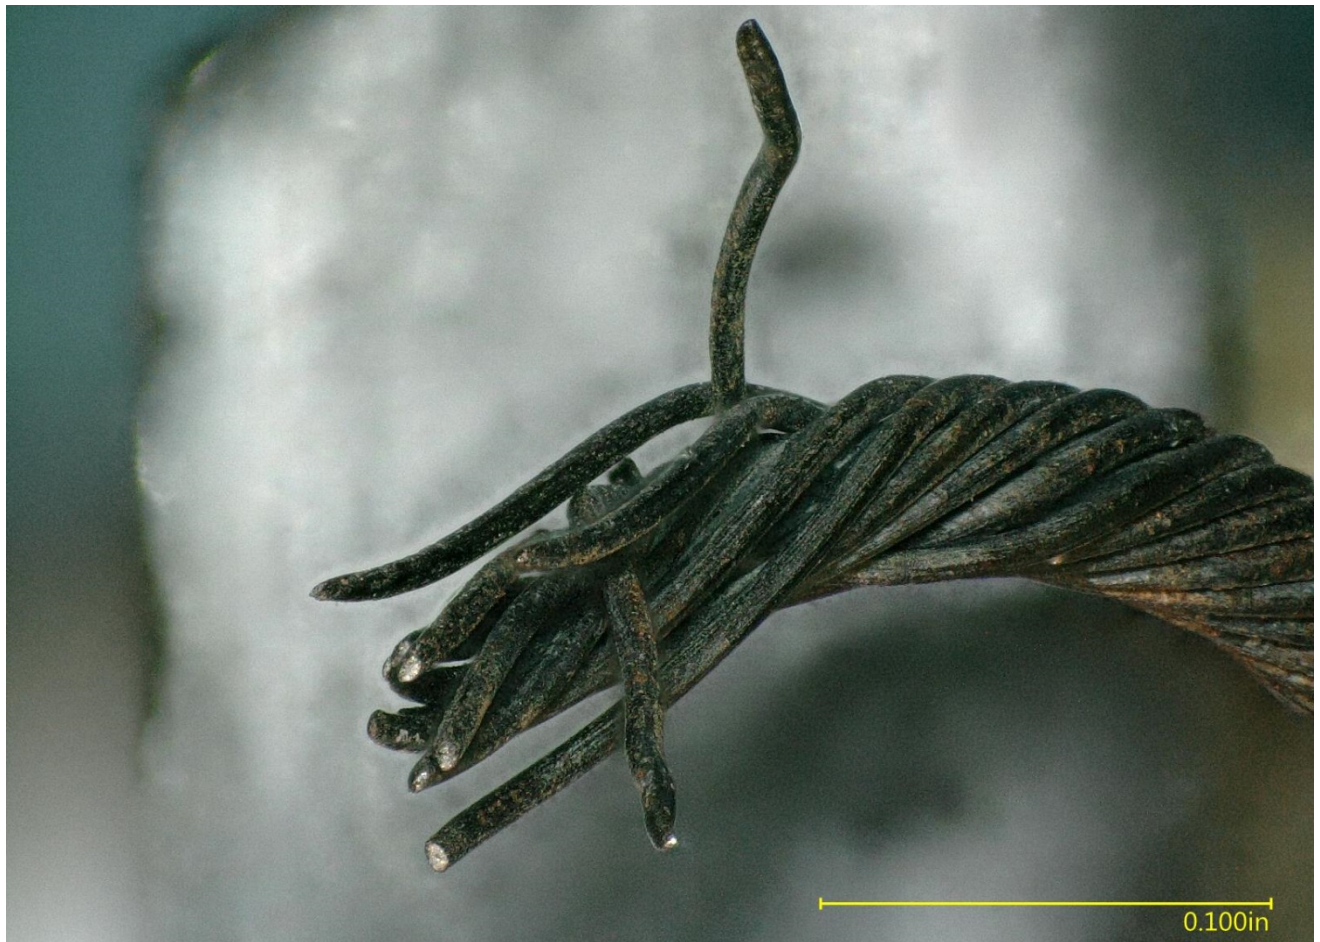
Figure 10 – View of the third set of wire strands on the fractured cable.

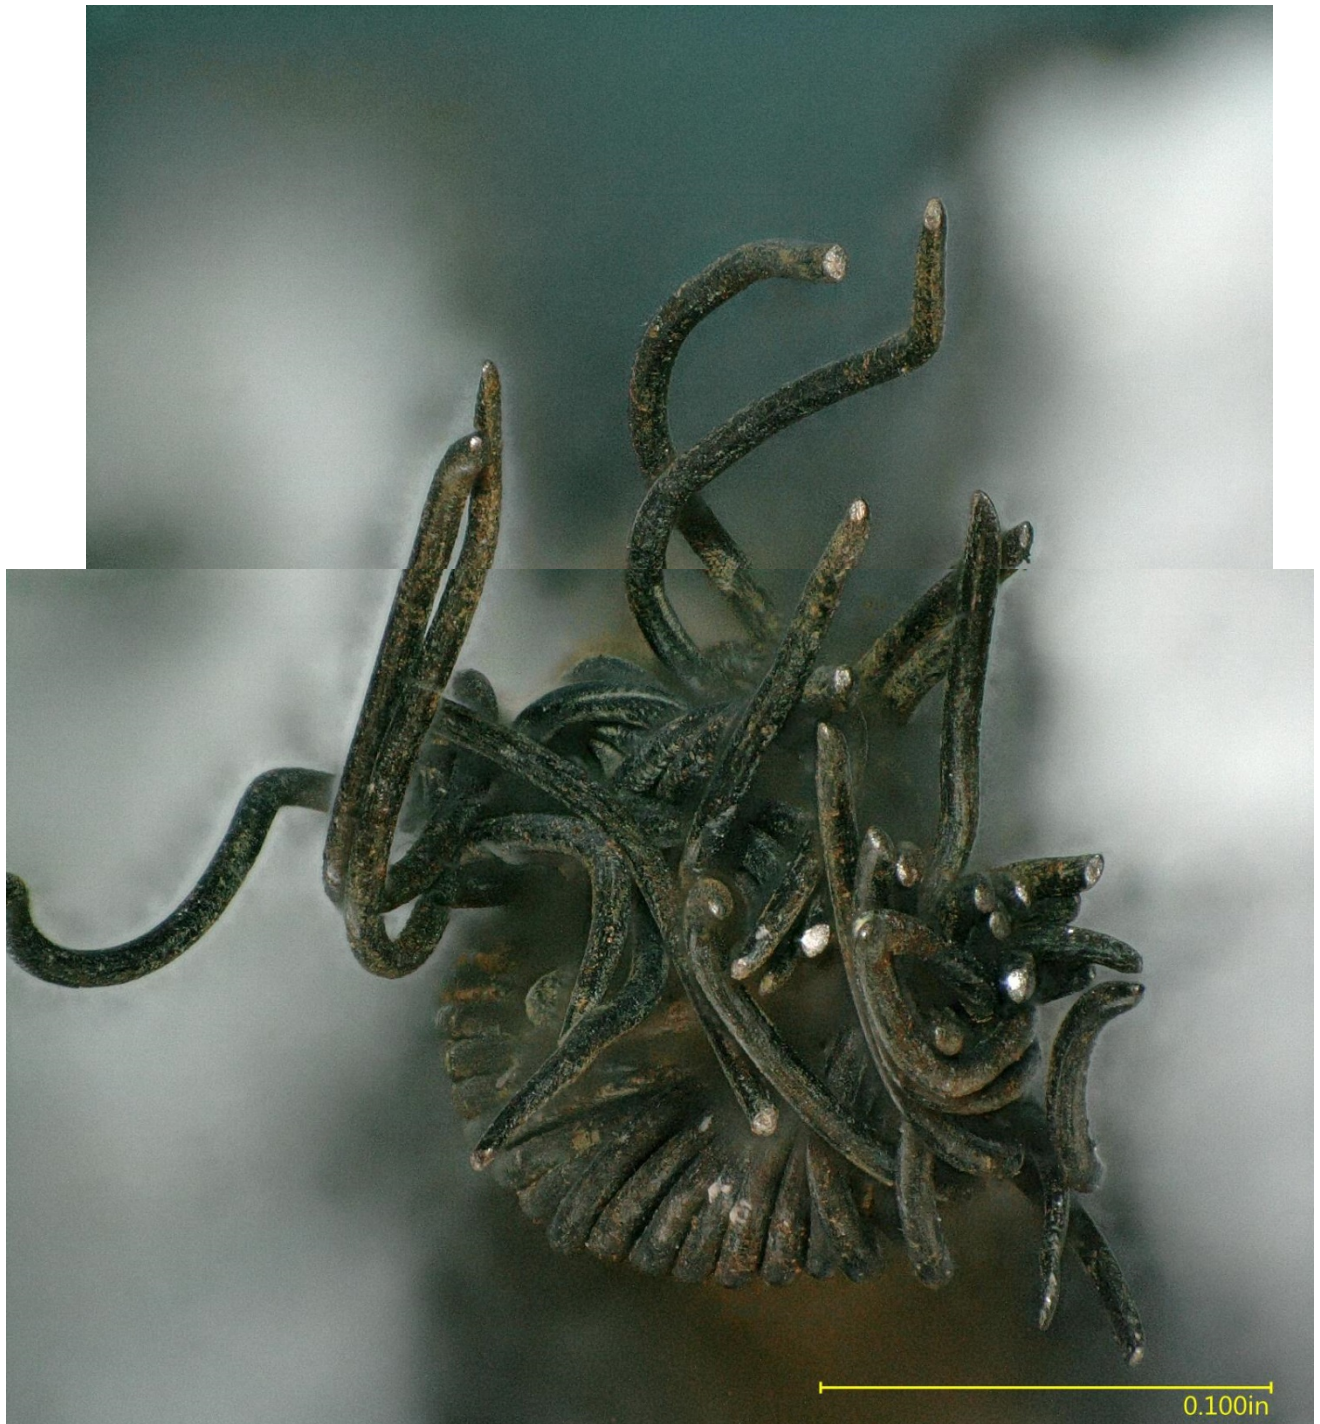
Figure 11 shows a montage of two of the most intact or unfrayed wire strands. Like the other bundles, these exhibited wire fractures with angled or cup-shaped fractures, with thinning or necking near the fracture surfaces. Several of the wires located outward from the main strand had been rounded or worn to a flat point, consistent with post-fracture damage.

Figure 11 – Montage view of the 4<sup>th</sup> and 5<sup>th</sup> wire strand sets from the fractured cable.

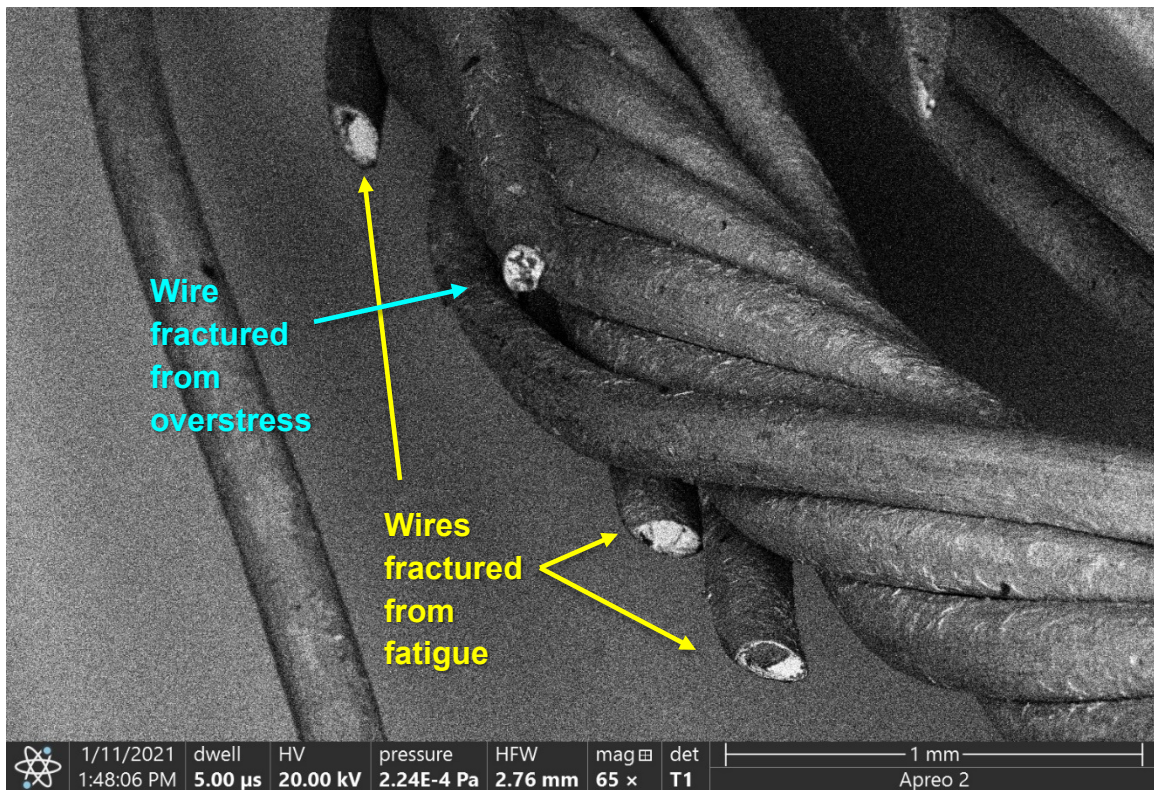
The two most damaged or frayed wire strands were inspected using a SEM, as shown in Figure 12. As observed visually, many of the fractured wires exhibited the features shown in Figure 13. This wire in this figure exhibited localized necking adjacent

Figure 12 – Backscattered electron (BE) micrograph of one of the frayed, fractured wire strands.

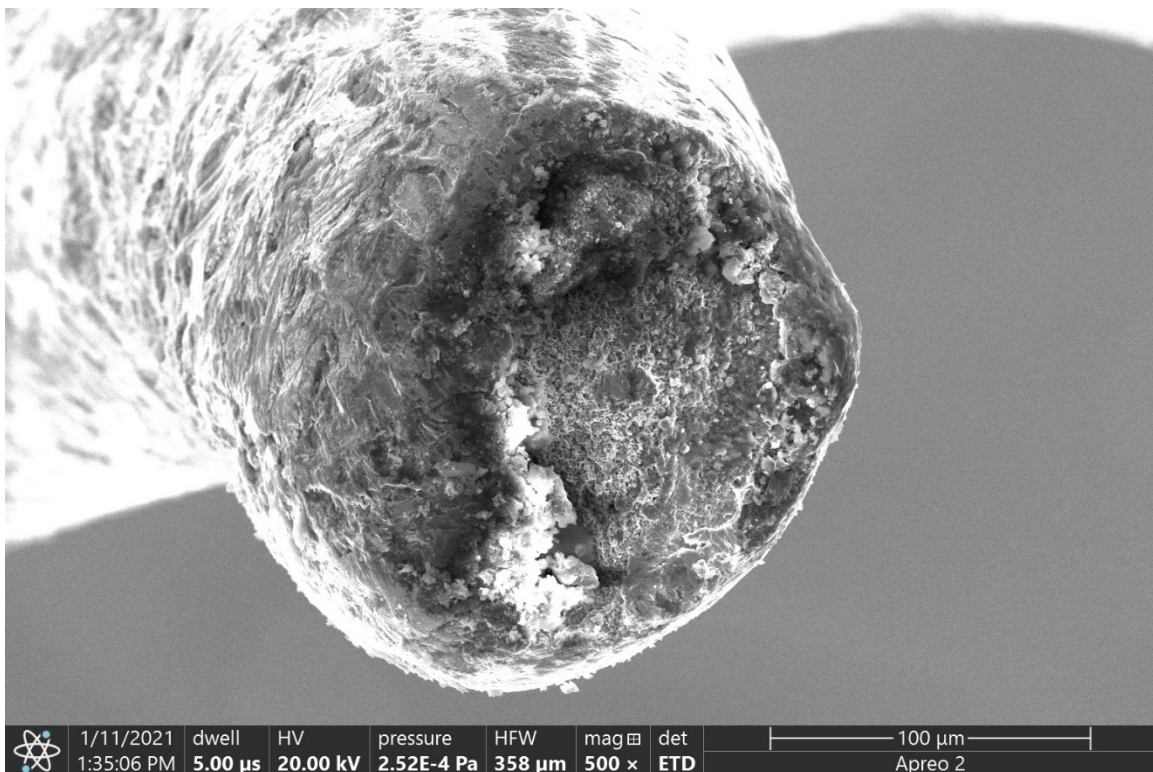
to the fracture surface, with a general cup-shape morphology. Most of the fractured wires contained post-fracture contamination, which manifests as non-conductive noise when imaging using a SEM. A closer view of the undamaged, uncontaminated portions of the fracture surface of the wire in Figure 13 is shown in Figure 14. This wire exhibited dimpled rupture, which along with the cup and cone fracture morphology, was consistent with tensile overstress fracture of a ductile material.

Figure 13 – Secondary electron (SE) micrograph of a fractured strand, showing necking.

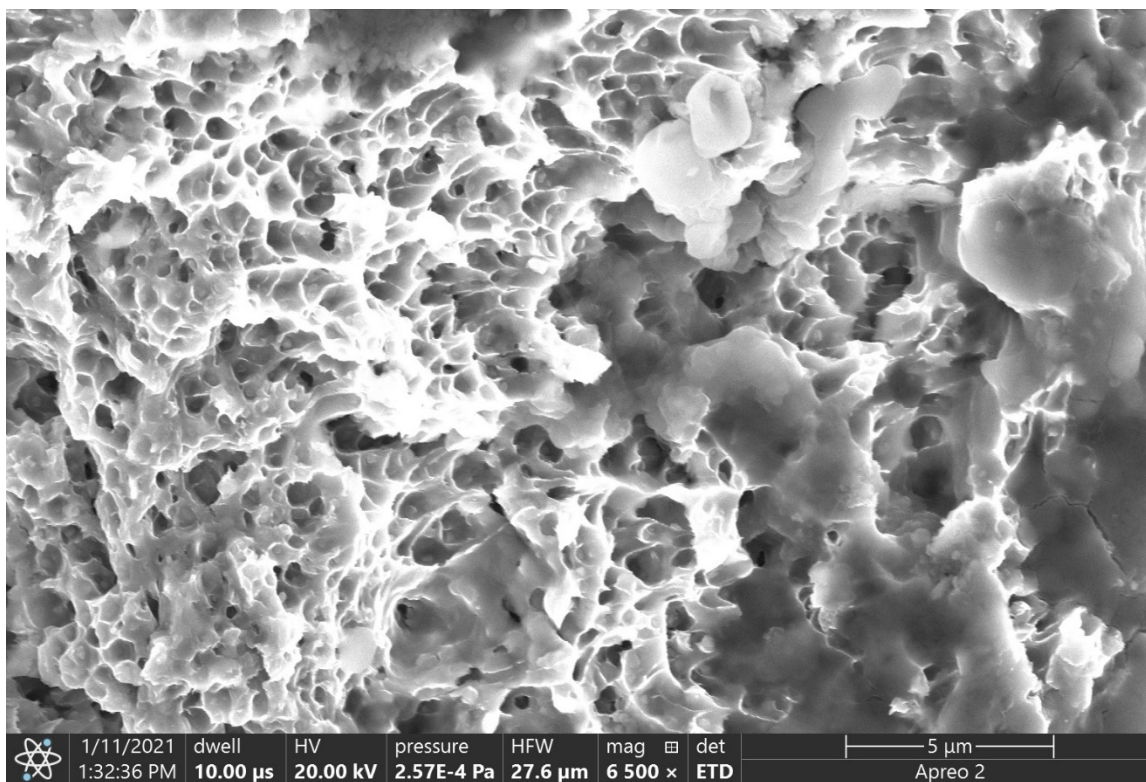
Figure 14 – SE micrograph showing dimple rupture from the fracture in Figure 13.

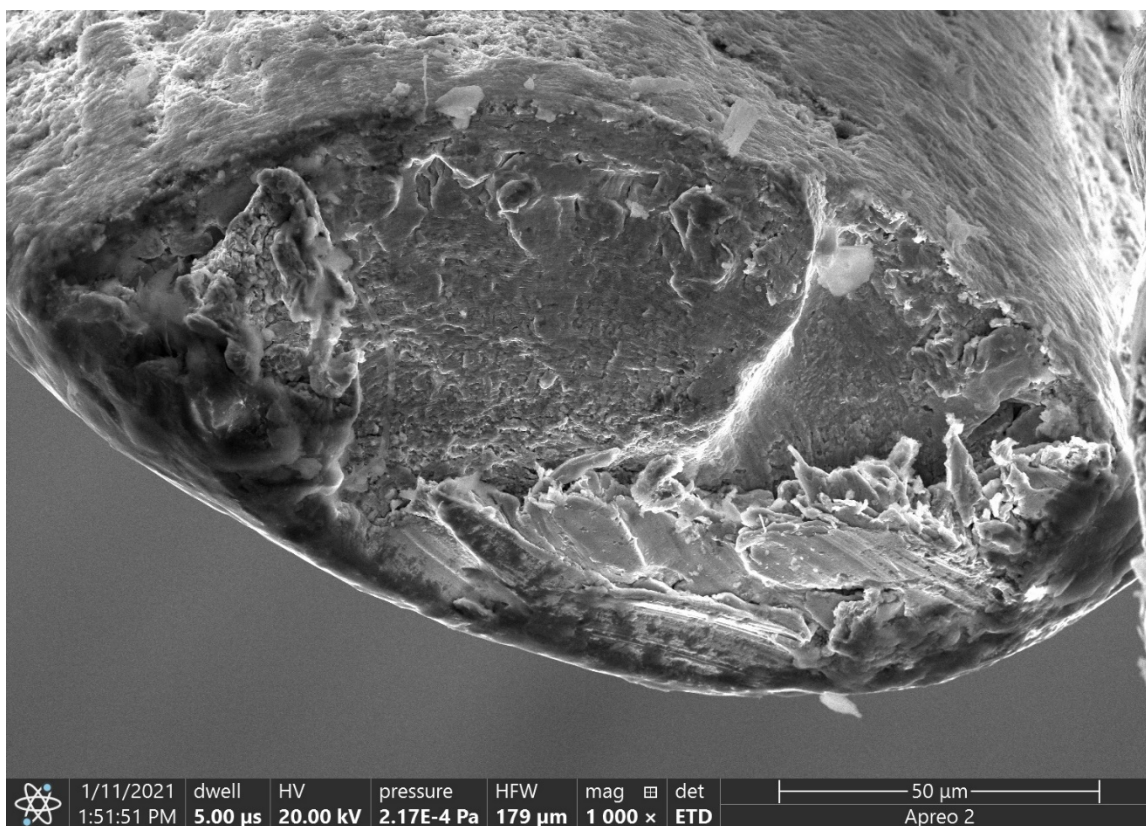
Three of the fractured wires in Figure 12 exhibited an oblong or flattened shape at the fracture surface. One of these wires is highlighted in Figure 15. Much of the wire fracture surface had been damaged by smearing, consistent with post-fracture damage. However, the undamaged portion of the fractured wire exhibited crack arrest marks and ratchet marks, consistent with progressive crack propagation and multiple crack initiation sites, respectively. A closer view of the wire fracture surface revealed fatigue striations, consistent with fatigue crack propagation (see Figures 16 and 17). As demonstrated in Figure 18, the fatigue crack initiation sites on this wire had been obliterated by smearing.

Figure 15 – SE micrograph of an oblong wire fracture, exhibiting fatigue features.

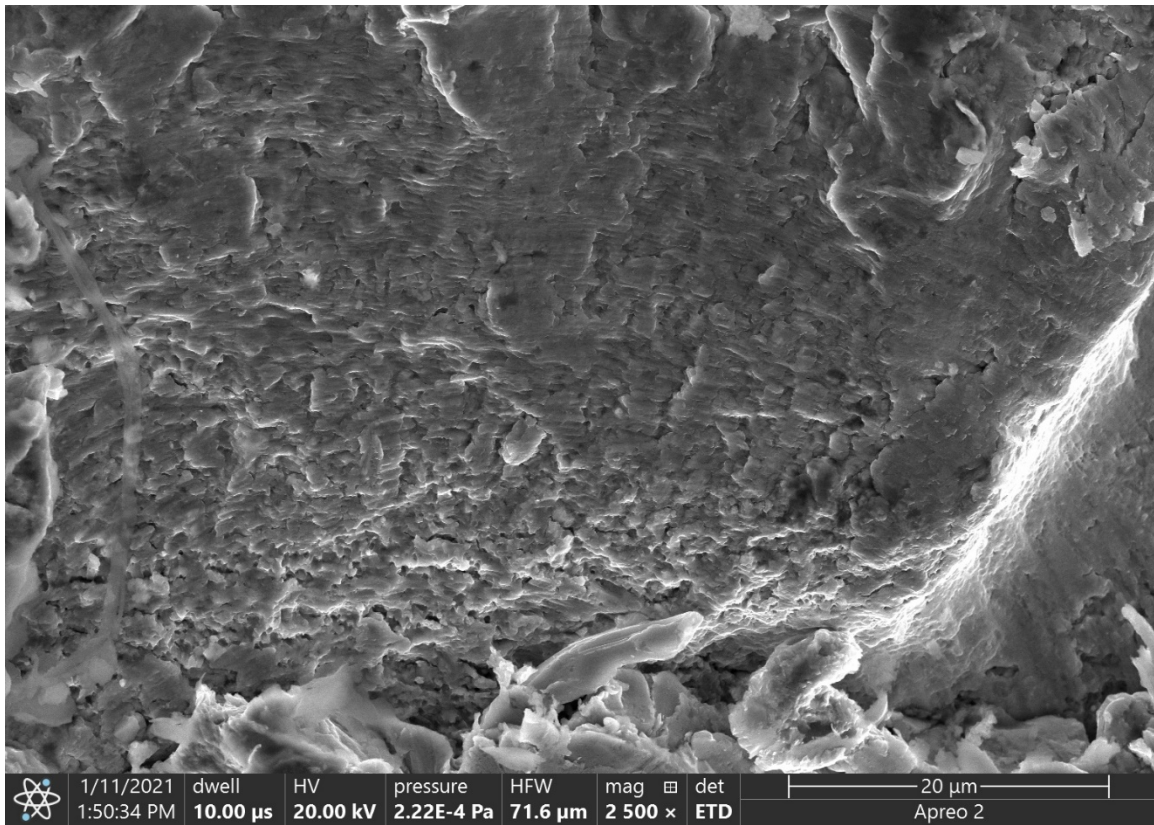
Figure 16 – SE micrograph of fatigue striations from the surface in Figure 15.

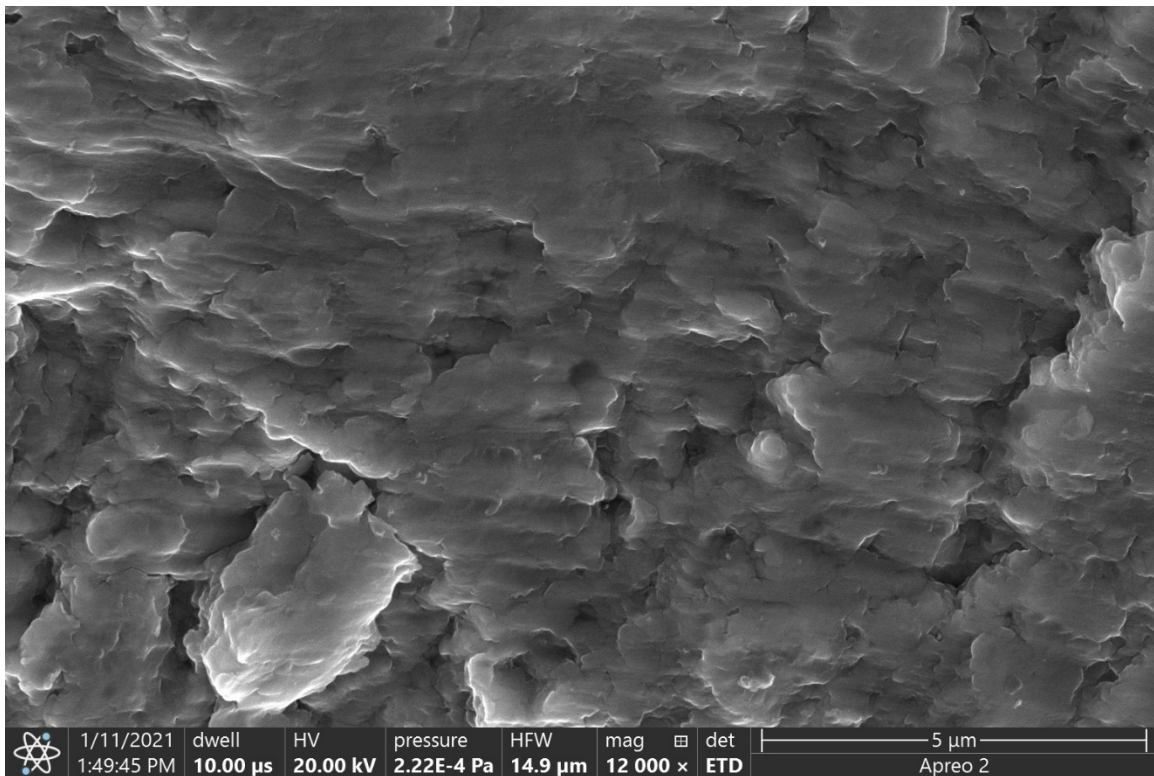
Figure 17 – SE micrograph showing a closer view of the striations in Figure 16.

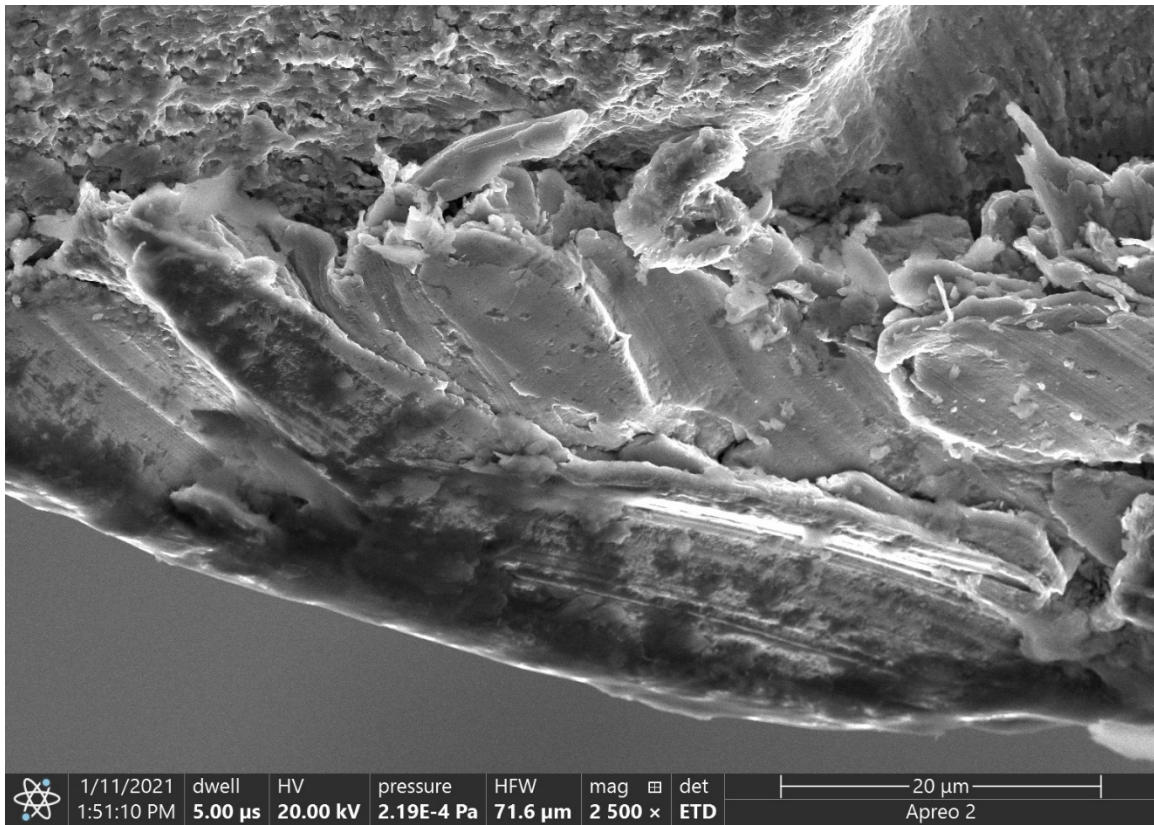
Figure 18 – SE micrograph of the damaged fatigue initiation site from Figure 15.

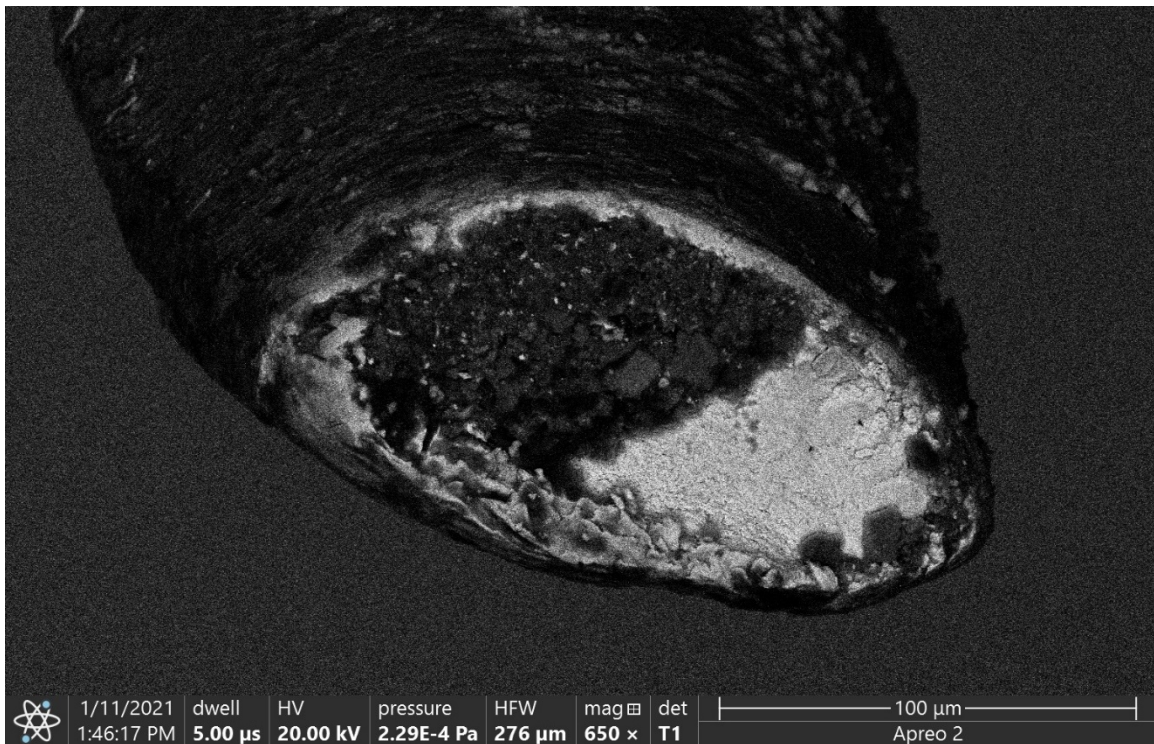
Figure 19 shows a second oblong-shaped fractured wire. As demonstrated by the dark material in the figure, the left half of the fracture surface exhibited non-conductive surface contamination.<sup>1</sup> The right side of the wire fracture surface exhibited fatigue striations, as shown in Figure 20. Figure 21 shows a third wire exhibiting fatigue striations from the strand. This surface exhibited clear fatigue striations and crack arrest marks (see Figure 22).

Figure 19 – Backscattered electron (BE) micrograph of a second wire with fatigue features, showing an oblong shape and surface contamination on the left.

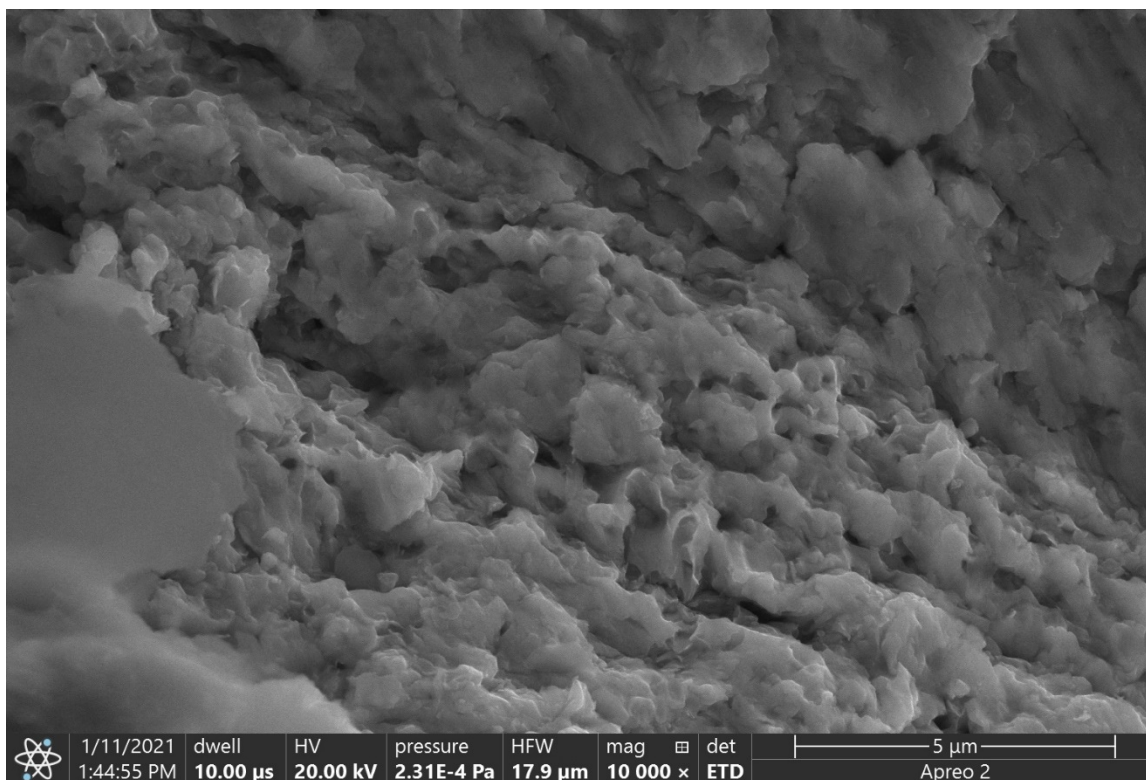
Figure 20 – SE micrograph of fatigue striations on the fractured wire in Figure 19.
