# NATIONAL TRANSPORTATION SAFETY BOARD

## MATERIALS LABORATORY FACTUAL REPORT

Report No. 21-002

Place : Hemet, California  
Date : April 30, 2020  
Vehicle : Piper PA-23-250, N6521Y  
NTSB No. : WPR20LA135  
Investigator : Fabian Salazar, AS-WPR

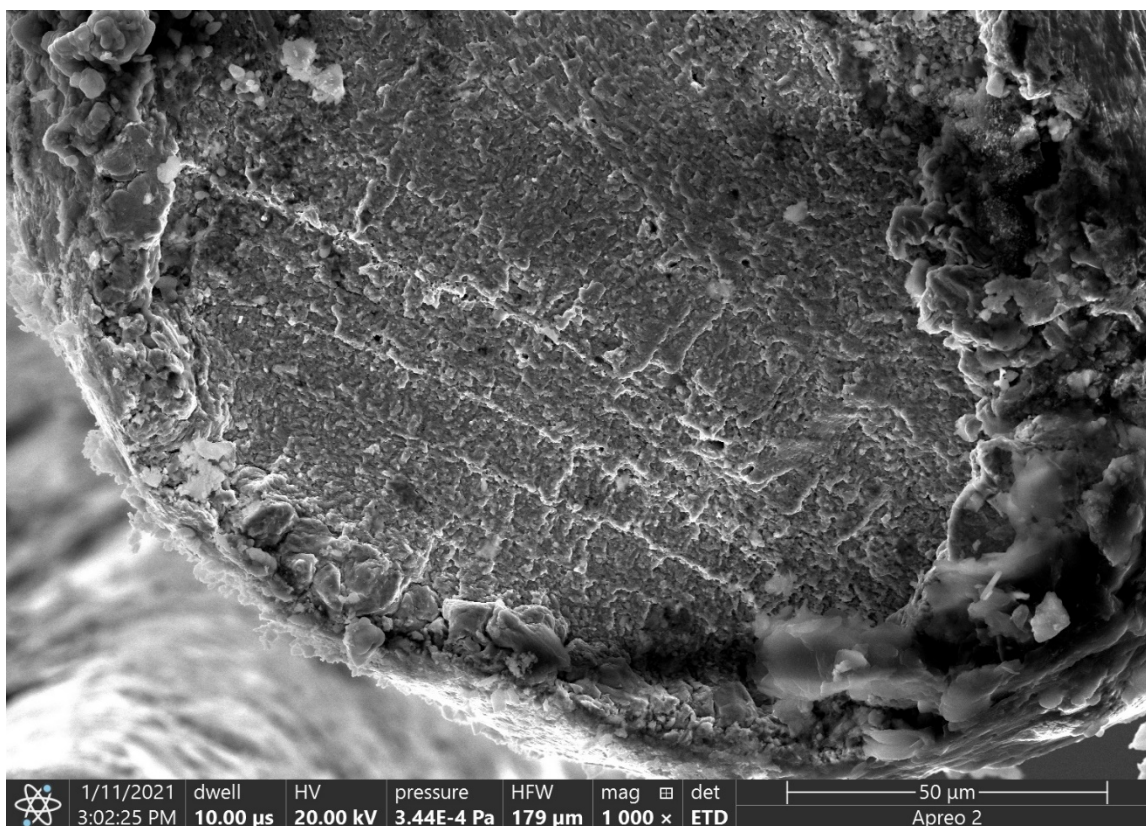
Figure 19 shows a second oblong-shaped fractured wire. As demonstrated by the dark material in the figure, the left half of the fracture surface exhibited non-conductive surface contamination.<sup>1</sup> The right side of the wire fracture surface exhibited fatigue striations, as shown in Figure 20. Figure 21 shows a third wire exhibiting fatigue striations from the strand. This surface exhibited clear fatigue striations and crack arrest marks (see Figure 22).

Figure 21 – SE micrograph of a third wire with fatigue features.

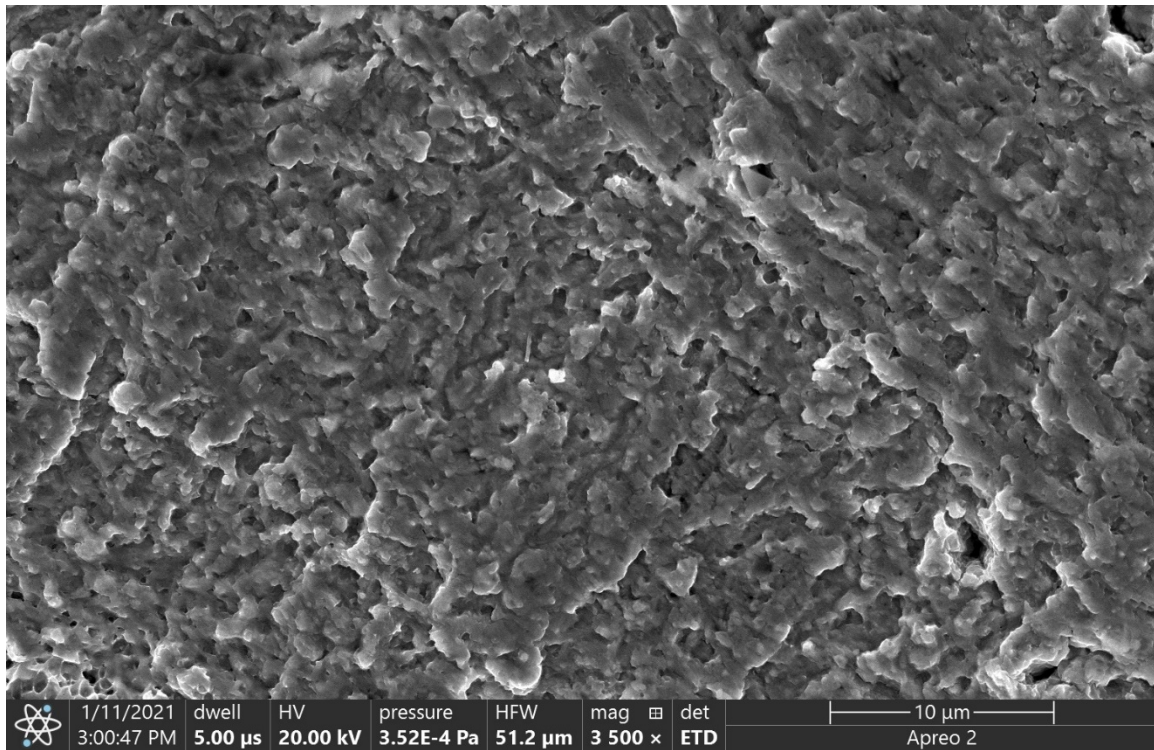
Figure 22 – SE micrograph of a closer view of fatigue striations on Figure 21.

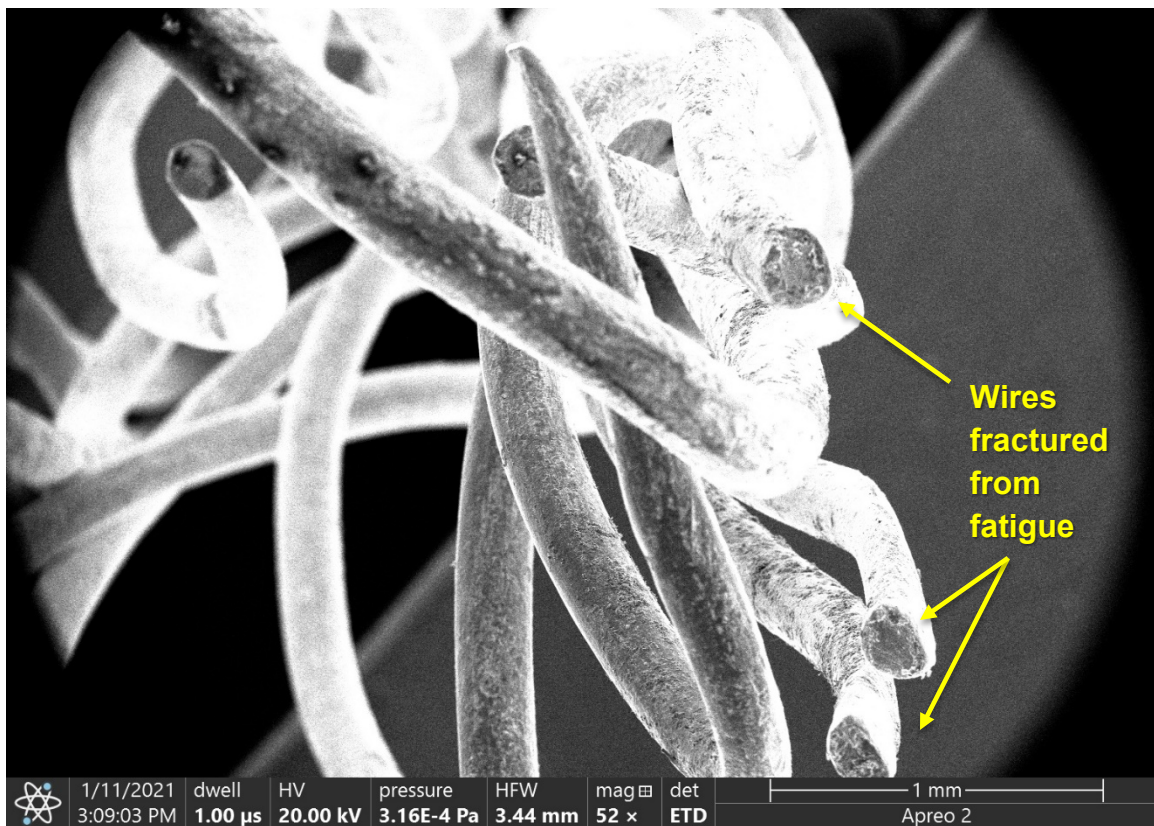
Figure 23 shows several of the fractured wires from the second wire strand. As seen in the figure, many of these wires exhibited flat fracture surfaces. One such wire fracture is highlighted in Figure 24. This wire exhibited three distinct fracture regions—two which showed fatigue striations (as highlighted in Figure 25), and a middle one exhibiting dimpled rupture. These features were consistent with fracture of this wire by reverse-bending fatigue.

Figure 23 – SE micrograph of a second set of fractured wires, several with fatigue features.

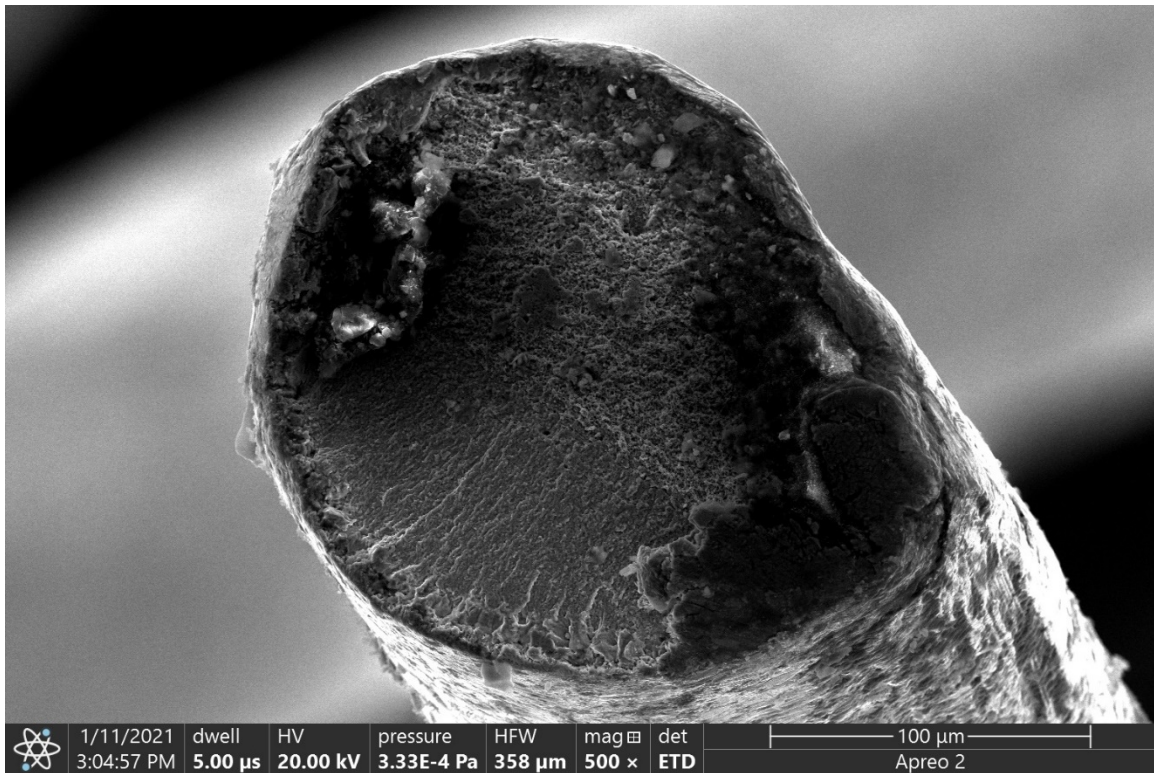
Figure 24 – SE micrograph of a fractured wire from, showing fatigue and overstress features.

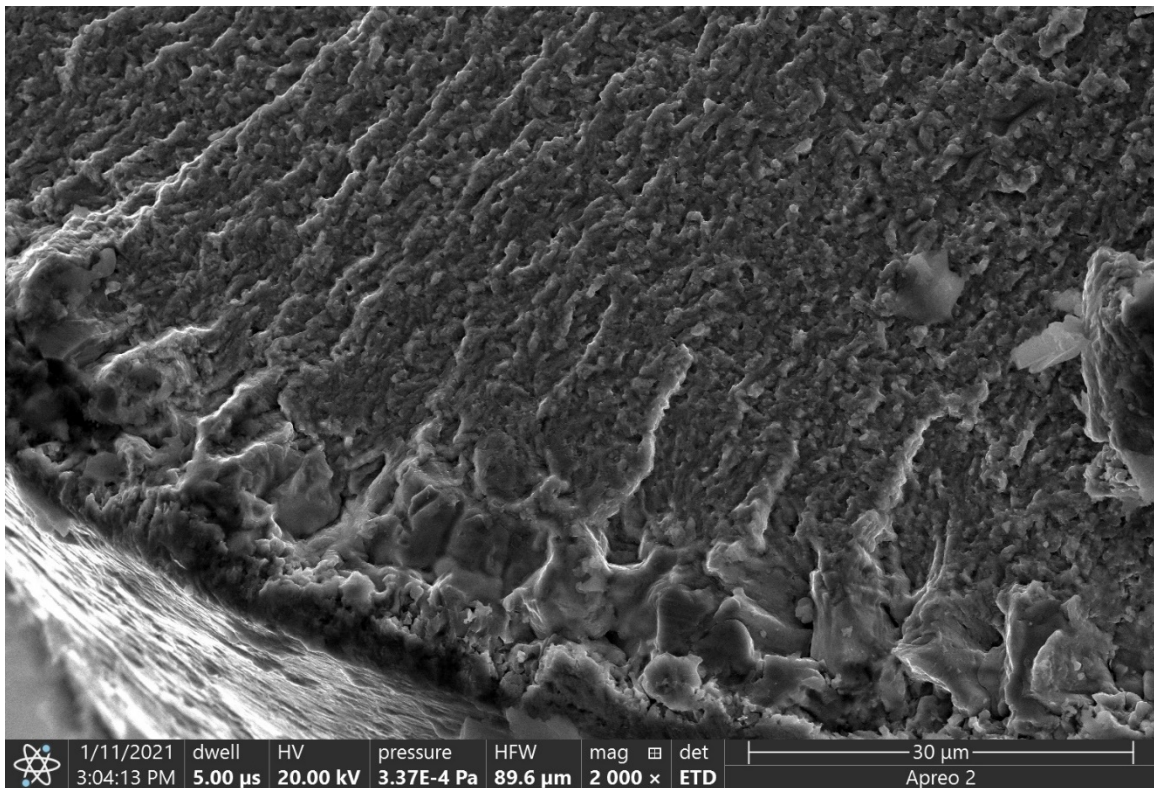
Figure 25 also shows some of the smaller fatigue crack initiation sites of the wire. These initiation sites exhibited some faceted features along the 10  $\mu\text{m}$  closest to the surface. Each of these sites had a corresponding ratchet marks at the first 20  $\mu\text{m}$  of the fatigue cracking on the fracture surface, consistent with these smaller fatigue cracks coalescing into a larger crack during propagation.

Figure 25 – SE micrograph of fatigue initiation sites of the wire in Figure 24.

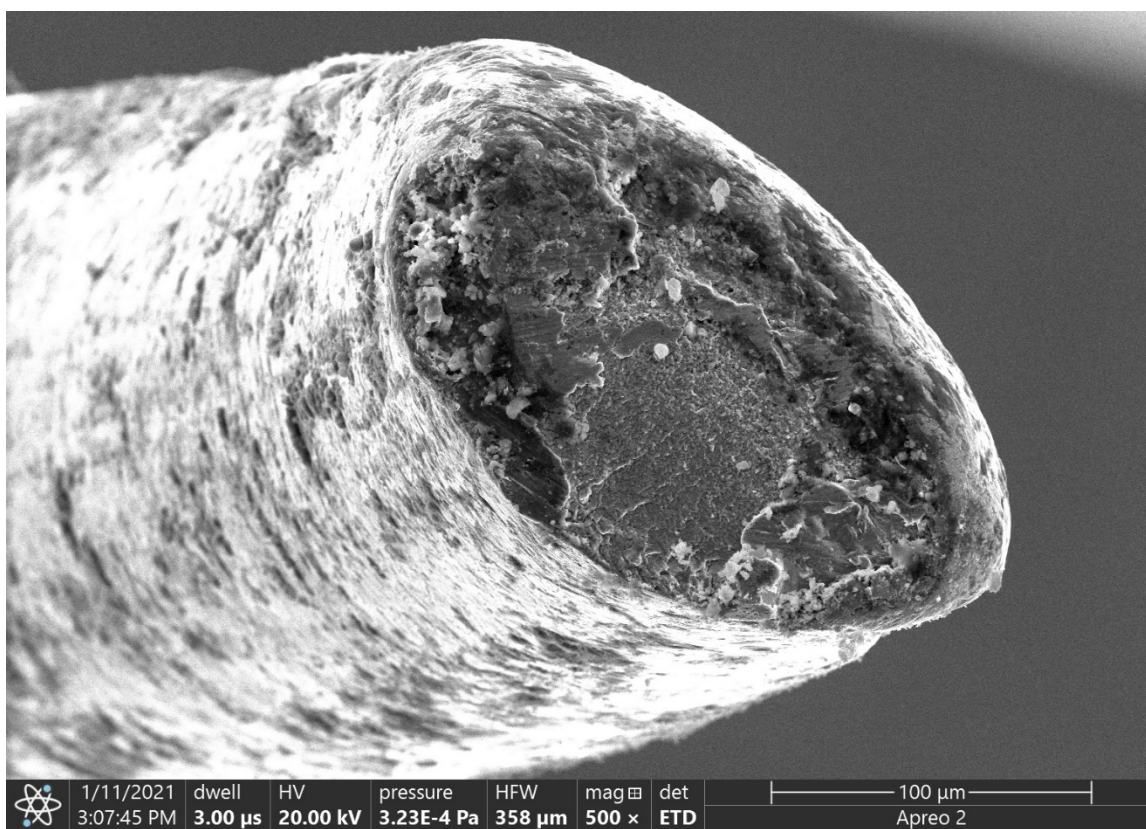
Figure 26 shows another fractured wire with fatigue striations on one half of the fracture. The other (upper) half of the fracture exhibited a rougher texture with dimpled rupture, consistent with subsequent overstress fracture. The portion of the wire along the overstress side also exhibited localized necking and cup-like features. These were consistent with a fatigue crack that had propagated approximate halfway through the wire cross section before the remainder succumbed to tensile overstress fracture.

Figure 26 – SE micrograph of a pinched and fatigued wire from Figure 23.

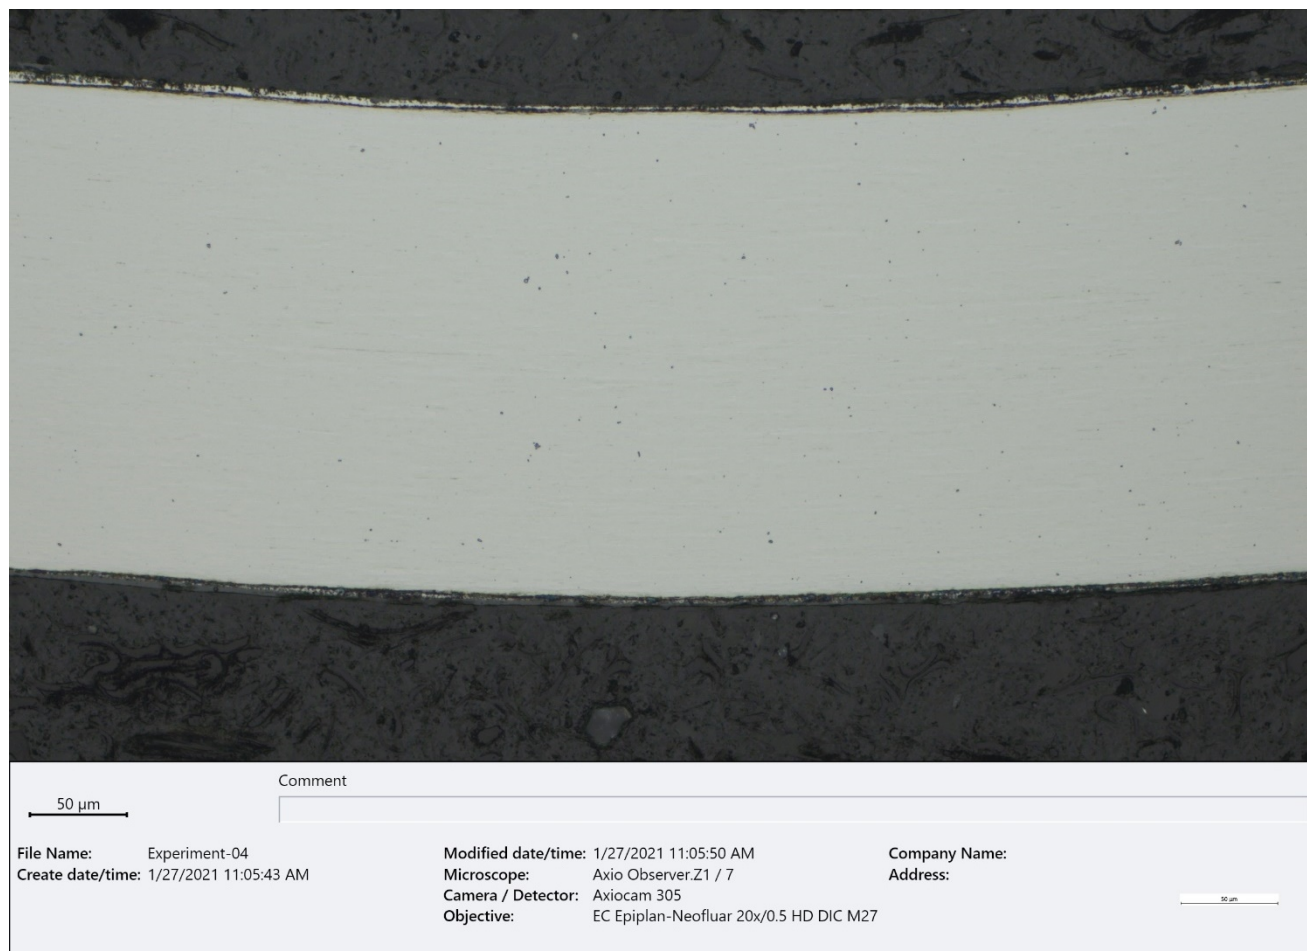
Several of the wire strands were mounted, ground, and polished for cross-sectional metallurgical examination. As shown in Figure 23, a longitudinal section of one of the wires that fractured from fatigue exhibited elongated grain flow and structure (parallel to the drawing direction of the wire). The surfaces of the wires exhibited a coating.

The chemical composition of the sectioned wires was examined using energy dispersive x-ray spectroscopy (EDS). From the data obtained, the wires were found to be consistent with carbon steel that had been galvanized (zinc coated). The hardness of one of the wires was inspected per ASTM E384.<sup>2</sup> The hardness averaged 47 HRC (493 HV<sub>500</sub>).

Figure 27 – Bright-field (BF) optical micrograph of a longitudinal (parallel) section of a wire, showing elongated grain structure along the drawing direction and a surface coating (~200X, as-polished).
