## **NATIONAL TRANSPORTATION SAFETY BOARD**

# **AIRFRAME AND ENGINE EXAMINATION**

**WPR20LA135**

Location: Hemet, CA.  
Date: April 30, 2020  
Aircraft: N6521Y, PA-23-250  
NTSB IIC: Fabian Salazar

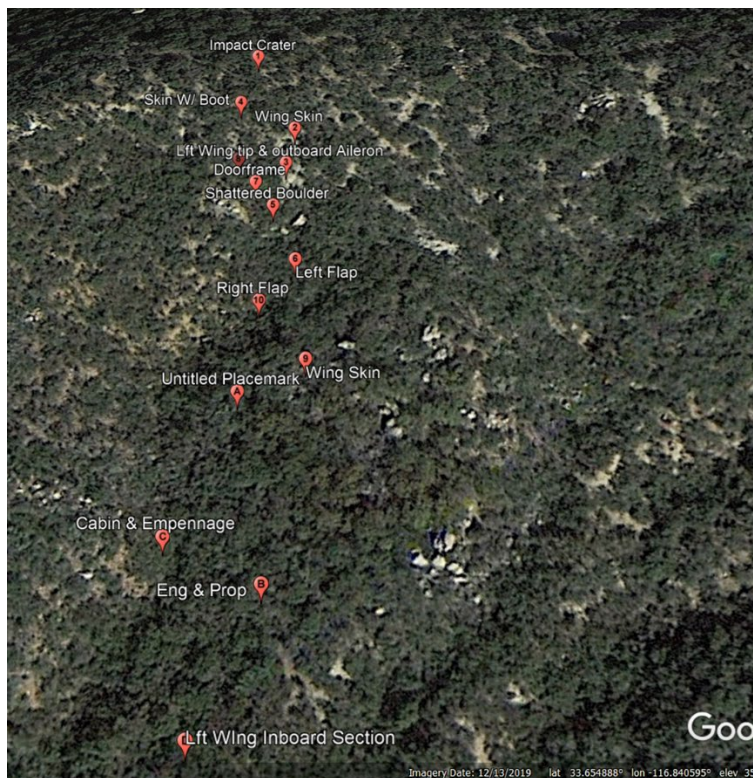
The airplane was substantially damaged by impact with terrain and post-crash fire. A debris path about 240 ft long extended away from the wreckage. Large amounts of airplane components, and sheet metal were strewn throughout the debris path. A post-crash fire damaged the cabin area,

1. First point of probable impact
2. Wing Skin
3. Door Frame
4. Skin with Boot
5. Shattered boulder
6. Left Flap
7. Door Frame
8. Left Wing Tip & outboard Aileron
9. Wing Skin
10. Right Flap
- A.
- B. Engine and Propeller
- C. Cabin & Empennage
- D. Left Wing Inboard Section

Figure 1. Overhead view of the accident site showing the location of wreckage items.

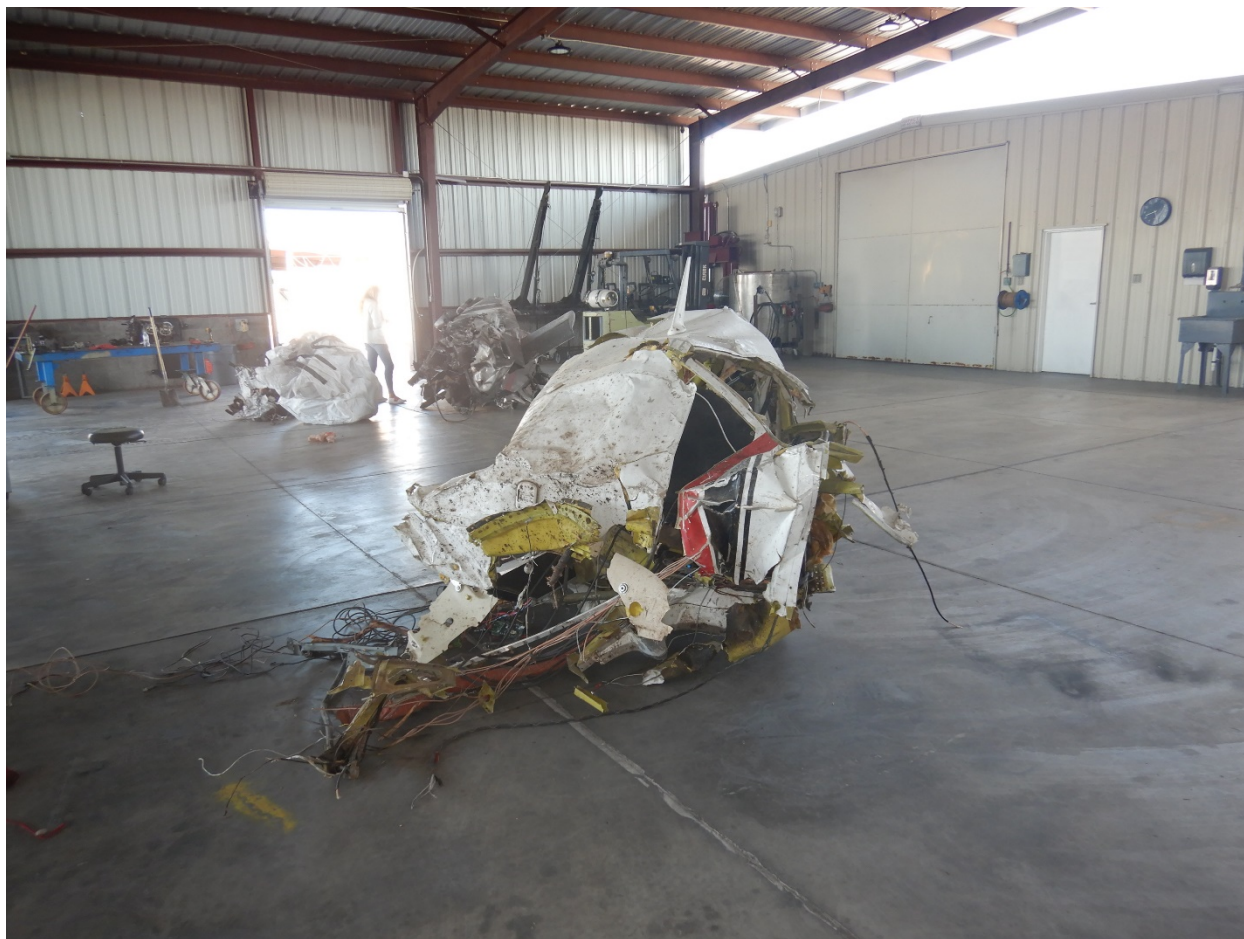
Fuselage. The fuselage exhibited substantial damage throughout its entirety. The nose of the airplane was crushed inwards and aft, with the top of the cabin crushed downwards over the nose. All windscreens and windshields were shattered and missing. The right side of the fuselage exhibited missing sections near the cabin area, exposing the cabin interior. The right-side aft fuselage was crushed inwards. The right-side stabilator was absent. The vertical stabilizer,

Figure 2. Front view of N6521Y. Photo courtesy of Piper Aircraft.

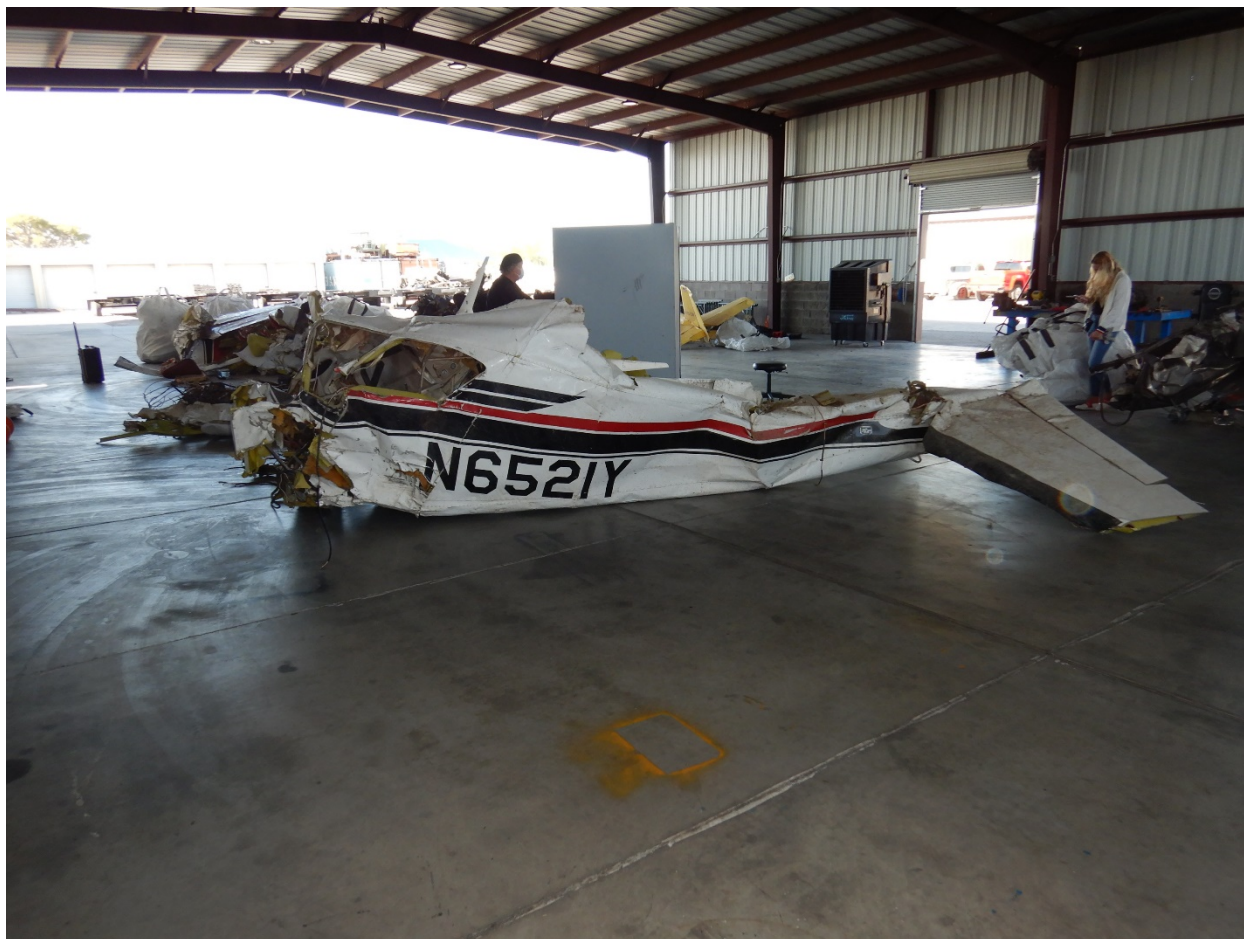
Figure 3. Left-side view of the fuselage. Photo courtesy of Piper Aircraft.

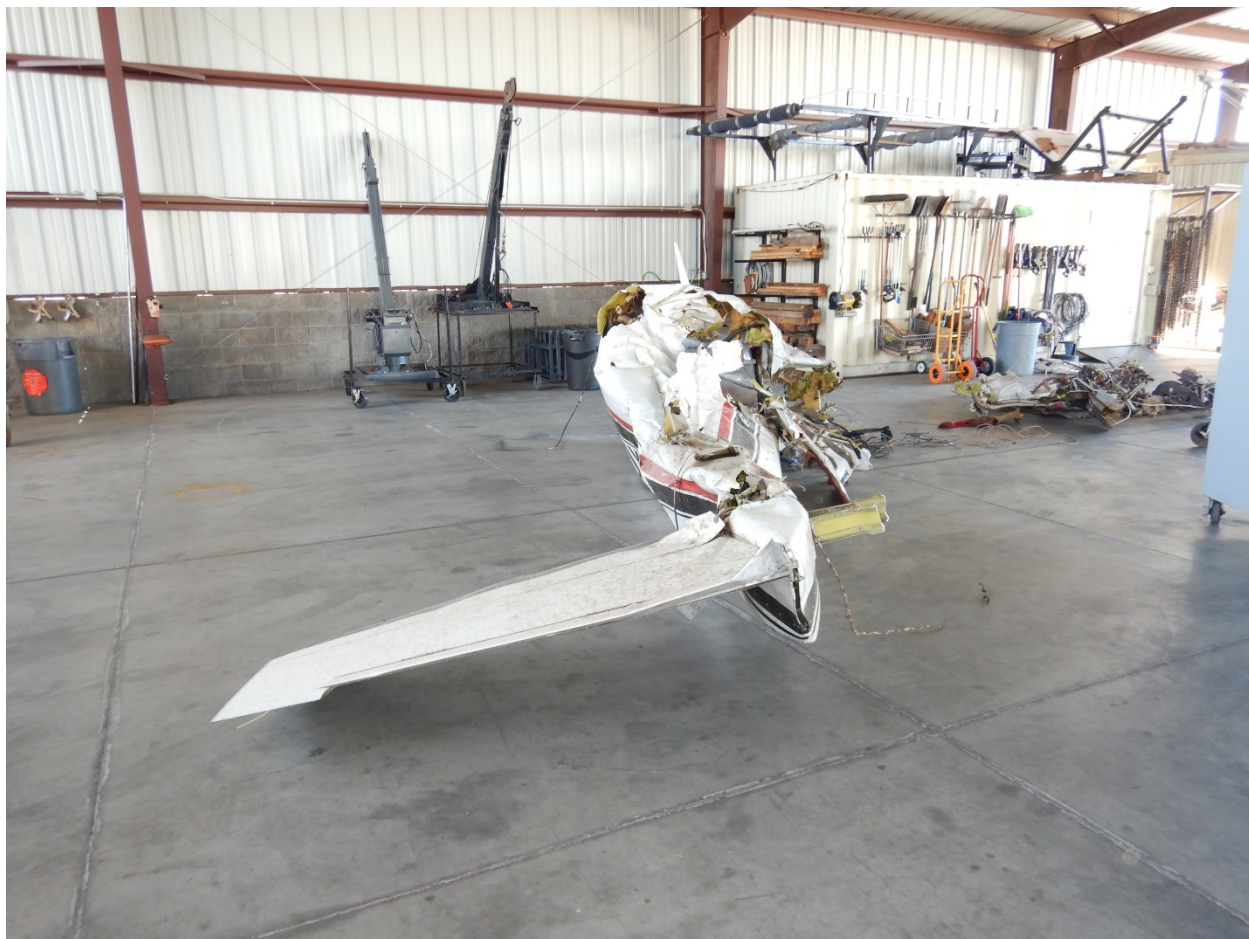
Figure 4. rear view of N6521Y. Photo courtesy of Piper Aircraft.

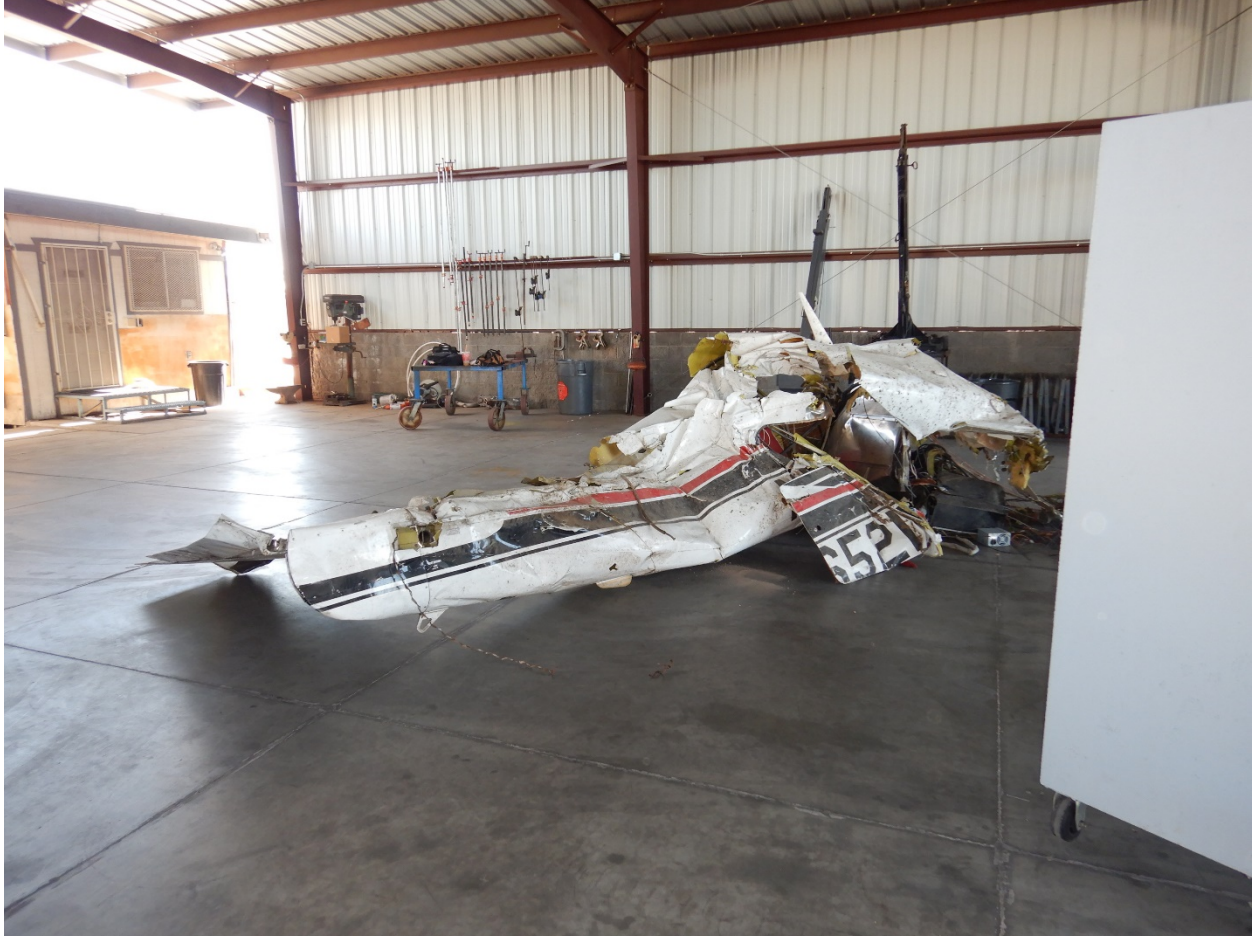
Figure 5. Right-side view of N6521Y. Photo courtesy of Piper Aircraft.

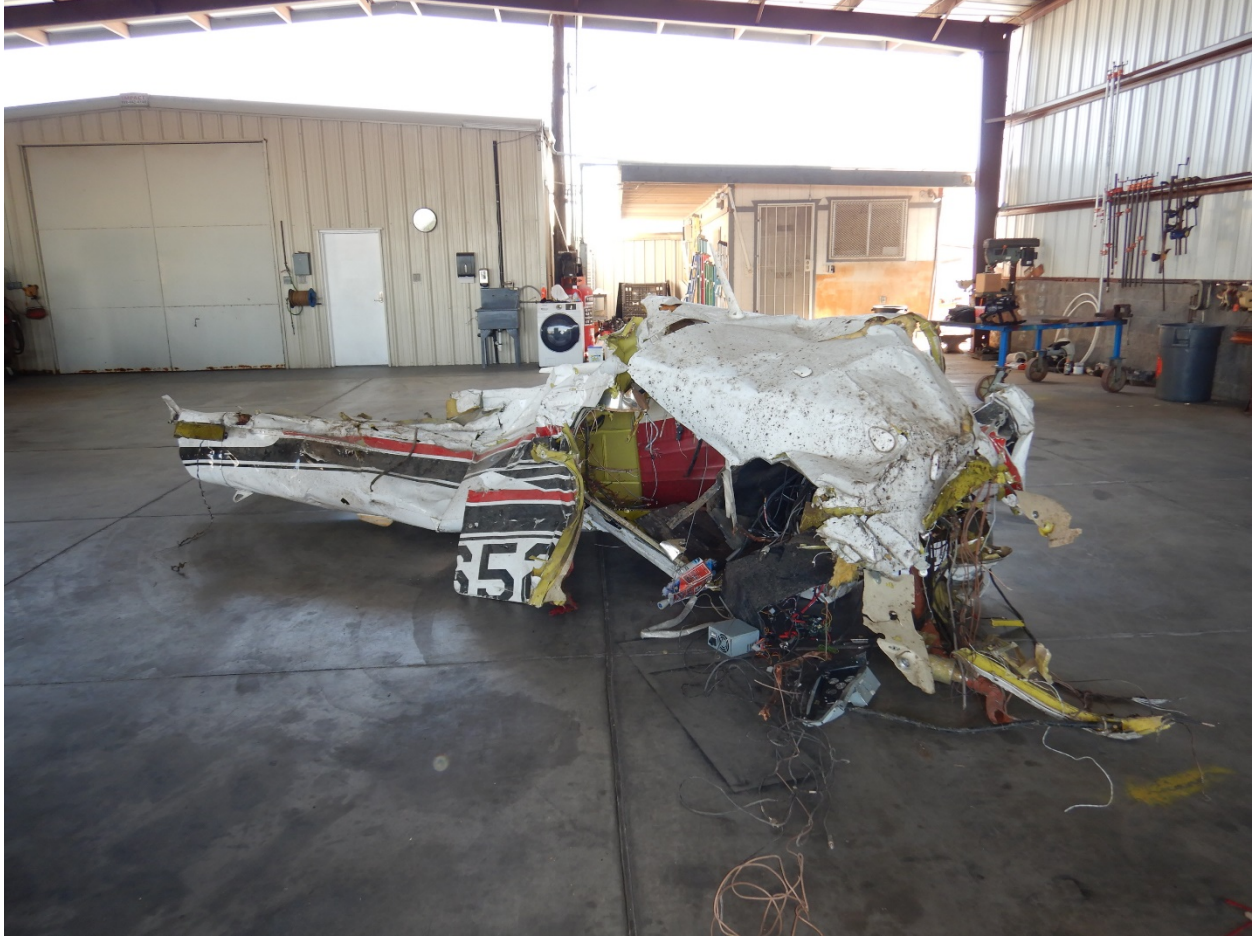
Figure 6. Right-front view of N6521Y. Photo courtesy of Piper Aircraft.

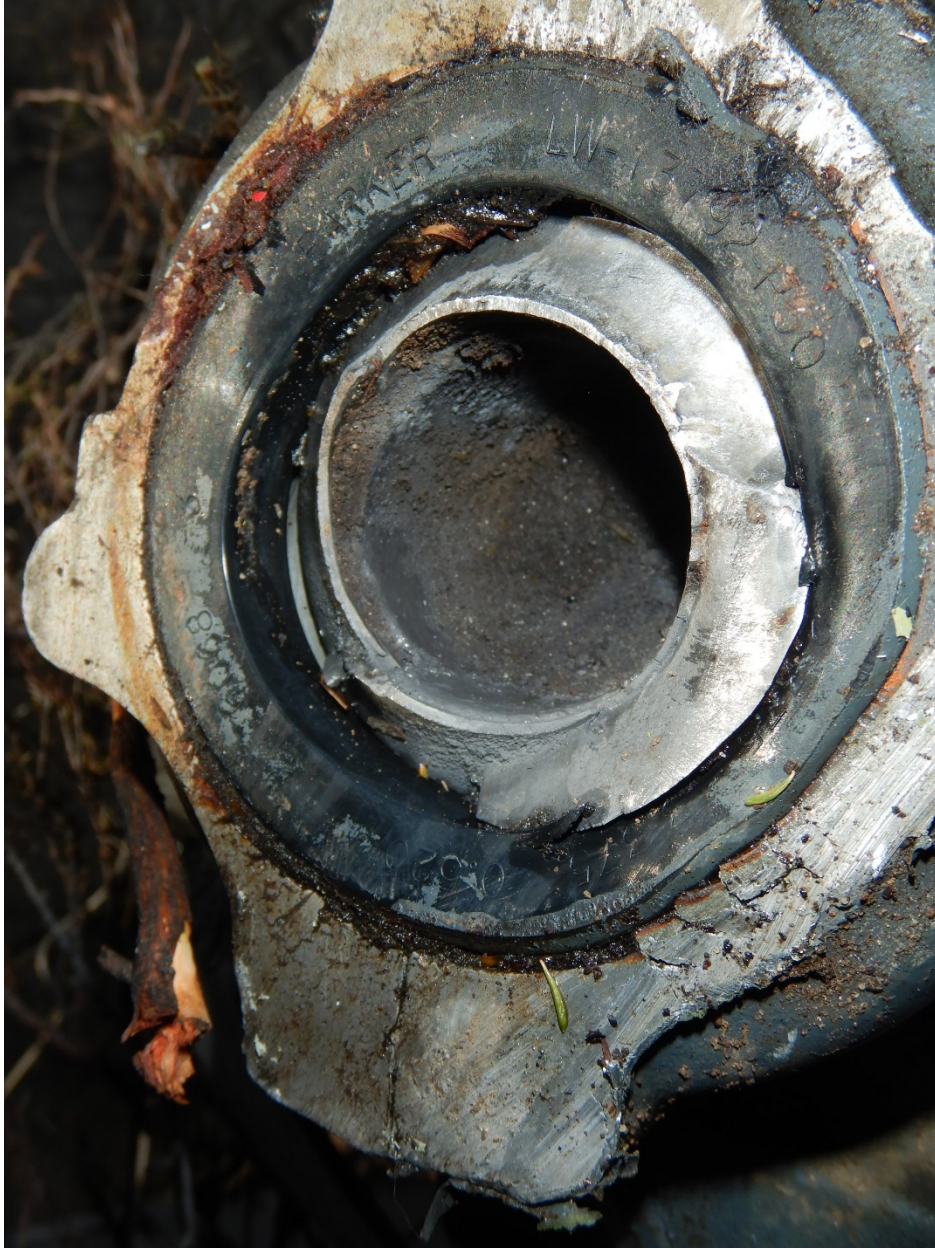
Right Propeller: The right propeller was not found at the accident site. Examination of the fracture site was consistent with overload separation. The remaining fractured surface was sent to the NTSB Materials Laboratory for further examination. Right propeller, model number: HC-E2YR-2RBSF/F8465B-7R, Serial Number: BP5949. July 29, 2016 overhauled. Annual Inspection November 21, 2019. Tach time: 72480.0, ACTT: 9148.0, PTSMOH: 1516.3. Blade serial numbers: F38129 and F38139.

Figure 7. Right-engine propeller shaft. Photo courtesy of Piper Aircraft.

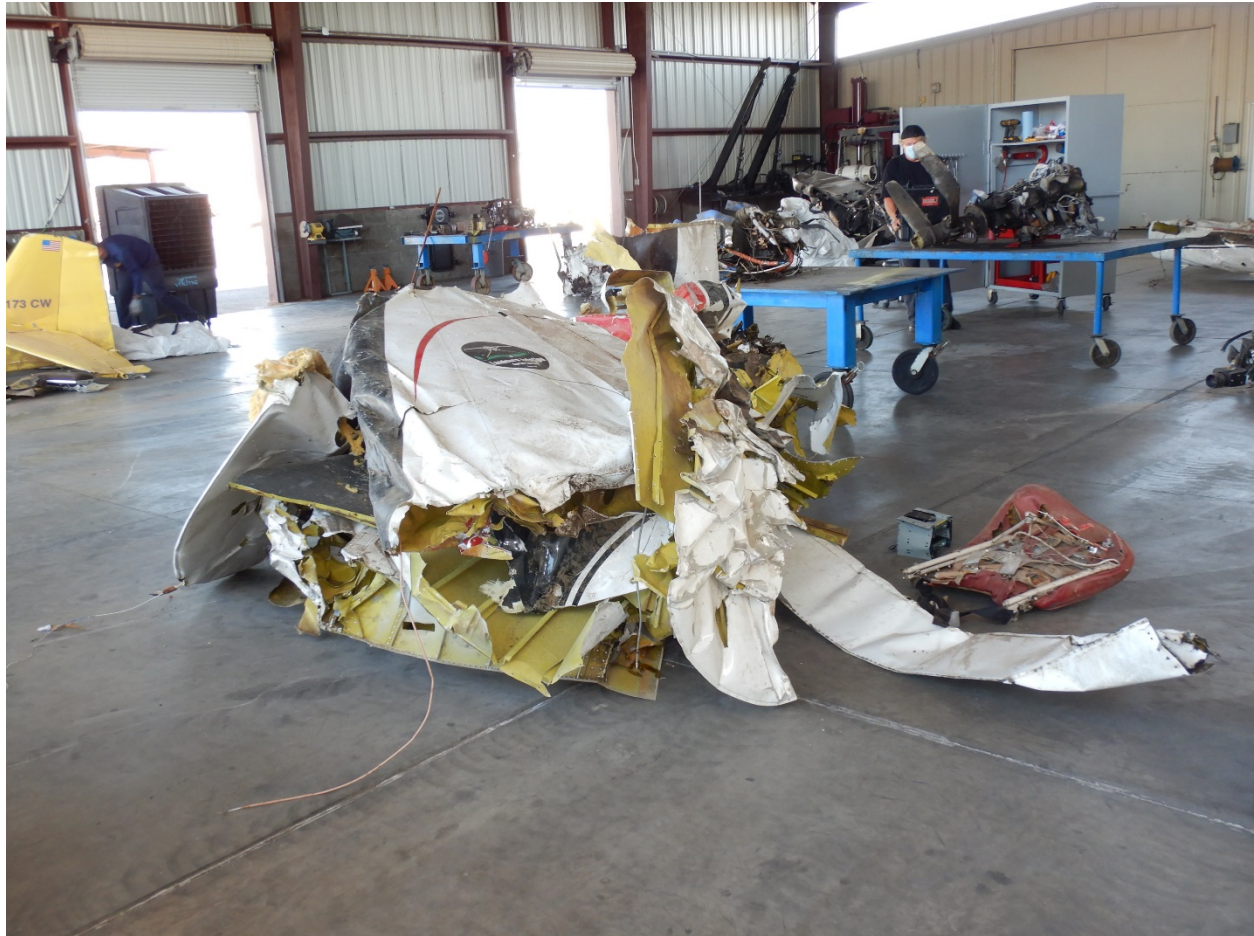
rudder, and rudder trim tab separated from the empennage. Examination of the vertical stabilizer, rudder and rudder trim exhibited damage to the top and leading edge of the vertical stabilizer and dents, gouging, and crushing throughout. The left-side of the stabilator remained attached to the empennage, as did the left-side trim tab. The left-side aft fuselage exhibited inward crushing, with damage to the top of the aft fuselage, running aft to the top of the empennage. The left-side forward fuselage, from the cabin area to the nose exhibited the most severe of the damage with crushing, gouging, and missing sheet metal.

Figure 8. Vertical stabilizer, rudder., and sheet metal. Photo courtesy of Piper Aircraft.

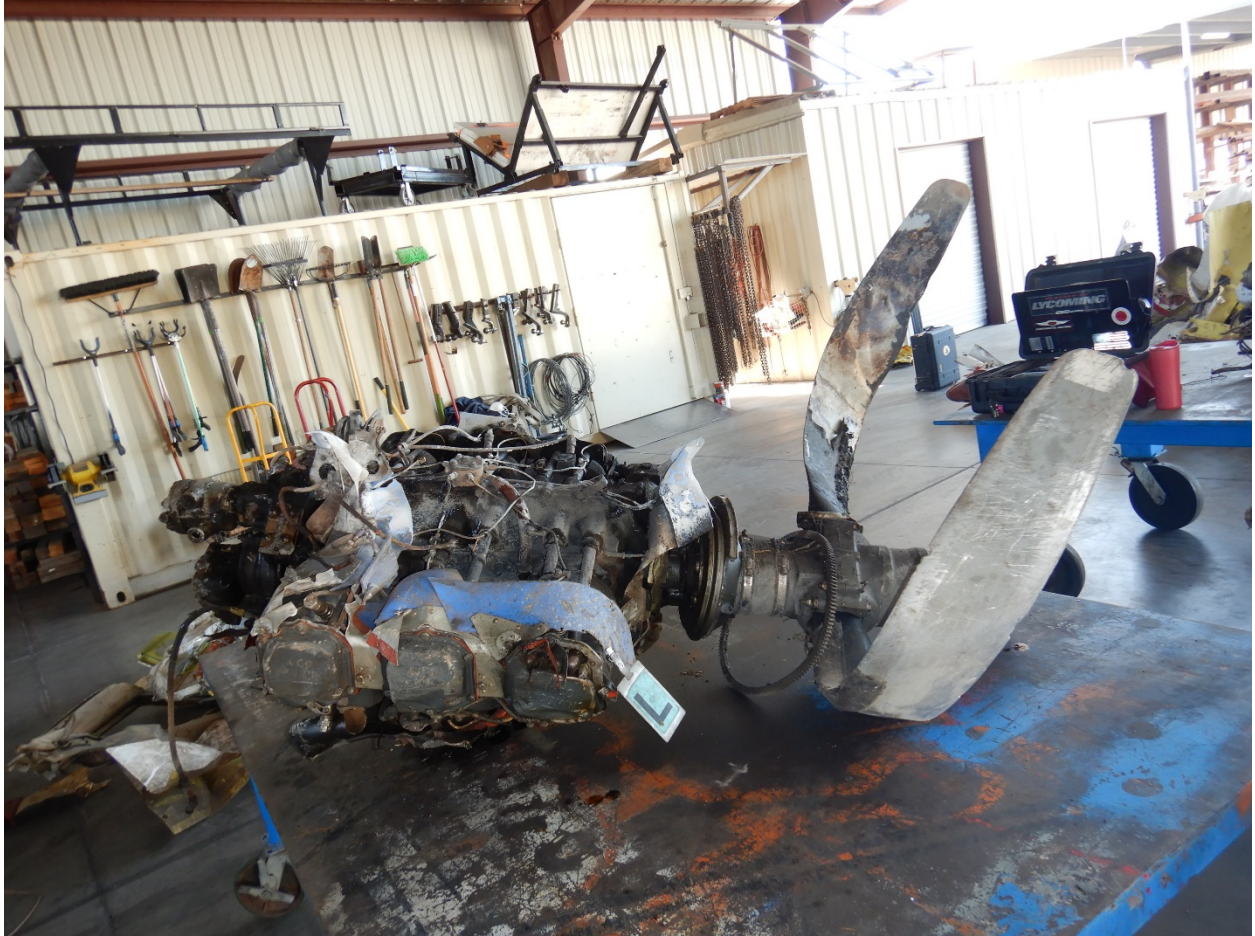
Left engine. The left engine separated from the engine nacelle and was thermally damaged. Left Engine: Model: IO-540-C4B5, Serial number: L-3784-48. 1906.3 hours since a field overhaul. October 30, 2015. Annual Inspection November 21, 2019. Tach Time: 6401.3, SMOH: 1516.3

Left propeller. The left propeller remained attached to the left engine and exhibited leading edge gouging, aft bending, and twisting. Left Propeller: Model: Serial number: HC-E2YR-2RBSF/F8465B-7R, Serial Number: BP3023, July 29, 2020 Overhauled. Annual Inspection: November 21, 2019, Tach Time: 6401.3, ACTT: 9148.0, PTSMOH: 1516.3. Blade serial numbers: C87356, E18986.

Figure 9. Left Engine and propeller. Photo courtesy of Piper Aircraft.

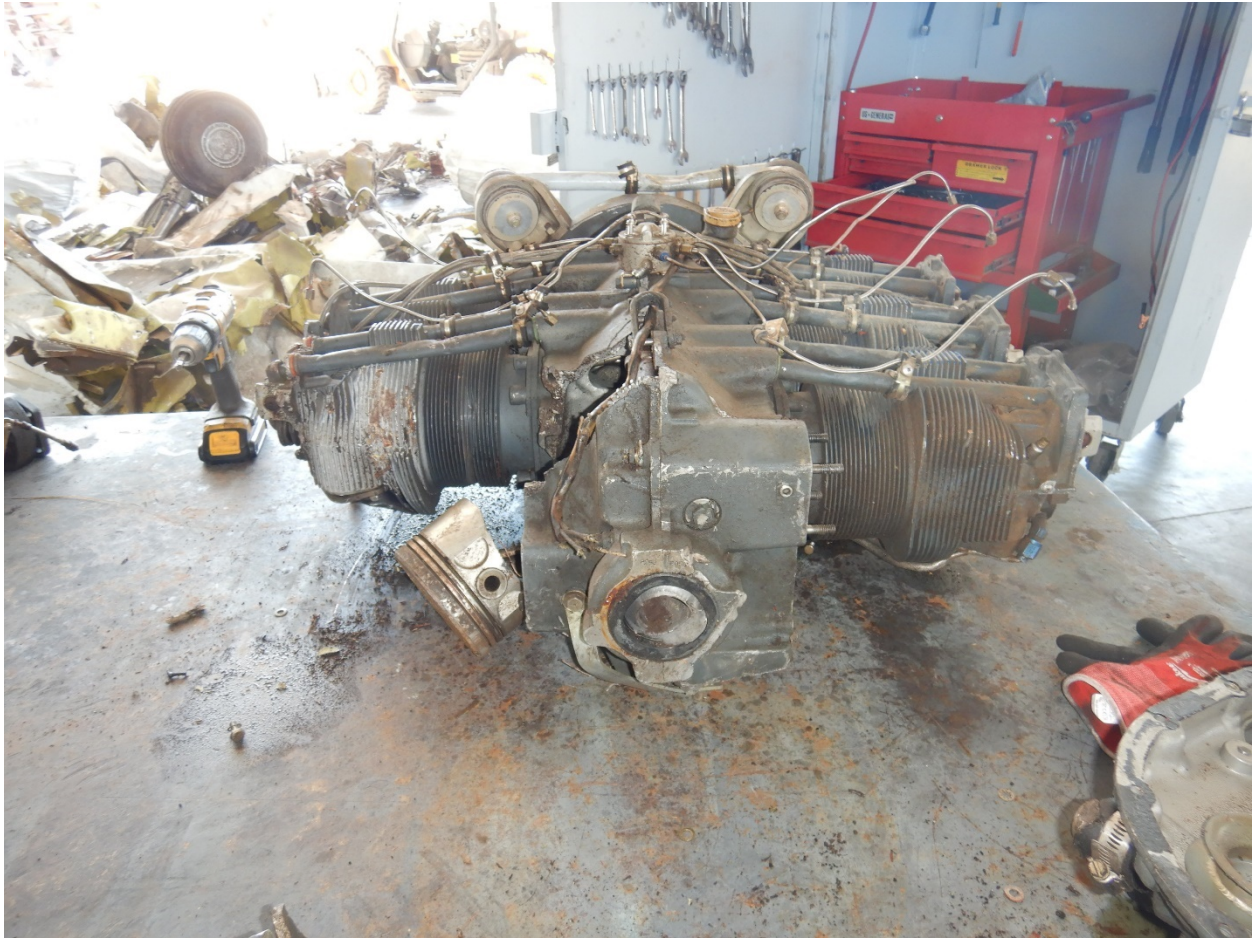
Right engine. The right engine, engine mount and nacelle separated from the wing, and came to rest near the end of the debris path. The propeller and propeller flange separated from the engine and were not recovered. The oil pump separated from the engine and was recovered. Right Engine: Model: IO-540-C4B5. Serial Number: RL-1664-48. 1906.3 hours since a field overhaul. October 23, 2015. Annual Inspection: November 21, 2019. Tach Time: 7248.0, SMOH: 1516.3

Figure 10. Right engine. Photo courtesy of Piper Aircraft.

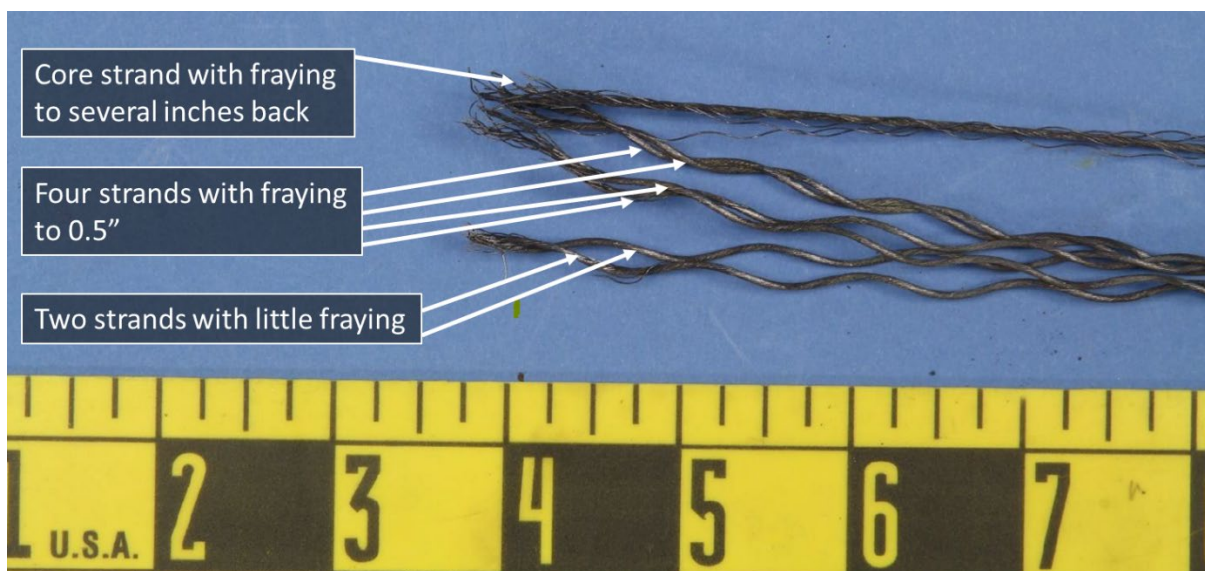
The control cables for the ailerons exhibited three fractures. One break occurred on the right side of the cable assembly and broomstraw features. The other break exhibited signatures not consistent with broomstraw features and warranted further examination. This section of the control cable was shipped to the NTSB for further examination. The balance cable for the ailerons a break with broomstraw features. Several wire fractures were observed protruding from the cable near the control yokes, and on the balance cable nearest the right aileron bellcrank.

Figure 11. Aileron control cable. Photo NTSB.

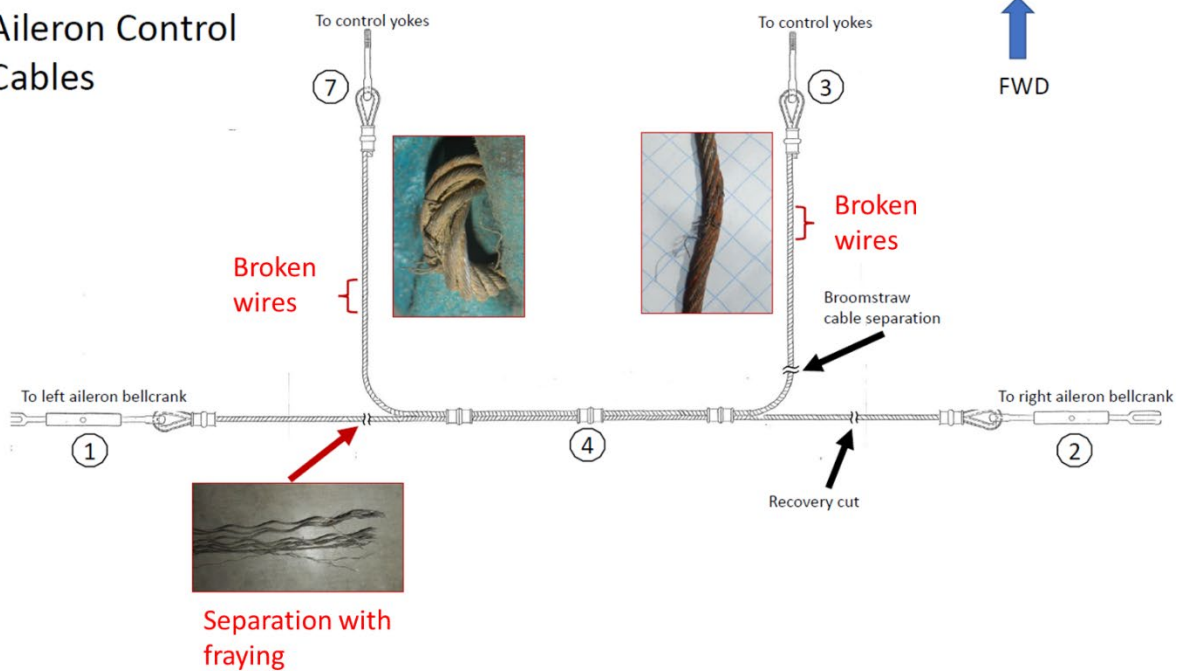
## Aileron Control Cables

Figure 12. Drawing showing the location of the breaks and broken wires in the aileron control cable. Image courtesy of Piper Aircraft.

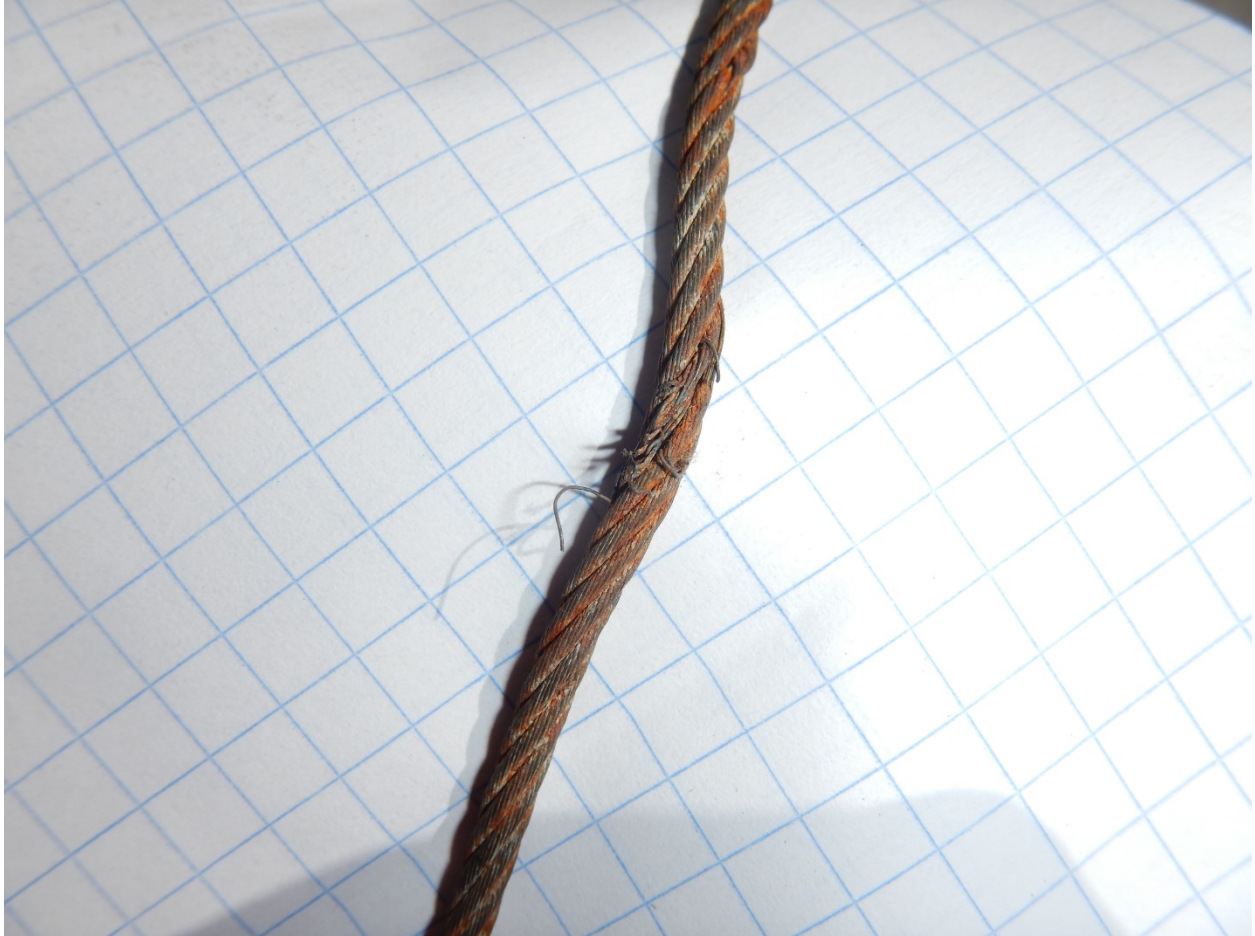
Figure 14. Example of the multiple broken wires found in the aileron control cables. Photo courtesy of Piper Aircraft.
