## **NATIONAL TRANSPORTATION SAFETY BOARD**

### **SECURITY VIDEO SUMMARY**

**WPR20LA141**

Location: Byron, California  
Date: May 9, 2020  
Aircraft: Bellanca 8GCBC, N4116Y  
NTSB Investigator-in-Charge: Joshua Cawthra

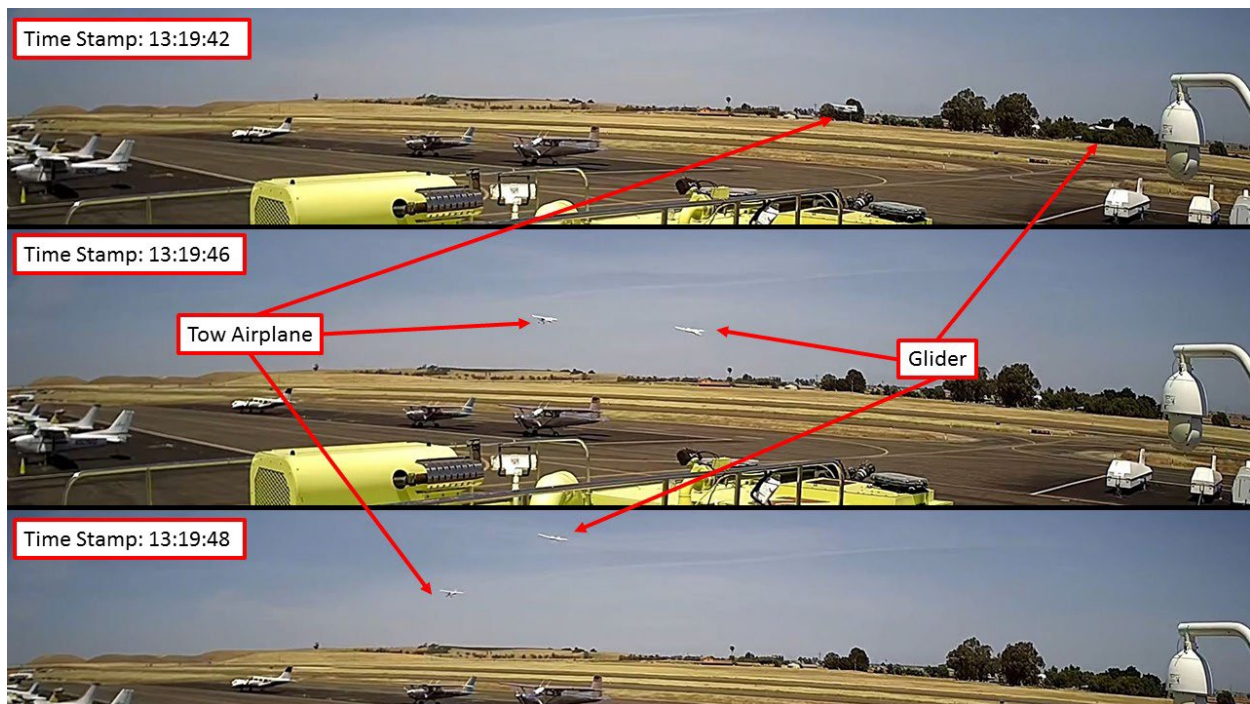
Airport security camera recordings, as shown in figure 1, captured the accident sequence showed that the tow airplane became airborne about mid length of the runway and proceeded a shallow climb with the glider in trail and at a similar altitude. About 7 seconds after the tow airplane became airborne, the glider pitched upward and ascended to a higher altitude, while the tow airplane remained in a shallow climb until 3 seconds later, when the tow airplane began a shallow descent. About 2 seconds later, the tow airplane and glider appeared to remain level, with the glider at a higher altitude than the tow airplane, for about 4 seconds, when the tow airplane and glider appeared to descend. The glider began to ascend about 4 seconds later, while the tow airplane pitched downward to a nose low attitude, impacted the runway, and nosed over, where a post impact fire ensued. The glider executed a 180° right turn and landed on runway 12 uneventfully.
