## **NATIONAL TRANSPORTATION SAFETY BOARD**

# **AIRFRAME & ENGINE EXAMINATION**

**WPR20LA141**

| Aircraft: | Bellanca 8GCBC, N4116Y |

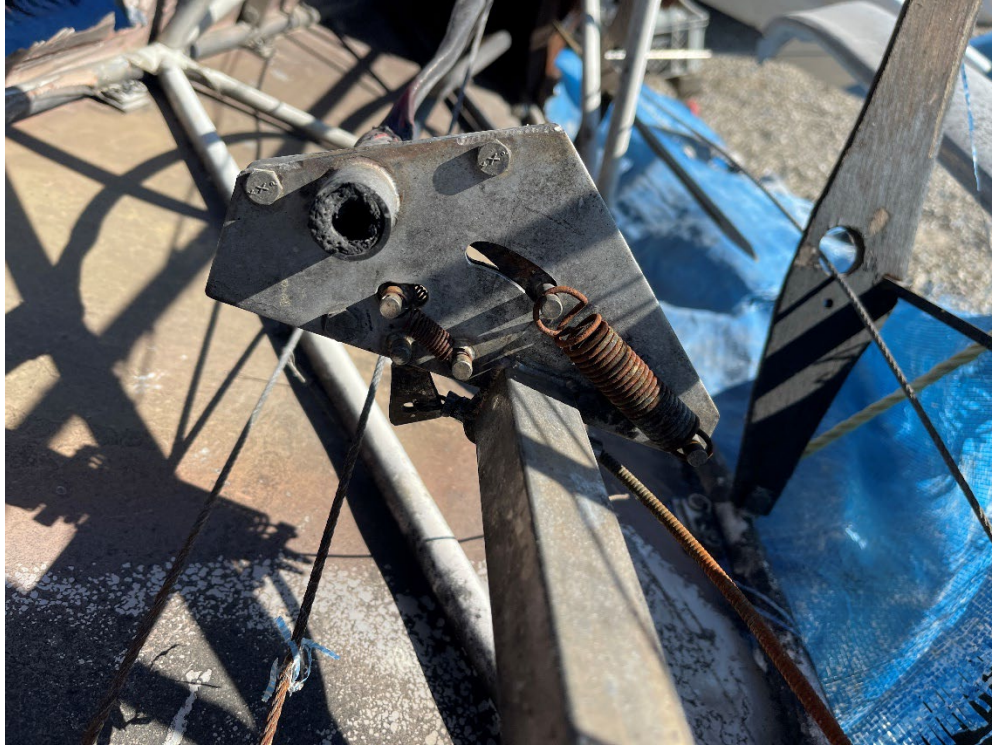
Examination of the recovered airplane revealed that the forward area of the fuselage significantly damaged by fire. The tow rope cutting mechanism was found the engaged position.

Figure 1: View of the airframe tow rope cutting mechanism.

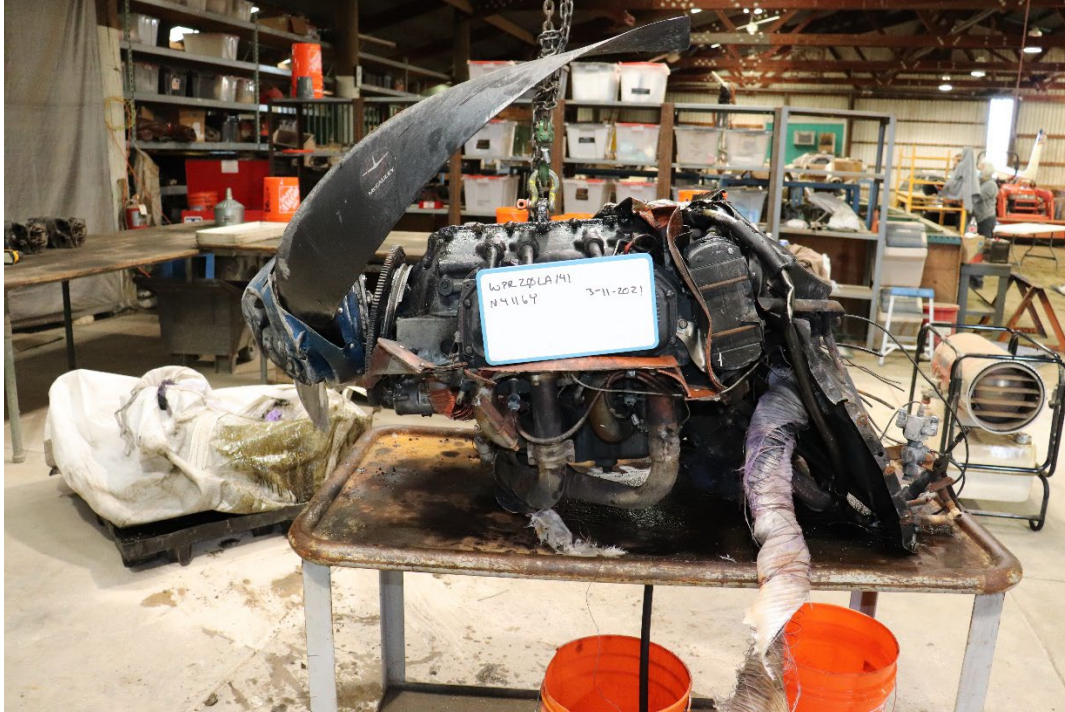
Examination of the recovered engine revealed that it was recovered and stored in a synthetic material bag. The firewall and engine mount remained attached to the engine. The engine had thermal damage to the rear of the engine. No evidence of any mechanical damage was observed to the engine crankcase. The firewall and engine mount had thermal and impact damage, separating it from the airplane. All cylinders remained attached to the engine. The oil filler neck was impact separated. Additional impact damage was observed to the lower area of the number two-cylinder rocker box cover. The engine oil pump and both magnetos remained attached to the accessories case. The carburetor was separated, however, a portion of the carburetor remained attached to the engine.

**Figure 2. View of the engine**

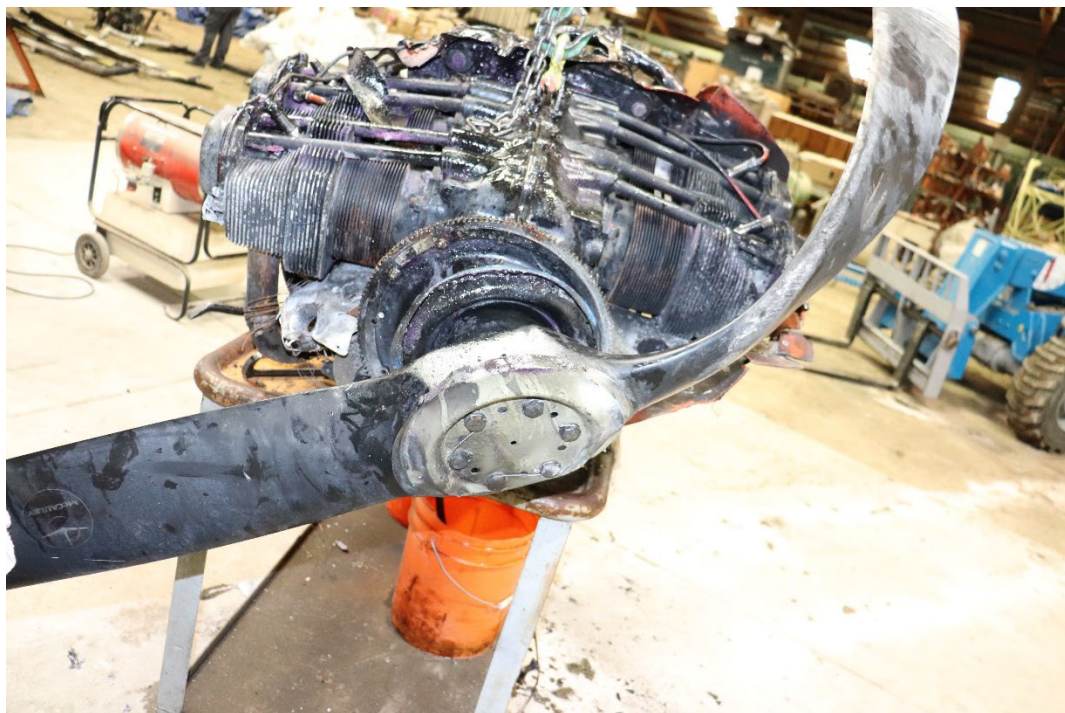
The propeller, starter ring gear and crank shaft propeller flange exhibited impact damage. The crankshaft propeller flange was impact damaged. One of the propeller blades was bent aft in the opposite direction of rotation and exhibited chordwise striations along the leading edge throughout.

**Figure 3. View of the propeller**

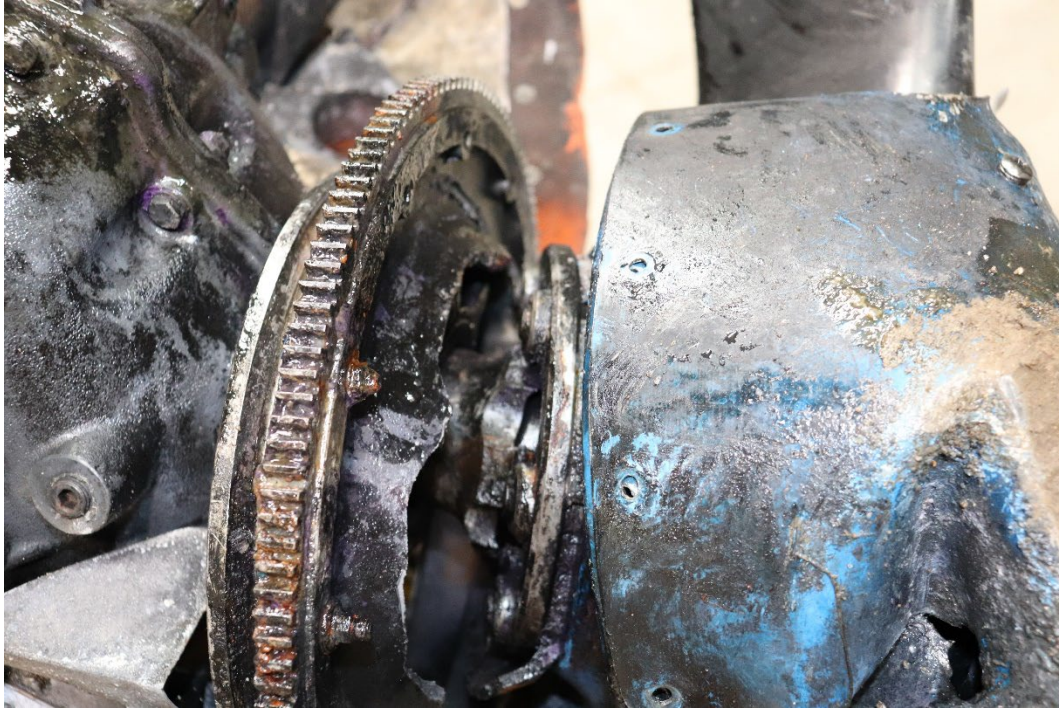
**Figure 4. View of starter ring gear and crankshaft propeller flange damage**

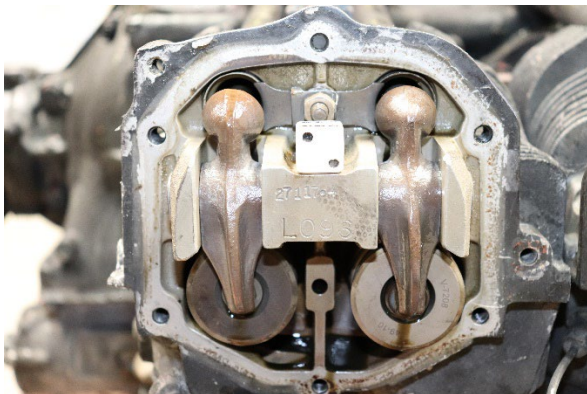
The rocker box covers were removed. The intake and exhaust rocker arms were all intact and oil coated on all cylinders. All intake and exhaust valve springs were in place and visually appeared to be undamaged. The upper spark plugs were removed, and all four cylinders were examined internally using a lighted borescope. With the exception of the number two cylinder, normal amount of combustion deposits was observed within the combustion dome of each cylinder and piston face. The number two cylinder had foreign object debris and rust within the combustion dome and on the piston face. Except for the number two-cylinder, all of the intake and exhaust valves were unremarkable. The number two-cylinder intake and exhaust valves exhibited some rust like discoloration. The propeller was removed, two propeller bolts were reattached to the propeller flange, the crankshaft was rotated by hand using a hand tool. Rotational continuity was established throughout the engine and valve train. Thumb compression and suction was obtained on all four cylinders.

**Figure 5. View of the number two-cylinder rocker arms**

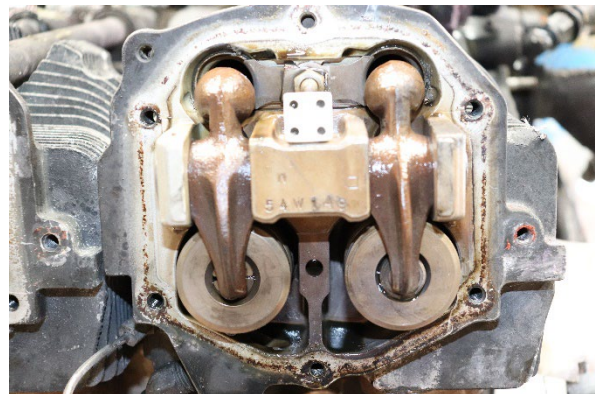
**Figure 6. View of the number four-cylinder rocker arms**

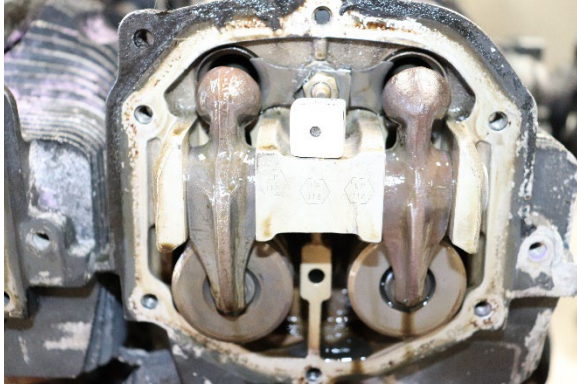
Figure 7. View of the number one-cylinder rocker arms

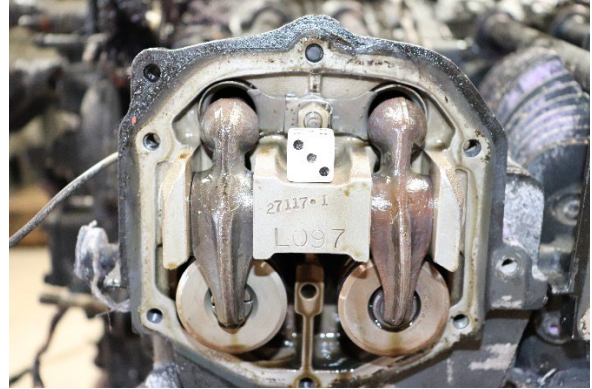
Figure 8. View of the number three-cylinder rocker arms

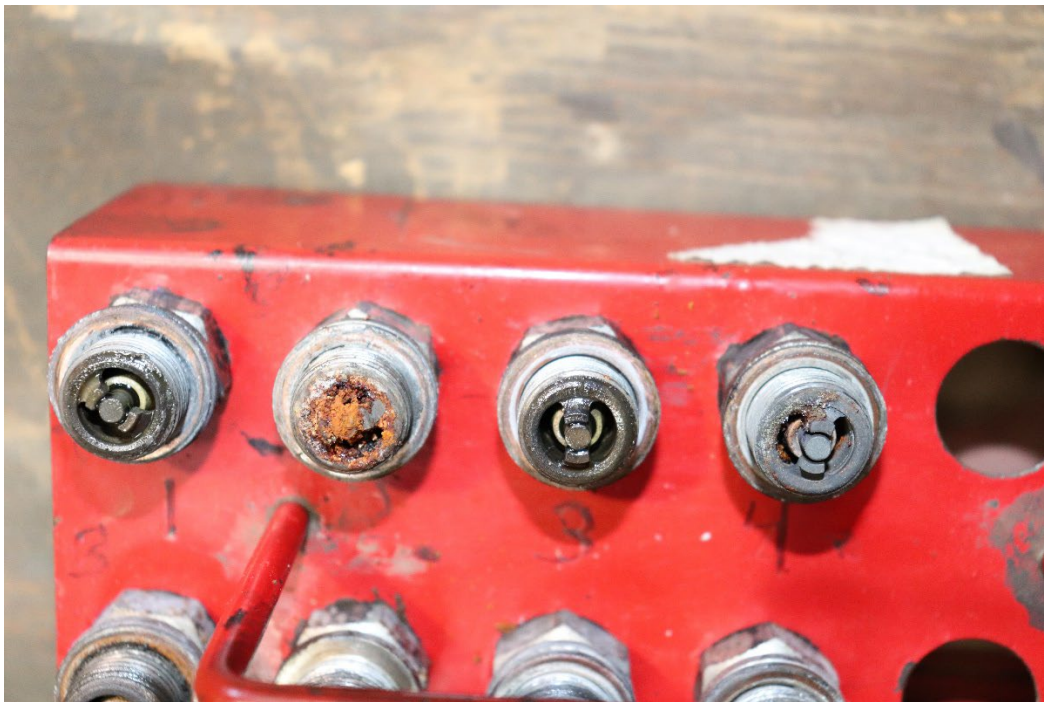
The number one, three and bottom four cylinder's spark plugs had black deposits within the electrode area. The number two and top four cylinder's spark plugs had debris consistent with the collection of water and debris during firefighting operations.

Figure 9. View of upper spark plugs

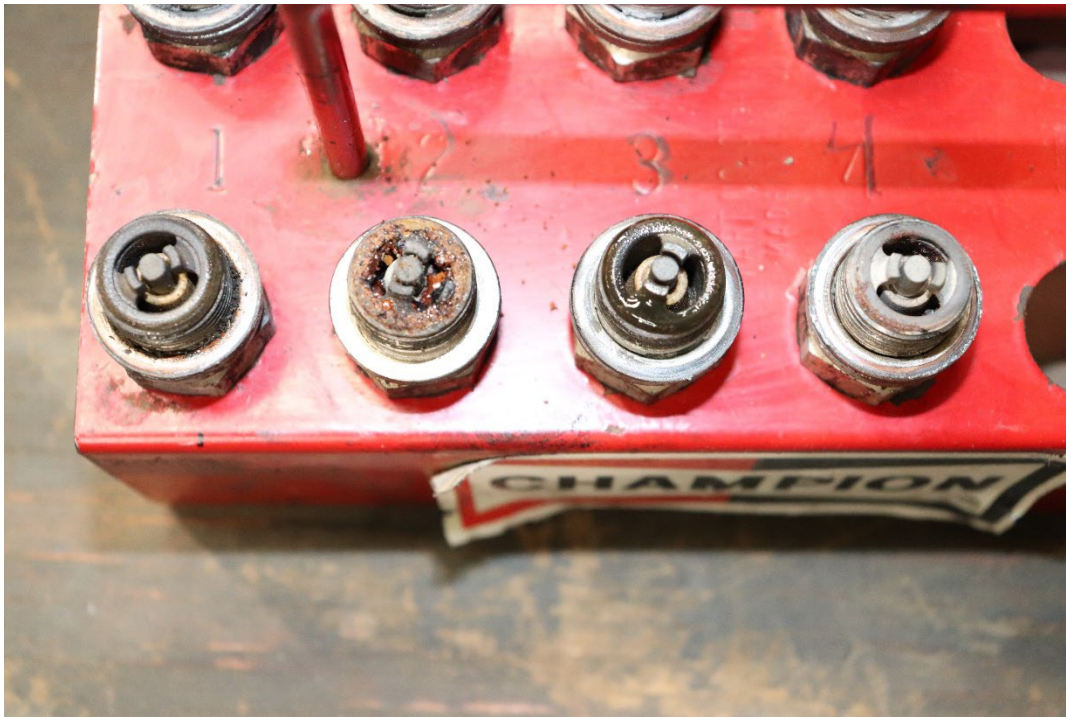
Figure 10. View of lower spark plugs

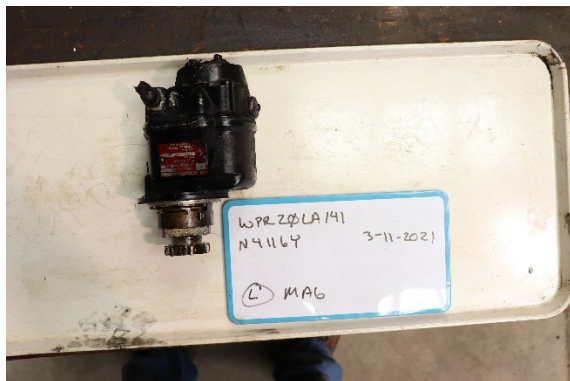
The left and right magnetos remained attached to the engine accessory case with no external damage noted. Both left and right were removed from the engine's accessories case. When the left magneto drive shaft was rotated by hand, spark was produced on four ignition posts and impulse coupling engagement was heard. The right magneto, which was not equipped with an impulse coupling, drive shaft was rotated by hand, spark was produced on four ignition posts.

Figure 11. View of left magneto

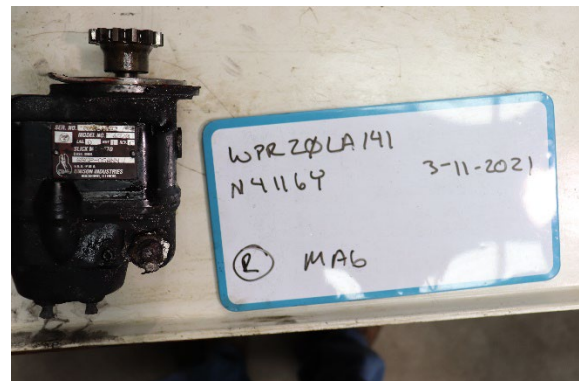
Figure 12. View of right magneto

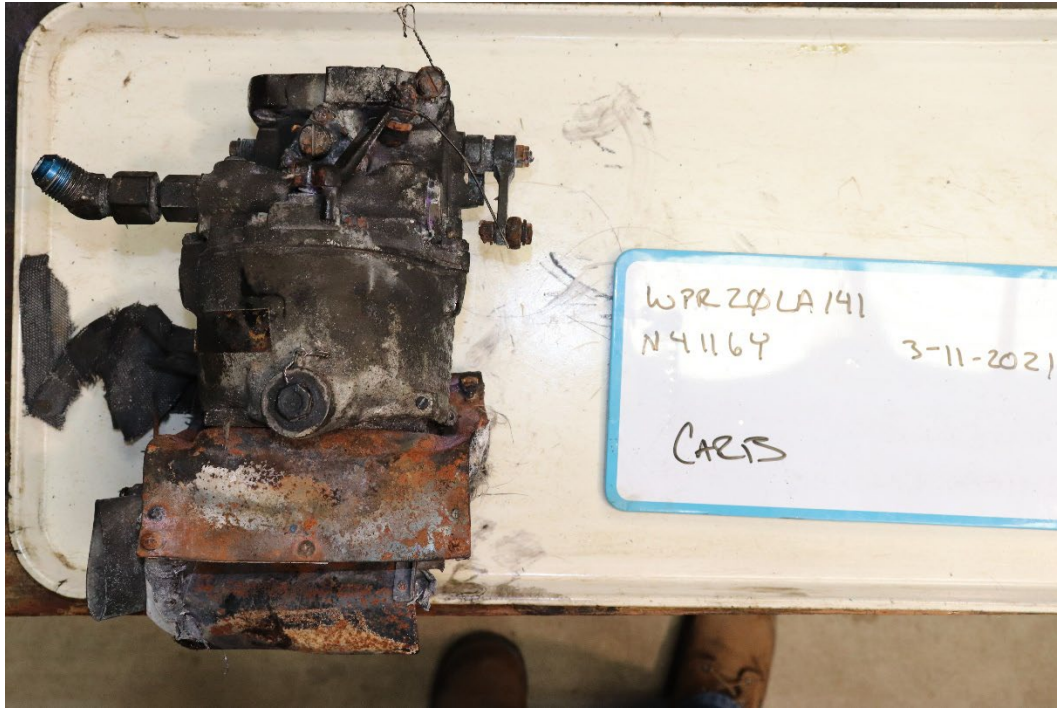
The carburetor had impact separated and exhibited damage to the top area of the carburetor and the air intake box. The float bowl was free of debris and found unremarkable. The throttle lever was intact, undamaged and freely from stop to stop. The needle was removed and found unremarkable.

**Figure 13. View of carburetor**
