# NATIONAL TRANSPORTATION SAFETY BOARD

## MATERIALS LABORATORY ADDENDUM REPORT

Report No. 21-008B

Place : Phoenix, Arizona  
Date : May 13, 2020  
Vehicle : Mooney M20J, N201HH  
NTSB No. : WPR20LA144  
Investigator : Stephen Stein, AS-WPR

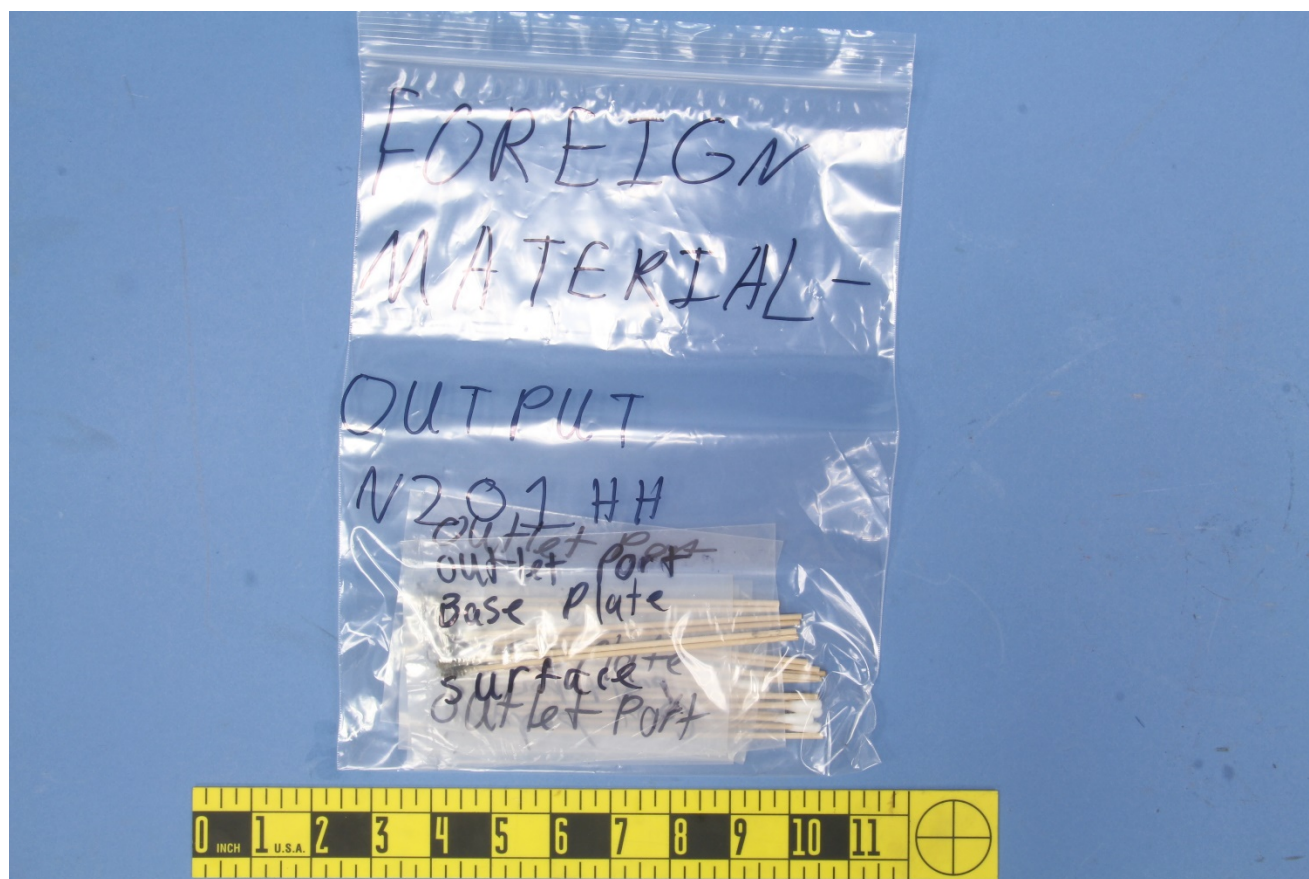
Figure 1 shows one of the two bags with collections of swabs. This bag was marked, "Foreign Material – Output N201HH." This bag contained five collections of swabs, shown in Figure 2. These were marked as follows:

Figure 1 – The bag of swabs marked “Foreign Material – Output”, as received.

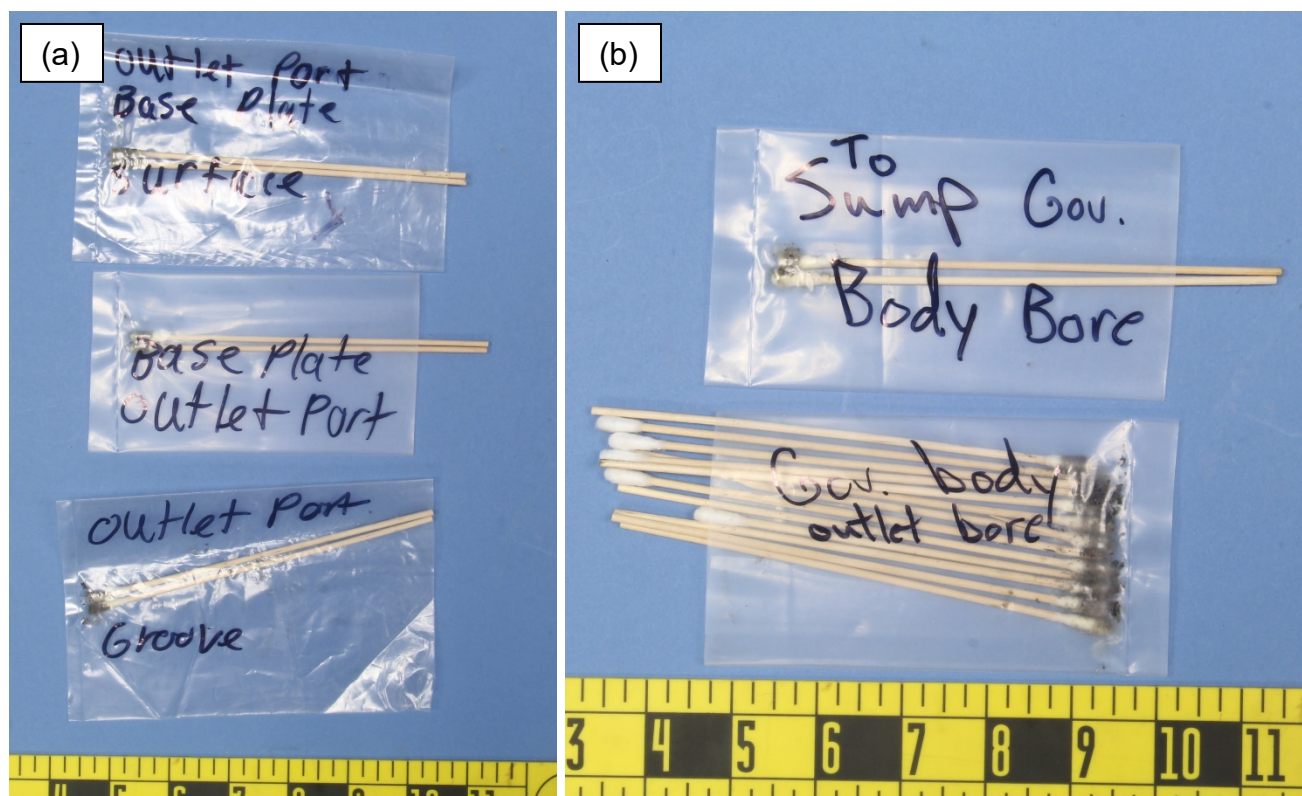
- "Outlet port base plate surface"
- "Base plate outlet port"
- "Outlet port groove"
- "To sump gov. body bore"
- "Gov. body outlet bore"

Figure 2 – The collections of swabs from various areas in the bag show in Figure 1.

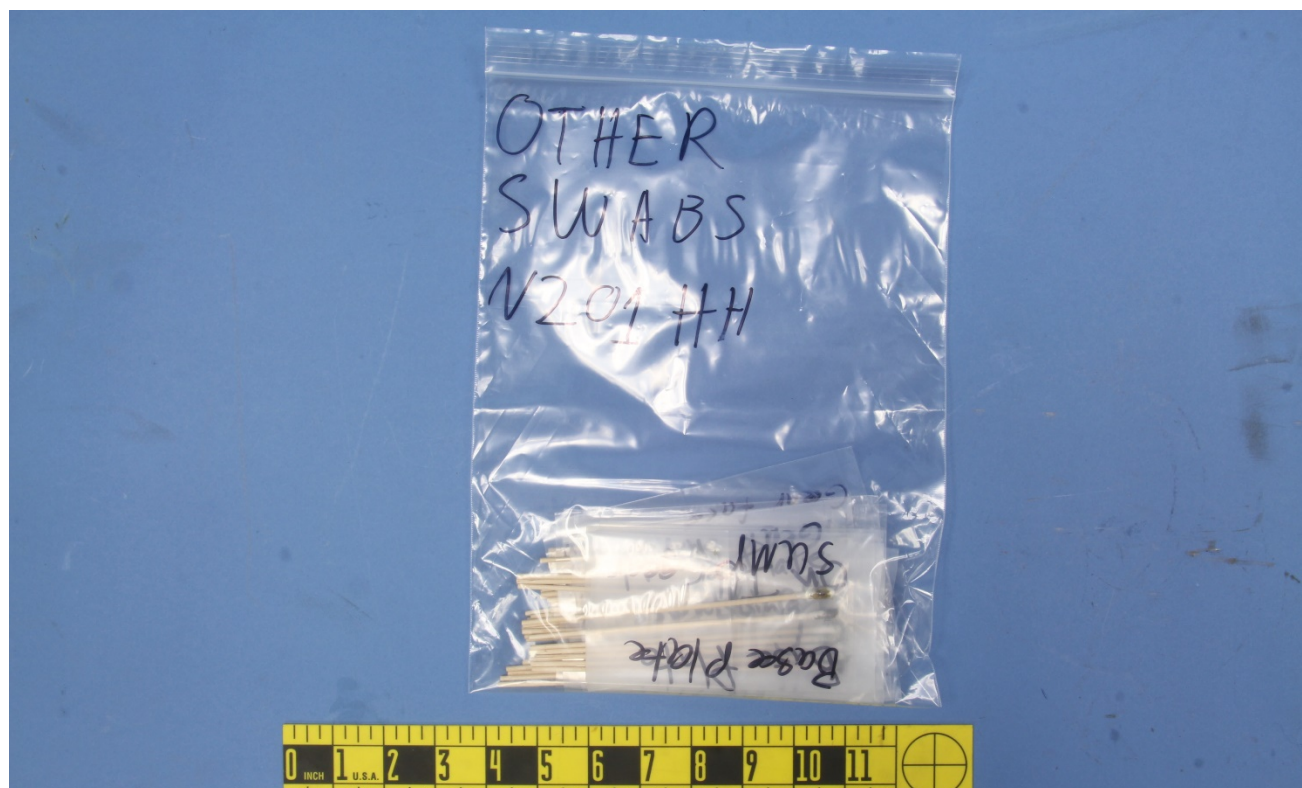
Figure 3 shows the second of the two bags with swab collections. This bag was marked, "Other Swabs N201HH." This bag held 13 collections of swabs, shown in Figure 4. These were marked as follows:

Figure 3 – The bag of swabs marked "Other Swabs", as received.

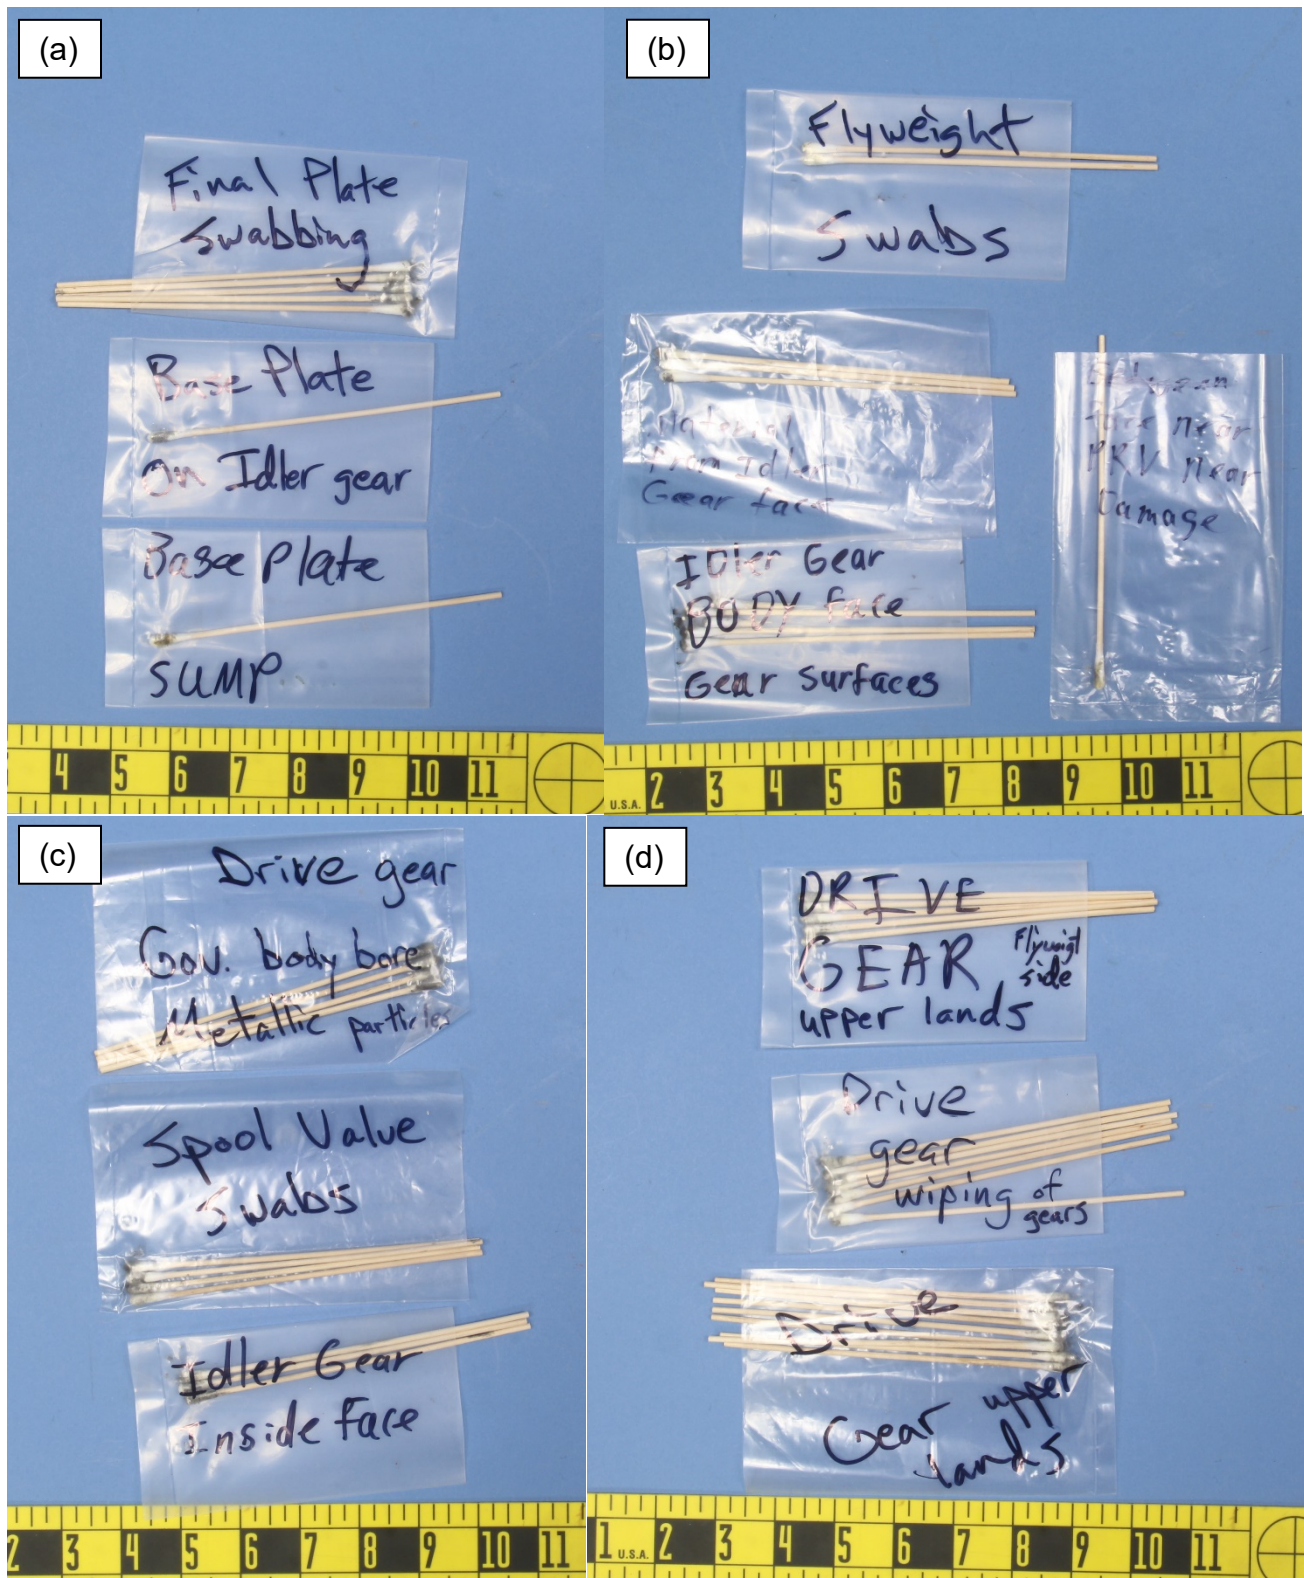
- "Final plate swabbing"
- "Base plate on idler gear"
- "Base plate sump"

- 
- “Flyweight swabs”
  - “Materials from idler gear face”
  - “Idler gear body face gear surfaces”
  - “Face near PRV near damage”
  - “Base plate outlet port”
  - “Drive gear gov. body bore metallic particles”
  - “Spool valve swabs”
  - “Idler gear inside face”
  - “Drive gear upper lands flyweight side”
  - “Drive gear wiping of gears”
  - “Drive gear upper lands”

Figure 4 – The individual swab collections from various locations in the bag in Figure 3.

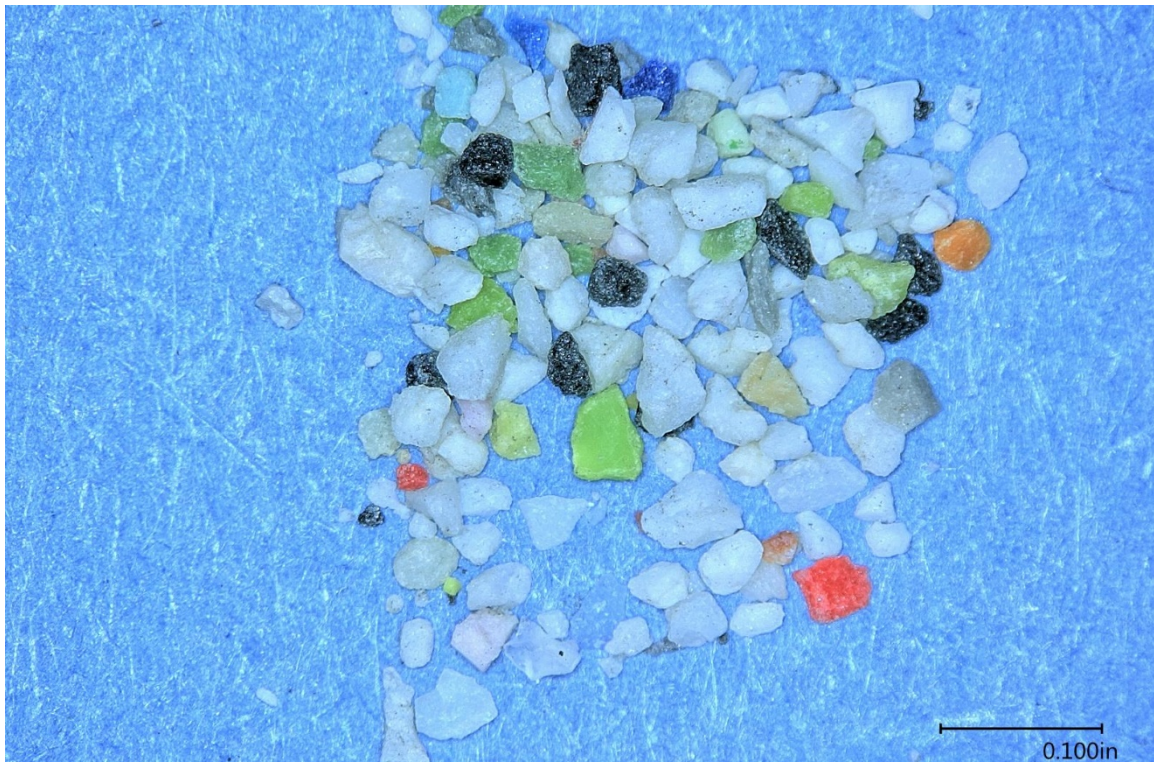
Loose debris from the collection marked “Gov. body outlet bore” in Figure 2 were cleaned using acetone in an ultrasonic bath and are shown in Figures 5 and 6. This debris exhibited multiple colors visually, with a blocky jagged appearance. These debris were consistent with non-metallic particles.

Figure 5 – The solid debris from the bag marked governor body outlet bore, after cleaning with acetone.

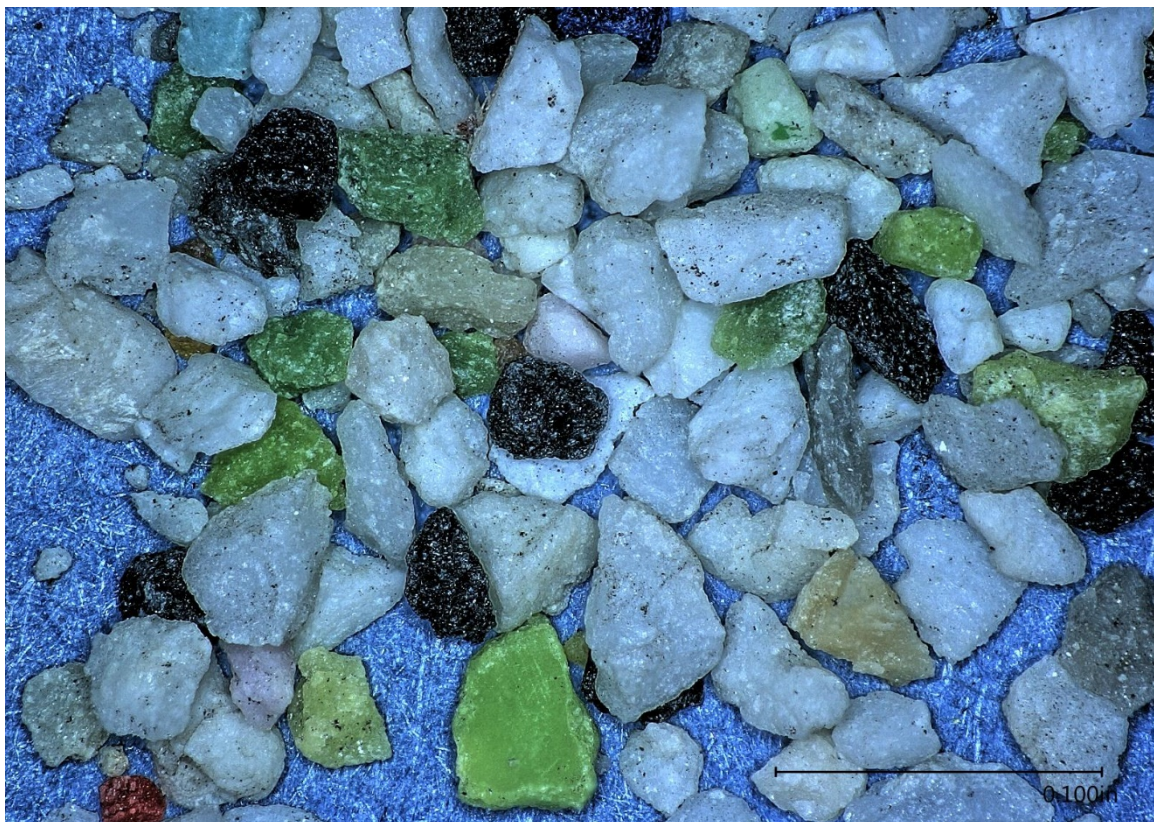
Figure 6 – Closer view of the debris particles in Figure 5.

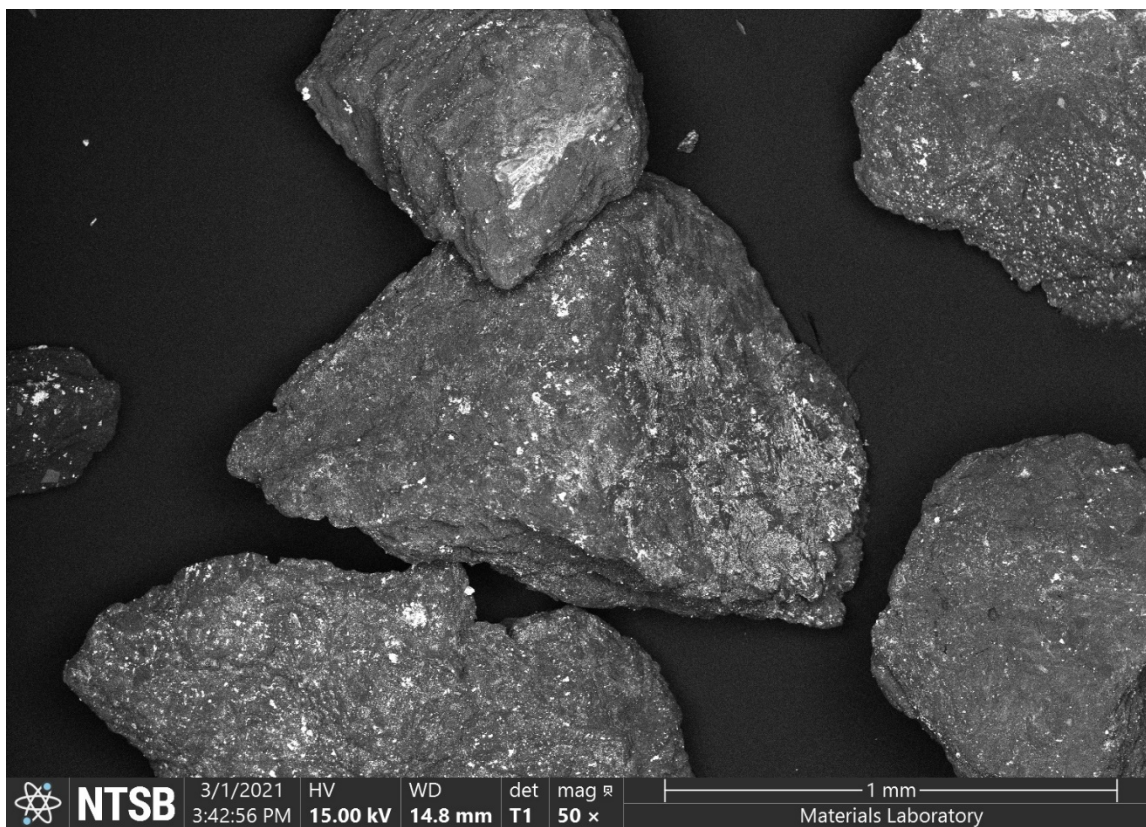
The debris in Figure 6 was examined using a scanning electron microscope (SEM) with an energy dispersive x-ray spectroscopy (EDS) instrument. A typical view of the debris is illustrated in Figure 7. The debris exhibited electron charging properties, consistent with nonconductive materials. A typical EDS spectrum of the debris is shown in Figure 8. This showed large peaks of carbon, oxygen, nitrogen, silicon, magnesium, and calcium, with minor peaks of aluminum (marked as Br in the figure) and titanium. These elements were consistent with materials found in soils or sands.

Figure 7 – Backscattered electron (BE) micrograph of some of the debris shown in Figure 5.

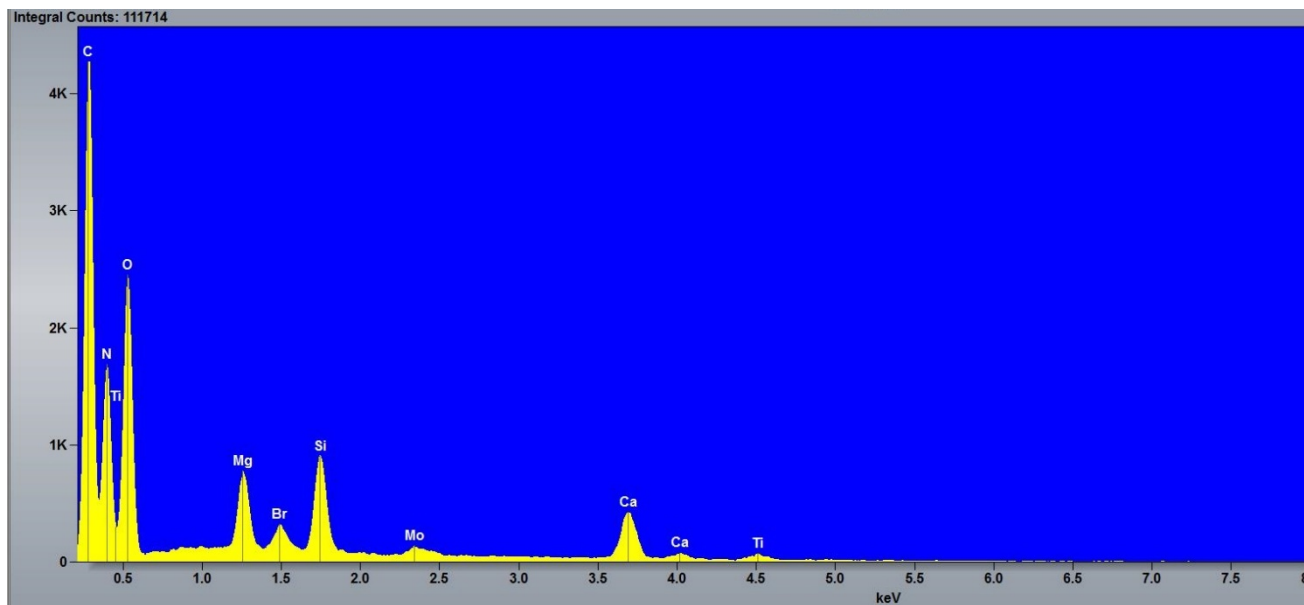
Figure 8 - Typical EDS spectrum of the debris in Figure 7.

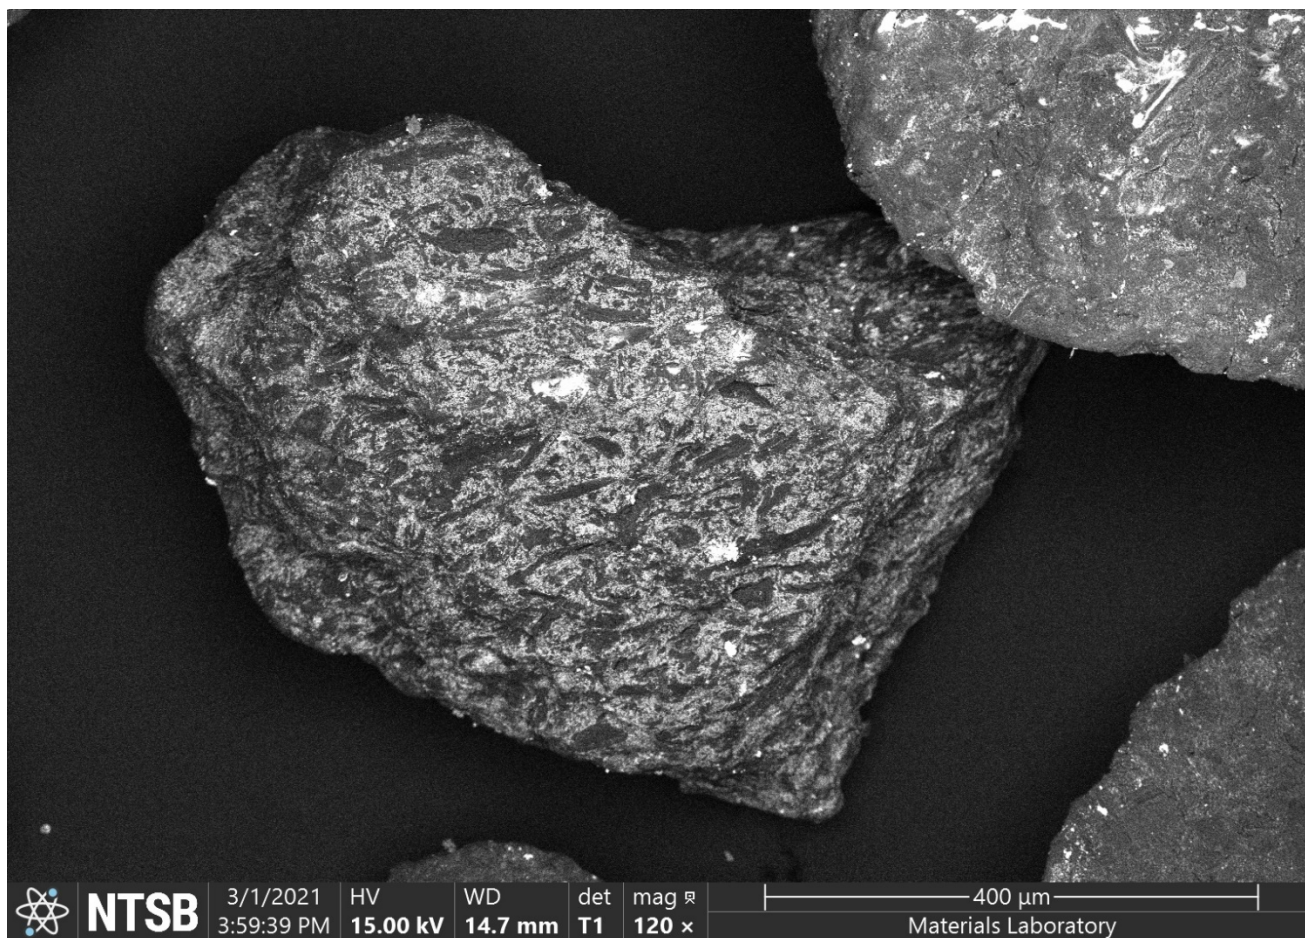
One particle (Figure 9) exhibited EDS spectra different than those of other particles, as shown in Figure 10. This spectrum exhibited multiple barium peaks and a sulfur peak, in addition to those displayed in Figure 8.

Figure 9 – BE micrograph of a debris particle exhibiting an EDS spectrum different than the other particles.

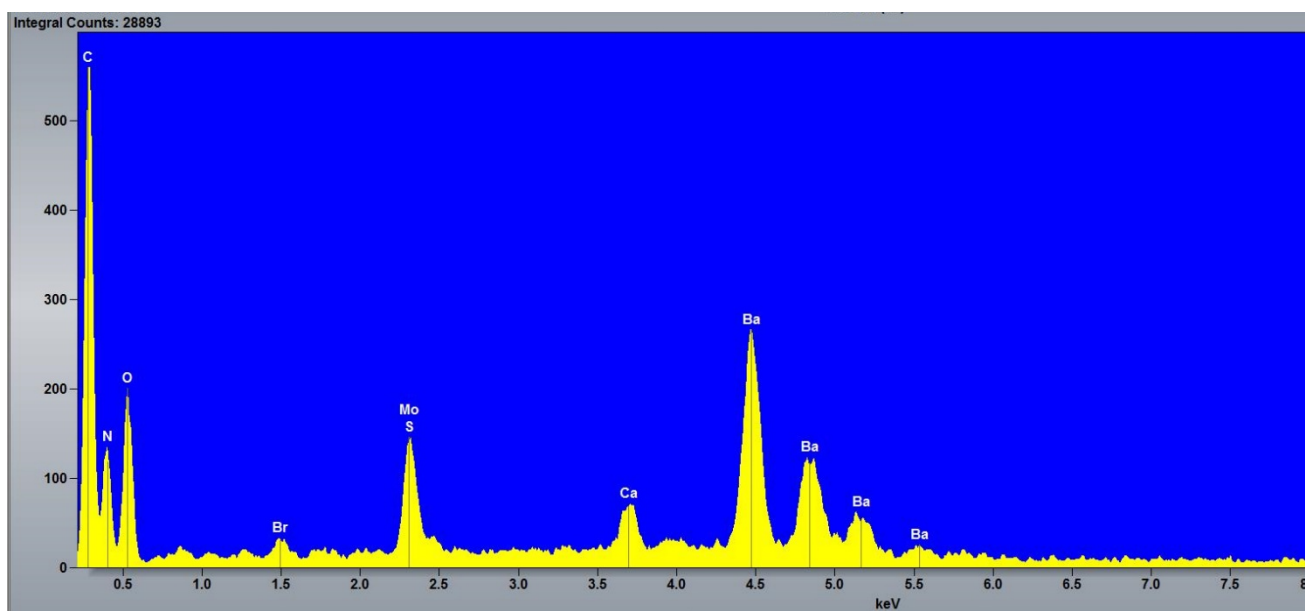
Figure 10 – Typical EDS spectrum of the particle in Figure 9.

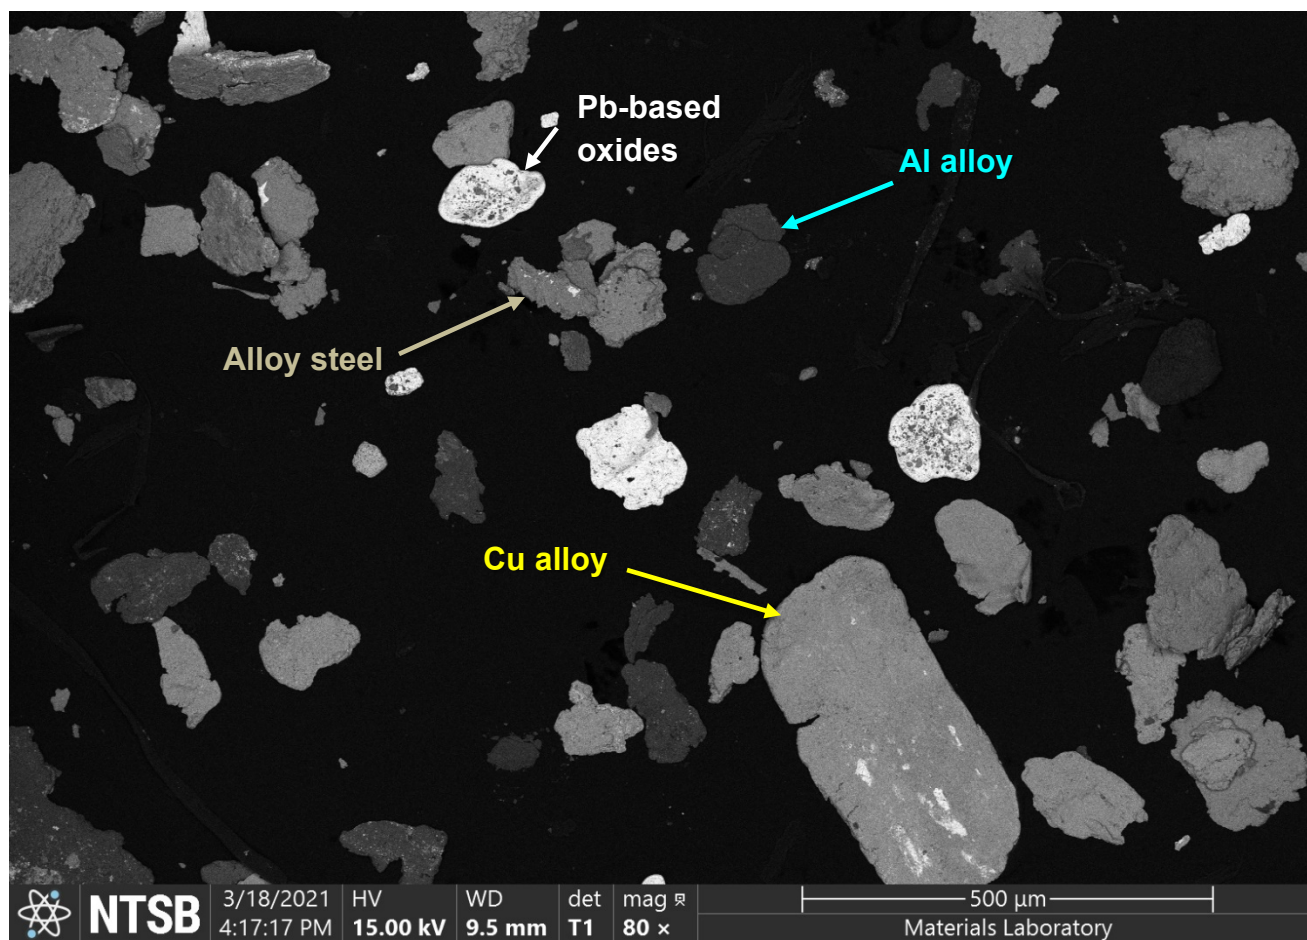
The debris in the collection marked “Drive Gear Gov. Body Bore Metallic Particles” in Figure 3 were also cleaned using acetone in an ultrasonic bath. These cleaned particles were examined using a SEM with an EDS, and a typical image of the particles is shown in Figure 11.

The light-colored particles in the figure were found to be consistent with lead (Pb) oxide compounds when examined using EDS. The particles also contained minor amounts of phosphorus and bromine. These were consistent with compounds that form after the combustion of avgas with tetraethyl lead additives. Similar lead-based particles were also found in a later re-examination of the particles from the governor body outlet bore.

The lighter gray particles were consistent with a copper-tin (or bronze) alloy. The darker gray particles were mostly iron, with detectable amounts of molybdenum, manganese, and chromium, consistent with an alloy steel. The darkest particles were consistent with an aluminum alloy. It should be noted that many of these particles exhibited areas of mixed constituents or cross-contamination, consistent with repeated impact with each other.

These compositions were consistent with those of materials typically used in the manufacture of rotating engine components, such as connecting rods, crankshafts, pistons, and bearings.

Figure 11 – BE micrograph of some of the metallic particles from the drive gear governor body bore.
