# NATIONAL TRANSPORTATION SAFETY BOARD

Office of Research and Engineering  
Materials Laboratory Division  
Washington, D.C. 20594

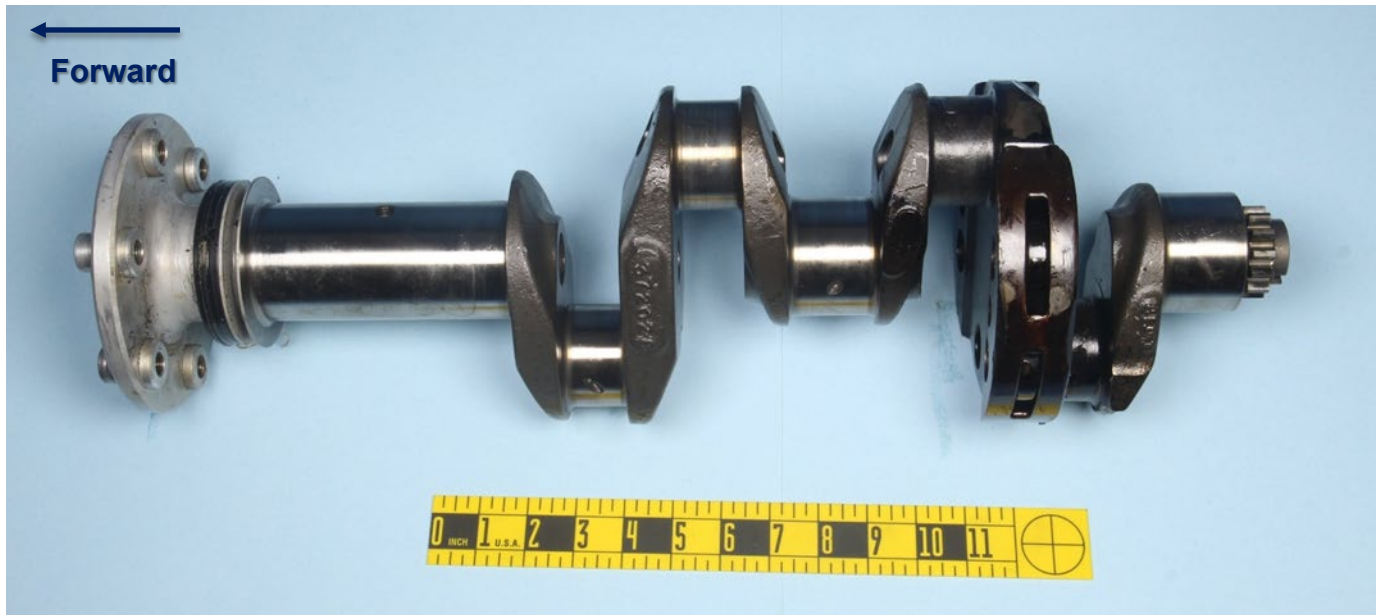
Figure 1 – A view of the crankshaft, as received.

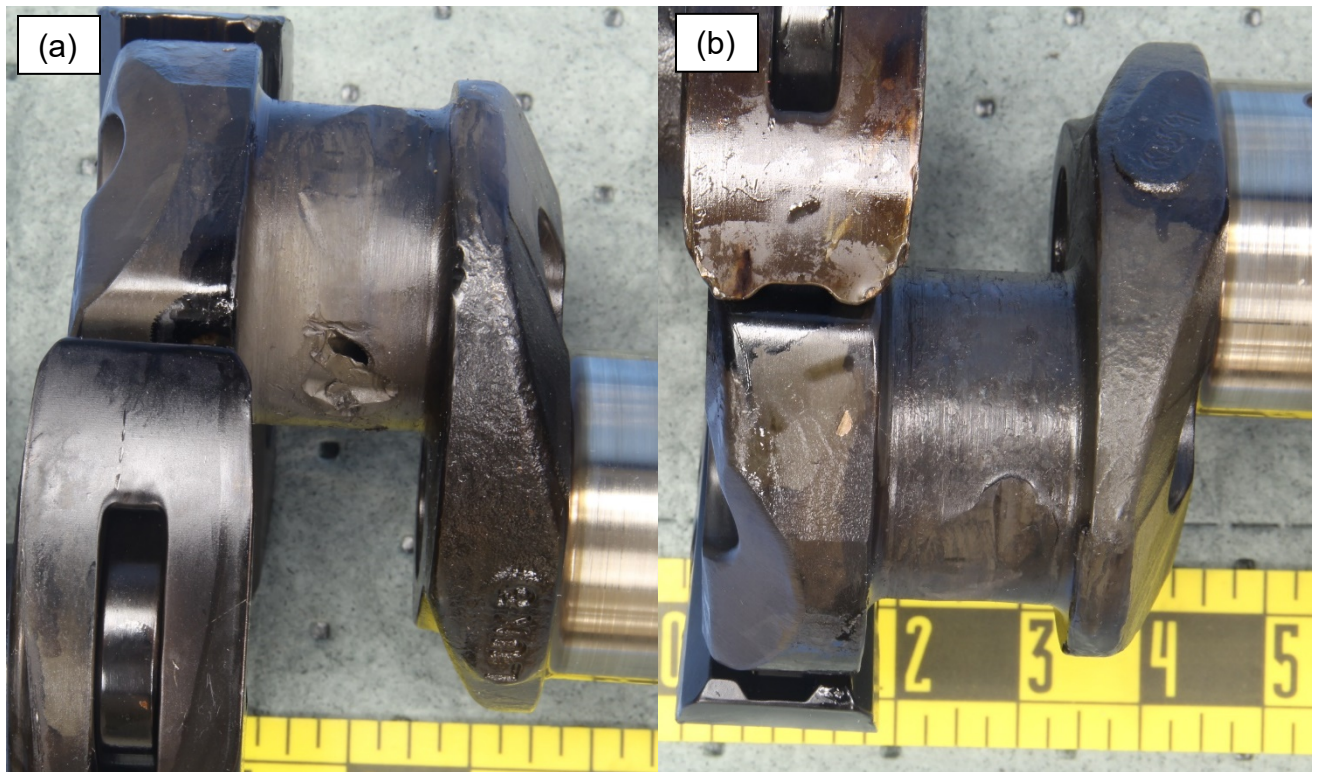
Figure 2 – View of the damaged C3 journal from (a) the top view and (b) a side view.

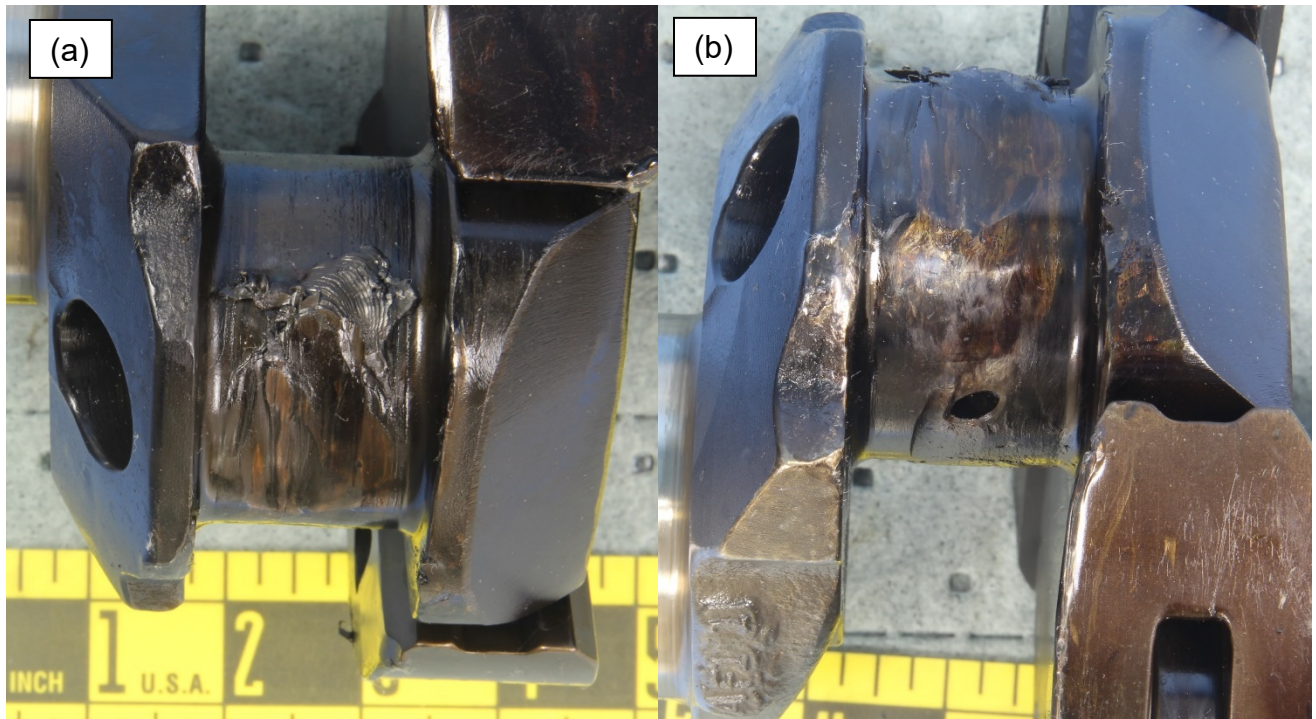
Figure 3 – View of the damaged C4 journal from (a) the top view and (b) a side view.

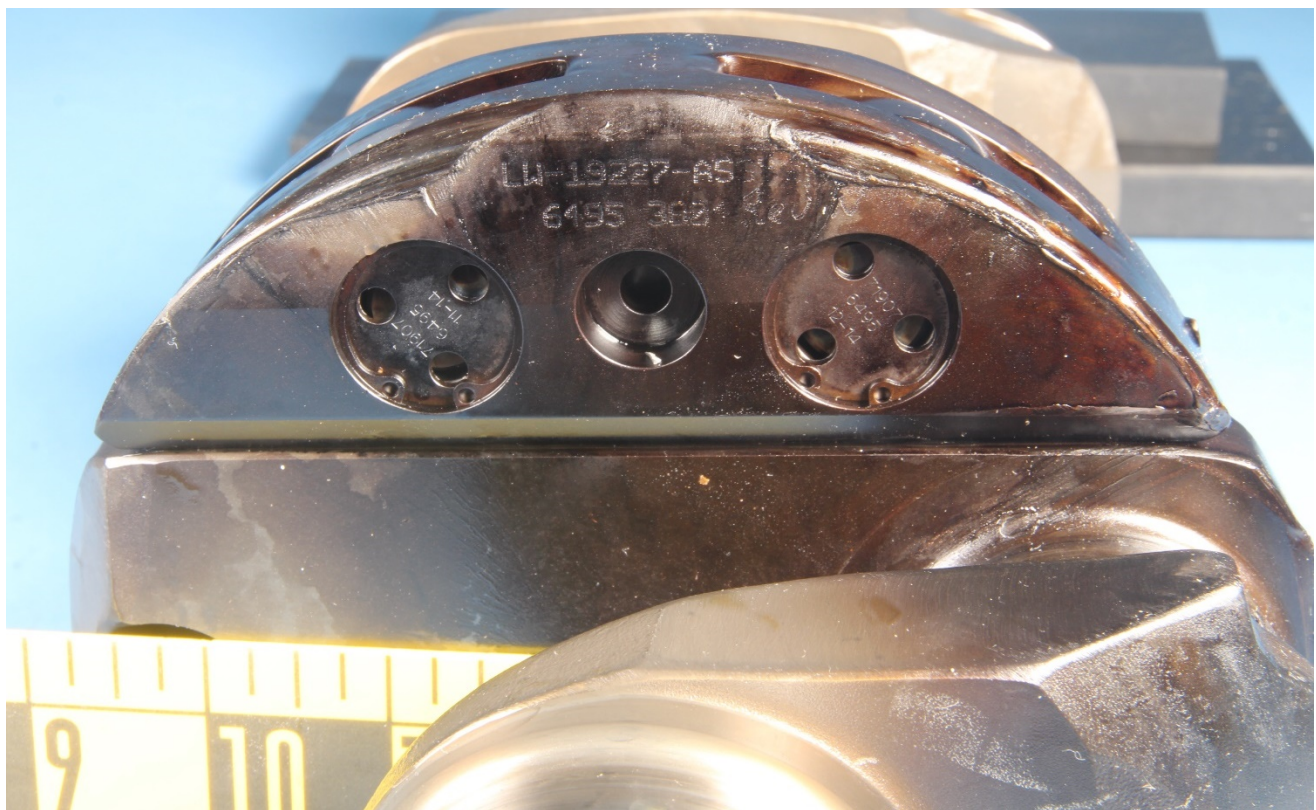
Figure 4 – View of one of the counterweights, as attached to the crankshaft, viewed aft looking forward.

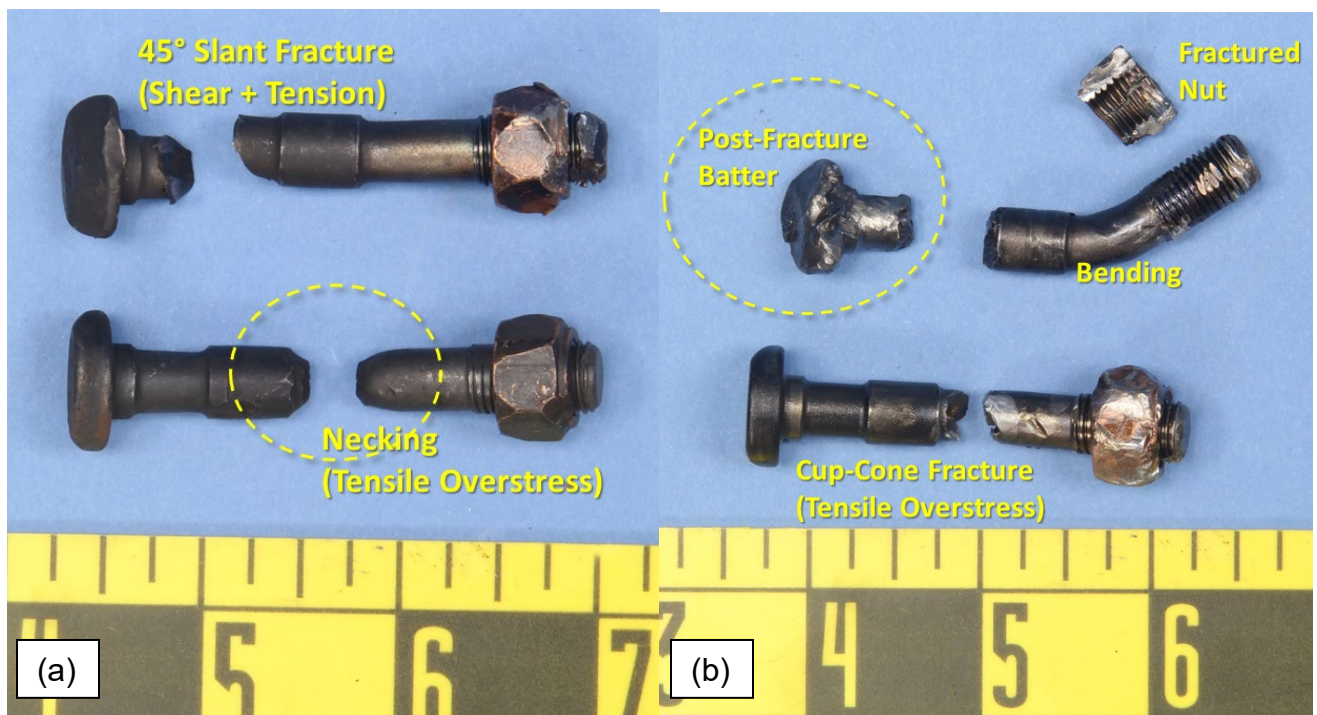
Figure 14 – View of the fractured attachment bolts from (a) the C3 connecting rod remnants and (b) the C4 connecting rod remnants, annotated to show fracture and damage features.

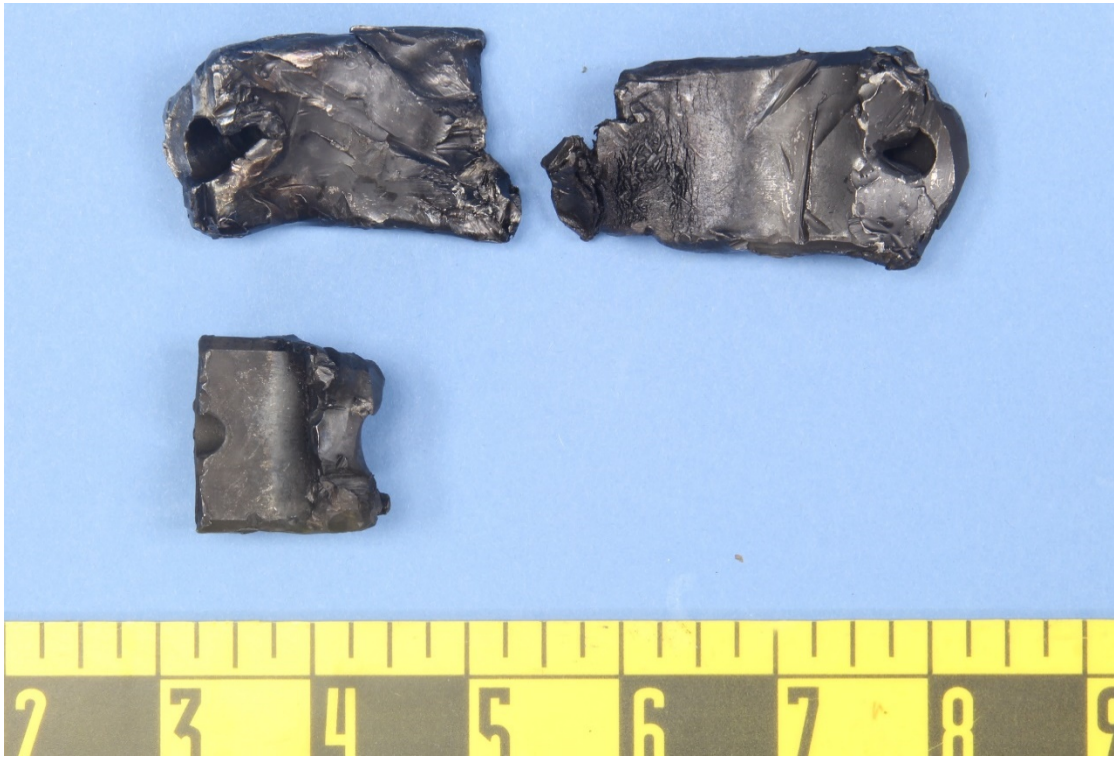
Figure 15 –The remnants of the C3 connecting rod cap (upper part of figure) and a piece of the connecting rod (lower).

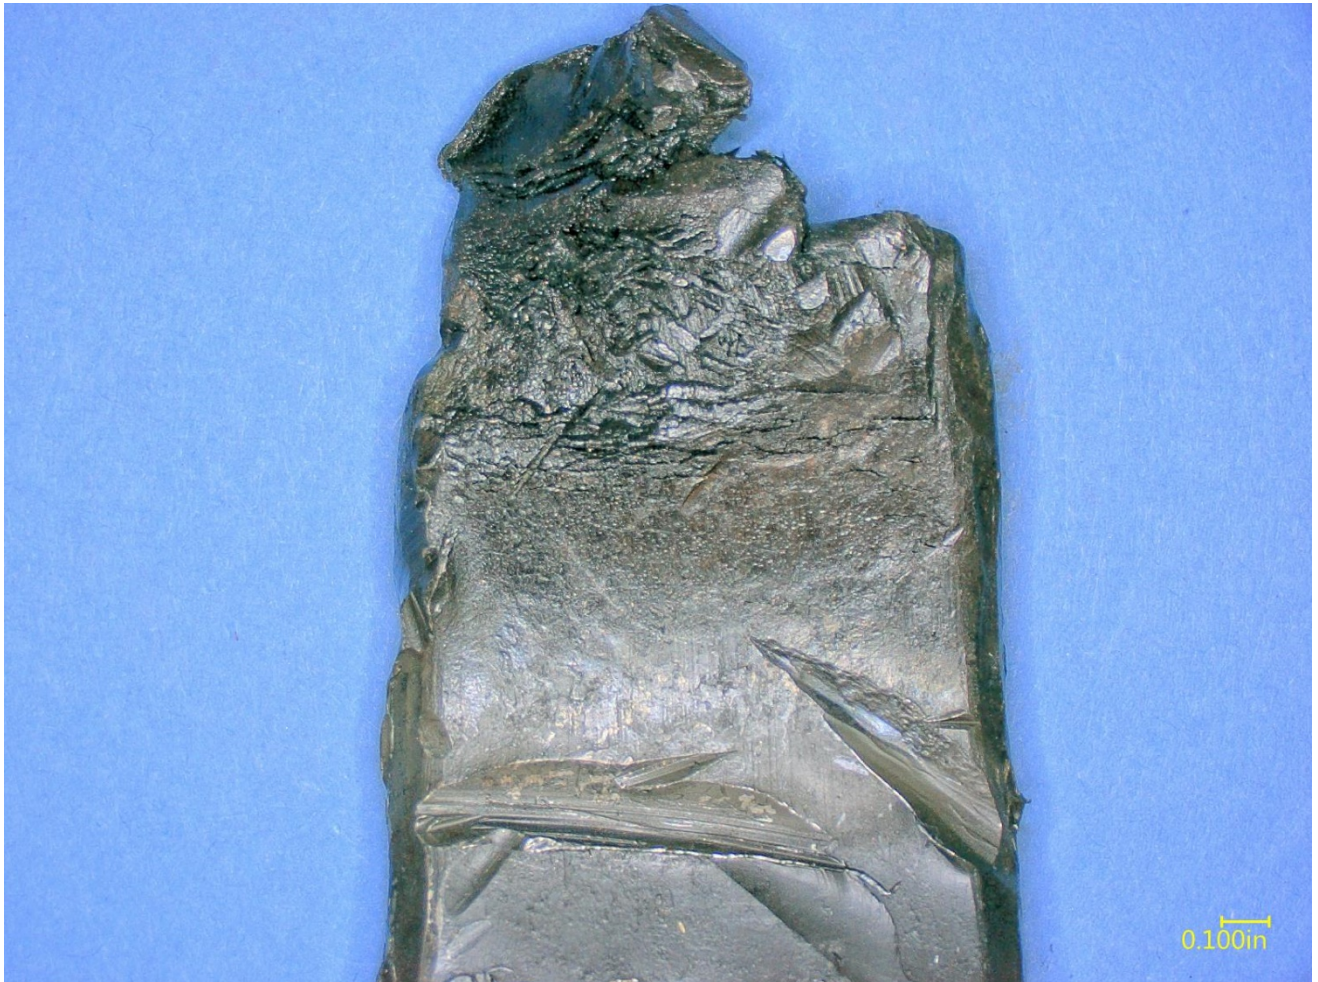
Figure 16 – View of the inner surface of the C3 cap remnant, showing gouges and rumpling near the fracture.

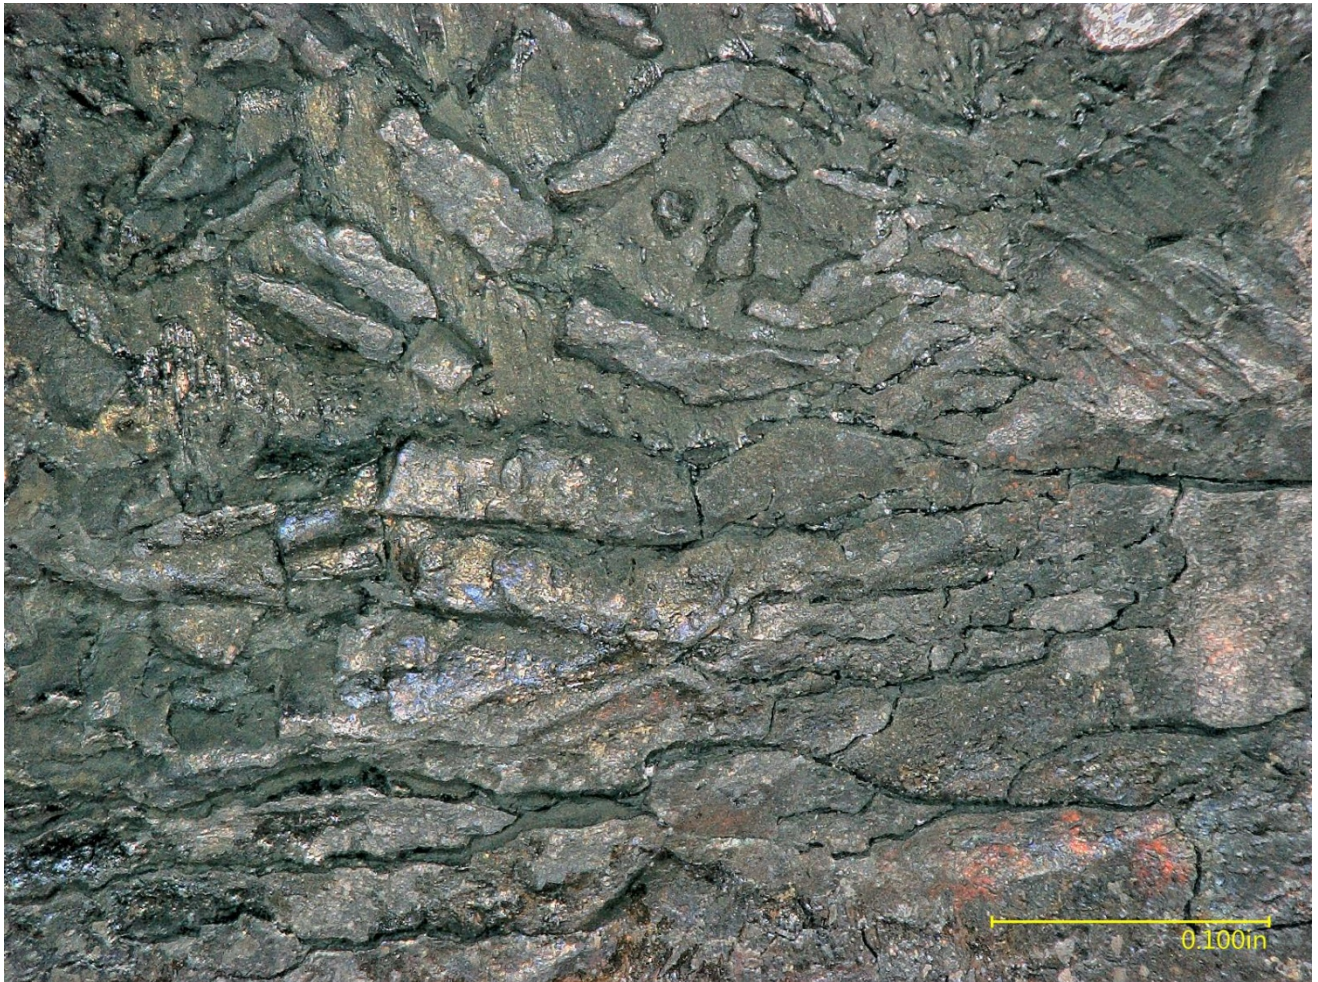
Figure 17 – View of the inner surface of fractured C3 cap remnant, showing a series of cracks parallel to the fracture surface.

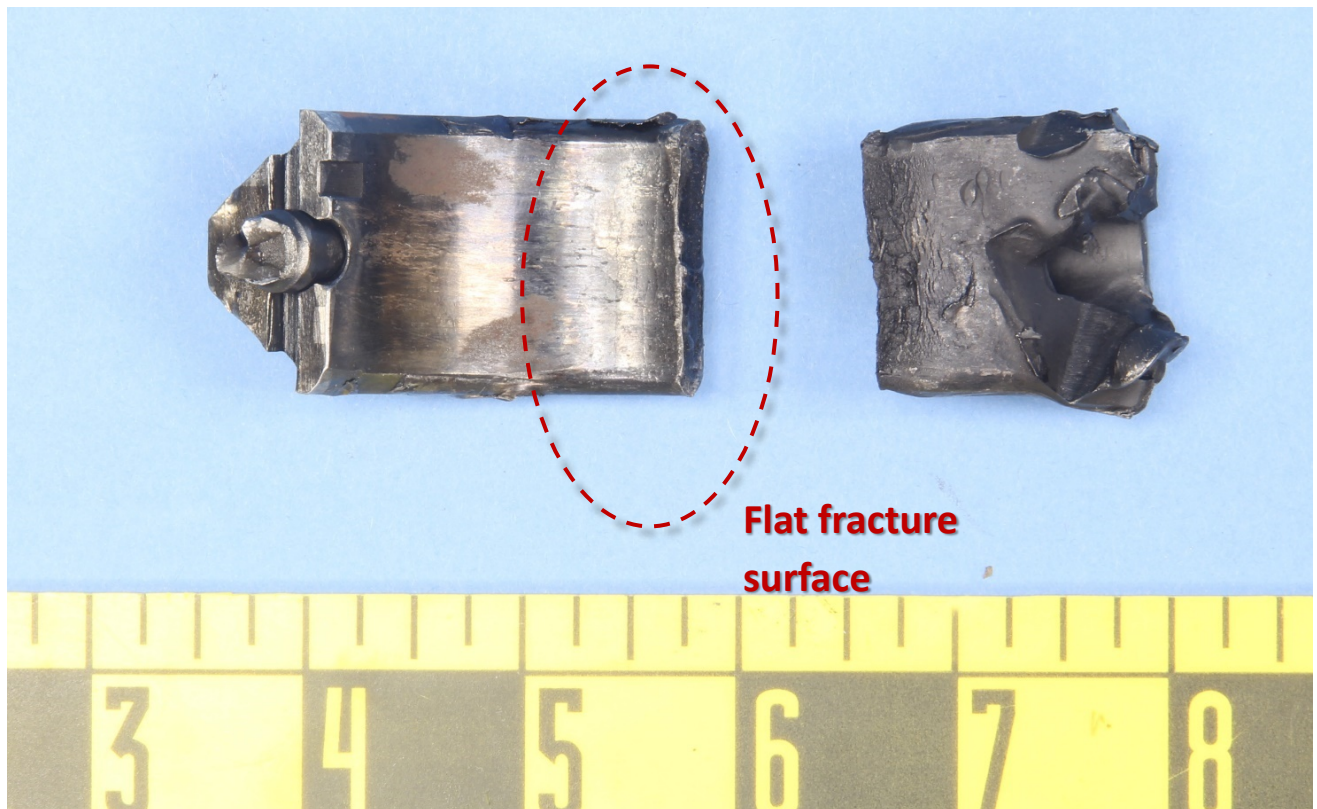
Figure 18 – The remnants of the C4 conrod cap, showing a flat fracture highlighted in Figure 19.

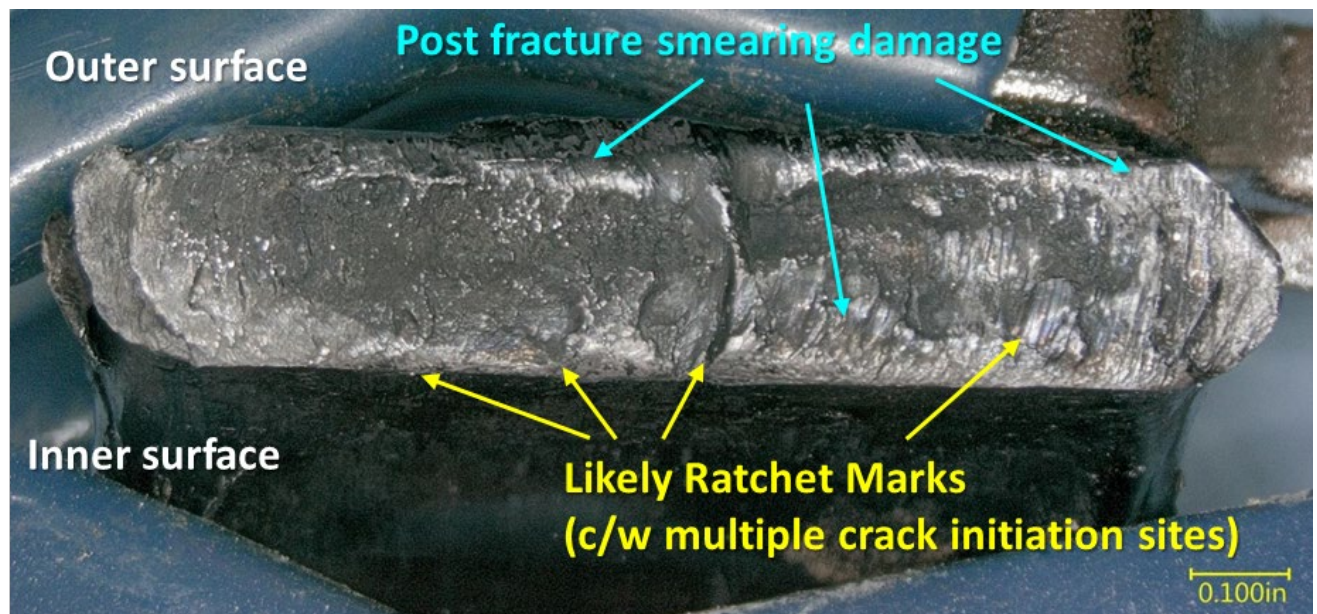
Figure 19 – View of the fracture surface of the C4 cap remnant with features annotated.

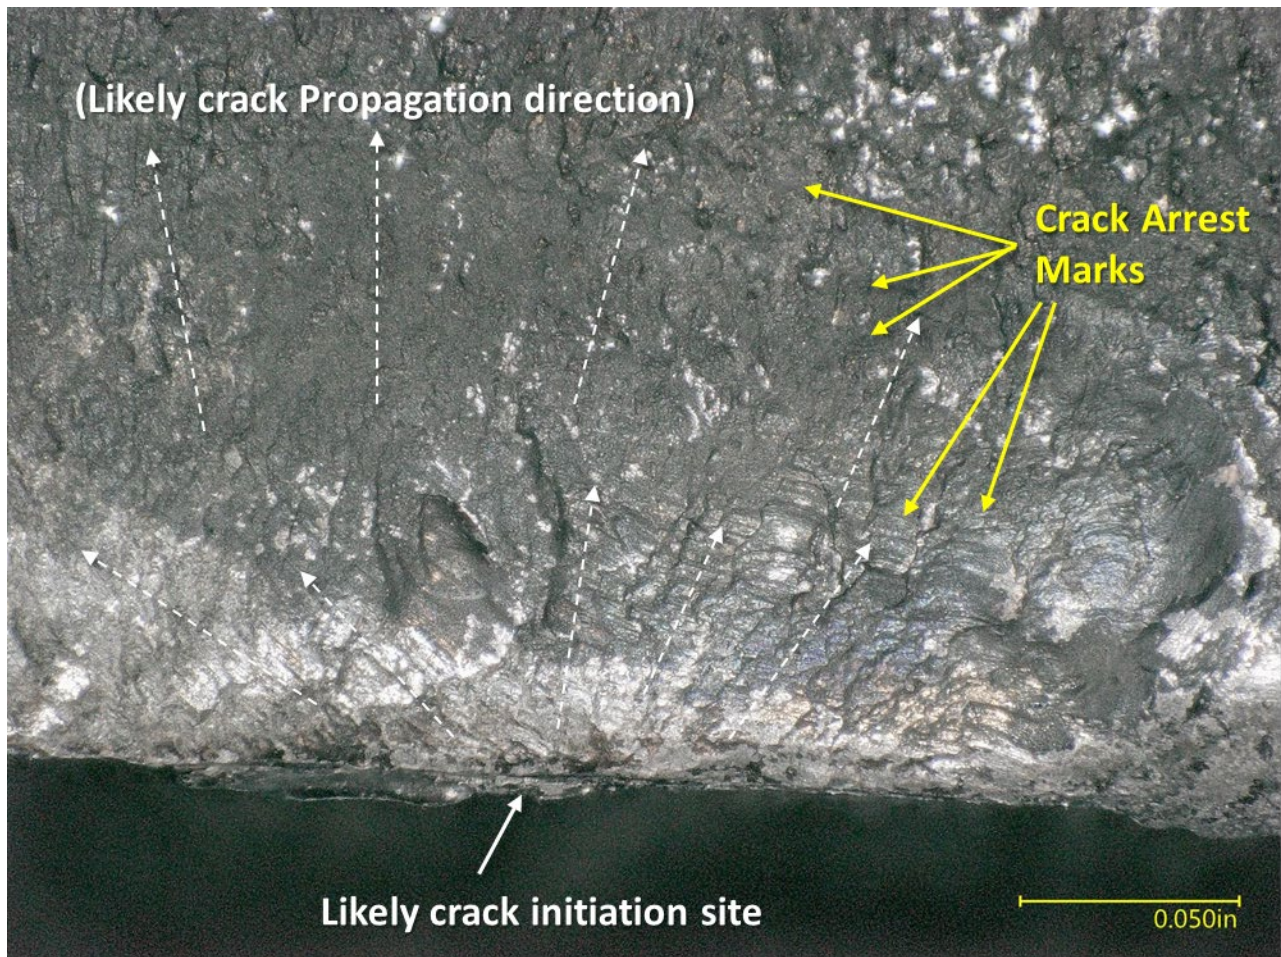
Figure 20 – View of a likely crack initiation site on the C4 cap fracture surface.

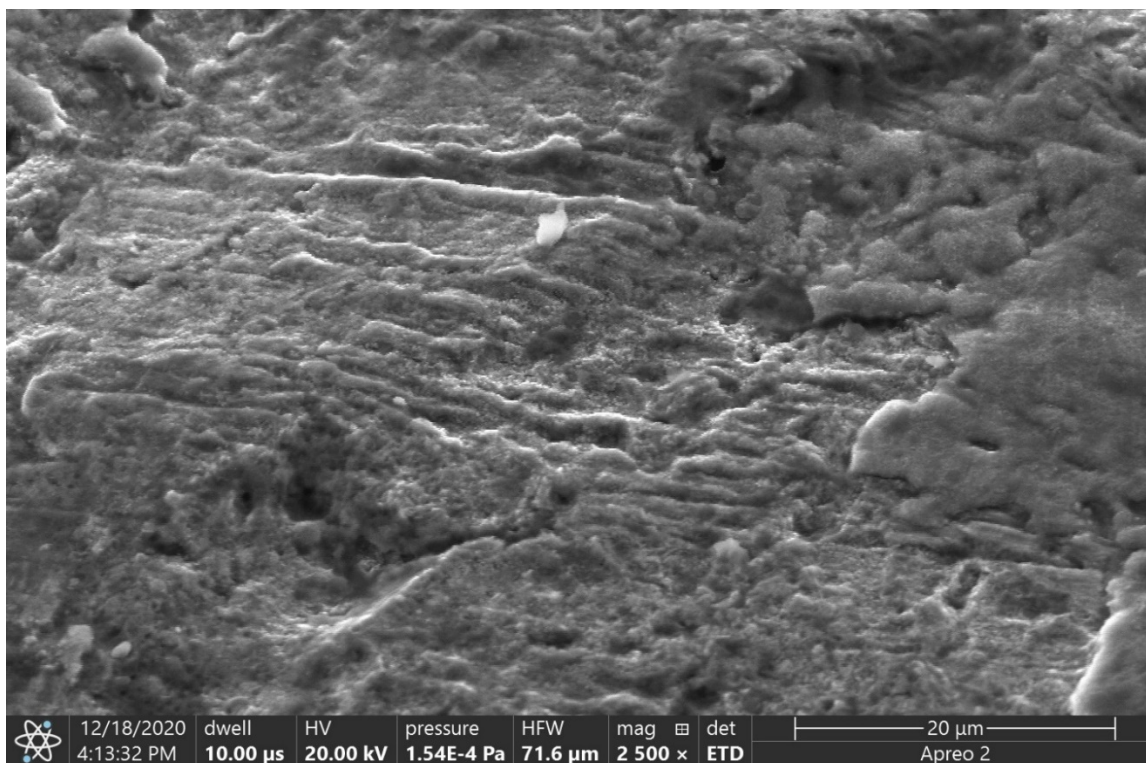
Figure 21 – Secondary electron (SE) micrograph view of the C4 cap fracture surface, showing fatigue striations.

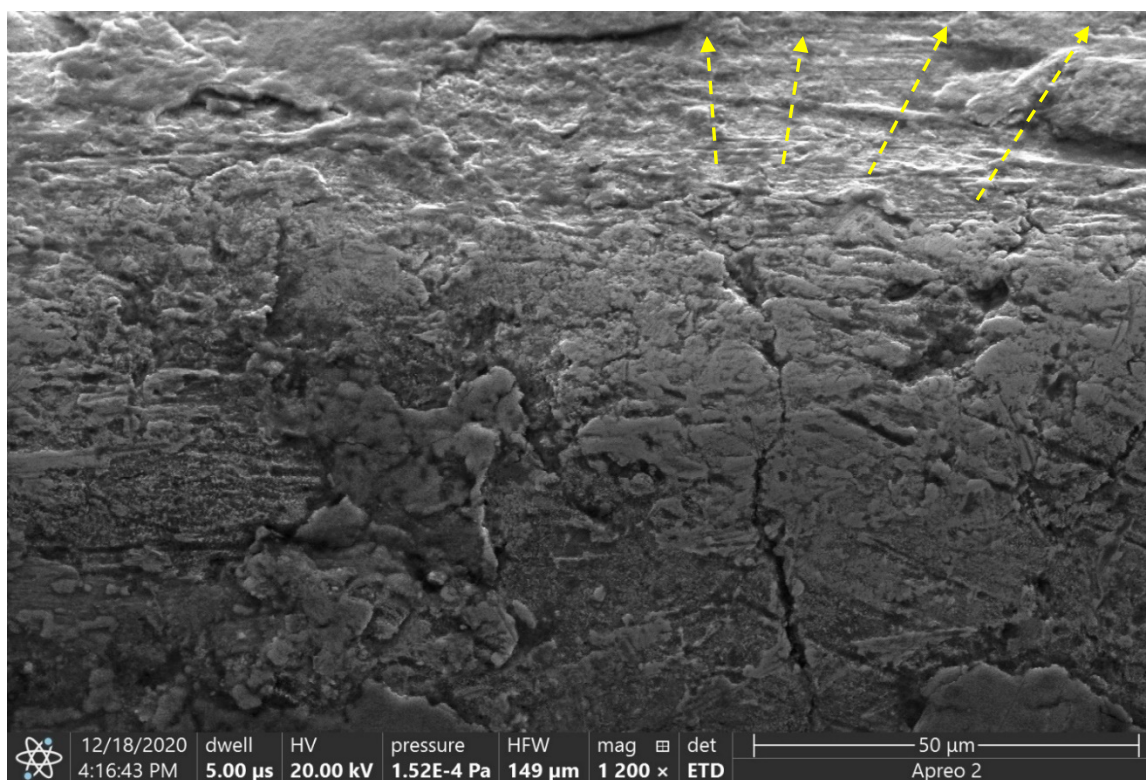
Figure 22 – SE micrograph of the rounded edge of the C4 cap fracture surface, showing fatigue striations emanating upward (arrows).

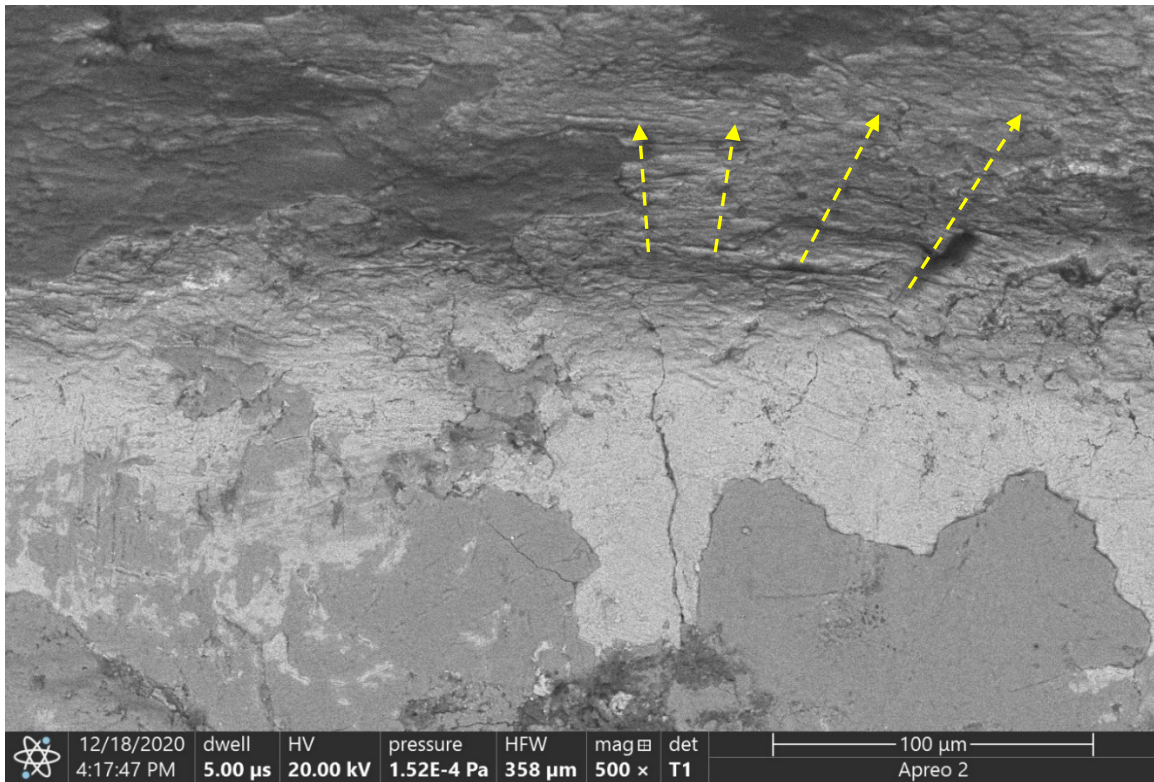
Figure 23 – Backscattered electron (BE) micrograph of the edge in Figure 22.

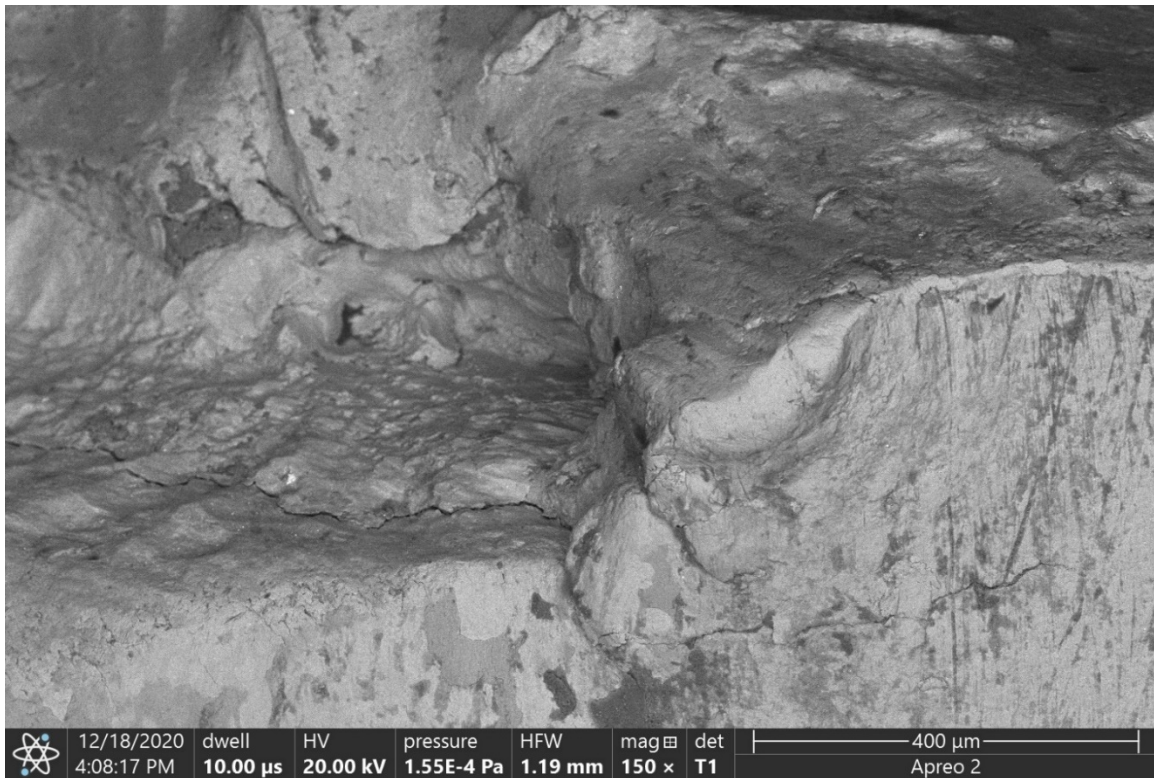
Figure 24 – BE micrograph of spalled material and cracking on the side edge of the cap remnant fracture.

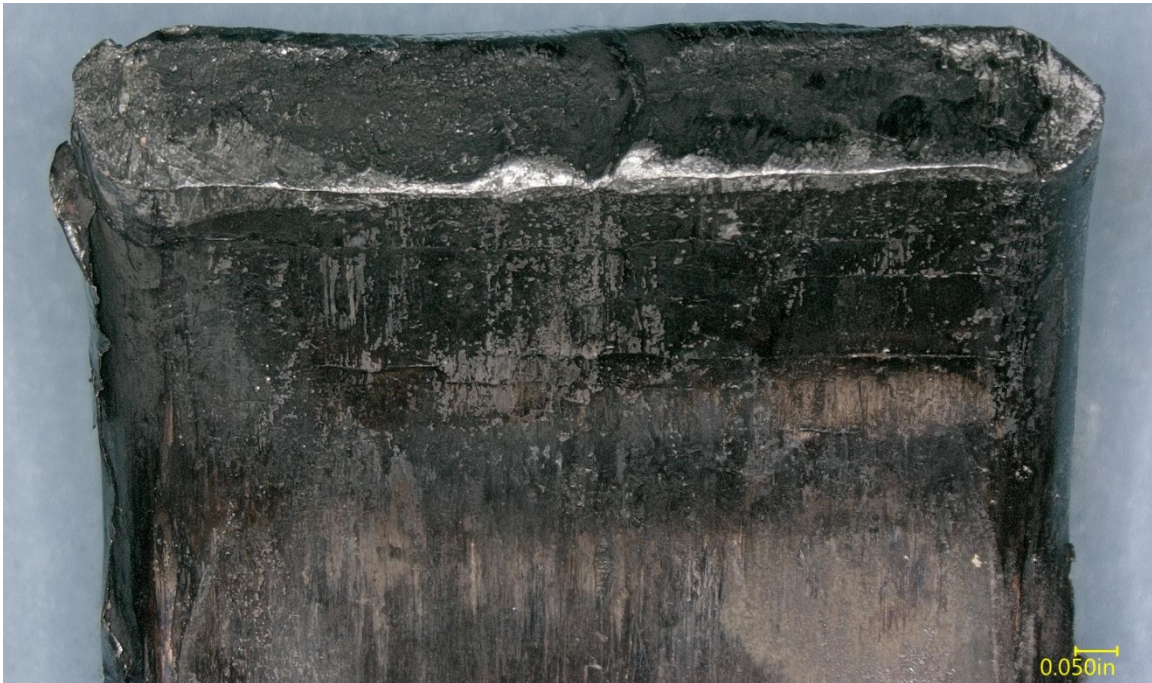
Figure 25 – Angled view of the inner surface of the C4 cap, showing parallel cracks below the fracture surface.

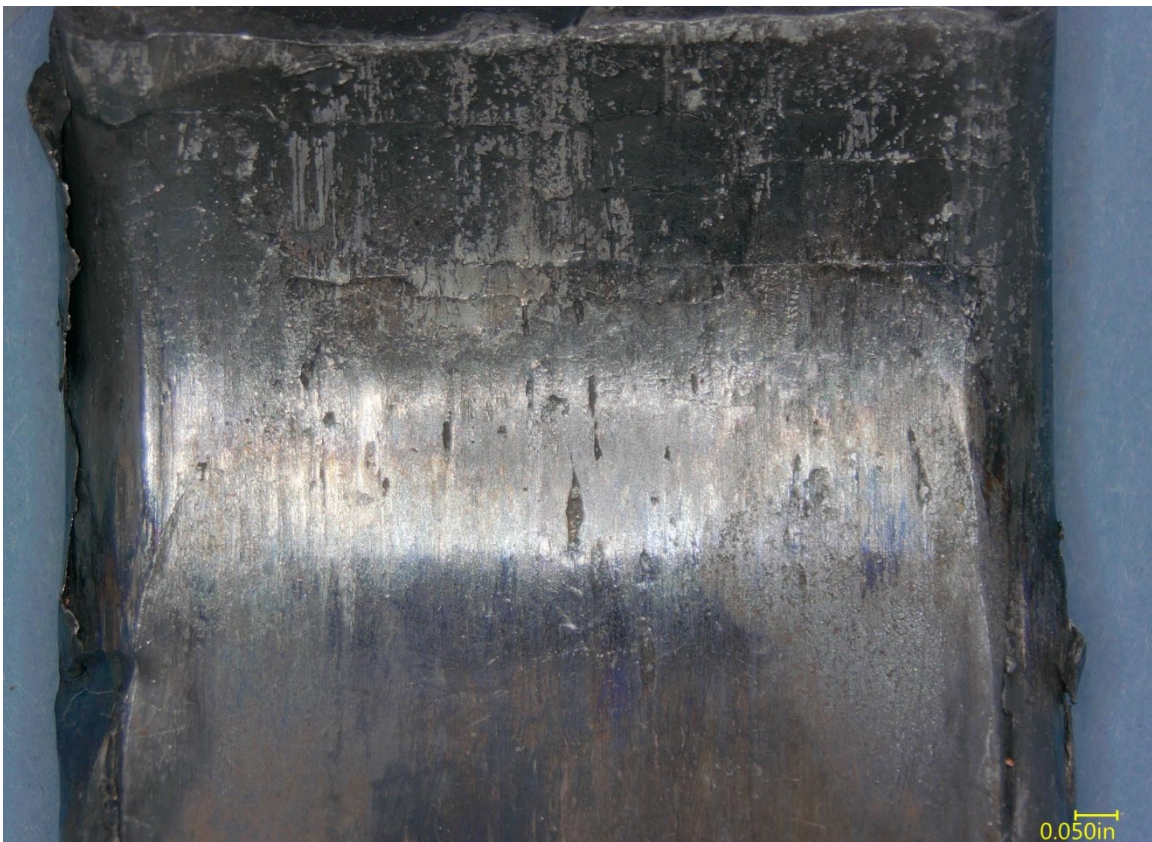
Figure 26 – Oblique view of the inner surface of the C4 cap, showing cracks and spalled material.

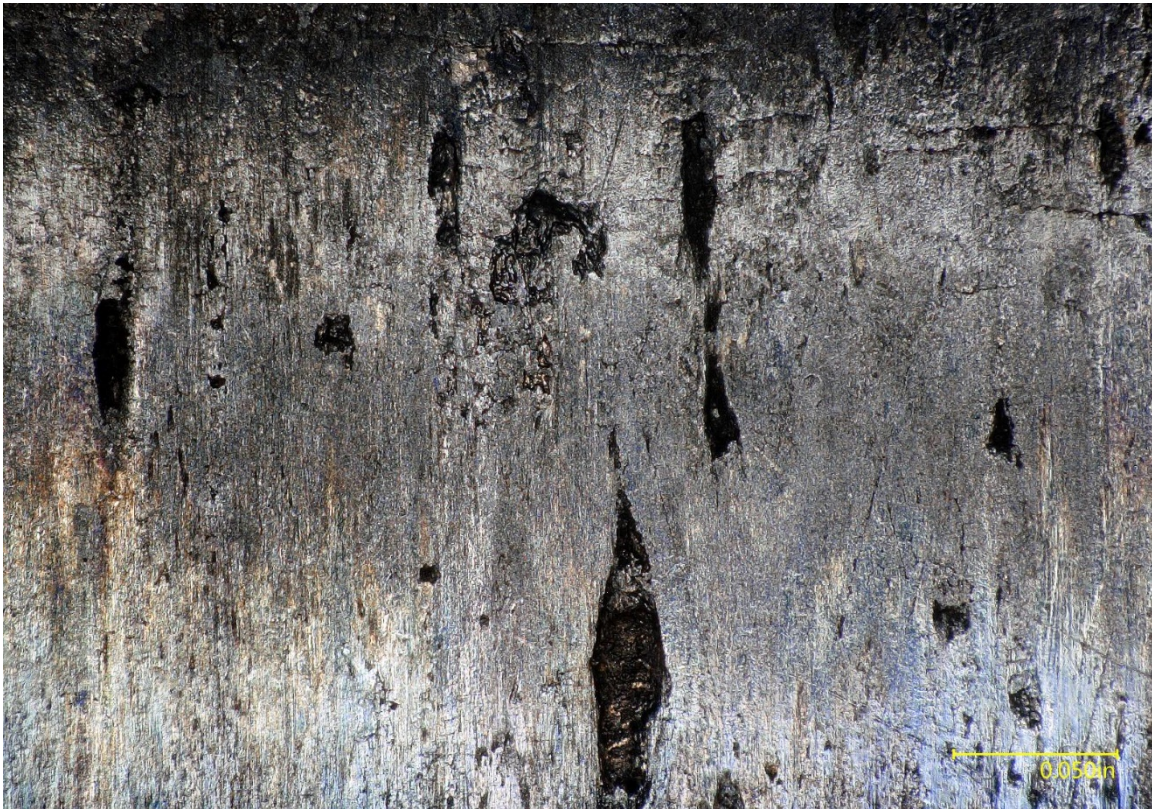
Figure 27 – Closer view of the spalled material on the inner surface of the C4 cap remnant.

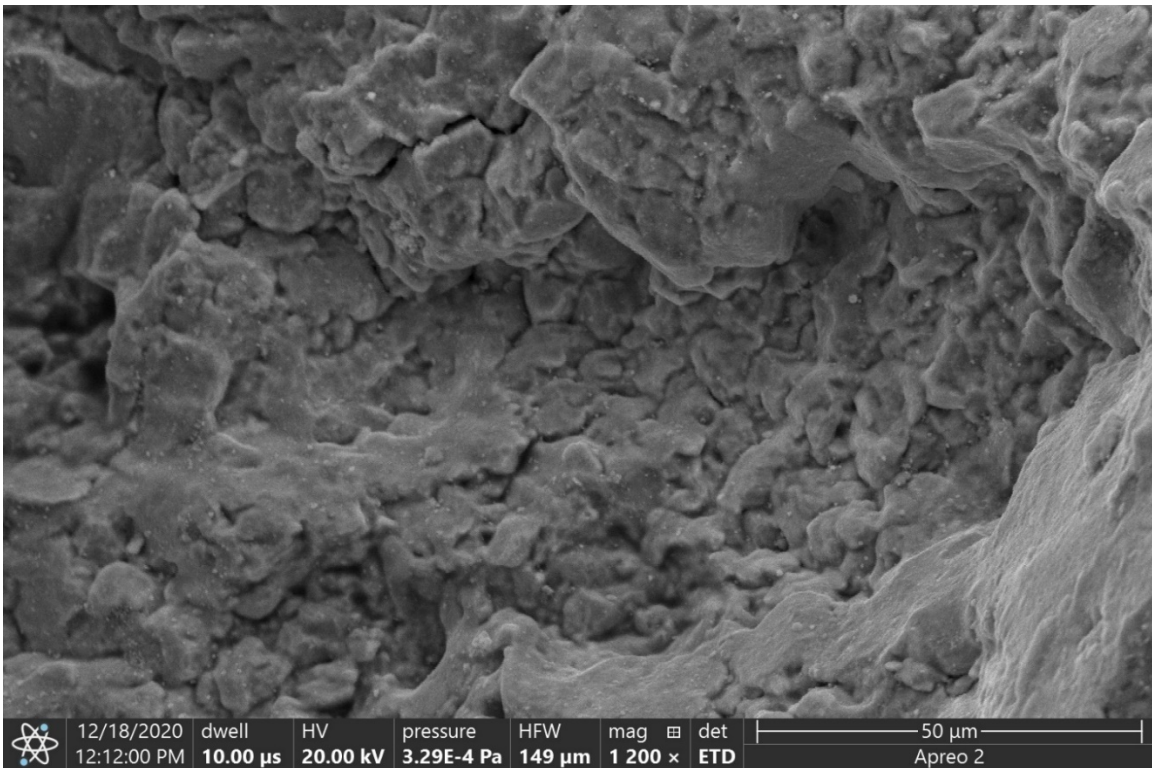
Figure 28 – SE micrograph of the inside of a spalled material streak in Figure 27.

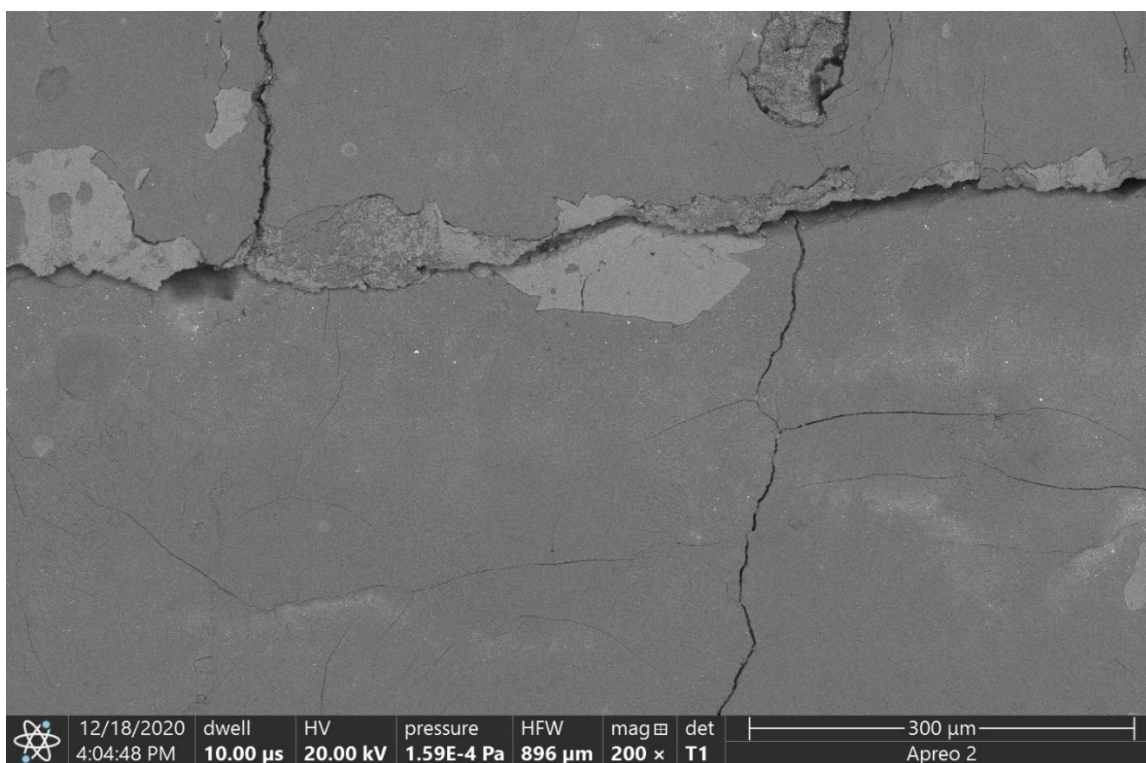
Figure 29 – BE micrograph of one of the parallel cracks on the C4 inner surface.

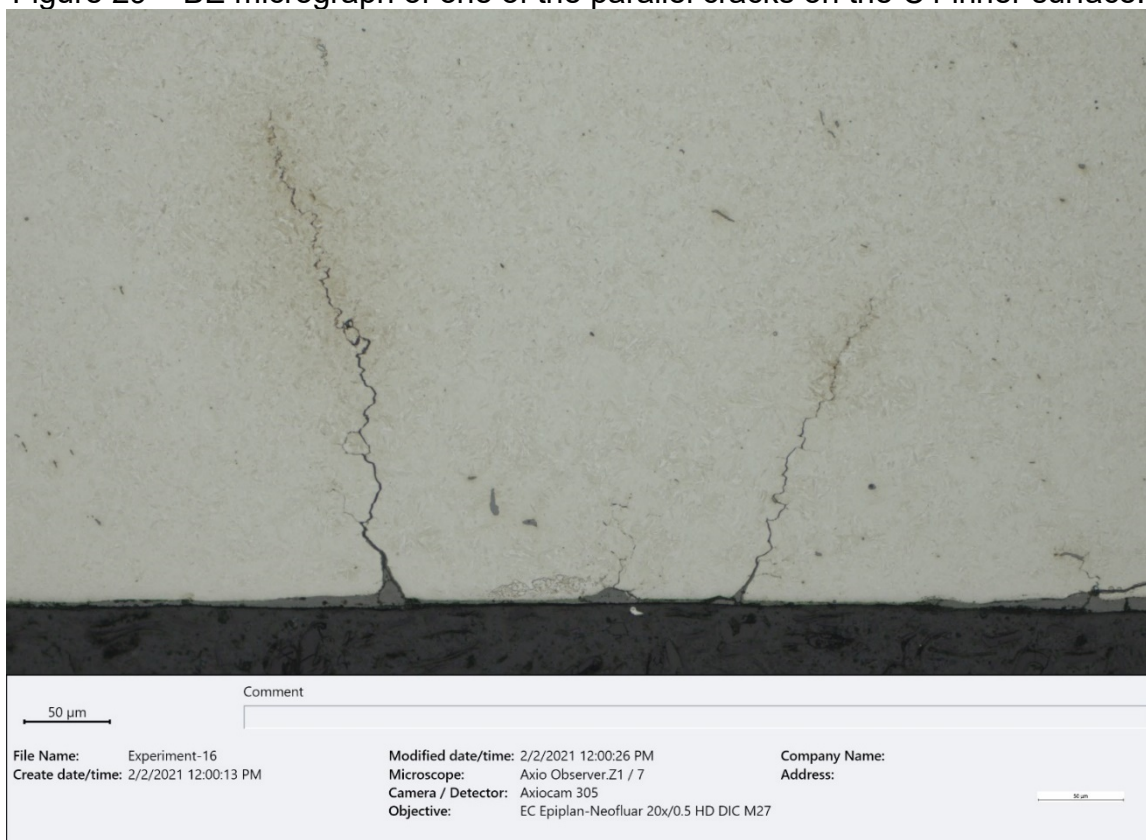
Figure 30 – Bright-field (BF) optical micrograph of a cross section through the C4 inner surface, showing multiple cracks (~200X, etched 2% Nital).

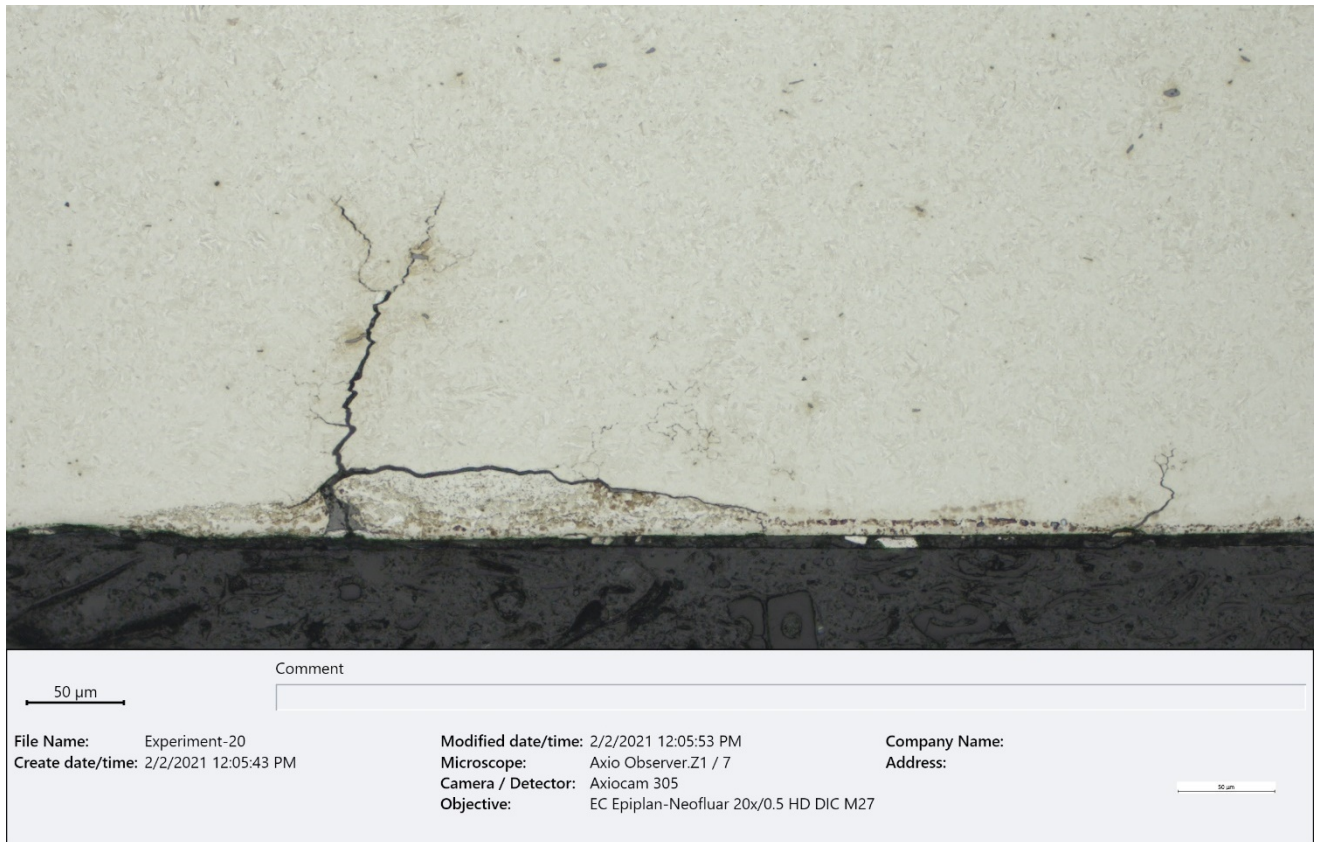
Figure 31 – BF optical micrograph of cracks perpendicular and parallel to the inner surface of the C4 cap remnant (~200X, etched 2% Nital).
