# NATIONAL TRANSPORTATION SAFETY BOARD

Office of Research and Engineering  
Materials Laboratory Division  
Washington, D.C. 20594

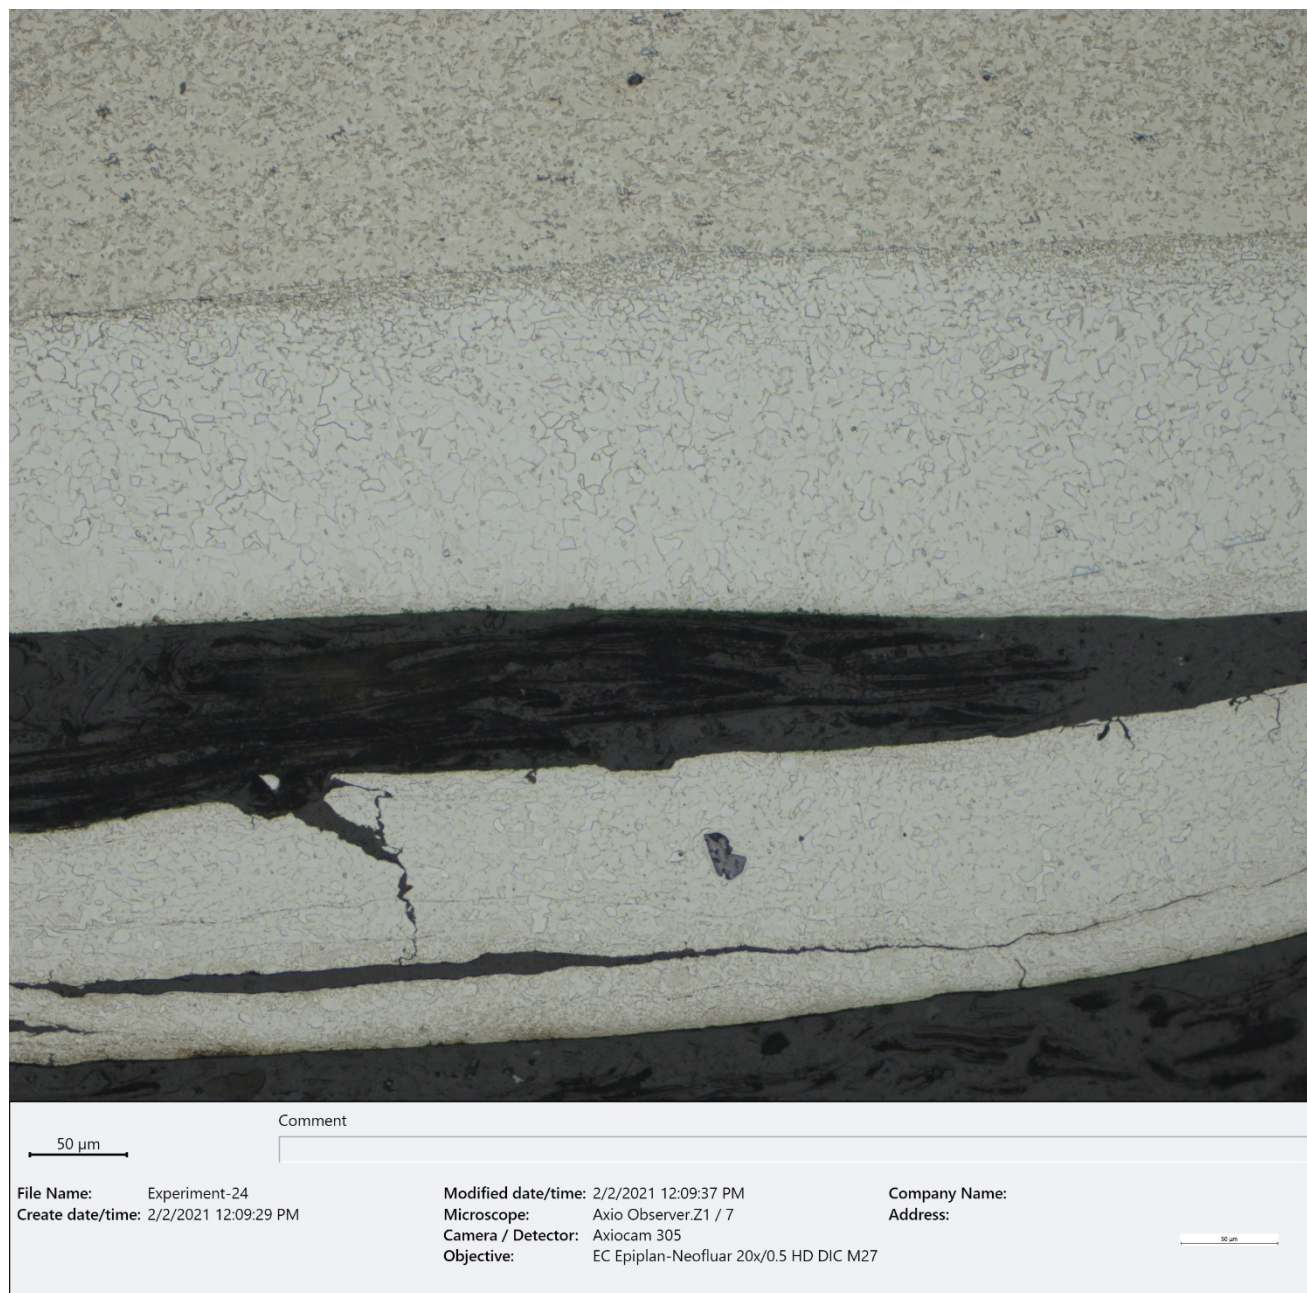
Figure 32 – BF optical micrograph of spalled and heat-damaged inner surface regions of the C4 cap remnant (~200X, etched 2% Nital).

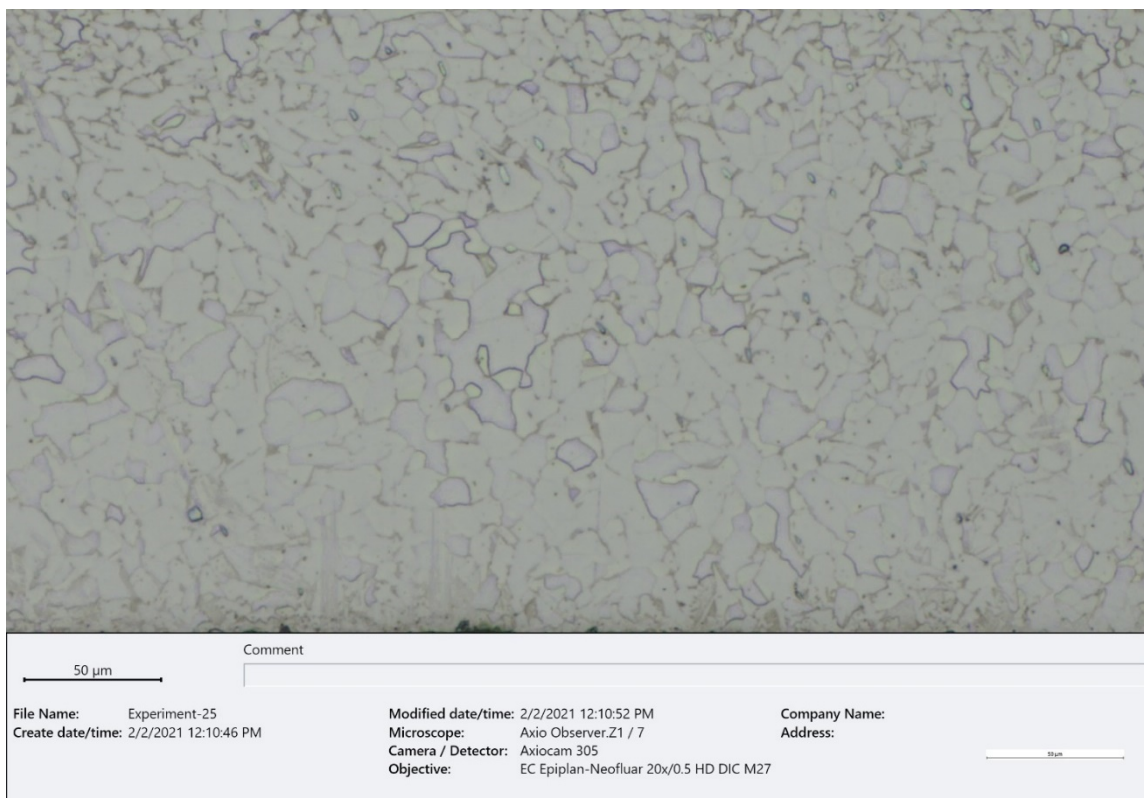
Figure 33 – BF optical micrograph of the heat damaged surface region in Figure 32, showing larger equiaxed grains (~500X, etched 2% Nital).

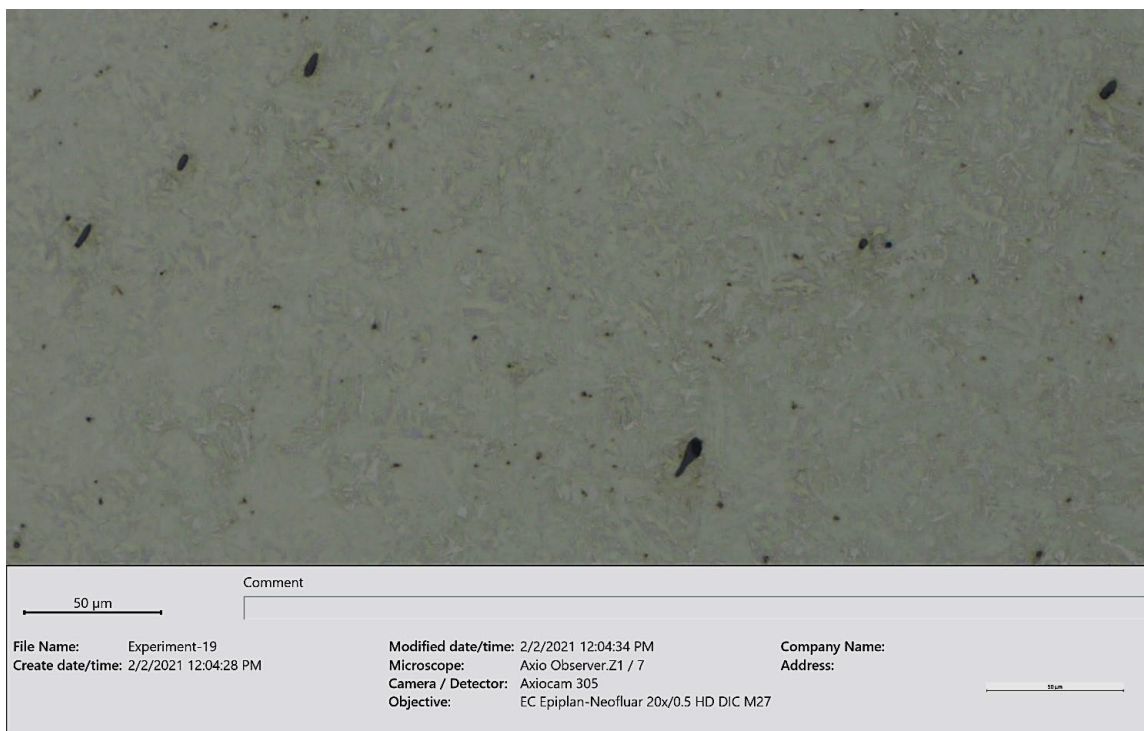
Figure 34 – BF optical micrograph of a typical region of the cap core microstructure (~500X, etched 2% Nital).

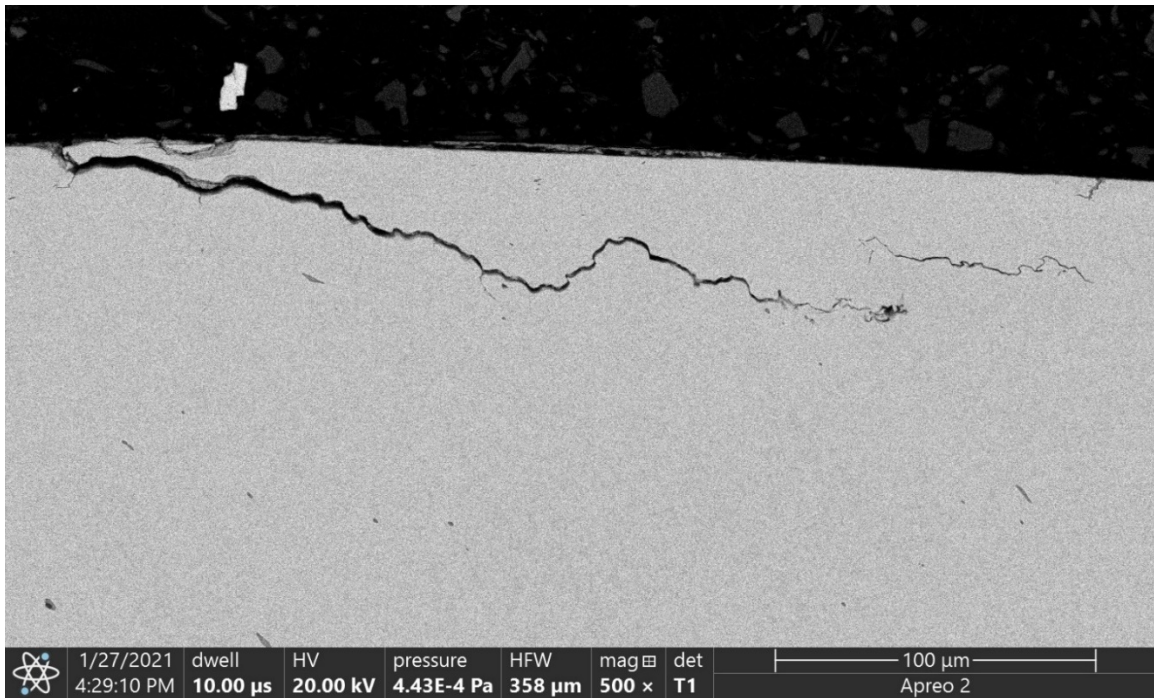
Figure 35 – BE micrograph of one of the inner parallel-oriented surface cracks.

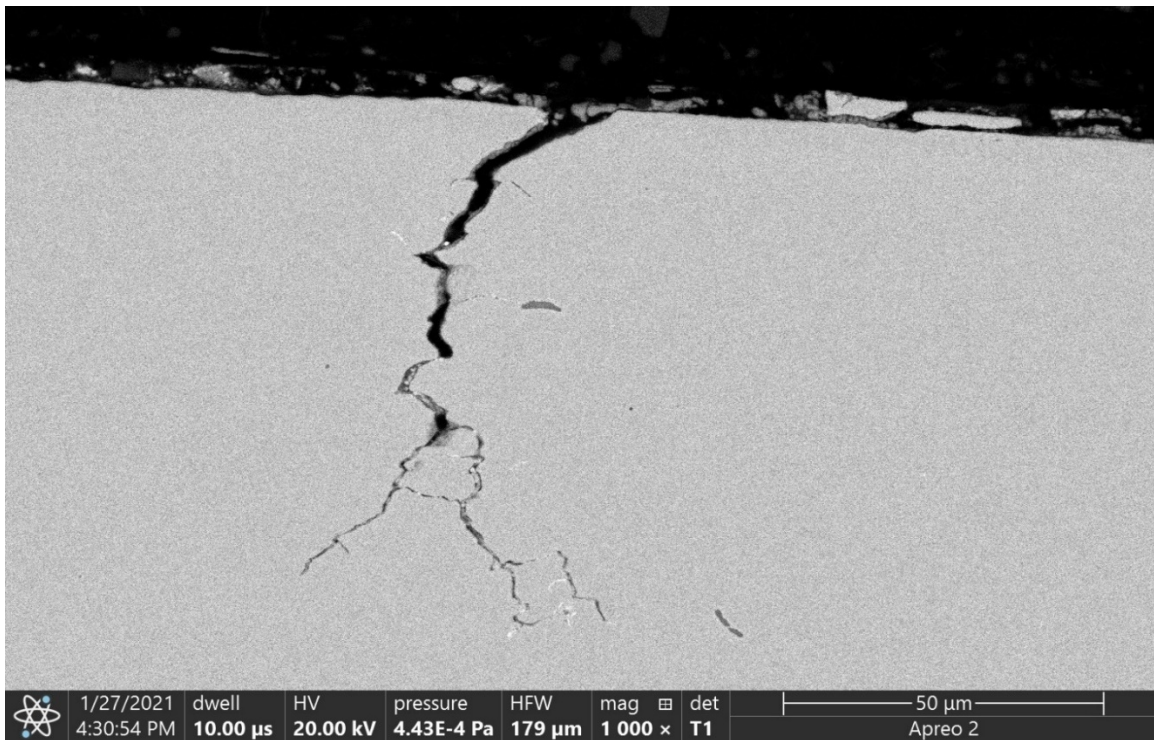
Figure 36 – BE micrograph of one of the perpendicular-oriented cracks, showing intergranular quality.

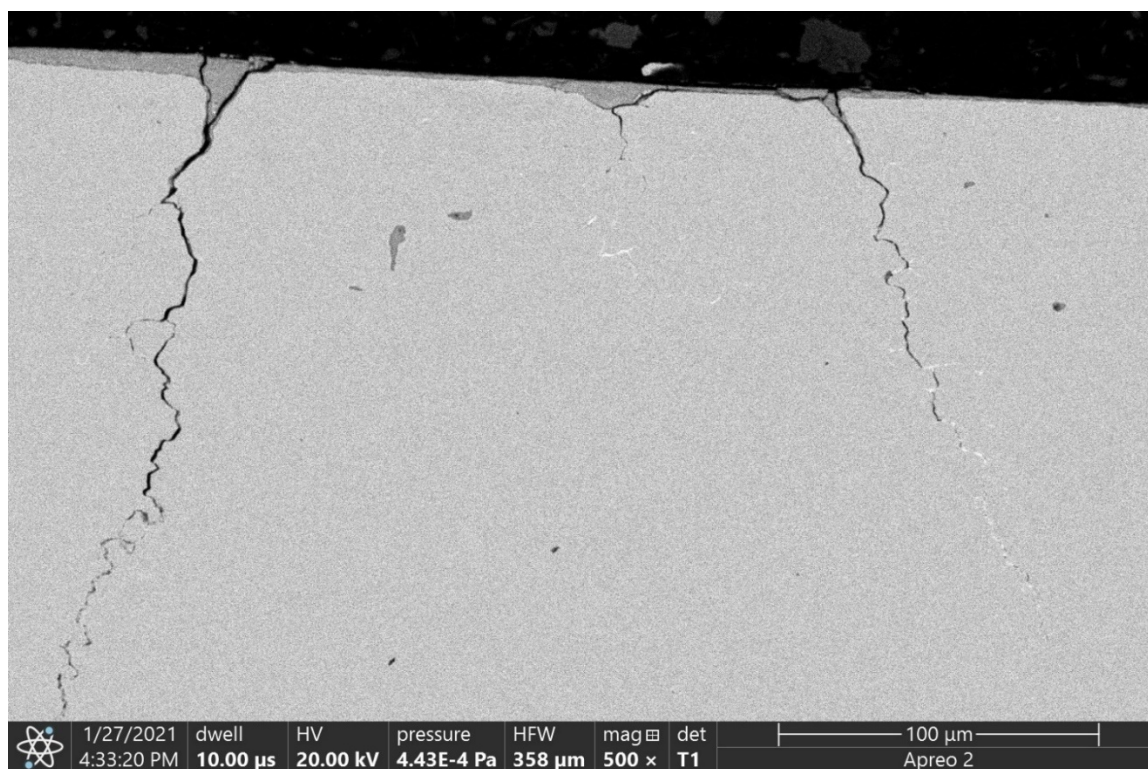
Figure 37 – BE micrograph of the cracks in Figure 30, showing lower-Z materials along the cracks.

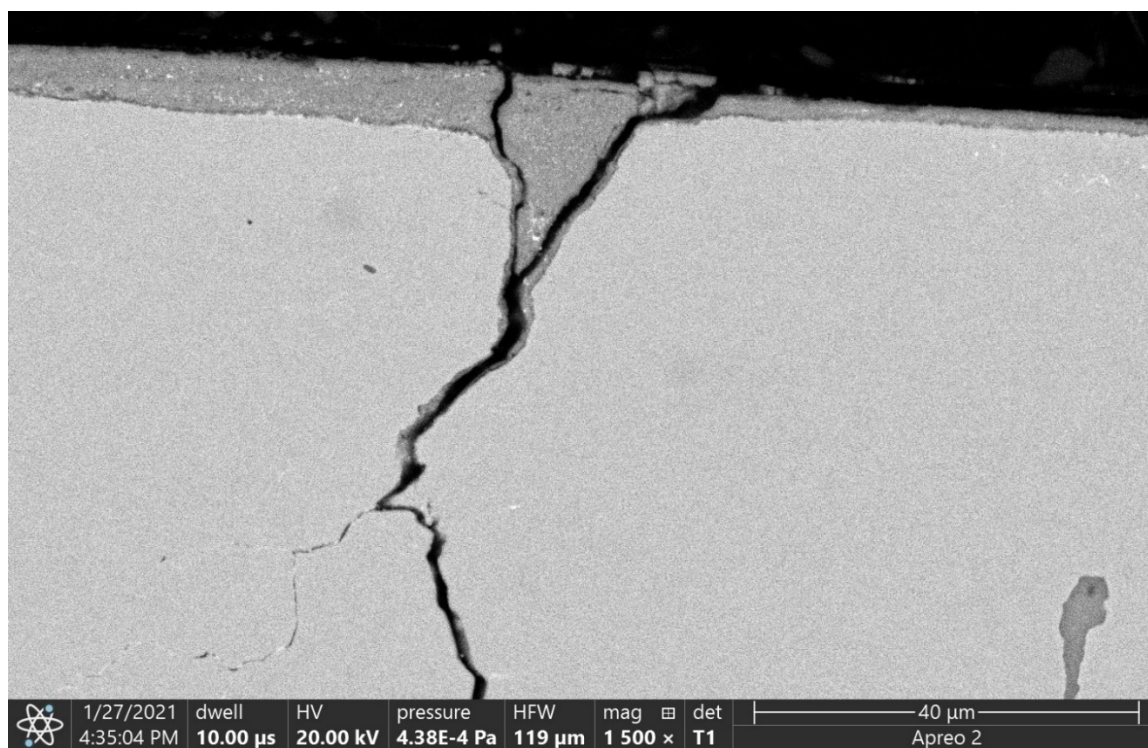
Figure 38 – BE micrograph showing the surface intersection of the left crack in Figure 37.

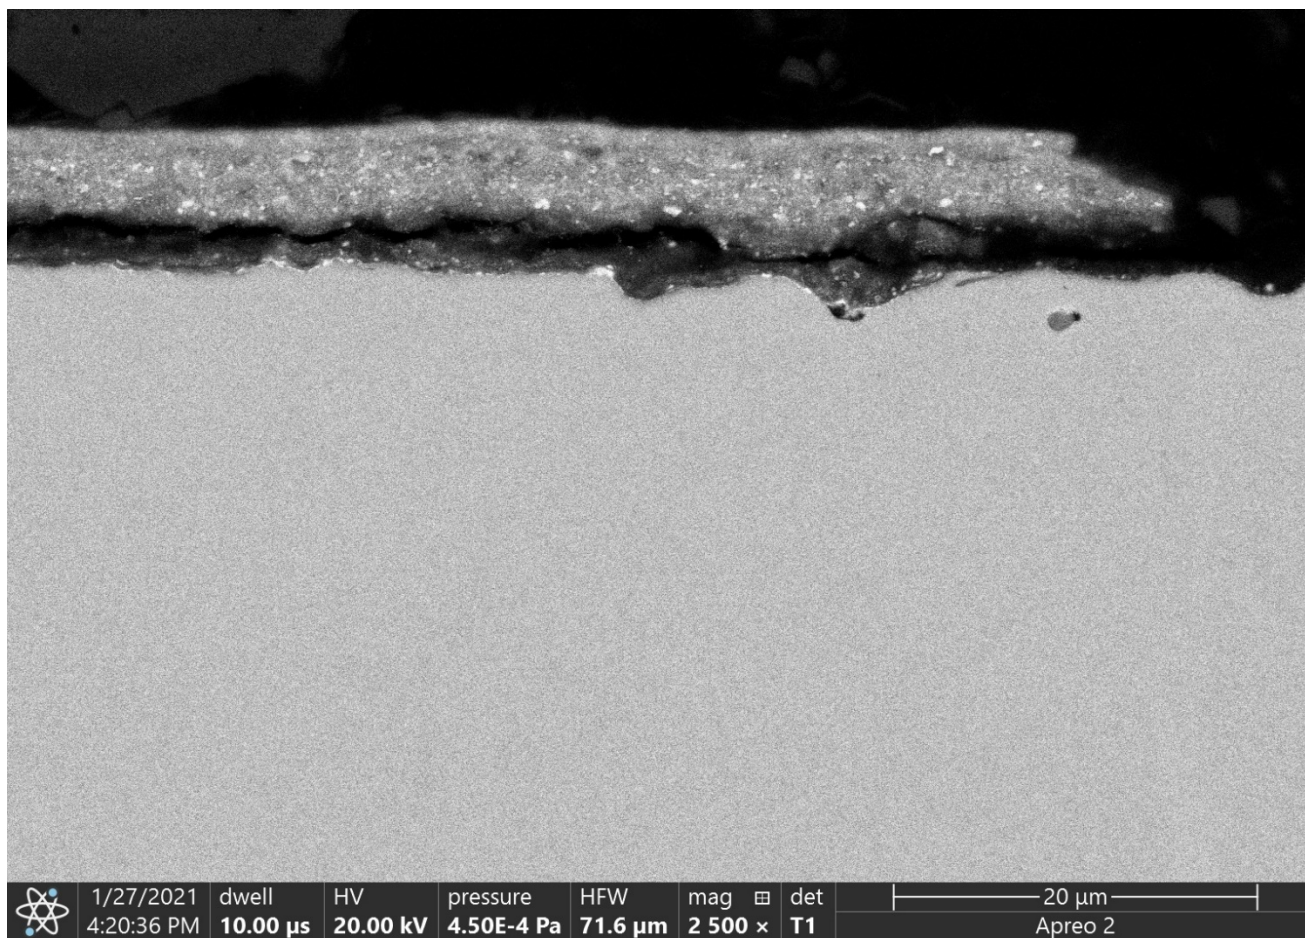
Figure 39 – BE micrograph of a cross section of other material layers along the inner surface of the C4 cap remnant.
