**From:** [Rupert, Judson](#)  
**To:** [Stein, Stephen](#)  
**Subject:** RE: WPR20LA144 -- JPI700 & Horizon Instruments P-1000 -- preliminary report  
**Date:** Thursday, March 25, 2021 10:29:47 AM  
**Attachments:** [image003.png](#)

This concerns that accident I spoke to you about a few weeks back that involved a Mooney with a recent prop and prop gov overhaul that suffered a brief overspeed and then catastrophic failure

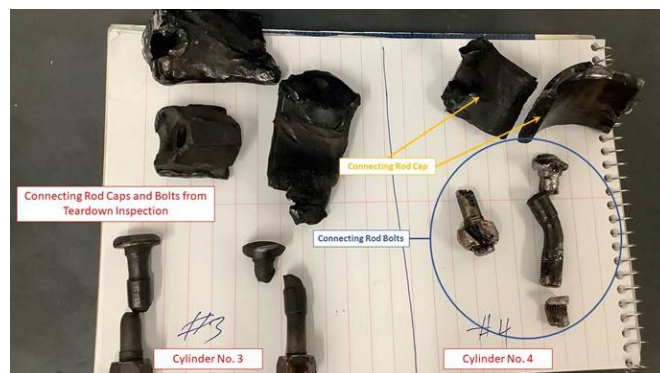
Concur, cylinder 3 and 4 crank journals show signs of lack of lubrication with high heat signatures on the connecting rod cap and bolts.

Based on the evidence at the cyl 3 and 4 rod caps/bolts, would you agree this is consistent with thermal damage to the cylinder no. 3 and 4 connecting rod caps and bolts and some evidence of high heat at the crankshaft. Even go so far as to say it's evidence of an absence of lubrication and excessive heat?

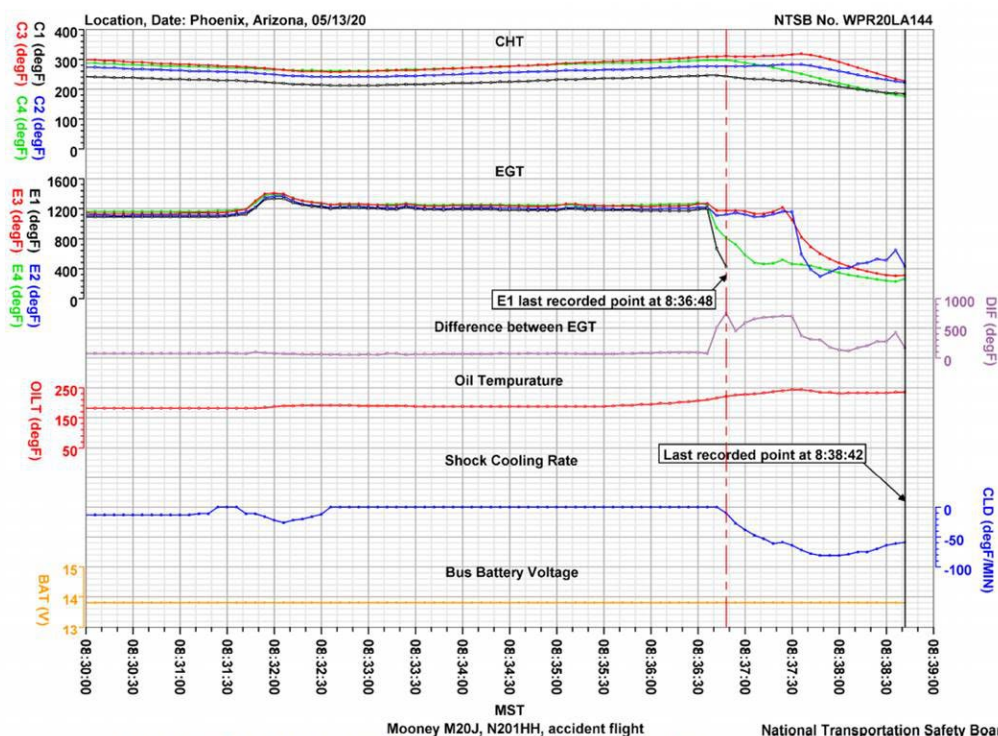
Figure 4: Plot of JPI EDM 700 data for the final portion of the accident flight recorded on May 13, 2020.

Firing order is 1-3-2-4, so I'm only theorizing here, but if 4 let go and the next in line was 1 to fire, it could have been effected by 4. 2 and 3 also drop at the same point but not nearly as much as 1. Once you have a broken connecting rod beating everything up, I'm not sure the intake charges are what they're supposed to be from that point forward.

Again, just one plausible explanation. The other could be one of cylinder probe location and wiring harness, are you sure the cylinder #1 trace is really cylinder #1 or could it be #3? Would not be the first time I've found connections crossed on the same side of the engine.

I'm re-reviewing the JPI results and was wondering since all the damage seems to be around cylinder no. 4 and subsequently cylinder no. 3, any reason why the JPI results would show cylinder no. 1's EGT reading drop around the same time as no. 4?
