## RECORD OF EMAIL

**NTSB Accident Number: WPR20LA147**

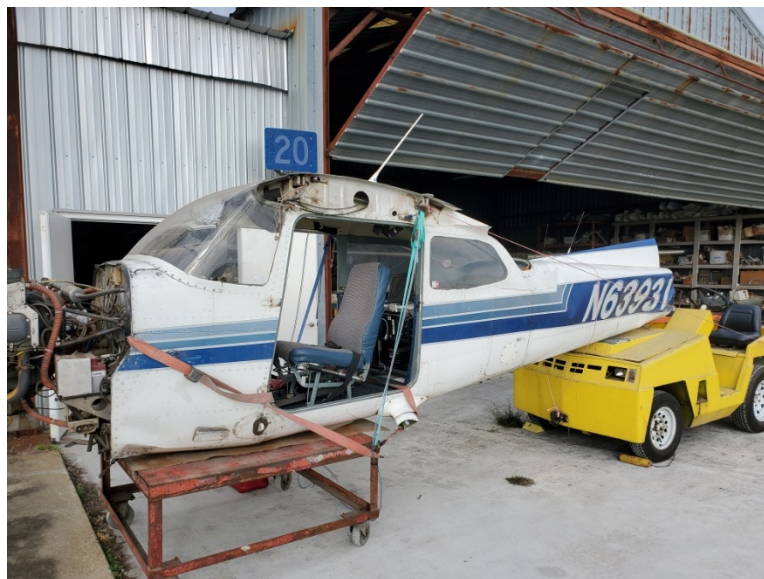
- The engine run was conducted on October 7, 2020 at the Hammond Northshore Regional Airport (HDC), Hammond, Louisiana.
- The airplane's fuselage was secured, an undamaged propeller was installed, and an external fuel tank was connected to the airframe's fuel system.
- The carburetor float bowl was drained of the old fuel and no contaminants were noted.
- The airplane fuel selector was positioned to both and the airplane was started using its key and normal start up procedures. The engine started uneventfully with no coughing or sputtering.
- After the engine warmed up, the fuel selector was switched from both to the left fuel tank, and then it was switched to the right fuel tank with no anomalies noted. The engine operated smoothly throughout the engine run.
- Mr. Gordon shared the below photograph of the airplane during the run:

*Figure 1: Airplane at Engine Run*
