## **NATIONAL TRANSPORTATION SAFETY BOARD**

# **AIRFRAME AND ENGINE EXAMINATION**

**WPR20LA152**

Location: Santa Maria, CA  
Date: May 20, 2020  
Aircraft: Cirrus SR20, Registration N883PJ, Serial #1217  
NTSB IIC: Samantha Link

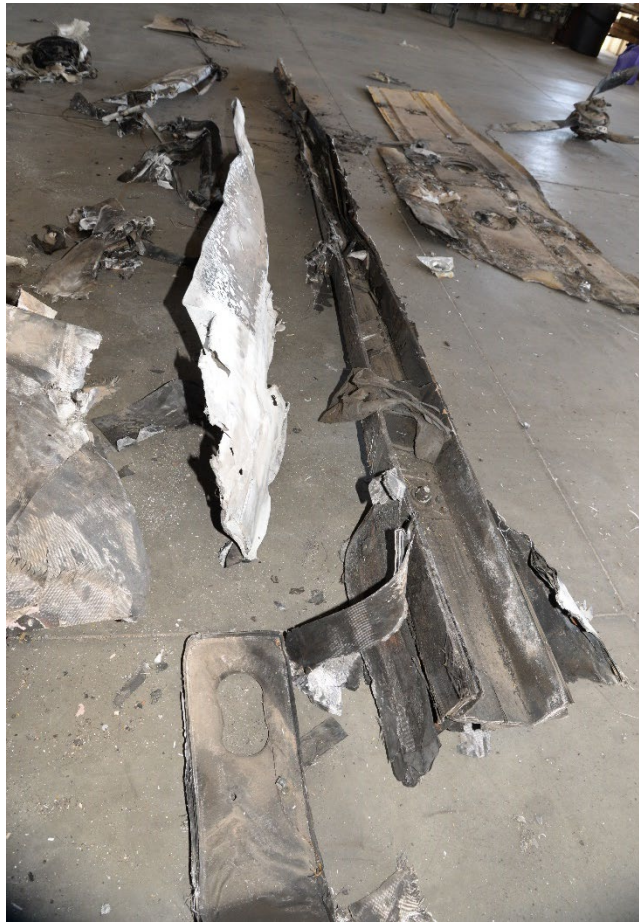
Figure 1: Left Wing

- The left wing:
  - About 3 feet of the inboard wing/torque box was present with the main landing gear attached.
  - The flap and aileron were separated from the wing and sustained thermal damage.

- A fragment of the aileron control cable remained in the actuation pulley
  - The flap actuator was extended about  $\frac{3}{4}$  inch, which is consistent with full flaps.

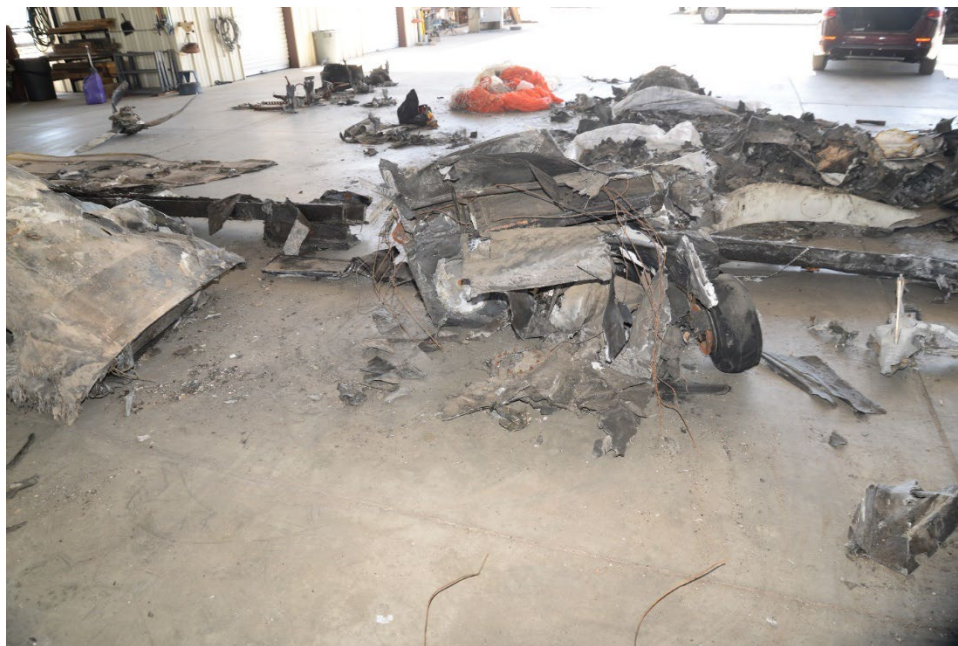
Figure 2: Center Fuselage and Wing Spar

- The airplane was mostly consumed by fire.
- The cabin area sustained extensive thermal damage and was mostly not present.
  - The instrument panel was destroyed. Instruments, radios, and other panel items were found loose within the wreckage.
    - All components sustained extensive thermal damage.
  - The front two seats were mostly consumed by fire.
    - Only the seat frames remained.
  - The rear seats were mostly consumed by fire.
  - The CAPS activation handle was found out of the holder.
    - About 4 feet of cable remained secured to the activation handle.
    - The rocket launch tube and parachute were present and examined with no anomalies noted.
- The aft fuselage and empennage were present and sustained some thermal damage.
- The wing spar sustained extensive thermal damage. (Single spar airplane)

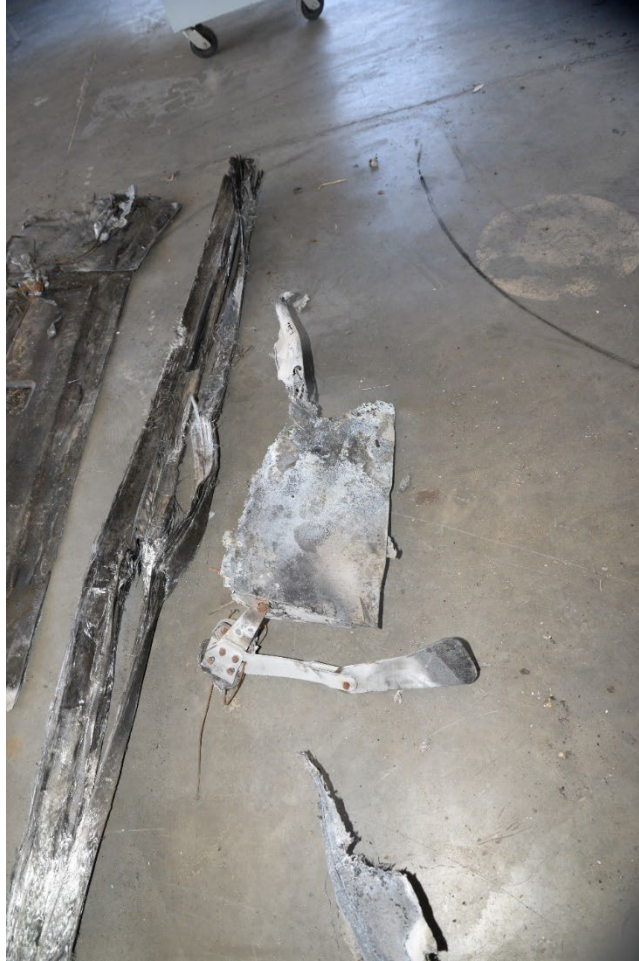
Figure 3: Right side Aileron Fragment and Wing Spar

- The right wing:
  - About 3 feet of the inboard wing/torque box was present with the main landing gear attached.
  - The aileron was fracture separated from the wing. The outboard portion was consumed by fire.

- A fragment of control cable was present at the actuation pulley.
  - Flight control continuity was mostly established throughout. The flight control system was thermally damaged throughout and the center cabin area controls were not present likely due to the post-crash fire.

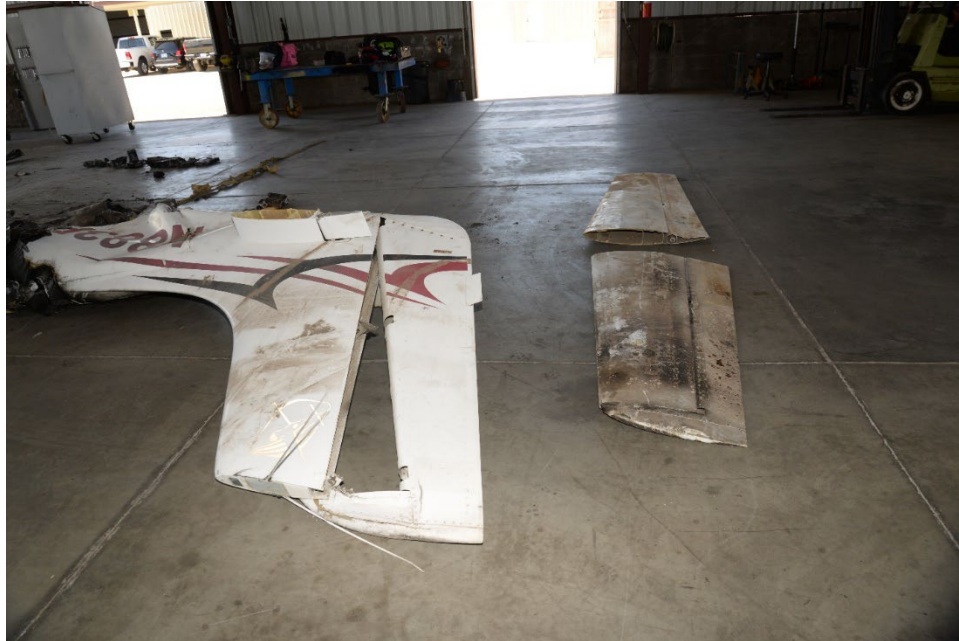
Figure 5: Empennage

- The vertical stabilizer remained attached to empennage and sustained thermal damage.
    - The rudder remained attached by the lowest attachment point.

- The horizontal stabilizers were cut to facilitate recovery.
    - The elevators remained secured and were able to be manipulated by hand.

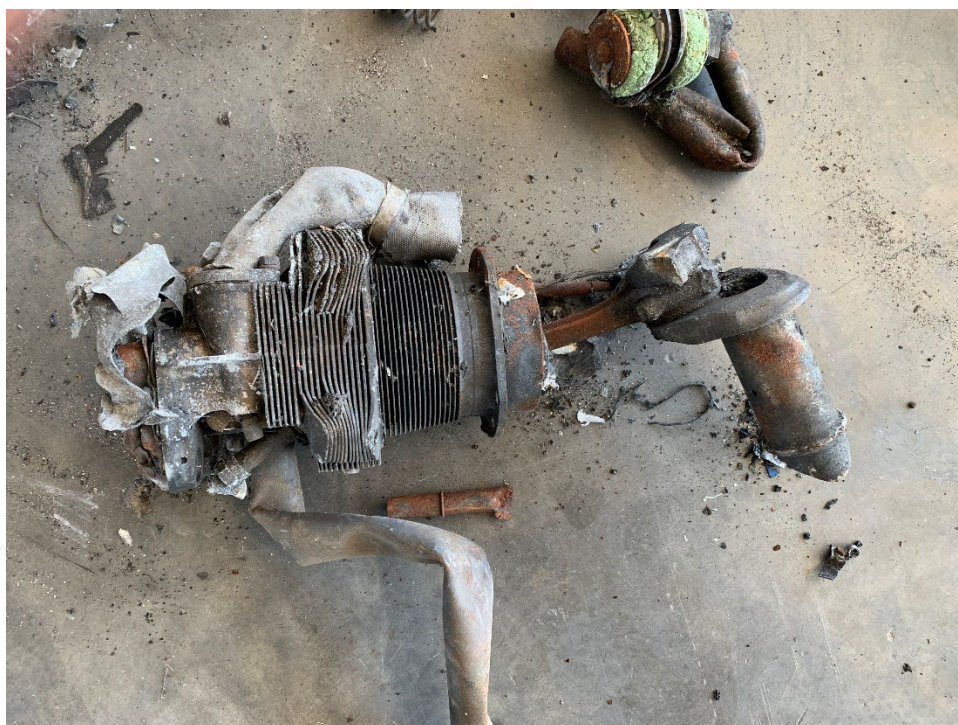
Figure 14: Number 6 Cylinder Assembly and Portion of Crankshaft

- The front of the engine case, camshaft, crankshaft, and the #6 cylinder assembly were fracture separated, exposing the core of the engine.
  - All fracture surfaces were consistent with overload.

- The crankshaft was fractured at the #6 journal.
    - The cylinder #6 assembly was found loose within the wreckage:
      - The piston arm remained attached to the crankshaft and piston.

- The piston was seized within the cylinder.
      - The push rods were fracture separated.
- The push rod and rocker arm for the intake valve on the #5 cylinder were fracture separated from the cylinder.

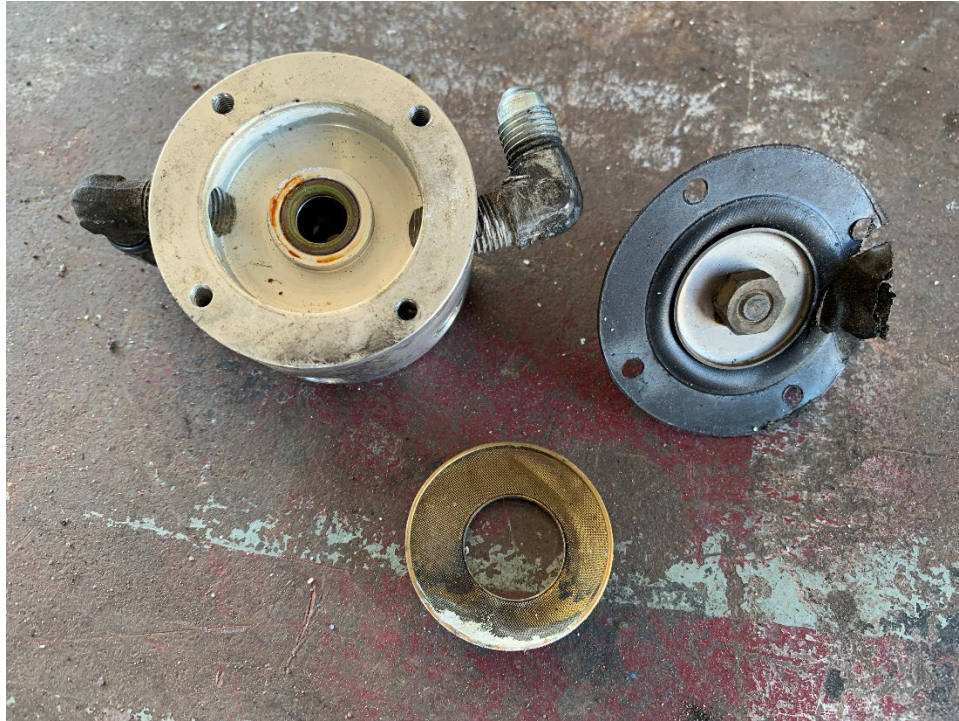
Figure 15: Fuel Manifold Valve

- The butterfly valve was intact and seized in the mostly closed position. It was unable to be manipulated.
- The fuel manifold valve remained attached to its mount, but its mount was fractured from the engine case.

- All lines remained attached at the fuel manifold valve.
    - They were removed at the manifold valve and all ports were clear of debris.
    - The lines sustained some thermal damage.

- The fuel manifold valve was disassembled.
    - The manifold valve cover was partially damaged exposing a portion of the rubber plunger.
      - This portion of the plunger was dry, stiff, and cracking.

- The plunger was somewhat stiff but otherwise malleable.
    - The screen was clear of debris. A small area exhibited some corrosion.
    - When the screen was removed, a small portion of rust was noted on the lower housing.

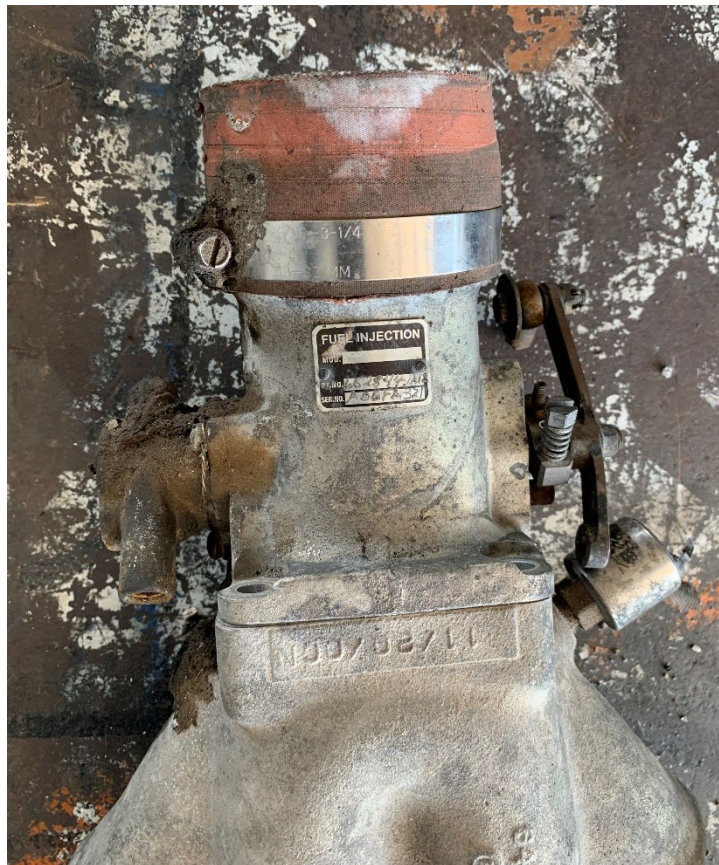
Figure 16: Fuel Control Unit

- The fuel control unit was removed.
  - The throttle arm was intact, and it moved freely without binding. However, no corresponding motion was observed on the butterfly valve.

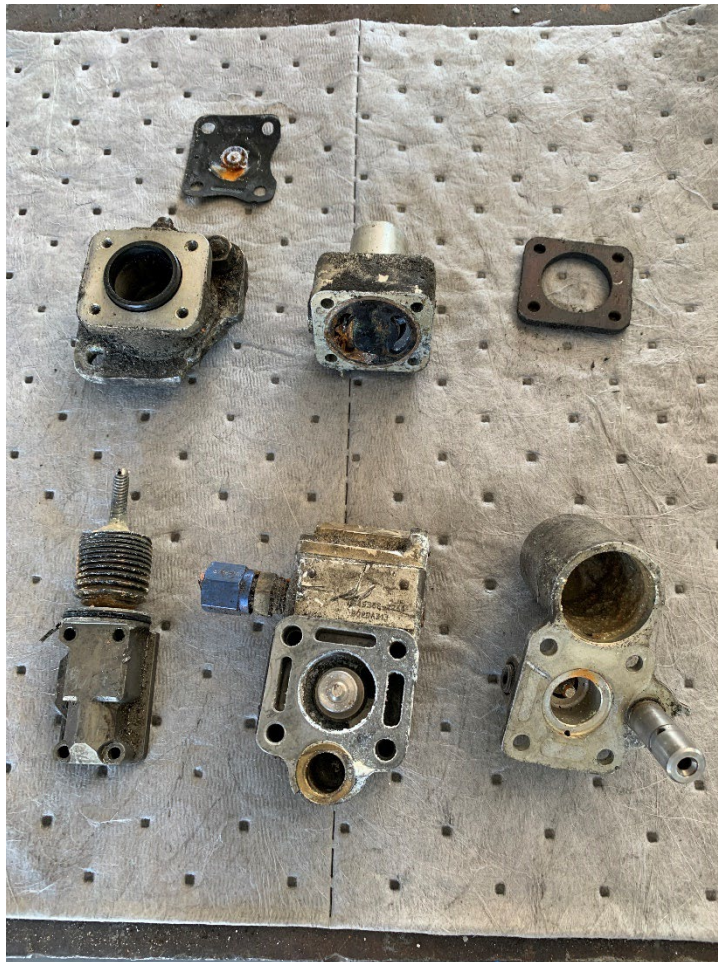
Figure 17: Fuel Pump

- The upper spark plug for cylinder #6 exhibited yellowy liquid corrosion and organic debris.
- The fuel pump was fracture separated from the engine and found loose within the wreckage. It sustained thermal damage.

- The mixture arm was bent and unable to be manipulated.
    - The mixture arm was disassembled, and the grooves remained intact.
  - The fuel pump drive remained intact.

- The fuel pump was disassembled. Yellowy liquid corrosion was noted consistent with firefighting efforts. Otherwise, no anomalies were noted with the internal components.

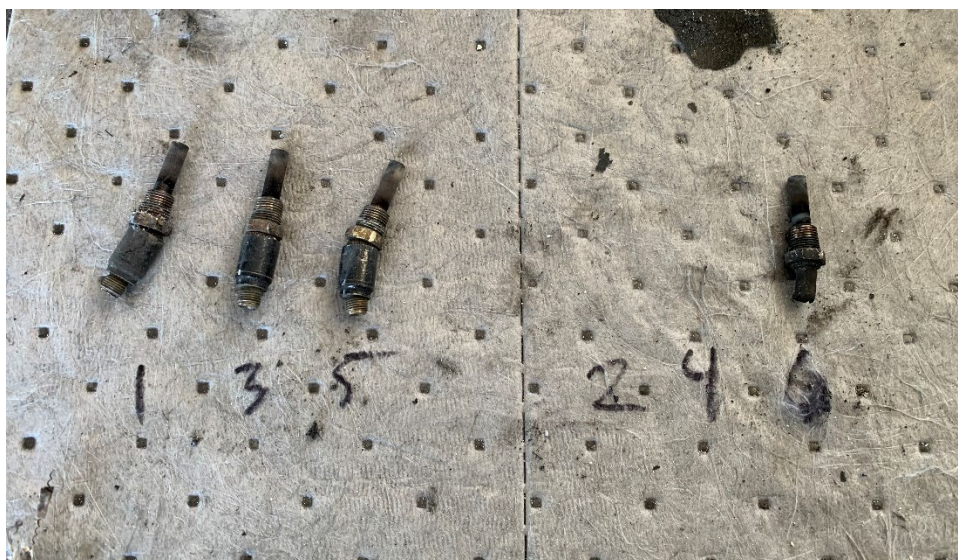
Figure 18: Fuel Nozzles

- The fuel nozzles for cylinders: 1, 3, 5, and 6 were removed and all were bent.
    - The fuel nozzle for cylinder #3 sustained a minor bend.
      - Light could be seen through it.

- The fuel nozzles for cylinders #1 and 5 were bent and unable to be seen through.
    - The fuel nozzle for cylinder #6 was mostly damaged and only the internal portion was present.

- Light could be seen through it.
    - The Fuel nozzles from cylinders #2 and 4 were unable to be removed.

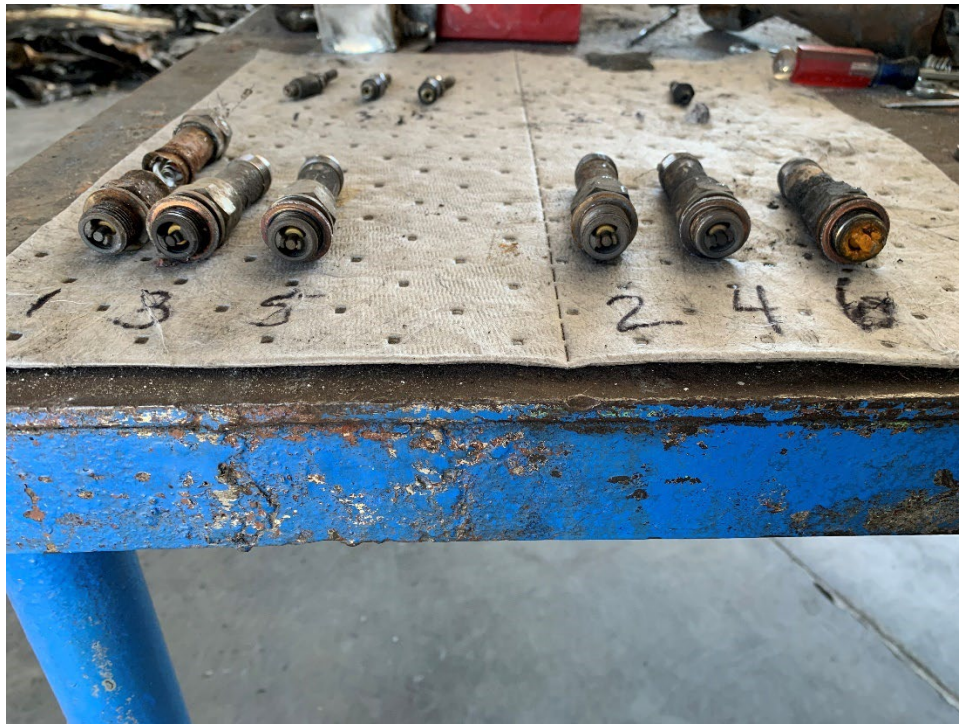
Figure 19: Upper Spark Plugs

- All upper spark plugs were removed and were consistent with normal operations.
  - The upper spark plug for cylinder #1 was fractured in half; the lower portion remained secured in the cylinder.

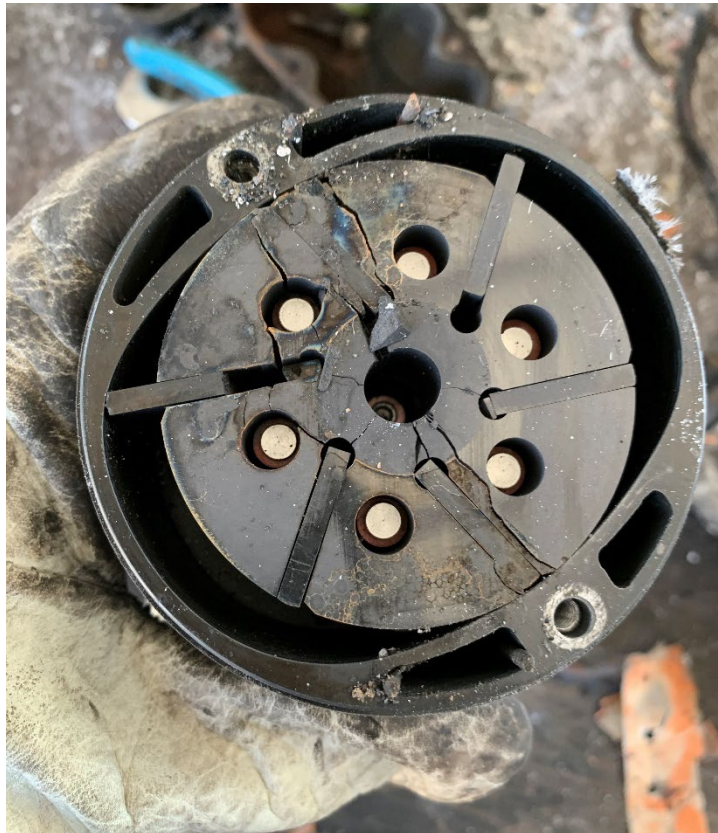
Figure 20: Vacuum Pump

- The filter was exposed and unable to be removed from the housing
    - Organic debris and rust was noted in the filter.
- The vacuum pump was found loose within the wreckage. It was thermally damaged.

- The pump was disassembled. The veins and internal components were cracked consistent with impact.
- The propeller governor was fracture separated from the engine and sustained extensive thermal damage.

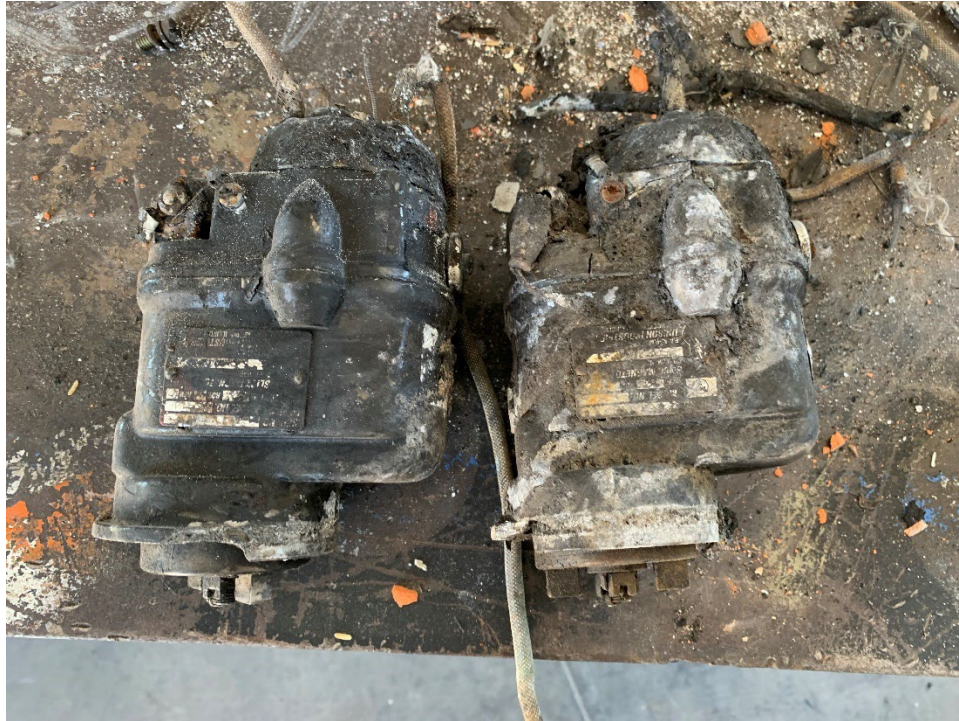
Figure 21: Both Magnetos

- The magnetos were found fracture separated from their mounting pads and found loose between the firewall and accessory section of the engine.
  - They exhibited extensive thermal damage.

- One magneto was able to be rotated.
    - The distributor cap was removed, and the harness points sustained thermal damage.
    - The magneto was disassembled further; the internal components were intact, and the gear and point operated when manipulated.

- The second magneto was only able to be rotated about ¼ turn. Given the damage, the distributor cap was unable to be removed, and therefore unable to be disassembled further.

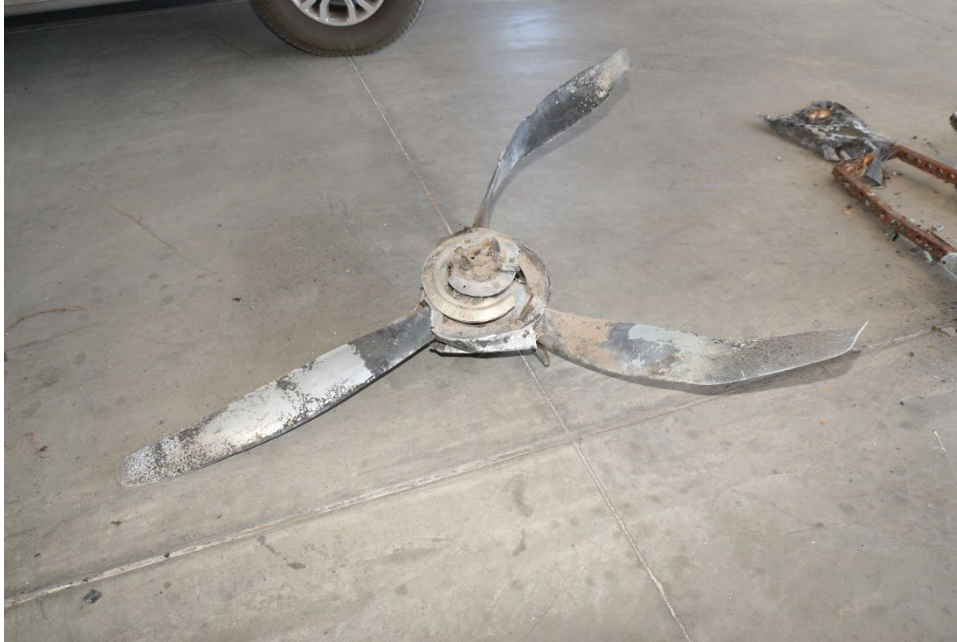
**Figure 23: Propeller Assembly**

- The internal components sustained extensive thermal damage.
- The propeller hub fracture separated from the crankshaft. All three propeller blades remained secured at the hub and sustained thermal damage.

- The crankshaft fracture was consistent with overload.
  - The spinner remained attached and was crushed aft over the hub itself.
  - One propeller blade was mostly straight and bent slightly forward. The Chamber side of the blade was facing the opposite direction of rotation.

- This blade was unable to rotate within the hub.
  - A second blade was bent aft, and the outboard portion was twisted. Chordwise scratching was noted on the chamber side of the blade.

- This blade was able to rotate within the hub.
  - The third blade was bent aft about midspan.
