# **National Transportation Safety Board**

## **Performance Study**

### **Specialist Report**

Location: Valley Center, California  
Date: May 31, 2020  
Time: 17:57 Pacific daylight time (PDT)  
Airplane: Cub Crafters CCK-1865, N303KP  
NTSB Number: WPR20LA157

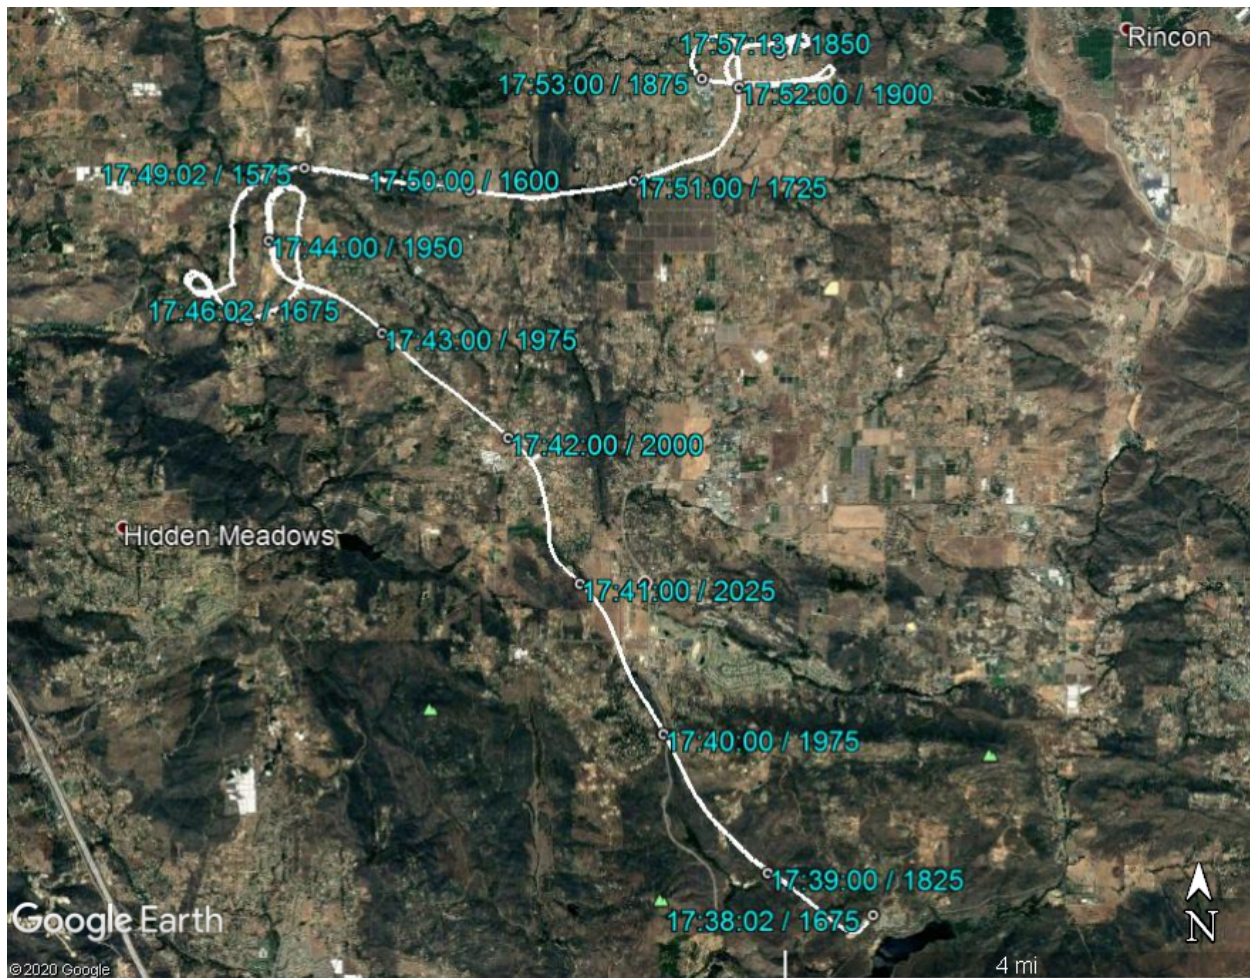
The aircraft took off at 17:38 from an airfield near Lake Wohlford, California. The airplane flew for just under 20 minutes before the flight ended north of Valley Center, California. Weather in the area at the time of the accident was winds from the west at 6 kts, 29.54 inHg, 66°F and a dew point of 57°F. Figure 1 shows the full flight with take off at the bottom of the figure and the end of flight at the top.

**Figure 1.** Accident flight in blue with select times and altitudes (msl) annotated in blue.

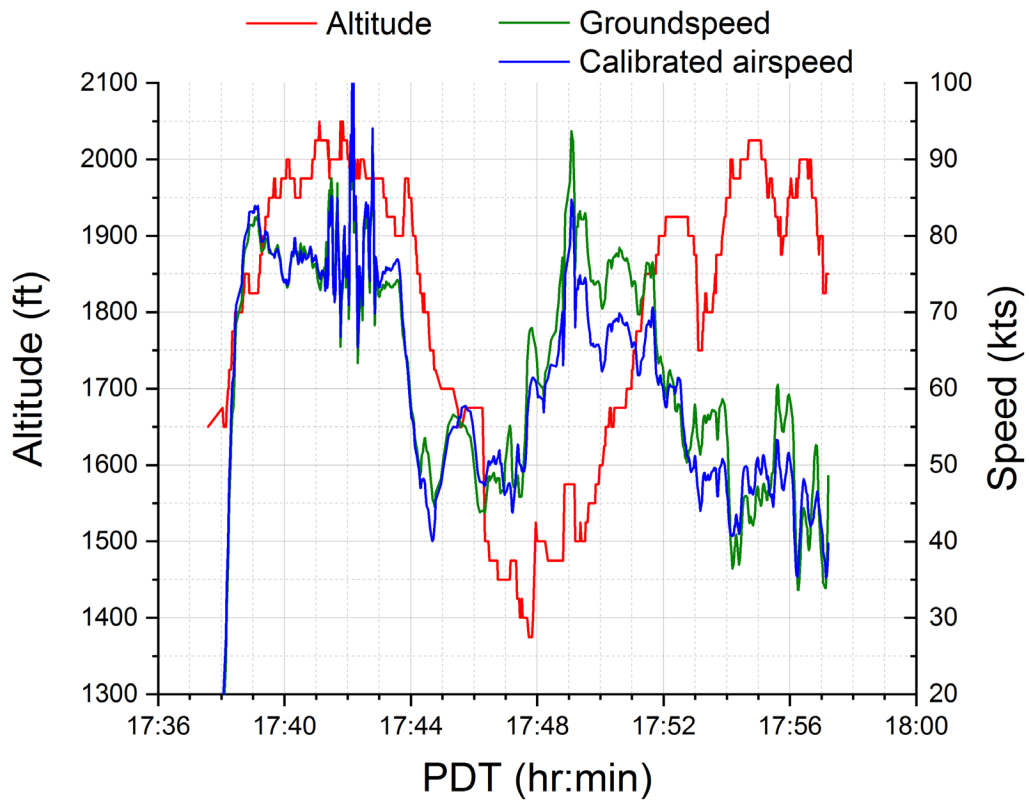
The airplane's altitude varied between 1,400 and 2,050 ft mean sea level (msl) (Figure 2), but its height above ground was initially between 450 ft and 800 ft before descending to 150 ft to 450 ft above the ground during the second half of the flight (Figure 3). Speed varied between 40 and 100 kts, slowing during maneuvering flight.

**Figure 2.** Altitude (msl) and calculated ground and airspeed.

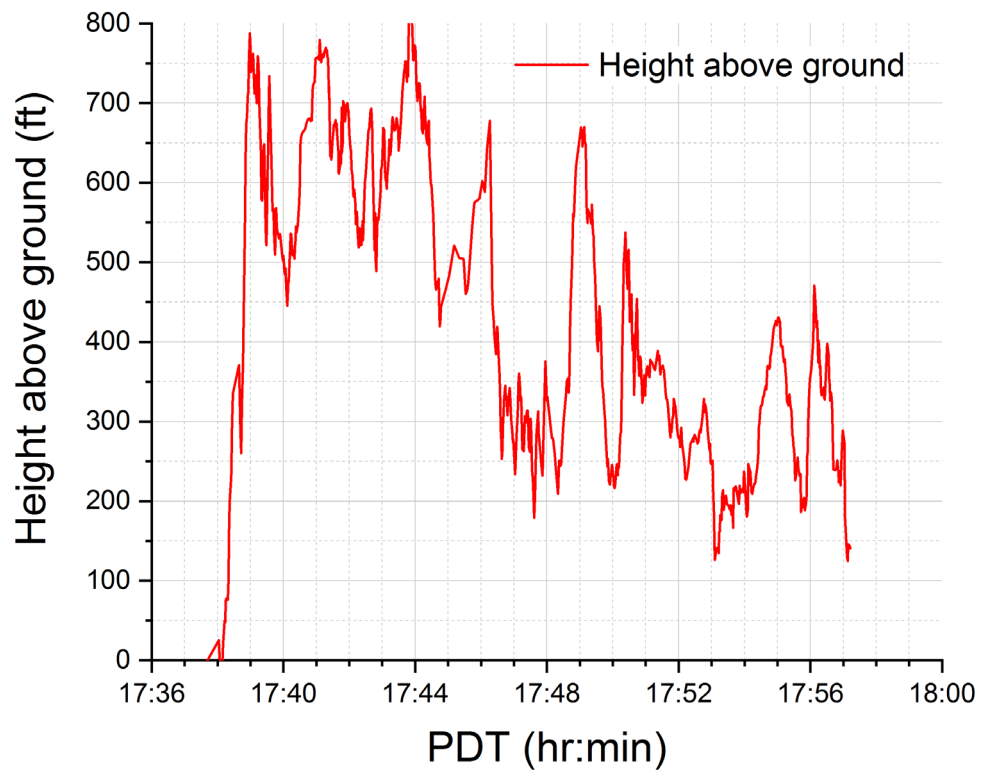
**Figure 3.** Height above ground.

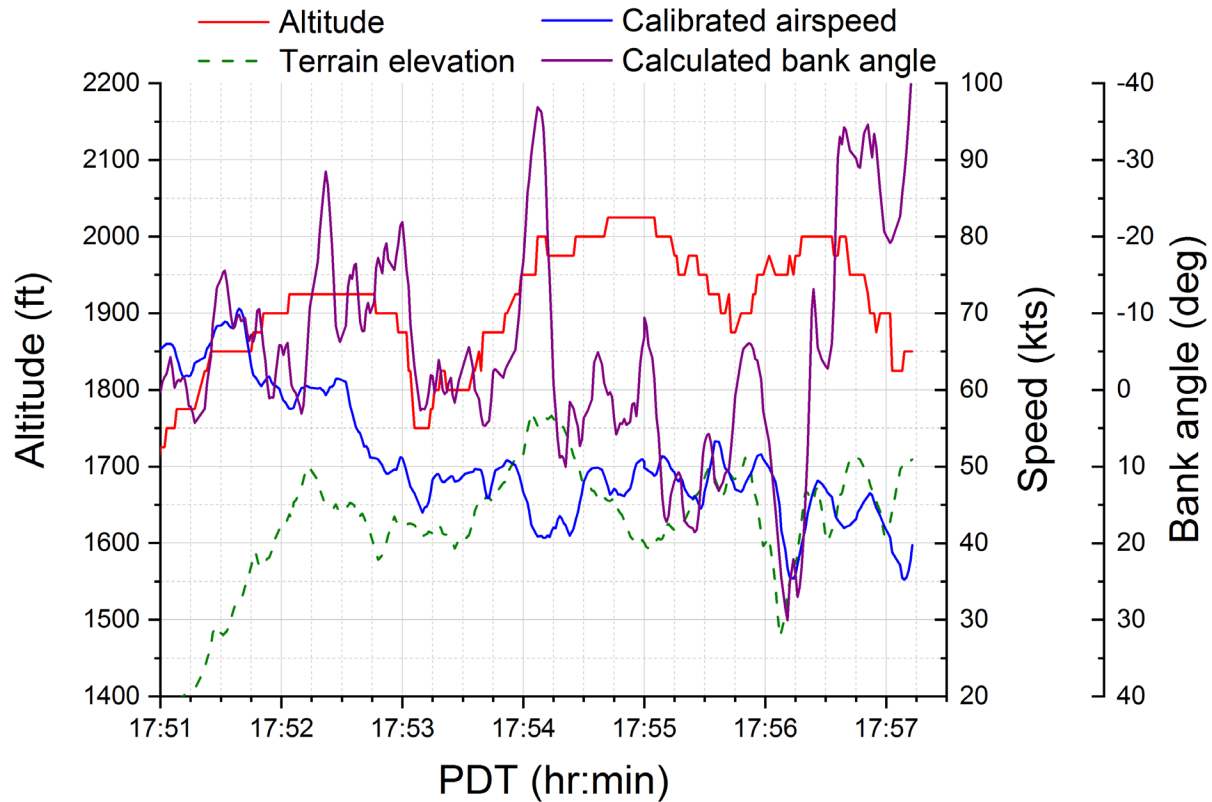
At 17:52 the airplane entered the area near the final wreckage location and began to circle over it. Airspeed, altitude, and calculated bank angle are shown in Figure 4. The calculated calibrated airspeed slowed to between 40 and 50 kts as the airplane executed a number of left and right turns. The airplane's height above the terrain varied between 100 ft and 300 ft.

**Figure 4.** Altitude (msl), terrain elevation, airspeed, and bank angle.

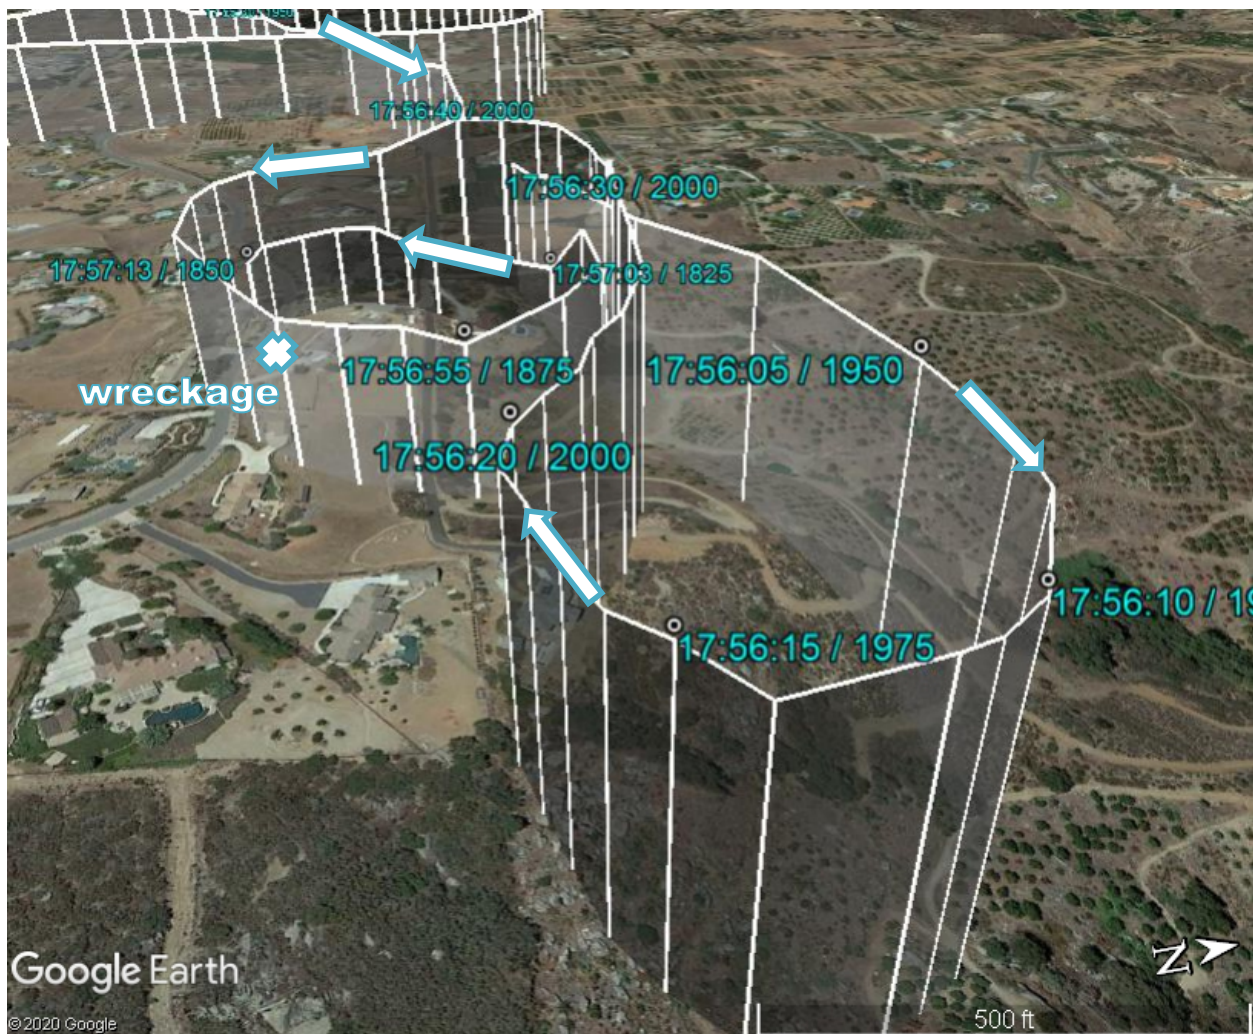
Figure 5 shows the flight path from 17:56 through the end of flight. The airplane executed a 180° right turn starting at 17:56. It climbed 100 ft while the calibrated airspeed dropped to near 35 kts. By 17:56:30 the airspeed was above 45 kts and the airplane began a left turn. By 17:57 the airplane had completed a full 360° turn and was continuing to turn and descend. The bank angle was greater than 40° left wing down. 17:57:13 was the last recorded data point.

**Figure 5.** End of flight path. Arrows show direction and wreckage location is marked with an x.

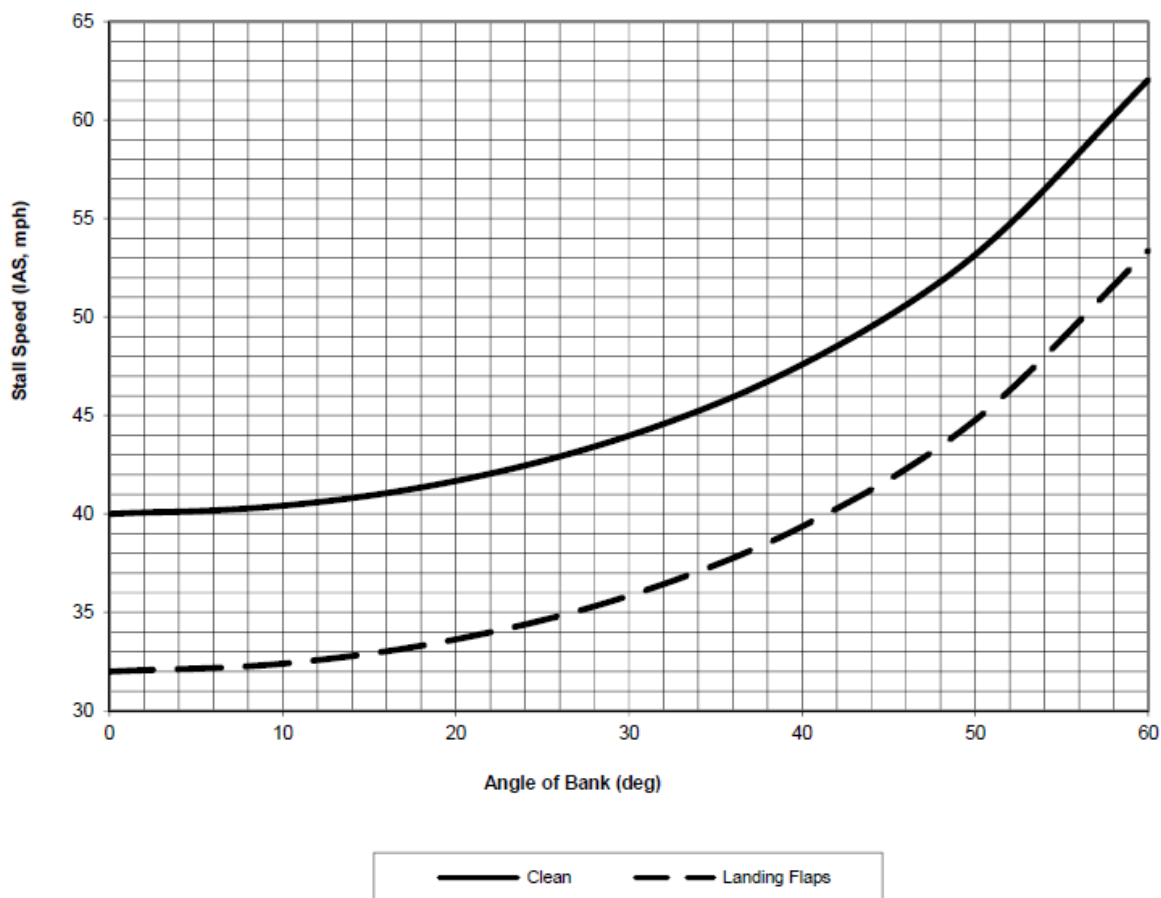
Cub Crafters provided estimated power-off stall speed versus bank angle information shown in Figure 6. Stall speed is shown in indicated airspeed (IAS) and is an estimate, as the airplanes are amateur-built and the pitot static system may not have been installed in the standard configuration. Also provided was an estimate of power-off stall speeds at two weights in calibrated airspeed, which was 7 kts higher than the IAS estimates. The airplane's wings-level, no flaps, power-off stall speed was reported as 40 mph, or 35 kts, indicated airspeed and 42 kts in calibrated airspeed. During the final minutes of the flight, the airplane's calibrated airspeed was between 40 and 50 kts while circling.

**Figure 6.** Power-off stall speed in mph versus Angle of Bank in degrees.

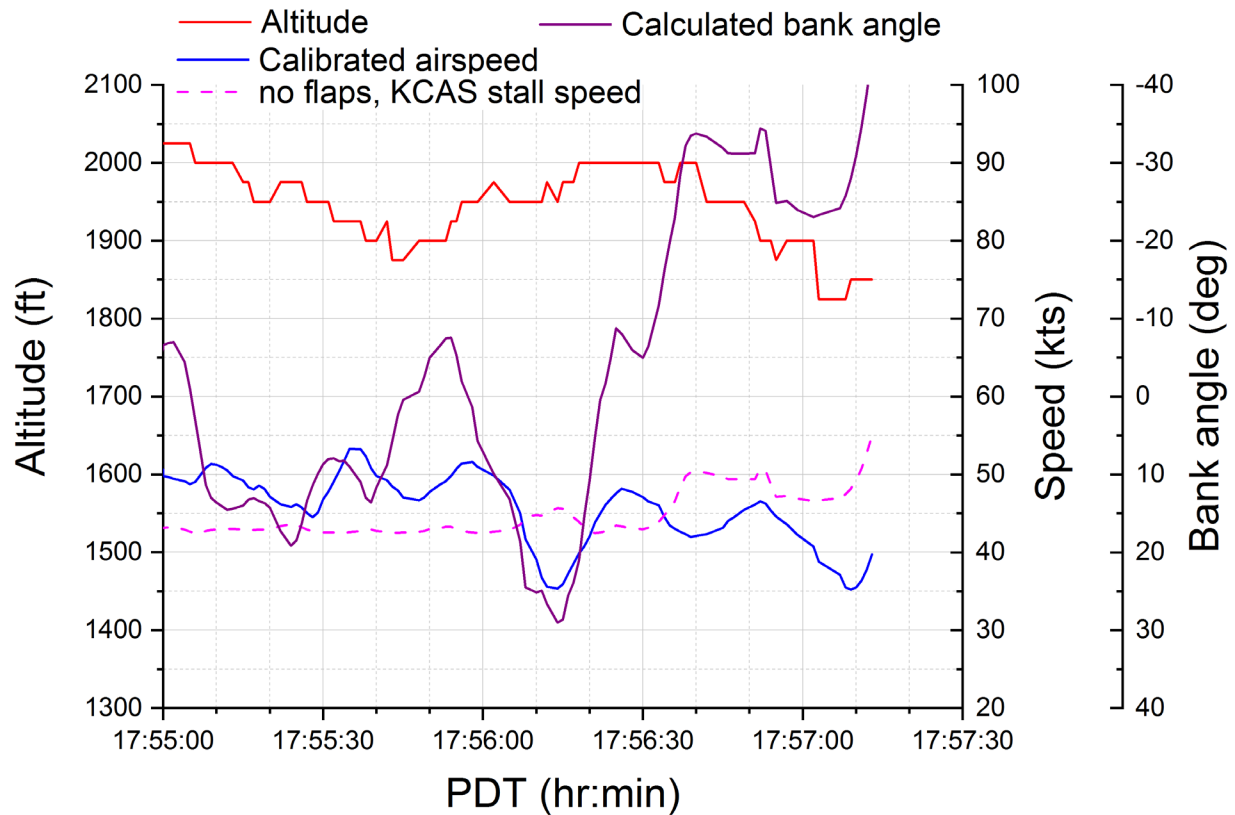
Using the relationship between bank angle and stall speed for the clean, no flaps configuration, Figure 7 shows the calculated stall speed including the effects of the bank angle for the end of flight. If the airplane was under power, it would have another few knots of stall margin compared to the reported power-off stall speeds. This would explain how the airplane's speed was able to drop below the predicted stall speed before the end of flight. However, after 17:57, the turn tightened, increasing the airplane's bank angle, and the stall speed continued to rise as the airplane's speed continued to drop. The airplane at this point was less than 200 ft above the terrain. It impacted the ground shortly after.

**Figure 7.** Altitude (msl), calibrated airspeed, and bank angle compared to power-off stall speed.

During the first portion of the 20-minute accident flight, the airplane was between 450 ft and 800 ft above the terrain. Speed varied between 40 and 100 kts, slowing during maneuvering flight. Near the accident location, the airplane descended and its height above the terrain varied between 100 ft and 300 ft. The airplane slowed to between 40 and 50 kts and executed several left and right turns. During the final turn, the airplane's airspeed dropped below the published banking stall speed shortly before impacting the terrain.
