# **NATIONAL TRANSPORTATION SAFETY BOARD**

## **Video Study**

**NTSB Case Number:  
WPR20LA157**

Location: Valley Center, California  
Date: May 31, 2020  
Time: 1757 PDT  
Aircraft: Cub Crafters CCK-1865

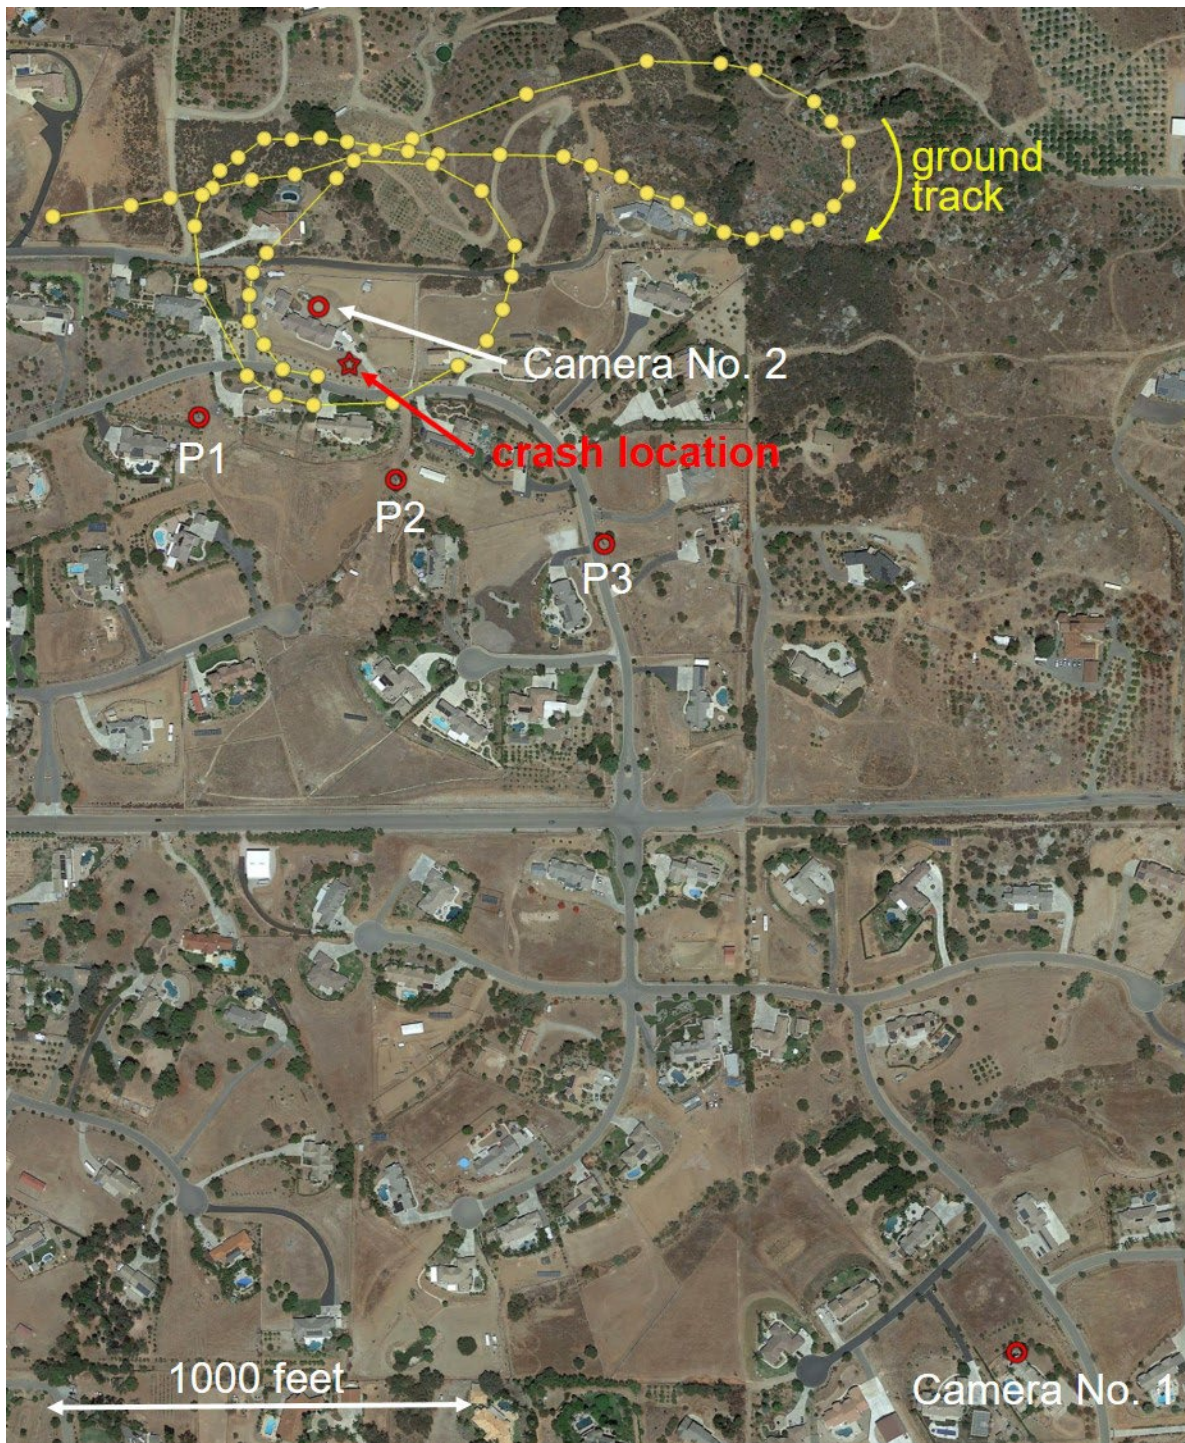
**Figure 1. Aerial Image of the Accident Area**

The goal of this investigation was estimating the airplane speed, orientation angles and engine speed based on videos recorded by viewers on the ground. Two videos were used in the analysis. The locations of the two cameras are shown in Figure 1 that displays an aerial view of the accident area. The figure also shows the crash location and the ground track of the airplane during the last 84 seconds before ground impact. The ground track in Figure 1 was based on available ADS-B data.

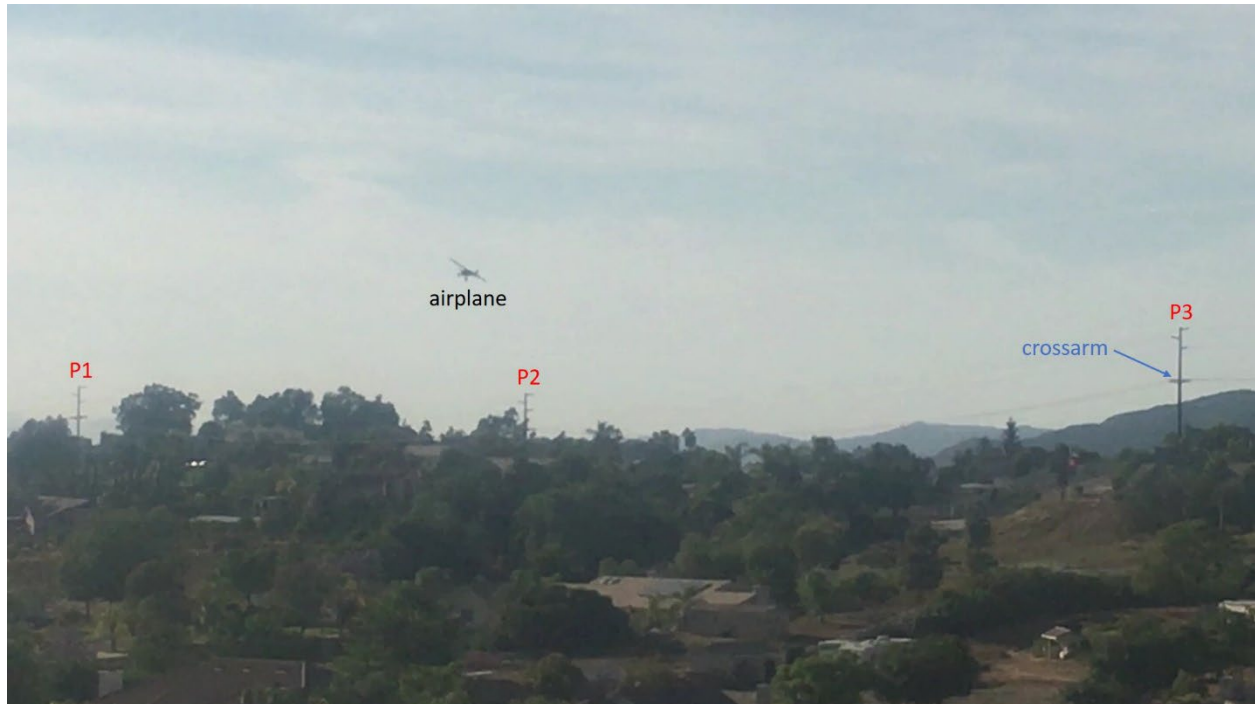
**Figure 2. Frame from Camera No. 1 Video**

The estimation was based on references that were visible both in aerial images such as Figure 1 and in video frames such as the one in Figure 2. The primary references used for calibration were the three power line poles, P1, P2 and P3, that are marked in Figure 1 and in Figure 2. Using Google Earth aerial images and Street View, the accurate locations of the three poles and the elevations of their crossarm members could be estimated. This made it possible to estimate accurately the camera HFOV, yaw, pitch and roll angles. The buildings seen in Figures 1 and 2 were used as secondary calibration references.

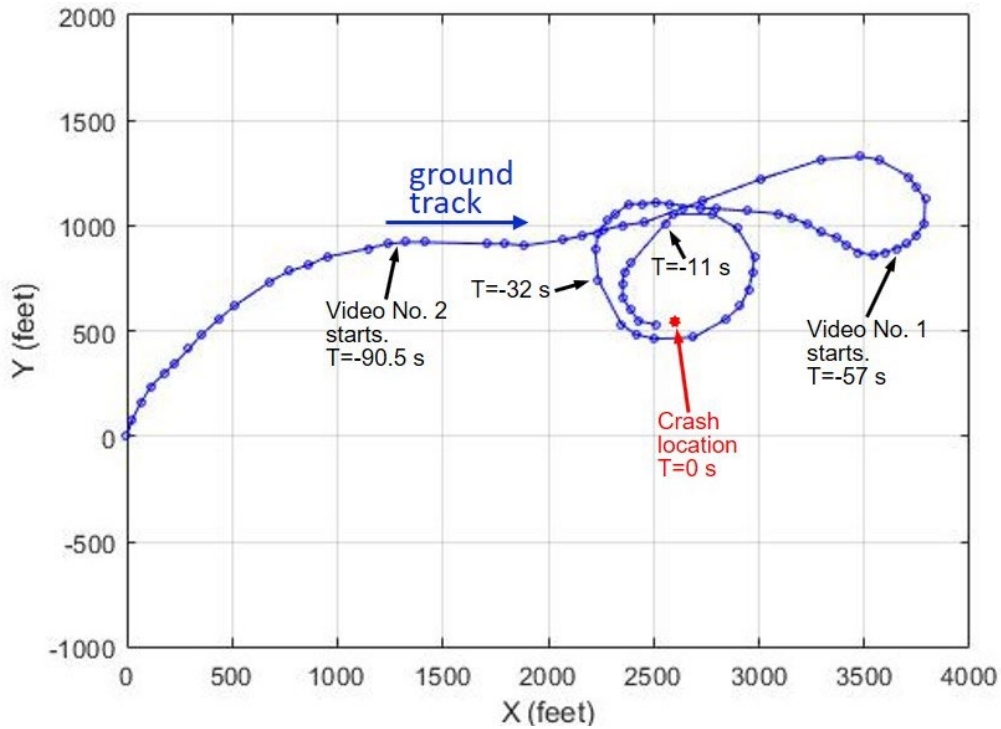
**Figure 3. Geometry and Timing Used in the Analysis**

Figure 3 illustrates the geometry and timing used in the analysis. The ADS-B data and the two videos were not time-synchronized. To synchronize them, analysis time was set to zero seconds at time of ground impact. The ADS-B data was sampled at one data point per second. The locations of the airplane at these times are marked by the blue circles in Figure 3. Data was occasionally missed for one, two or three seconds as evident in the occasional wider gaps between the markers. It was assumed that the airplane impacted the ground one second after the last ADS-B data point. The coordinates in Figure 3 were set to (0,0) at the first shown ADS-B location.

Since the ground impact times in the two analyzed videos were 57 seconds and 90.5 seconds, the starting times of these videos were at -57 seconds and -90.5 seconds, respectively. The locations of the airplane at these times are marked in Figure 3. Airplane locations and orientation angles were estimated at ten times corresponding to ten Video No. 1 frames. The first analyzed frame was recorded at time  $T = -11$  seconds. The location of the airplane at that time, based on ADS-B data, is marked in Figure 3. The last frame was recorded at time -2.67 seconds. The pitch angle of the airplane at that time was about  $-90^\circ$ .

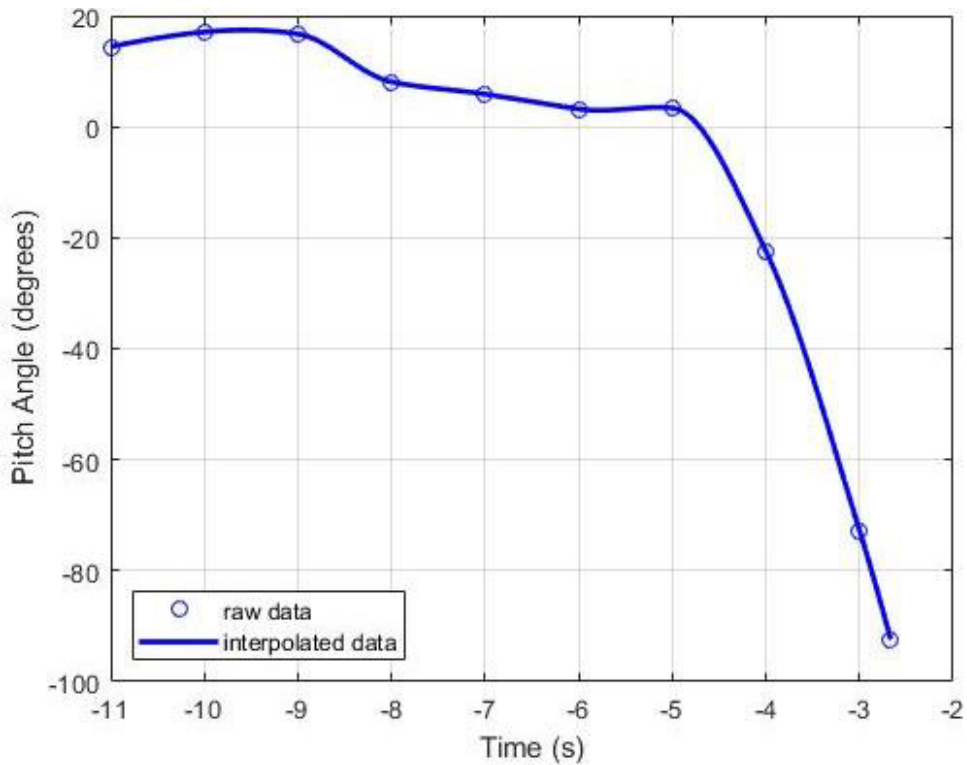
**Figure 4. Estimated Pitch Angle of the Airplane**

Figure 4 shows the estimated pitch angle during the analyzed time period. As can be seen in the figure, during the first six seconds, the pitch orientation did not indicate that a nose-down crash was imminent. Figure 5 shows the estimated airplane roll angle and Figure 6 shows the estimated airplane yaw angle.

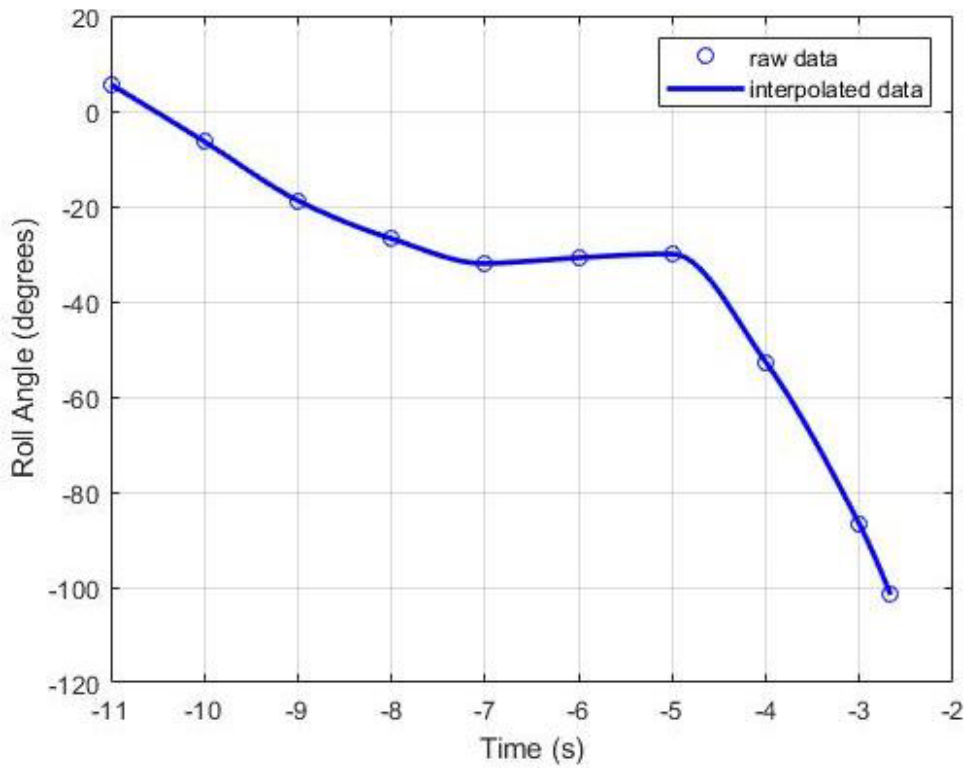
**Figure 5. Estimated Roll Angle of the Airplane**

The negative roll angle in Figure 5 indicates that the airplane was in a left turn during the analyzed time, as can be seen in the ADS-B ground track in Figure 3. The relatively constant yaw angle curve slope between time -10 seconds and -5 seconds indicates that the airplane was in a constant-radius turn. Figure 7 was used to estimate the radius of the turn. A circular arc was fitted to this segment of the video-based ground track. An arc with a 160-foot radius provided the best fit. Therefore, during these 5 seconds, the estimated radius of the turn that the airplane was executing was 160 feet.

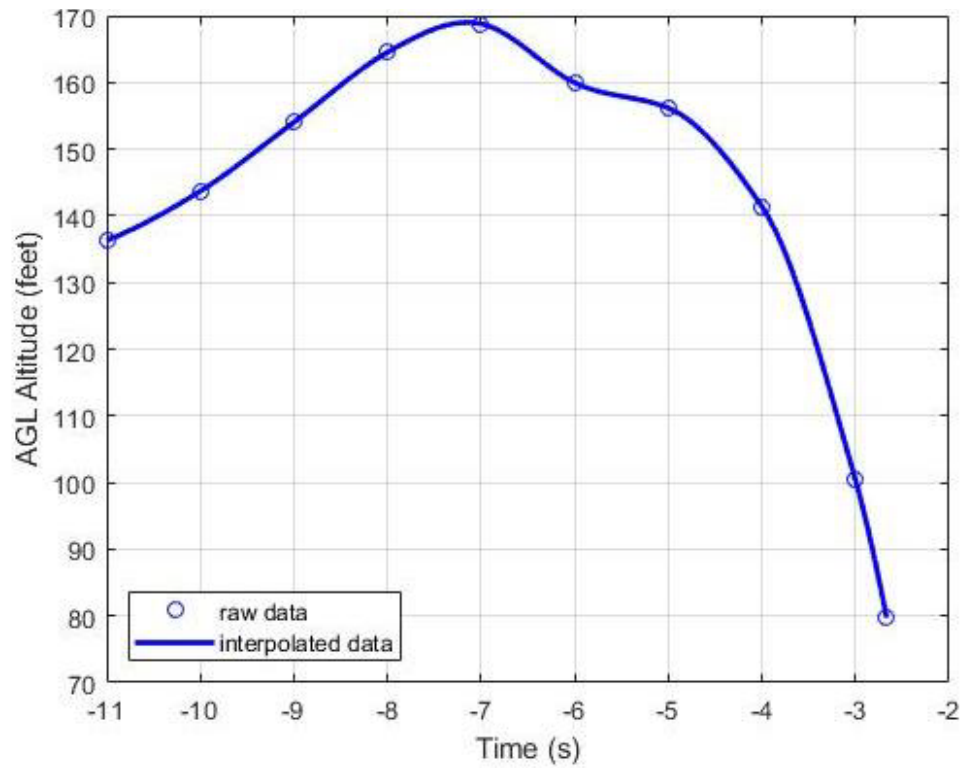
**Figure 8. Estimated AGL Altitude of the Airplane**

Figure 8 displays the estimated AGL altitude of the airplane. It shows that the descent toward ground impact started at about time -7 seconds. Figure 9 shows the total speed, defined as the vector sum of the ground speed and the descent rate, and it also shows the ground speed. Only after time -4 seconds, when the airplane was already rapidly descending toward ground impact, is the total speed significantly higher than the ground speed due to the vertical speed component.

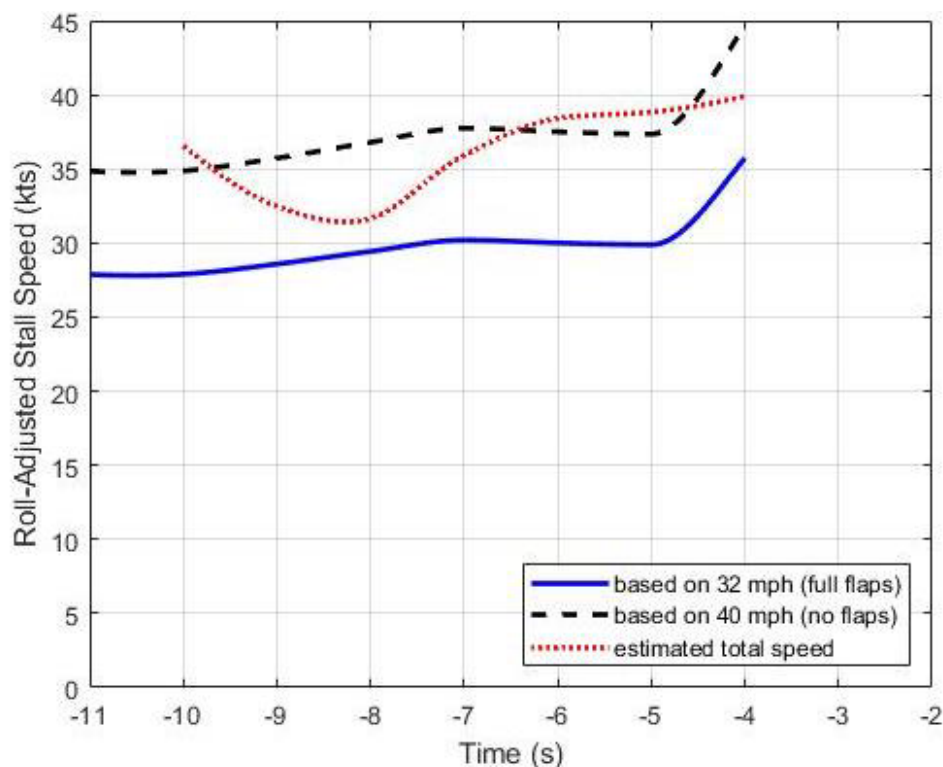
**Figure 10. Roll-Adjusted Stall Speeds**

In a level turn, the stall speed increases as the roll angle of an airplane increases. Figure 10 shows the roll-adjusted stall speed of the airplane. Two curves are shown, one for assumed full-flaps, zero-roll stall speed of 32 mph (27.8 kts) and the other for no-flaps, zero-roll stall speed of 40 mph (34.8 kts). Video No. 2 shows that the flaps were deflected during the last 11 seconds of flight that ended in ground impact. The deflection angle could not be accurately estimated, but full deflection, at the third notch setting, was unlikely. Therefore, the actual stall speed is believed to be in between the two curves in Figure 10.

The stall speed curves in Figure 10 are not shown past time -4 seconds because the airplane was already starting its nose-down descent toward ground at that time. The estimated total speed curve from Figure 9 is also shown in Figure 10. It shows that near time -8 seconds, the airplane speed could have dropped below the stall speed.

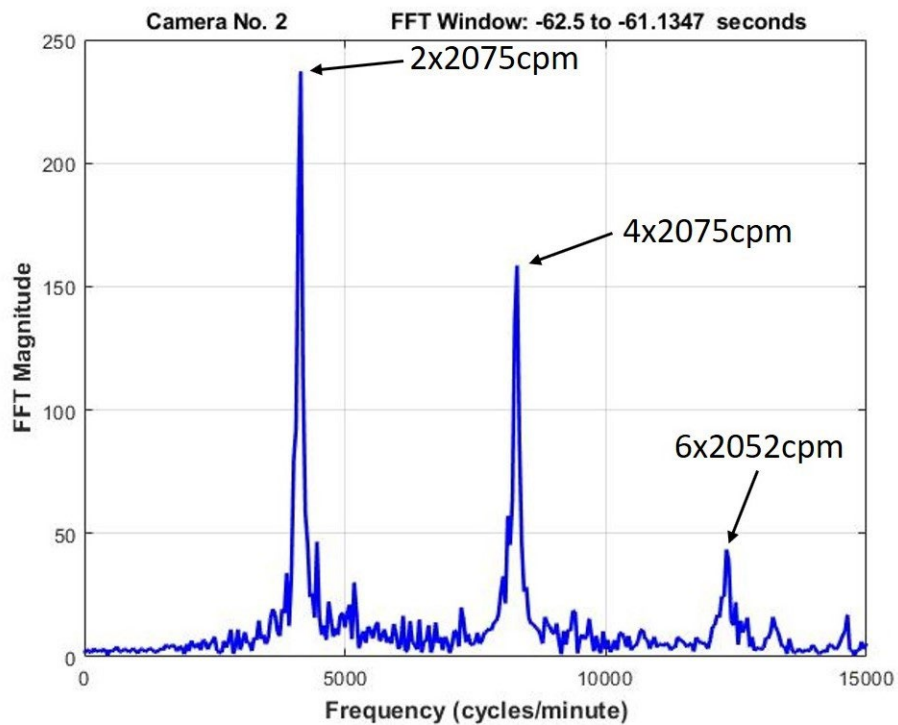
**Figure 11. Sound Spectrum at Time -62.5 seconds**

Figure 11 shows the sound spectrum in a time window starting at time -62.5 seconds. The highest spectral peak is at 4150 cycles/minute. It is either due to the blade passage frequency of the two-bladed propeller, or it is the second harmonic of the engine 2075 rpm speed, or a combination of both. Spectral peaks at the second and the third harmonic frequencies are also clearly visible.

The Cub Crafters specifies the continuous power speed of the CC340 engine as 2100 rpm at the altitude of 2000 feet MSL. The airplane was at about 1850 feet MSL, indicating that the engine was operating at the recommended speed. However, the engine speed remained near the recommended value for only about 11 seconds. Except for the last ten seconds before ground impact, the speed estimated based on the Camera No. 2 video was below 1800 rpm. Figure 12 shows the estimated engine speeds during the 90 seconds that Camera No. 2 was recording the sound.

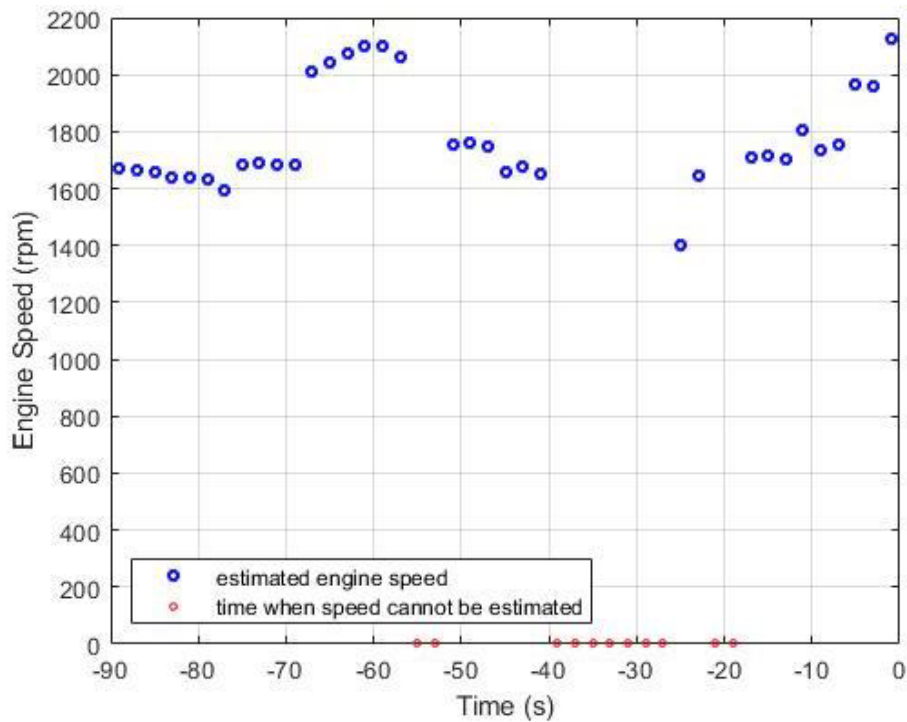
**Figure 12. Estimated Engine Speed**

The red markers in Figure 12 are at times when the speed could not be estimated because the sound intensity was low and there were no clearly identifiable spectral peaks. It is believed that at these times the engine speed was low, probably below 1600 rpm. The expected blade passage frequency if the engine speed was the recommended 2100 rpm was 4200 blades/minute. The frame rate of the video was 30 fps or  $30 \times 60 = 1800$

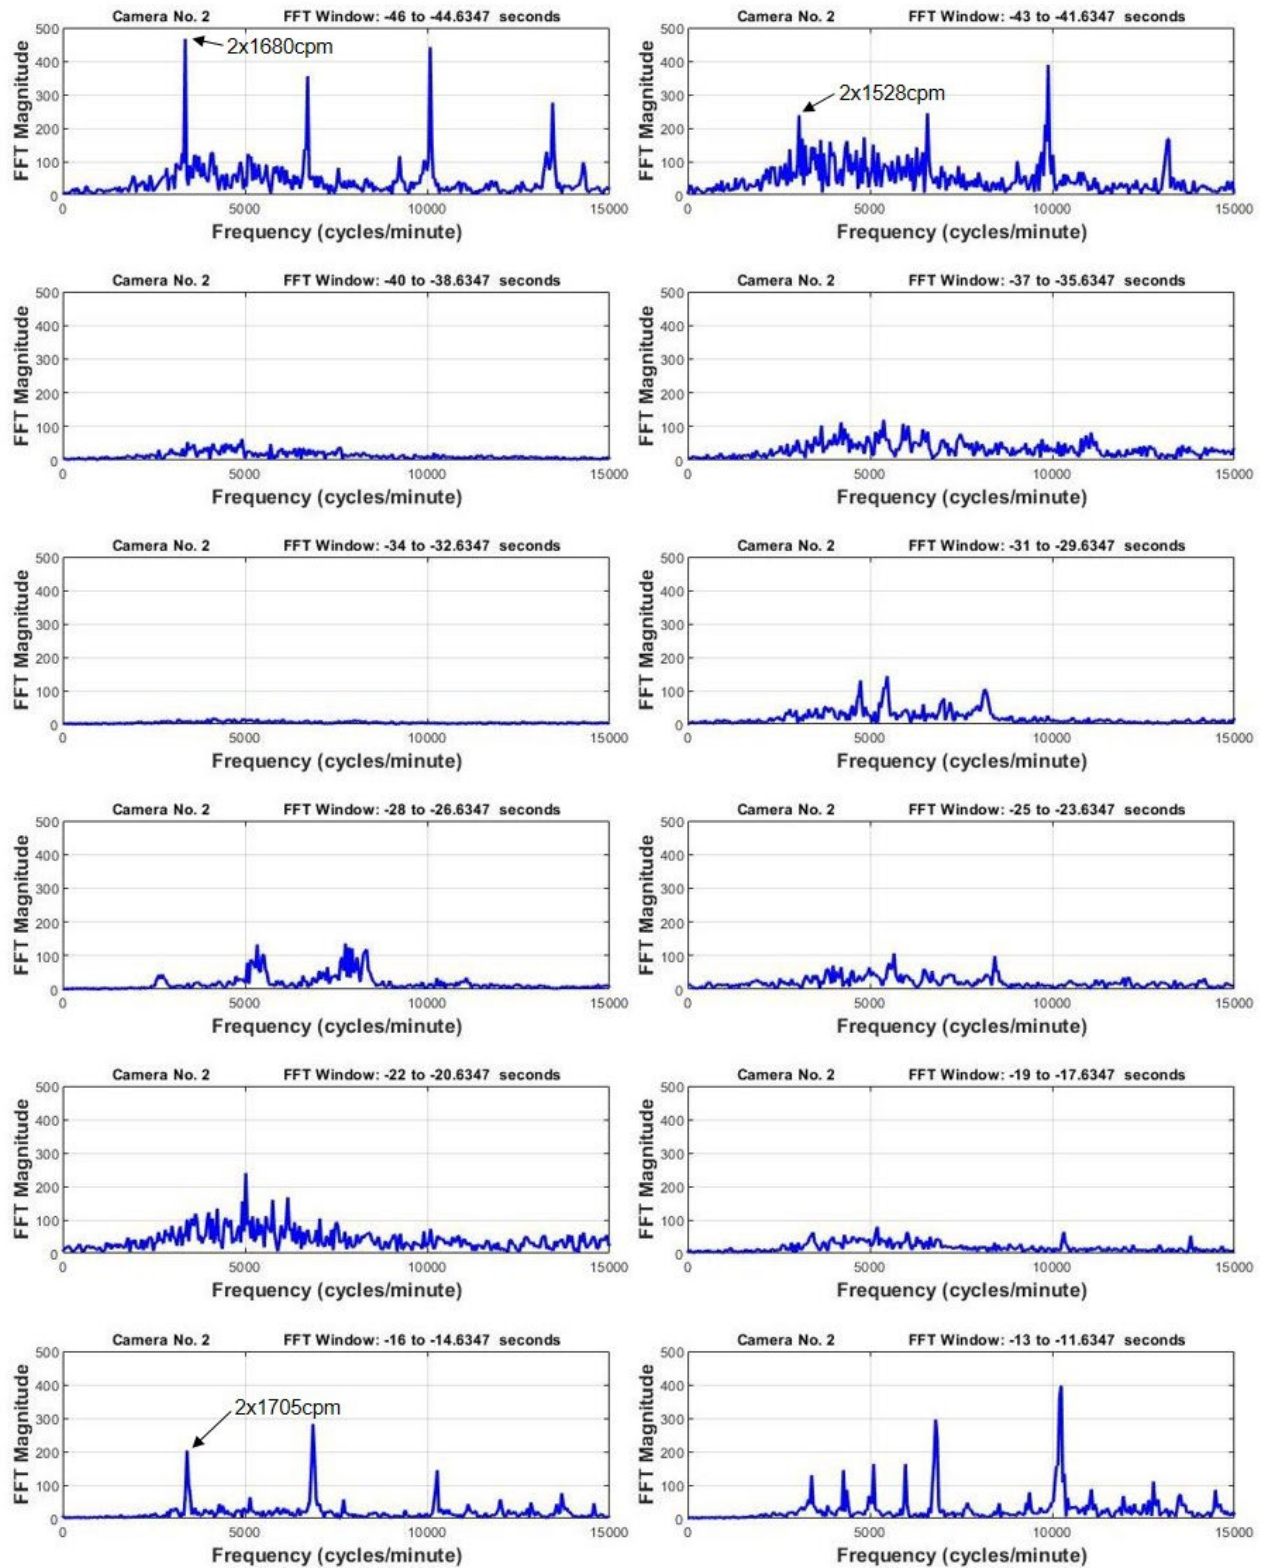
**Figure 13. Sound Spectra between Time -46 seconds and Time -11 seconds**

Since the video frame rate was 1800 frames/minute the video recorded the propeller twice per each engine revolution which made the two-bladed propeller look as if it was not rotating. Figure 13 shows twelve sound spectra computed in time windows that started at times separated by 3 seconds. The figure covers a period of about 35 seconds that includes the two times when the propeller appears to be not spinning in the video.

The spectrum for FFT period starting at time -43 seconds and the spectrum for FFT period starting at time -16 seconds look like the spectrum in Figure 11 but the peaks are at lower frequencies. In between these times, the FFT magnitudes are low and the peaks due to the engine speed and/or the blade passage are not as obvious as those in Figure 11. The spectrum for FFT period starting at time -34 seconds is the extreme case where the engine sound is almost inaudible. It is believed that the engine speed at that time was near 900 rpm.
