## **Summary**

All fractures appeared to be overload due to the accident sequence. Nothing was noted that would have precluded normal operation of the aircraft.

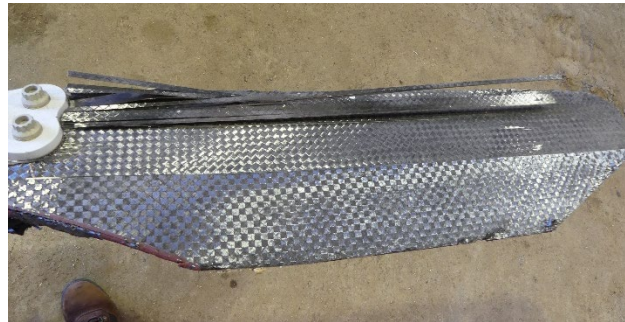
*Figure 1 Top of Red Main Rotor Blade*

**Red Blade:** The red blade was fractured about 36" from the grip. The outer skin separated from the carbon layup of the top surface of the blade (Figure 1). The white interior core separated from the lower surface of the blade (Figure 2). The trailing edge of the red blade was split down the length in a few locations with the interior core missing. The red PCL was fractured at the lower end connection.
