# National Transportation Safety Board

WPR20LA163

## **AIRFRAME AND ENGINE EXAMINATION**

Location: Fairfield, California  
Date: June 2, 2020  
Time: 1327 Pacific daylight time  
Helicopter: Bell 206L3; N65PJ

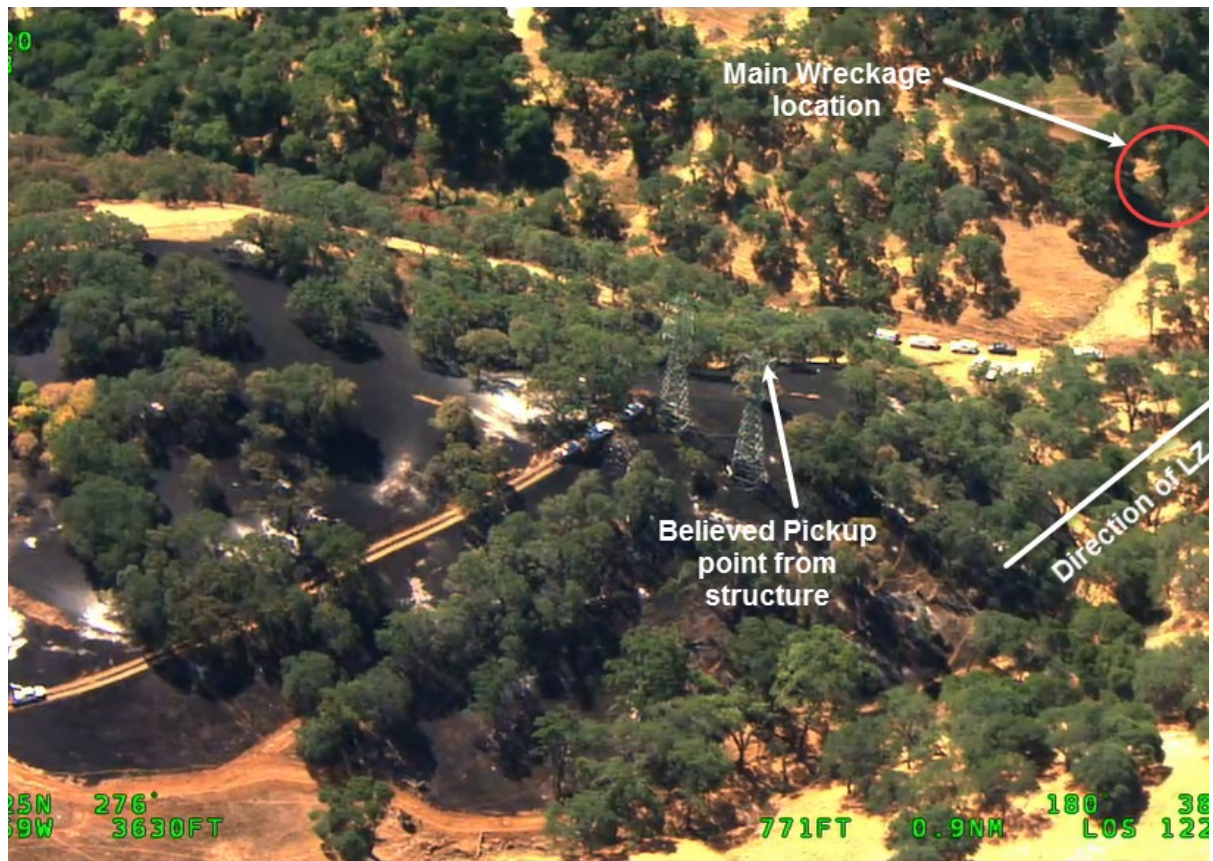
Photo 1 - Overview of Accident Site (Photo Courtesy of PGE)

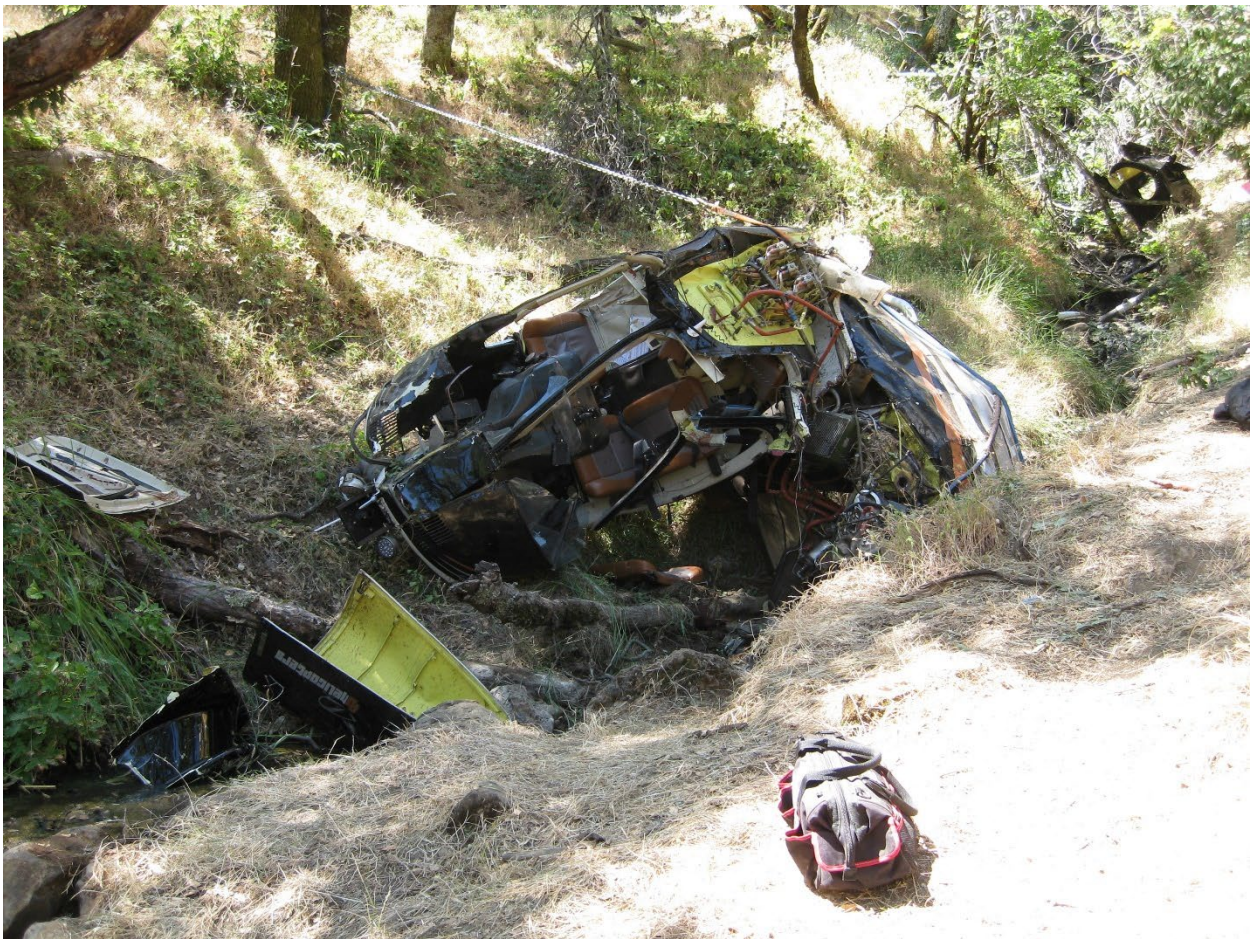
The helicopter and engine were examined at Plain Parts on May 11, 2021. Overall examination revealed no mechanical problems that would have precluded normal operation.

Photo 2 - Main Wreckage (FAA)

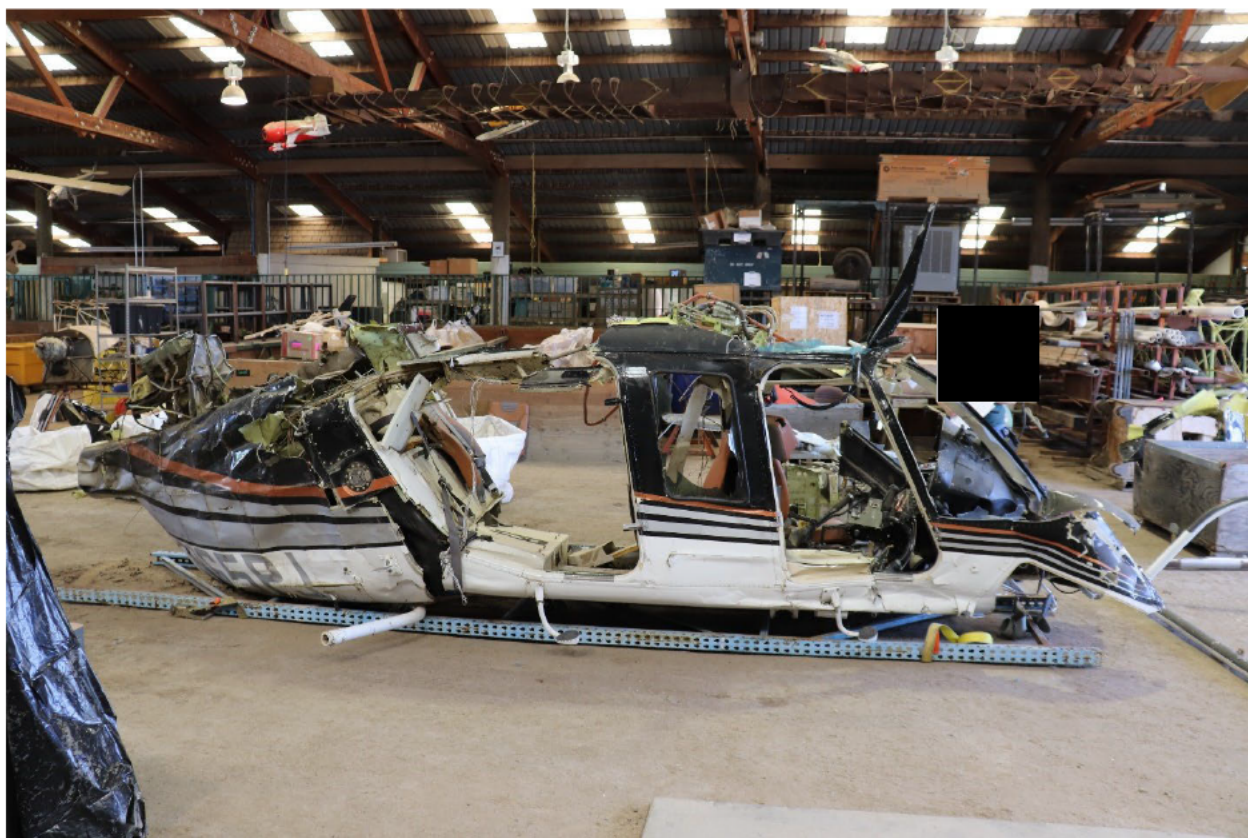
The fuselage sustained crush and deformation damage from the nose of the helicopter to the tail boom. The transmission and main rotor blades had separated at the upper deck and exposed the support bracket and flight controls (3 flight control servos (2 cyclic servos and 1 collective servo) as well as the hydraulic and manifold lines), the windshield/windows were broken because of the accident sequence. There was no evidence of main rotor blade contact with the fuselage.

Photo 3 - Layout of Wreckage (Photo Courtesy of NTSB)

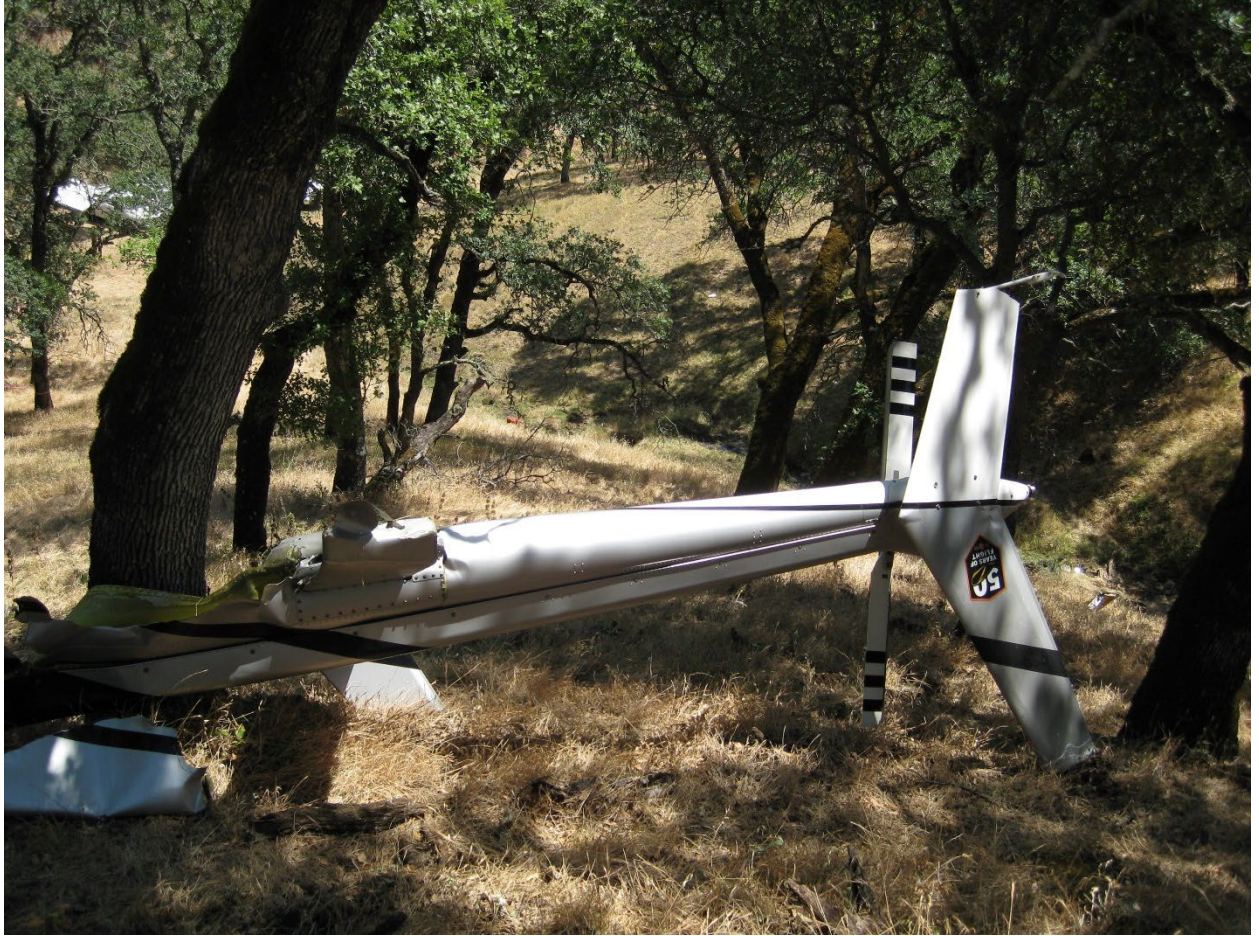
The tail boom separated from the fuselage and exposed the tail rotor drive shaft. Tail rotor shaft moved without restriction and continuity was established to the tail rotor blades and the hanger bearings remained connected. The tail rotor gear box chip detector was clean. The pitch change links remained connected, and the pitch change control tube remained intact but had a bend in it.

Photo 4 - Tail boom at Accident Site (FAA)

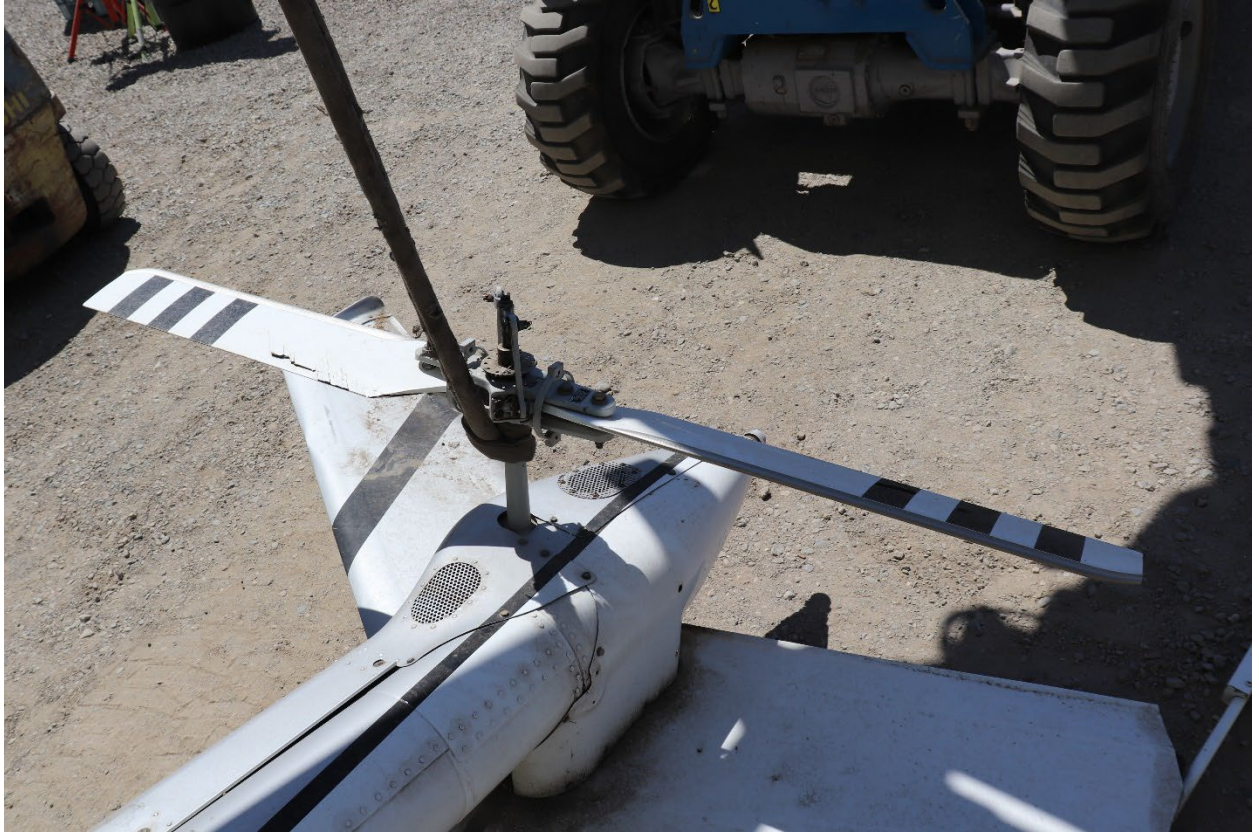
Photo 5 - Close up of Tail rotor (NTSB)

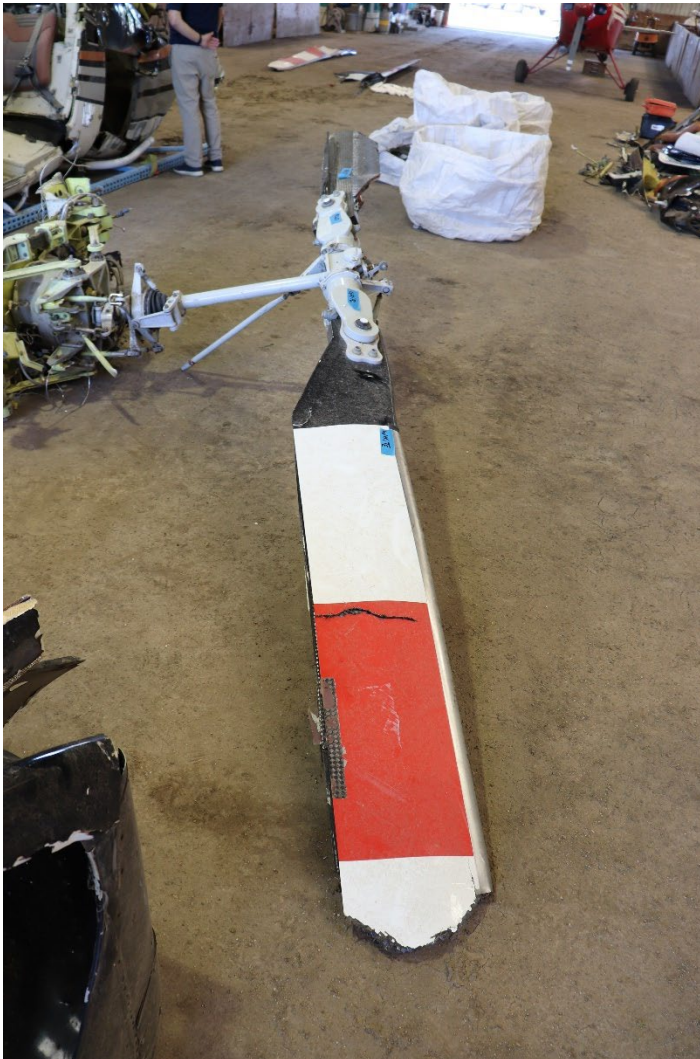
Photo 6 - Main Rotor Mast with Transmission (NTSB)

The main rotor blade assembly remained attached to the transmission, which separated from the fuselage. The helicopter had the composite Van Horn main rotor blades installed (part No. 20633000-101. Control continuity was established from the cockpit to the main rotor.

The K-flex shaft had fractured but remained connected on the transmission side.

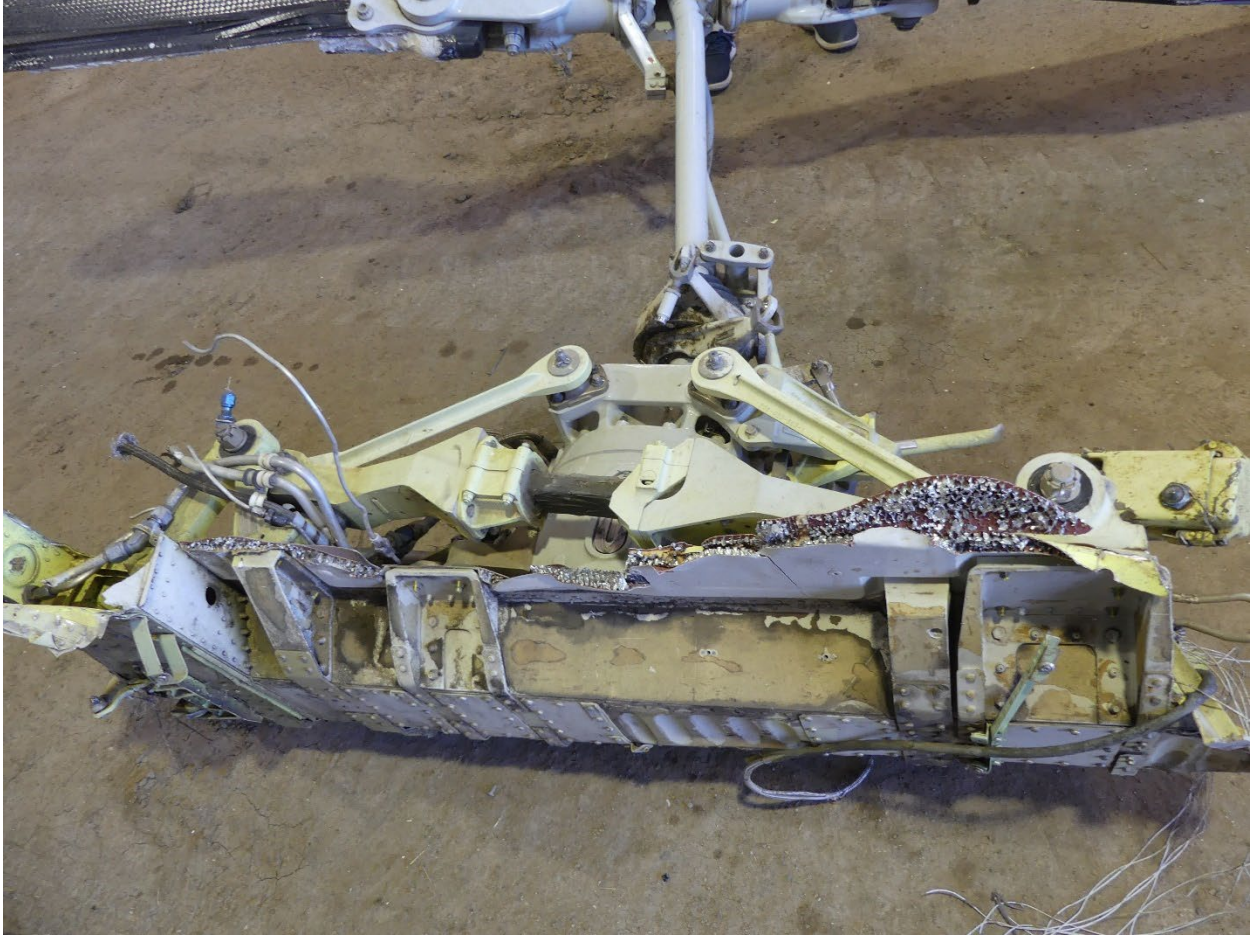
Photo 7 - View of Transmission (Bell)

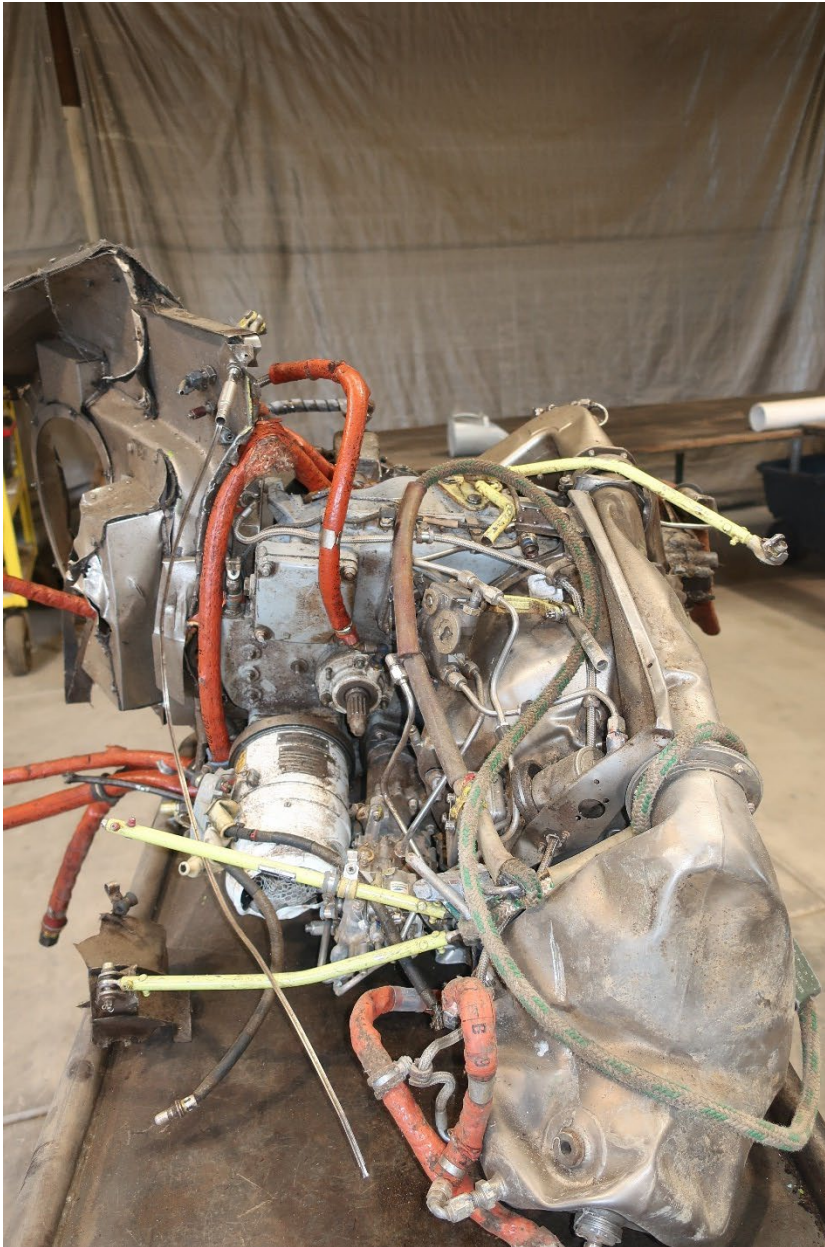
Photo 8 - View of Engine (NTSB)

All lines were tight and secure but deformed from impact damage  
The throttle input rotated freely

Power turbine drive body and main body had impact damage and was fractured. The input shaft turns freely.

Initially the N1 and N2 did not turn (side of xxx was impact damaged), when it was separated, they rotated freely. Fuel nozzle was not removed due to deformation of the cannister.

Starter impact damage, there was rotational damage; however, the drive shaft was intact.

The oil system was compromised due to impact damage

N1 shaft broken, also consistent with impact forces.
