# Vaca-Vacaville-Jameson-North-Tower 115kv Wire Strike Analysis

6/22/2020

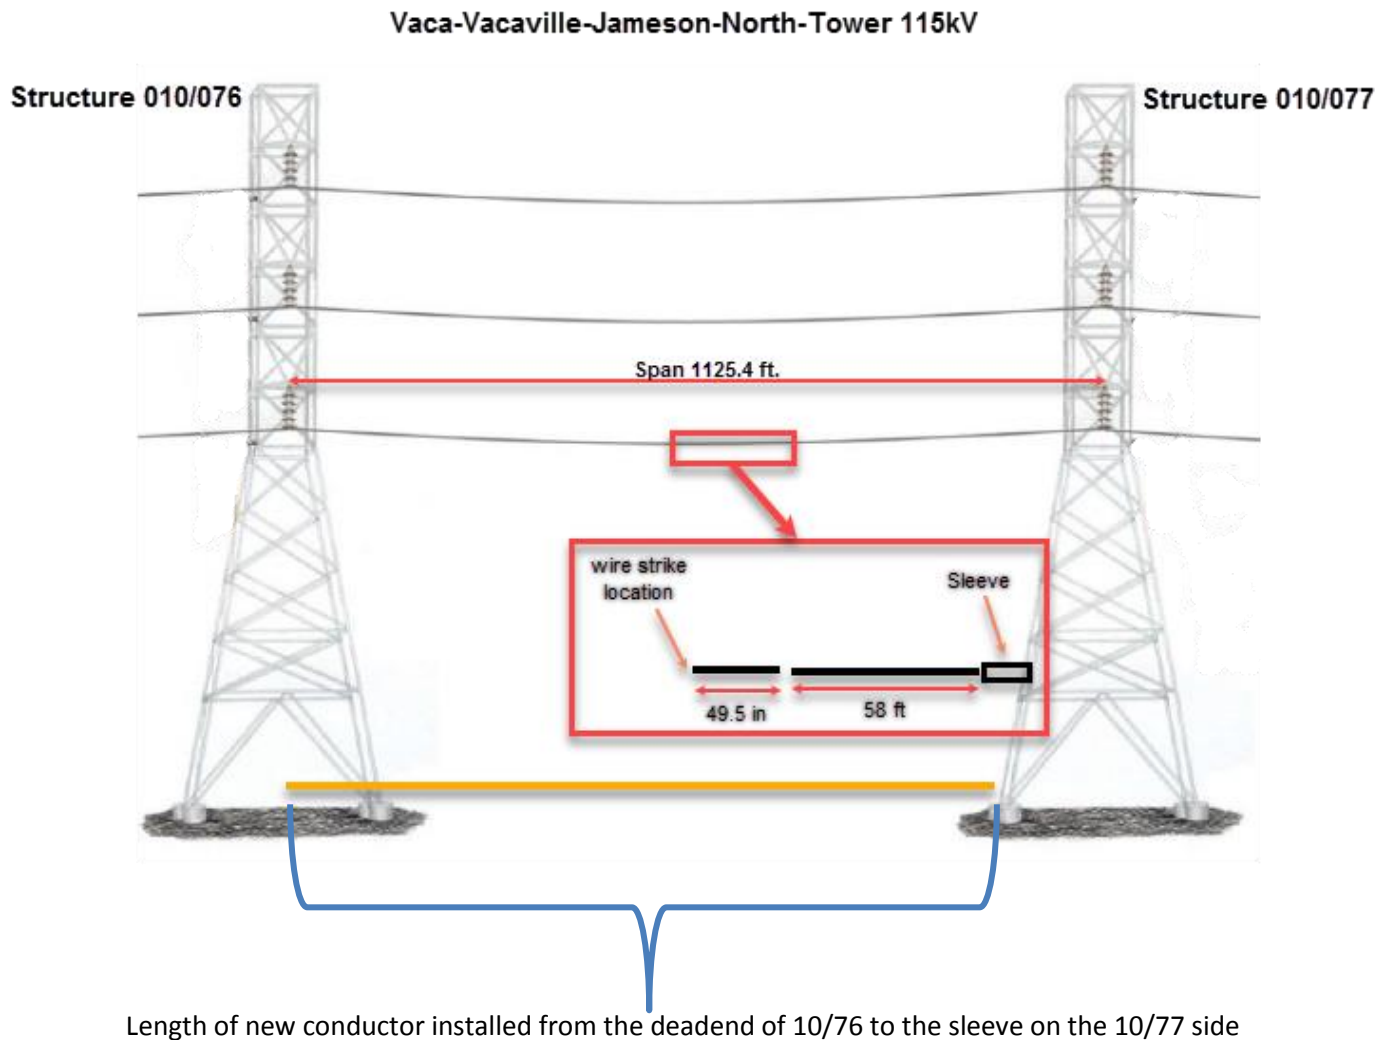
The sketch below was created to support the additional analysis to determine the location of the conductor separation from field measurements and engineering modeling. Both ends of the damaged conductor were measured after being cut from each end of the downed conductor. Additional measurements were made from this cut to the next cut where the new conductor would be spliced to the remaining conductor.

Only the dimensions of the cuts on the side of structure 010/077 were required as a field decision was made during the repair to replace the entire length from structure 010/076 to ensure that only a single splice would be in that span.
