# NATIONAL TRANSPORTATION SAFETY BOARD

## MATERIALS LABORATORY FACTUAL REPORT

Report No. 20-045

Place : Glendale, Arizona  
Date : June 2, 2020  
Vehicle : OMF Aircraft OMF-100-160, N225CK  
NTSB No. : WPR20LA165  
Investigator : Stephen Stein, AS-WPR

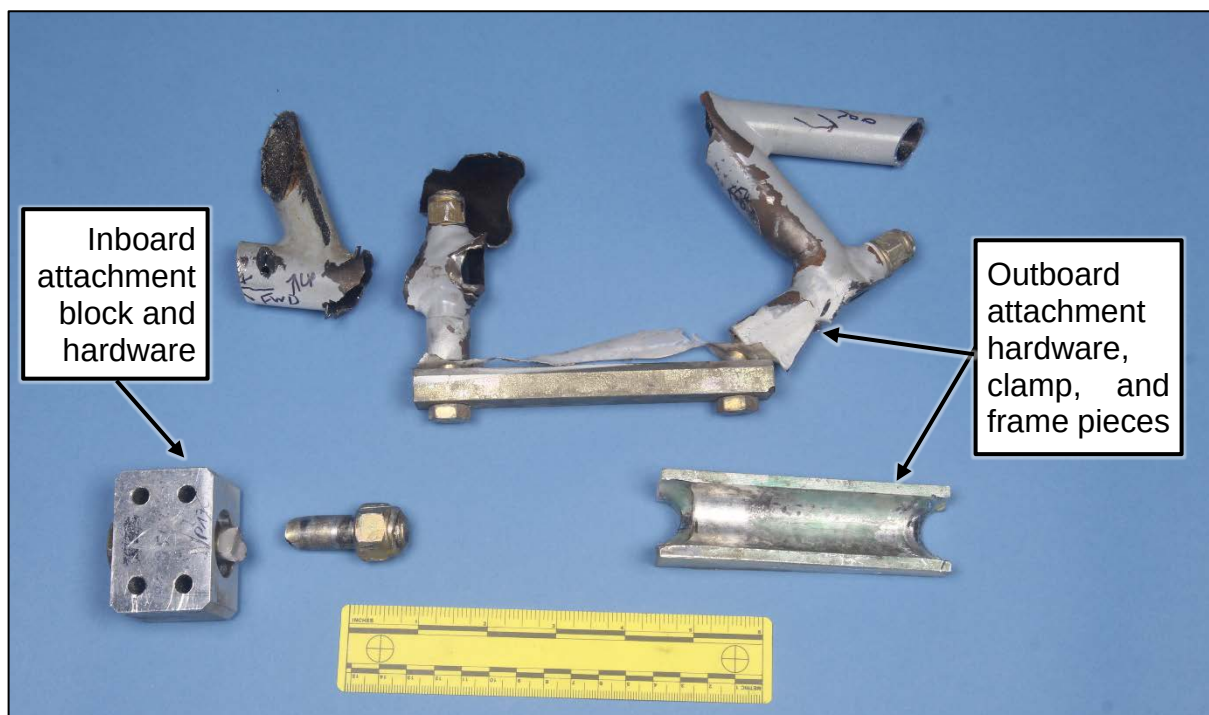
A photograph of the submitted right main landing gear (RMLG) attachment hardware, clamp, block, and frame pieces is shown in figure 1. The submitted components included the inboard attachment block with a fractured attachment bolt with nut attached to the lower bolt piece and the outboard attachment clamp and hardware with associated tube structure pieces that had been cut from the remainder of the fuselage frame. The longitudinal frame tube was fractured both forward and aft of the forward attachment bolt, and the aft attachment bolt was bent aft.

Figure 1. Overall view of the submitted RMLG attachment hardware, clamp, block, and fuselage frame pieces.

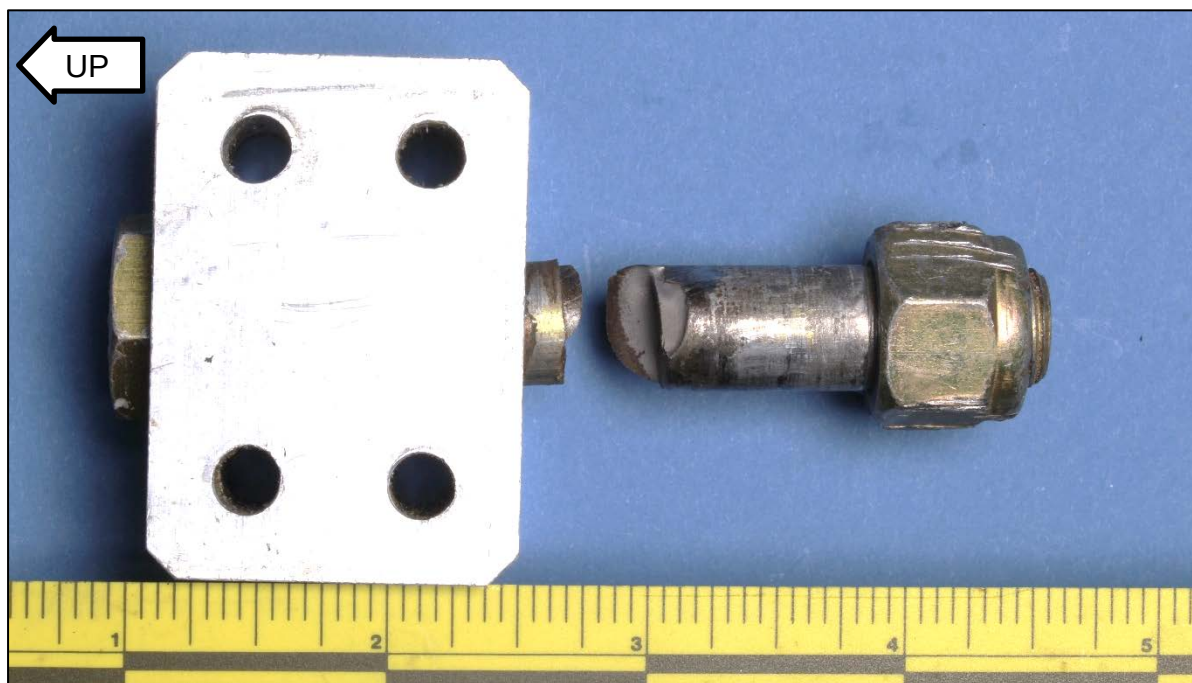
An overall view of the submitted RMLG inboard attachment components is shown in figure 2. The bolt was fractured in the grip near the lower side of the attachment block, and a view of the fracture surface on the upper piece is shown in figure 3. Portions of the fracture were in a plane perpendicular to the longitudinal axis and had curving crack arrest lines, features consistent with fatigue. Two fatigue regions were observed, and dashed lines in figure 3 indicate fatigue boundaries. The fatigue regions had relatively broad origin areas at locations indicated with unlabeled brackets in figure 3. The smaller fatigue region had an undulating boundary shape consistent with multiple fatigue origins, and ratchet marks were observed in the origin area associated with the larger fatigue region, also consistent with multiple fatigue origins. Relatively rough fatigue features were observed across most of the fatigue regions, and the fatigue regions extended across less than a quarter of the cross-sectional area, features consistent with fatigue with relatively high peak stresses.

Figure 2. RMLG inboard attachment bolt, nut, and block.

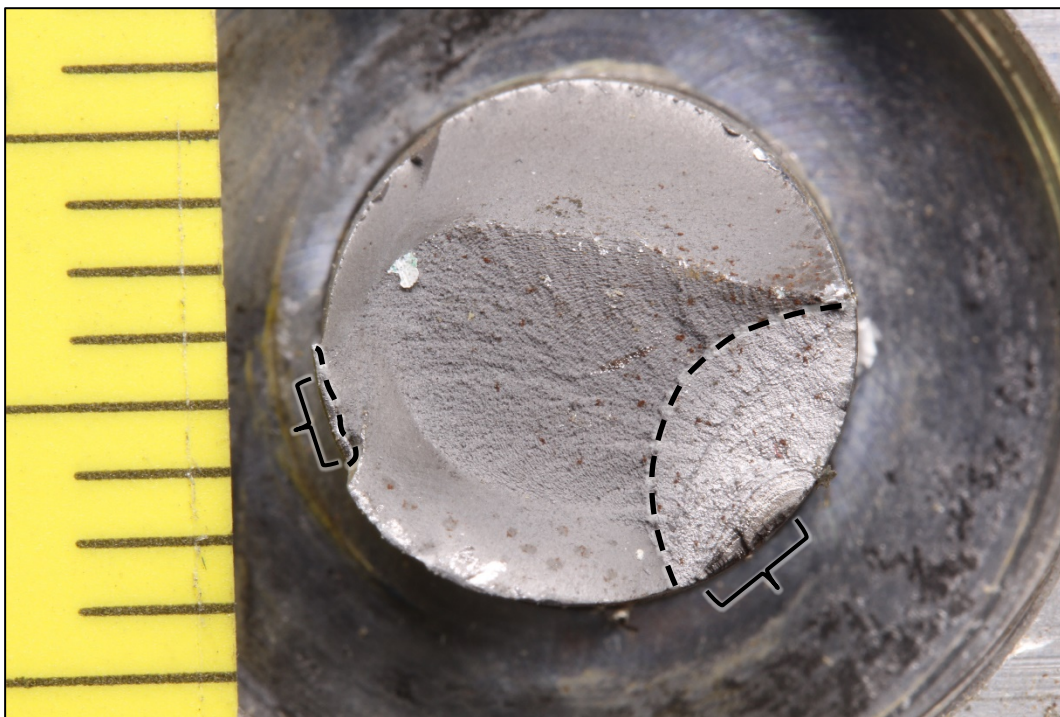
Figure 3. Upper fracture face on the RMLG inboard attachment bolt. Dashed lines indicate fatigue boundaries, and unlabeled brackets indicate fatigue origin areas.

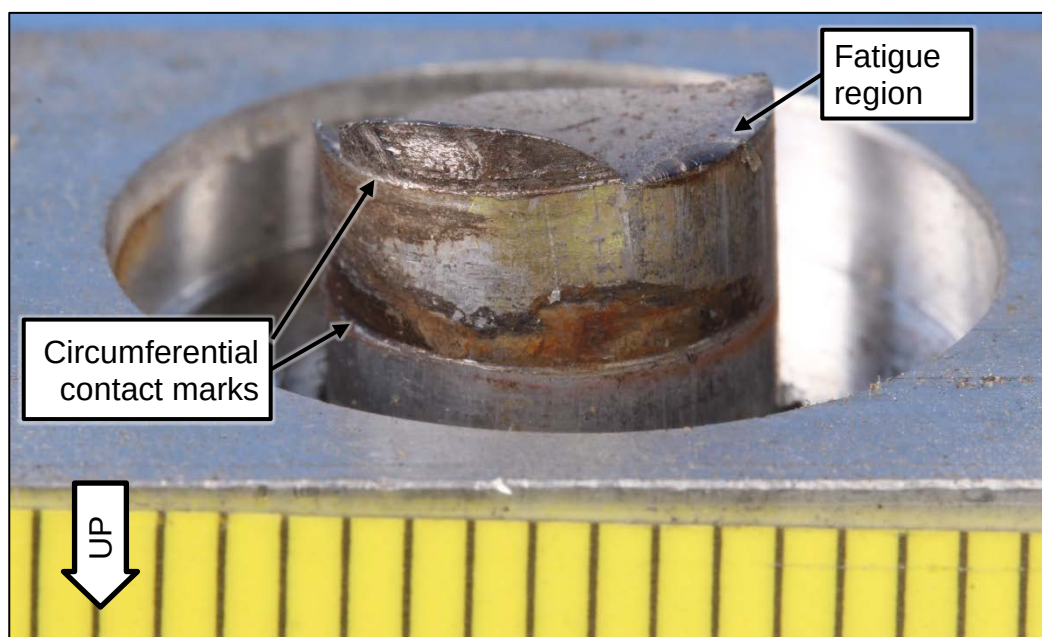
The RMLG inboard attachment bolt grip was rubbed and showed circumferential contact marks as indicated in figures 4 and 5. Fatigue origins for both regions corresponded to the lower circumferential contact mark on the grip.

Figure 4. Close view of the grip adjacent to the upper fracture face on the RMLG inboard attachment bolt upper piece.

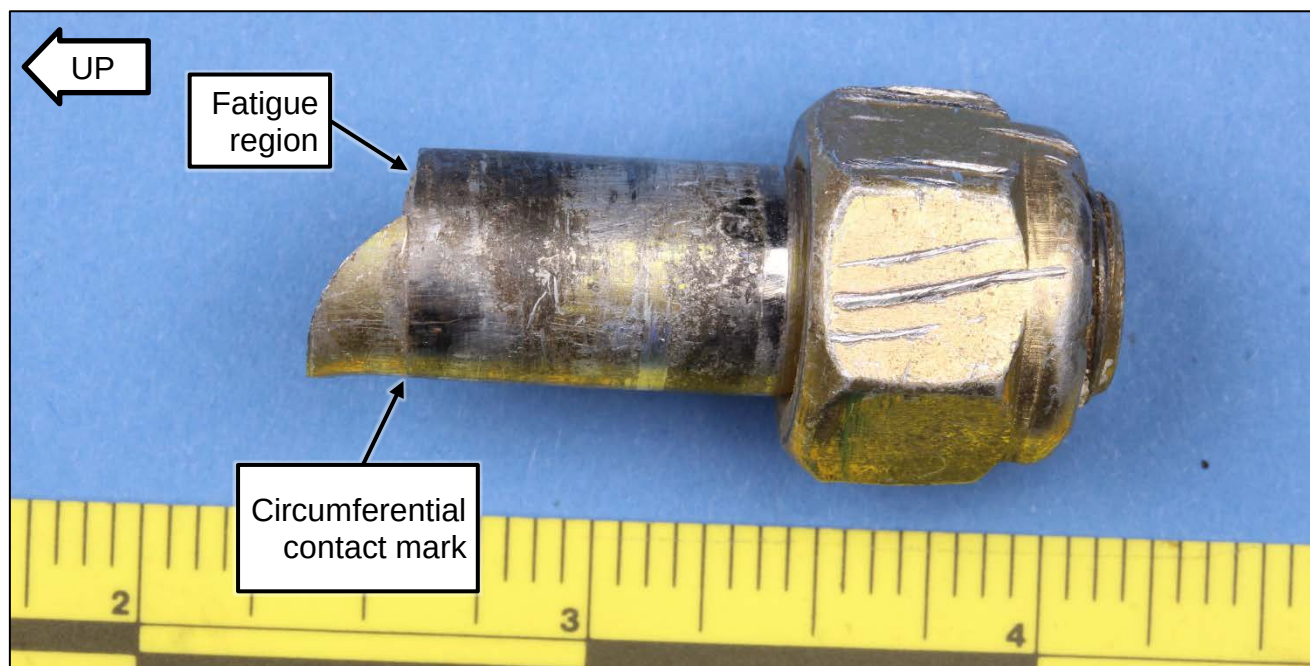
The nut on the lower end of the RMLG attachment bolt did not move when attempted to rotate by hand. The grip of the lower piece was placed in a vice with a rubber-coated clamping surface, and torque was applied in the clockwise (tightening) direction. The peak breaking force was 4.3 pound feet. Continuing with the test, the nut was rotated approximately 60 degrees clockwise. The tare torque value was not recorded, but was lower than the peak breaking force. The nut still did not rotate by hand after the torque test was completed.

Figure 5. Side view of the lower piece of the RMLG inboard attachment bolt with attached nut.

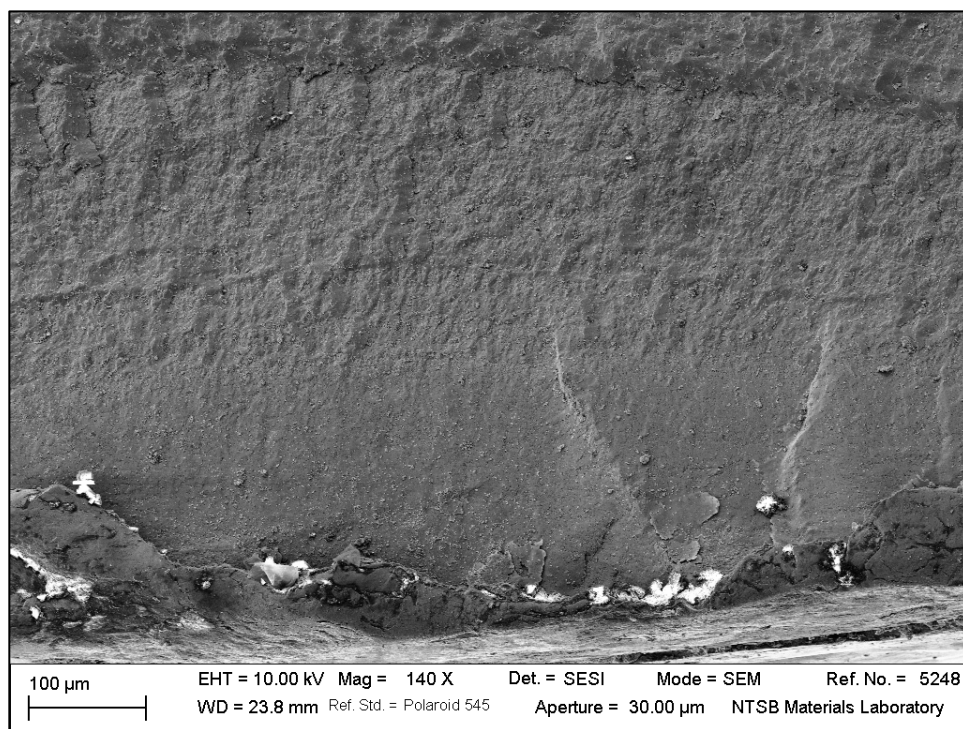
The fracture face on the lower piece of the RMLG inboard attachment bolt was examined using a scanning electron microscope (SEM). An SEM image of the origin area is shown in figure 6 showing relatively smooth fatigue features within approximately 150 micrometers of the surface that transition to rougher features further from the surface. An SEM image of fatigue features near the fatigue boundary is shown in figure 7 showing relatively rough fatigue features and secondary cracks consistent with high peak stresses. Figure 8 shows dimple features consistent with ductile overstress fracture at the center of the bolt.

Figure 6. SEM image of the lower face of the inboard attachment bolt fracture showing the fatigue origin area of the larger fatigue region.

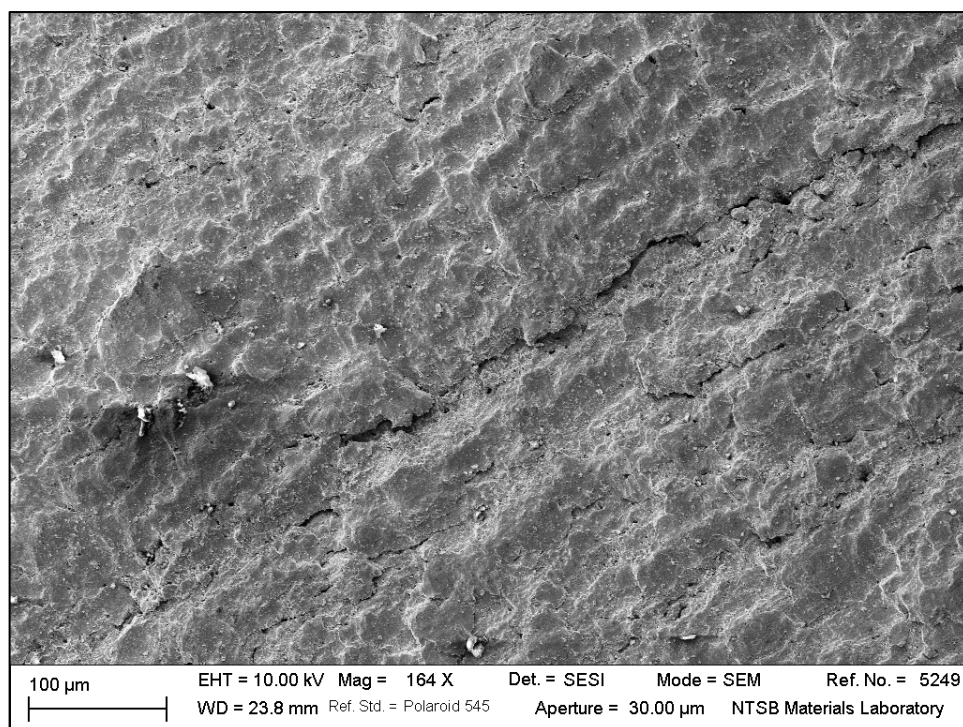
Figure 7. SEM image of the lower face of the inboard attachment bolt fracture showing fatigue fracture features near the boundary of the larger fatigue region.

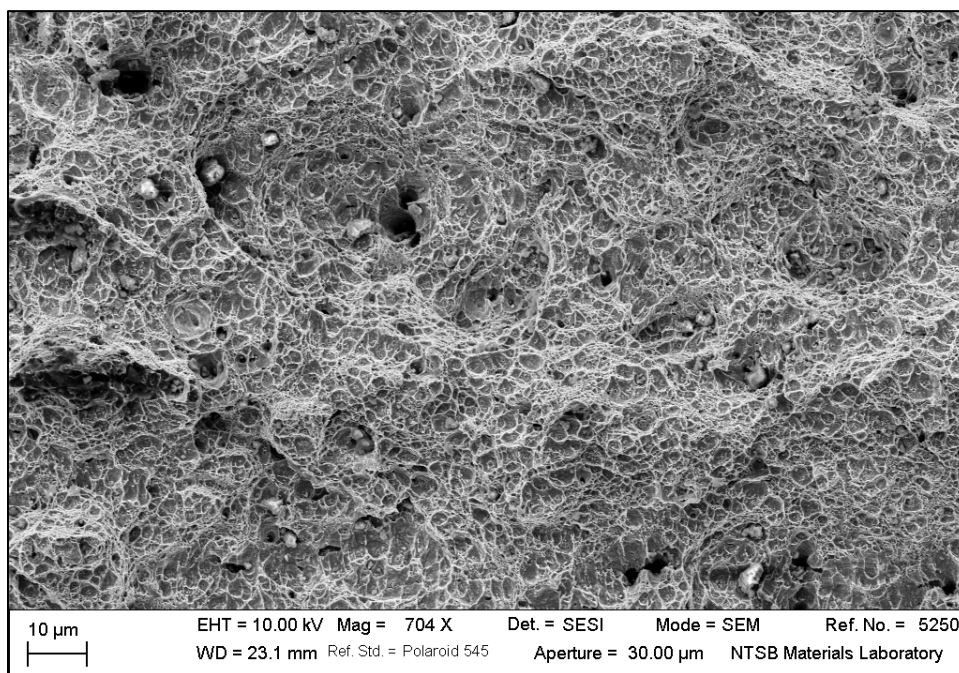
Figure 8. SEM image of the lower face of the inboard attachment bolt fracture showing dimple features near the center of the bolt.

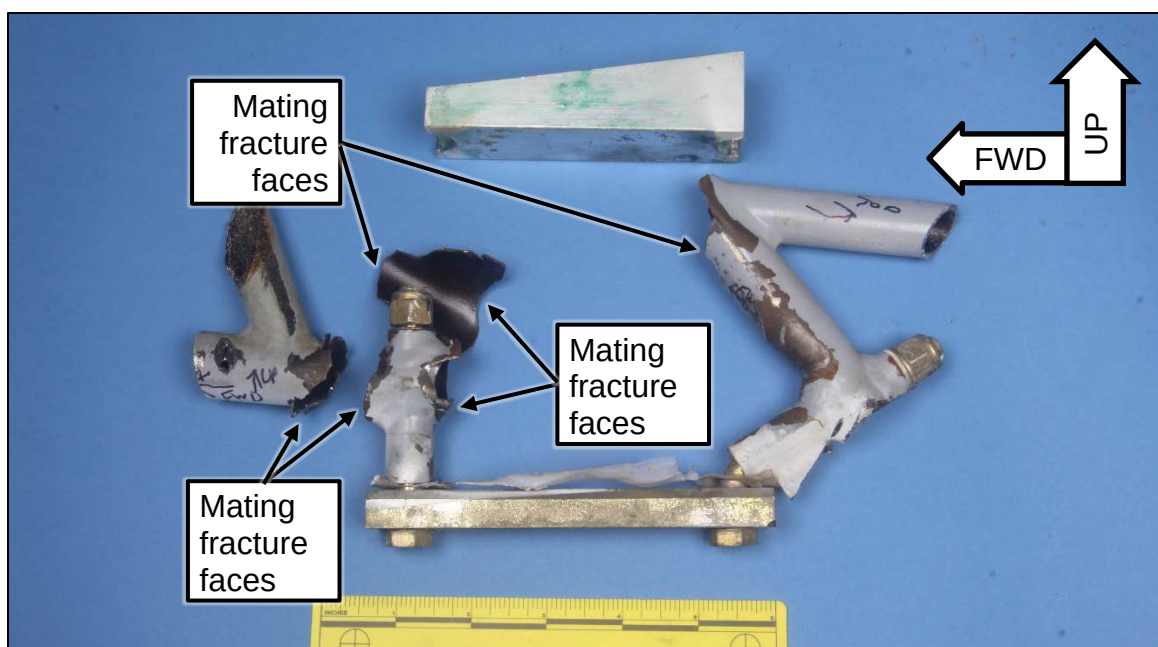
An overall view submitted components from the RMLG outboard attachment area is shown in figure 9. As assembled on the airplane, the landing gear is sandwiched between a trapezoid-shaped upper clamp and a flat-plate lower clamp at the outboard attachment. The lower clamp is attached with bolts extending through vertical frame tubes forward and aft of the landing gear strut. The upper clamp has a groove on the upper face where it contacts the longitudinal frame tube when the landing gear is clamped in place by the two outboard attachment bolts.

The longitudinal frame tube was fractured in several locations, and mating fracture faces associated with the longitudinal tube are indicated in figure 9. The aft attachment bolt was bent aft, and the attached fuselage frame pieces were rotated upward and aft.

Figure 9. Overall view of the RMLG outboard attachment area. Mating fracture surfaces in the longitudinal frame tube are identified.

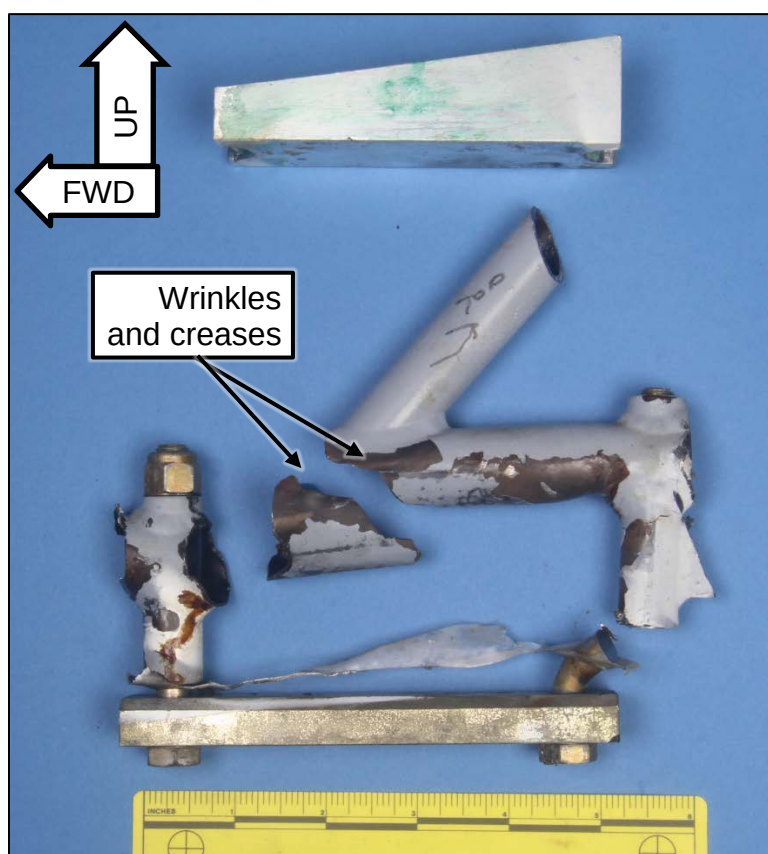
However, evidence of deformation to the longitudinal tube associated with contact with the upper clamp before the tube fractured was observed. As noted in figure 10, the upper tube was wrinkled and creased on both sides of the aft fracture through the longitudinal tube, and the location of the wrinkles and crease corresponded to contact with the upper side of the upper clamp. At the aft attachment tube, the lower surface of the longitudinal tube was bowed upward as shown in figure 11. The lower portion of the longitudinal tube had a more reflective appearance, appearing burnished relative to the surrounding surfaces. On the aft post, two impressions of the lower aft corner of the upper clamp were observed on the inboard side of the post. One impression was surrounded by white paint consistent with the as-assembled position, and another impression was observed above the original impression consistent with the lower aft corner of the upper clamp displaced upward and rotated counterclockwise (as viewed looking outboard) relative to the as-assembled position against the aft post.

Figure 10. View of the RMLG outboard attachment area with fractures in the longitudinal frame tube placed in close proximity after cutting the aft attachment bolt.

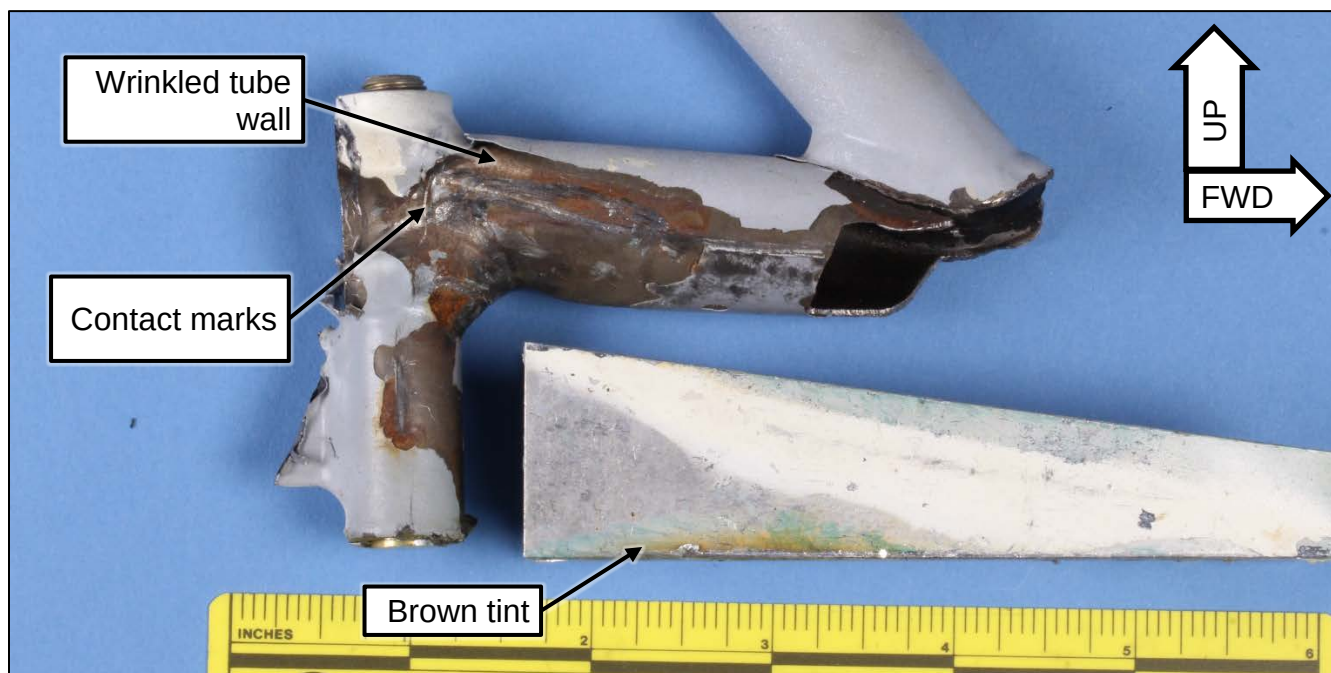
The outboard side of the aft frame piece and upper clamp are shown in figure 13. Contact marks were observed on the outboard side of the longitudinal tube corresponding to contact with the upper and aft edges of the upper clamp with the clamp displaced upward and rotated clockwise (as viewed looking inboard) relative to the as-installed position. The longitudinal tube wall was wrinkled just above the contact marks as indicated in figure 13.

Figure 12. Outboard side of the sectioned frame piece and upper clamp. A wrinkle in the tube wall and marks consistent with contact with the upper corner of the displaced upper clamp are indicated. An area of brown tint is shown on the upper clamp.

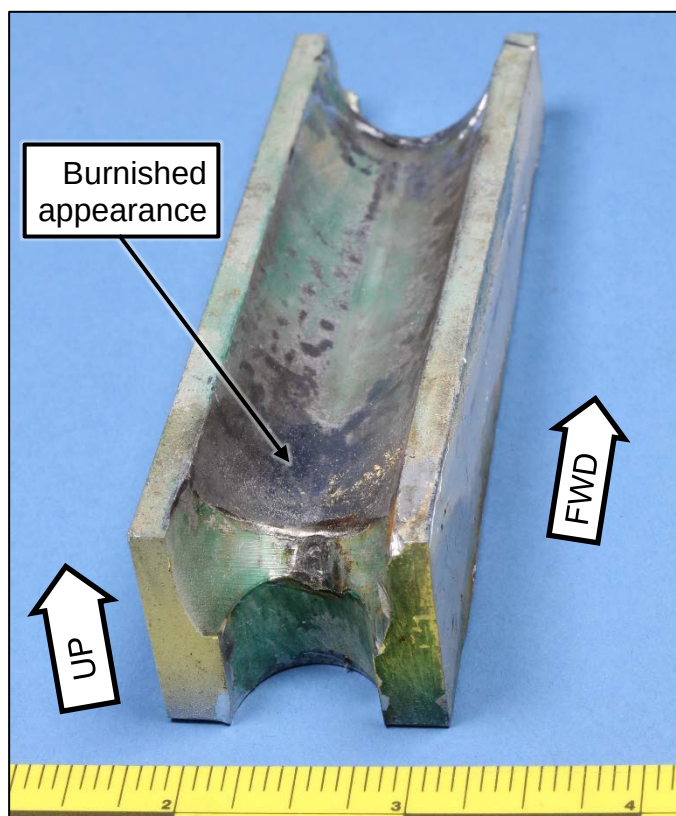
An oblique view of the upper clamp is shown in figure 14. Contact marks corresponding to contact with welds between the longitudinal tube and the vertical attach bolt tubes were observed at each end of the upper side of the clamp. On the contact face with the longitudinal tube, paint was missing from the forward and aft ends, and an area at the aft end of the contact face was relatively reflective, having a burnished appearance.

Figure 13. Oblique view of the upper aft side of the upper clamp showing an area with a burnished appearance near the aft end of the frame contact surface.

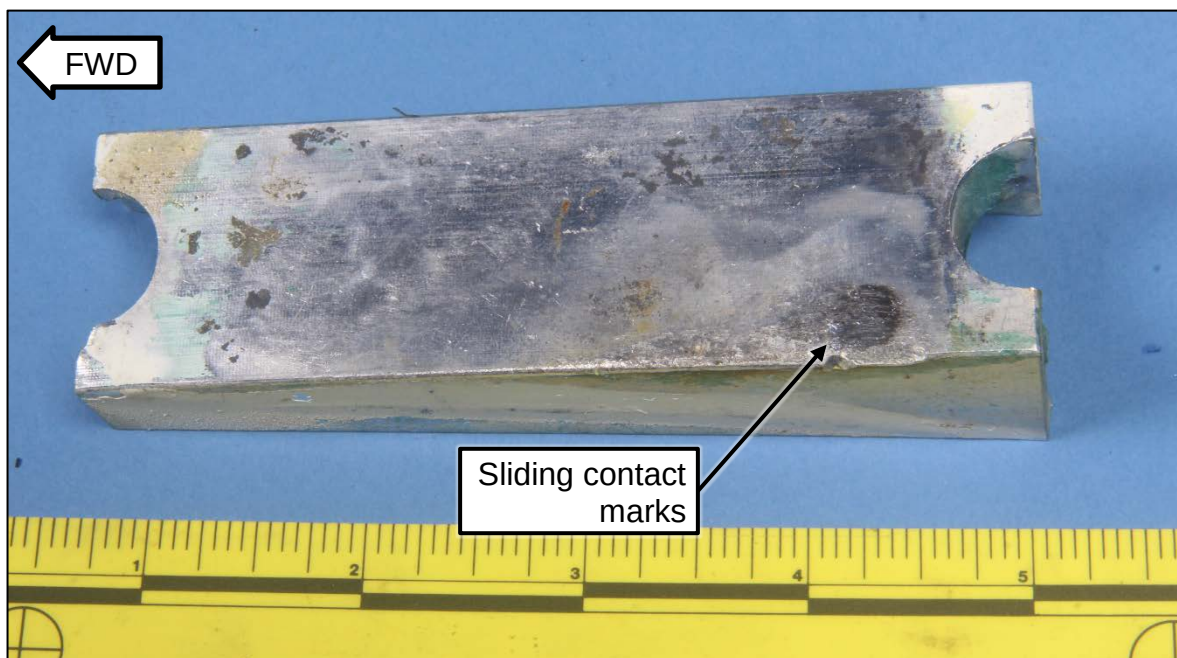
The lower face of the upper clamp is shown in figure 15. Sliding contact marks corresponding to movement with the mating landing gear strut was observed near the aft outboard side as shown. The sliding contact marks were also associated with an area of dark-colored oxidation. The outboard surface adjacent to the area with sliding contact marks had a brown tint as indicated in figure 13.

Figure 14. View of the underside of the upper clamp showing an area of sliding contact marks that was discolored dark near the outboard edge of the lower surface.

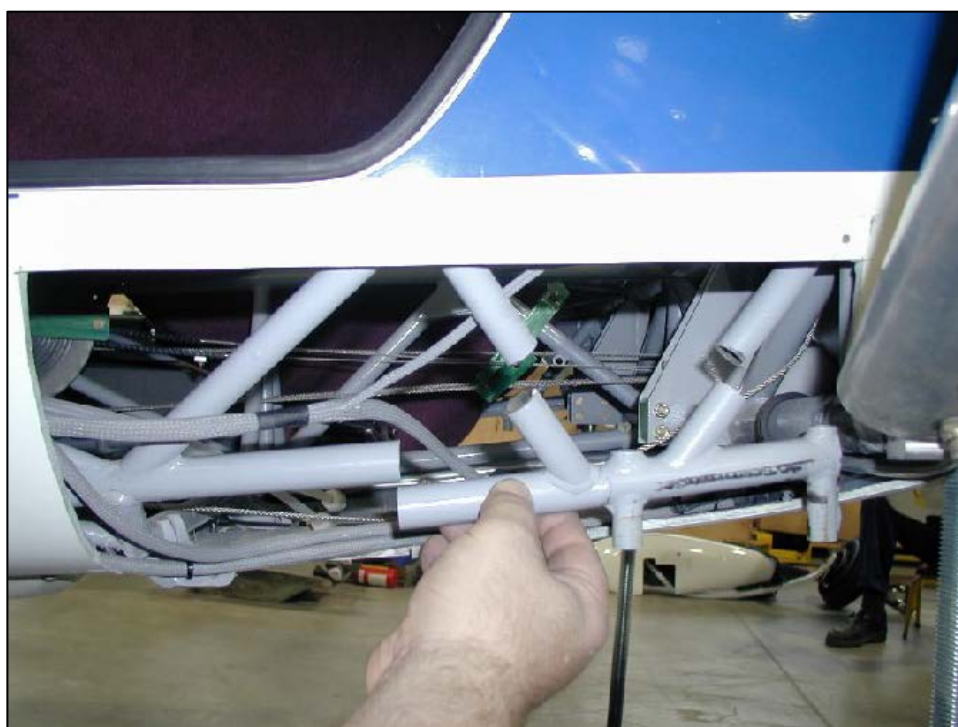
Figure 15. Image from OMF Process Specification PS-OMF 100-0006 showing the frame piece cut from the left side of the fuselage of an exemplar airplane being repaired.

OMF Aircraft Process Specification PS-OMF 100-0006, dated October 1, 2003, provides instructions for repair of the frame tubes supporting the main landing gear leg. In the repair, the longitudinal piece above the main landing gear leg is cut from the frame as shown on an exemplar airplane in figure 15, and replacement pieces are welded into its place as shown in figure 16.

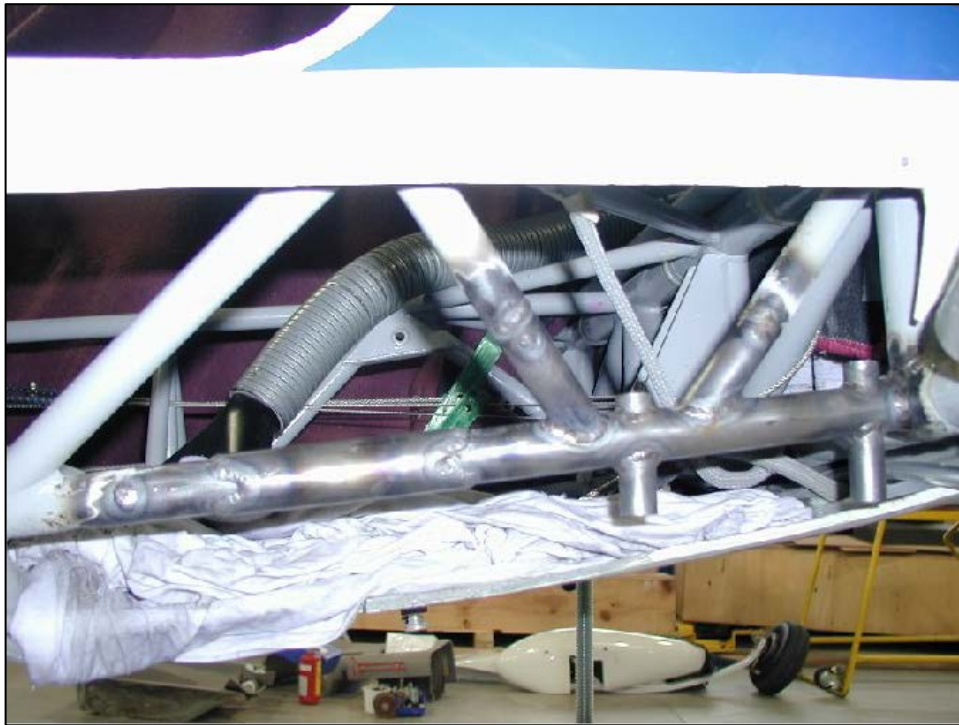
Figure 16. Image from OMF Process Specification PS-OMF 100-0006 showing the frame repair on the left side of the exemplar airplane after the replacement pieces are welded into place.
