OMF 100-160

## ALERT SERVICE BULLETIN

Alert Service Bulletin No.: 1107/ 0002

SUBJECT: Cage, outside tube supporting main landing gear leg.

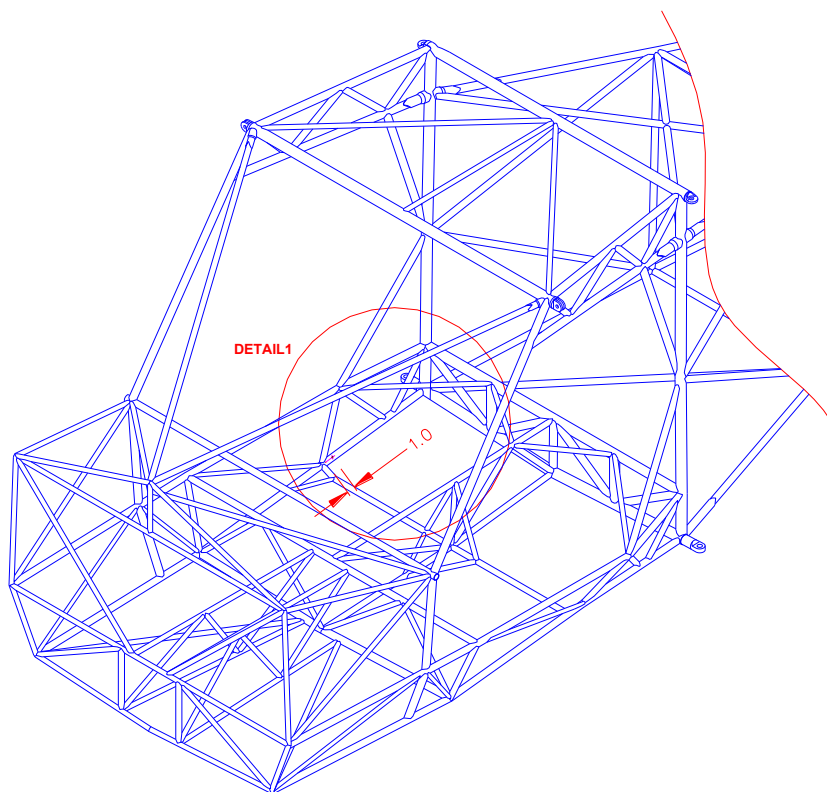
Locate hole as shown in Detail1 of pictures.

DRILL HOLE IN SIDE  
 $\phi.127''$

- Remove RH seat
- Drill hole in the tube as shown in enclosed picture
- Measure wall thickness (required dimensions: 0.058 inch)
- Close the hole with a blind rivet, specification: CR 3213-4-2 (cherrymax rivet)
- Install RH seat

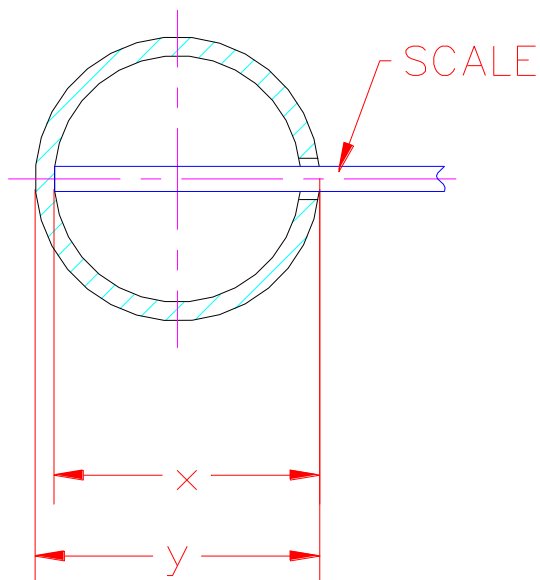
**Measure of Wall Thickness**  
 **$Y-X=.058''$**

**NOTE: Cracks or deformations can also be indications of a hard landing.  
(see MM chapter 05-50-00)**

Should a tube be found with a lower wall thickness, the tube will have to be reinforced in accordance with OMF repair instructions.  
Please contact OMF for repair instructions.
